NATIONAL GUARD REGION SOUTH
INDUSTRIAL HYGIENE OFFICE
510 PLAZA DRIVE, SUITE 1530
COLLEGE PARK, GA 30349

SUBJECT: Industrial Hygiene Baseline Survey of the Ada Armory.

LAE CONSULTING

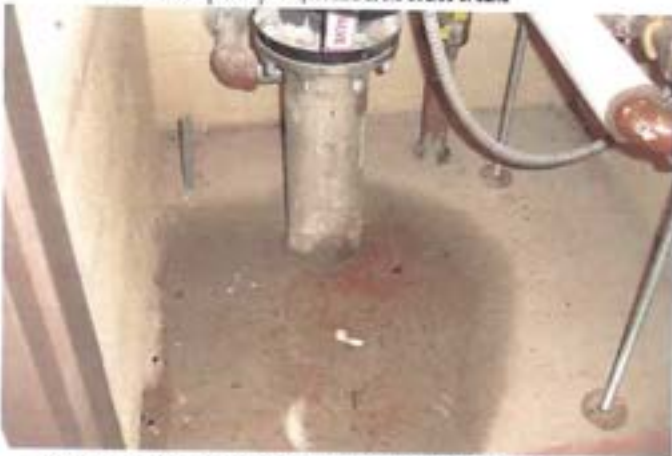
f. Water was noticed on the floor around a pipe of the fire suppression system. The area is located inside the fire suppression closet in the locker room. Water stains were noticed on the acoustic ceiling near entrance to the locker room. The construction contractor stated that the ceiling was installed during the renovation and not part of the original indoor firing range.

View of possible water leak on the floor in the fire suppression room

f. Contact the state Facility Engineers inspect and repair the source of the water leak. Monitor the ceiling tiles for water stains which maybe indicative to water intrusions from the roof. (RAC 4)

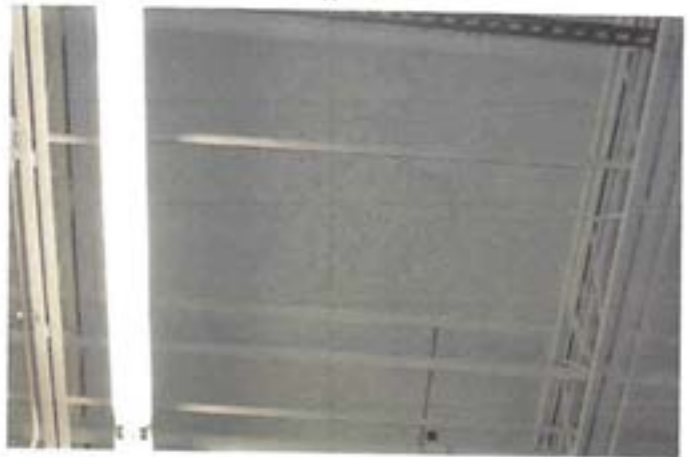
View of water stain on the acoustic ceiling tile in the locker room

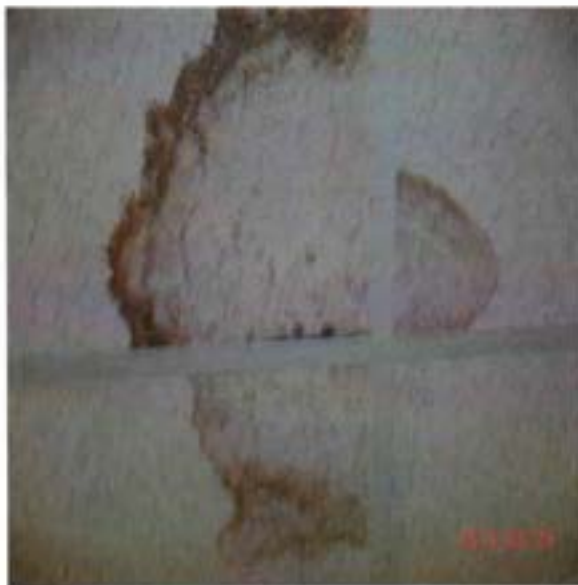
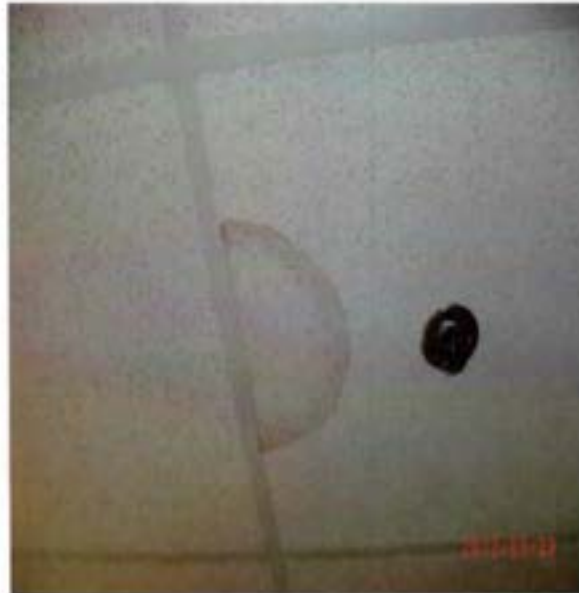
- a. There were a few ceiling tiles that appeared damaged and stained.

- Determine where leaks are coming from, either from the roof, AC duct work or overhead piping. Then replace broken and stained ceiling tiles. Clean all vents annually or as needed. RAC 3
- Numerous areas tested for lead levels came up above the reporting limit for the lab but not over the ARNG standard of 200ug. All areas that showed levels above the 20ug. Can be cleaned and by using normal floor detergent and water. No health risk is present at this time. RAC 4

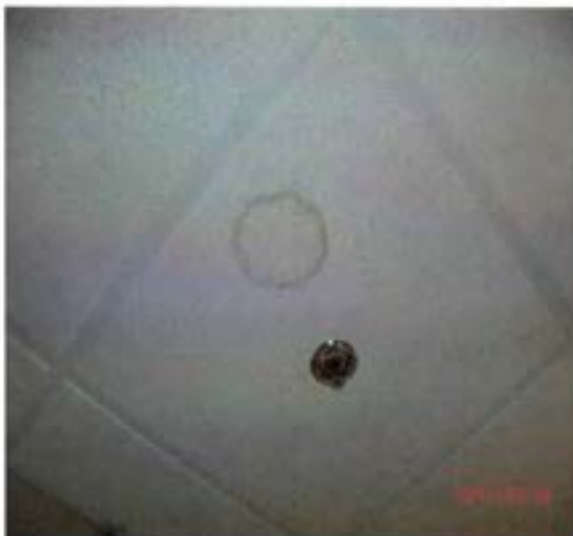
- a. All ceiling tiles looked in new condition at the time of the survey, except for one.

- Recommendation: Evaluate tile of the next few months and if stain increases in size, find the cause of the leak and replace the tile **RAC 3**
- Recommendation: For levels not meeting the illumination standard. Lights that are out or broken should be fixed. In other areas supplemental lighting could be used. **RAC 3**

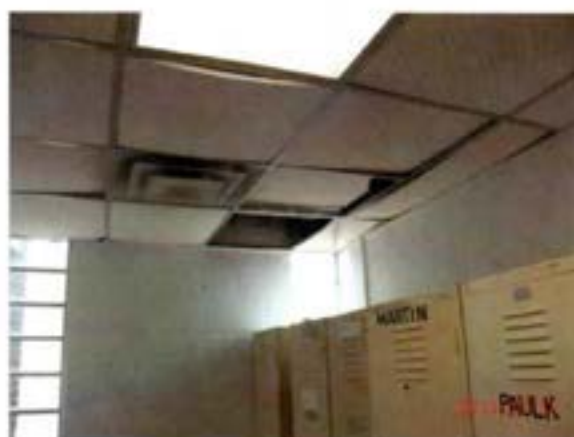
- a. Numerous ceiling tiles appeared damaged and stained.

- Determine where leaks are coming from, either from the roof, AC duct work or overhead piping. Then replace broken and stained ceiling tiles. Clean all vents annually or as needed. RAC 3
- For levels not meeting the illumination standard. Lights that are out or broken should be fixed. In other areas supplemental lighting could be used. RAC 3
- Housekeeping needs to be addressed. The status of cleanliness for the platoon rooms, the locker room and some offices are perfect breeding grounds for insects and rodents. RAC 3
- Numerous areas tested for lead levels came up above the reporting limit for the lab but not over the ARNG standard of 200ug. All areas that showed levels above the 20ug. Can be cleaned and by using normal floor detergent and water. No health risk is present at this time. RAC 4
- Replace missing shower drain covers to prevent injury to personnel. RAC 4

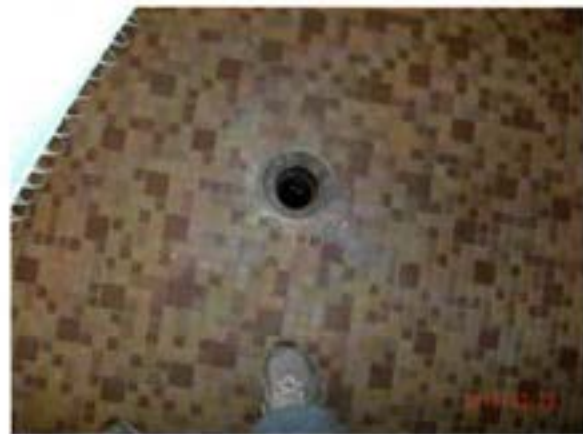
Drain cover missing/Could be a hazard

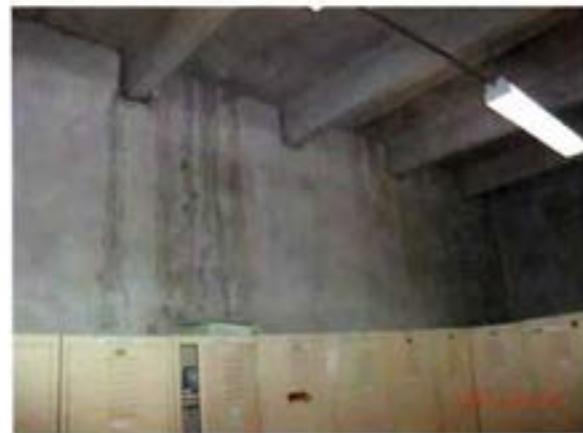
Basement/leak along wall

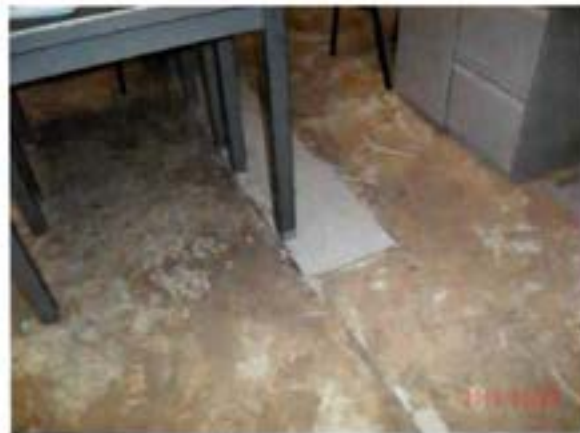
Tiles taken up/never replaced

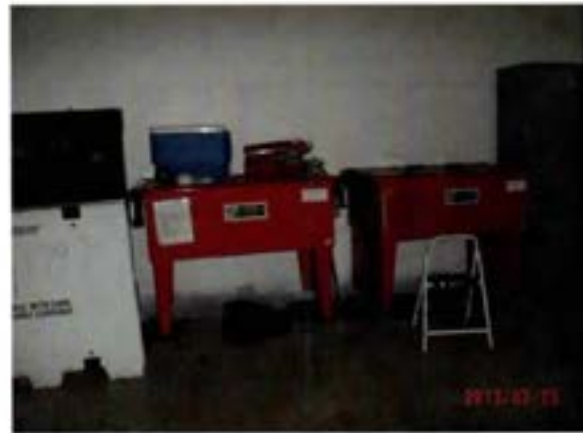
Eyewash station/appeared to be out of order/no tag

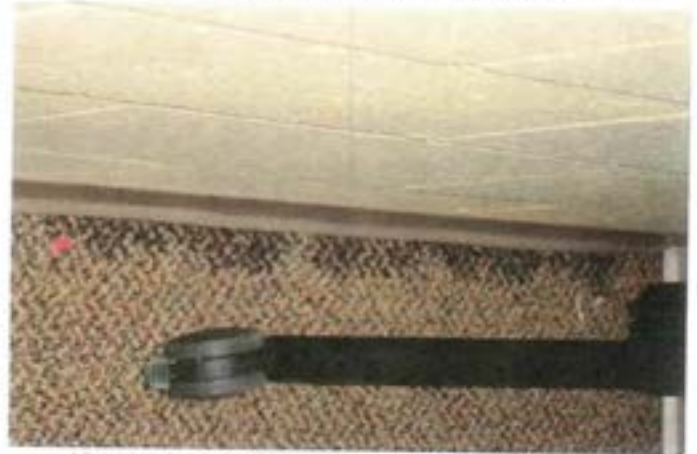
View of water infiltration (wet carpet) onto carpet in the main classroom water is from the shower located along the opposite wall

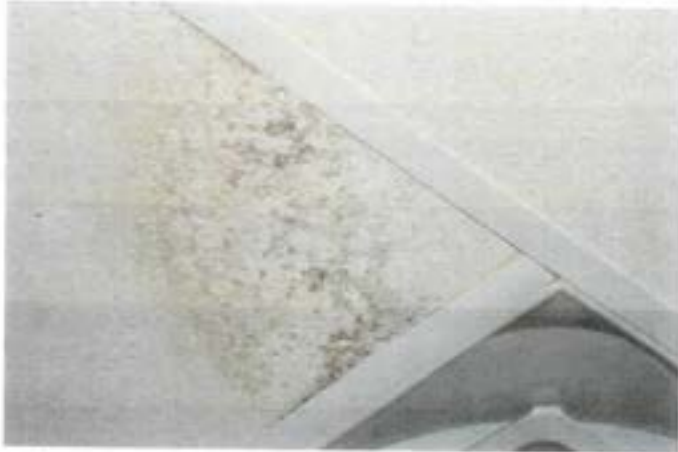
Mold and water stained ceiling tiles located in the main conference room

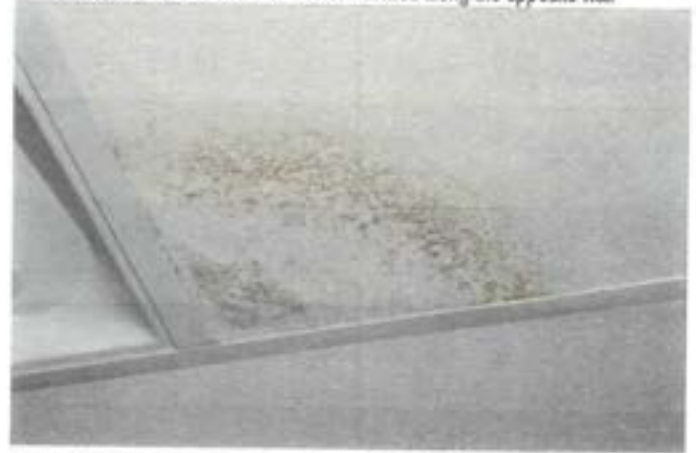
Mold and water stained ceiling tiles located in the main conference room

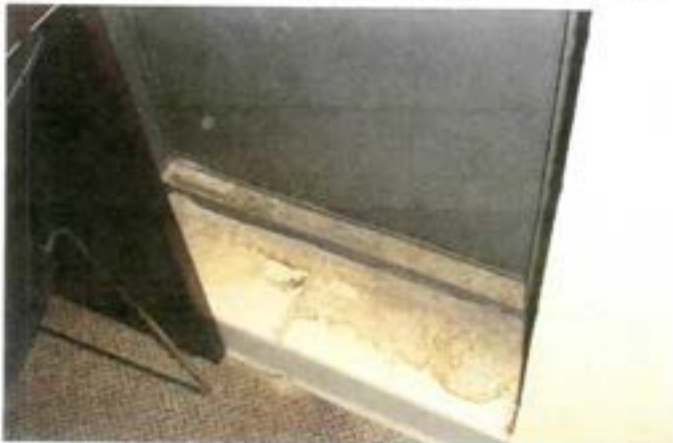
View of water infiltration under the sill in the office.

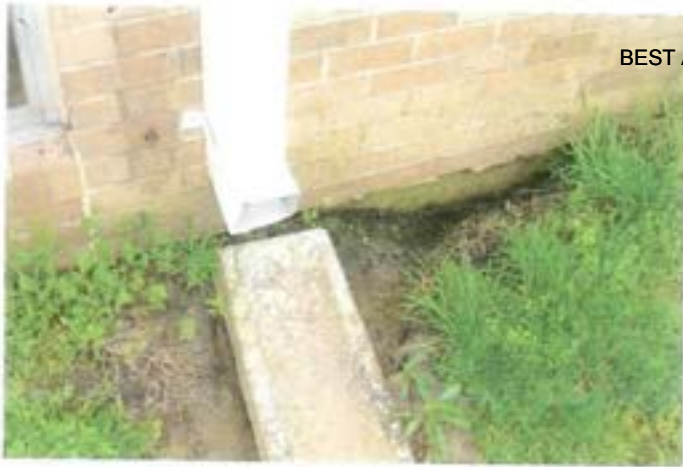
View of soil erosion at the buildings foundation

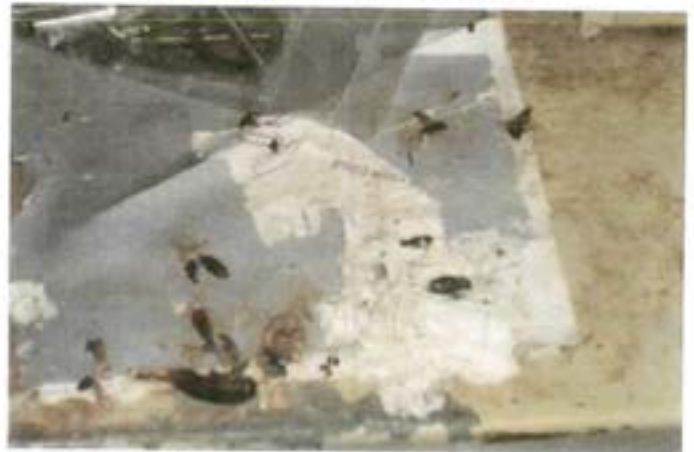
View of rodent droppings on air conditioning unit in HVAC room

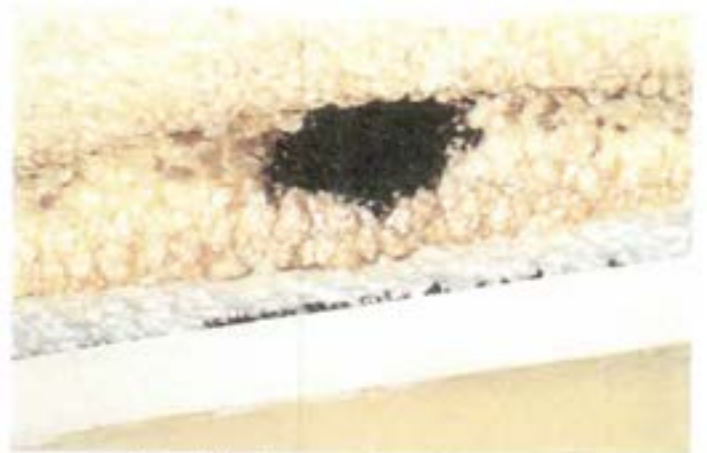
View of black substance (possible product from burning) located on the styrofoam ceiling tile in an office

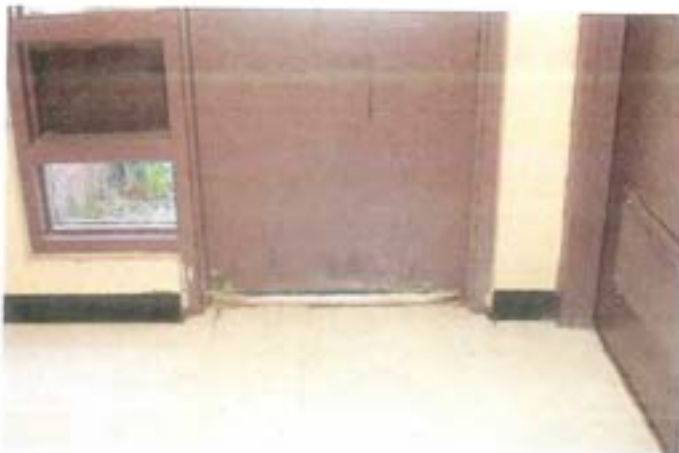
View of vegetation growing under door into the Armory

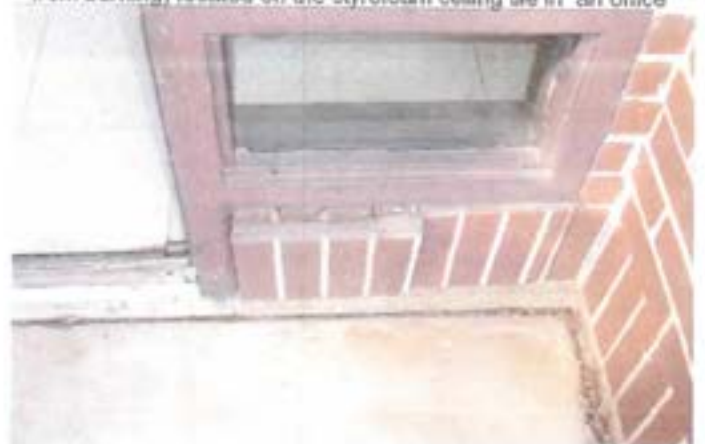
View of loose brick at entrance under window

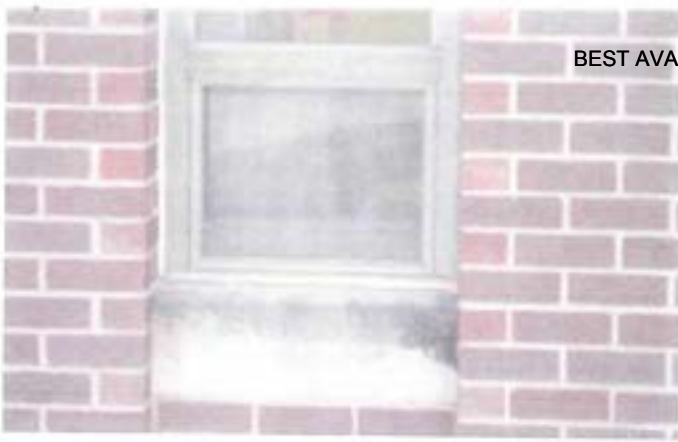
View of mold growth around concrete under window

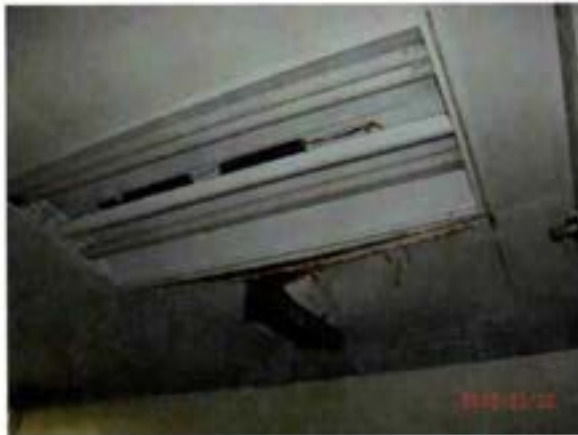
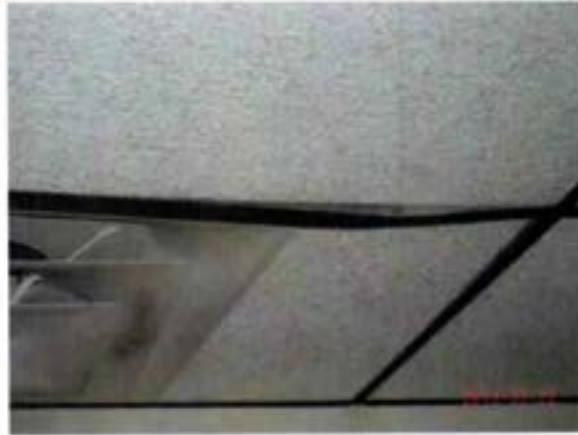
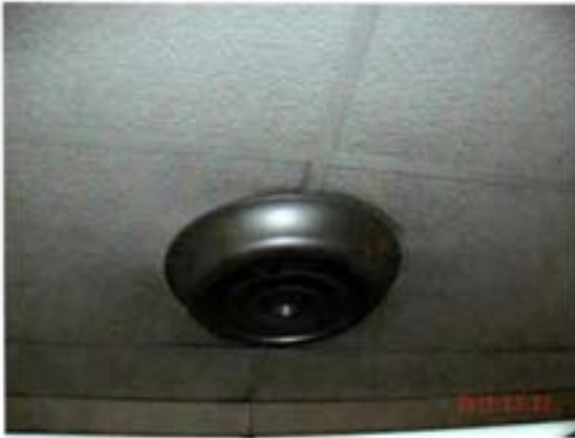
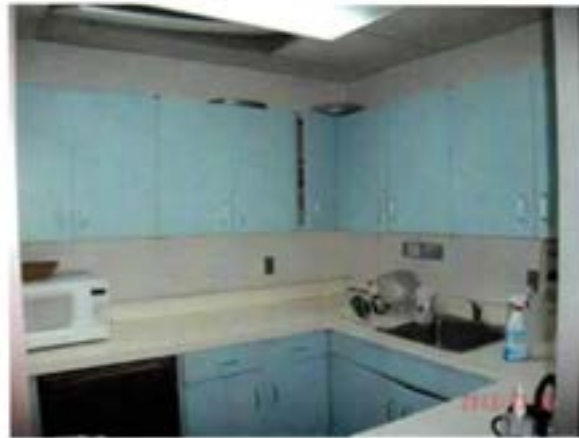
- a. Numerous ceiling tiles appeared damaged and stained. Frames bent or broken

Ceiling tiles damaged and stained

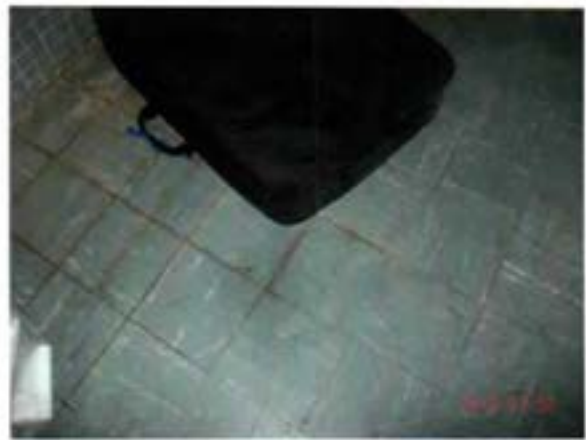
Water leaking from ceiling onto floor

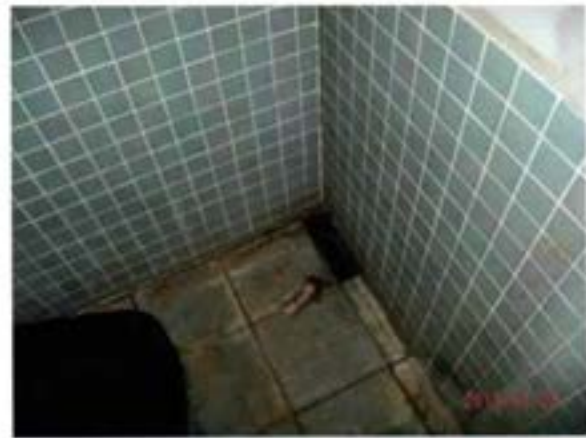
Water leaking from ceiling onto floor

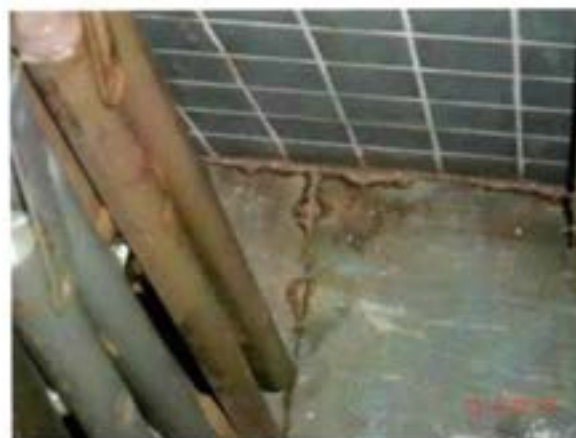
Water damaged floor in kitchen

- Housekeeping needs to be addressed. The units were in the process of obtaining new lockers and storage cabinets. RAC 4
- The kitchen needs to be addressed from the leaking roof, broken floor and wall tiles and mildew building up on the walls. RAC 3

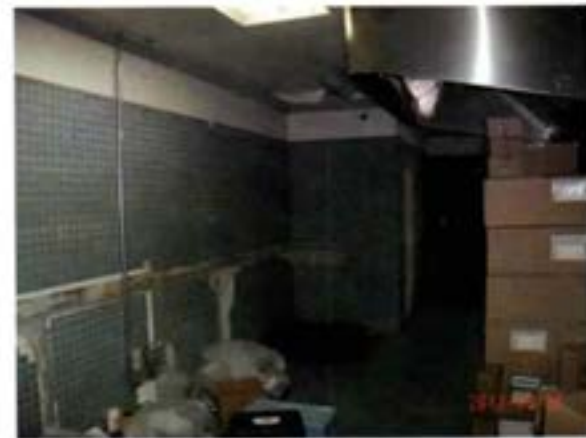
POC states kitchen to be gutted

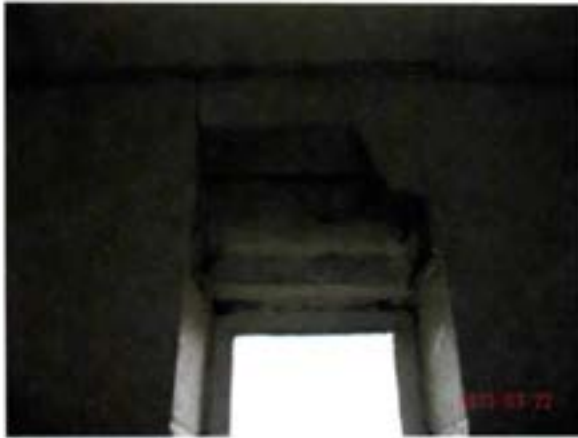
Broken cinder block above office window

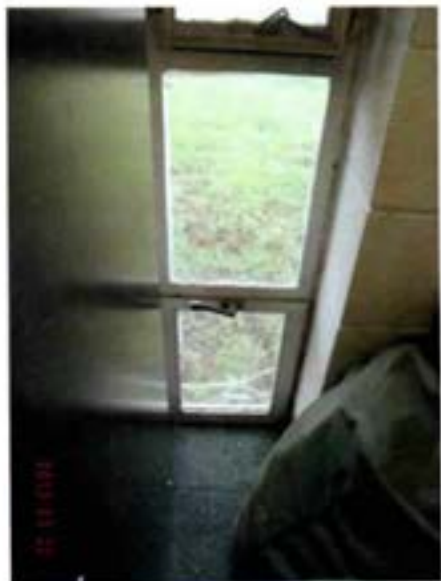
Broken window

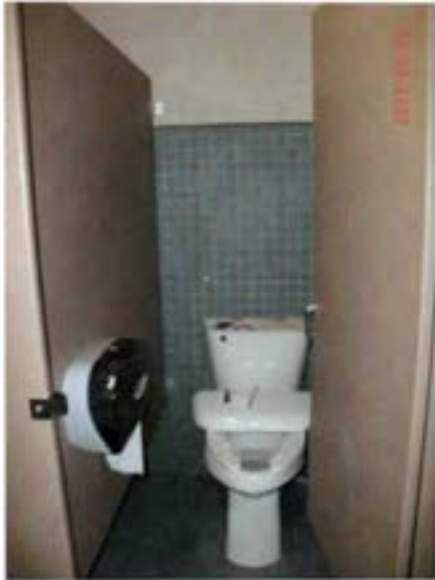
Broken latrine

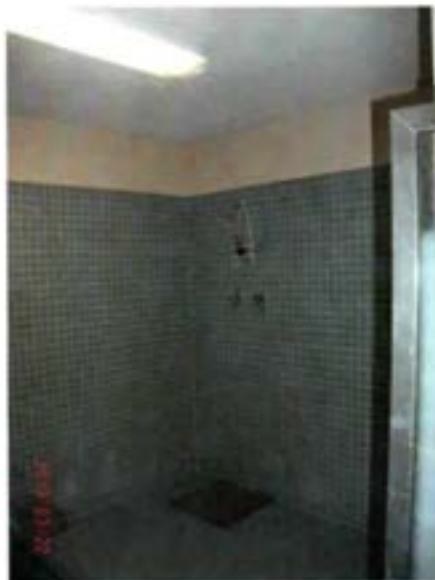
Shower/Housekeeping needed

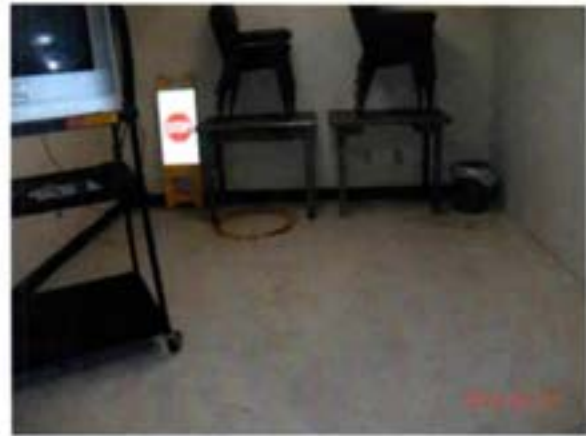
Water/rust stains on floors

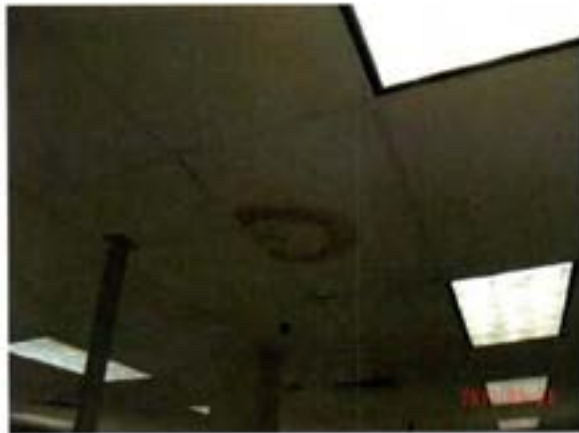
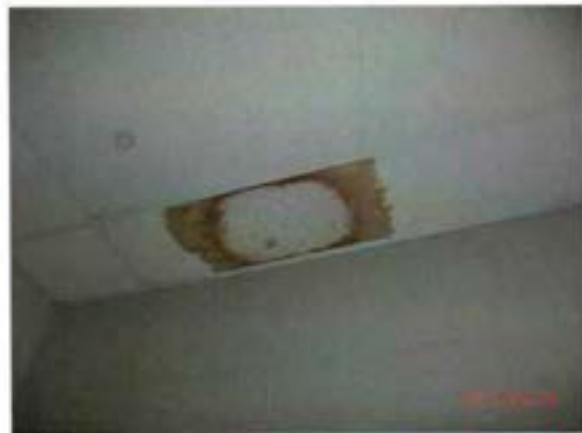
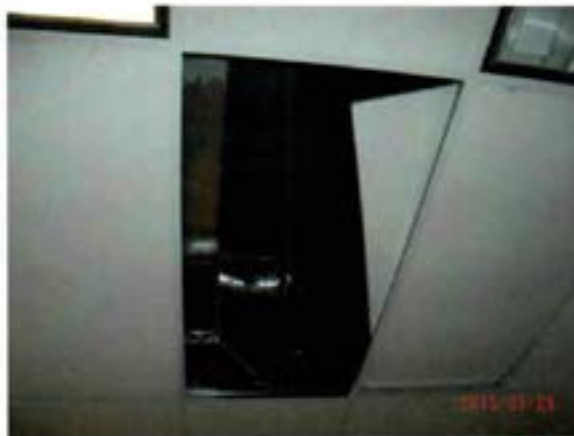
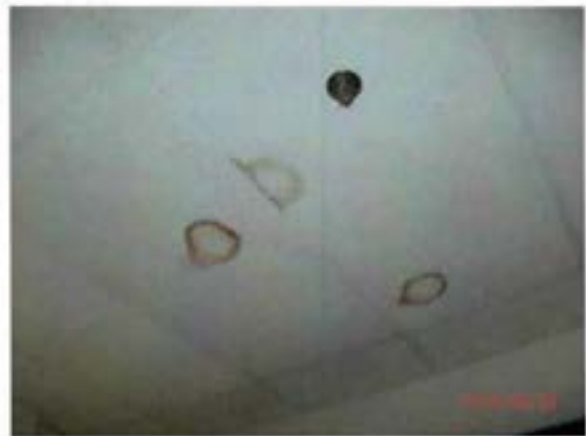
- a. At the time of the survey, numerous ceiling tiles appeared damaged and stained. The cause could be from a roof leak, condensation on AC/Heating duct work or an overhead pipe with a leak.

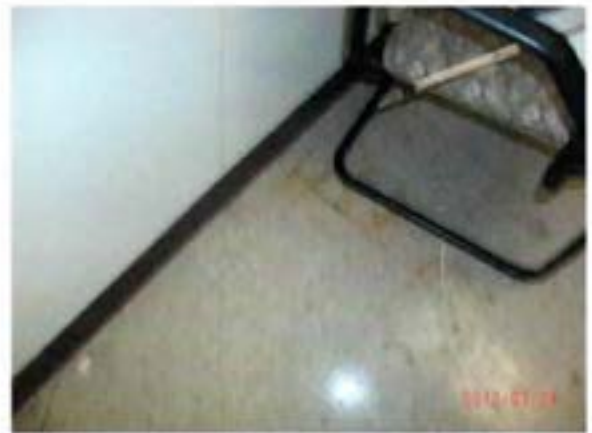
Water damage second floor storage

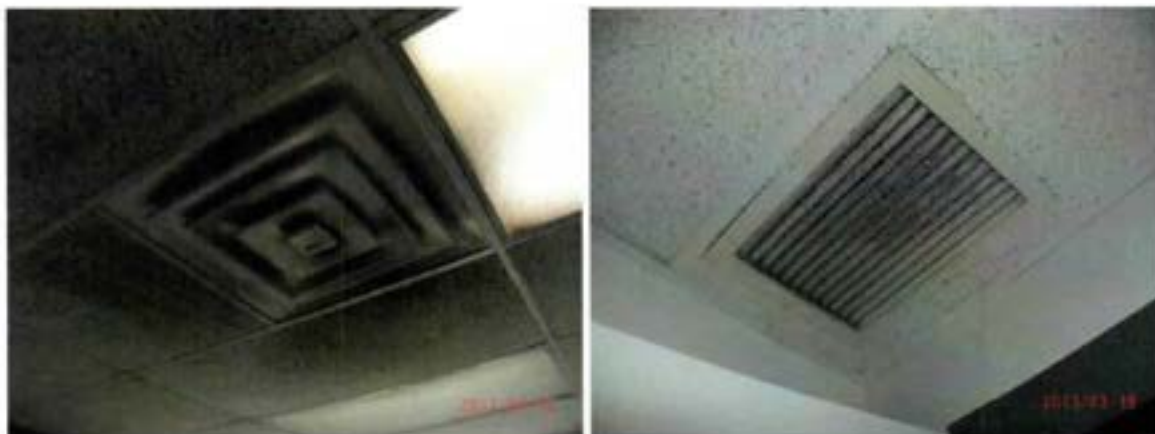
- a. Numerous ceiling tiles appeared damaged and stained. A number of the intake and exhaust covers were covered with soot.

Ducts covered from soot

- Determine where leaks are coming from, either from the roof, AC duct work or overhead piping. Then replace broken and stained ceiling tiles. Clean all vents annually or as needed. **RAC 3**
- The floor inside (263ug) the vault exceeded the recommended level of 200 ug. This area and all other areas around the vault should be cleaned and retested.
RAC 3
- For levels not meeting the illumination standard. Lights that are out or broken should be fixed. In other areas supplemental lighting could be used. **RAC 3**
- General housekeeping needs to be conducted throughout the armory and drill hall. The buildup of old boxes, papers, broken and stained ceiling tiles, provide a habitat for future pest. **RAC 3**

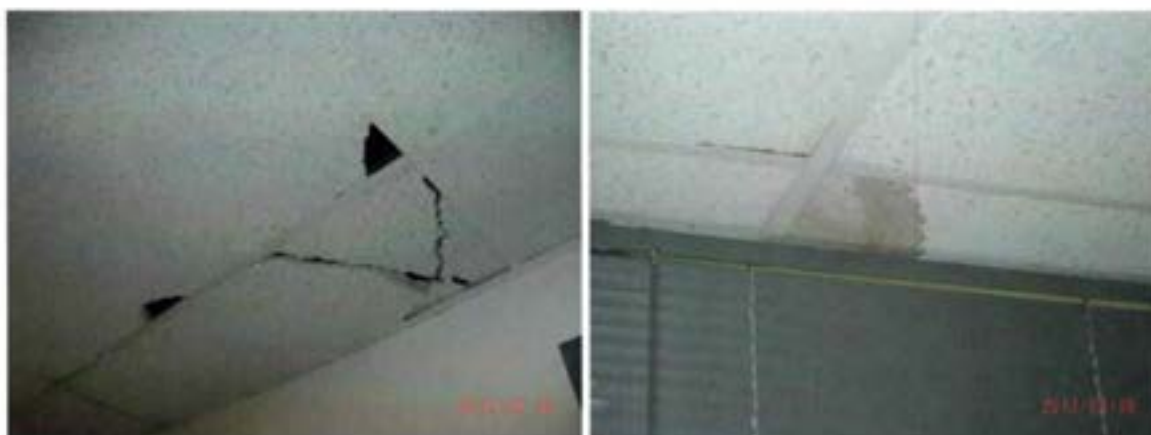
Ceiling tiles damaged and stained

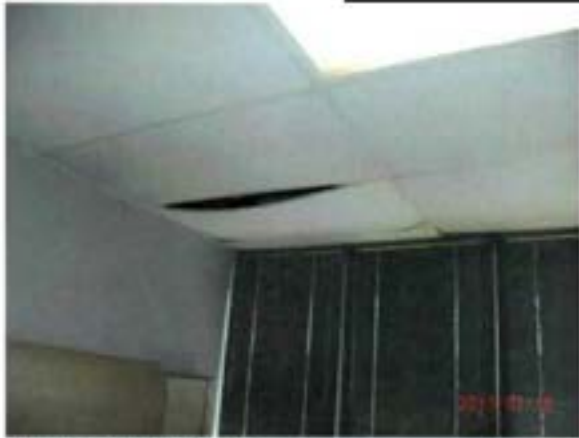
Damaged Ceiling Tiles

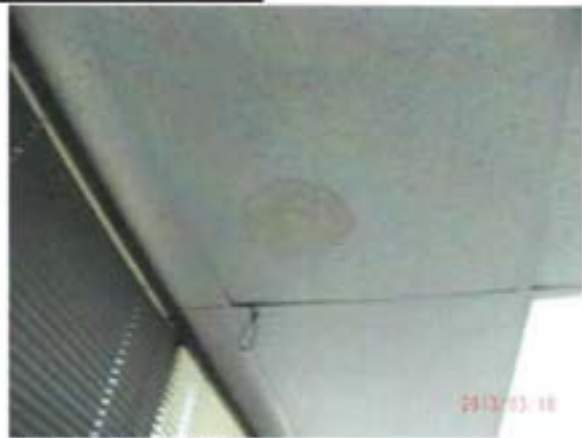
Damaged Ceiling Tiles

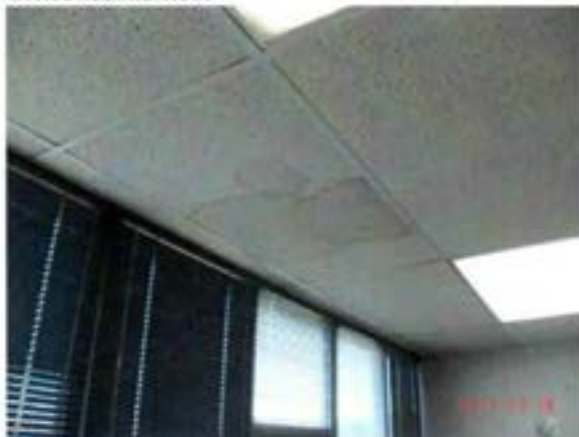
Damaged Ceiling Tiles
