**NATIONAL GUARD REGION SOUTH
INDUSTRIAL HYGIENE OFFICE
510 PLAZA DRIVE, SUITE 1530
COLLEGE PARK, GA 30349**

SUBJECT: Industrial Hygiene Survey of the Abbeville National Guard Armory,
Abbeville, South Carolina.

**ABBEVILLE, SC
ARMORY**

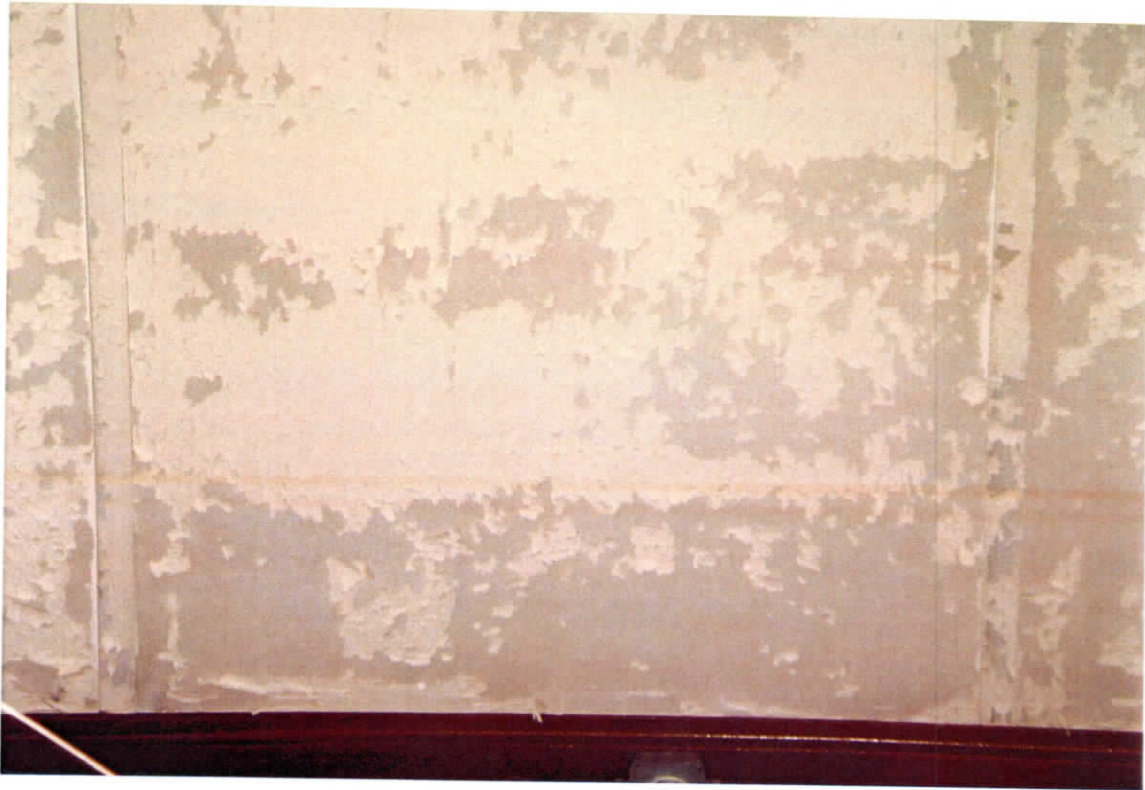
**DRILL HALL, PAINT
PEELING OFF, CEILING**

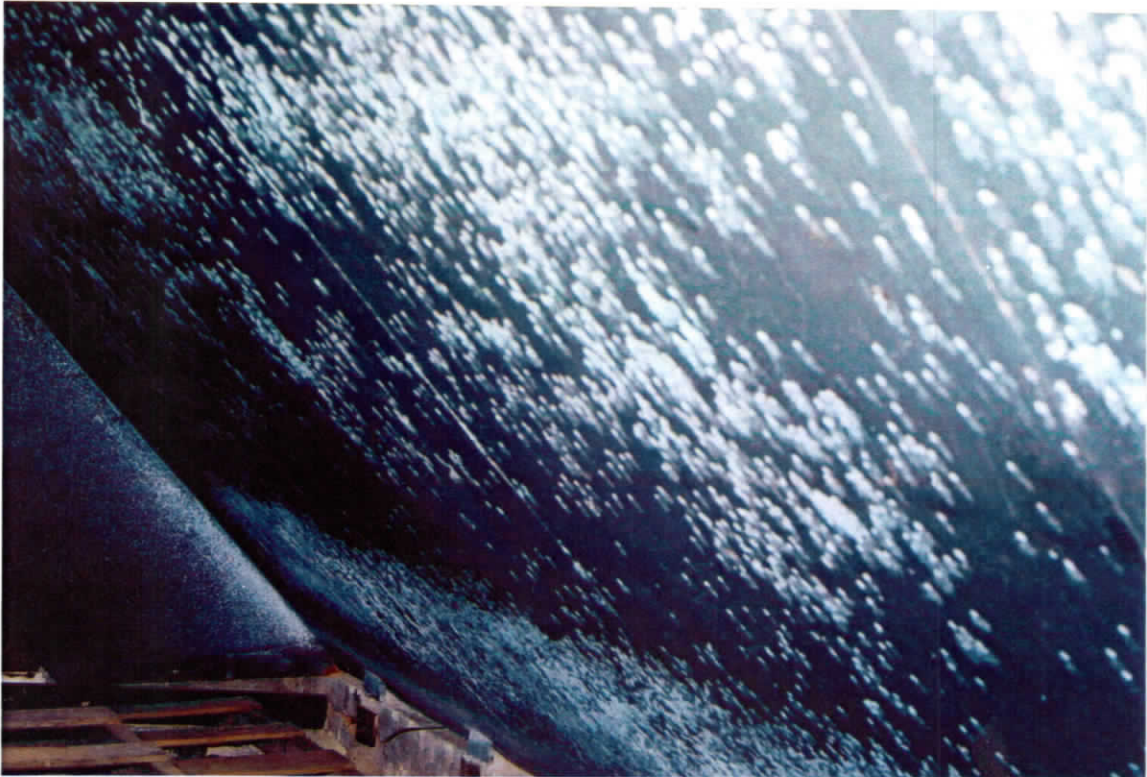
**IFR, BULLET
BACKSTOP**

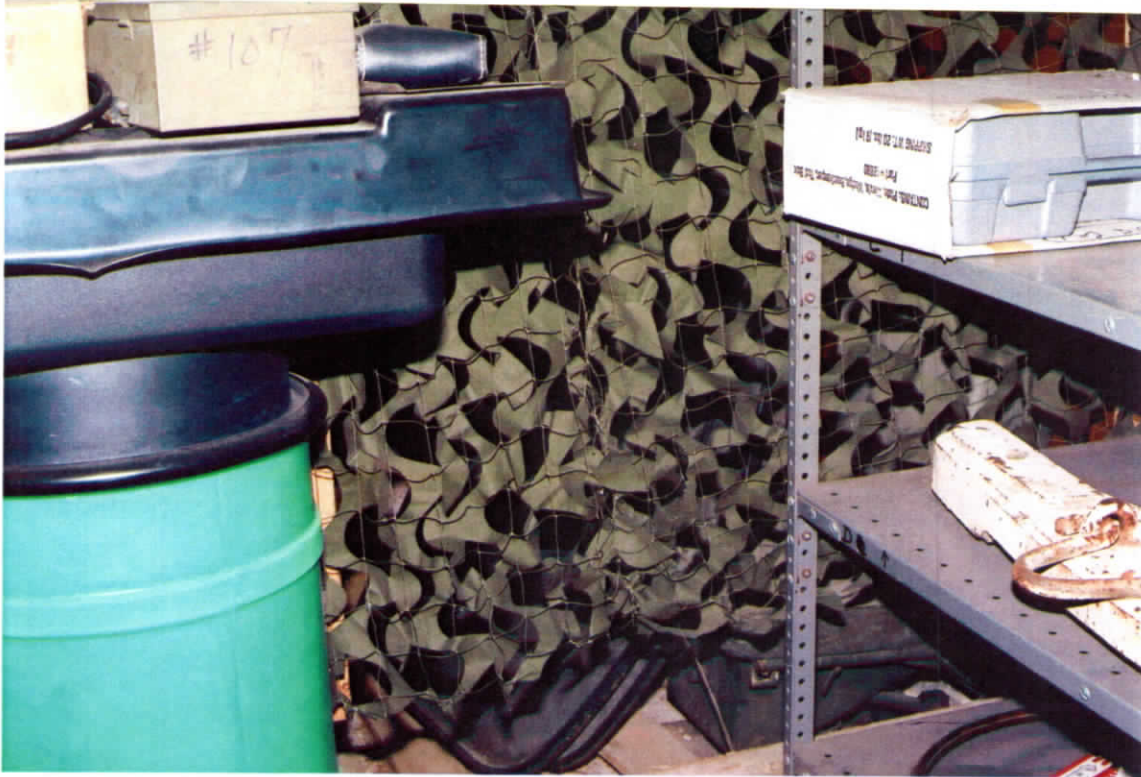
**IFR, FLOOR IN FRONT OF
BACKSTOP (SAND)**

**IFR, CAMOUFLAGE
COVERING ENTRANCE
TO BACKSTOP AREA**

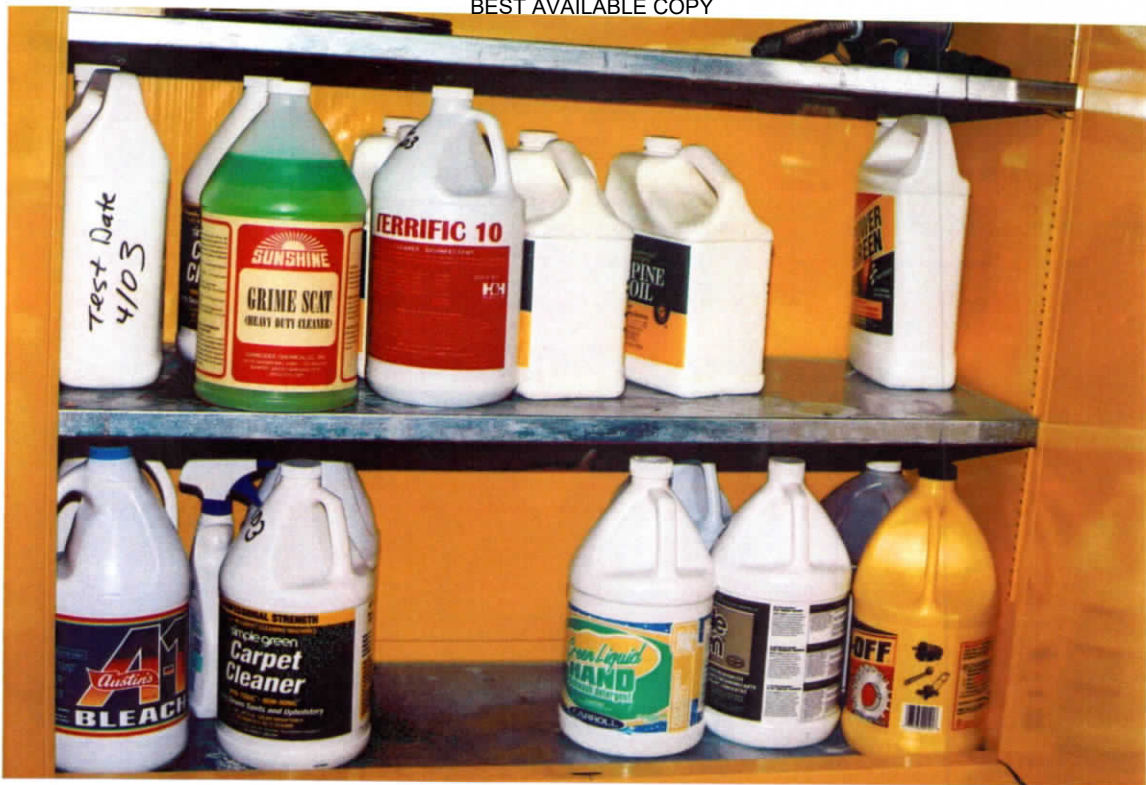
**FLAMMABLES CABINET,
INSIDE**

**FLAMMABLES CABINET,
MAINTENANCE AREA**

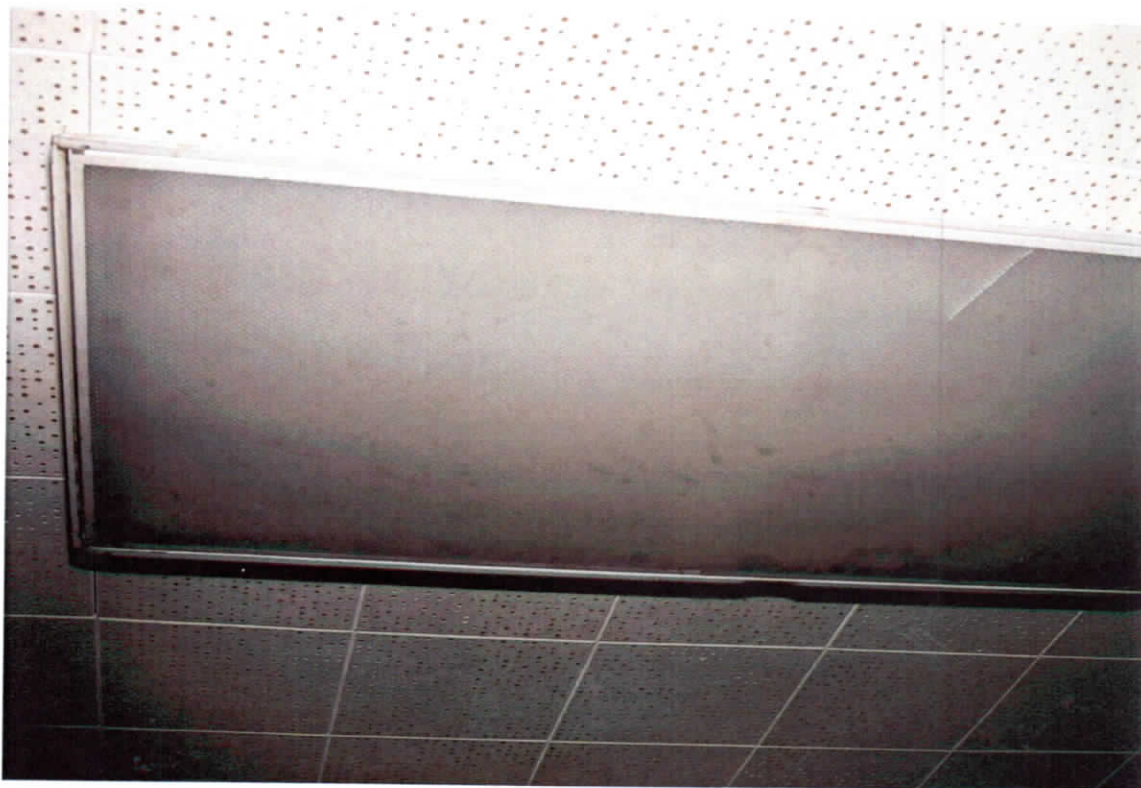
**LIGHT FIXTURE OUT,
DAY ROOM**

**LIGHT FIXTURES
OUT, CLASSROOM**

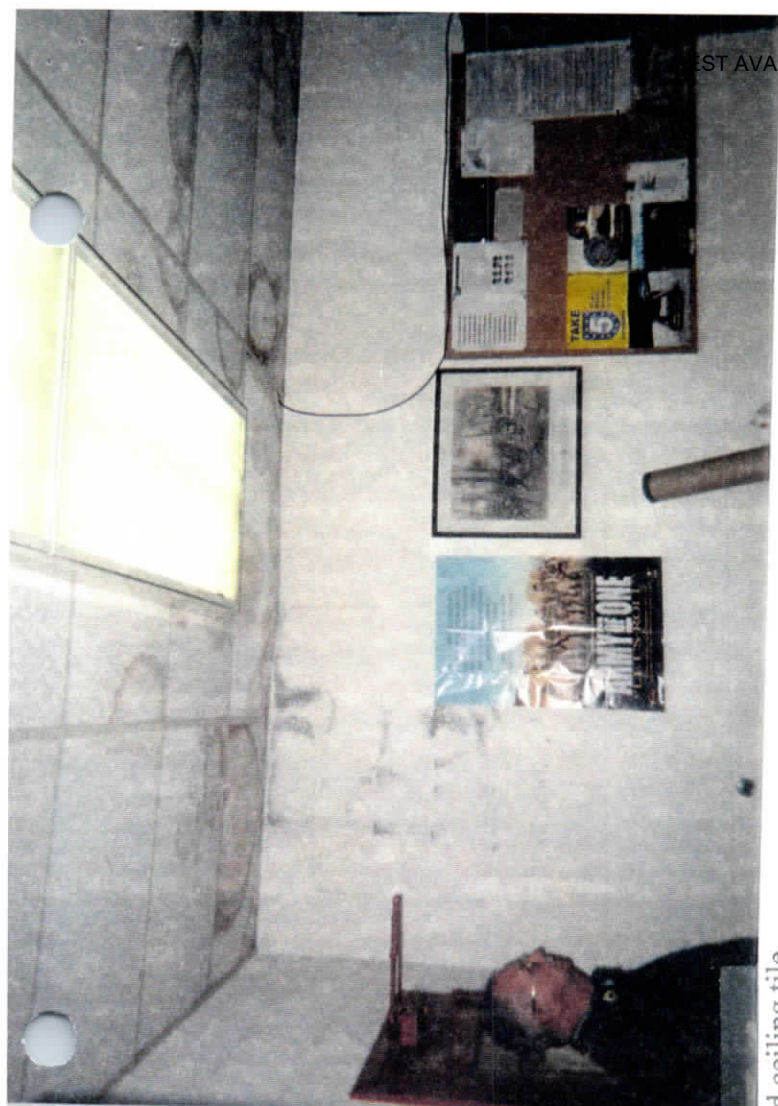
H2O damaged ceiling tile

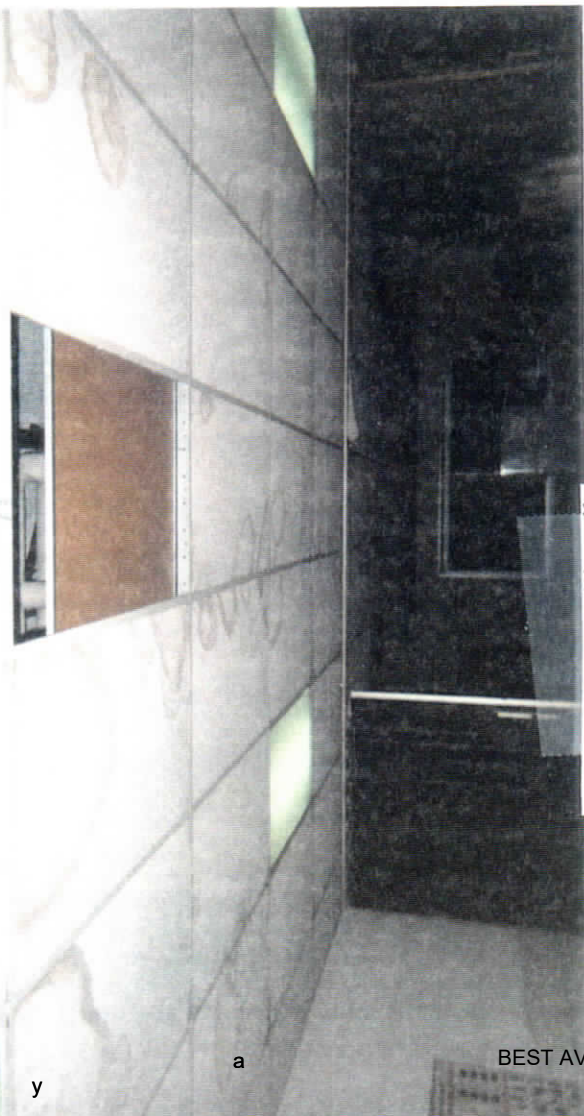
H2O damaged ceiling tile

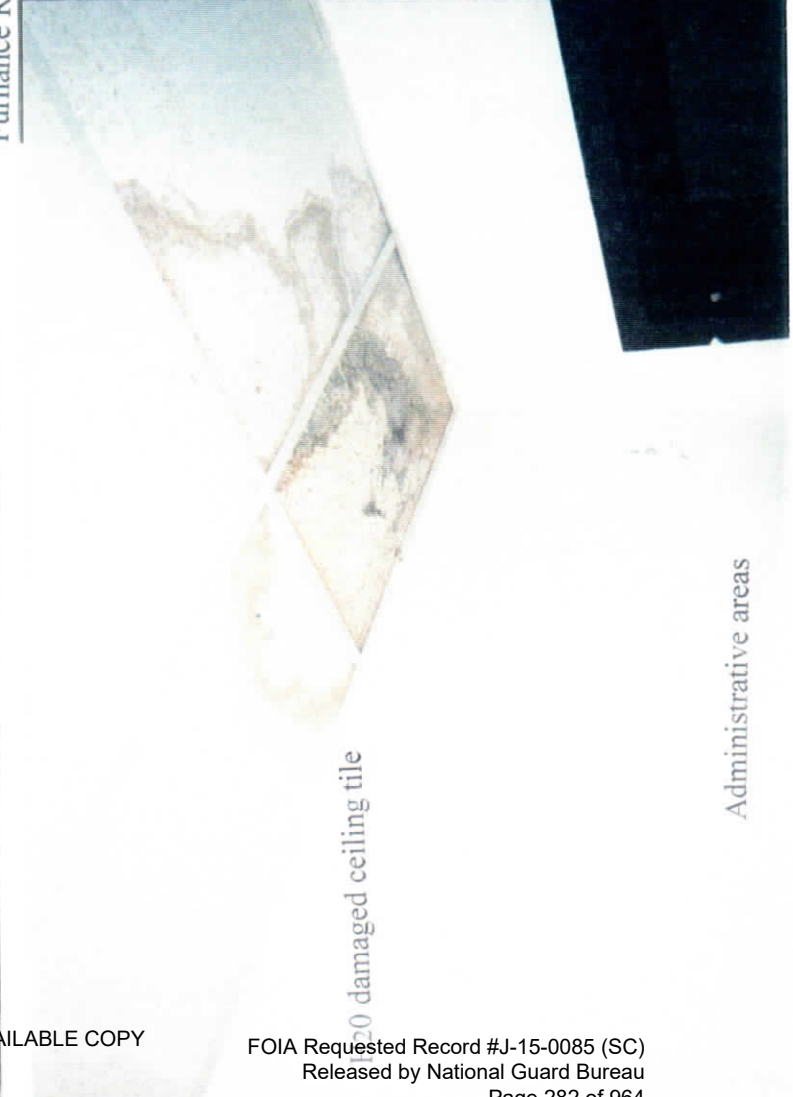
20 damaged ceiling tile
