BEST AVAILABLE COPY
DEPARTMENT OF THE ARMY AND THE AIR FORCE
NATIONAL GUARD BUREAU
REGIONAL INDUSTRIAL HYGIENE OFFICE
AIRPORT PLAZA SUITE 1530
510 PLAZA DRIVE
COLLEGE PARK, GA 30349

SUBJECT: Transmittal of IH Survey, Angleton Armory 272 EN (VERT) (386EN) 1716 County
Road 428 Angleton, Texas 77515

- a. In accordance to the JFTX-H-OH Industrial Hygiene Implementation Plan of 2007, a follow-up industrial hygiene survey was performed at the Angleton Armory located at 1716 County Road 428 Angleton, Texas 77515. The purpose of the survey was to perform a follow-up industrial hygiene survey to evaluate potential health hazards present in the building.
- b. The Point of Contact during the survey was **Non-Responsive**
- c. **Non-Responsive** Industrial Hygiene Technician for the Texas Army National Guard conducted the survey on 23 January 2008.

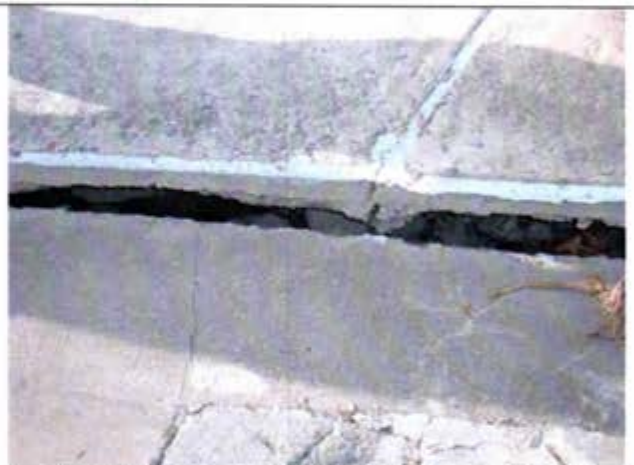
Cracked Concrete At Sinkhole, Rear Of Building

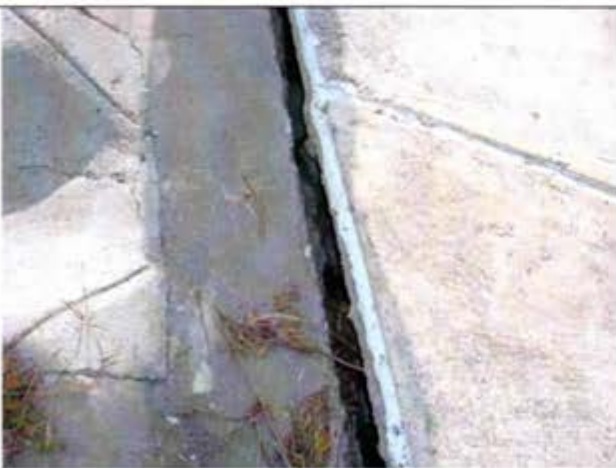
Cracked Concrete At Sinkhole, Another View

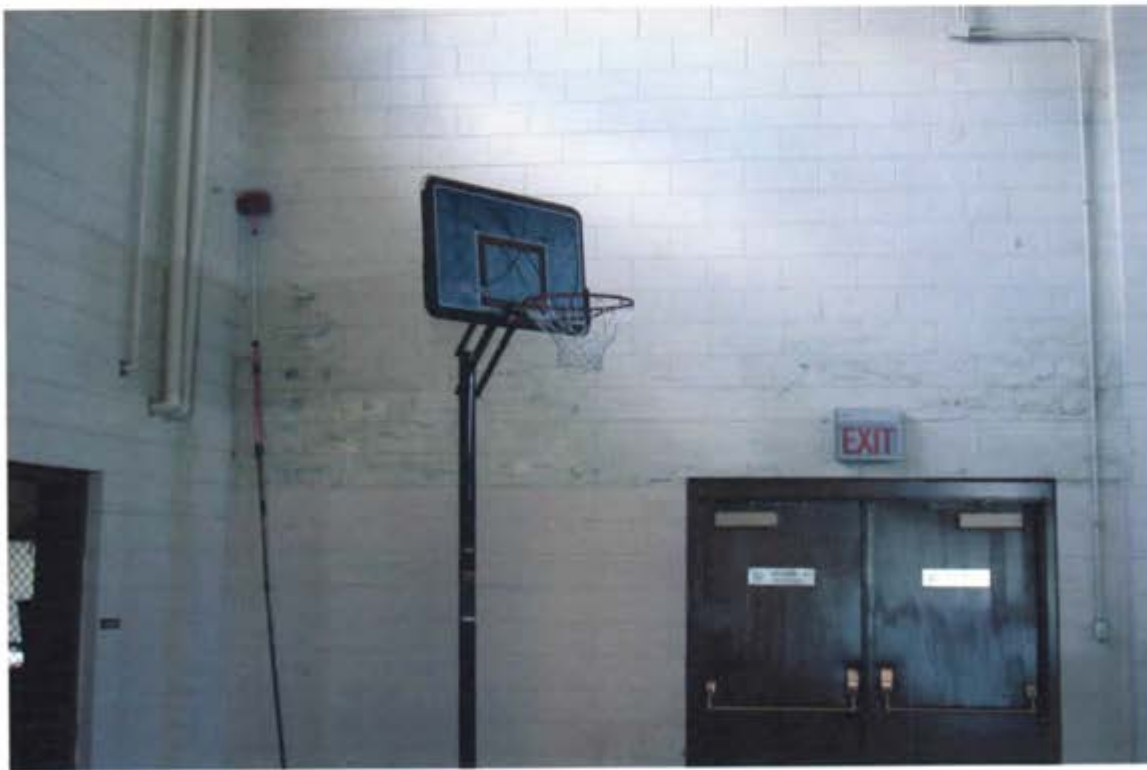
Photo #12: Water damage in the drill hall.

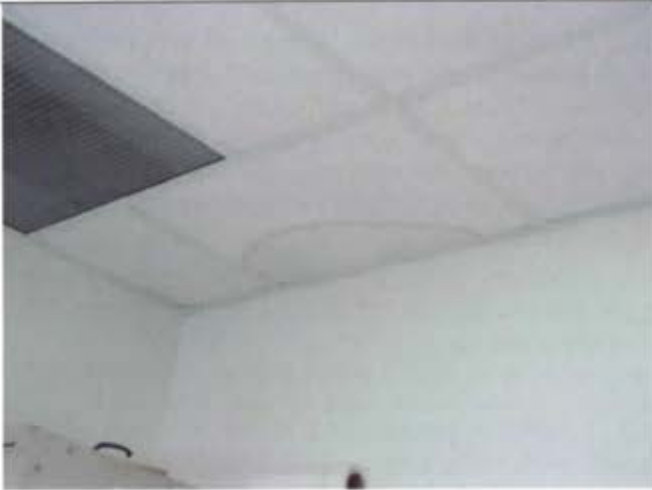
**Photo # 1**

There is evidence of roof leakage in the Readiness NCO office

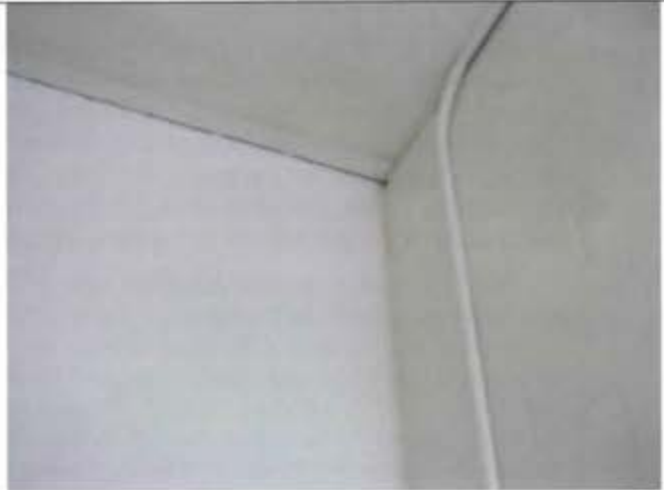
**Photo # 2**

There is evidence of water leakage in male latrine

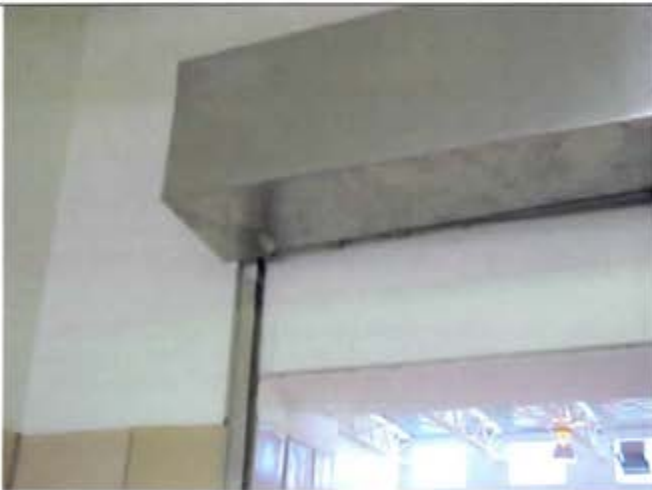
**Photo # 3**

Evidence of roof leakage in the kitchen area

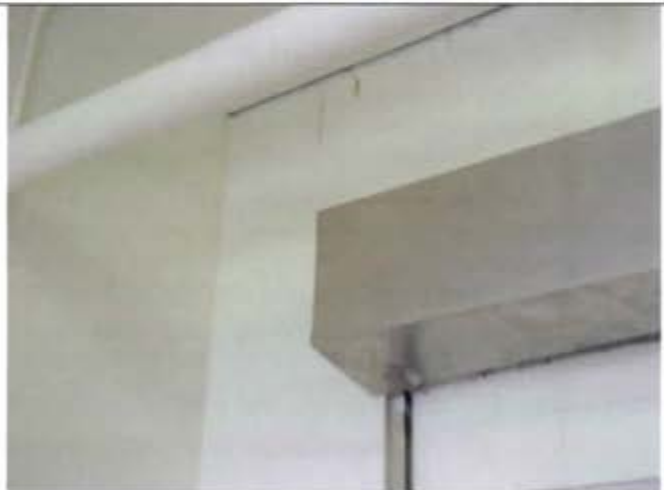
**Photo # 4**

Another view of the area that is showing signs of roof leakage in the kitchen area.
