### **EXECUTIVE SUMMARY**

An initial baseline industrial hygiene survey was conducted at the Conway Armory on 3 May 2005 as part of the South Carolina Army National Guard Occupational Health Program to identify potential health hazards in the workplace. The survey consisted of collecting lead wipe samples and bulk asbestos samples as needed, conducting a noise and illumination survey and an evaluation of the condition of the building as it related to indoor air quality. A review of the Hazard communication program, ergonomics, and personal protective equipment was also performed.

Initial Baseline Industrial Hygiene Survey of the Conway Armory performed 3 May 2005 in Conway, South Carolina.

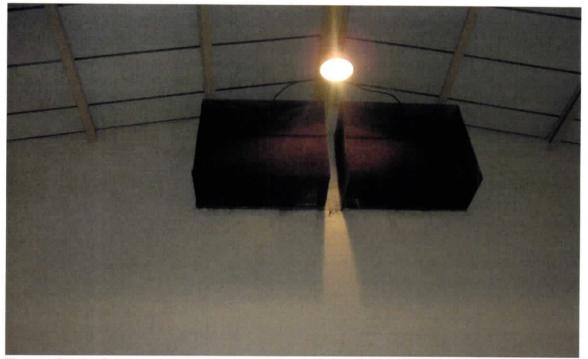
Two exhaust fans are located in the ceiling of the drill hall. It was noted that they were dirty and full of spider webs. The photo shows how dirty they were. It was stated that they had been unplugged.

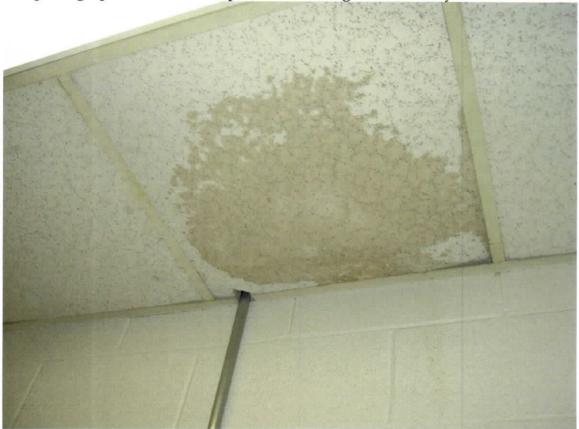
Ceiling tile in an office of Echo Company Mold was noted on this tile.

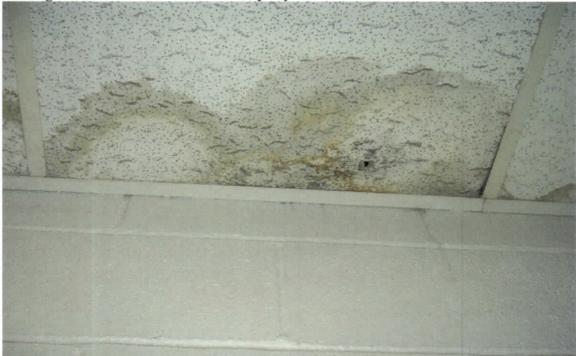
The mold on these tiles were noted in the hall of Echo Company

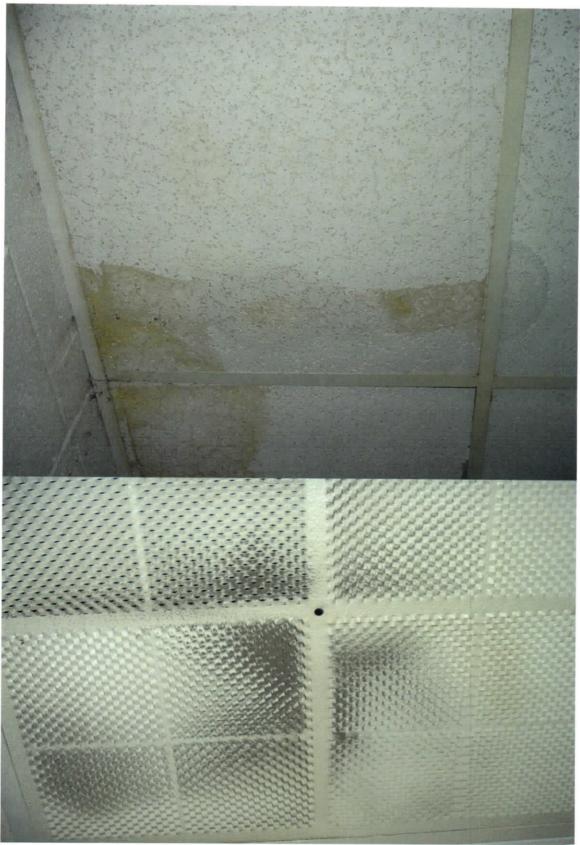
The vents were dirty in several offices also.

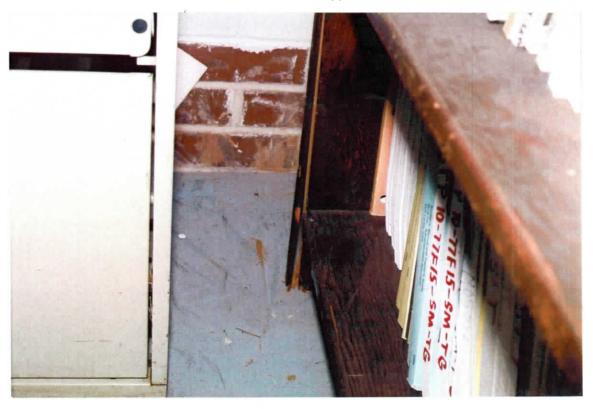
IFR, WHERE BACKSTOP WAS

- d. The deactivated IFR will always be a firing range until the backstop is removed. Remove the backstop.
- e. Consider additional Industrial Hygiene services to monitor operations that were not looked at or surveyed during the contract visit, especially if this will help eliminate health hazards and reduce medical surveillance cost.

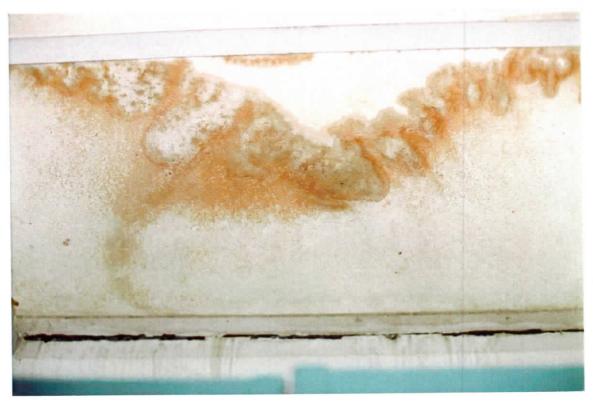
### STAINED CEILING TILES, LOCKER ROOM

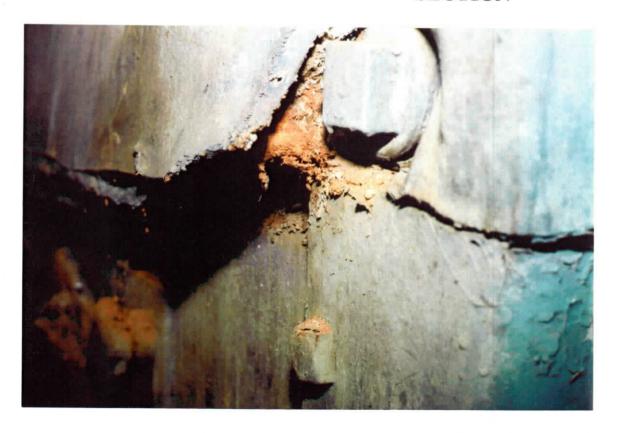
# BOILER, BROKEN SECTION

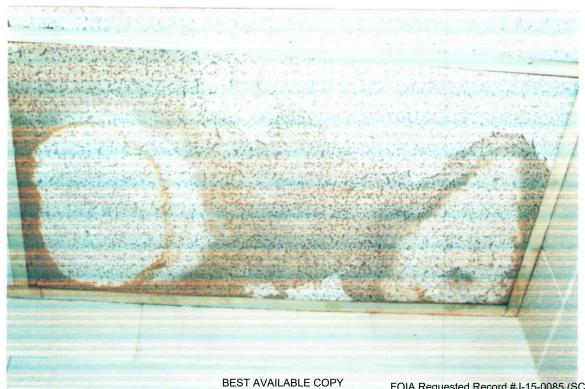
### STAINED CEILING TILE, READINESS NCO OFFICE

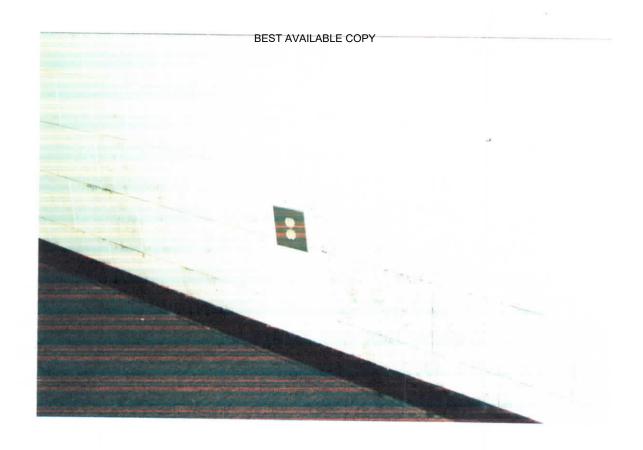
## MOLD AT WALL, COMMANDER OFFICE

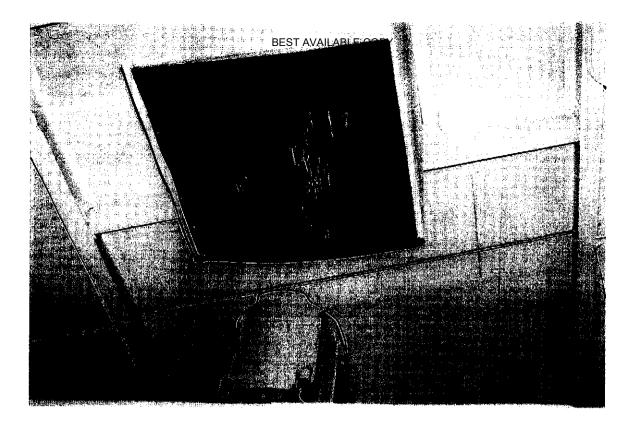
SUPPLY ROOM, ROOF WATER LEAK

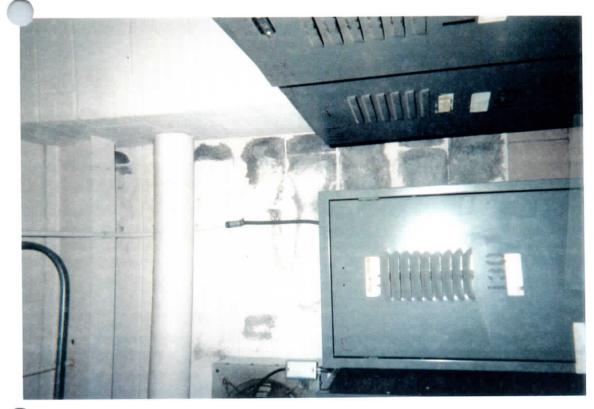
H20 damage

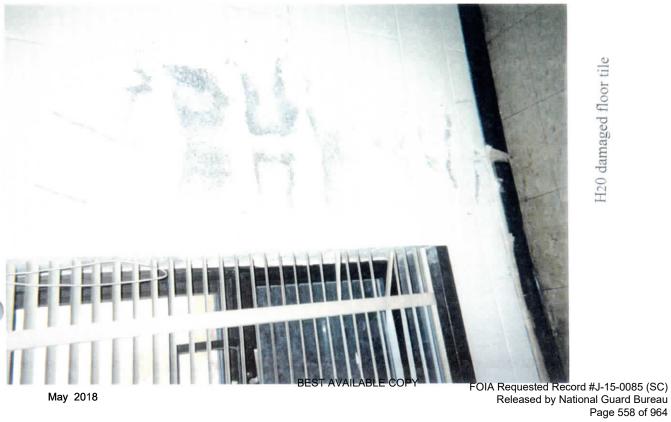
H20 damaged floor tile

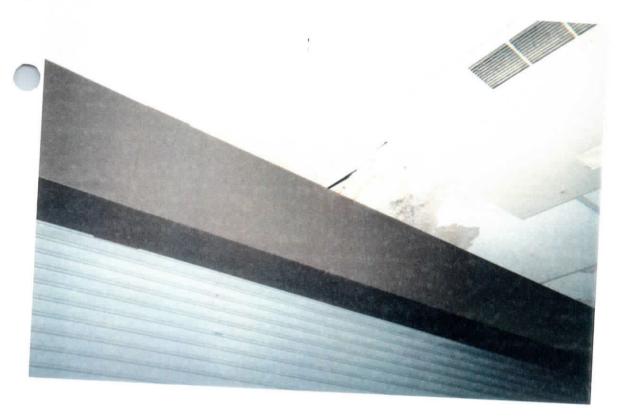
H20 damaged ceiling tile
