In accordance to the JFTX-H-OH Industrial Hygiene Implementation Plan of 2009, a follow-up industrial hygiene survey was performed at the Irving Armory located at 1007 O'Connor Road Irving, Texas 75061. The purpose of the survey was to evaluate potential health hazards present in the building

**DEPARTMENT OF THE ARMY AND THE AIR FORCE
NATIONAL GUARD BUREAU
REGIONAL INDUSTRIAL HYGIENE OFFICE
AIRPORT PLAZA SUITE 1530
510 PLAZA DRIVE
COLLEGE PARK, GA 30349**

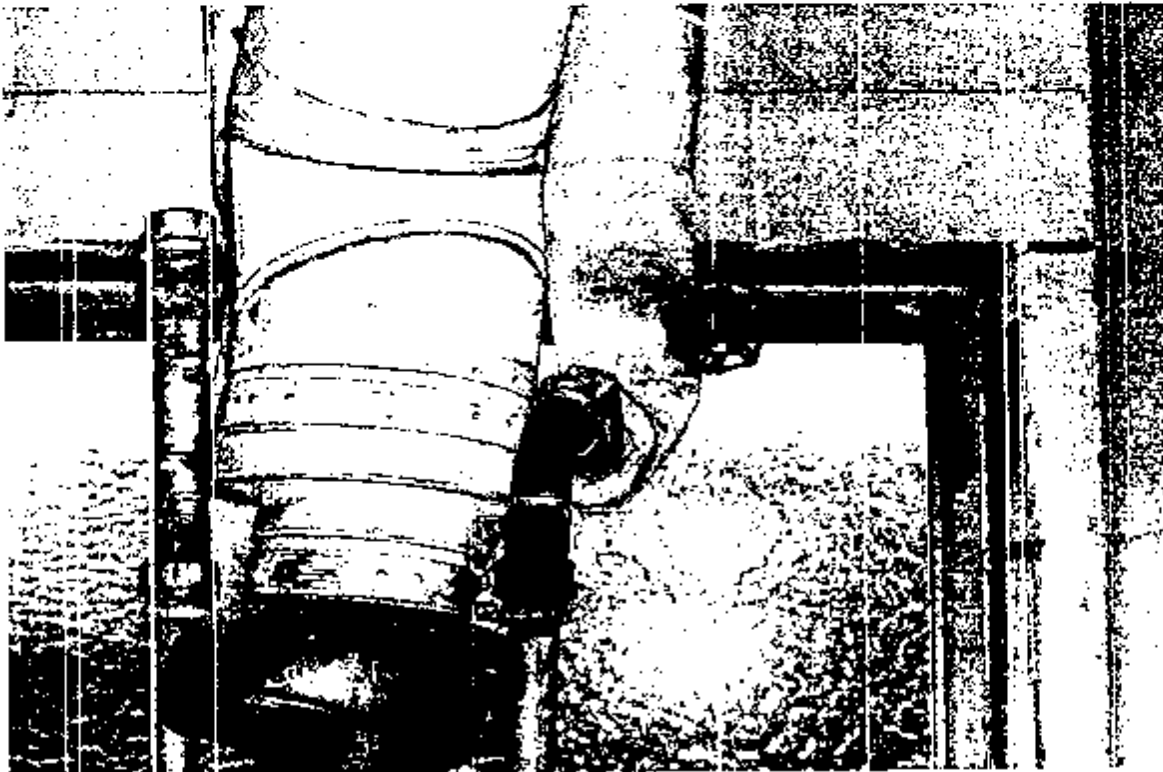
Photo 12: Thermal pipe insulation found on the hot water system.

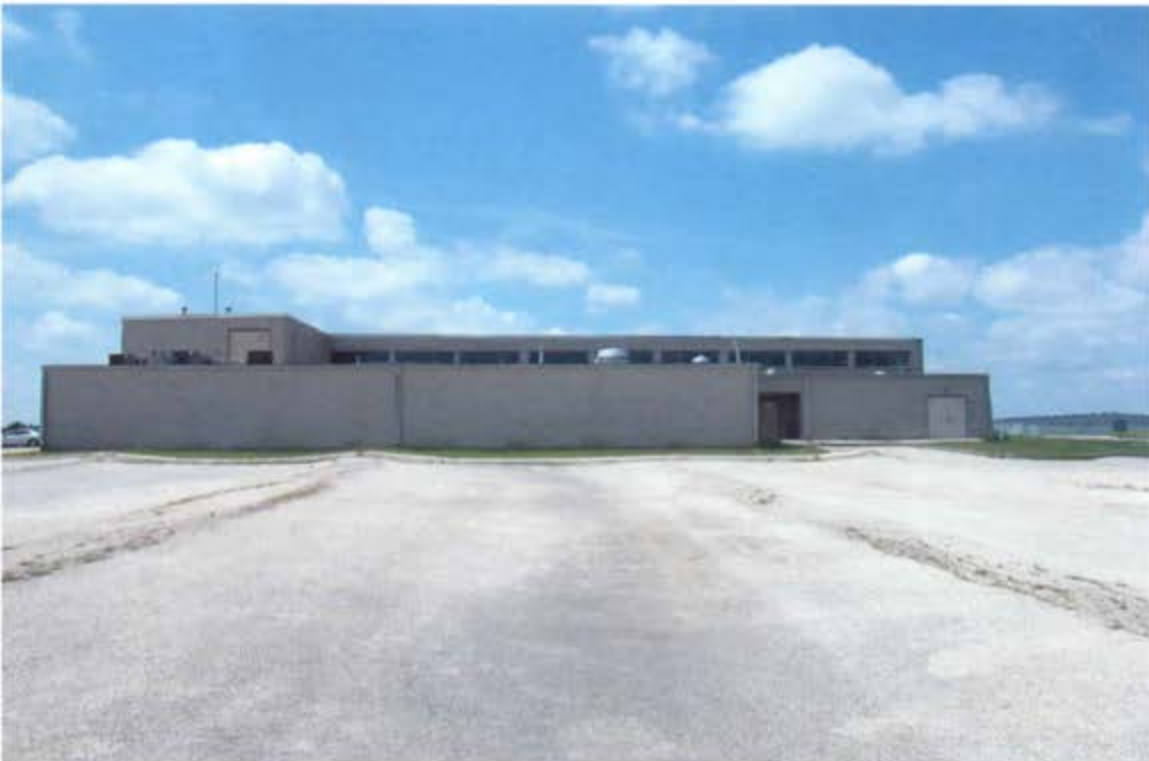
Photo #2: North side of the armory showing settling damage in the parking lot.

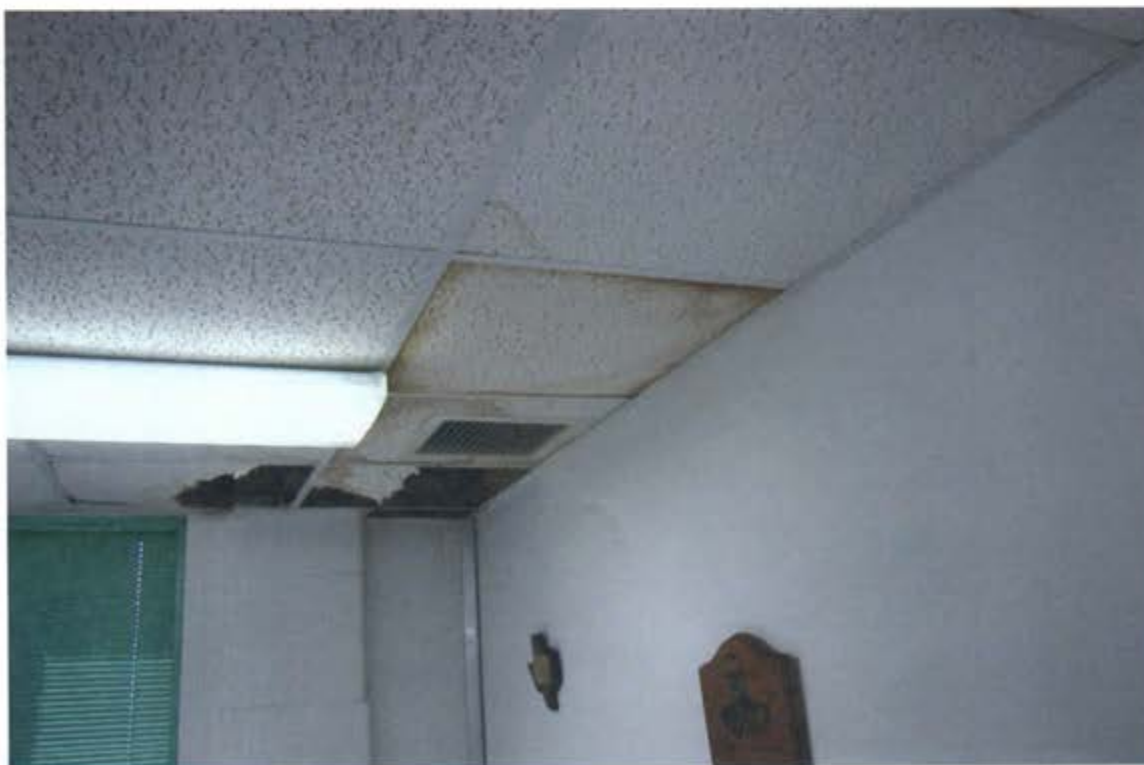
Photo #14: Water damaged ceiling tiles in the administrative area.

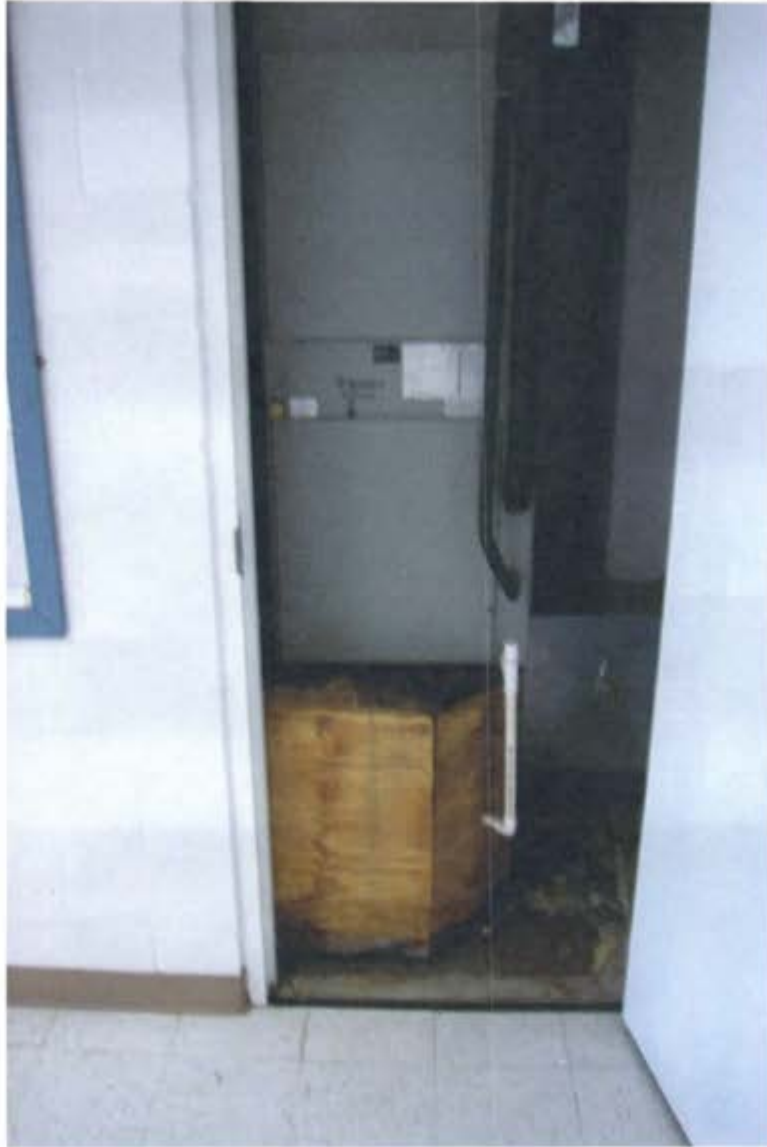
Photo #17: Water damaged wood return air plenum in the mechanical closet.

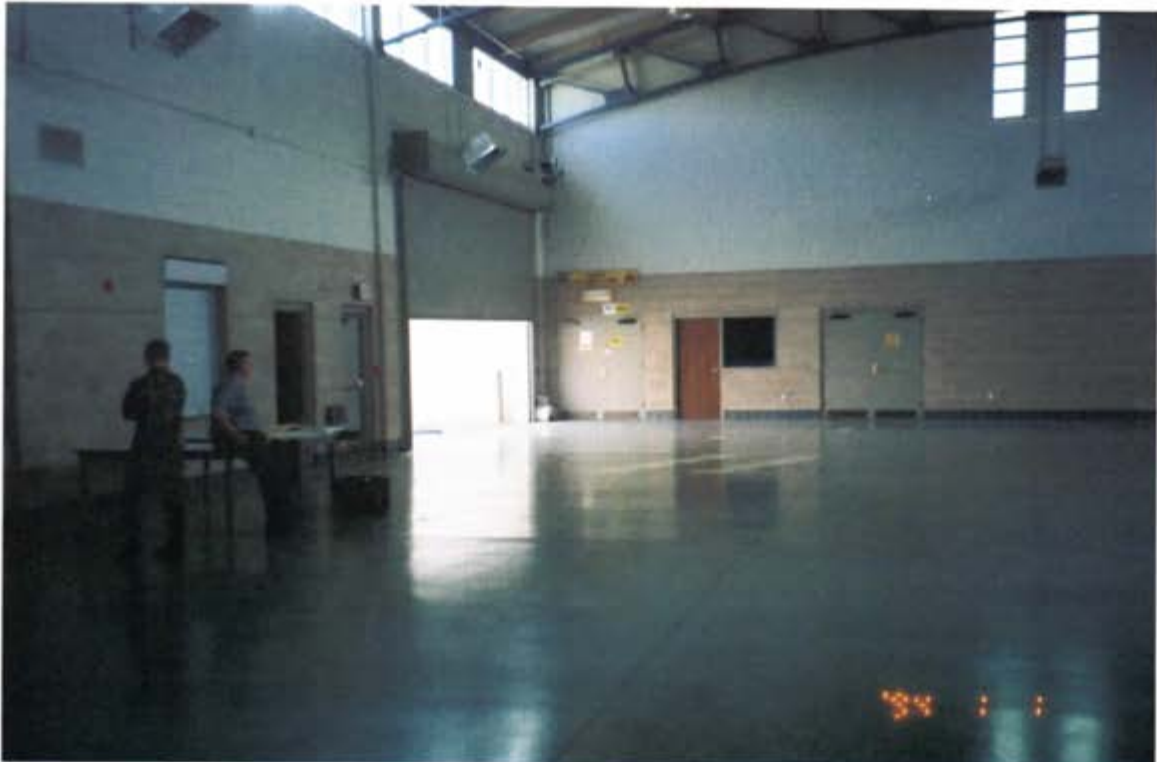
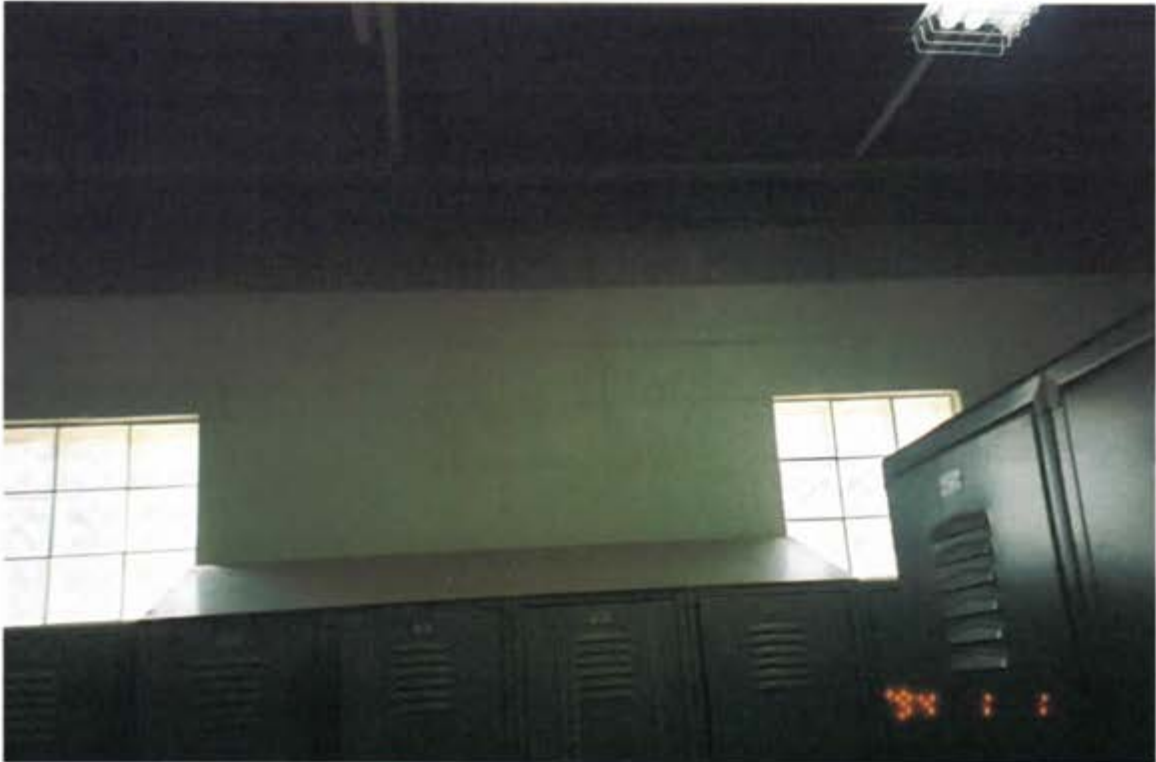
Views of Leaks above the wall locker
in the Locker room

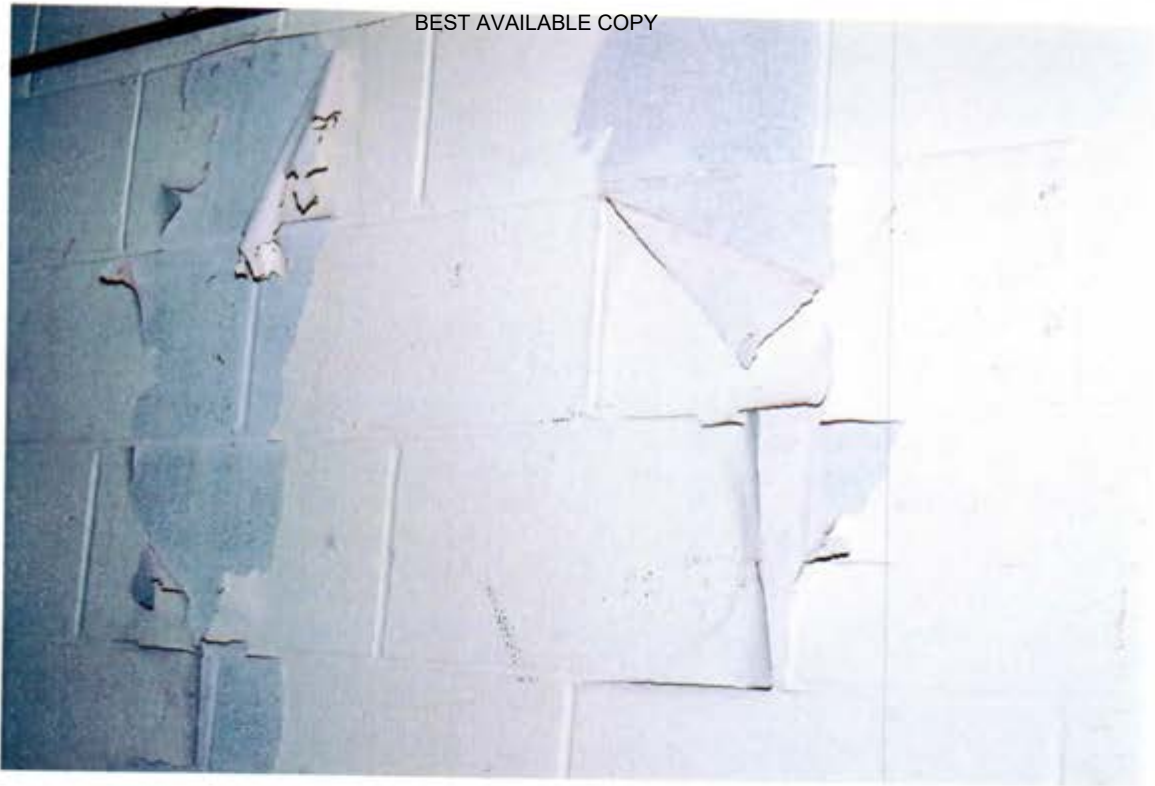
**PAINT OFF, SUPPLY
ROOM**

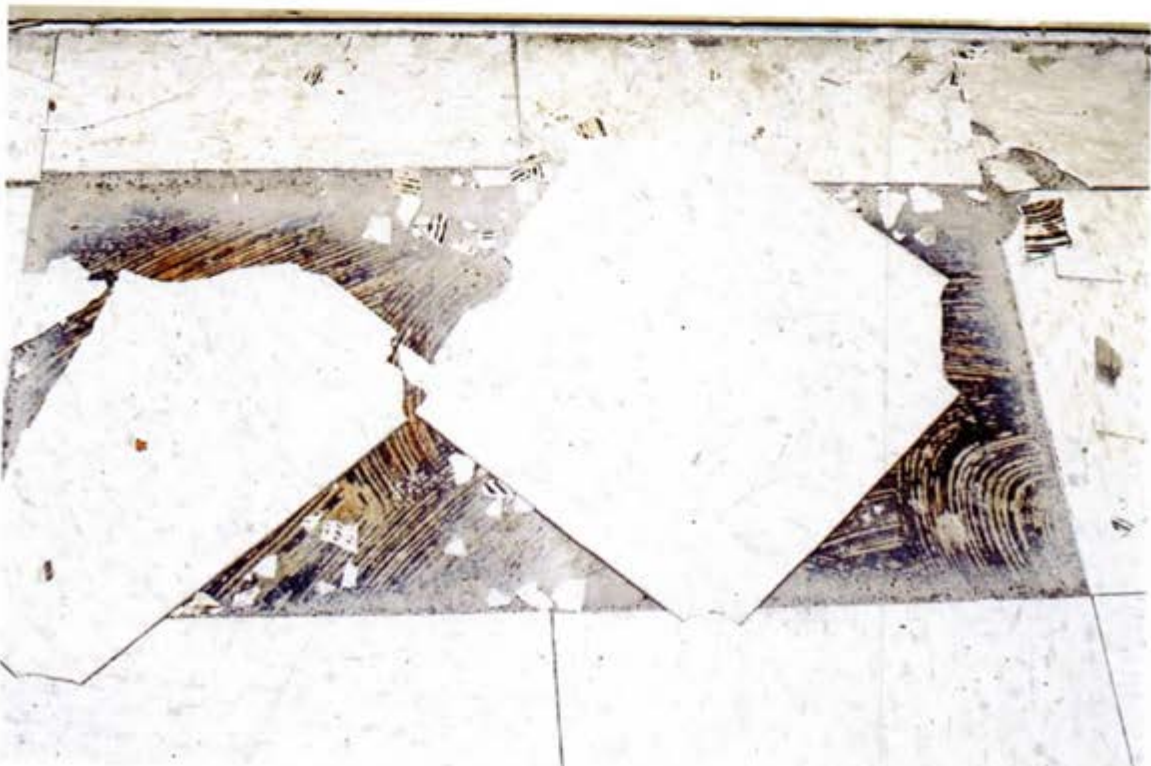
**BROKEN FLOOR
TILES, KITCHEN**

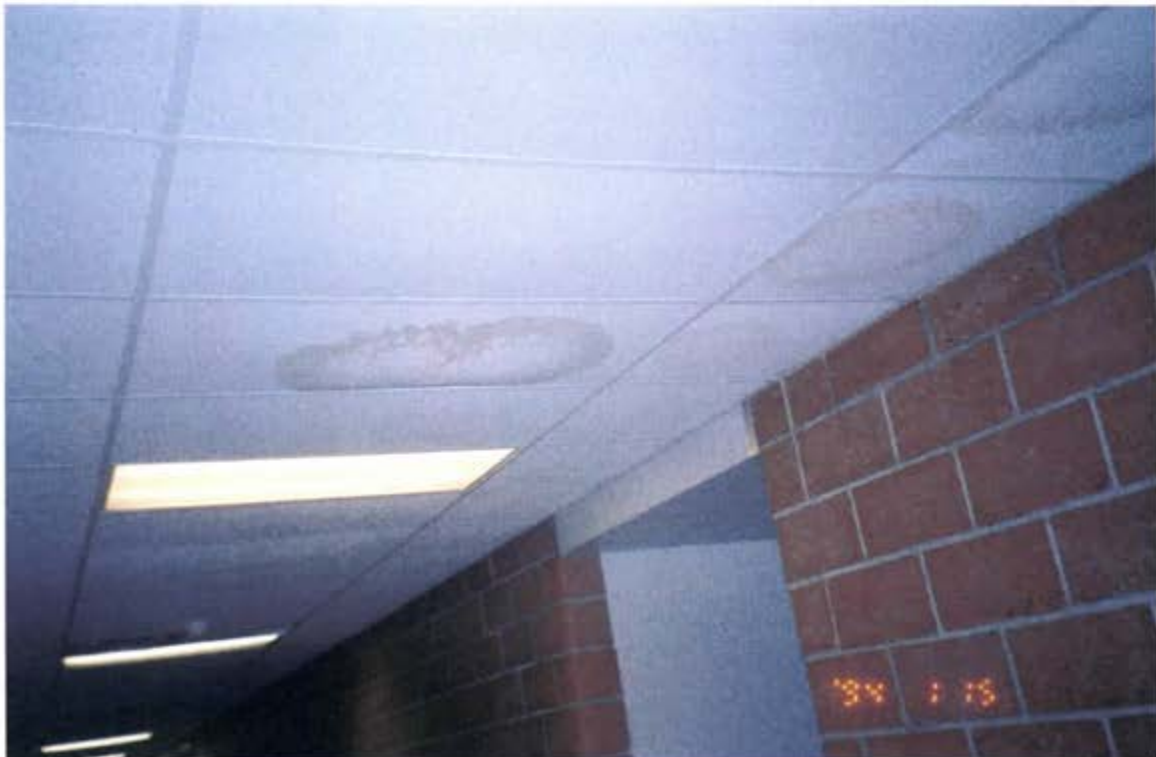
View of water leak in the classroom hallway ceiling

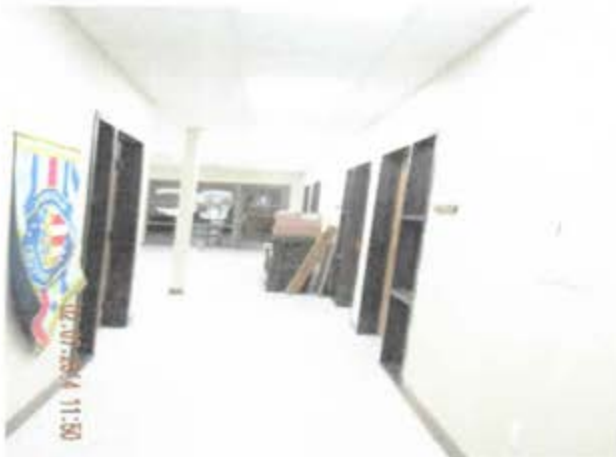
Water-damaged Tile in converted IFR
