Industrial Hygiene Site Assistance Visit

American Fork Armory
251 South 200 East
American Fork, UT 84003

SUBJECT: Executive Summary for Industrial Hygiene Site Assistance Visit for the American Fork Armory, 251 South 200 East, American Fork, UT conducted on 28 June 2012.

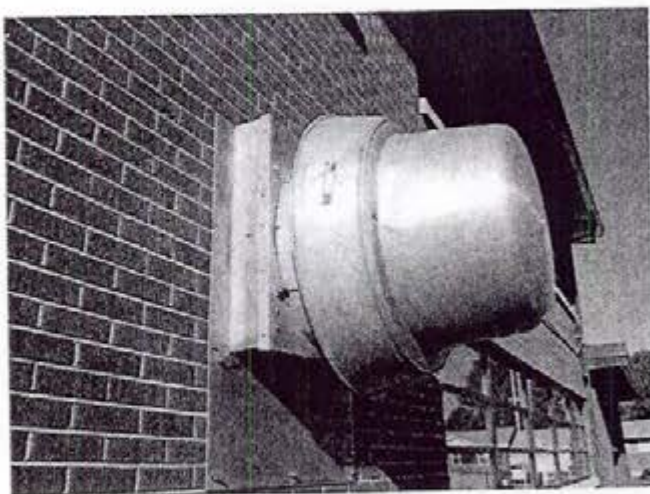
Photograph 5
Kitchen exhaust duct, Exterior

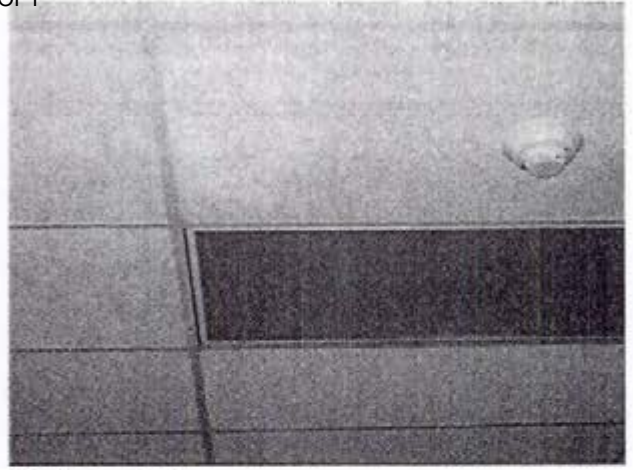
Photograph 8
Water-damaged Ceiling Tile

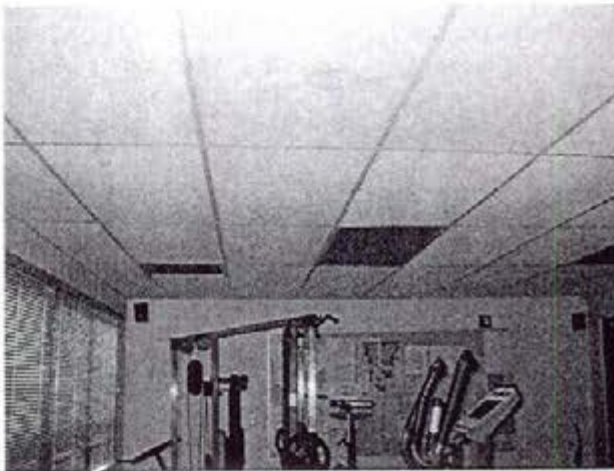
Photograph 9
Water-damaged Ceiling Tile

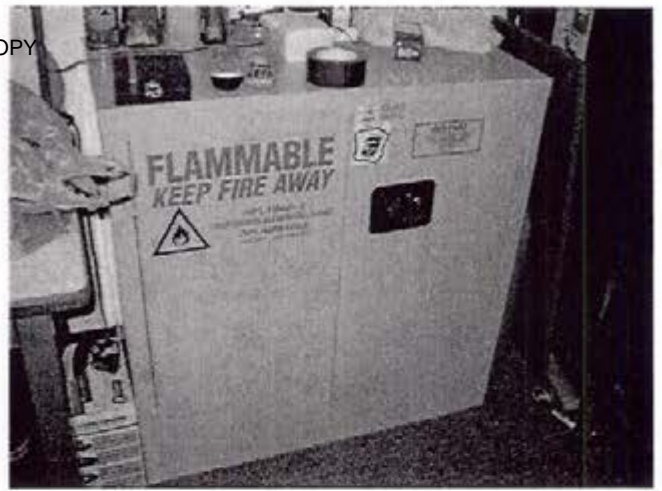
Photograph 8
Flammable cabinet 2 closed

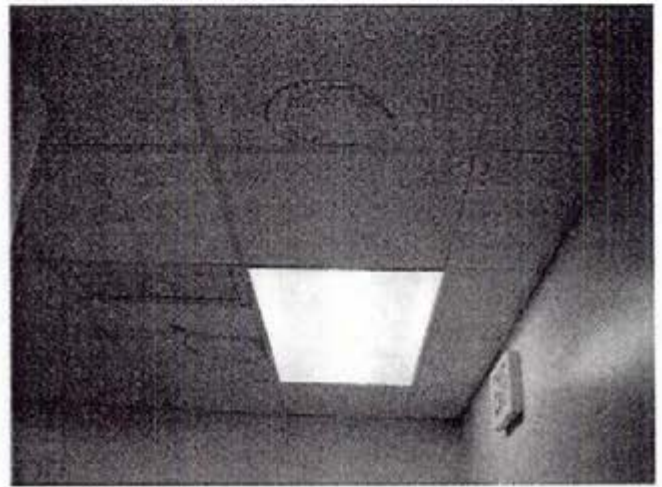
Photograph 10
Water-stained ceiling tiles located in central area of building

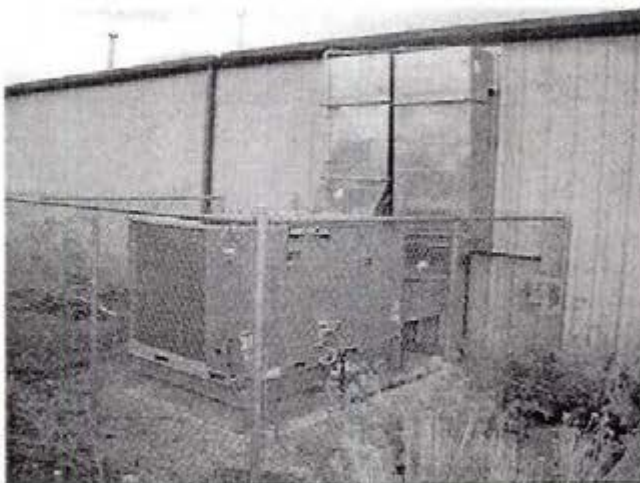
Photograph 11
Three HVAC units behind building were on and blowing cold air during winter

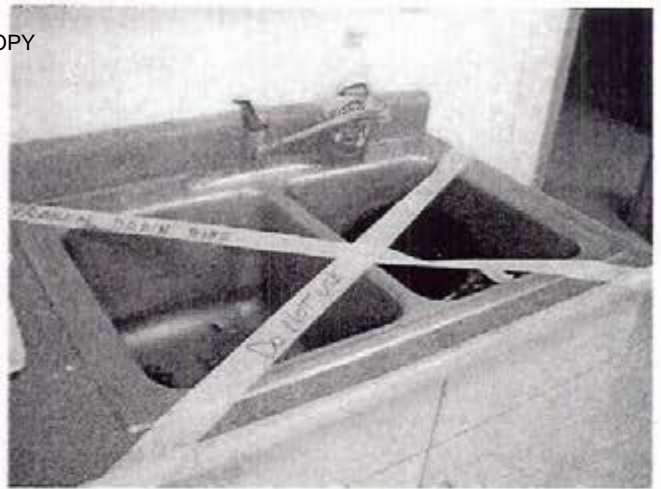
Photograph 14
Sink not working in break room

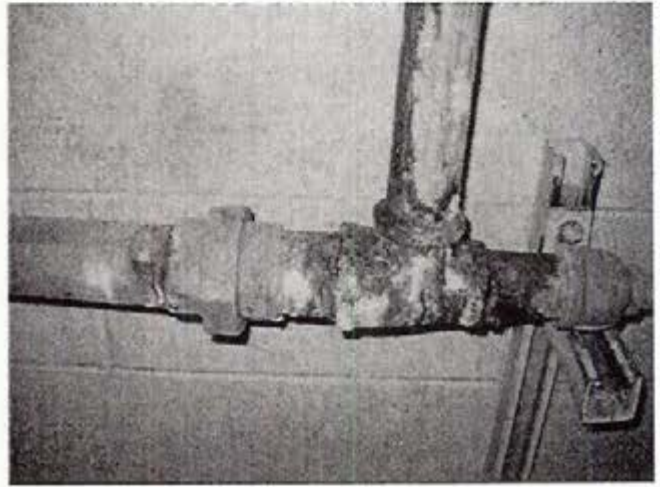
Photograph 4
Severely corroded pipes in janitor's closet

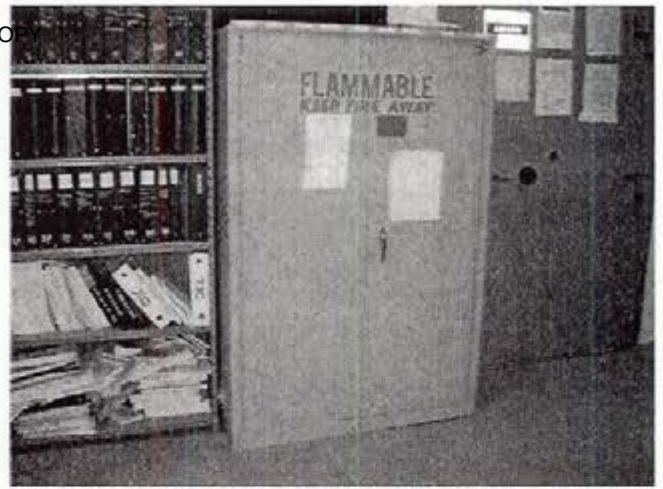
Photograph 8
Flammable cabinet closed

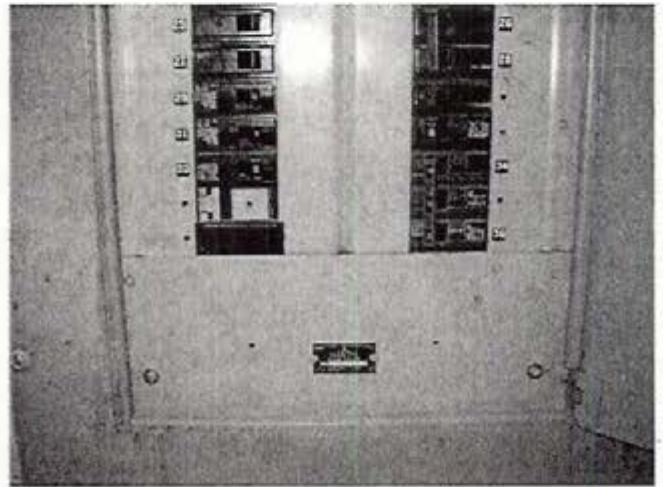
Photograph 10
Open breaker panel in janitor's closet

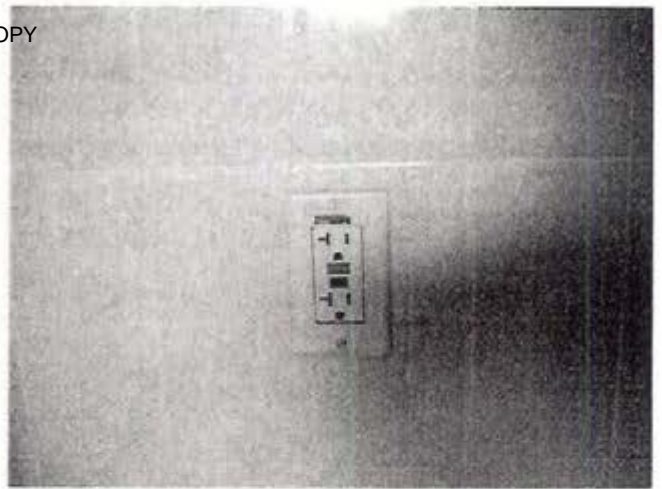
Photograph 14
Non-working GFCI outlet in Men's Restroom

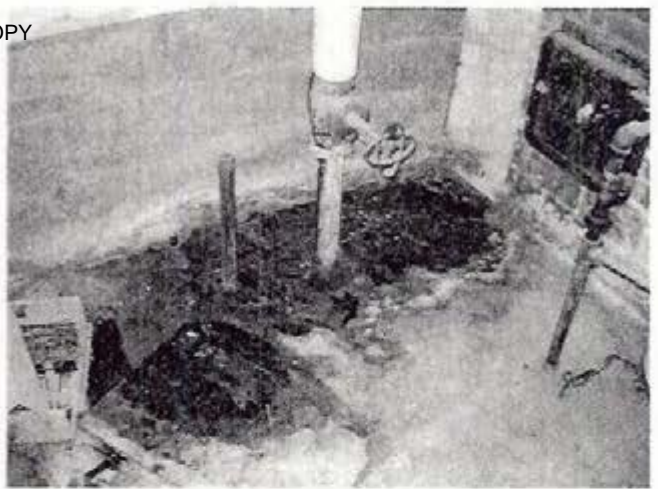
Photograph 8
Water leak and fungal growth in mechanical room

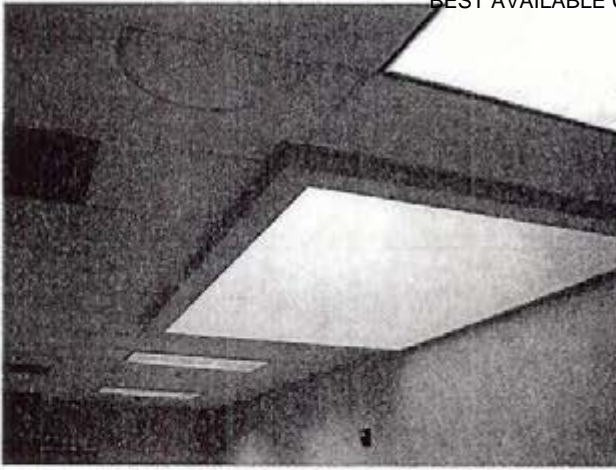
Photograph 7
Water damage on 2nd floor

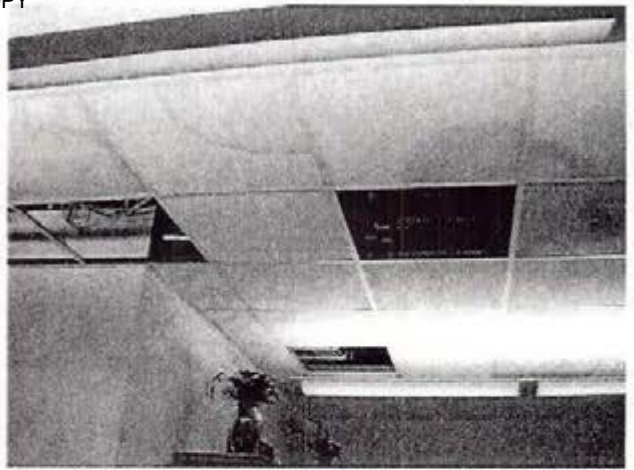
Photograph 8
Water damage on 1st floor
