Army National Guard Armory Survey **(To Be Included In Report)**

Summary of Recommendations for UTARNG
Camp Williams Readiness Center, Riverton, Utah

INDUSTRIAL HYGIENE ASSISTANCE VISIT CEDAR CITY ARMORY CEDAR CITY, UTAH

**Industrial Hygiene Site Assistance Visit
Draper / IFR
Draper, UT
April 24, 2014**

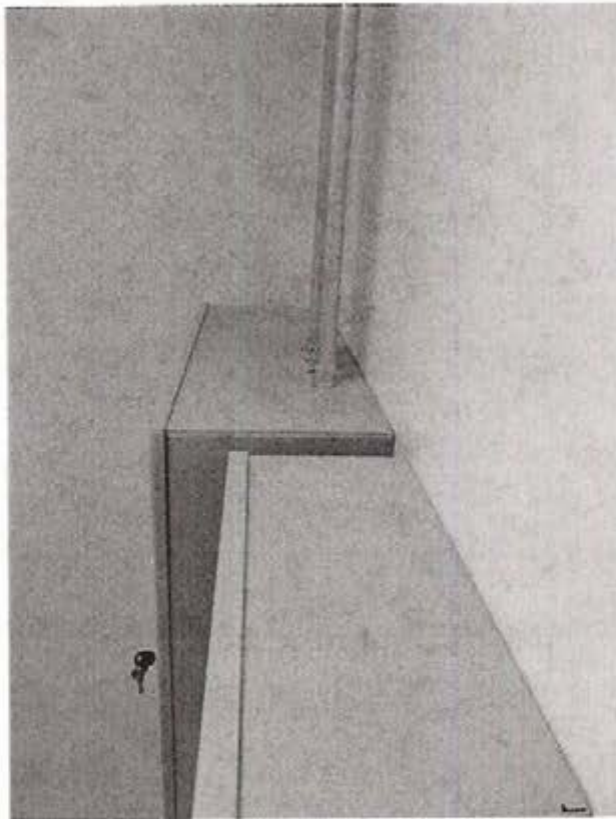
Photo 6: Visible dust on horizontal surfaces; electrical room.

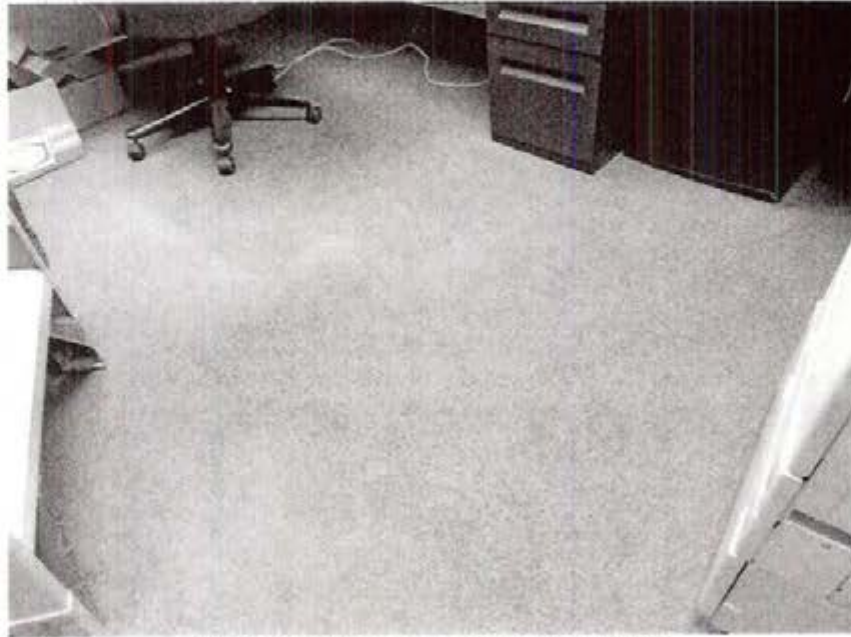
Photo 7: Worn carpet in office G-26.

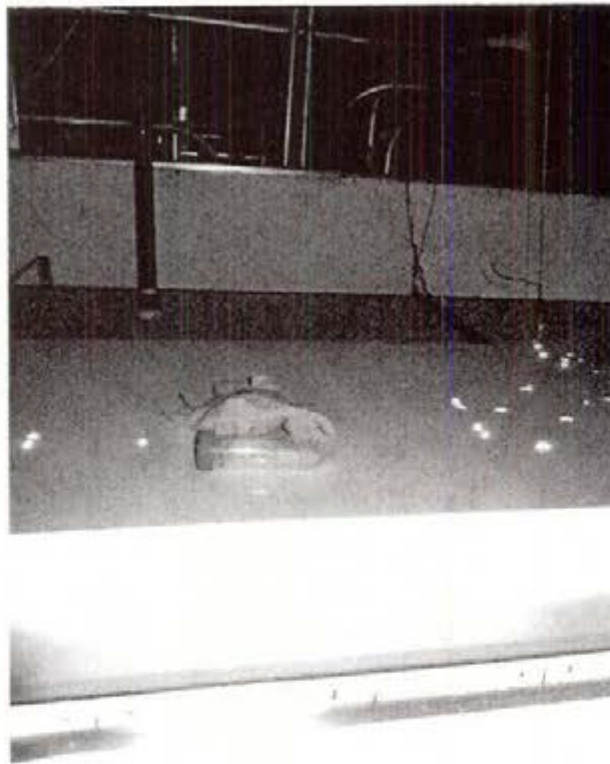
Photo 8: Lead wipe sample (042414-IFR-W-01) collected from the top of a fluorescent light fixture; above the drop ceiling of the copy room.

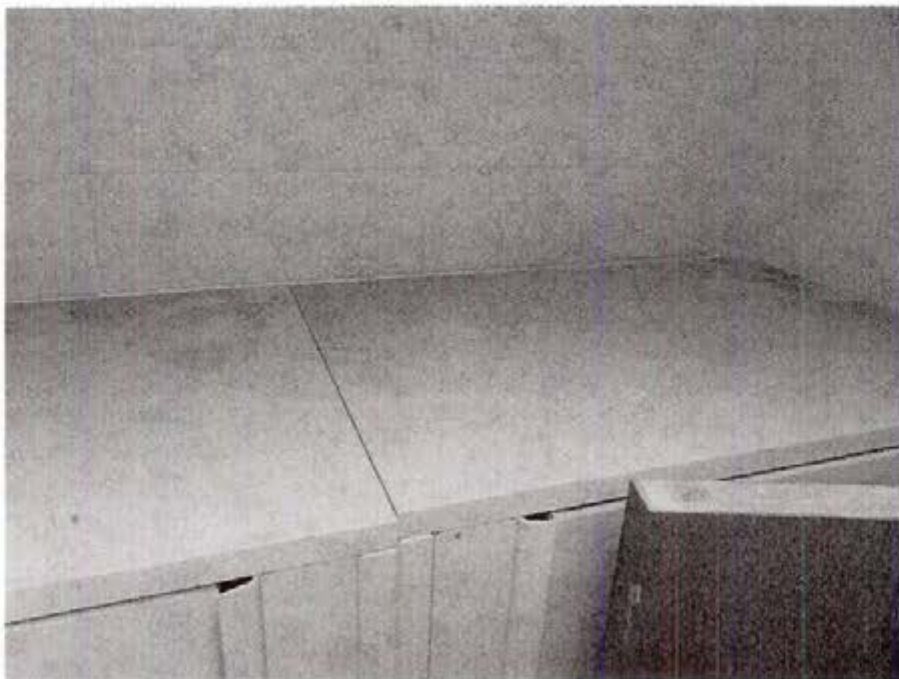
Photo 9: Lead wipe sample (042414-IFR-W-02) collected from the top of the metal cabinets in the copy room.

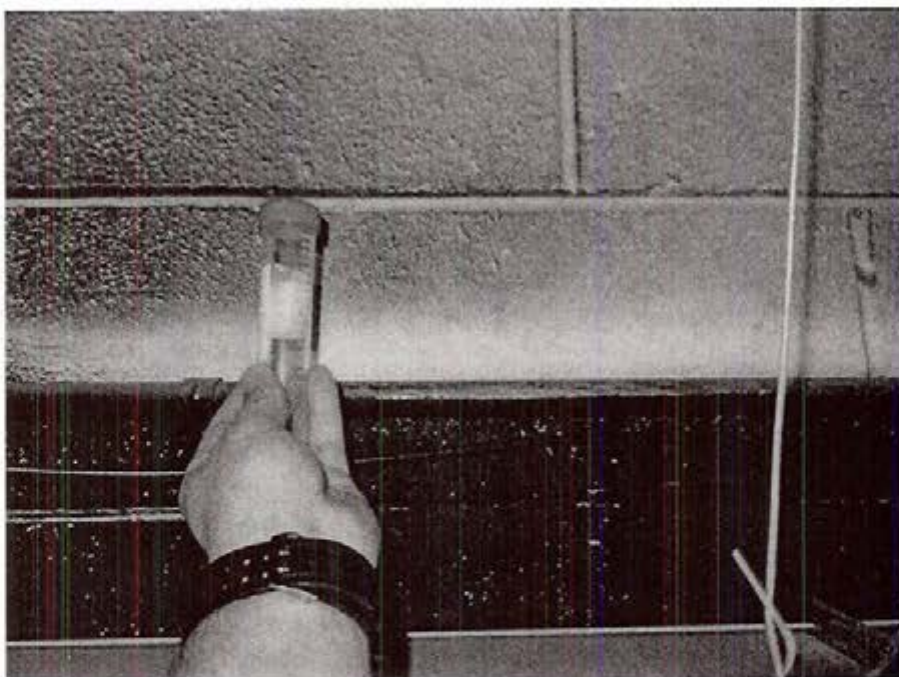
Photo 10: Lead wipe sample (042414-IFR-W-03) collected from the shell wall and attached conduit; above the drop ceiling of the east wall of the conference room.

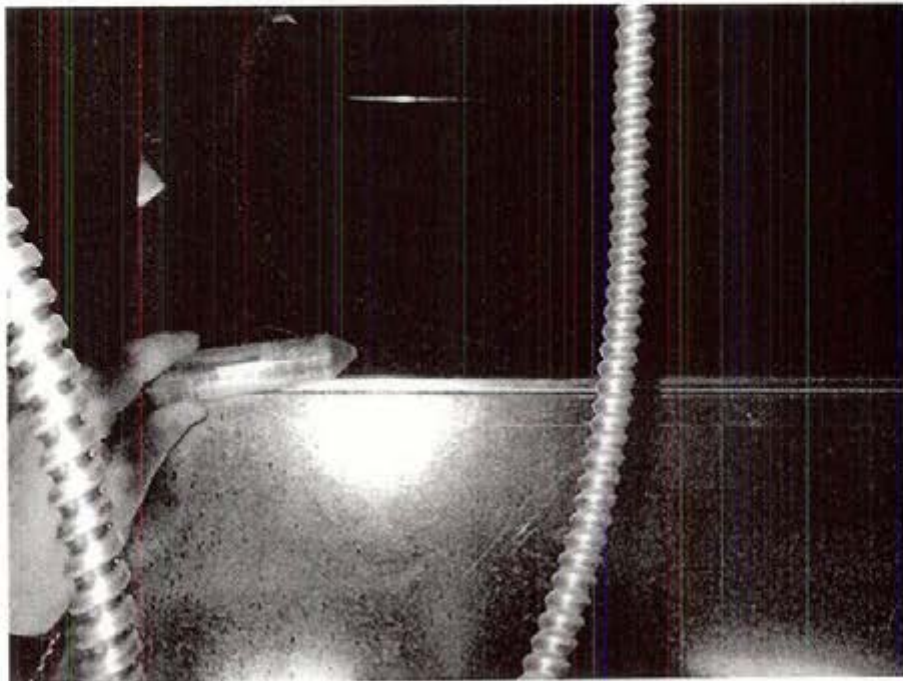
Photo 11: Lead wipe sample (042414-IFR-W-04) collected from the top of a metal duct; above the drop ceiling of the east wall of the conference room.

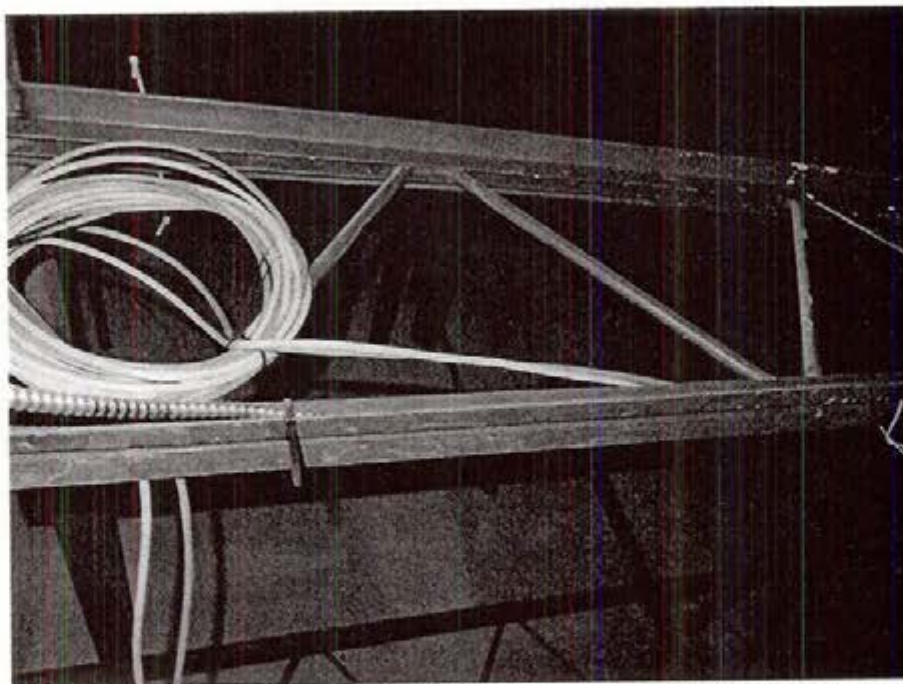
Photo 12: Lead wipe sample (042414-IFR-W-05) collected from a metal cable tray; above the drop ceiling of the west wall of the conference room.

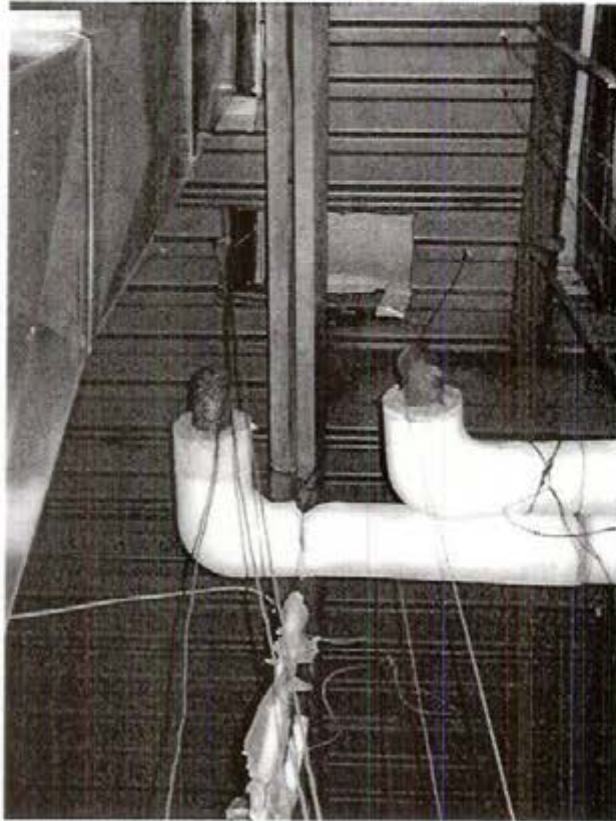
Photo 31: Hole on the roof deck; Plenum Access Point #6.

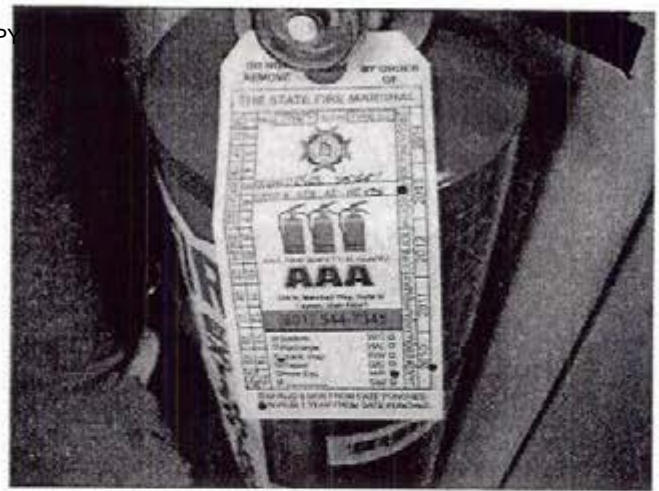
Photograph 8
Fire extinguishers in both buildings have not had annual inspections.

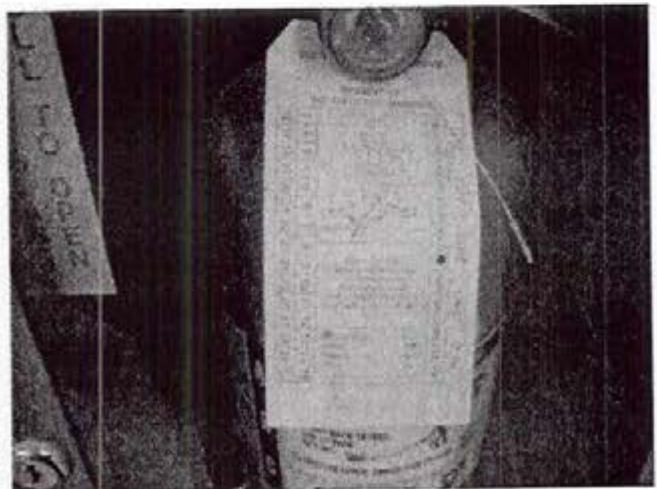
Photograph 4
Logan Armory, Fire extinguisher not current on annual inspection in kitchen
