ARMY NATIONAL GUARD INDUSTRIAL HYGIENE - SOUTHWEST

Industrial Hygiene Site Assistance Visit

Anacortes Readiness Center 2219 M Avenue Anacortes, WA 98221

SUBJECT: Executive Summary for the Industrial Hygiene Survey of Anacortes Readiness Center at 2219 M Ave, Anacortes, WA on 20 JUN 2012.

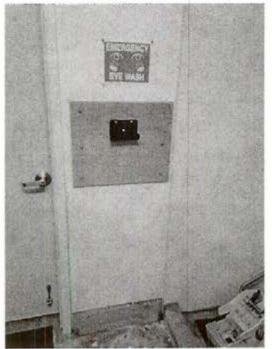
Photo 13: Building 6A chemical storage/use are missing an emergency eyewash station.

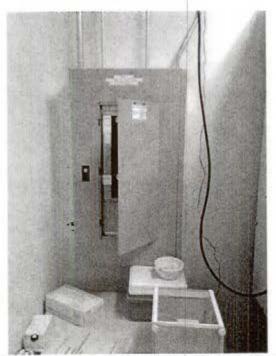
Photo 14: Obstructed electrical panel in the biological safety hood room in Building 6A.

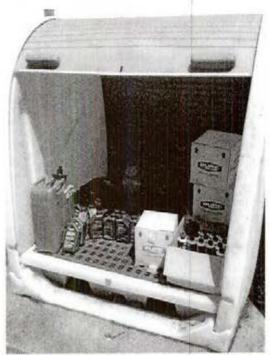
Photo 19: POL storage shed located behind Building 6A, missing inventory and MSDS.

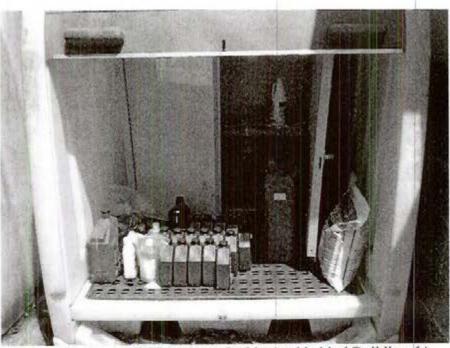
Photo 20: Second POL storage shed located behind Building 6A, missing inventory and MSDS.

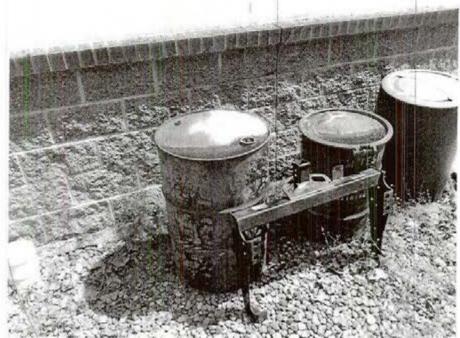
Photo 21: Rusted drums stored behind Building 6A, reportedly used for training exercises.

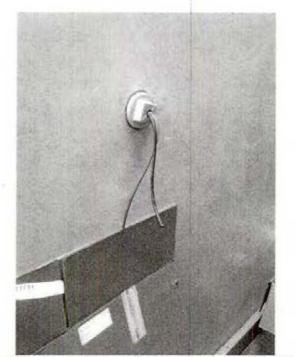
Photo 22: Loose wiring on the western wall of Building 6A.

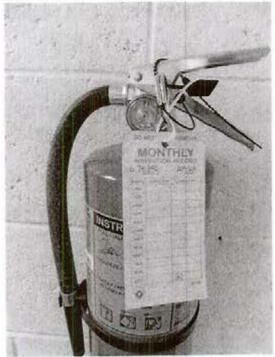
Photo 7: Fire extinguisher missing monthly inspections and annual servicing dates.

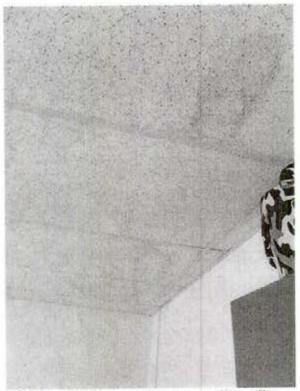
Photo 12: Water staining on ceiling tiles.

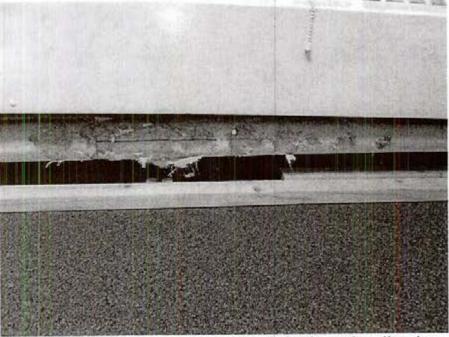
Photo 4: Damaged Thermal System Insulation beneath wall register of West Wall of Room 107.

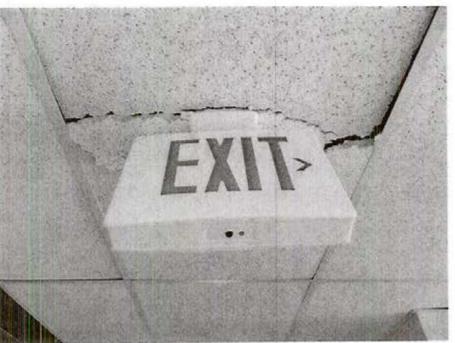
Photo 5: Exit sign in main hallway, operational but anchored to broken ceiling tile.

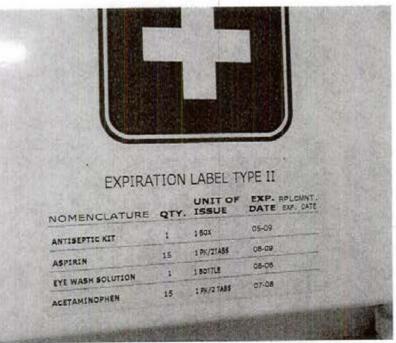
Photo 6: First aid kit with expired supplies.

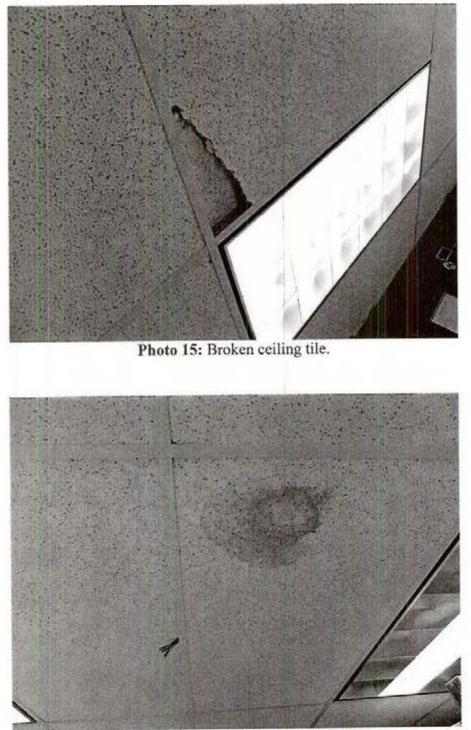
Photo 16: Water staining on ceiling tile.

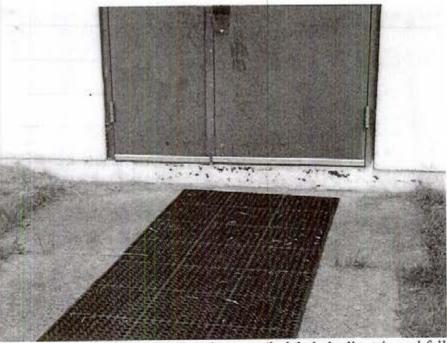
Photo 24: Entrance to Building, improperly labeled; slip, trip and fall hazard.

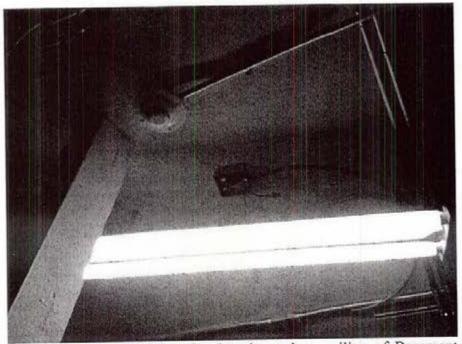
Photo 22: Uncovered junction box located on ceiling of Basement Supply Room 011.
