FINAL Preliminary Assessment Report McEntire Army Aviation Support Facility, South Carolina

Perfluorooctanesulfonic Acid (PFOS) and Perfluorooctanoic Acid (PFOA) Impacted Sites ARNG Installations, Nationwide

October 2020

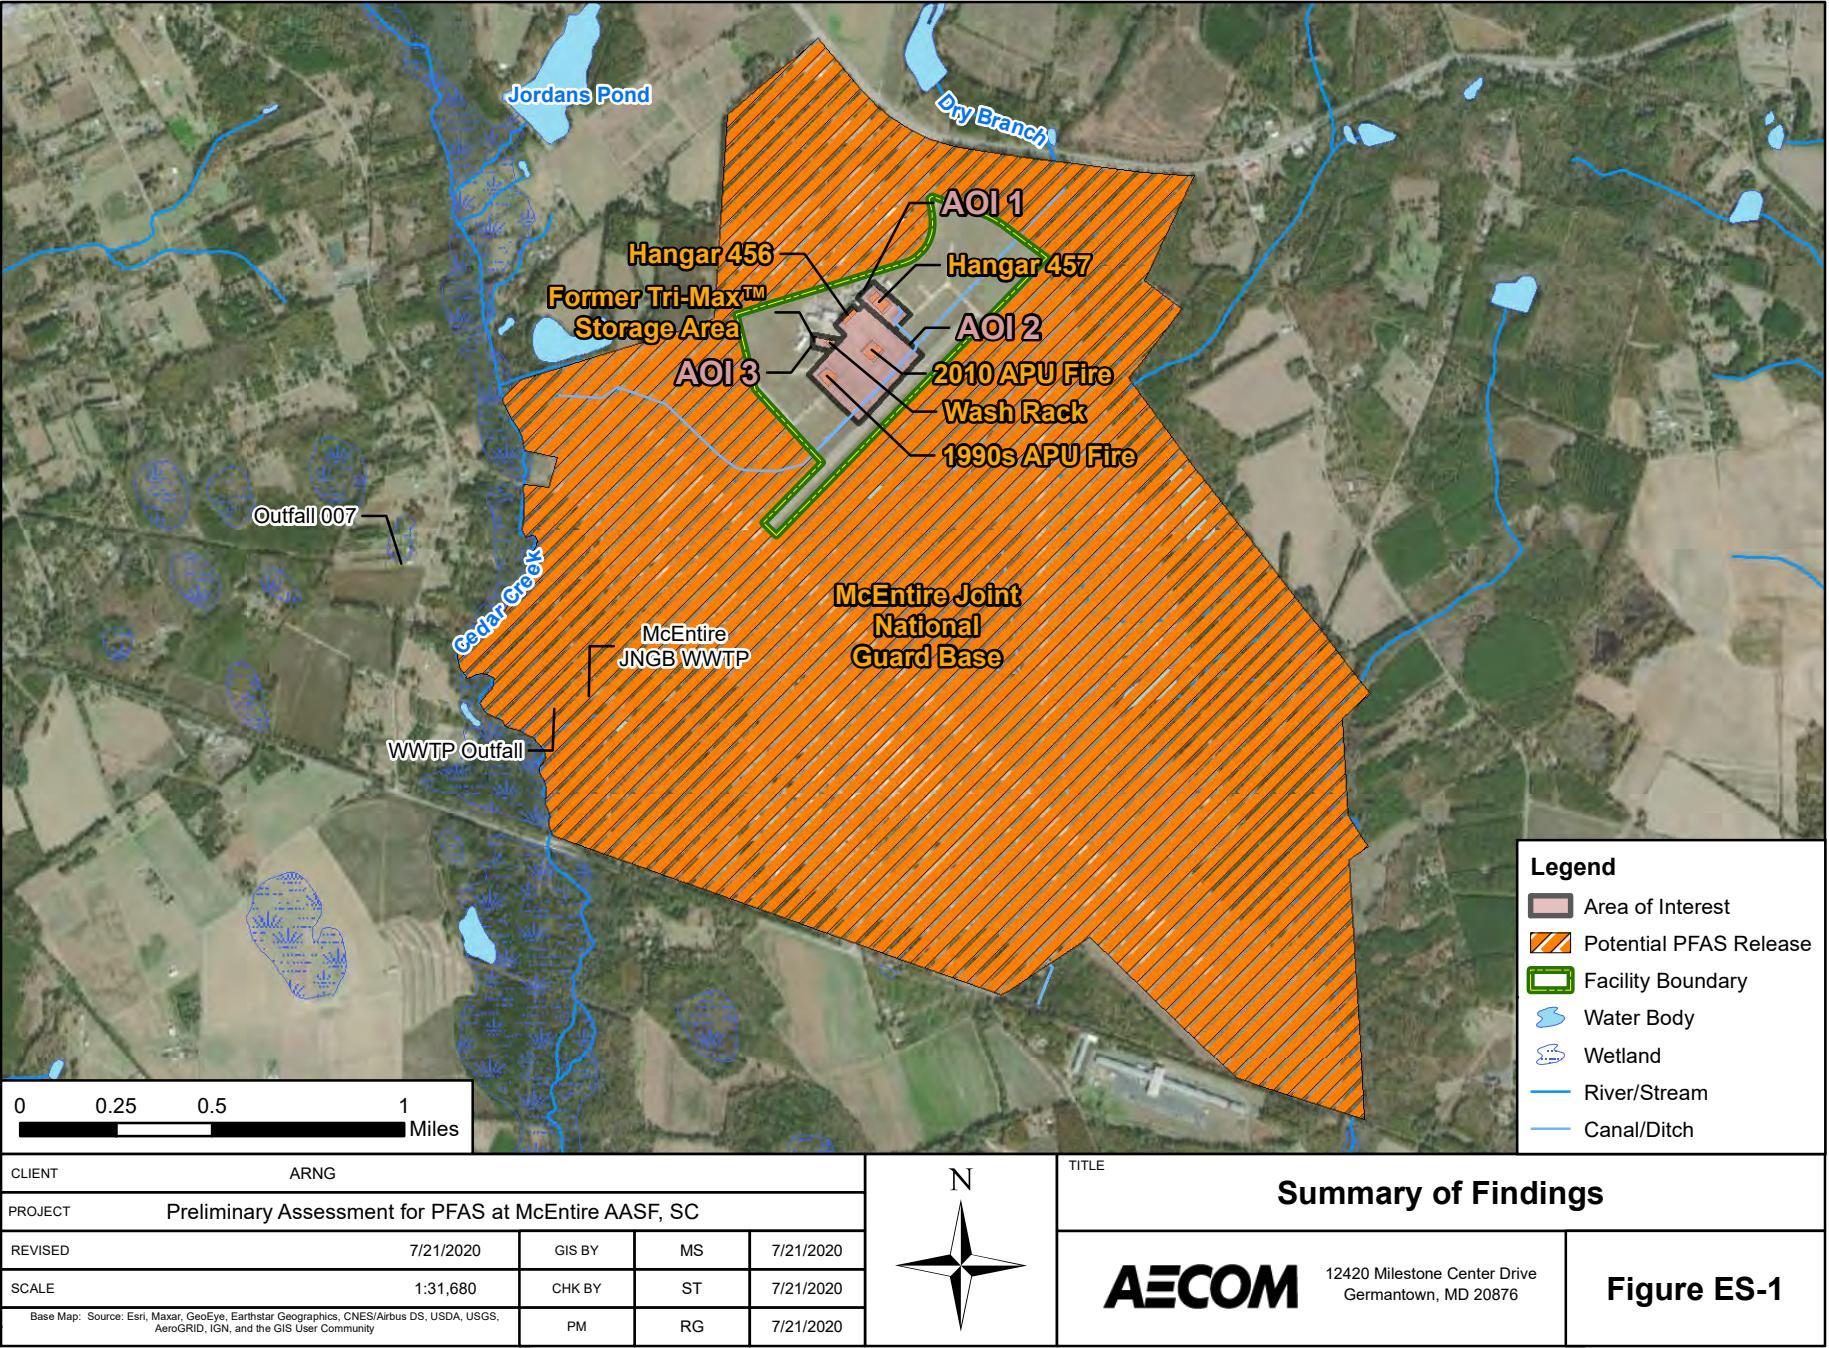
Three AOIs related to PFAS releases were identified at the McEntire AASF during the PA. The AOIs are shown on **Figure ES-1** and described in **Table ES-1** below:

Area of Interest	Name	Used by	Potential Release Dates
AOI 1	Hangar 457	SCARNG	2013
AOI 2	Helicopter Apron & Hangar 456	SCARNG	1990s/2010/2015
AOI 3	Building 467 & Wash Rack	SCARNG	1990s-2000s

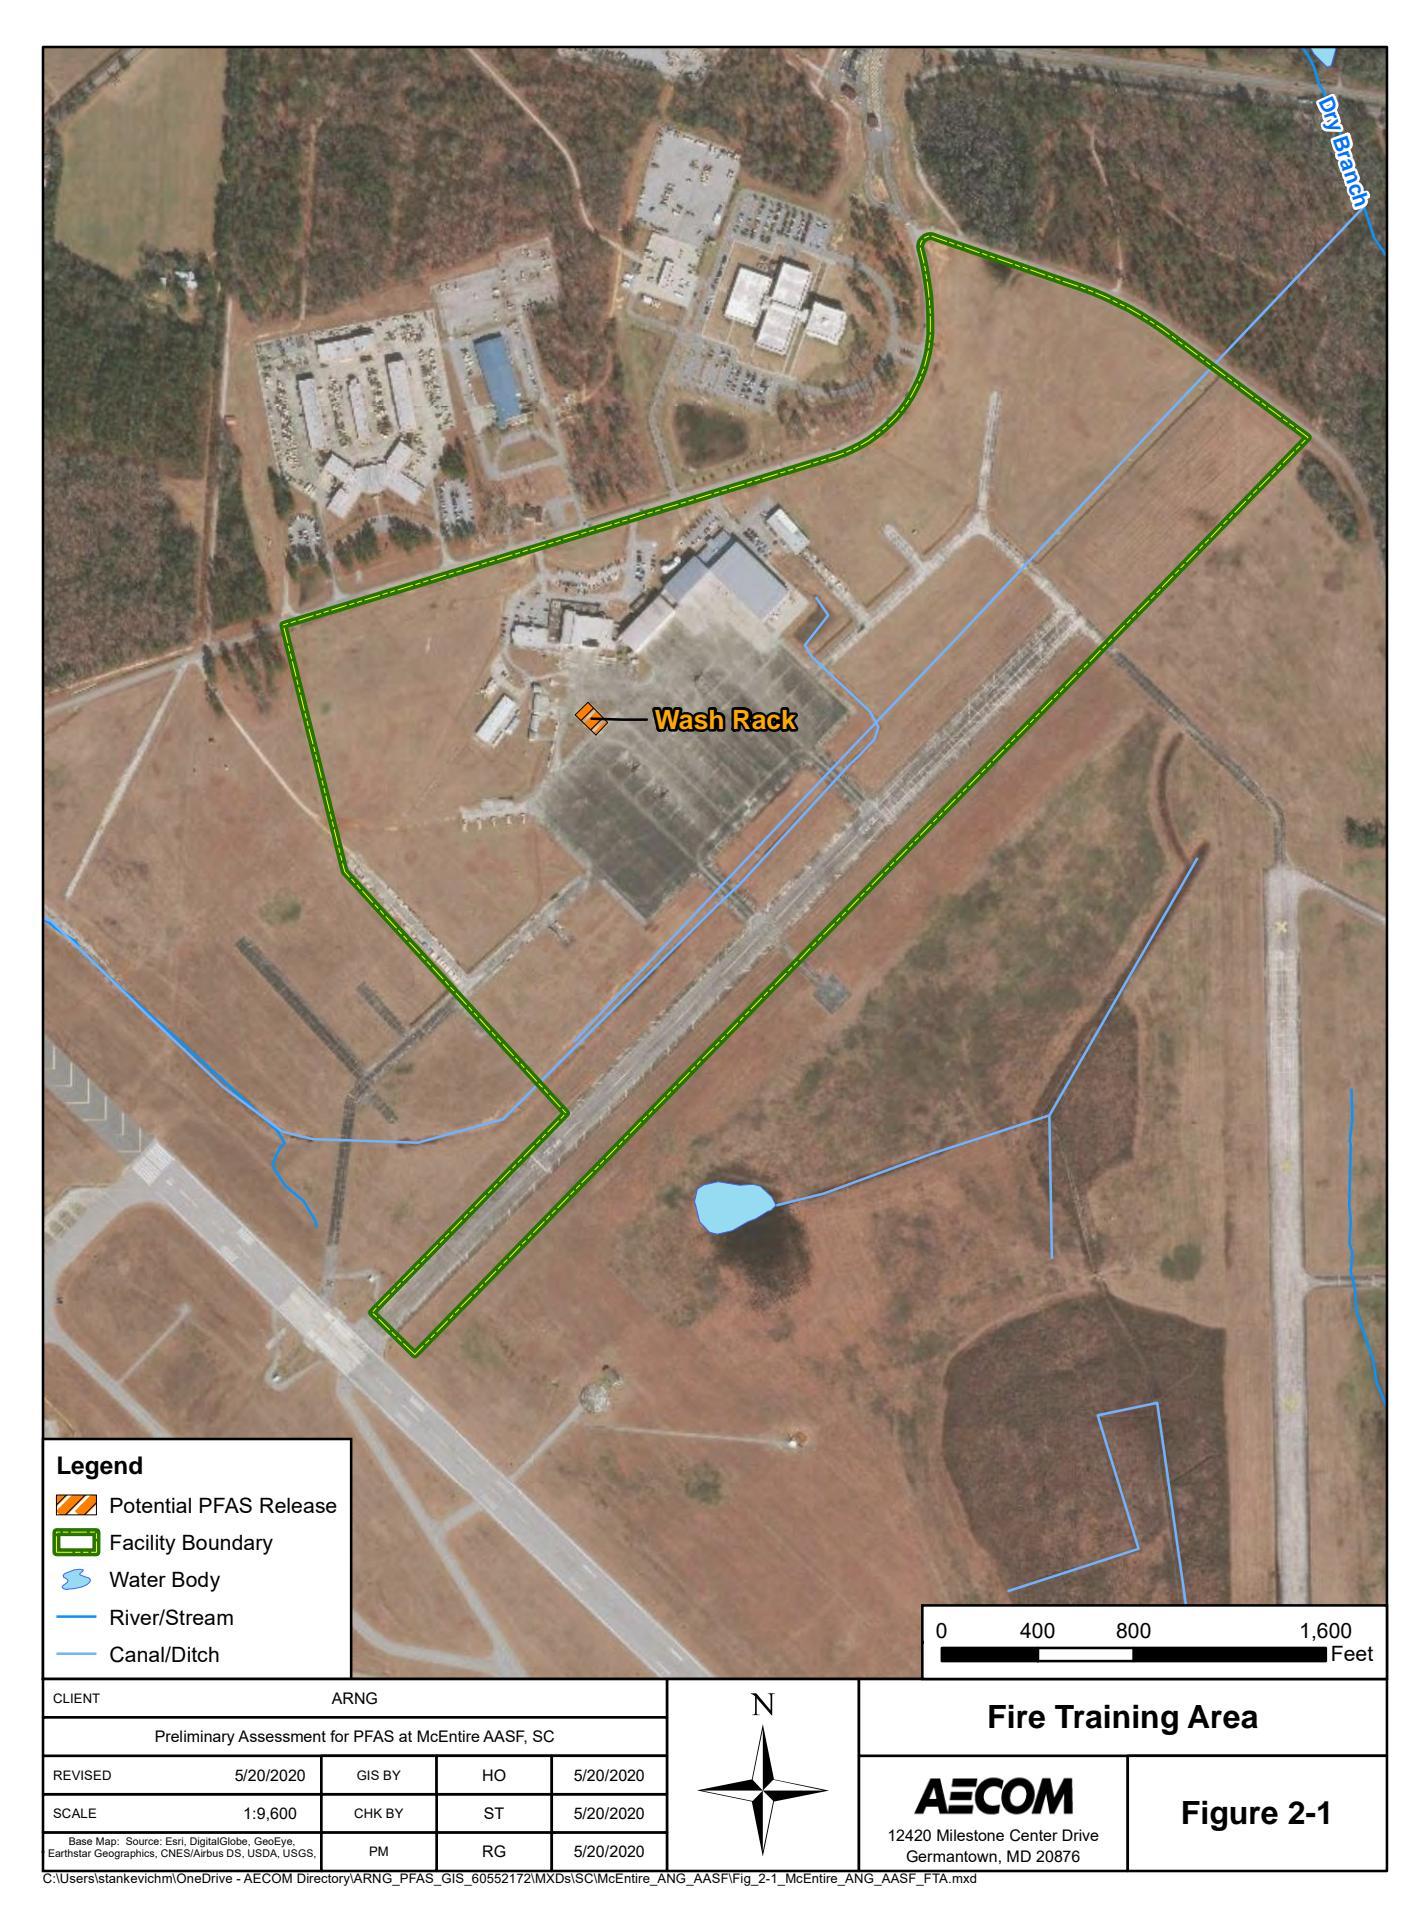
One FTA was identified at the McEntire AASF during the PA. A description of the FTA is presented below, and the location is shown on **Figure 2-1**. Photographs of the FTA appear in **Appendix C**.

Based on PA interviews, the wash rack was formerly used as an FTA from the 1990s to sometime in the 2000s, possibly as late as 2010. Interviewees with tenure going back to 1991 confirmed that this was the only FTA associated with the AASF to their knowledge. During the active timeframe of the FTA, the FTA was used between one and three times per year. Each event consisted of fully discharging one Tri-Max[™] 30 cart until it was empty. Trainees each took a turn operating the Tri-Max[™] and took part in simulated egress and rescue activities during the training events at the wash rack. No live-fire training took place at the FTA. No outside entities came to the facility for fire training; the FTA was only used by SCARNG AASF personnel. The releases occurred directly to the asphalt in the wash rack and drained through a storm grate before entering a diversion structure where the position of a valve determines the fate of the drain water. During the AFFF releases, the valve diverted the water to the sanitary sewer after passing through an oil-water separator. While the wash rack is inactive, the valve is set to divert water to the stormwater outfall (Outfall #007). During equipment washing, the wash rack water is diverted to the sanitary sewer. If oil and grease are mixed with the drained water, the water is diverted to a holding tank and later pumped out by a contractor. Sometime in July 2015, helicopters and tools located in Hangar 456 were washed in the wash rack after being covered in AFFF due to a malfunction of the suppression system in the hangar. The AFFF rinsate drained through the grate at the wash rack and was diverted to the sanitary sewer. Due to the AFFF releases at the wash rack, it is possible that residual PFAS on the asphalt in the wash rack were inadvertently transported with other drain water to the stormwater outfall, sanitary sewer, and holding tank. The geographic coordinates of the FTA are 33° 55' 56.77"N; 80° 48' 18.93"W.

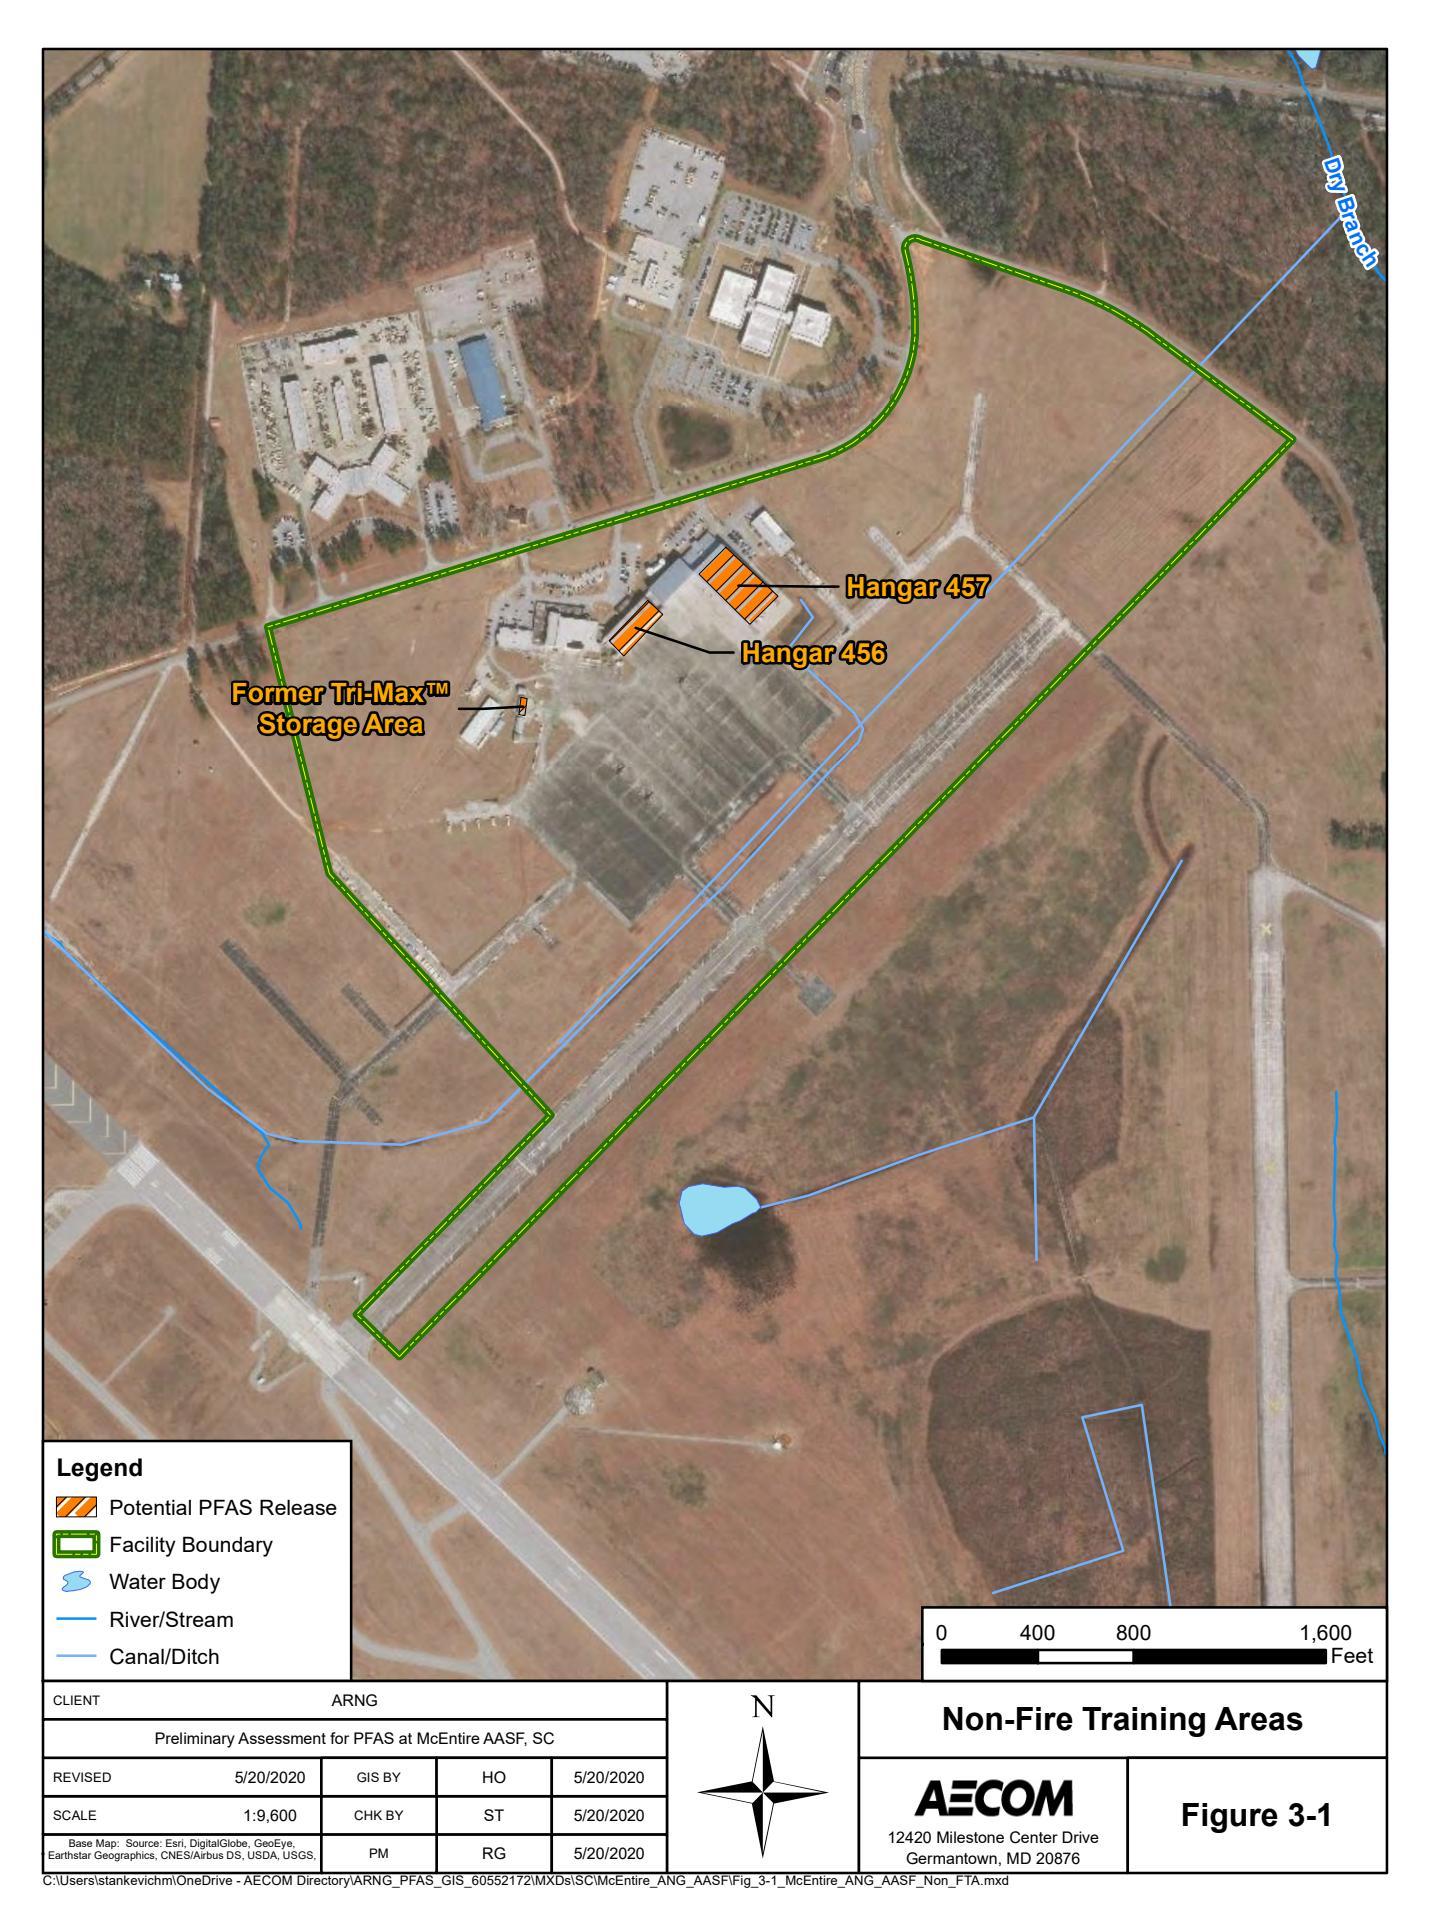
In addition to FTAs, the PA evaluated areas where PFAS-containing materials may have been broadly used, stored, or disposed. This may include buildings with fire suppression systems, paint booths, AFFF storage areas, and areas of compliance demonstrations. Information on these features obtained during the PA are included in **Appendices A** and **B**. Three non-FTAs where AFFF may have been released were identified during the PA. A description of each non-FTA is presented below, and the non-FTAs are shown on **Figure 3-1**. Photographs of the non-FTAs appear in **Appendix C**.

To the interviewees' knowledge, four separate AFFF releases are associated with this hangar. In 2013, a contractor performed a flow test of the system and released an unknown amount of AFFF from an exterior door to the asphalt located outside the northern wall of the hangar. This release drained to a storm grate approximately 100 feet southeast of the discharge, where it was diverted to the stormwater retention pond. A separate incident in 2013 resulted in an AFFF release of 5 gallons when one of the nozzle heads in the hangar suppression system malfunctioned. The AFFF was pushed outside the hangar doors. Sometime after 2013, two leaks occurred in the suppression system and caused AFFF releases to the utility room floor and through an exterior pipe outside the building. An unknown volume of AFFF was released to the utility room floor, which drained to the sanitary sewer through a floor drain. It is also possible that some volume of the AFFF was mopped up and discharged outside of the same location as the flow test. The leak outside the building was estimated to be no more than 5 gallons and was discharged to the grass.

To the interviewees' knowledge, a malfunction of the system in July 2015 caused a release of an unknown volume of AFFF from one of the nozzles in the hangar. The AFFF under the nozzle was reportedly confined to a small area of the hangar, with some small spherical pieces of foam blowing out of the hangar. The AFFF was pushed outside the hangar and was allowed to drain onto the surrounding storm grates. The AFFF had also coated three helicopters and several tools, which were rinsed in the wash rack. The wash rack water was drained to the sanitary sewer. No other known releases were associated with the suppression system in Hangar 456, including scheduled maintenance and testing activities.

In the past, the building housed four Tri-Max[™] 30 carts, which were all turned into the state in 2010. To the interviewees' knowledge, no other AFFF was stored in the building; however, it is unknown where the AFFF was stored for the Tri-Max[™] units. No known leaks or spills have occurred in the building, but none of the interviewees have direct experience with maintaining the Tri-Max[™] units. Former AASF personnel were responsible for maintaining the ground support equipment and were unavailable for interview. It is reasonable to assume that all AFFF filling and transfers of the Tri-Max[™] units were performed in or near this building. Historically, a bambibucket had been stored in the building along with an old firetruck that only carried water. An unknown type of firefighting gel had also been formerly stored in the building, but it is unknown whether the agent contained PFAS.

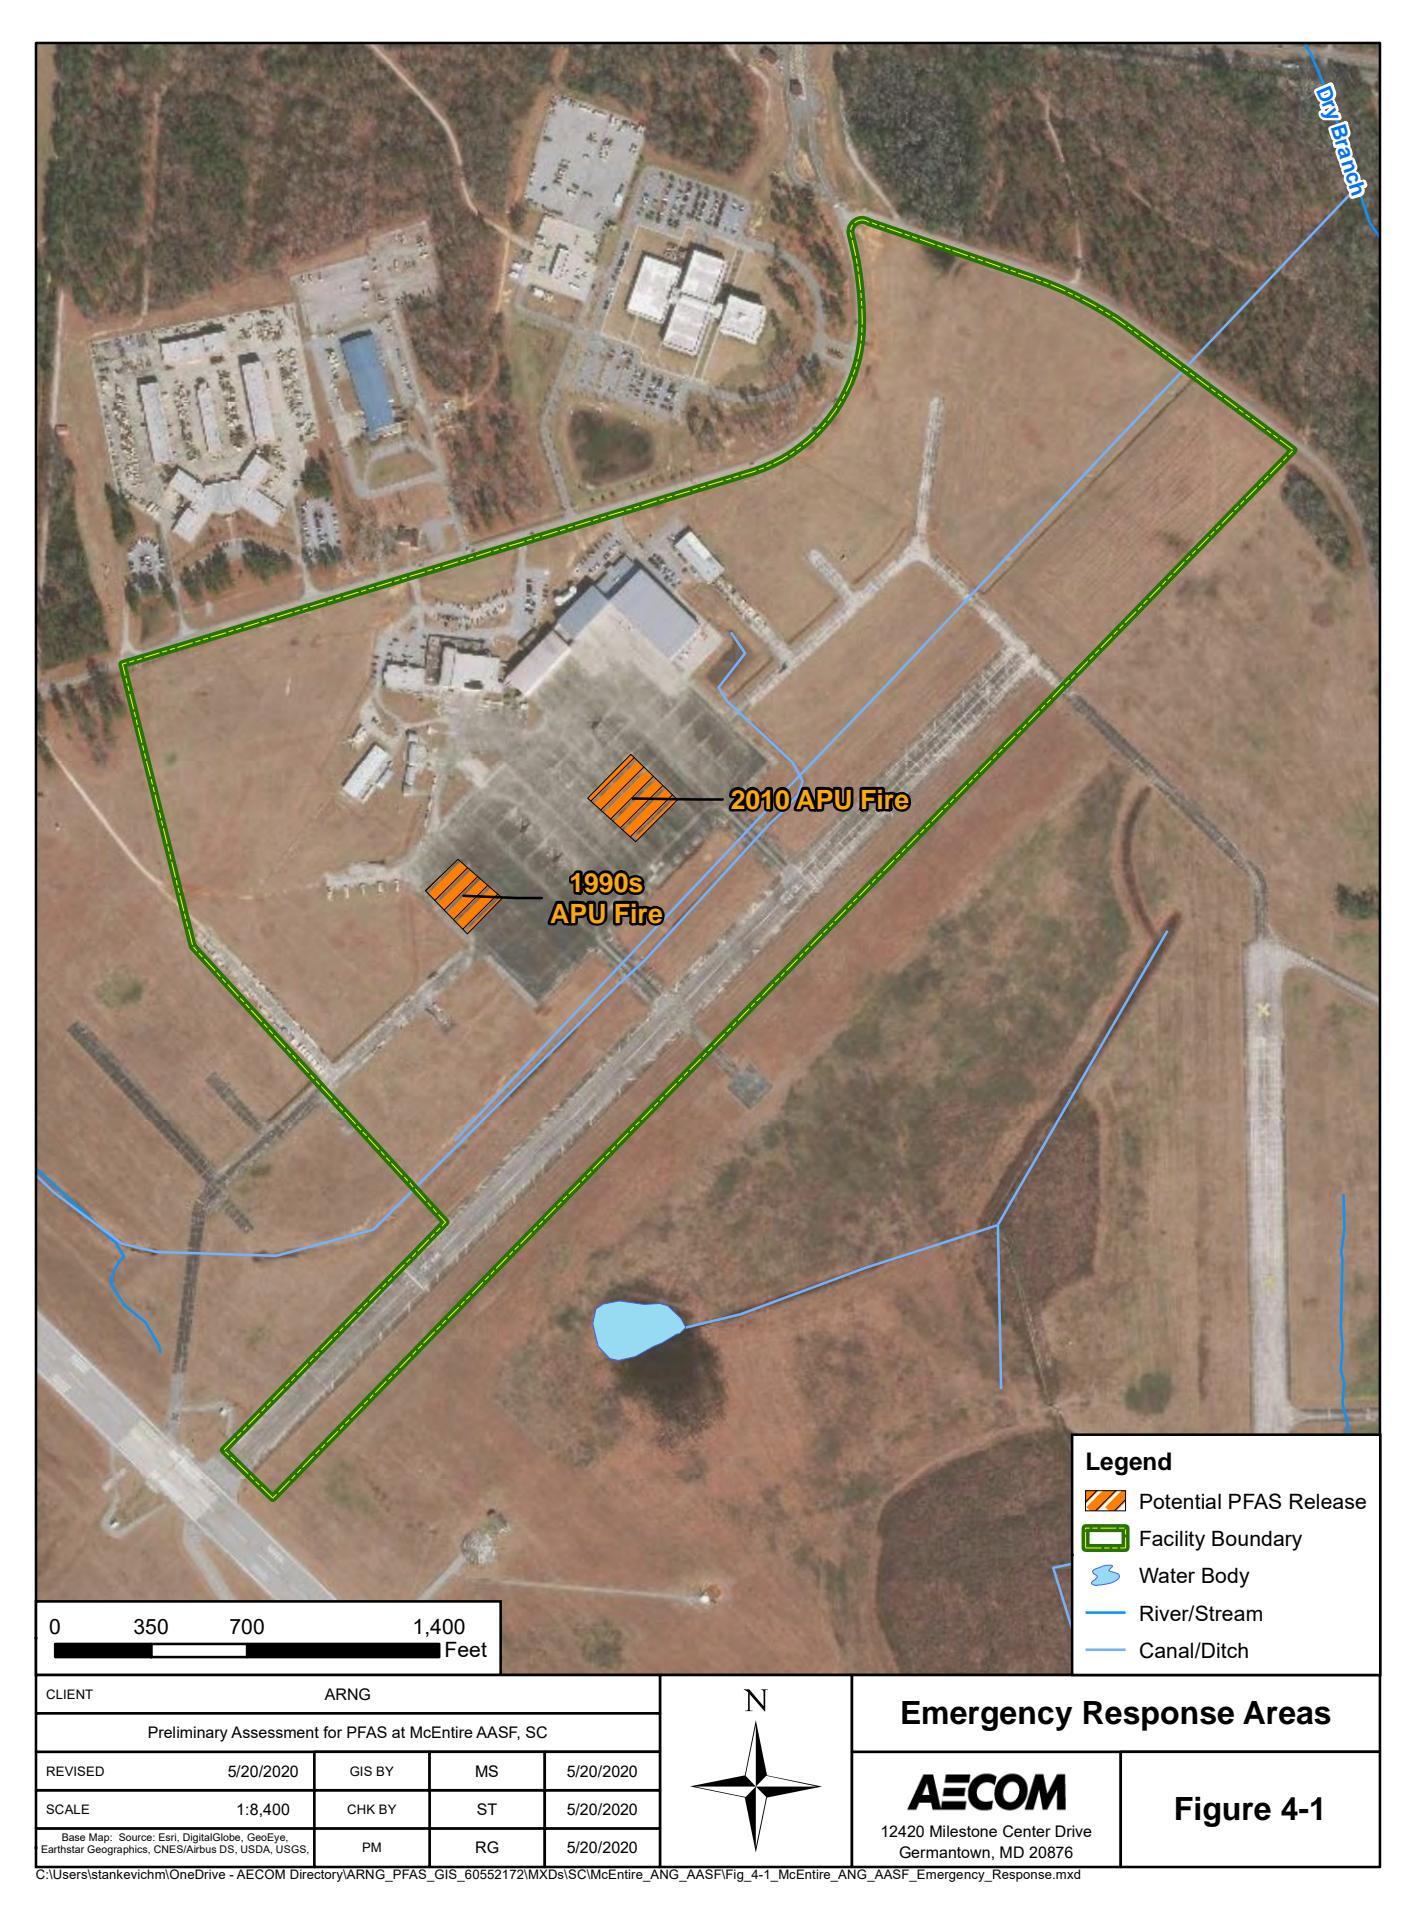
Sometime in the 1990s, the auxiliary power unit (APU) on a helicopter parked on the apron caught fire and was extinguished by AASF personnel using AFFF dispensed from a Tri-Max[™] 30 unit. The entire 30-gallon capacity of one Tri-Max[™] unit was used to extinguish the fire. The incident occurred near the southwestern edge of the helicopter apron. The approximate geographic coordinates of the AFFF release are 33°55′51.56″N; 80°48′18.91″W.

In 2010, another APU fire occurred on a helicopter parked on the apron. The fire was extinguished by AASF personnel using AFFF dispensed from a Tri-Max[™] 30 unit, and the total estimated volume of AFFF released during the incident was 5 gallons. The emergency response occurred near the center of the helicopter apron. The approximate geographic coordinates of the AFFF release are 33°55'55.35"N; 80°48'11.54"W.

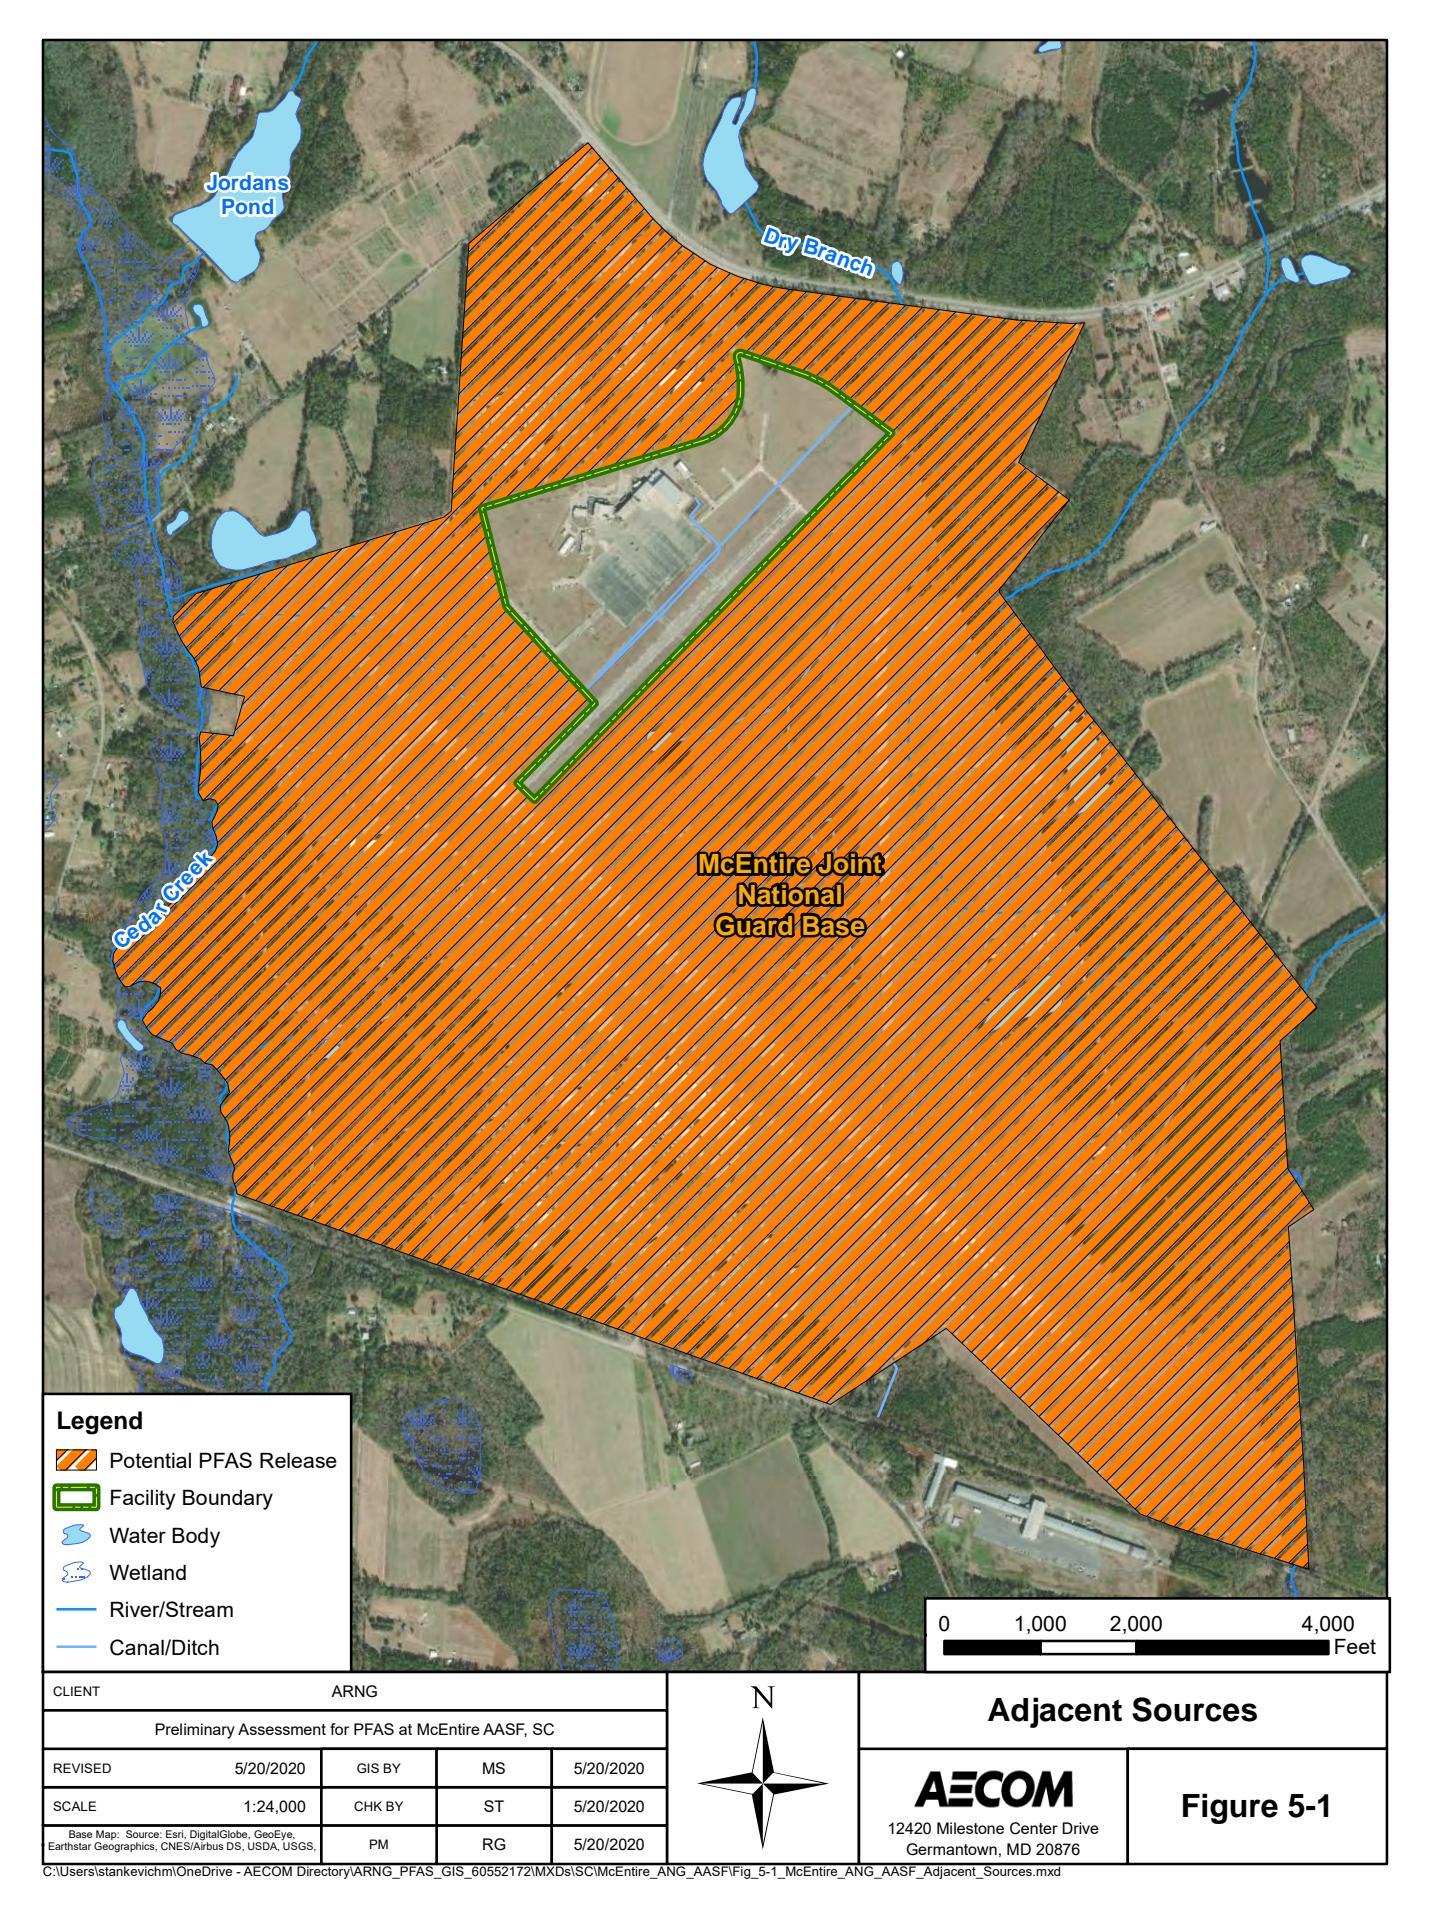
One potential off-facility PFAS source was identified adjacent to the McEntire AASF during the PA. The location of potential off-facility source area is shown on **Figure 5-1**.

The McEntire AASF is an enclave of McEntire JNGB, with the remaining areas affiliated with the South Carolina ANG. The ANG Firefighting unit provides mutual aid to the AASF; however, AASF personnel confirmed that the ANG firefighters never applied AFFF on the AASF property. The ANG fire station is located to the northwest of the control tower and currently stores AFFF and AFFF-charged equipment. An SI for PFAS was performed at the McEntire JNGB in 2018. The SI investigated 17 potential release locations affiliated with ANG activities and identified exceedances of the screening criteria for PFOS/PFOA for groundwater or surface water at 11 potential release locations (Leidos, 2019). The PFAS SI report for McEntire JNGB is included in **Appendix A**.

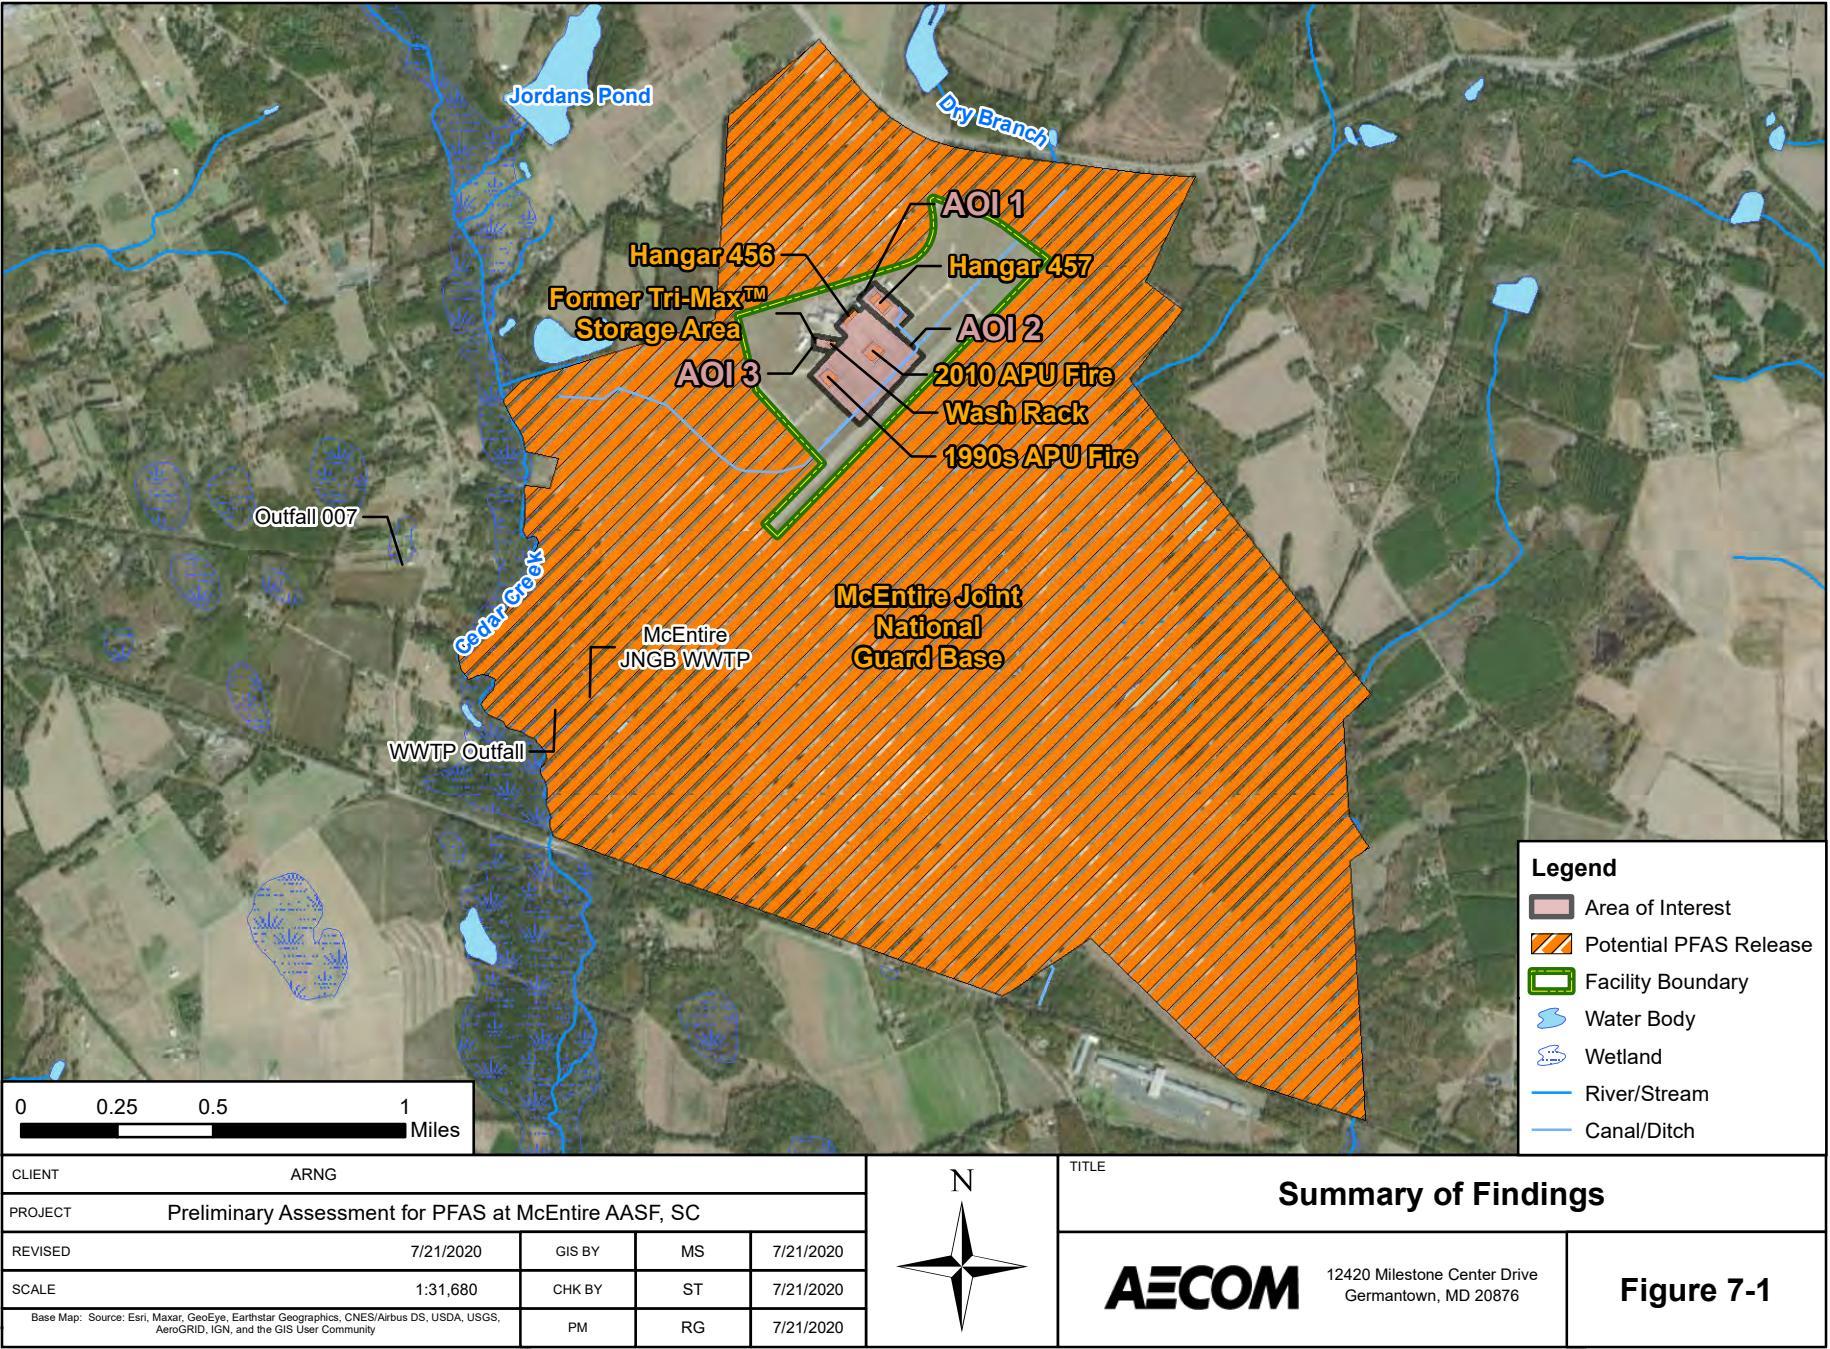
Table 7-3: PA Findings Summary

ARNG will evaluate the need for an SI at the McEntire AASF based on the potential receptors, the potential migration of PFAS contamination off the facility, and the availability of resources.
