FINAL Preliminary Assessment Report Florence Military Reservation, Florence, Arizona

Perfluorooctanesulfonic Acid (PFOS) and Perfluorooctanoic
Acid (PFOA) Impacted Sites
ARNG Installations, Nationwide

September 2020

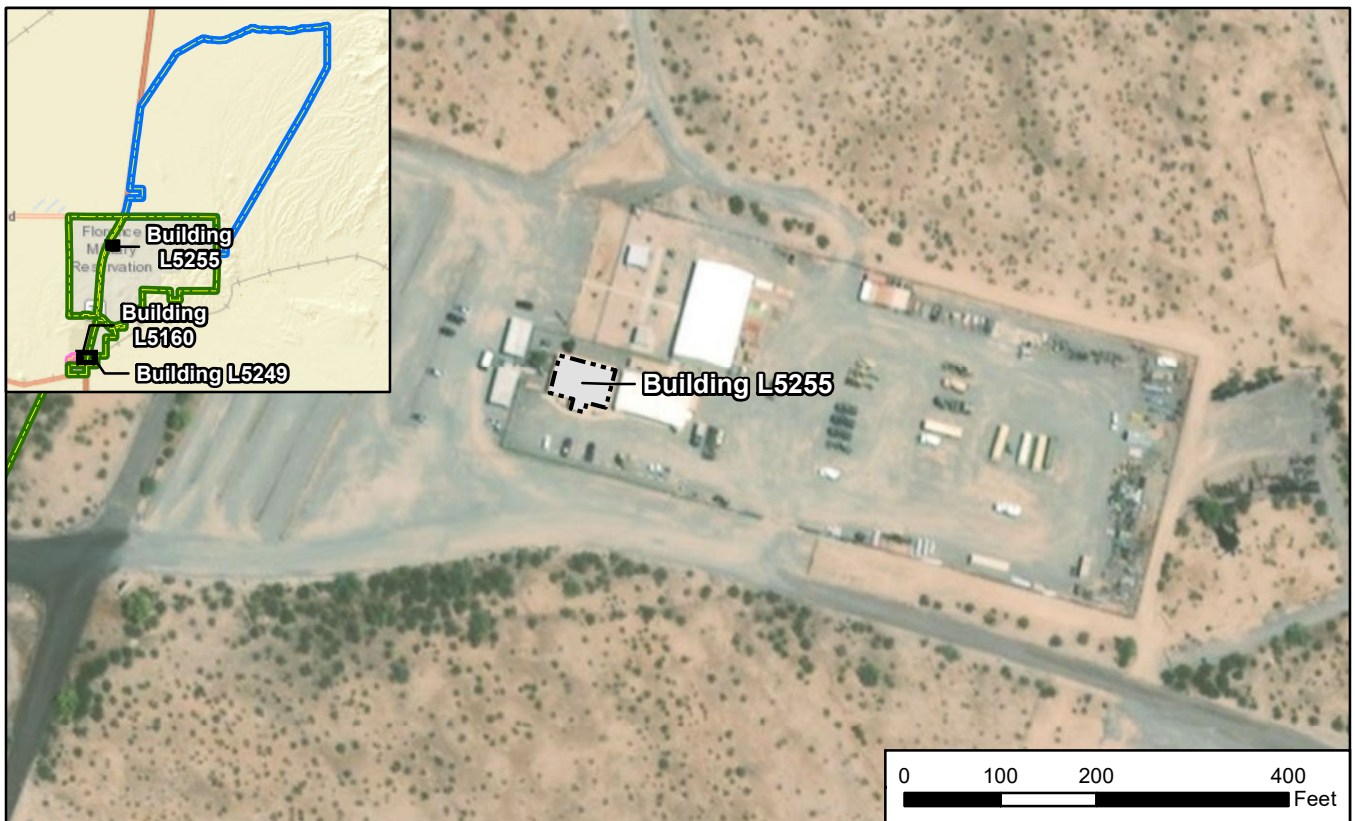
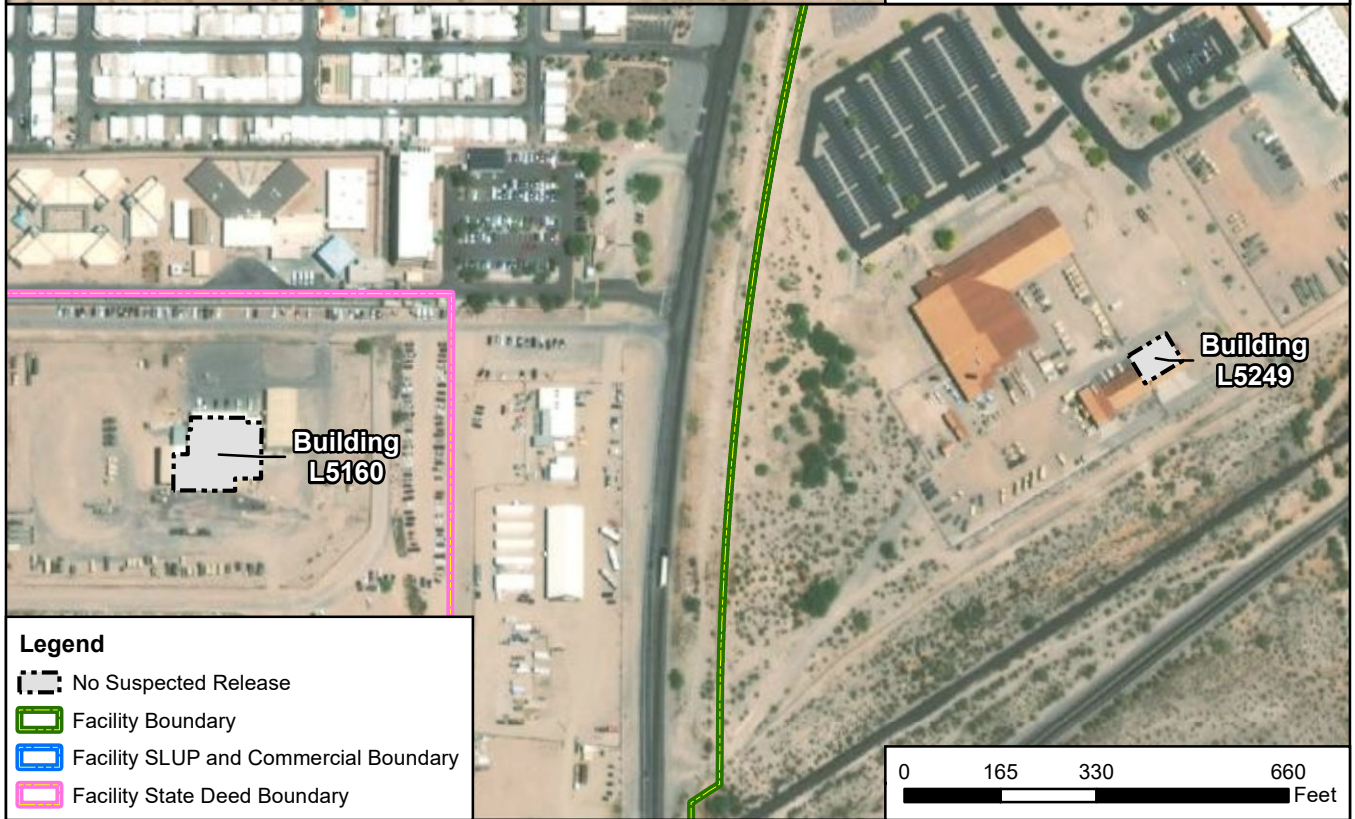
Figure ES-1

Three areas (firefighting bays [Building L5249], the Range Operations and Storage [Building L5255] building, and Vehicle Maintenance Shop [Building L5160]) have been identified as No Suspected Release (**Figure ES-1**). Based on the documented absence (2009-present) of the use or release of PFAS-containing materials at FMR, no AOIs were identified during the PA. The USEPA Unregulated Contaminant Monitoring Rule 3 (UCMR3) data indicate that PFOS/PFOA were not detected in a public water system above the USEPA Health Advisories within a 20-mile radius of the facility. PFAS analyses performed in 2016 had method detection limits that were higher than currently achievable. Thus, it is possible that low concentrations of PFAS were not detected during the UCMR3 but might be detected if analyzed today.

Summary of Findings

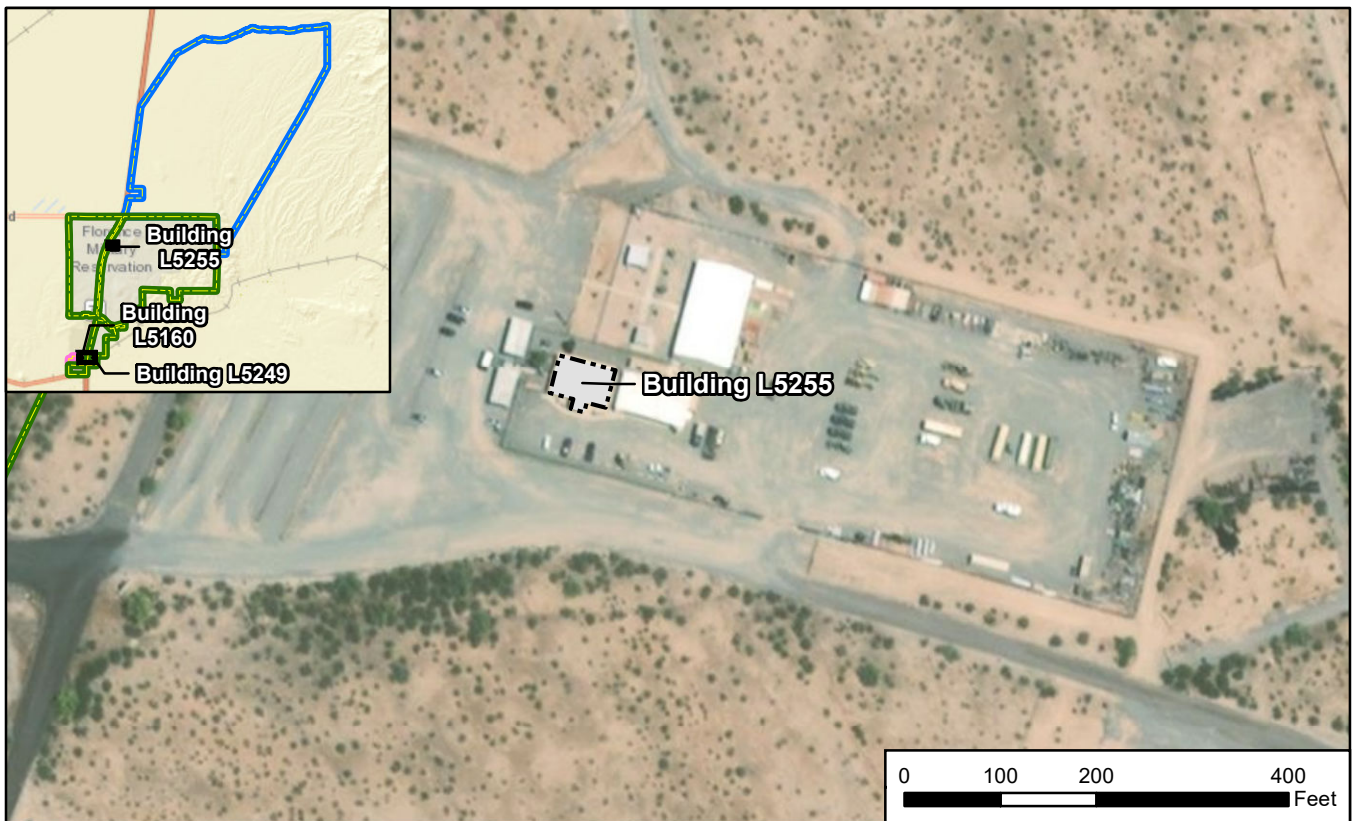
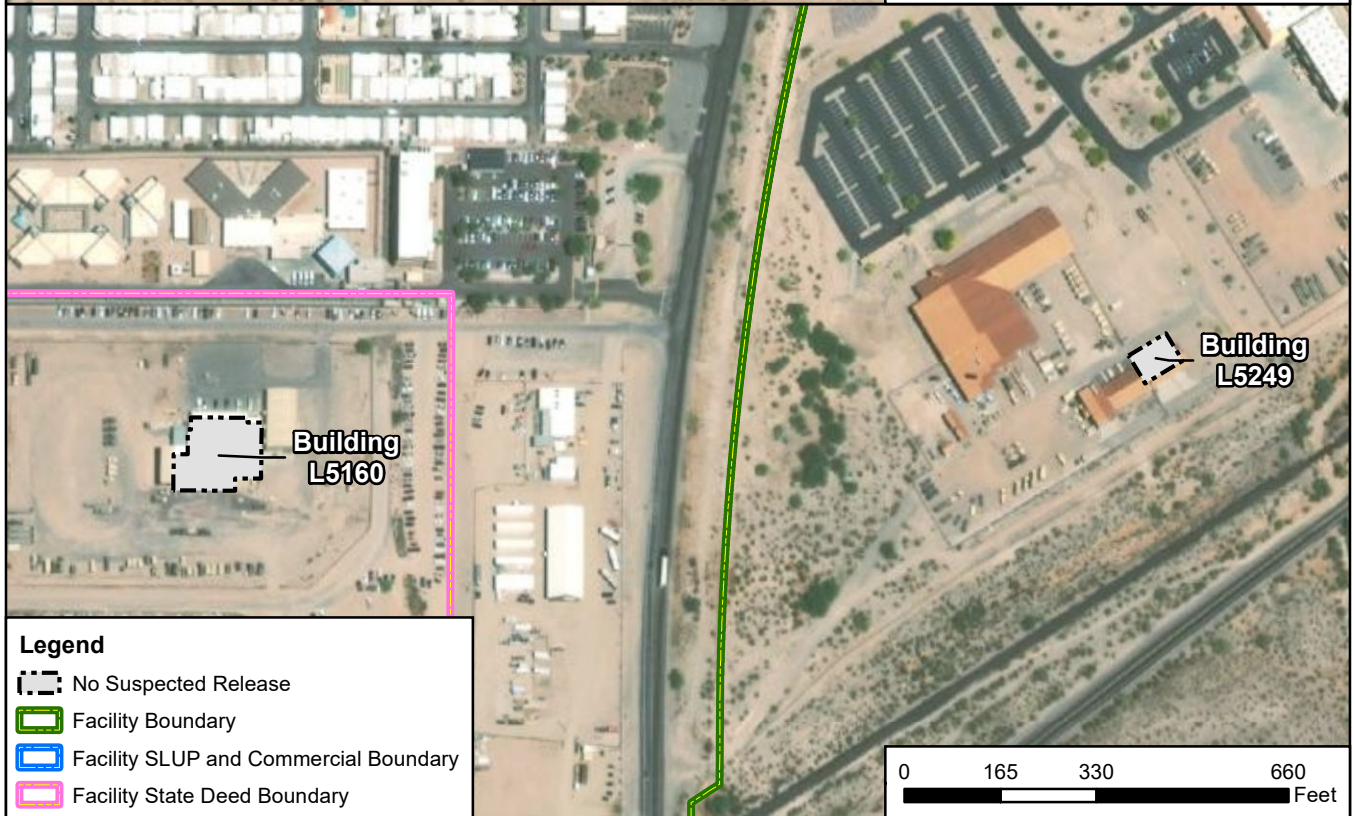
Figure 3-1

Three non-FTAs were identified as a result of this PA; however, no releases of AFFF are known or suspected to have occurred in these areas. Each non-FTA is described below and shown on **Figure 3-1**.

The firefighting bays (Building L5249) are located on the southeastern side of FMR. The geographical coordinates are 33°03'48.2"N and 111°22'34.4"W. A firetruck containing AFFF was previously stored on occasion in the firefighting bays (L5249). The firetruck was driven to SBAH for maintenance and use in fire training activities. FMR personnel stated the firetruck was not used or washed at FMR. The firetruck was removed from FMR sometime between 2011 and 2013, and the building currently serves as vehicle storage. The building is fitted with a fire suppression system that does not contain AFFF. Emergency response is provided by the town of Florence and Pinal County. No bulk AFFF was known to be stored at the facility. No releases of AFFF occurred at the firefighting bays (L5249), and PFAS release to the environment at the firefighting bays (L5249) is not suspected.

The Range Operations and Storage Building (Building L5255) is located on the northernmost side of FMR. The geographical coordinates are 33°06'24.86"N; 111°22'0.39"W. The Range Operations and Storage Building (L5255) contains buildings and an aboveground storage tank containment area. FMR currently does not have a fueling point, but one may have existed previously. During the site visit, Class A fire extinguishers were confirmed as the fire suppression agent used for the area. Local emergency services are provided by the town of Florence for significant fires on the ranges caused by tracers or other munitions. The few fires that have been started on the ranges have been put out with water or the use of flappers. In some cases, the fires were allowed to burn themselves out due to lack of vegetation in the area. No AFFF was used on the ranges. No releases of AFFF to the environment at the Range Operations and Storage Building (L5255) are suspected.

The Vehicle Maintenance Shop (Building L5160) is located on the southernmost side of FMR. The geographical coordinates are 33° 3'46.70"N; 111°22'53.80"W. Full vehicle maintenance is conducted in the maintenance shop. No reported vehicle fires or fire incidents in the maintenance shop. No AFFF extinguishers were ever present or used at the vehicle maintenance shop. No releases of AFFF to the environment at the Vehicle Maintenance Shop are suspected.

Non-Fire Training Areas

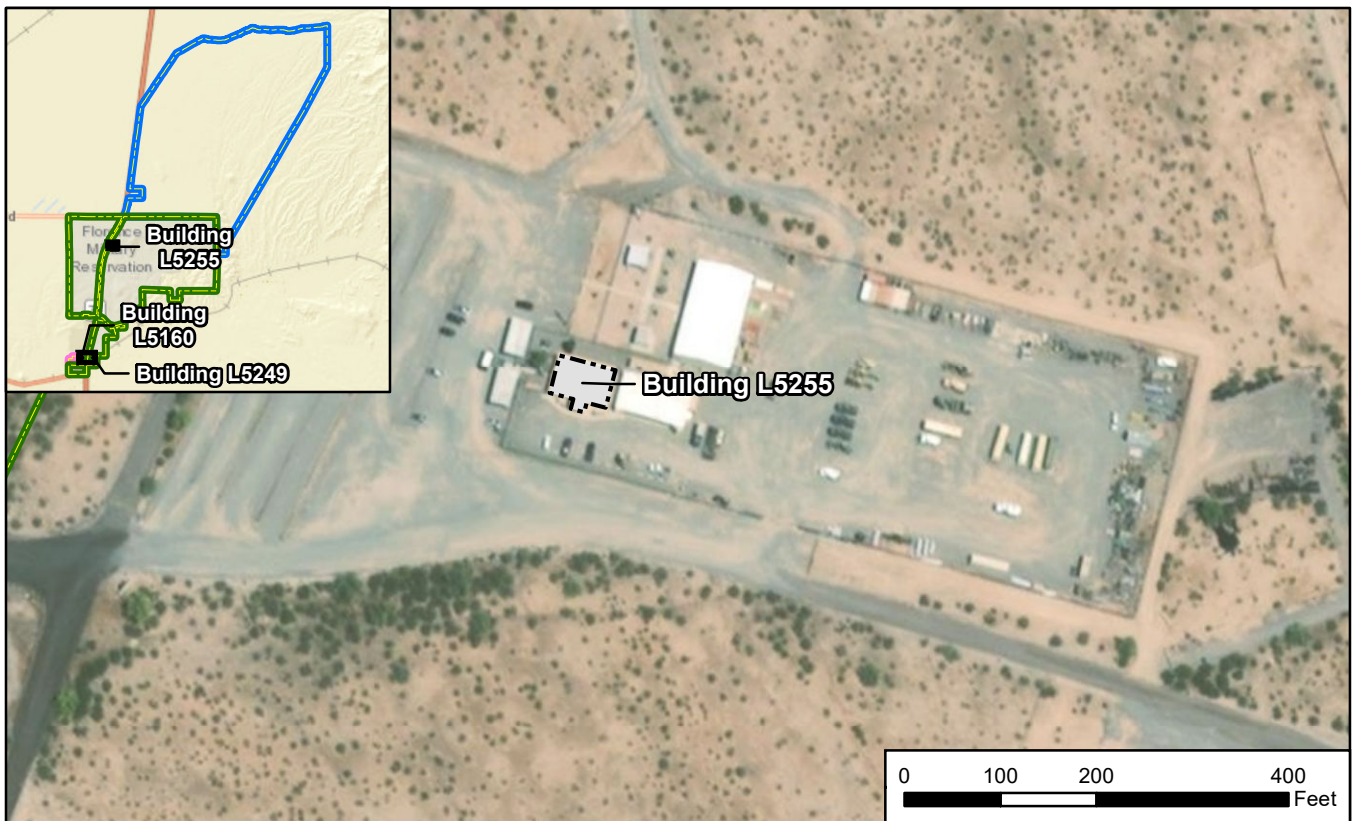
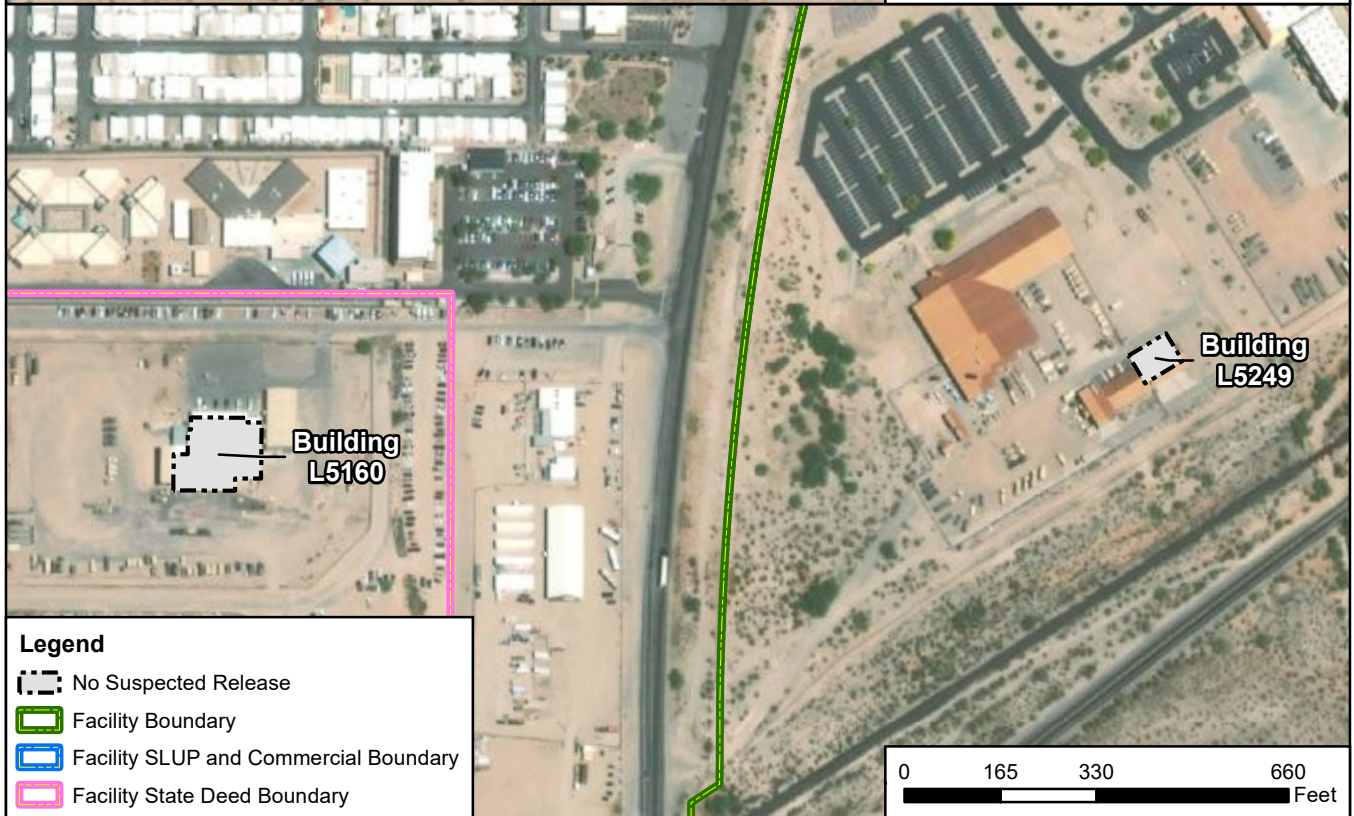
12420 Milestone Center Drive Germantown, MD 20876	Figure 7-1
REVISED	9/11/2020	GIS BY	MS	9/11/2020			
SCALE	1:2,400	CHK BY	MG	9/11/2020			
Base Map: Source: Esri, Maxar, GeoEye, Earthstar Geographics, CNES/Airbus DS, USDA, USGS,		PM	RG	9/11/2020

No PFAS releases relating to current or historical activities at FMR were identified during this PA. **Section 3 (Figure 7-1)** discusses three areas suspected of managing AFFF or PFAS. **Table 7-1** summarizes these areas and presents the rationale as to why they are not considered to be definite sources of PFAS:

Summary of Findings	
NOTES		Preliminary Assessment for PFAS at Florence MR, AZ

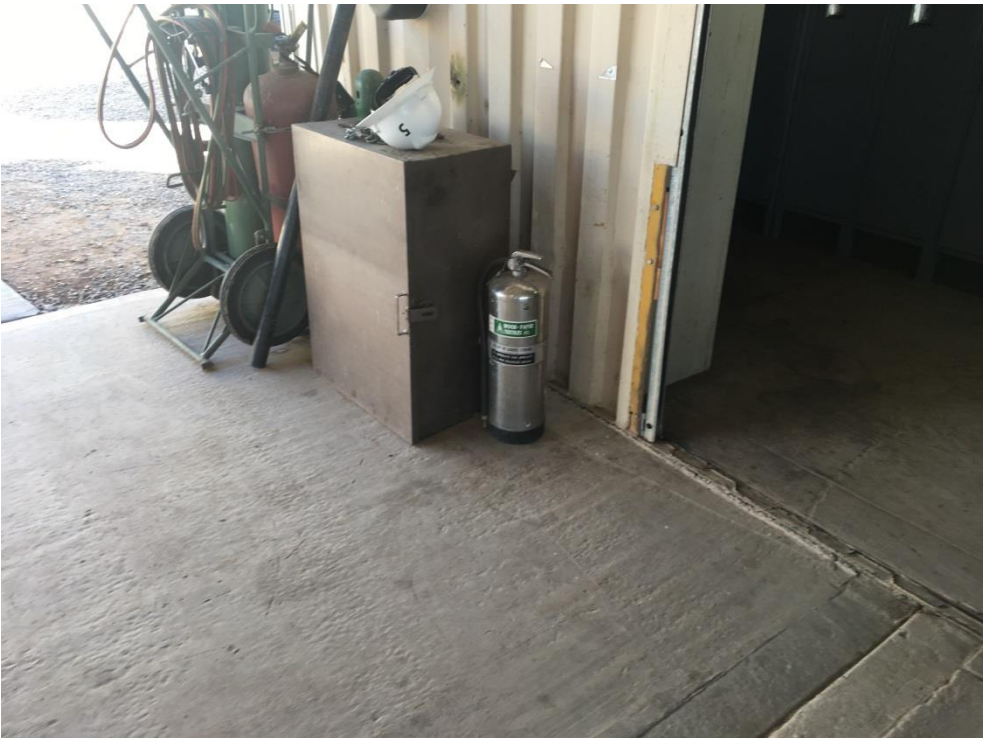
Army National Guard, Preliminary Assessment for PFAS	Florence Military Reservation	Florence, Arizona
<p>Photograph No. 1</p> <p>Description:</p> <p>Location: Range Operations and Storage Building (L5255)</p> <p>Looking east. ASTs situated on spill/overfill containment. Location is northern most Florence Military Reservation.</p> <p>Photo Date: 11/08/18</p>	 	
<p>Photograph No. 2</p> <p>Description:</p> <p>Location: Range Operations and Storage Building (L5255)</p> <p>Looking northeast. Typical Class A fire extinguisher located at the facility. Location is northern most Florence Military Reservation.</p> <p>Photo Date: 11/08/18</p>

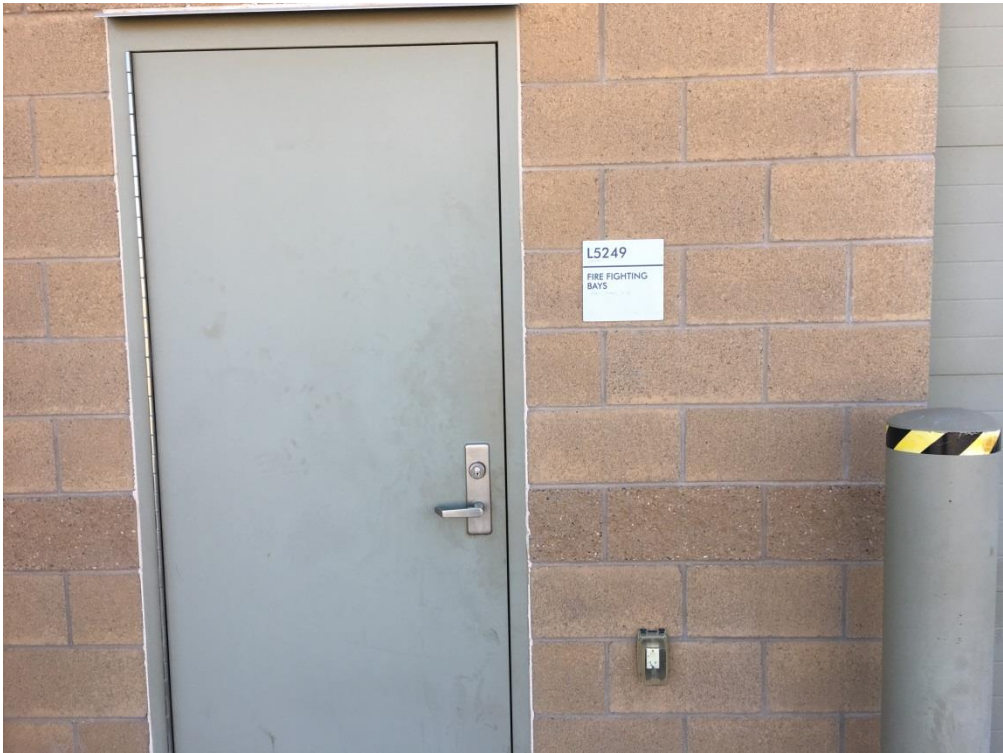
APPENDIX C – Photographic Log		
Army National Guard, Preliminary Assessment for PFAS	Florence Military Reservation	Florence, Arizona
Photograph No. 3 Description: Location: Fire Fighting Bays (L5249) Looking east. Entry door to fire bays. Location is southeastern Florence Military Reservation. Photo Date: 11/08/18

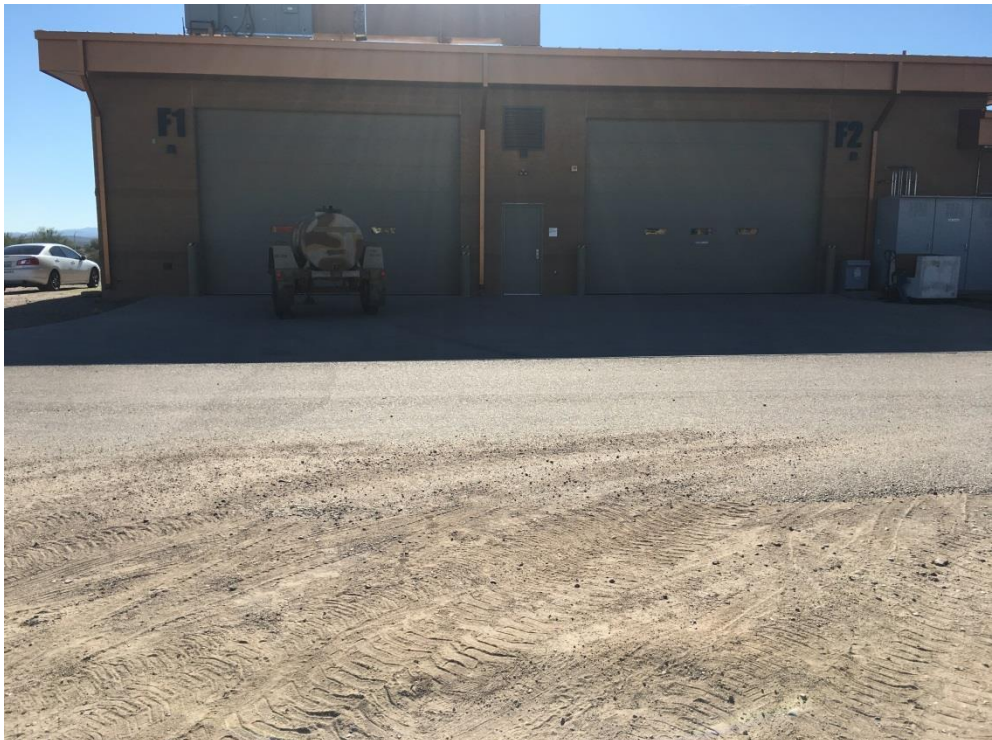
Photograph No. 4 Description: Location: Fire Fighting Bays (L5249) Looking east. West side of Fire bay. Location is southeastern Florence Military Reservation. Photo Date: 11/08/18
