FINAL Preliminary Assessment Report Mansfield Lahm Fire Station Mansfield, Ohio

Perfluorooctane-Sulfonic Acid (PFOS) and Perfluorooctanoic
Acid (PFOA) Impacted Sites
ARNG Installations, Nationwide

August 2019

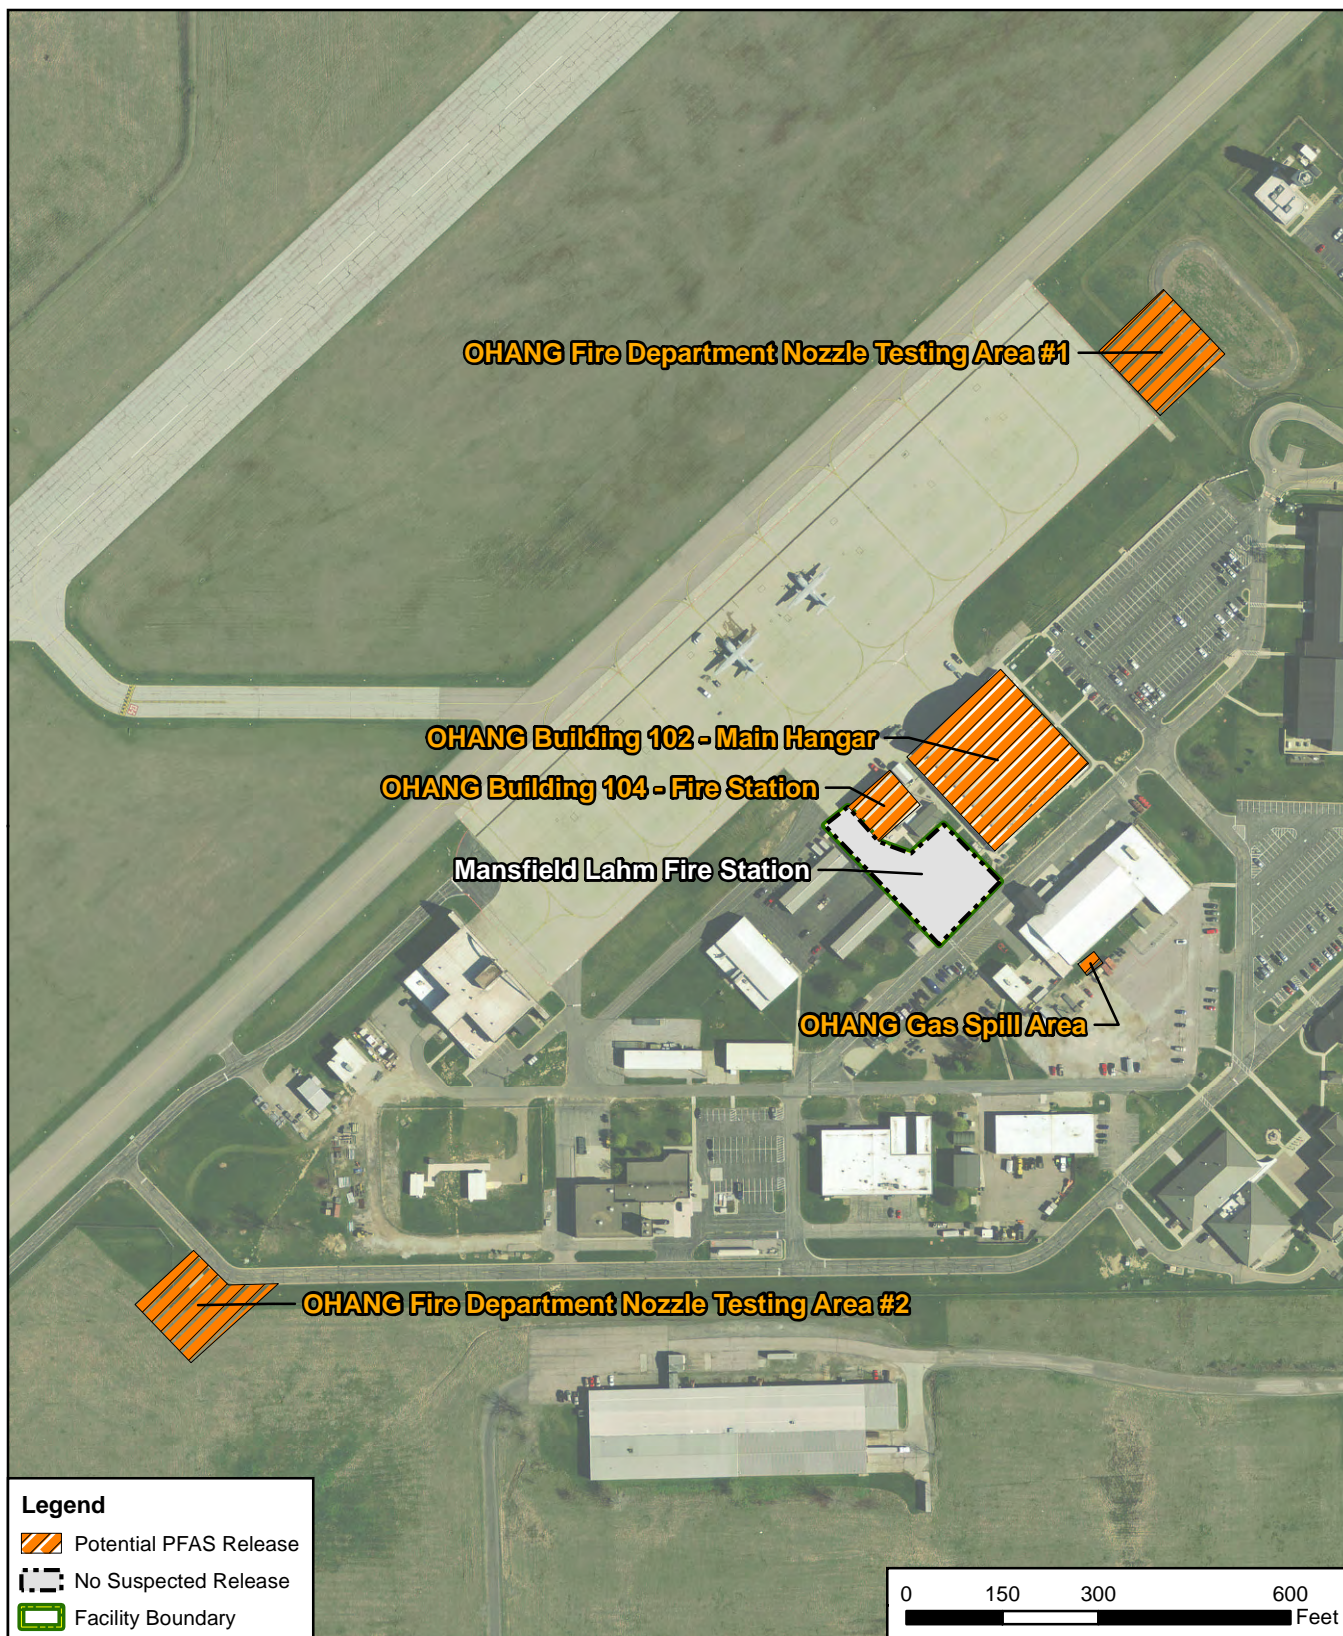
12420 Milestone Center Drive Germantown, MD 20876	Figure ES-1
REVISED	2/7/2019	GIS BY	MS	2/7/2019			
SCALE	1:3,600	CHK BY	TK	2/7/2019			
Base Map: OSIP Imagery		PM	RG	2/7/2019

No Area(s) of Interest (AOIs) related to potential PFAS use, release, or storage were identified at the Mansfield Lahm Fire Station during the PA, although several potential PFAS sources are located adjacent to the Mansfield Lahm Fire Station, within OHANG property (**Figure ES-1**). The OHANG is currently conducting their own PFAS study. Contact the OHANG for further information.

Summary of Findings	
NOTES Preliminary Assessment for PFAS at Mansfield Lahm Fire Station, OH

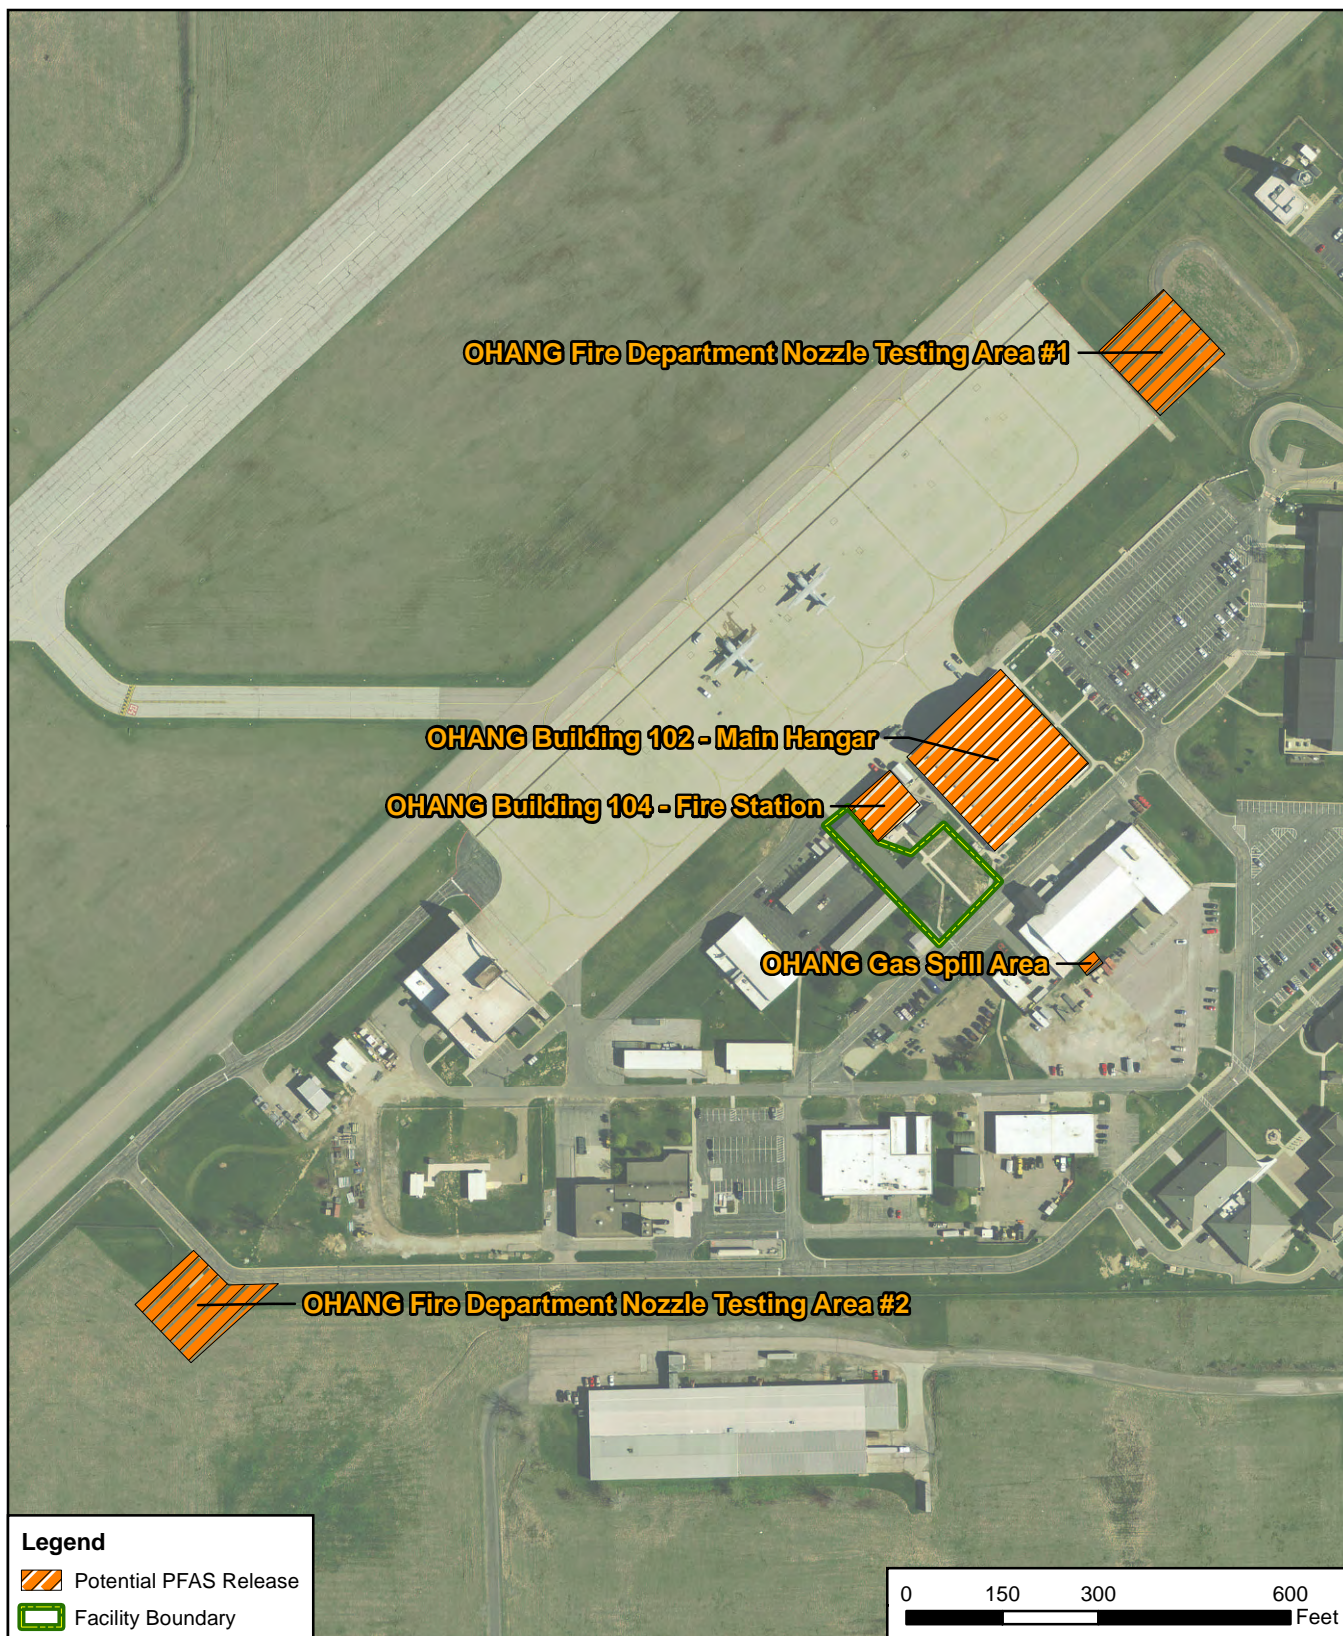
Adjacent Sources	
AECOM 12420 Milestone Center Drive Germantown, MD 20876	Figure 5-1

The Mansfield Lahm Fire Station sits within the OHANG's 179th Airlift Wing (179AW). During the PA, several areas of potential use, storage, or release, not under control of OHARNG, were identified within the OHANG facility. The 179AW has utilized AFFF since the 1970s; therefore, these areas have the potential to impact soil, sediment, and surface water within the OHANG property. Descriptions of the adjacent sources are presented below and are shown on **Figure 5-1**.

According to a PA conducted by engineering firm BB&E, several potential AFFF releases have occurred on OHANG property that are adjacent to the Mansfield Lahm Fire Station (BB&E, 2016). The Mansfield Lahm Fire Station sits within the OHANG's 179th Airlift Wing (179AW). The 179AW has utilized AFFF since the 1970s, and may be a potential source of PFAS. The OHANG is currently conducting PFAS investigations at the 179AW. Contact the 179AW for any details on the status of this investigation.

Based on surface water flow directions surrounding the facility, there is the potential for AFFF releases from OHANG property to impact the Mansfield Lahm Fire Station. Surface water runoff from the north, west, and central areas surrounding the Mansfield Lahm Fire Station collects in an underground drainage system on the southwest of OHANG property. This drainage system then discharges to an off-site outfall in Rocky Fork. Any surface water runoff not captured within the underground drainage system has the potential to flow through the property boundary of the Mansfield Lahm Fire Station, leaving the potential for AFFF releases to impact the Mansfield Lahm Fire Station.

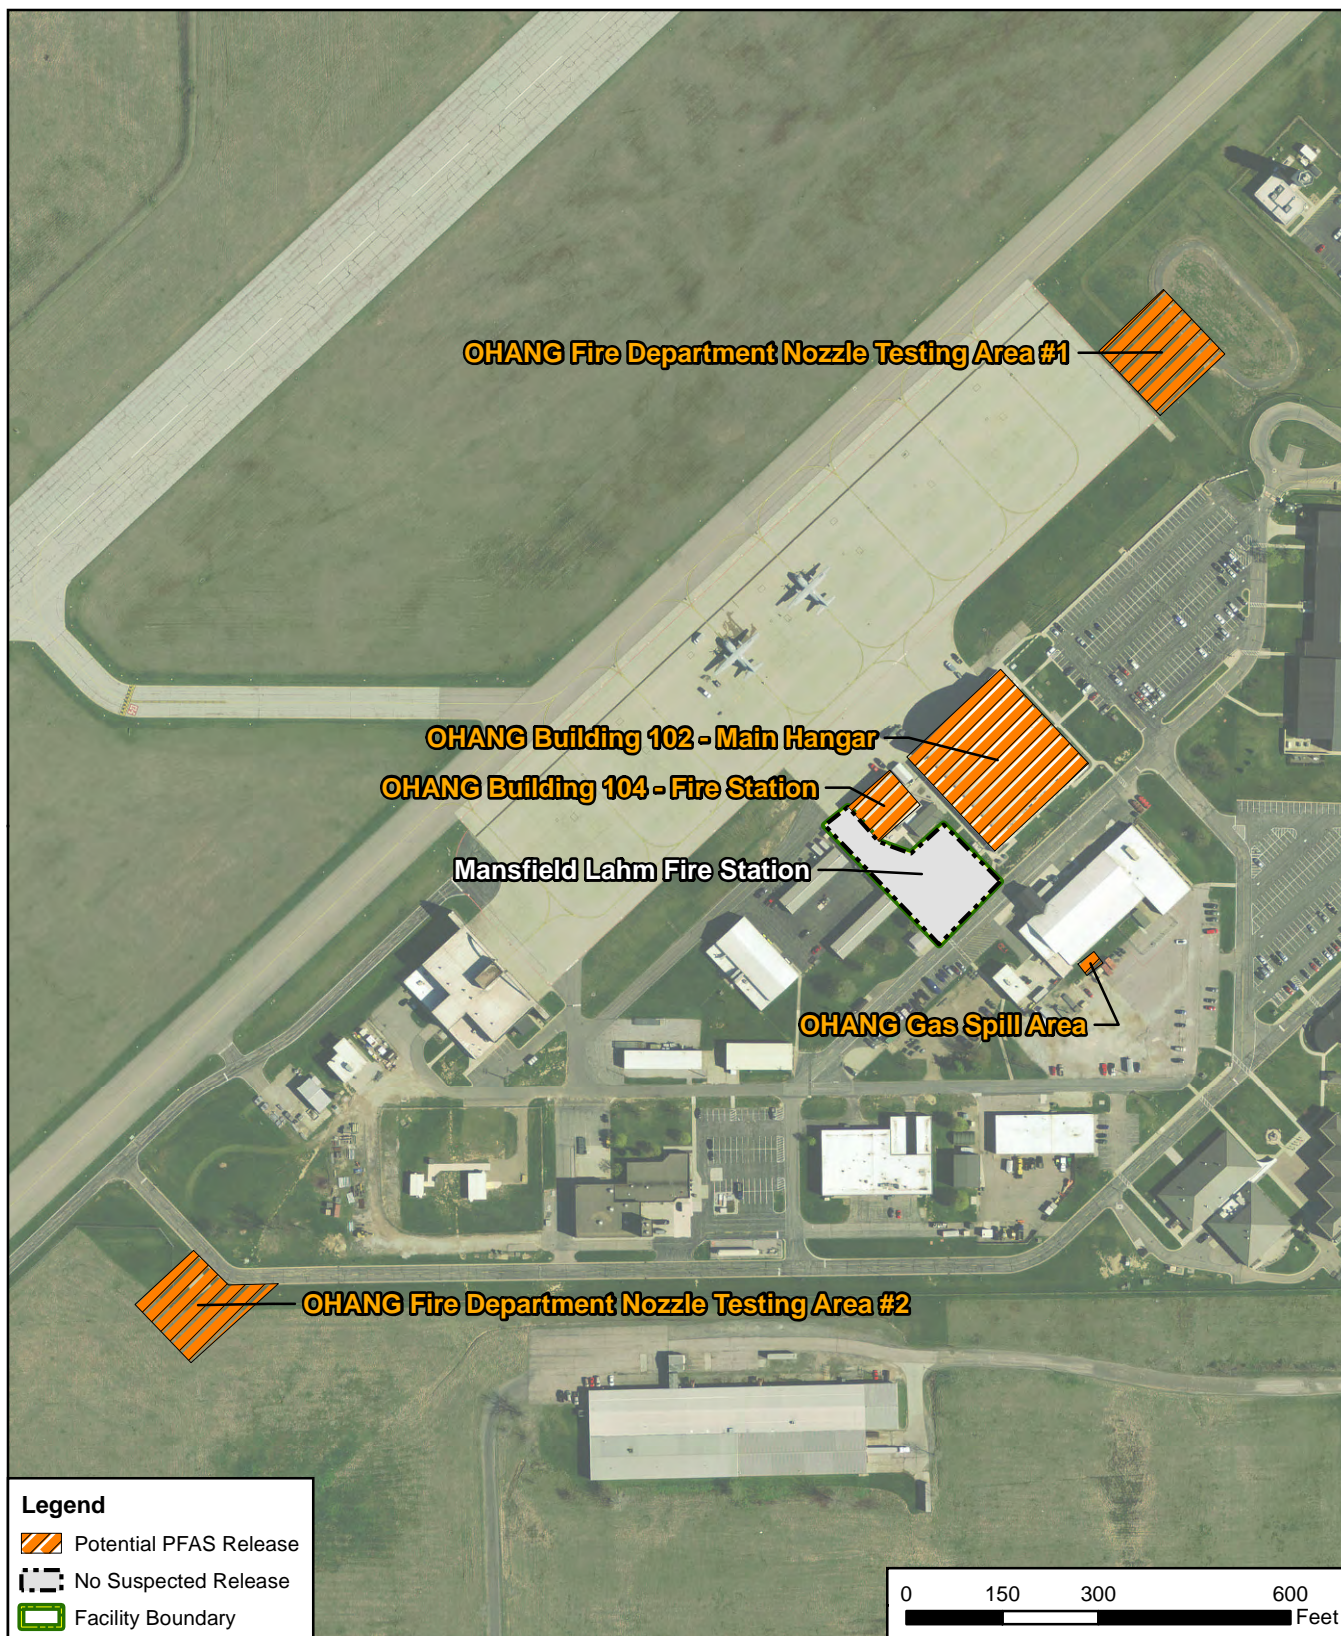
12420 Milestone Center Drive Germantown, MD 20876	Figure 7-1
REVISED	2/7/2019	GIS BY	MS	2/7/2019			
SCALE	1:3,600	CHK BY	TK	2/7/2019			
Base Map: OSIP Imagery		PM	RG	2/7/2019

Based on information obtained during interviews conducted with facility personnel, facility observations, and reviewed documentation, it is confirmed that AFFF has not been stored, used, or released at the Mansfield Lahm Fire Station; therefore, no AOlS related to PFAS release were identified at the Mansfield Lahm Fire Station.

Summary of Findings	
NOTES Preliminary Assessment for PFAS at Mansfield Lahm Fire Station, OH

Based on the documented absence (2007-present) of the use, storage, or release of PFAS-containing materials at Mansfield Lahm Fire Station, no AOIs were identified during the PA. Evidence does not indicate that current or former ARNG activities contributed PFAS contamination to soil, groundwater, surface water, or sediment at the facility or adjacent areas. Mansfield Lahm Fire Station will not move forward in the CERCLA process.

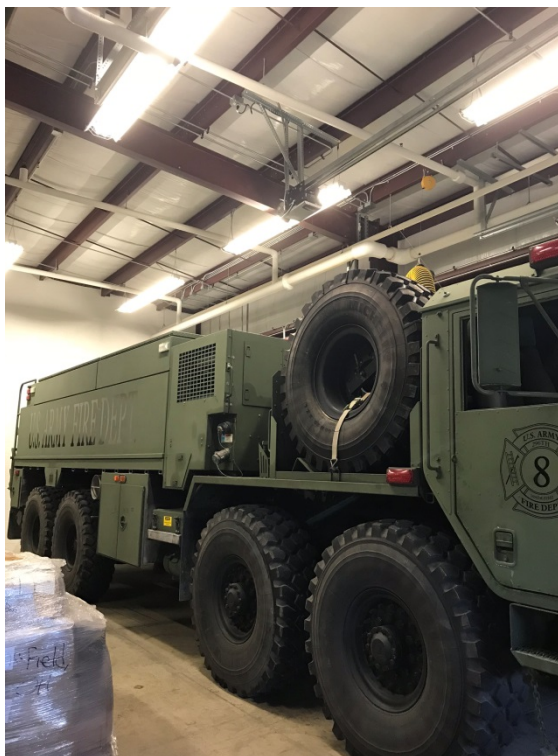
One of the firetrucks inside of the Mansfield Lahm Fire Station. This truck does not contain an AFFF-capable tank.

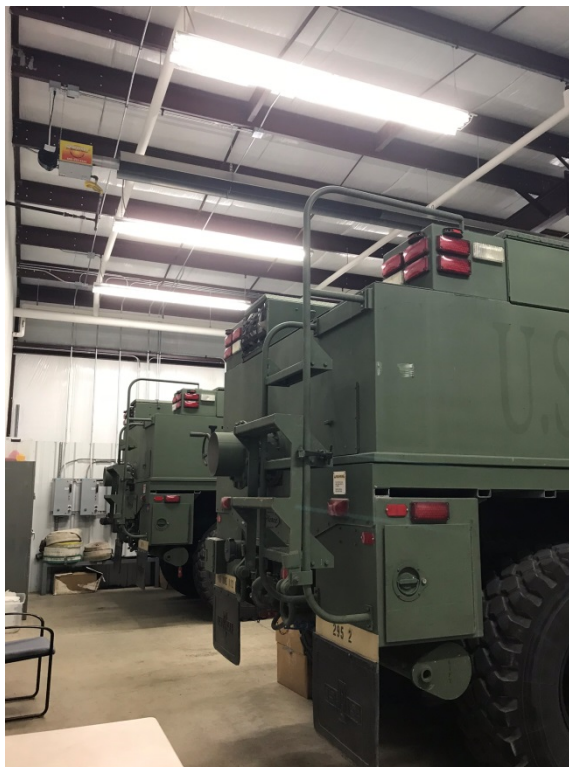
Photograph No. 2

View of two of the firetrucks from the back of the fire station. Picture was taken at the entrance door into the fire station from the administration side. No fire suppression system is present in this fire station and no storage of AFFF occurs at this location.
