FINAL Preliminary Assessment Report AASF Byrd Field, Virginia Virginia Army National Guard

Perfluorooctanesulfonic Acid (PFOS) and Perfluorooctanoic
Acid (PFOA) Impacted Sites
ARNG Installations, Nationwide

July 2020

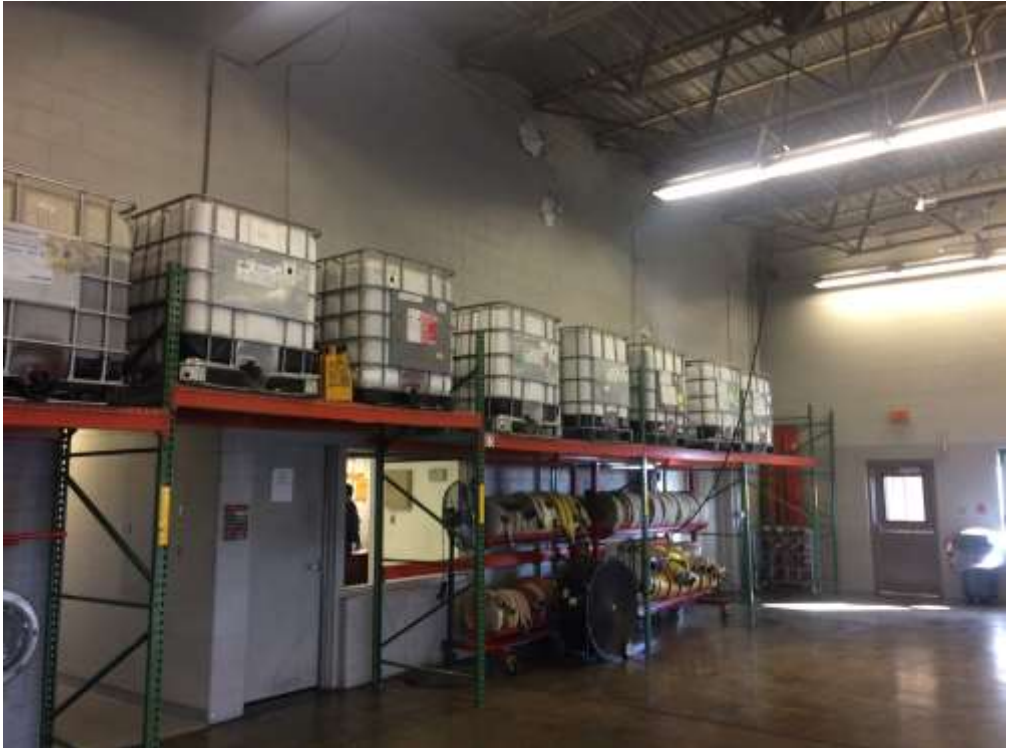
Army National Guard, Preliminary Assessment for PFAS		AASF Byrd	Richmond, Virginia
Photograph No. 1 Date 2/5/2019 Time 10:11 Description: AFFF storage totes at the off-facility Richmond International Airport Aircraft Rescue Fire Fighting Department Orientation: Northeast

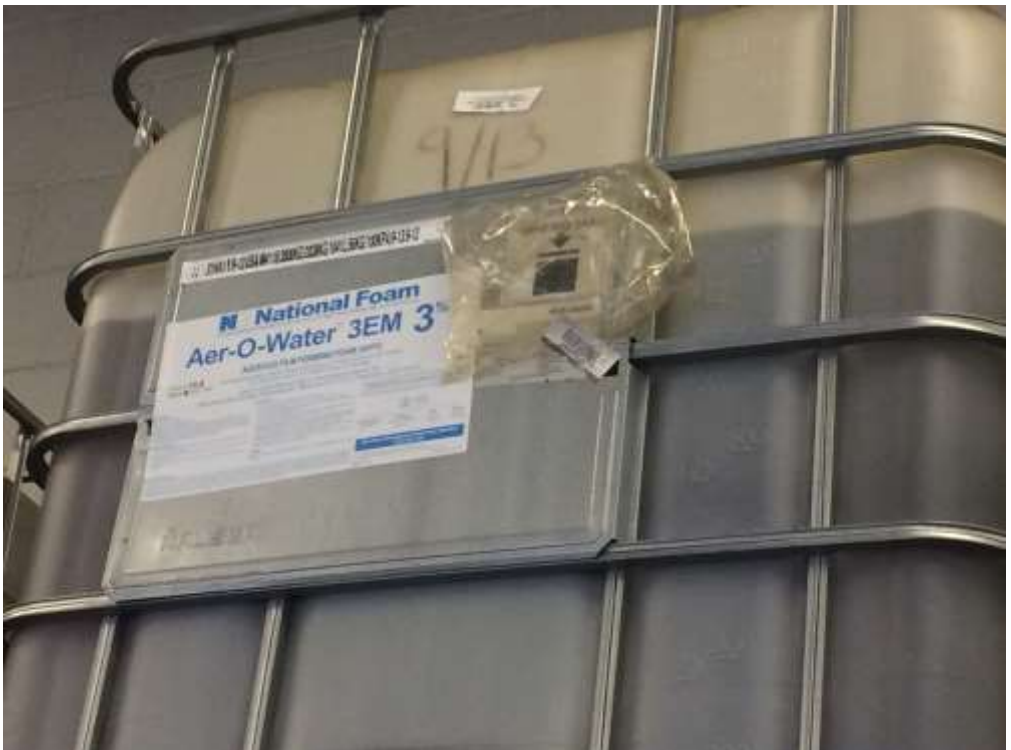
Photograph No. 2 Date 2/5/2019 Time 10:11 Description: National Foam Aer-O-Water 3% AFFF stored at the Richmond International Airport Aircraft Rescue Fire Fighting Department Orientation: North

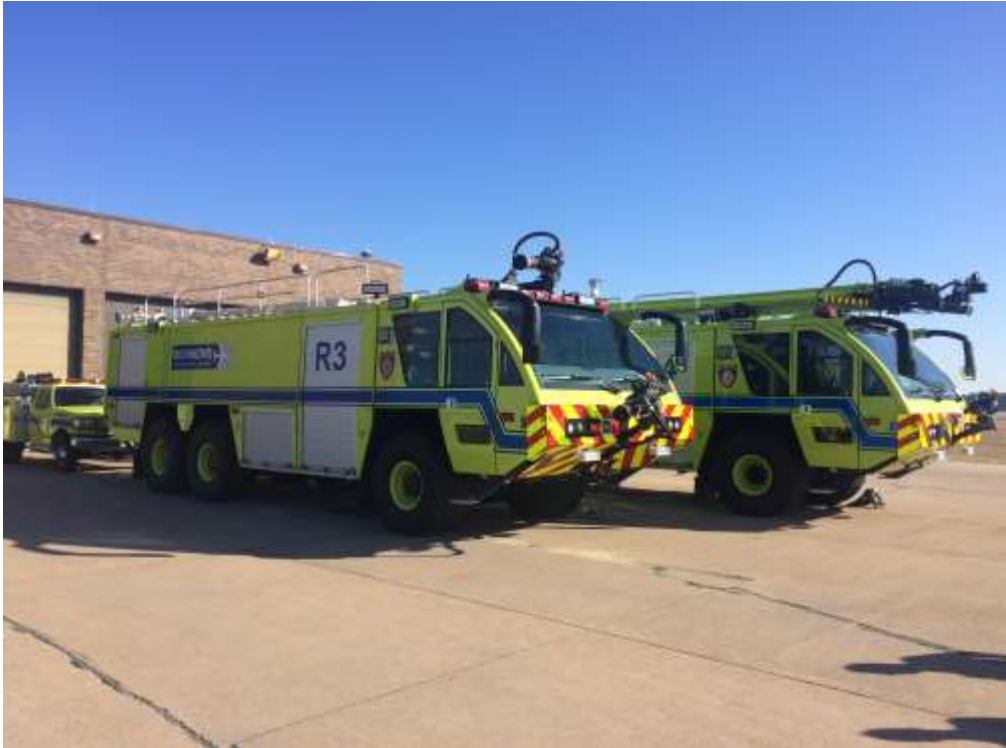
Army National Guard, Preliminary Assessment for PFAS	AASF Byrd	Richmond, Virginia
<p>Photograph No. 3</p> <p>Date 2/5/2019 Time 10:15</p> <p>Description: Two Rosenbauer rescue trucks capable of AFFF use stored at the Richmond International Airport Aircraft Rescue Fire Fighting Department</p> <p>Orientation: East</p>

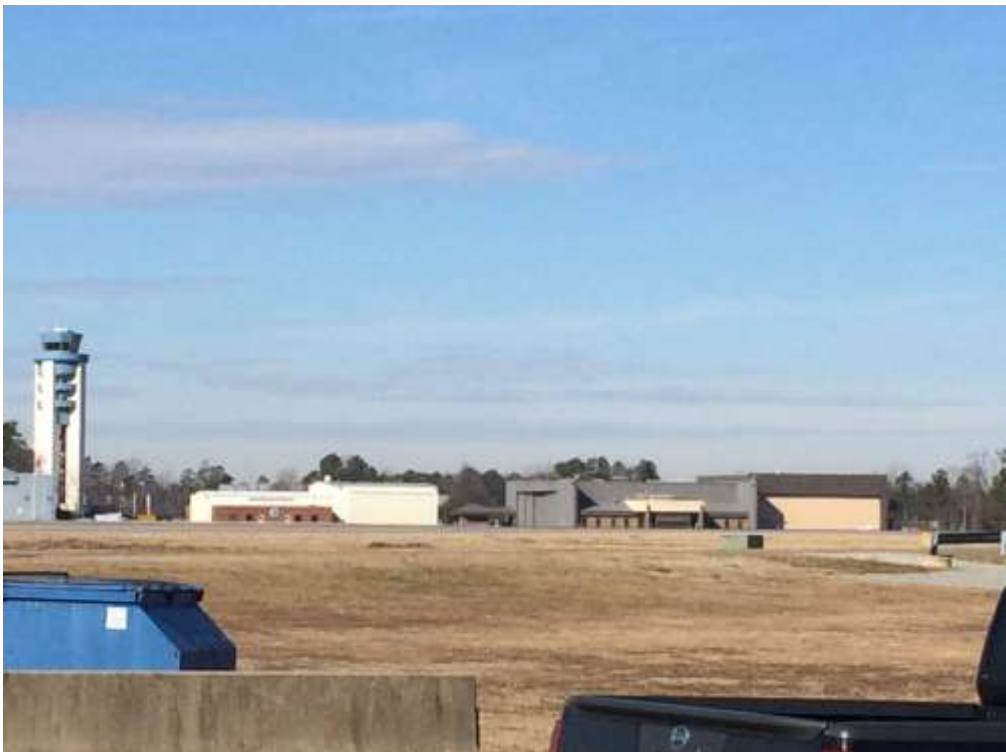
<p>Photograph No. 4</p> <p>Date 2/5/2019 Time 10:37</p> <p>Description: The off-facility Virginia Department of Aviation hangar (left) and Altria hangar (right) located at the Richmond International Airport; both have AFFF suppression systems</p> <p>Orientation: Northwest</p>

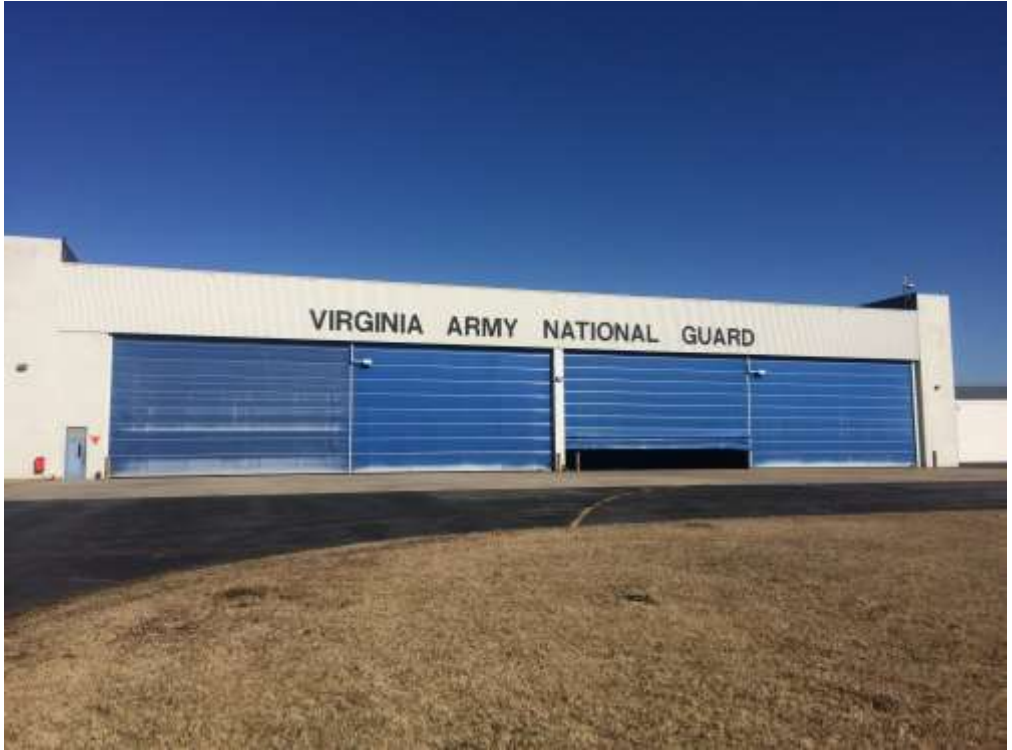
Army National Guard, Preliminary Assessment for PFAS		AASF Byrd	Richmond, Virginia
Photograph No. 5 Date 2/5/2019 Time 10:55 Description: The AASF Byrd VAARNG hangar; no AFFF system present Orientation: West

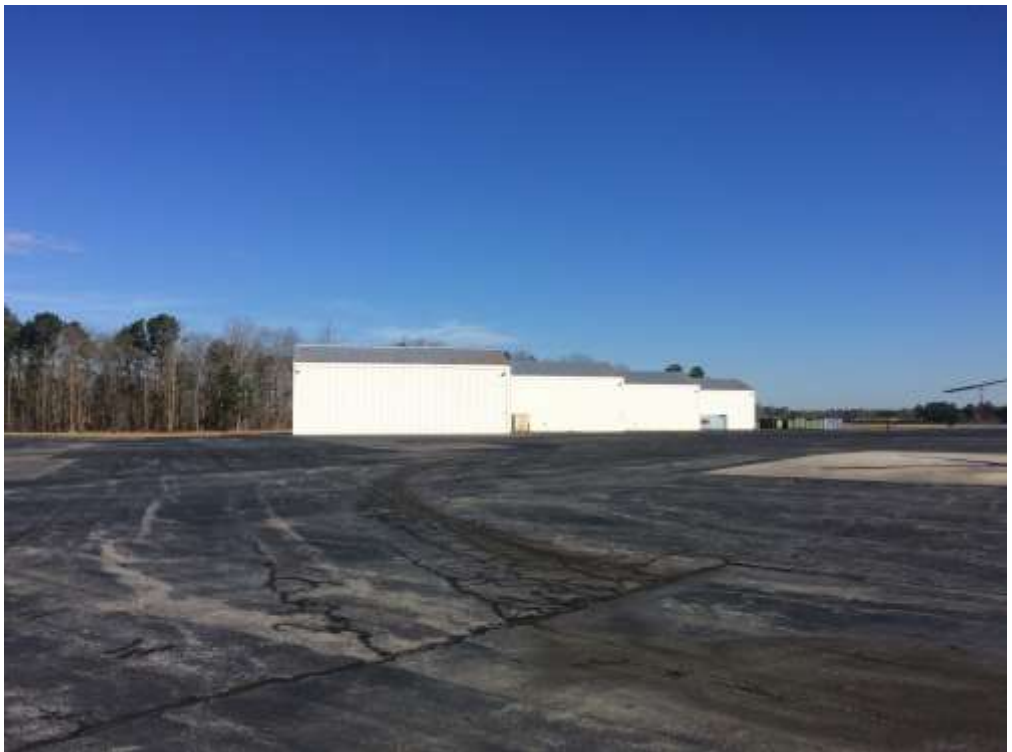
Photograph No. 6 Date 2/5/2019 Time 10:56 Description: Cold storage hangars at AASF Byrd; two have potentially been used to store AFFF Tri-Max mobile fire extinguishers Orientation: Northeast

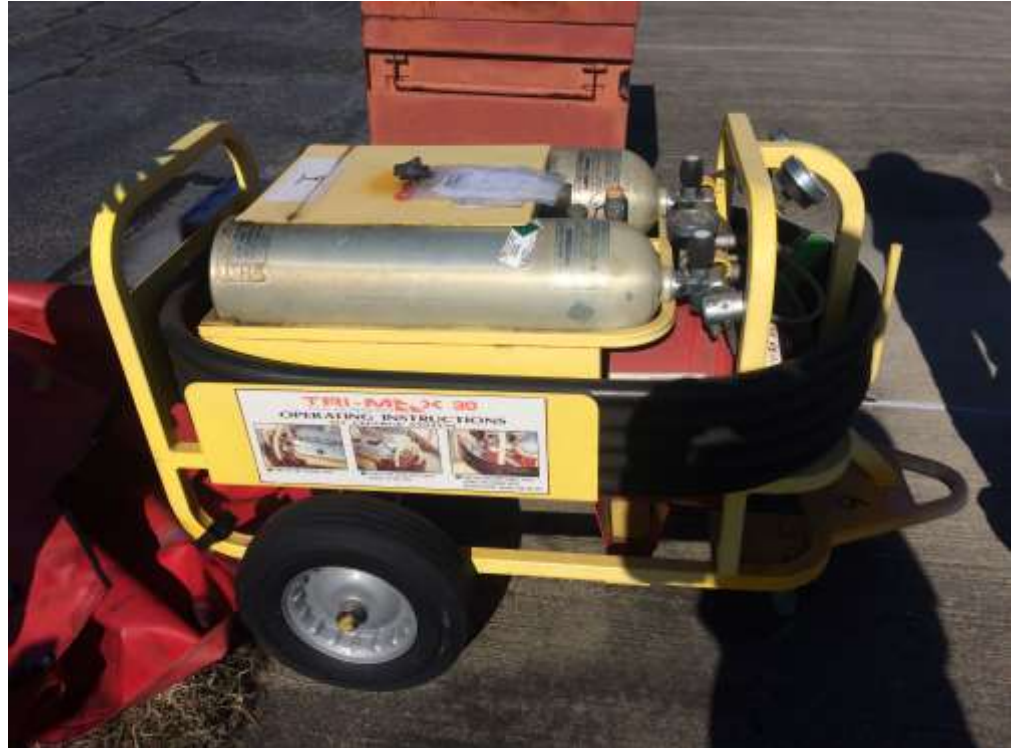
Tri-Max 30 mobile fire extinguisher staged on the AASF Byrd flightline; approximately 10 total are stored across the flightline

AFFF is stored in ten Tri-Max™ 30 Fire Extinguishers staged across the flightline and fuel point. According to airport and VAARNG staff, there is no known history of the Tri-Max™ extinguishers being used or replaced after the Tri-Max™ extinguishers were acquired in 2010. Inspection tags on each of the Tri-Max™ extinguishers appear to indicate that the Tri-Maxes are inspected by VAARNG staff on a monthly basis. The Tri-Max™ extinguishers are currently planned for removal and replacement with Purple K extinguishers.

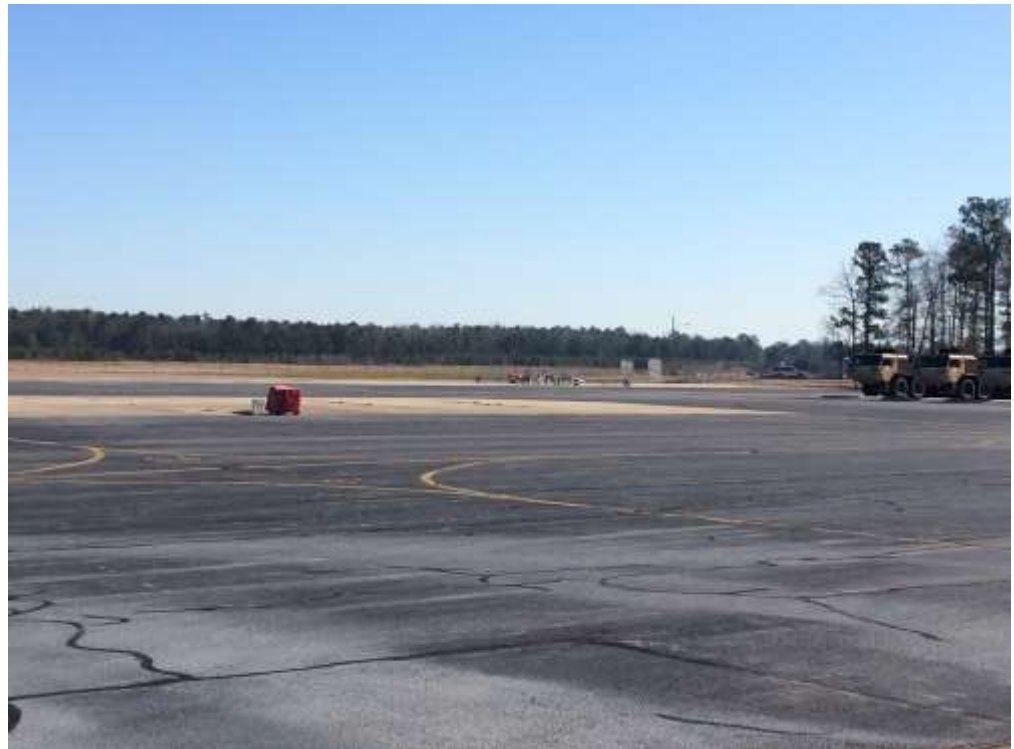
Tri-Max 30 mobile fire extinguishers visible on the AASF Byrd flightline; approximately 10 total are stored across the flightline
