FINAL Preliminary Assessment Report Fort McClellan Army National Guard Training Center Anniston, Alabama

Perfluorooctane-Sulfonic Acid (PFOS) and Perfluorooctanoic
Acid (PFOA) Impacted Sites
ARNG Installations, Nationwide

September 2020

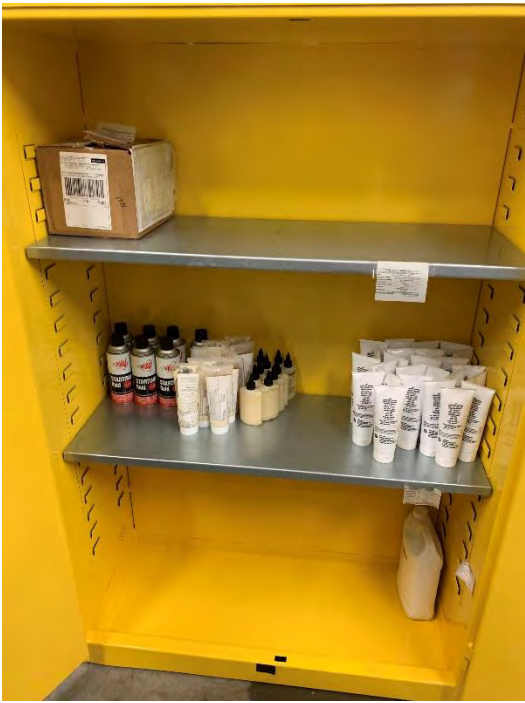
Army National Guard, Preliminary Assessment for PFAS	Fort McClellan Army National Guard Training Center- Anniston AL	Anniston, Alabama
<p>Photograph No. 1</p> <p>Description:</p> <p>Cleaners and lubricants in the Weapons Cleaning Area</p> <p>Photo date 4/12/19</p>

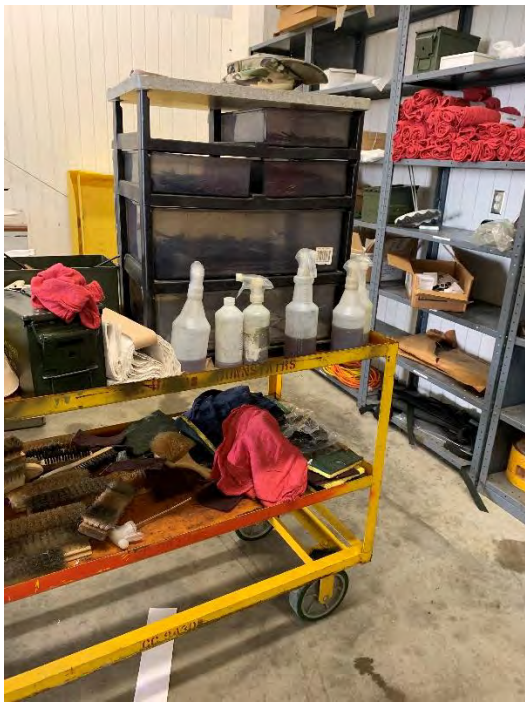
<p>Photograph No. 2</p> <p>Description:</p> <p>Cleaners, lubricants and rags in the Weapons Cleaning Area</p> <p>Photo Date: 4/12/19</p>

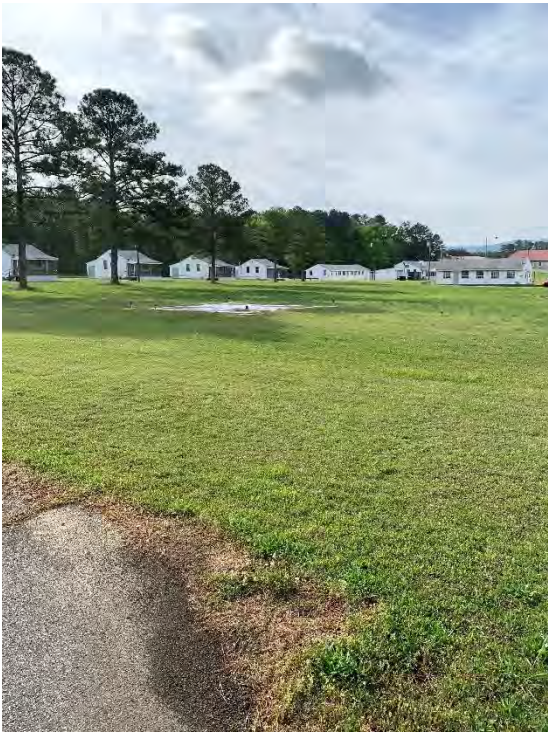
APPENDIX C – Photographic Log		
Army National Guard, Preliminary Assessment for PFAS	Fort McClellan Army National Guard Training Center- Anniston AL	Anniston, Alabama
Photograph No. 3 Description: Looking southeast General view of Helicopter Pad Photo Date: 4/12/19

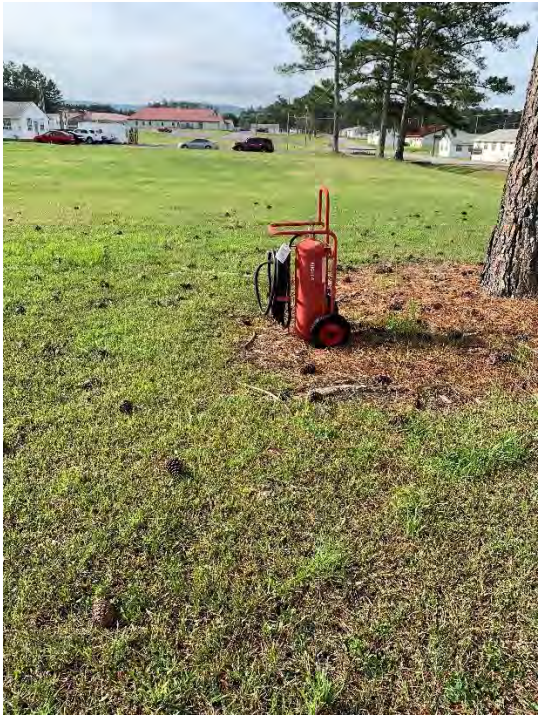
Photograph No. 4 Description: Looking southeast General view of ABC fire extinguisher at Helicopter Pad Photo Date: 4/12/19

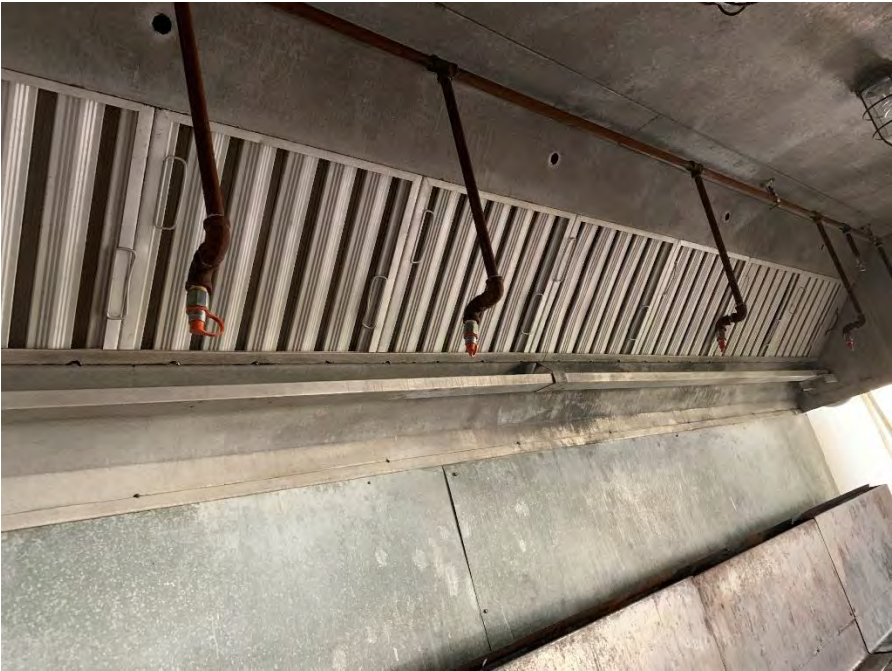
Army National Guard, Preliminary Assessment for PFAS	Fort McClellan Army National Guard Training Center- Anniston AL	Anniston, Alabama
<p>Photograph No. 5</p> <p>Description:</p> <p>General view of hood fire suppression system in dining facility</p> <p>Photo Date: 4/12/19</p>

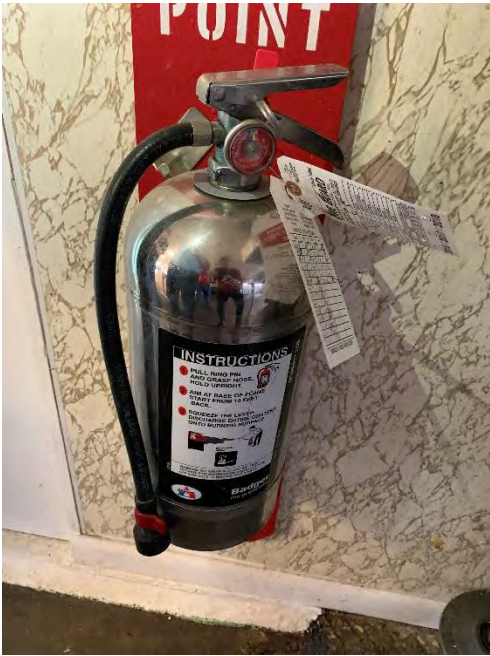
<p>Photograph No. 6</p> <p>Description:</p> <p>General view of Class K fire extinguisher in dining facility</p> <p>Photo Date: 4/12/19</p>

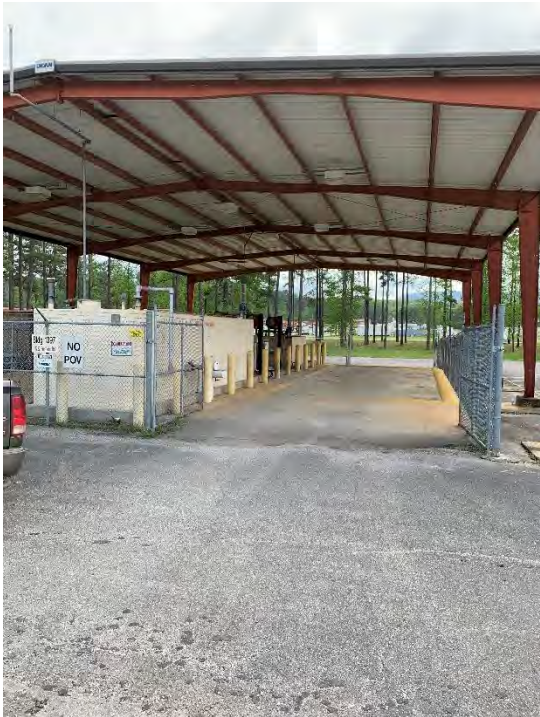
APPENDIX C – Photographic Log		
Army National Guard, Preliminary Assessment for PFAS	Fort McClellan Army National Guard Training Center- Anniston AL	Anniston, Alabama
Photograph No. 7 Description: Looking east General view of Fuel Point Photo Date: 4/12/19

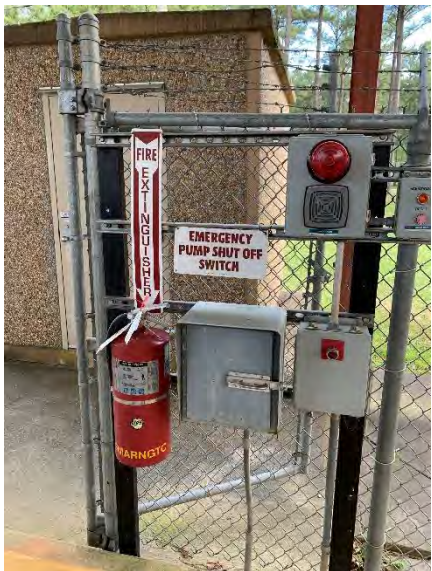
Photograph No. 8 Description: Looking north General view of ABC fire extinguisher at Fuel Point Photo Date: 4/12/19

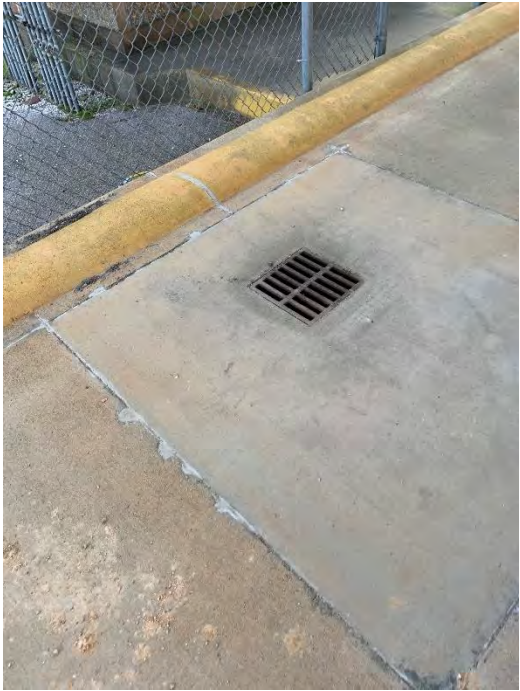
APPENDIX C – Photographic Log		
Army National Guard, Preliminary Assessment for PFAS	Fort McClellan Army National Guard Training Center- Anniston AL	Anniston, Alabama
Photograph No. 9 Description: Looking north Storm drain at Fuel Point Photo Date: 4/12/19
