Preliminary Assessment Report

Pelham Range, Anniston, Alabama

Perfluorooctanesulfonic Acid (PFOS) and
Perfluorooctanoic Acid (PFOA) Impacted Sites
ARNG Installations, Nationwide

September 2020

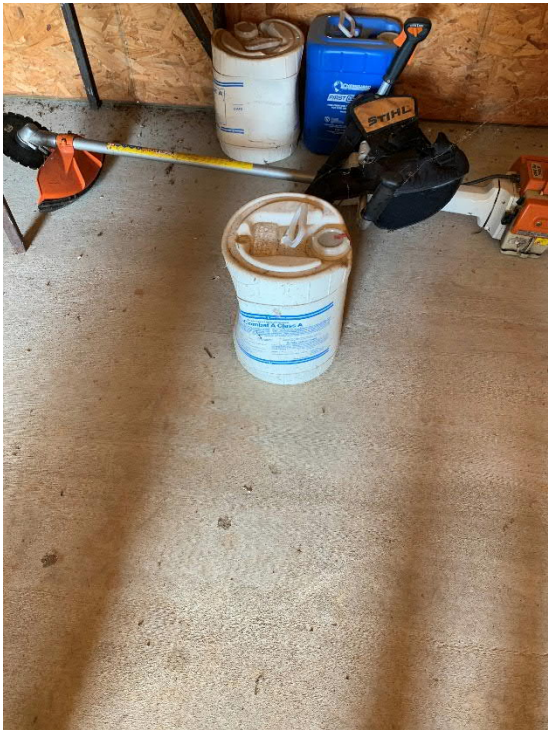
The Forestry Compound is currently used for storage of road-building materials. Two 5-gallon buckets of Hi-Combat A™ Class A Foam were observed in the maintenance shed. One ALARNG personnel stated that the Class A Foam was rarely used as a foam additive on firetrucks. The Class A Foam (non-AFFF) concentrate is not suspected to contain PFAS. The safety data sheet for the Hi Combat A™ Class A Foam is included in **Appendix A**.

APPENDIX C – Photographic Log		
Army National Guard, Preliminary Assessment for PFAS		Anniston, Alabama
Photograph No. 3 Description: Looking Northeast Two 5-gallon containers of Hi-Combat A foam located in the Forestry Compound Photo Date: 4/11/19
