FINAL Site Inspection Report Army Aviation Support Facility #3 Bates Field Mobile, Alabama

Site Inspection for Perfluorooctanoic acid (PFOA),
Perfluorooctanesulfonic acid (PFOS), Perfluorohexanesulfonic
acid (PFHxS), Perfluorononanoic acid (PFNA),
Hexafluoropropylene oxide dimer acid (HFPO-DA), and
Perfluorobutanesulfonic acid (PFBS) at ARNG Installations,
Nationwide

August 2023

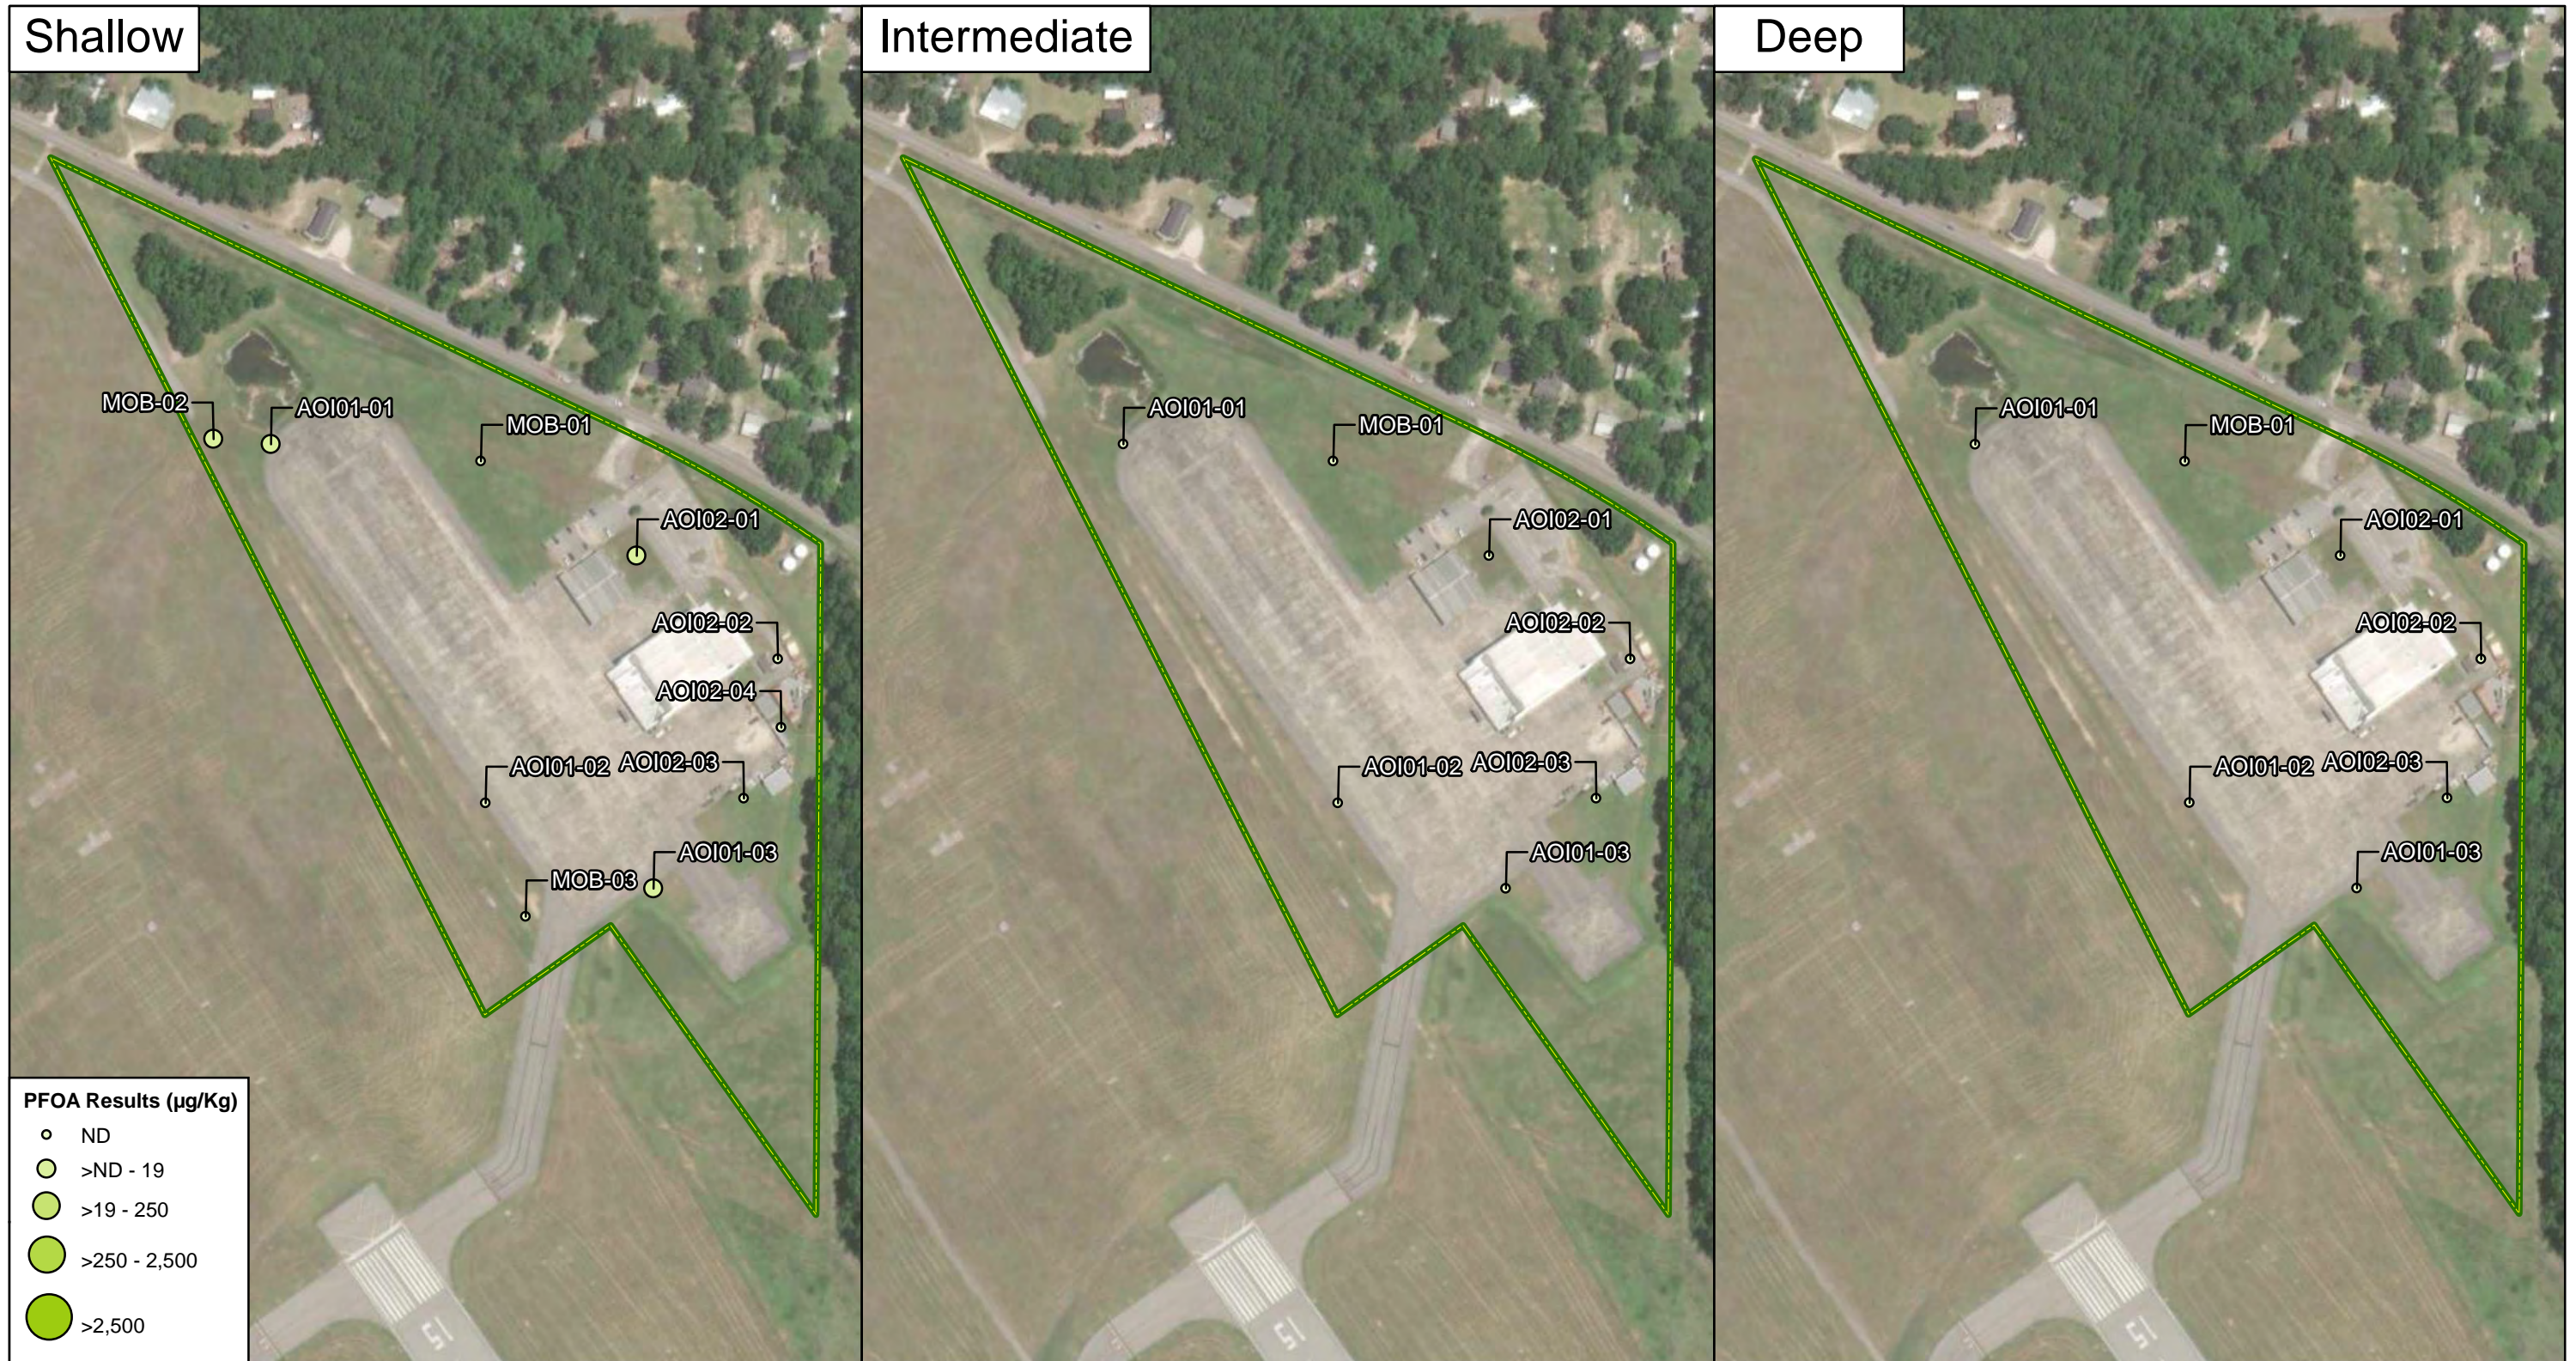
Figure 6-1

PFOA Results (µg/Kg)

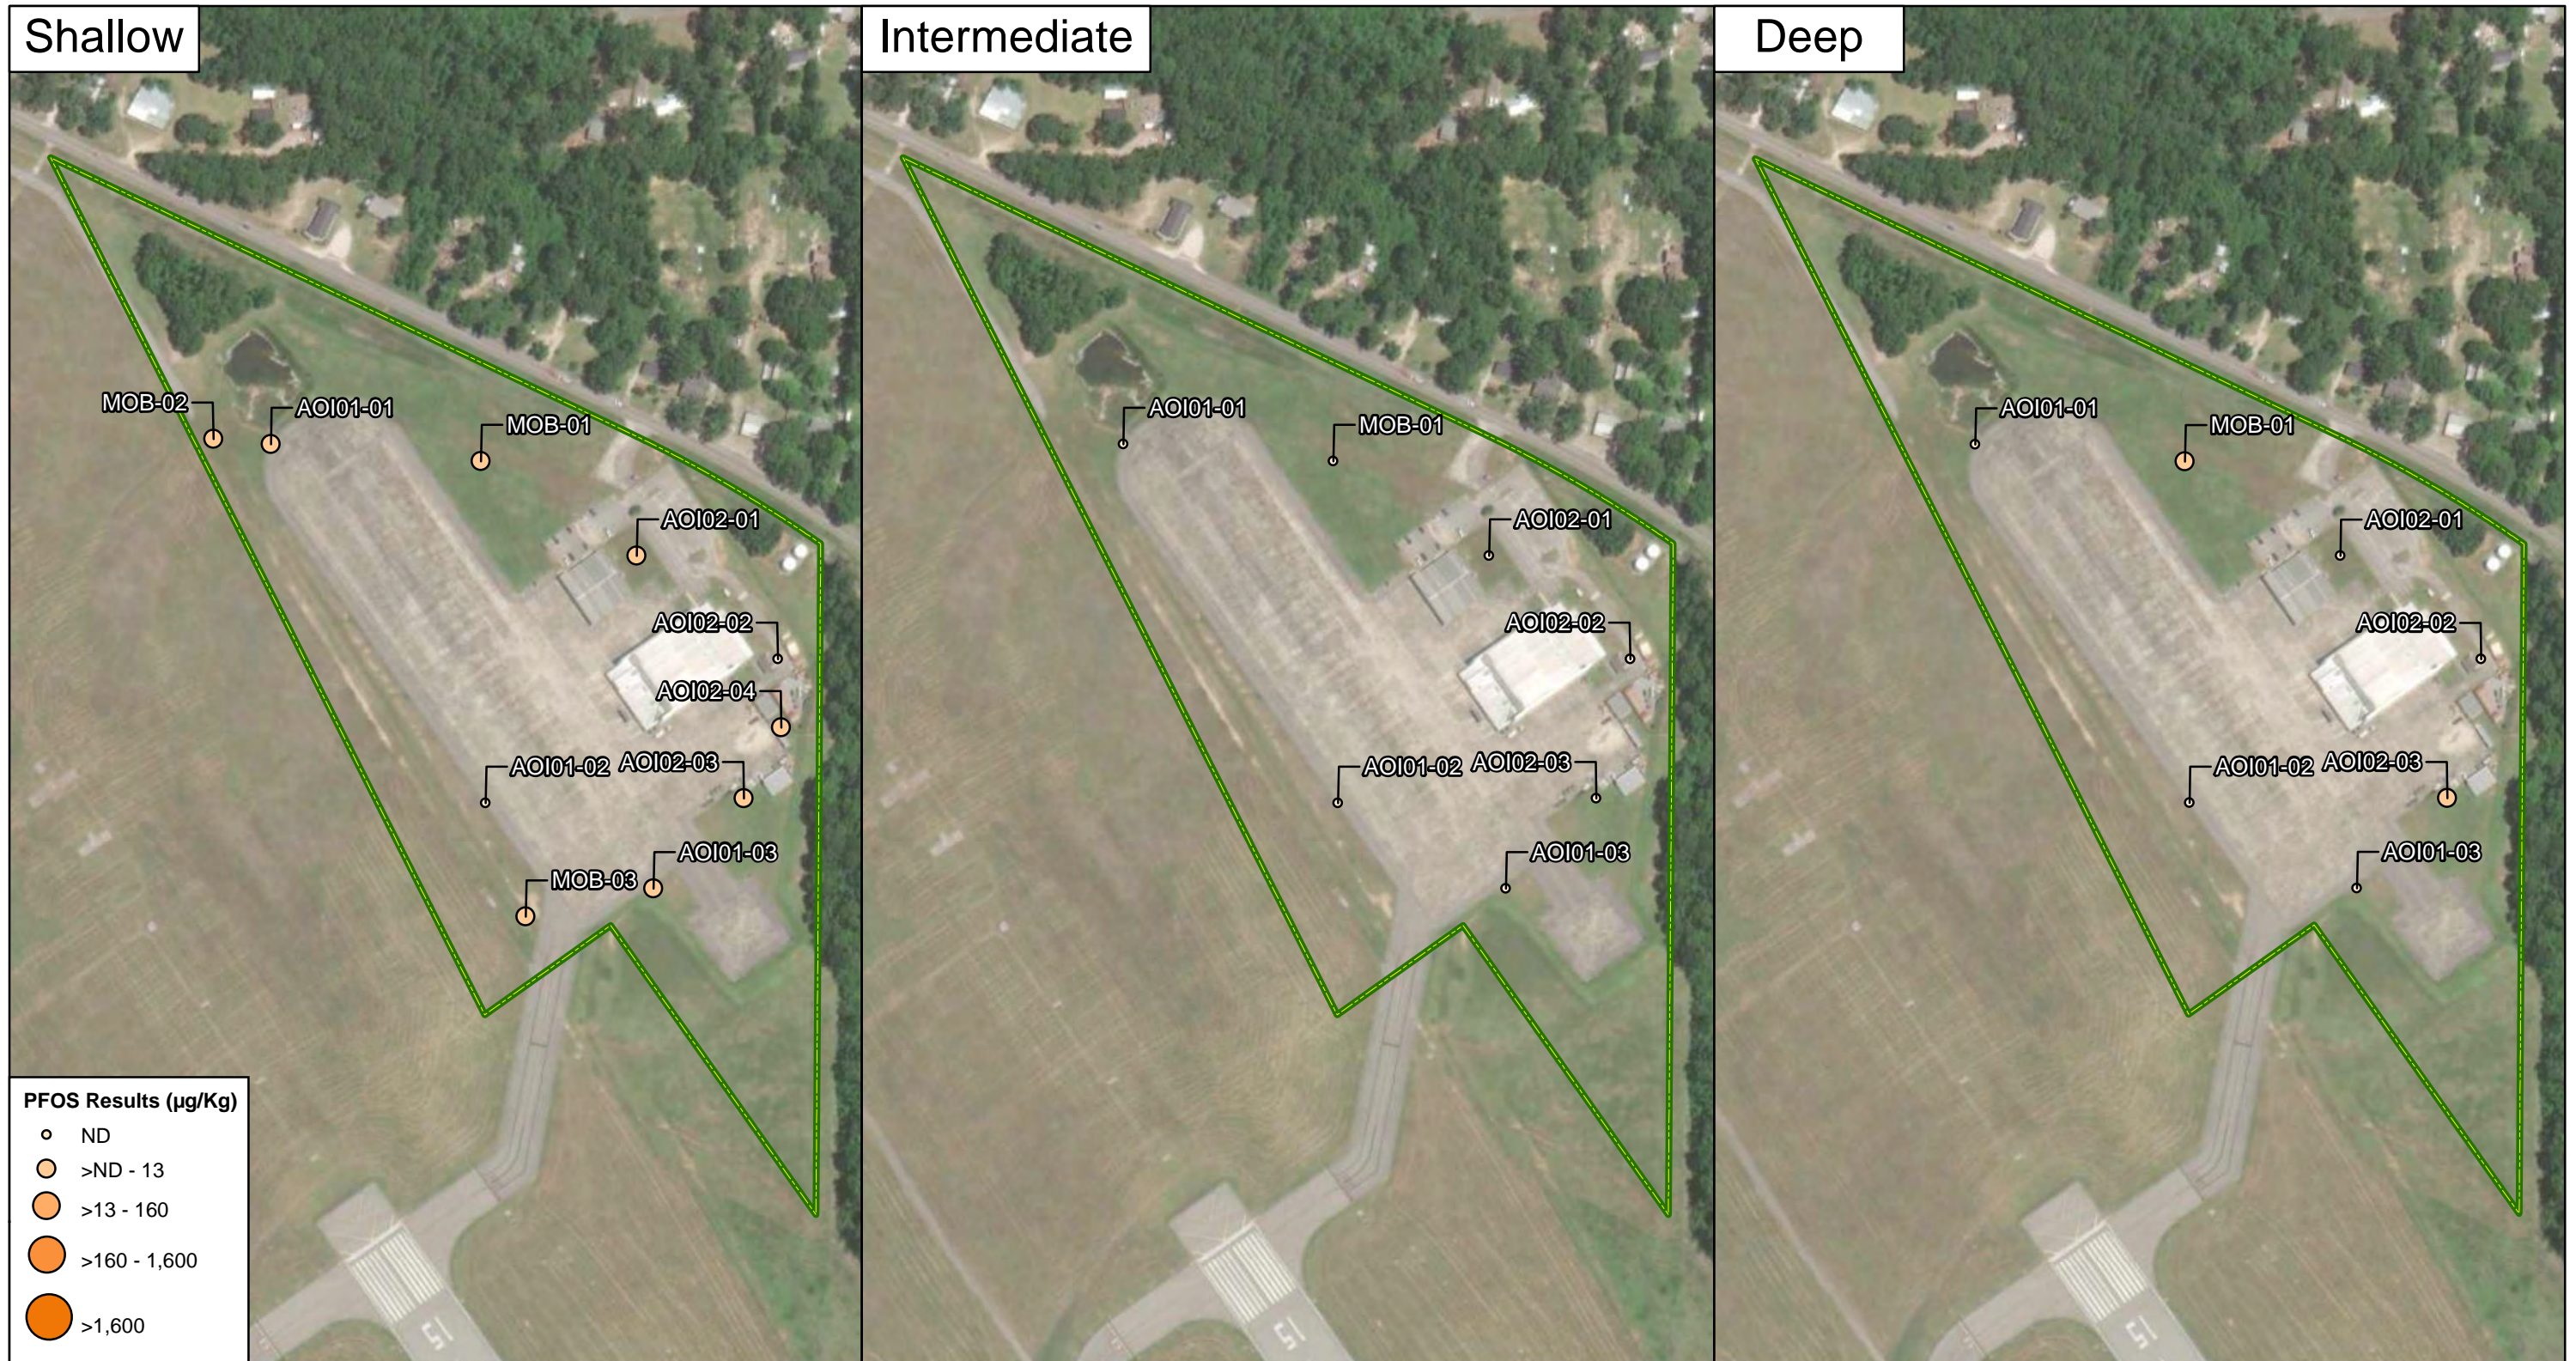
Figure 6-2

PFOS Results (µg/Kg)

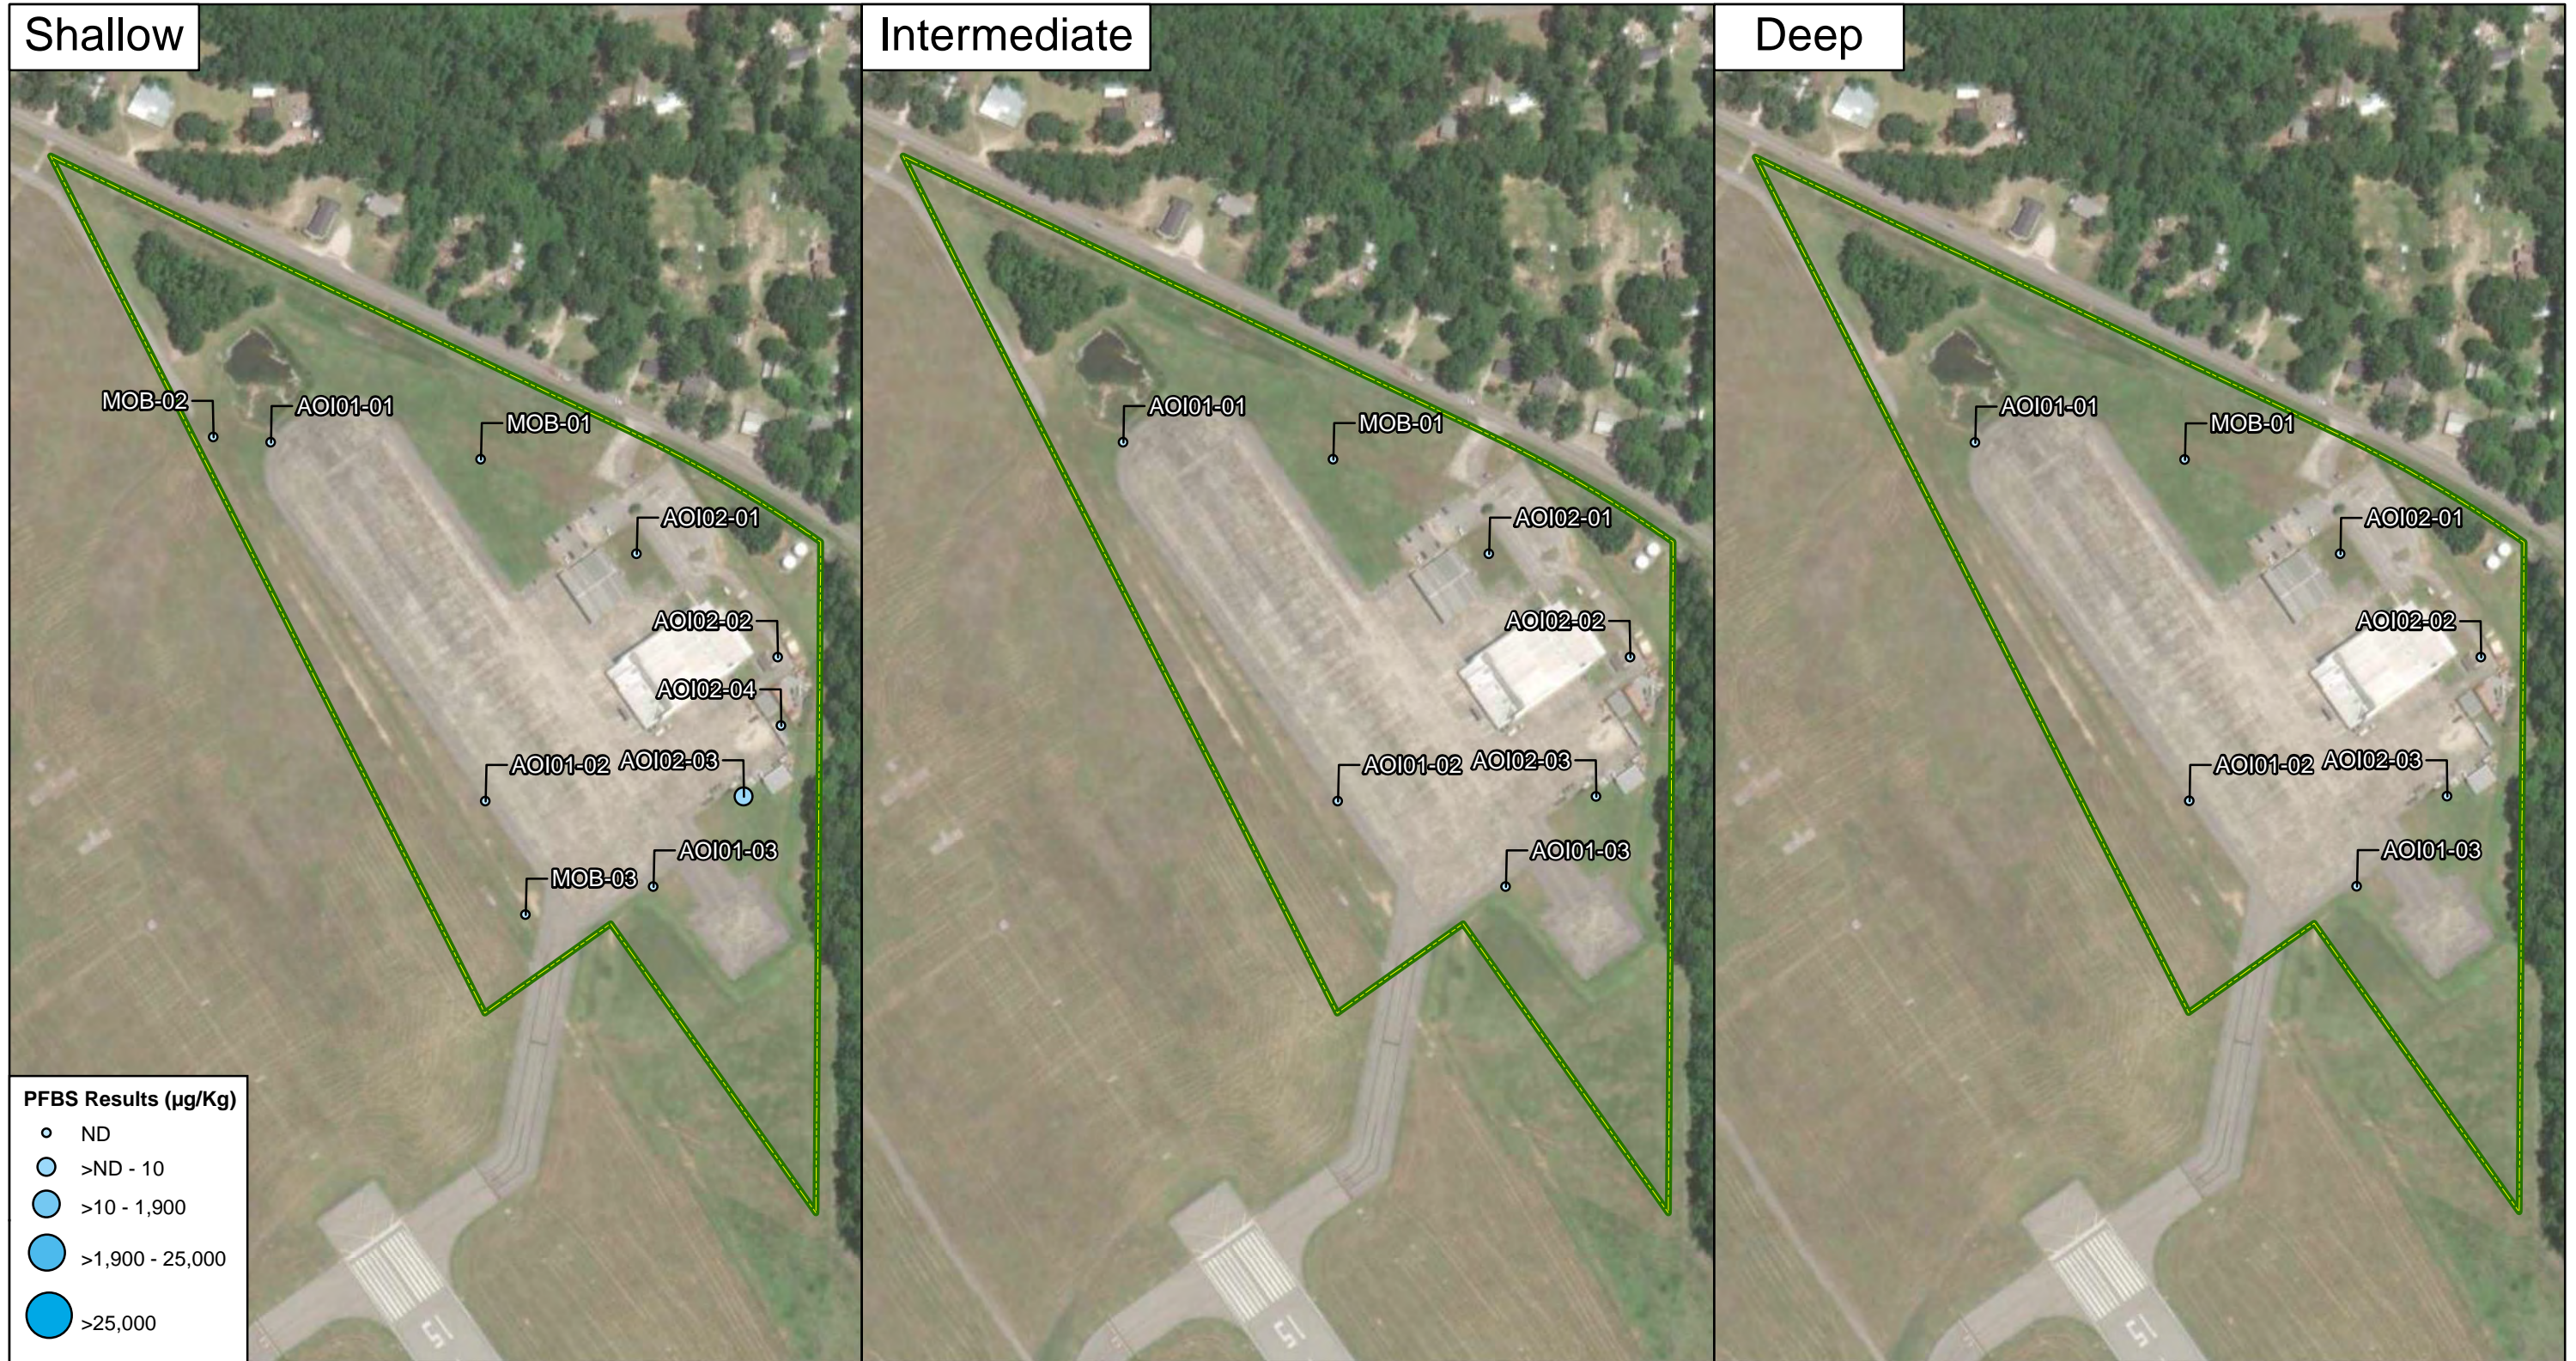
Figure 6-3

PFBS Results ($\mu\text{g}/\text{Kg}$)				
○	ND			
○	>ND - 10			
○	>10 - 1,900			
○	>1,900 - 25,000			
○	>25,000

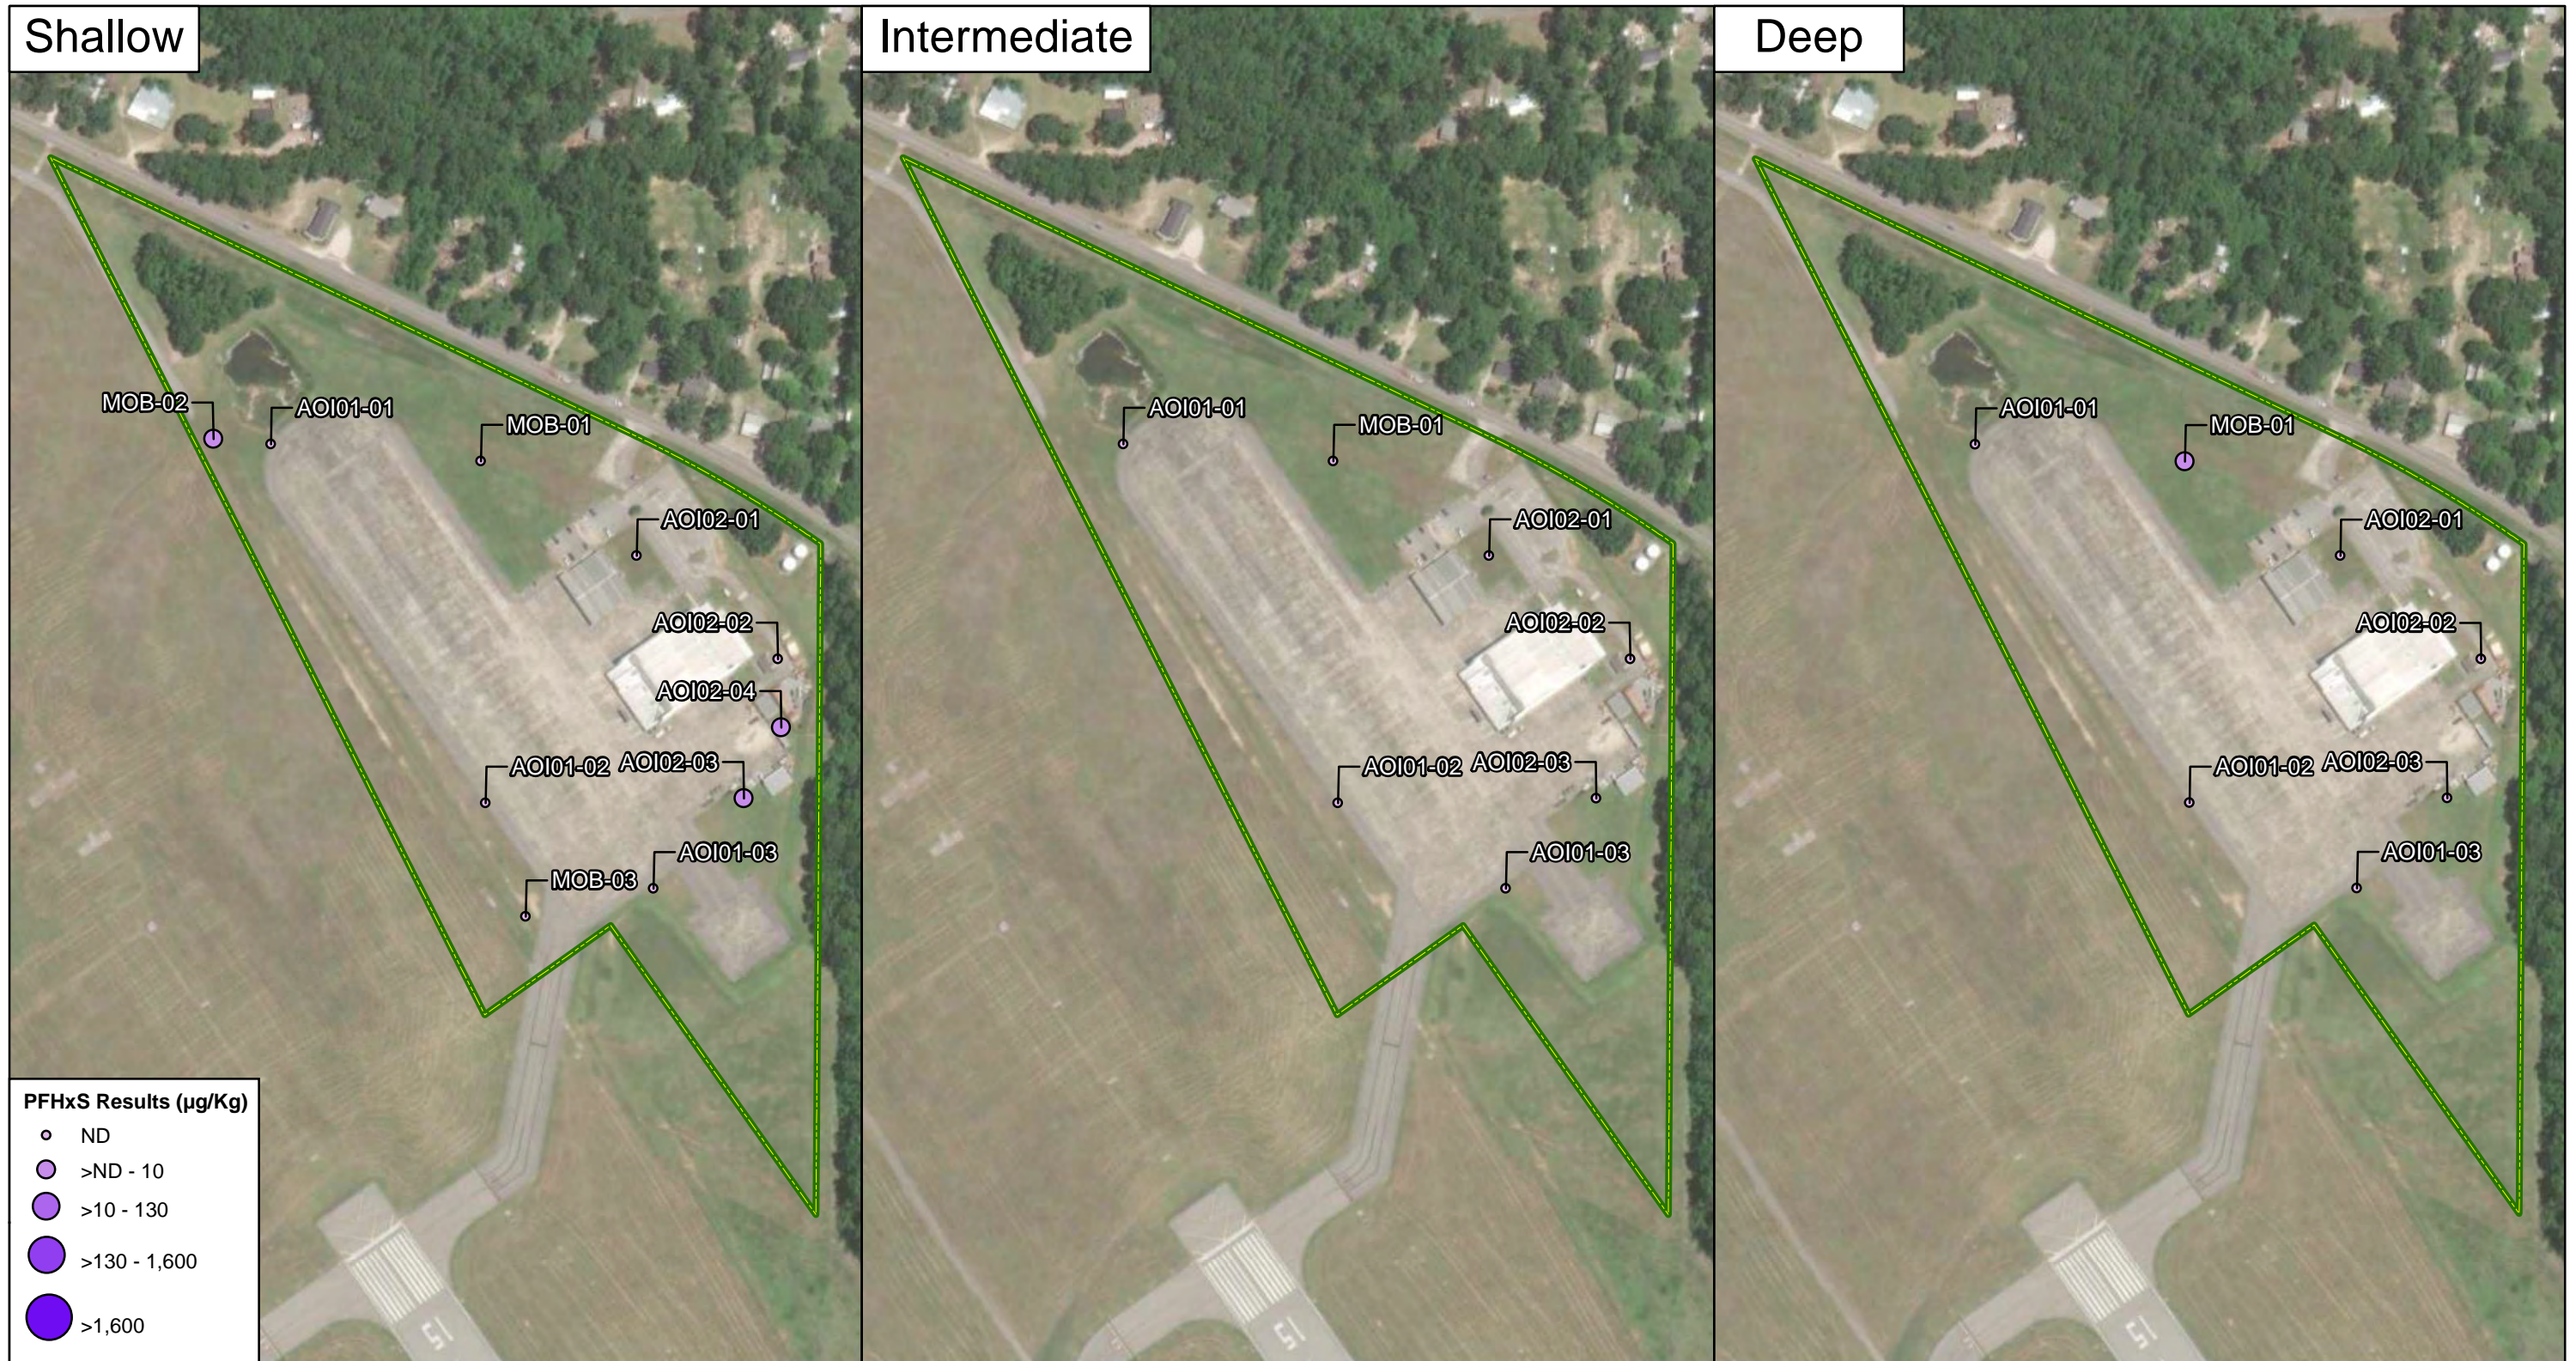
Figure 6-4

PFHxS Results ($\mu\text{g}/\text{Kg}$)

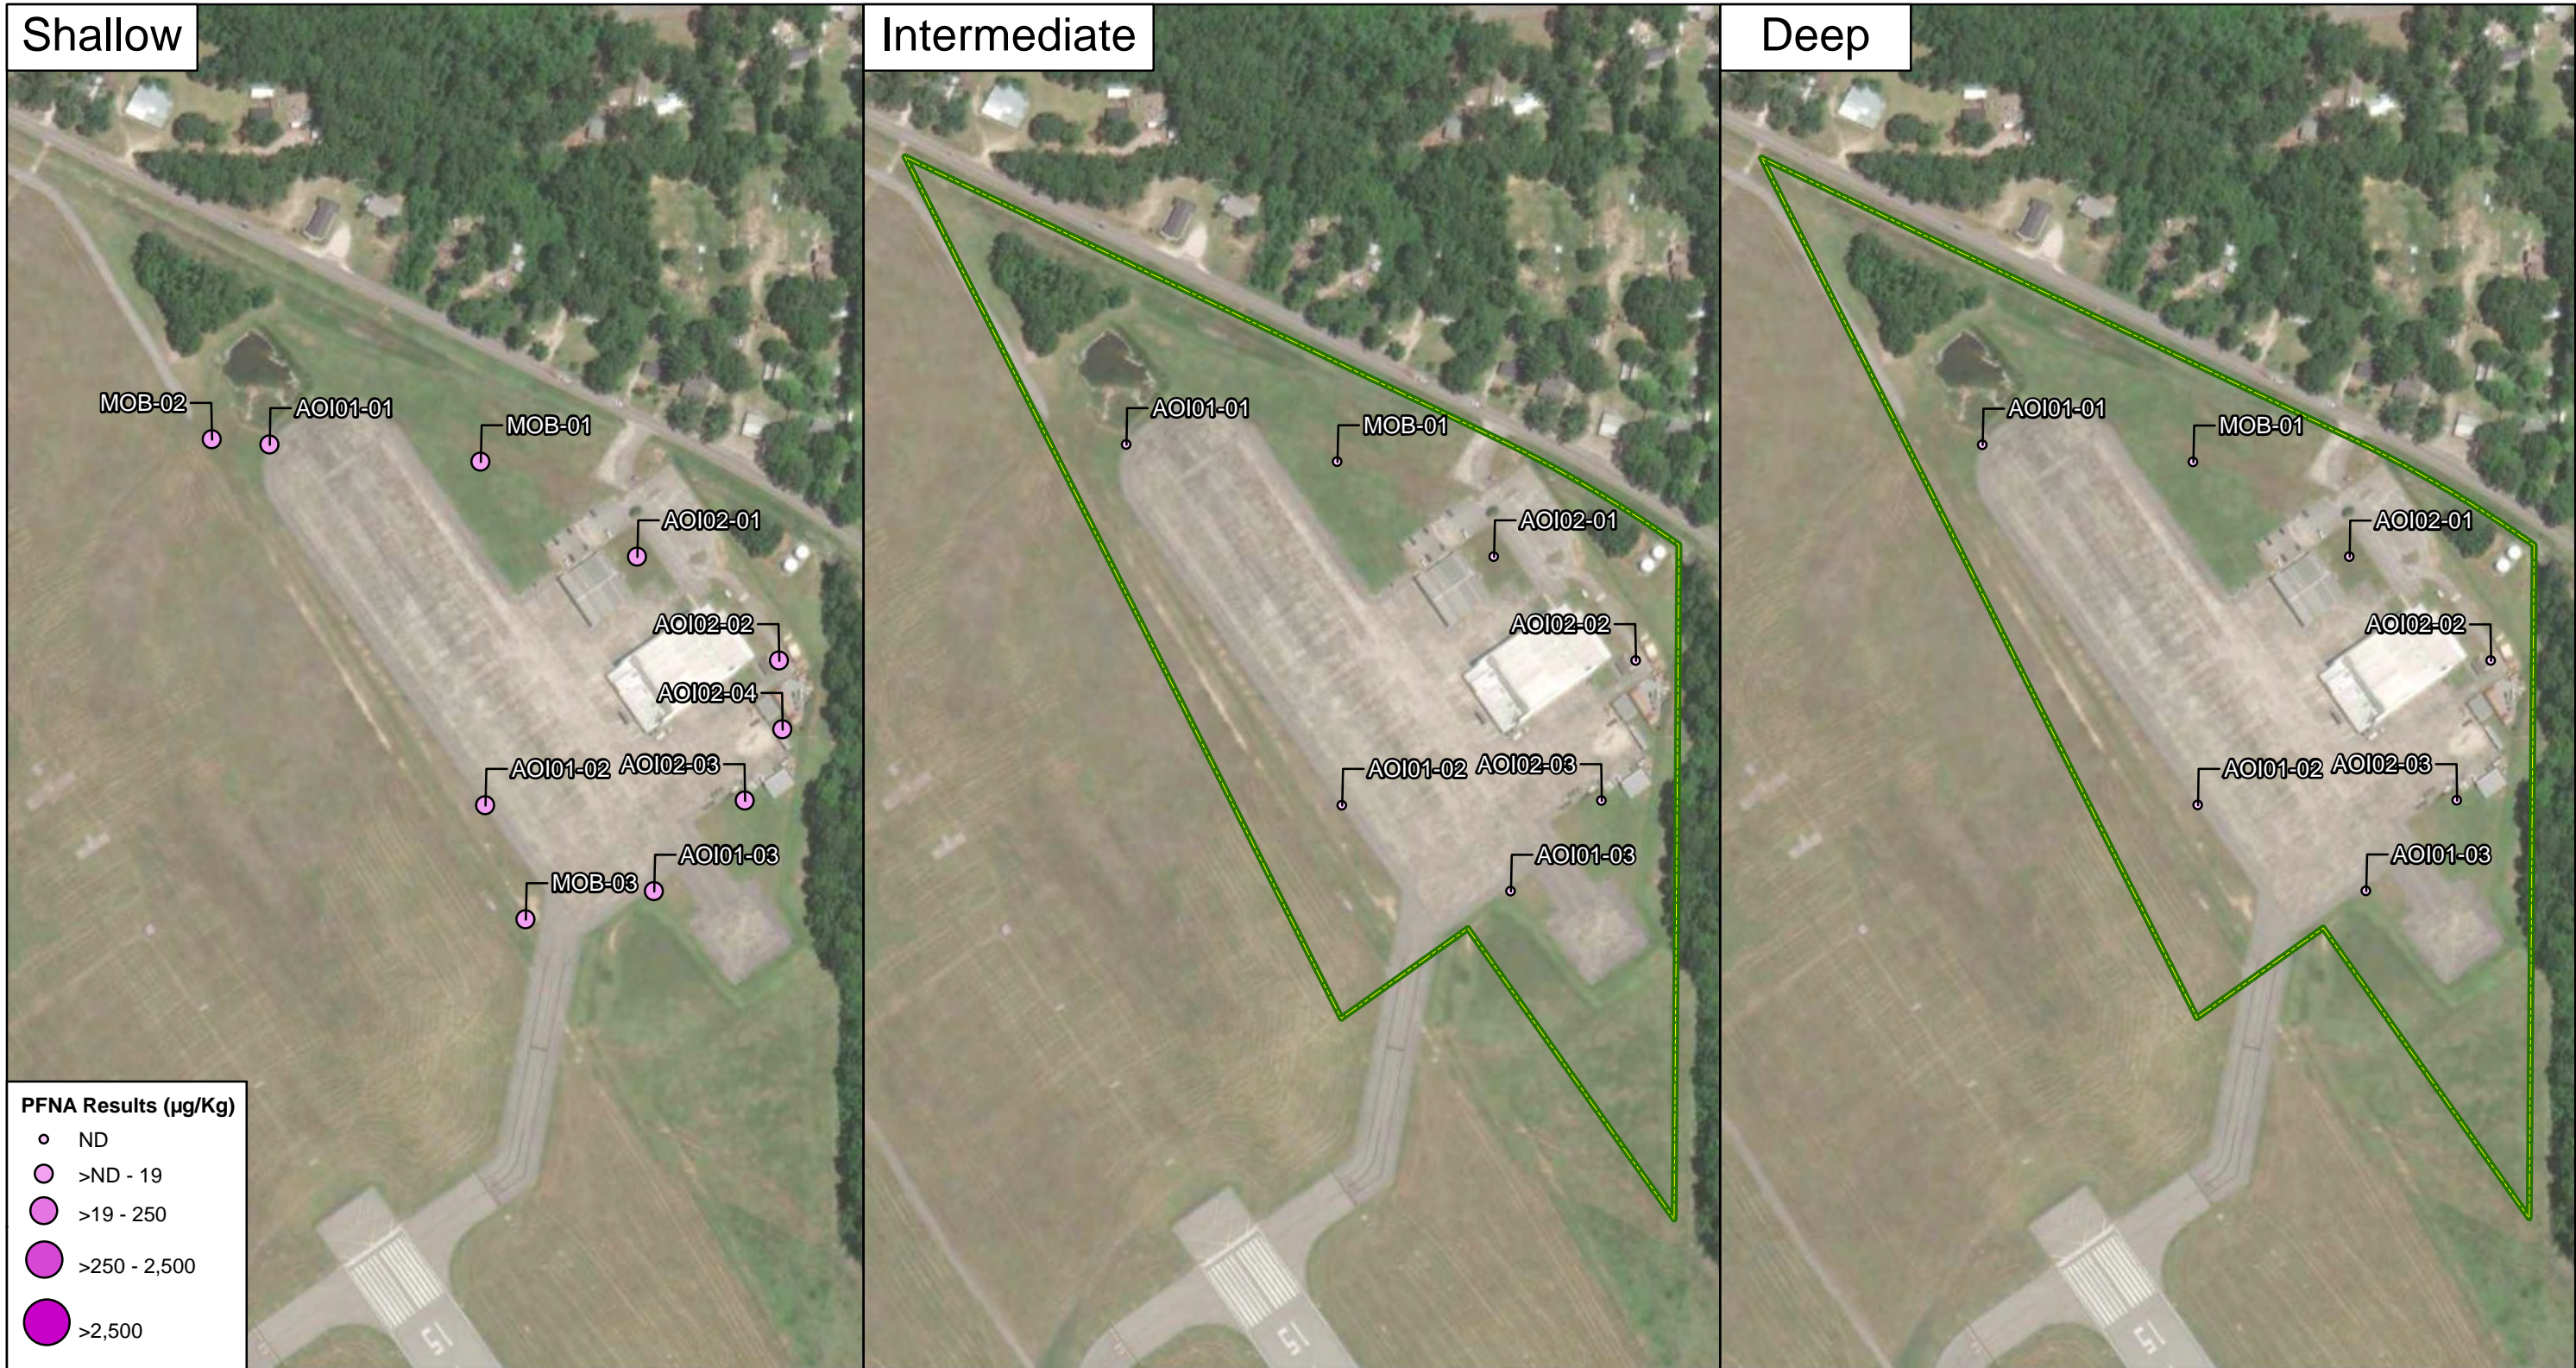
Figure 6-5

PFNA Results (µg/Kg)
