Site Inspection Report

Bethel Army Aviation Operating Facility

Bethel, Alaska

Site Inspections for Perfluorooctanoic Acid (PFOA), Perfluorooctanesulfonic Acid (PFOS), Perfluorohexanesulfonic Acid (PFHxS), Perfluorononanoic Acid (PFNA), Hexafluoropropylene oxide dimer Acid (HFPO-DA) and Perfluorobutanesulfonic Acid (PFBS)
ARNG Installations, Nationwide

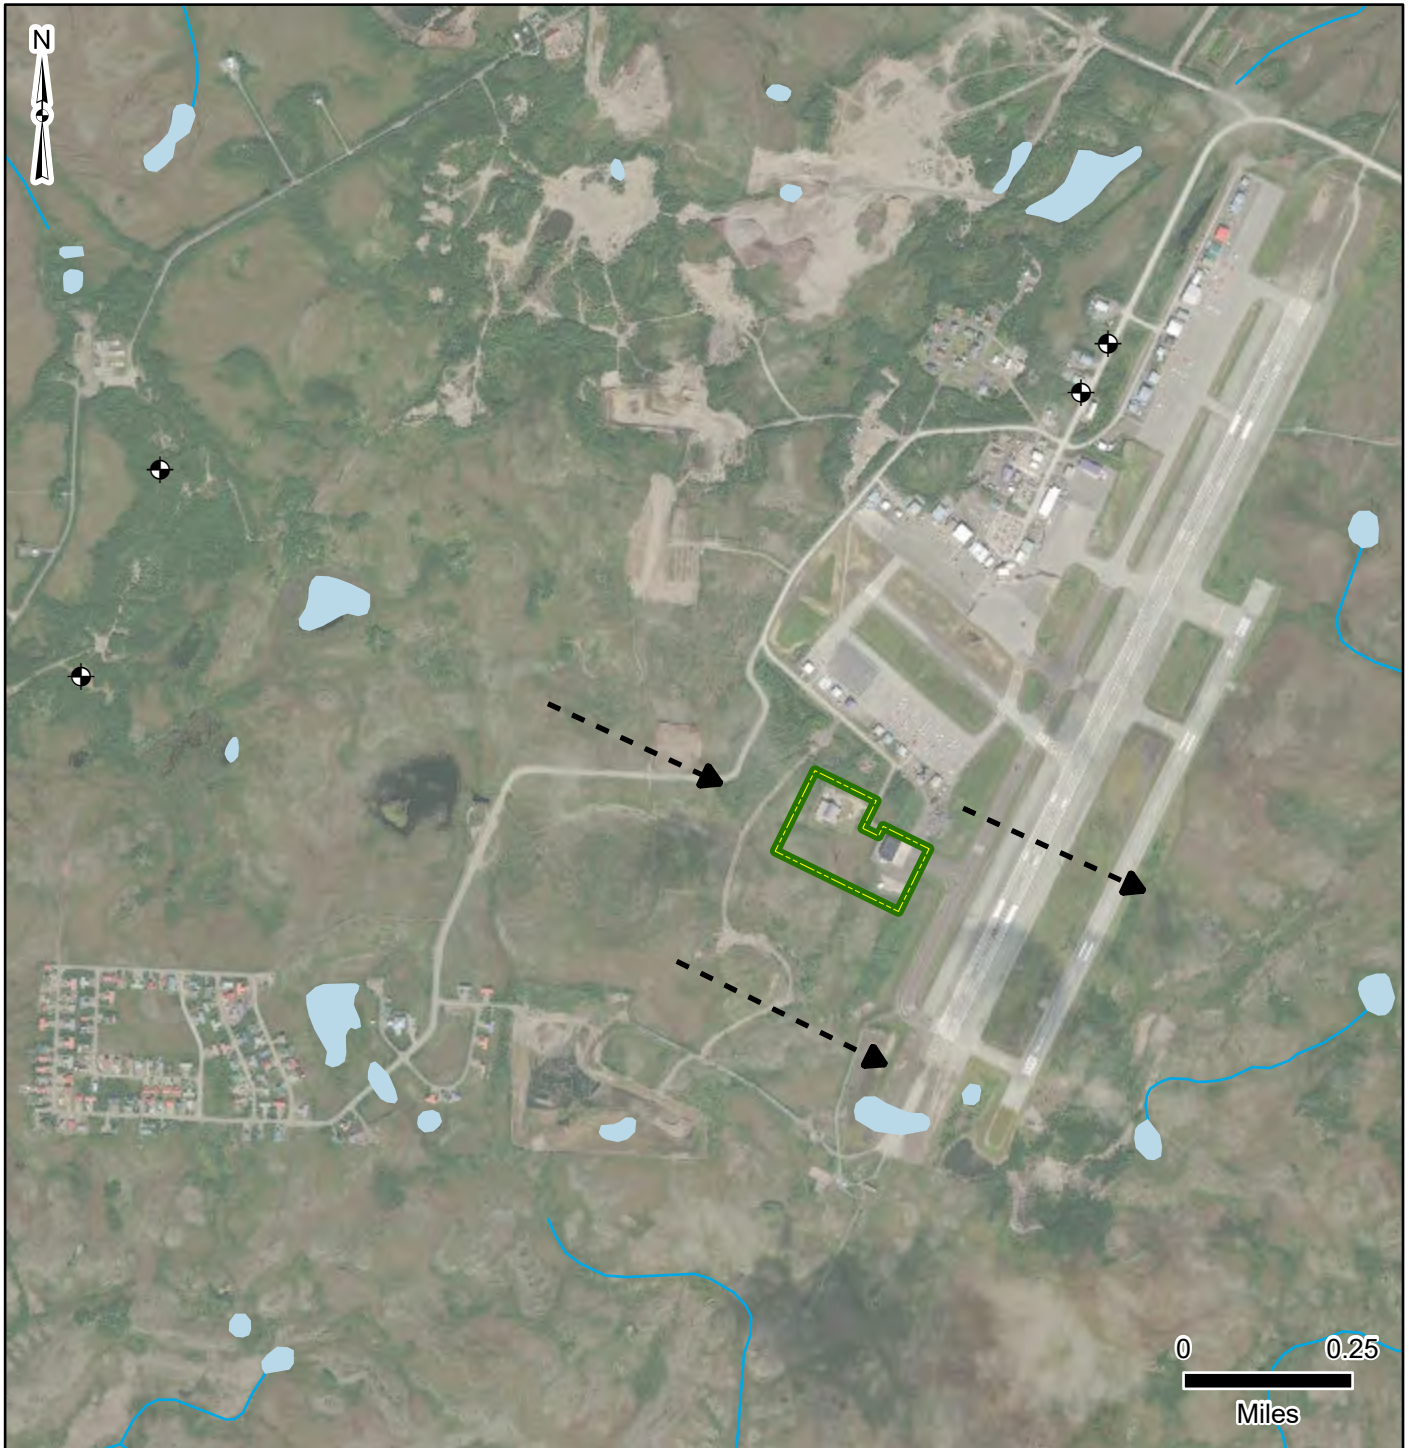
Figure 2-3
Groundwater Features

Regional static groundwater levels, determined from wells drilled in the area, range from 9 to 38 ft bgs. Regional groundwater flow is believed to the southeast toward the Kuskokwim River (**Figures 2-3 and 2-4**). During the SI, depth to groundwater at Bethel AAOF ranged from 10.74 to 17.25 ft bgs. However, survey accuracy was diminished due to weather conditions. More information on survey accuracy is described in **Section 5.8**.

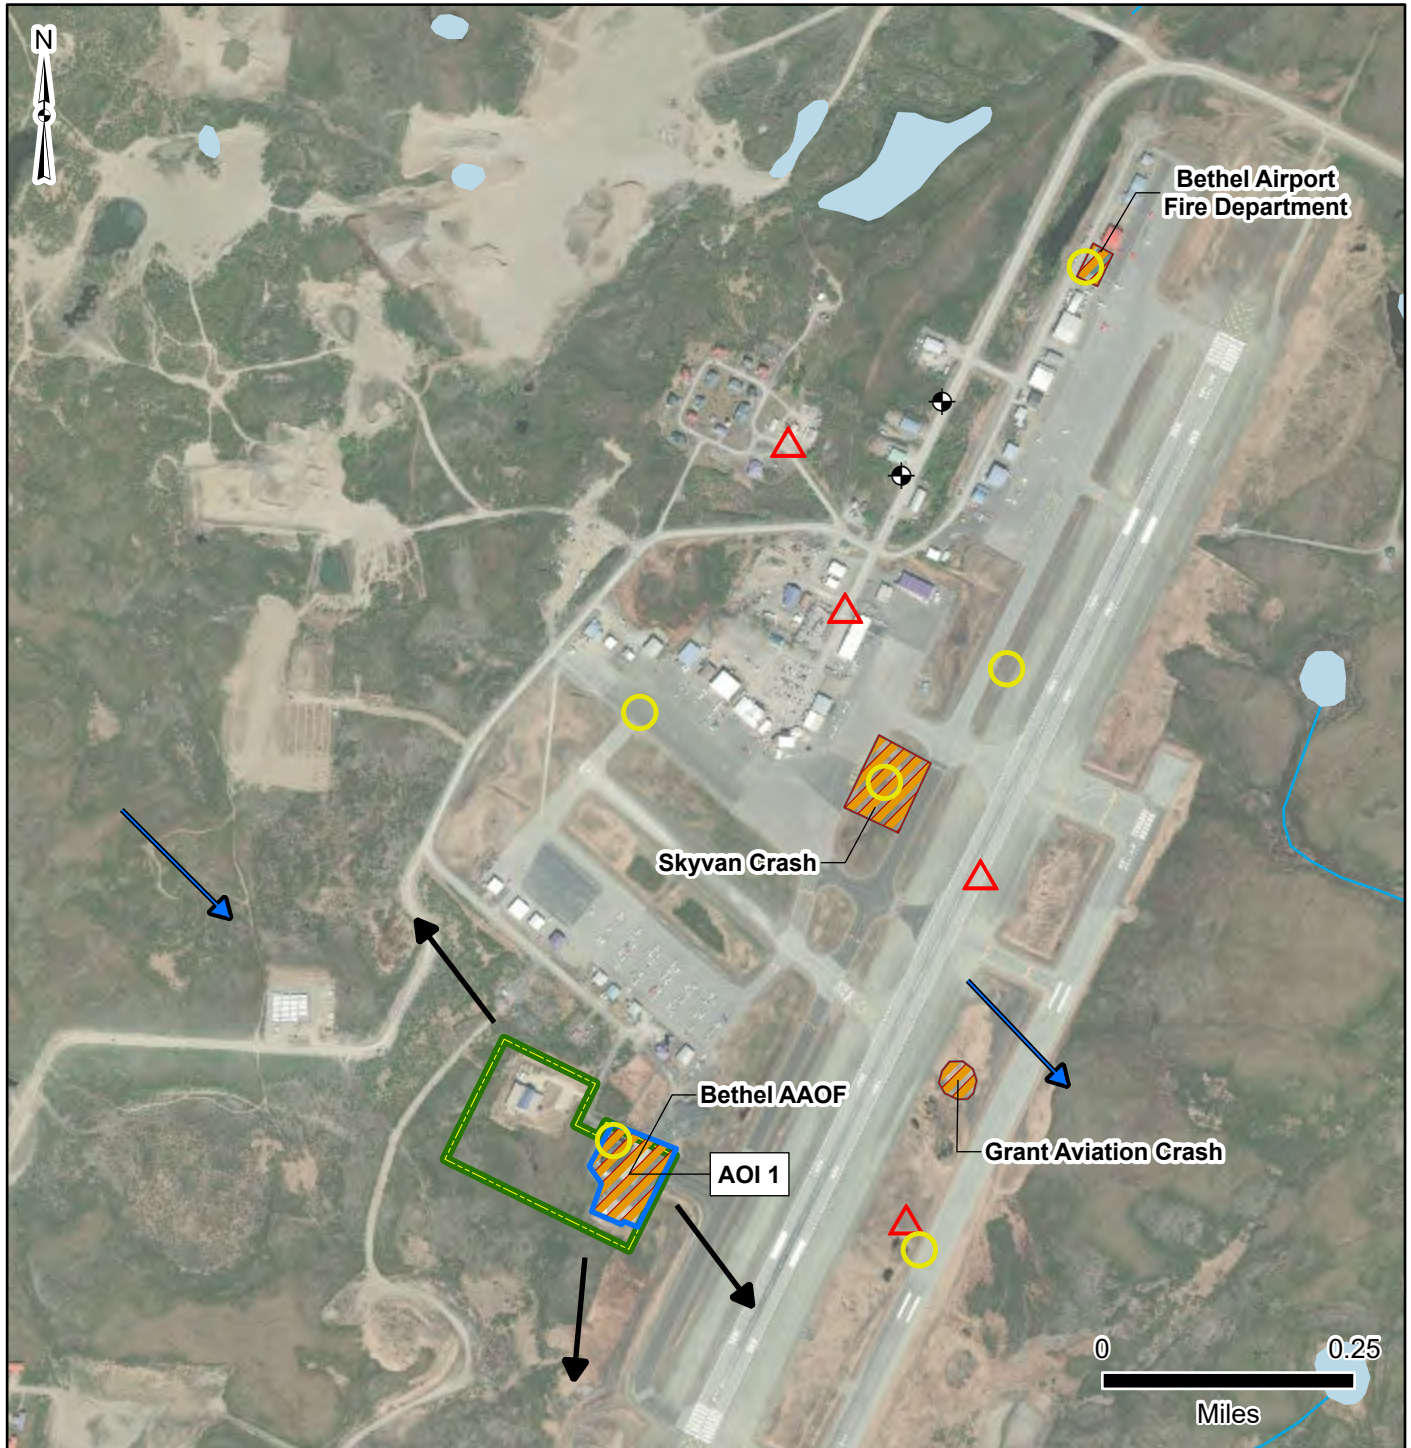
Figure 3-1
Areas of Interest

The Bethel AAOF Hangar (60°46'31.44"N, 161°50'45.91"W) has been continuously occupied by the AKARNG since 1995, a few years after its construction, and is equipped with an FSS supplied with AFFF by two 800-gal tanks. The FSS has had no reported releases; however, the AFFF tank has a leaky sight gauge. The gauge only leaks when checked, and less than 1 quart of AFFF foam is discharged each time the tank is serviced. Servicing is performed by a third-party company, Frontier Fire. According to interviews with maintenance personnel, the system has been serviced twice in the past 10 years. Each release is wet mopped immediately and disposed of through the Facility's drainage system. The Facility drainage system is connected to an RGF Environmental sediment/hydrocarbon filter, which does not filter for PFAS, and wastewater is not chemically tested before or after being filtered. A holding tank contains the wastewater until it is pumped out by a Bethel municipal service.
