FINAL Site Inspection Report Bryant Army Airfield Anchorage, Alaska

Site Inspection for Perfluorooctanoic acid (PFOA),
Perfluorooctanesulfonic acid (PFOS), Perfluorohexanesulfonic
acid (PFHxS), Perfluorononanoic acid (PFNA),
Hexafluoropropylene oxide dimer acid (HFPO-DA), and
Perfluorobutanesulfonic acid (PFBS) at ARNG Installations,
Nationwide

September 2023

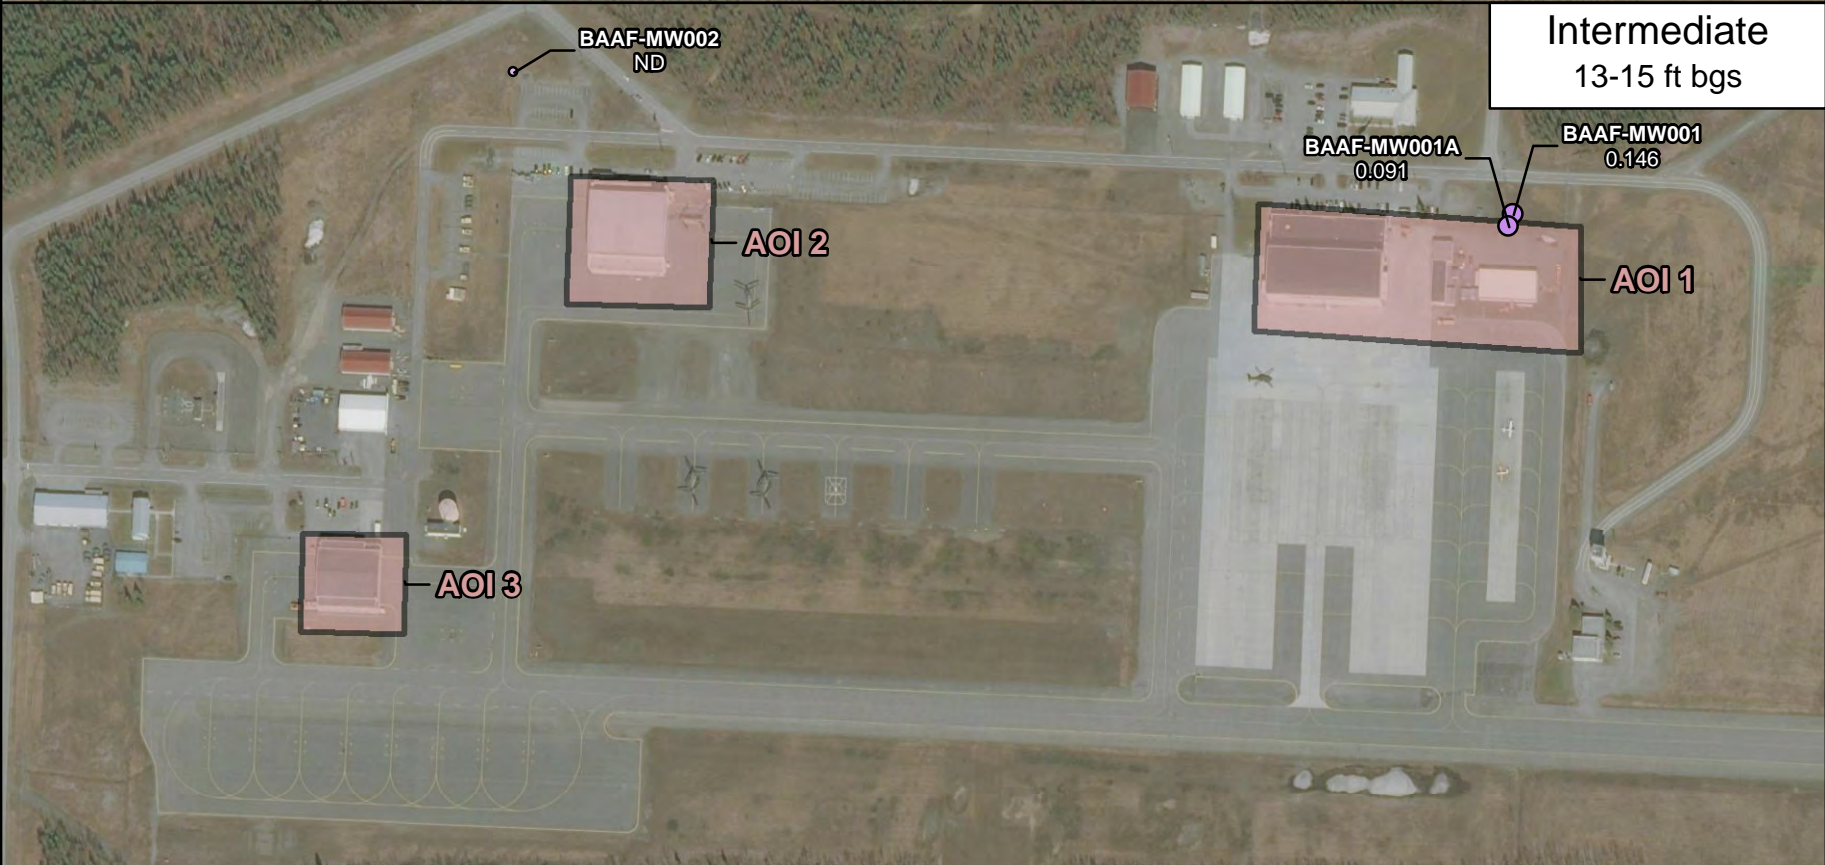
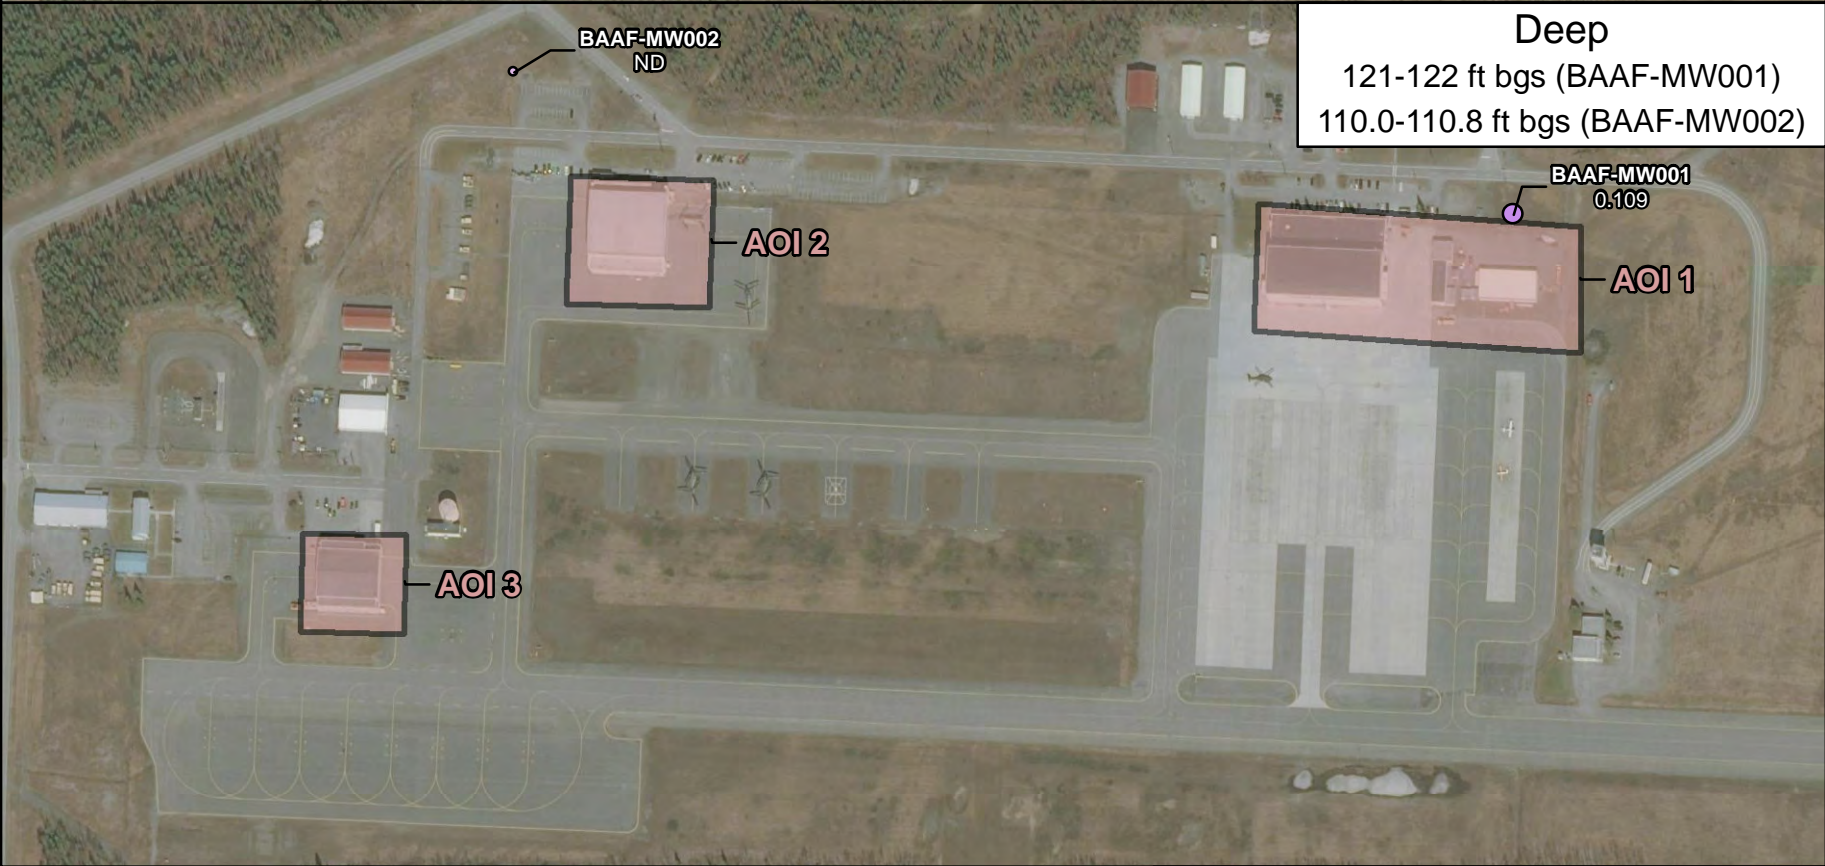
Figure 6-4

Exceedances of the OSD SL are depicted with a yellow halo.
Depth intervals shown represent respective sampling position within a given soil boring location.
