FINAL Preliminary Assessment Report Bethel Army Aviation Operating Facility and Armory Alaska

Perfluorooctanesulfonic Acid (PFOS) and Perfluorooctanoic Acid (PFOA)
Impacted Sites
ARNG Installations, Nationwide

August 2020

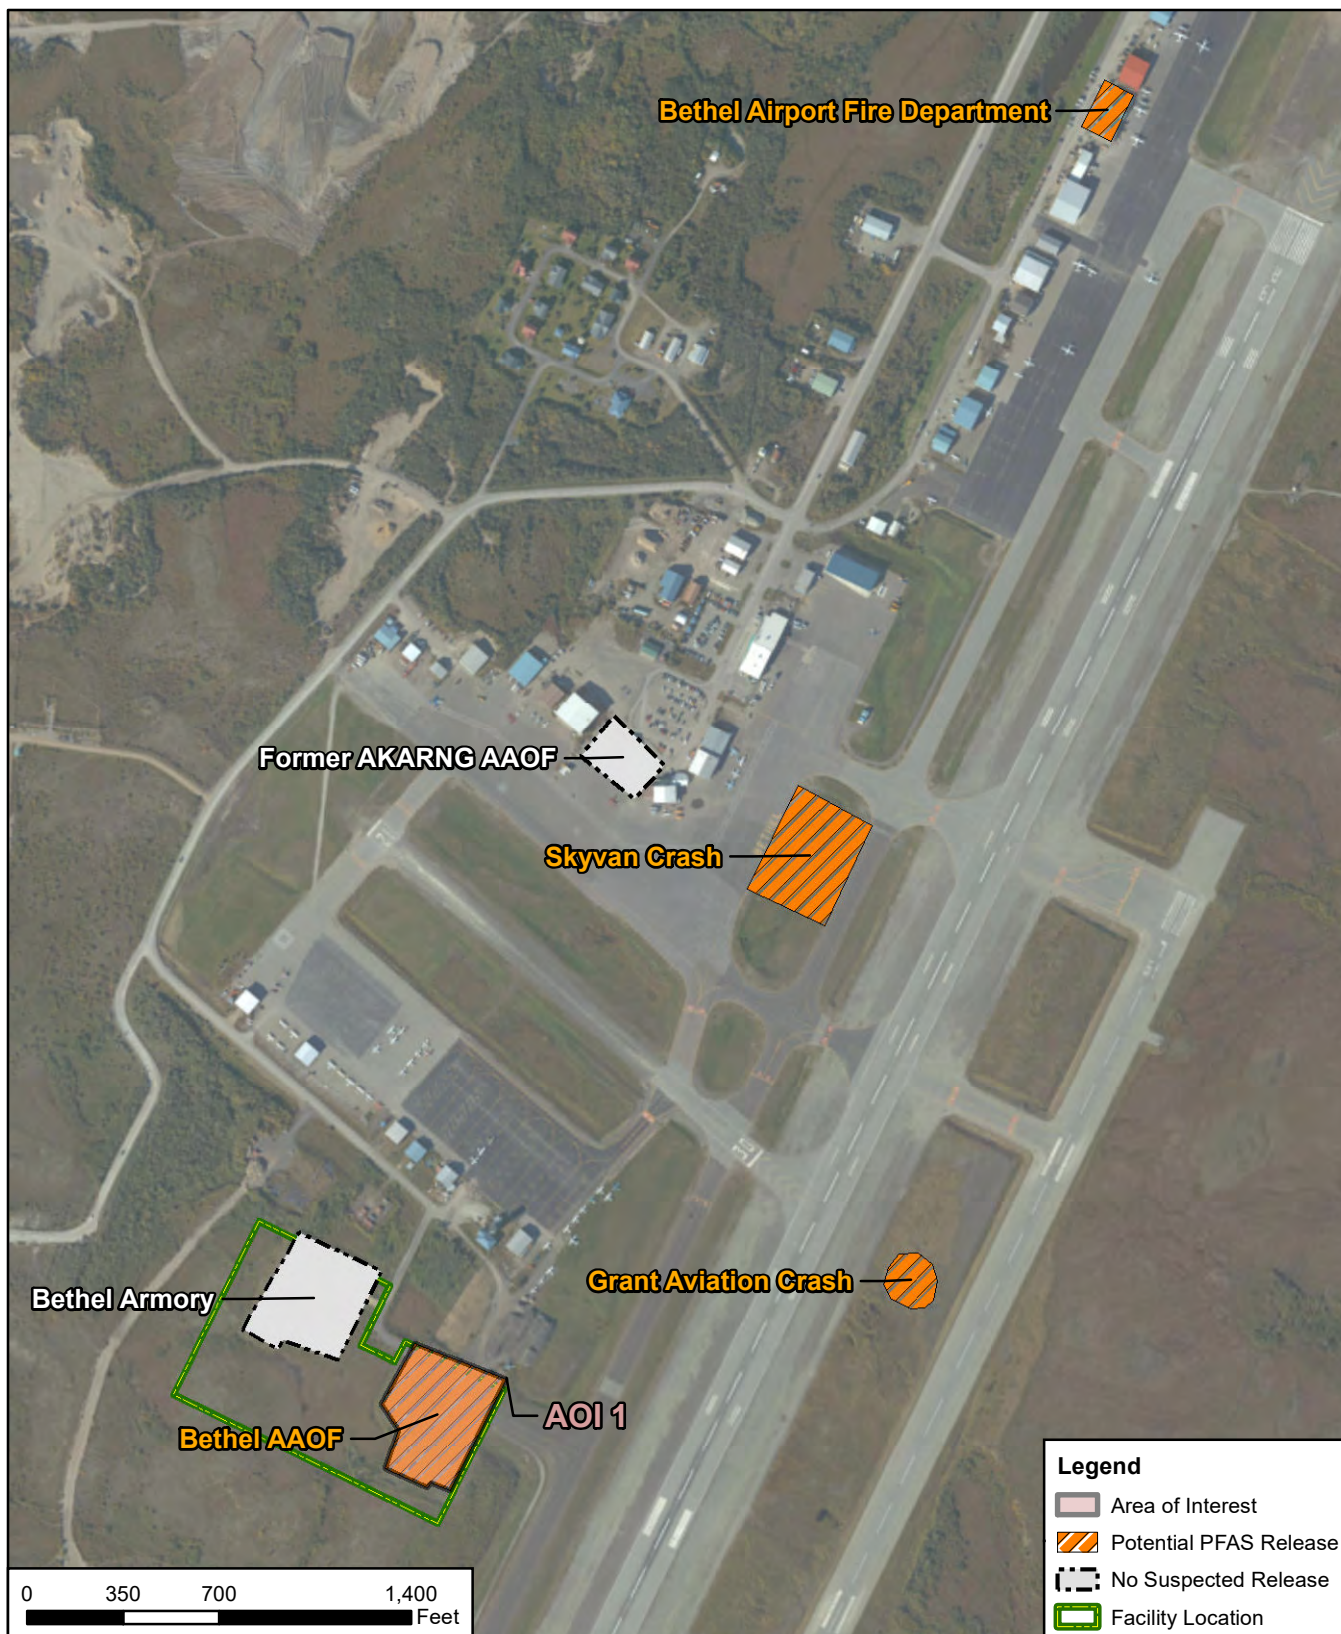
12420 Milestone Center Drive Germantown, MD 20876	Figure ES-1
SCALE	1:8,400	CHK BY	LC	7/8/2020			
Base Map: Source: Esri, DigitalGlobe, GeoEye, Earthstar Geographics, CNES/Airbus DS, USDA, USGS,		PM	RG	7/8/2020

One AOI related to a potential PFAS release was identified at the facility during the PA. The AOI is shown on **Figure ES-1** and described in **Table ES-1** below:

Summary of Findings	
NOTES		Preliminary Assessment for PFAS at Bethel AAOF, AK					
REVISED	7/8/2020	GIS BY	MS	7/8/2020

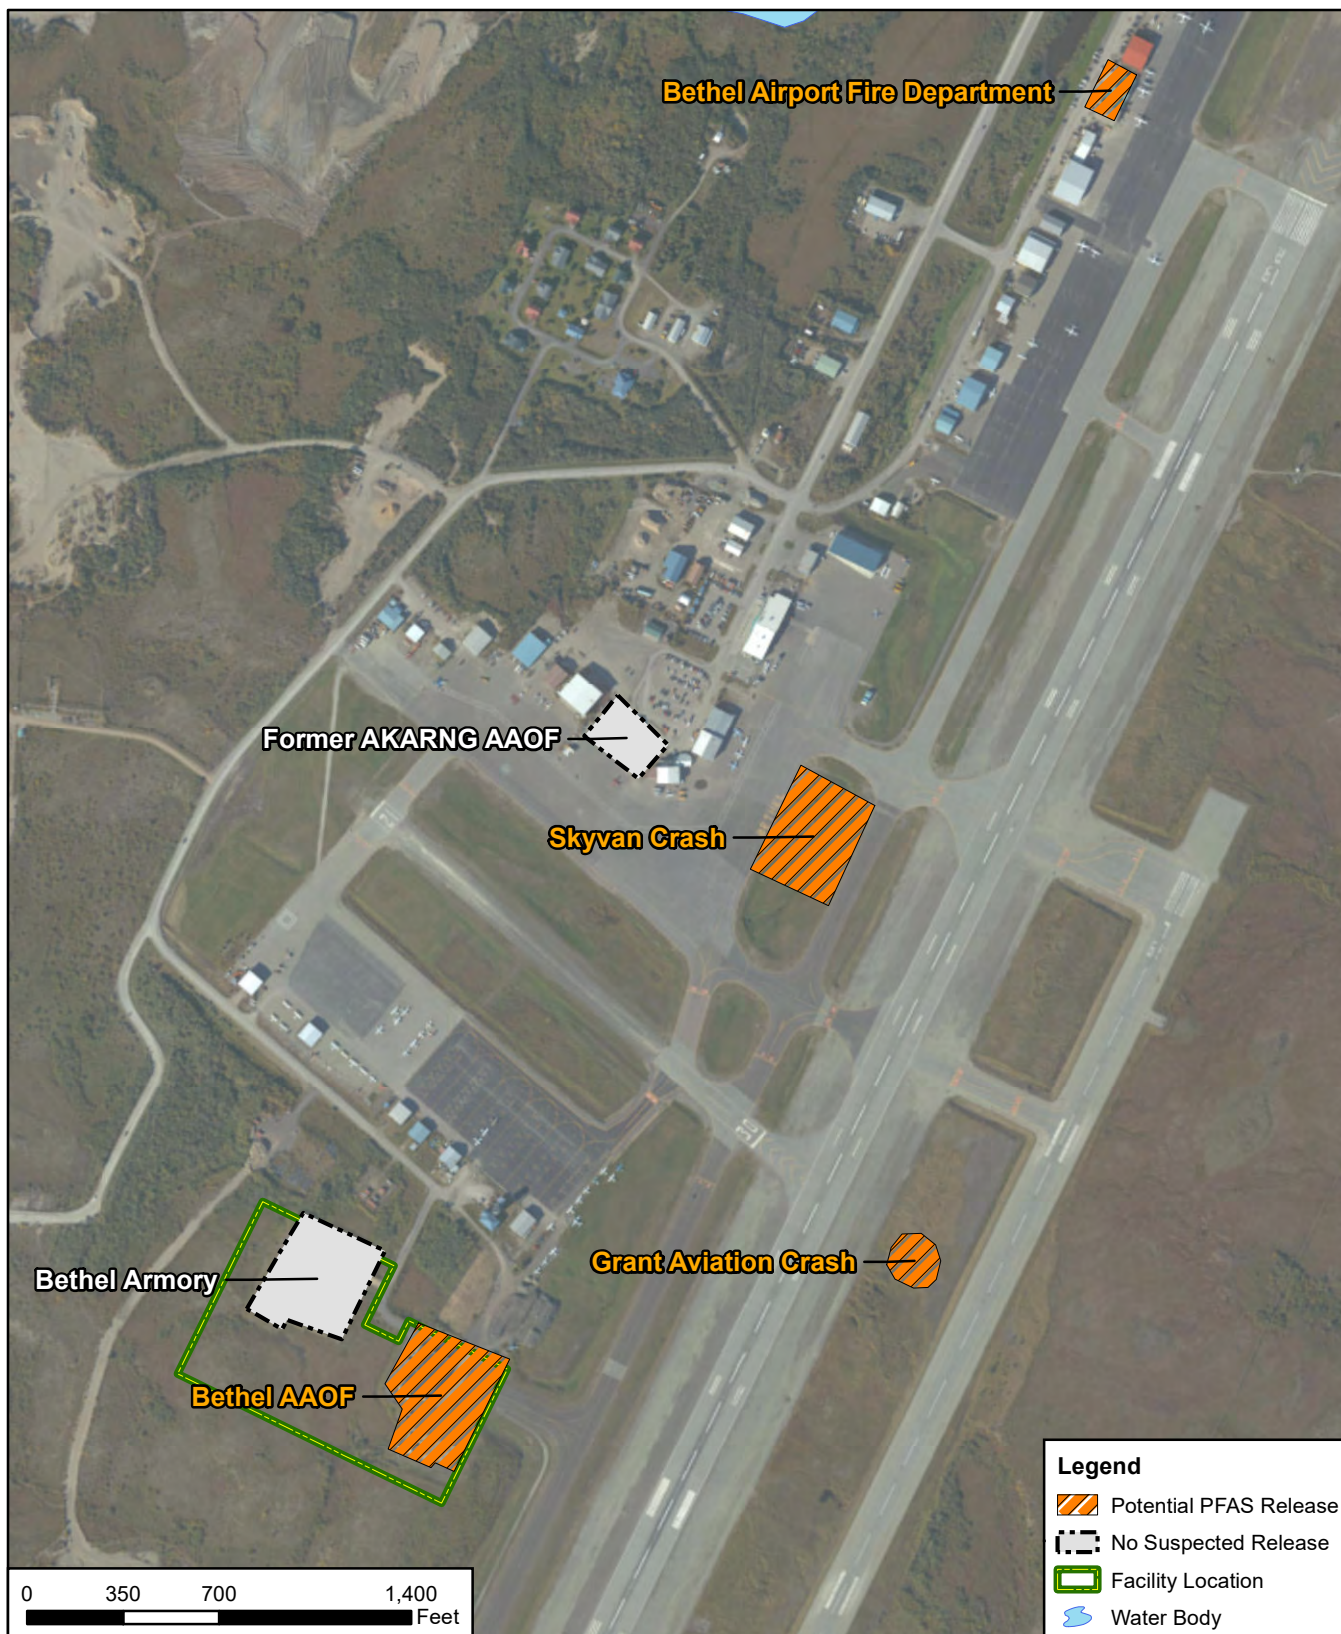
5.4 Grant Aviation Crash

On 8 July 2019, a Grant Aviation aircraft crash-landed in the grassy drainage ditch between Bethel Airport's two main runways. The crash was responded to by the Bethel Airport Fire Department and the Bethel Municipal Fire Department. According to the spill incident report (**Appendix A**), approximately 80 gallons of 3% AFFF was applied to the aircraft fire at the incident site. The Grant Aviation crash area is hydrologically downgradient from the AAOF and Armory.

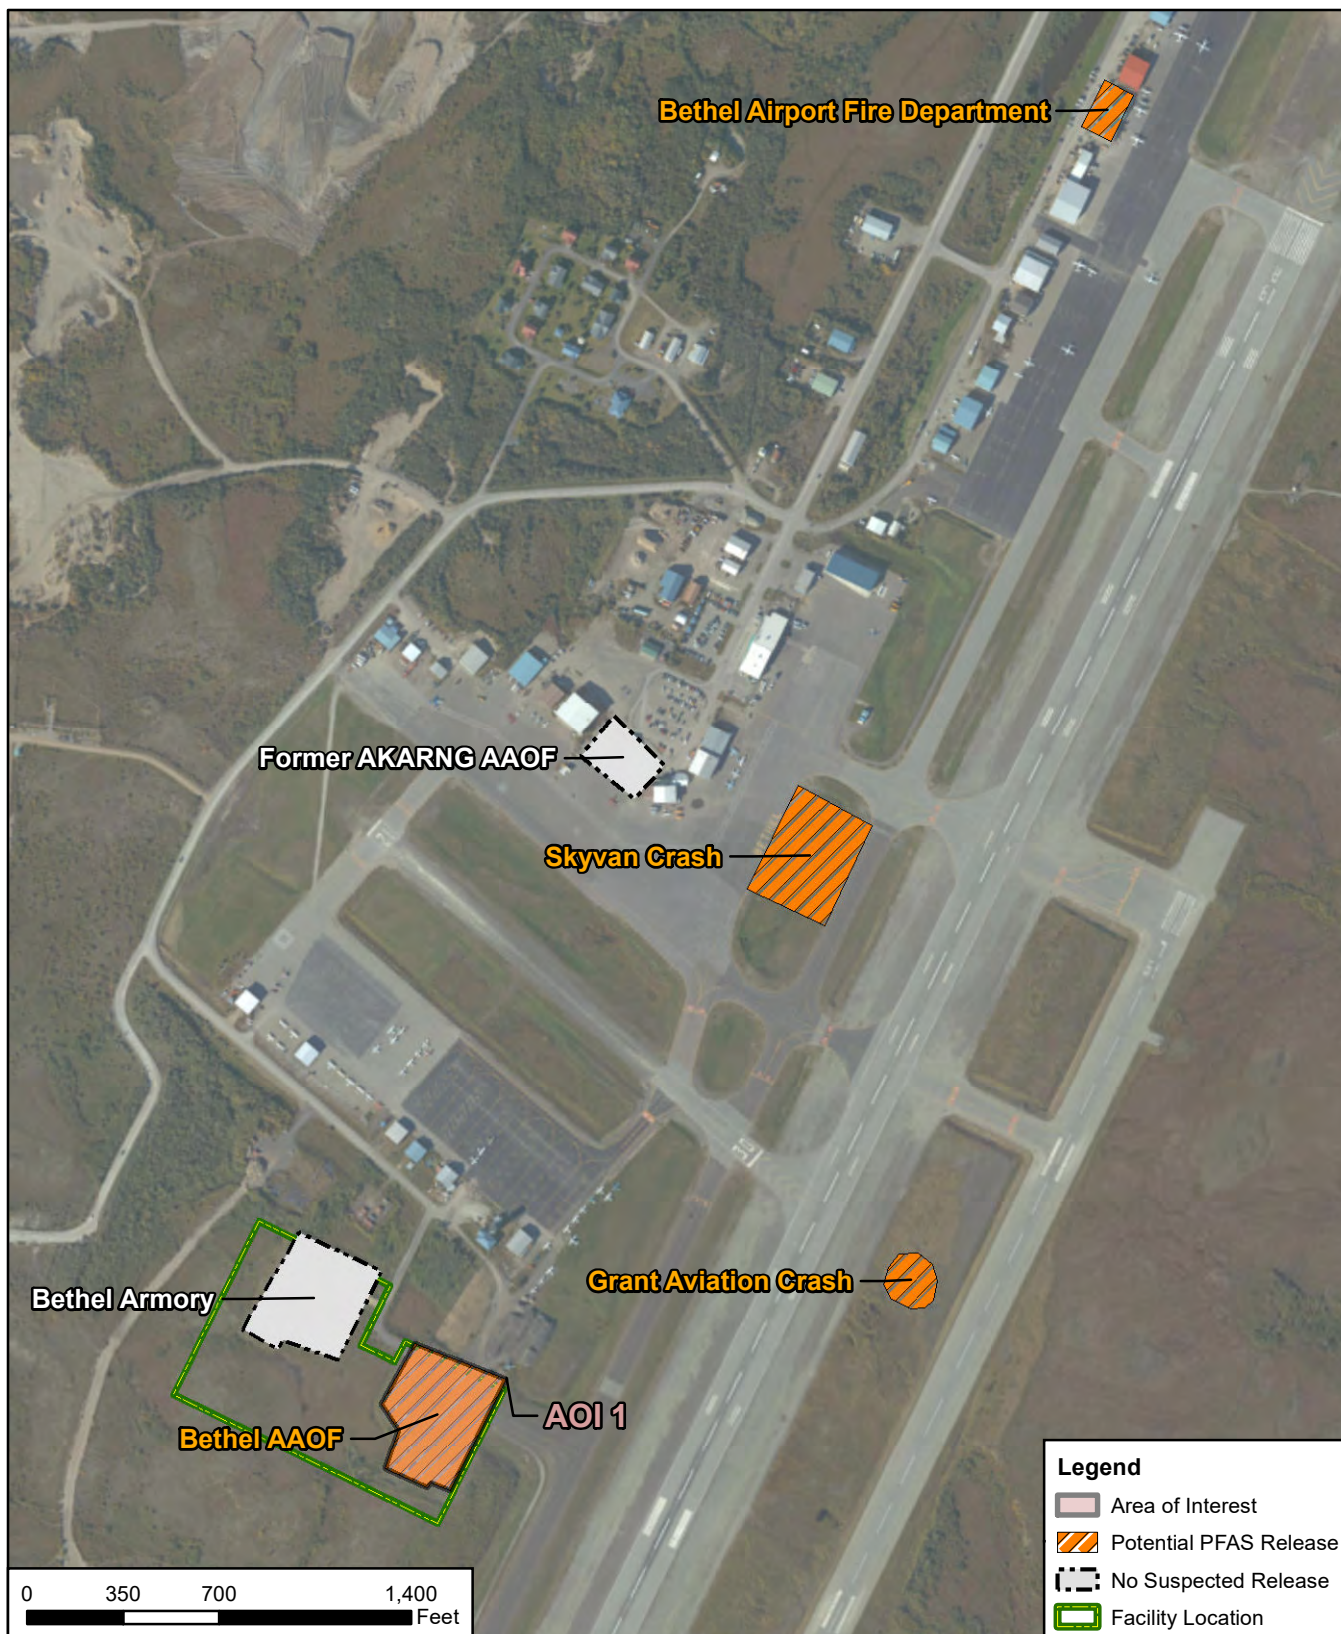
Table 7-4: PA Findings Summary

Area of Interest	AOI Location	Rationale	Potential Future Action
AOI 1: Bethel AAOF	60°46'31.44"N, 161°50'45.91"W	Leakages of AFFF from servicing and testing of the FSS; Tri-Max™ Storage	Proceed to an SI, focus on soil, groundwater, surface water, sediment

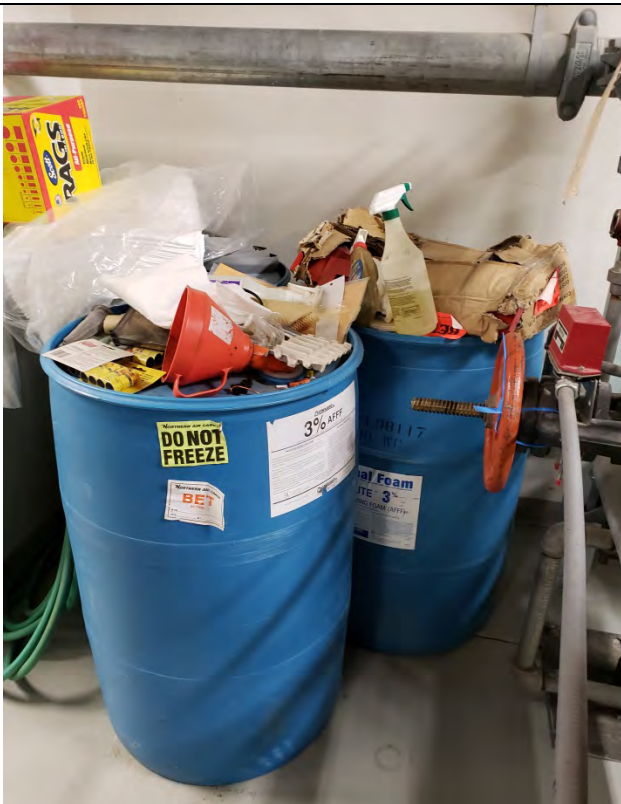
Photograph No. 5 Description: AFFF drums inside the Bethel AAOF Hangar. Date Taken: 30 August 2018

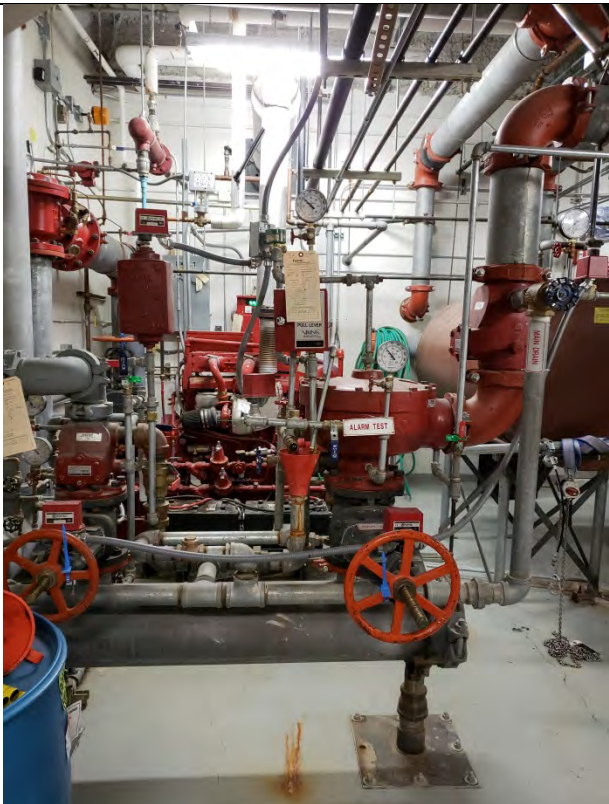
Photograph No. 6 Description: Valve system for the AFFF Fire Suppression System inside the Bethel AAOF Hangar. Date Taken: 30 August 2018

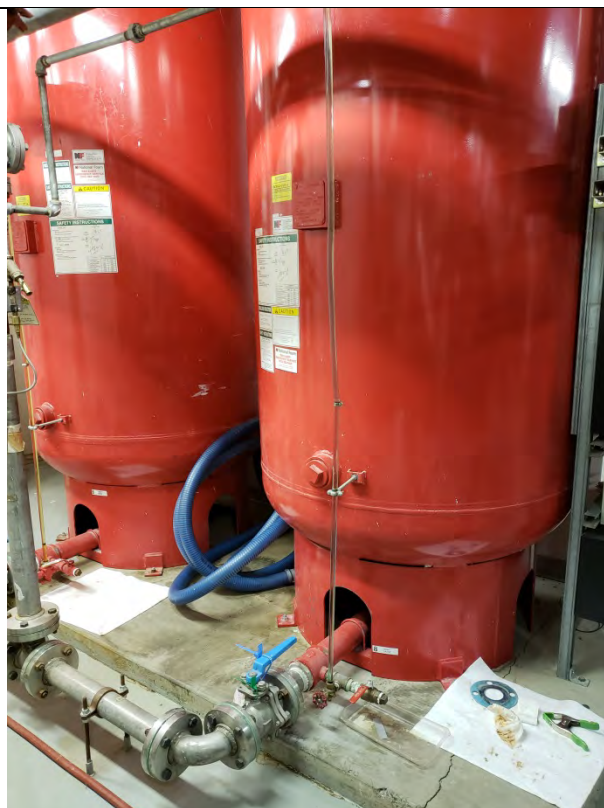
Photograph No. 8

gate valve for sight gauge, East Tank, drips on floor/hay, is mopped up immediately, only leaks when checking the sight gauge. Been leaking since he's been here. From the Fire does system inspection.

Two 800 gallon tanks of
 AFFF that supply the Fire
 Suppression System. Photo
 shows the leaky sight valve
 on the right tank.

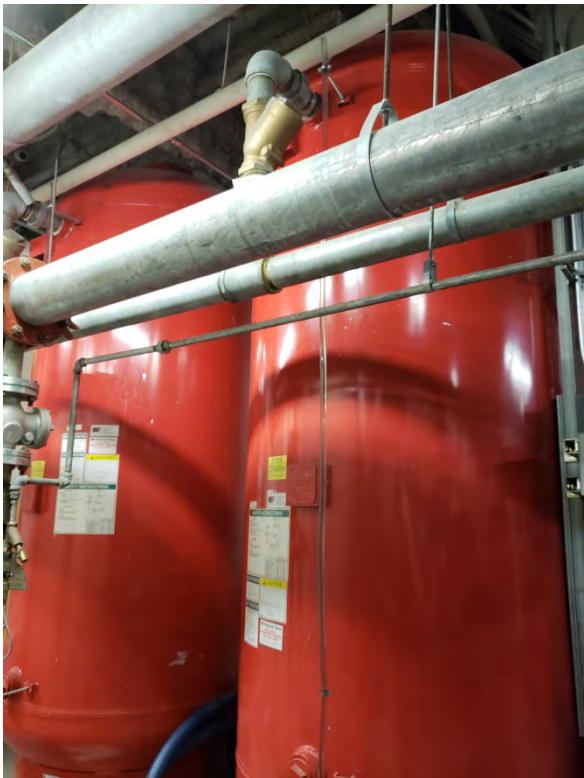
Photograph No. 9 Description: Tops of the AFFF tanks and the sight gauge valves (clear tube) at $\frac{3}{4}$ full. Date Taken: 30 August 2018

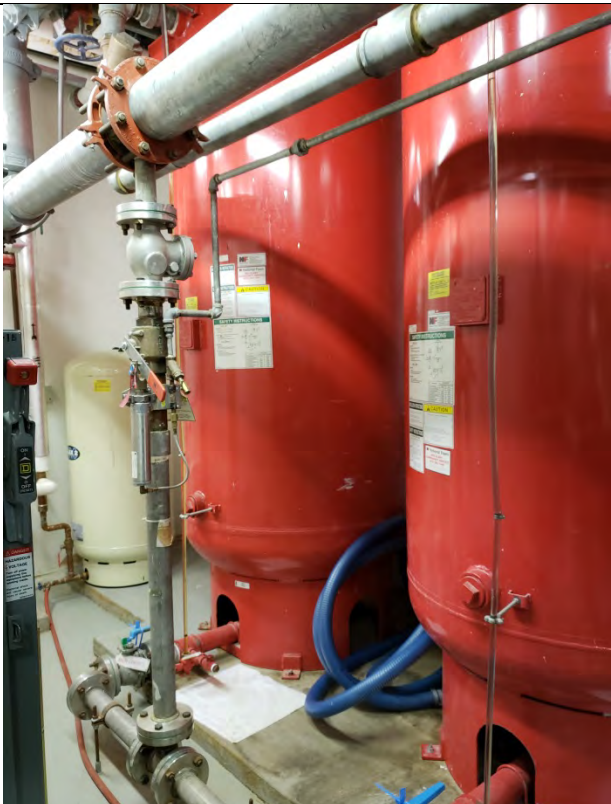
Photograph No. 10 Description: Left AFFF tank and surrounding system components. Date Taken: 30 August 2018

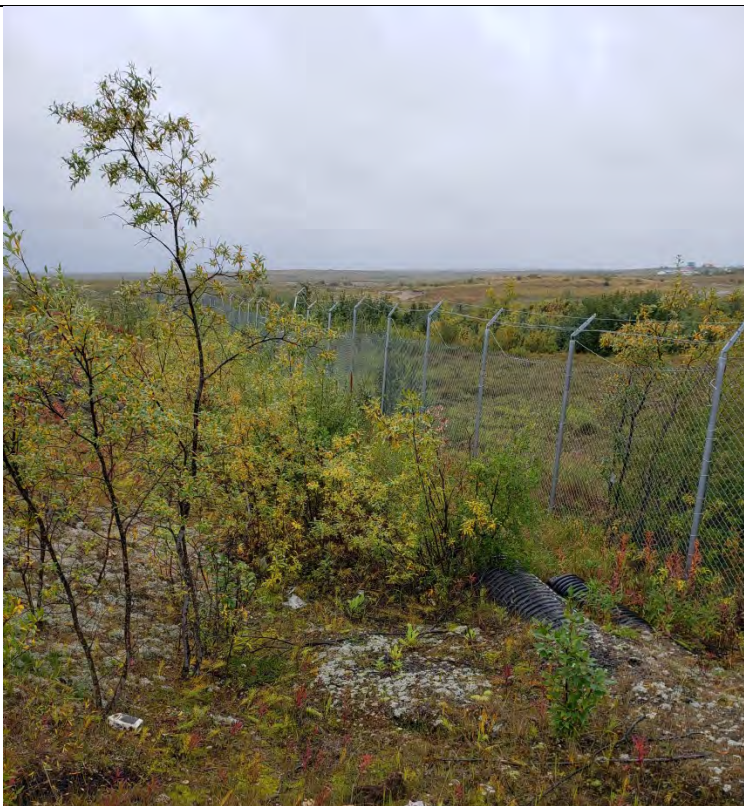
Photograph No. 13 Description: Hangar floor drain outlet, disconnected in 2016, facing southwest. Date Taken: 30 August 2018
