FINAL Site Inspection Report Camp Navajo, Bellemont, Arizona

Site Inspection for Perfluorooctanoic acid (PFOA),
Perfluorooctanesulfonic acid (PFOS), Perfluorohexanesulfonic
acid (PFHxS), Perfluorononanoic acid (PFNA),
Hexafluoropropylene oxide dimer acid (HFPO-DA), and
Perfluorobutanesulfonic acid (PFBS) at ARNG Installations,
Nationwide

June 2023

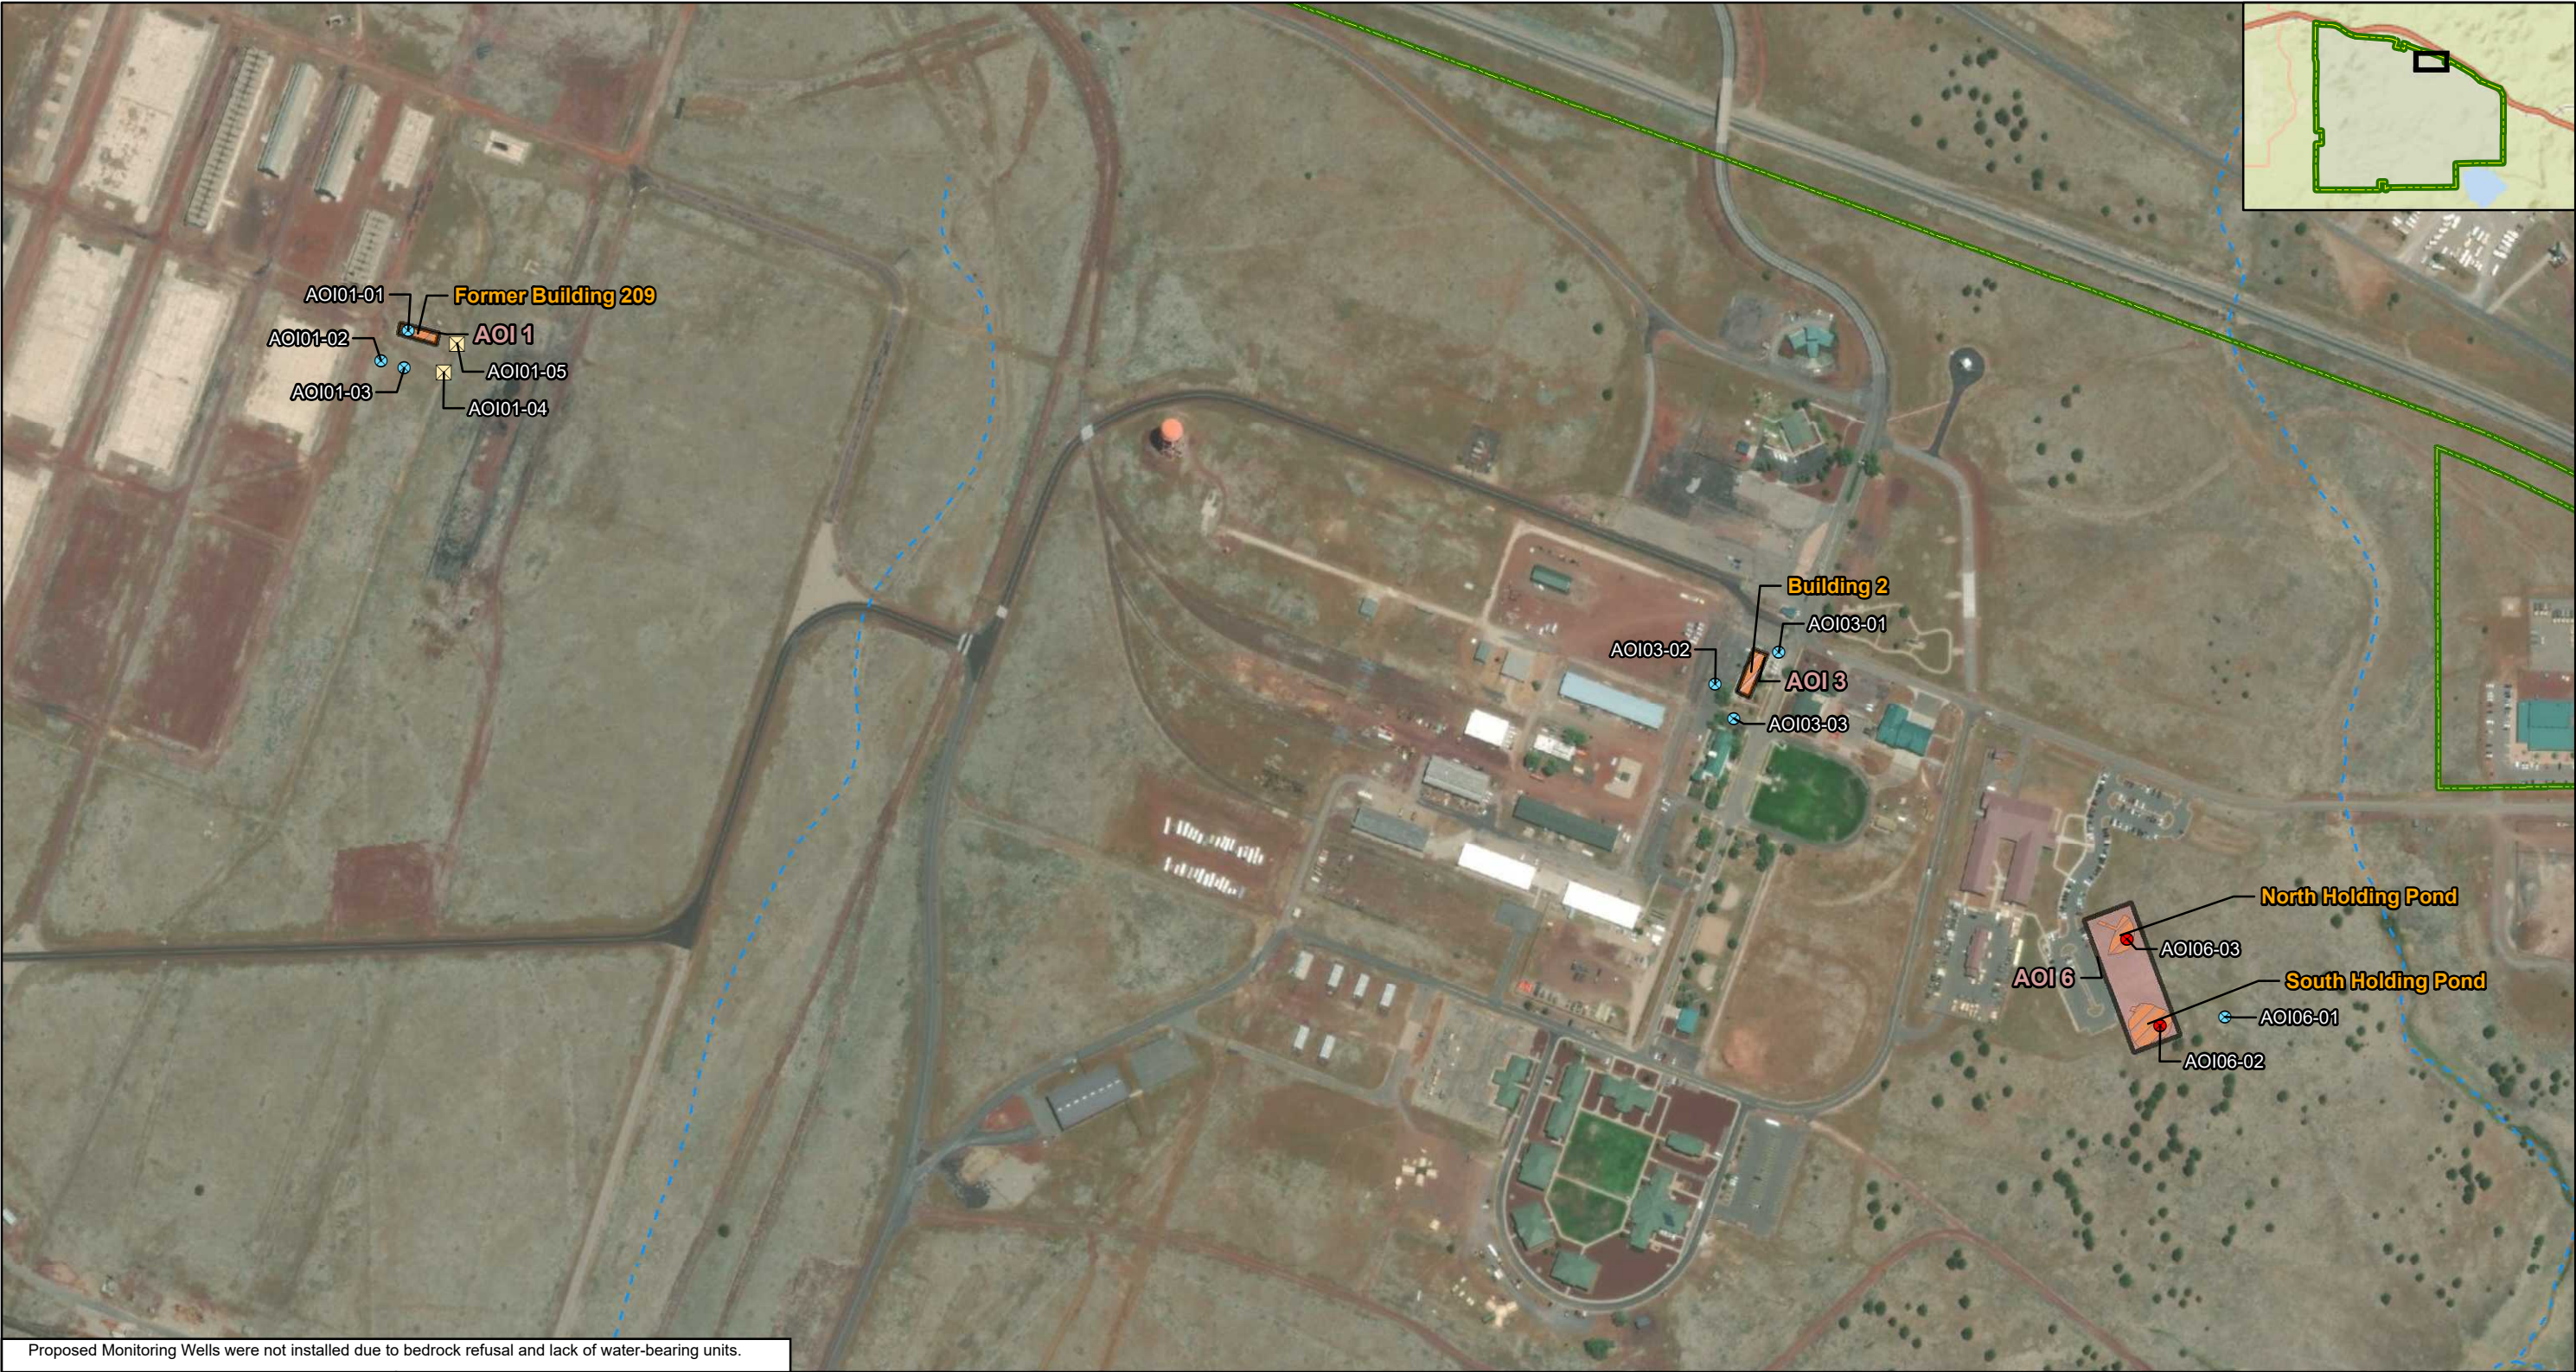
Figure 5-2

Proposed Monitoring Wells were not installed due to bedrock refusal and lack of water-bearing units.

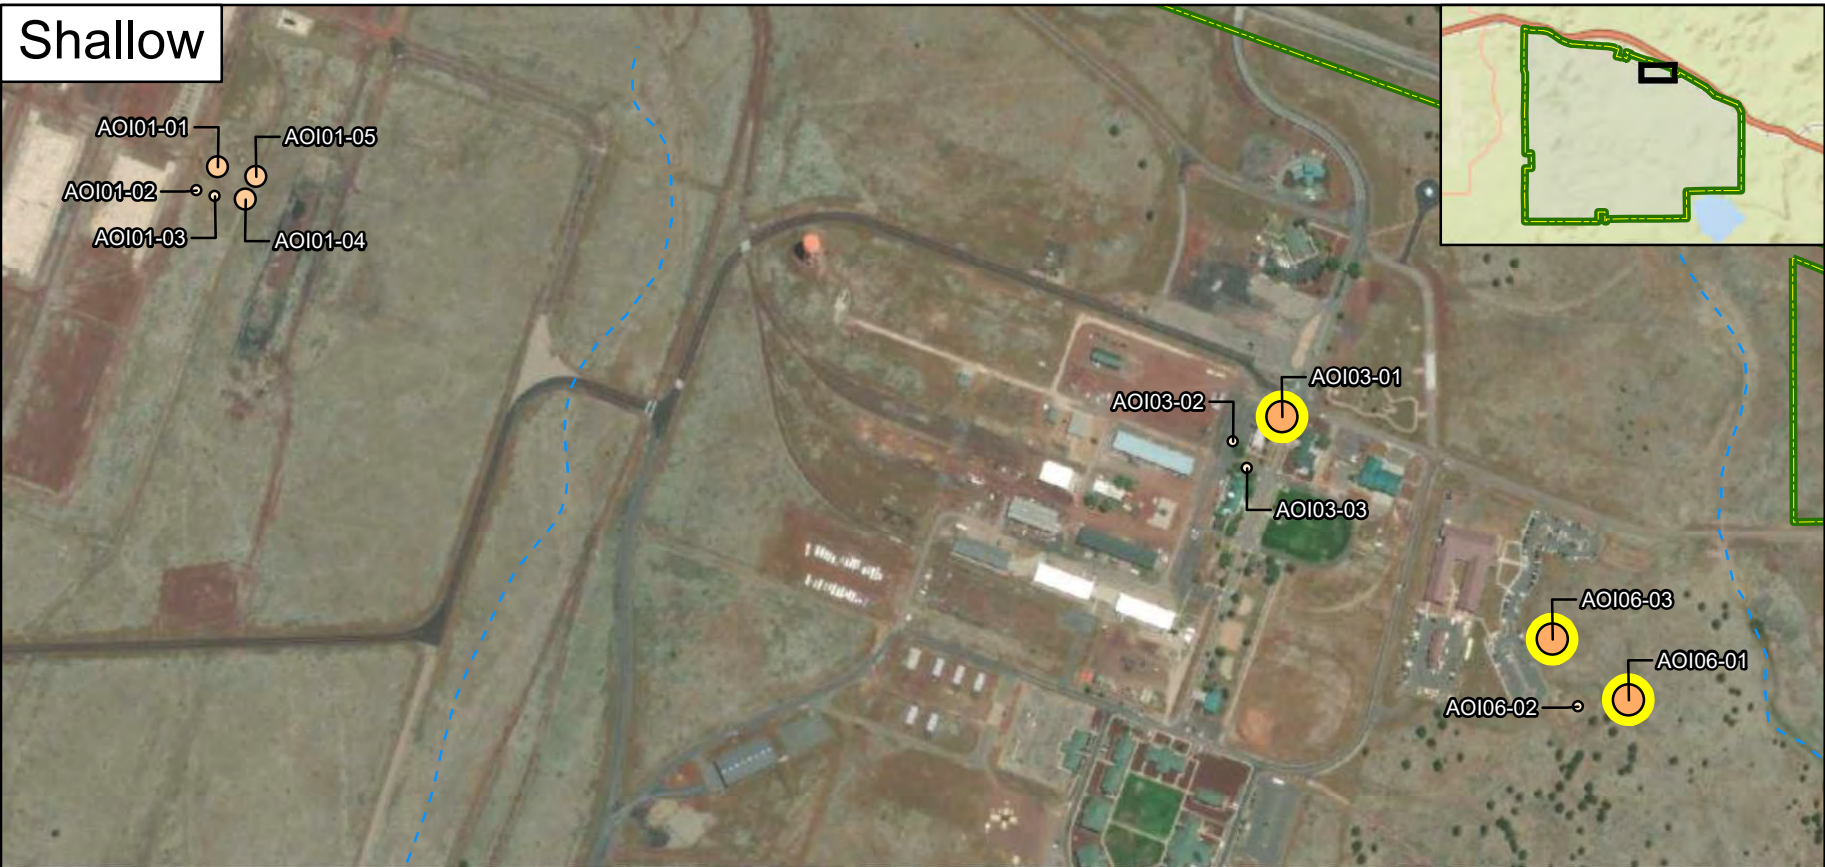
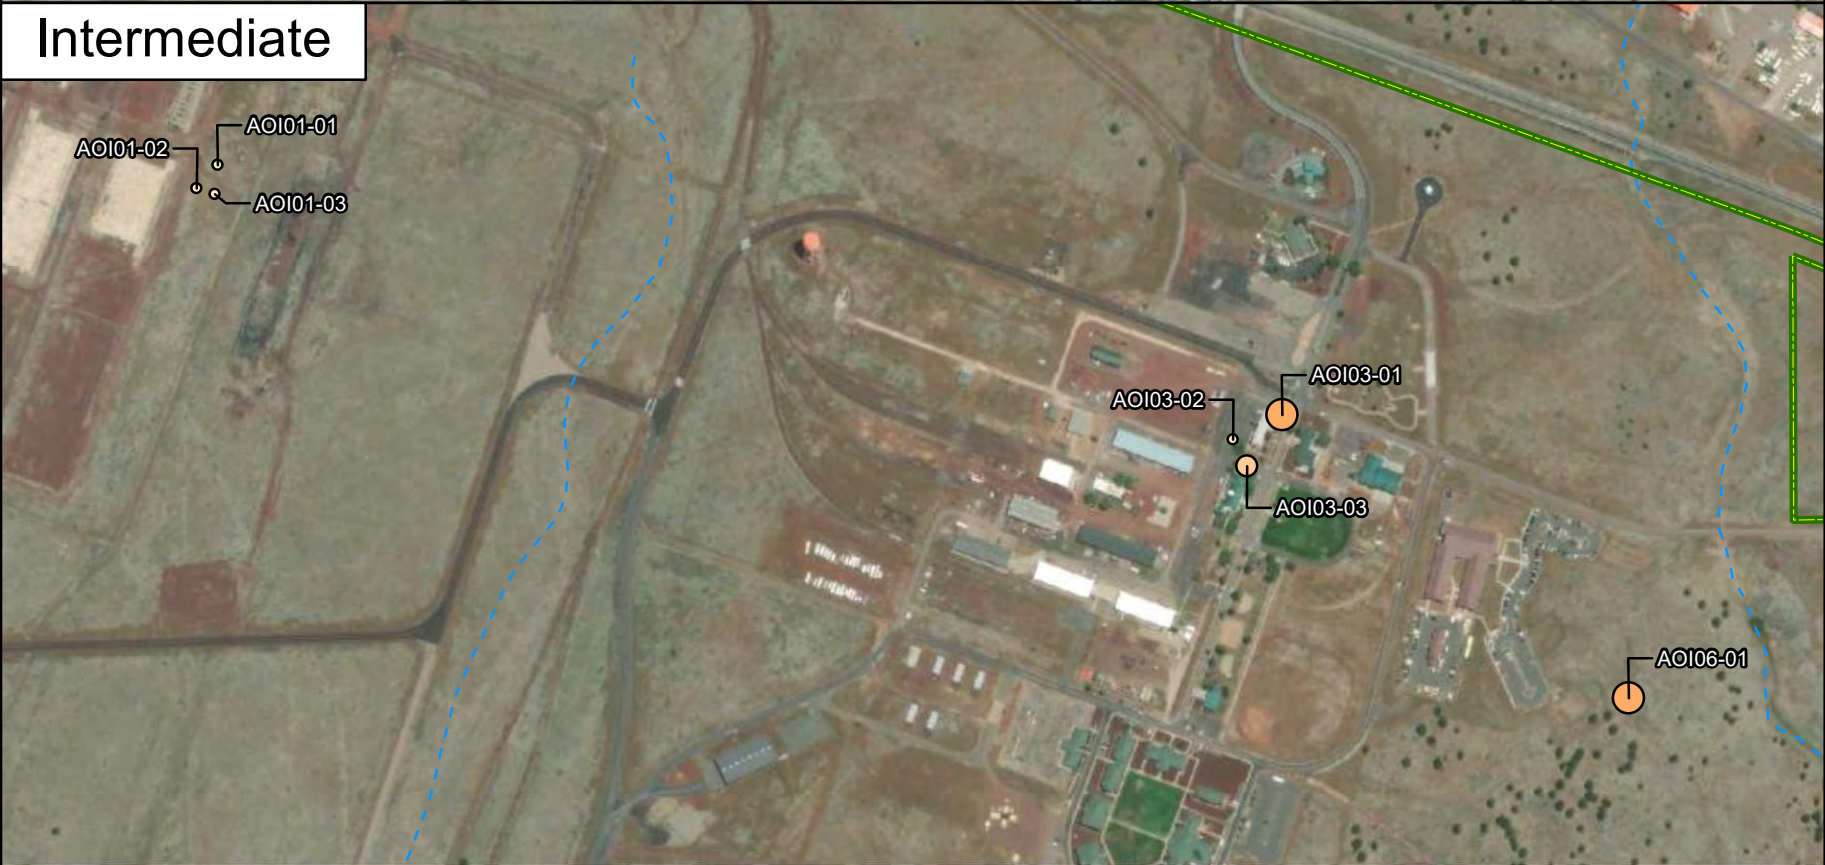
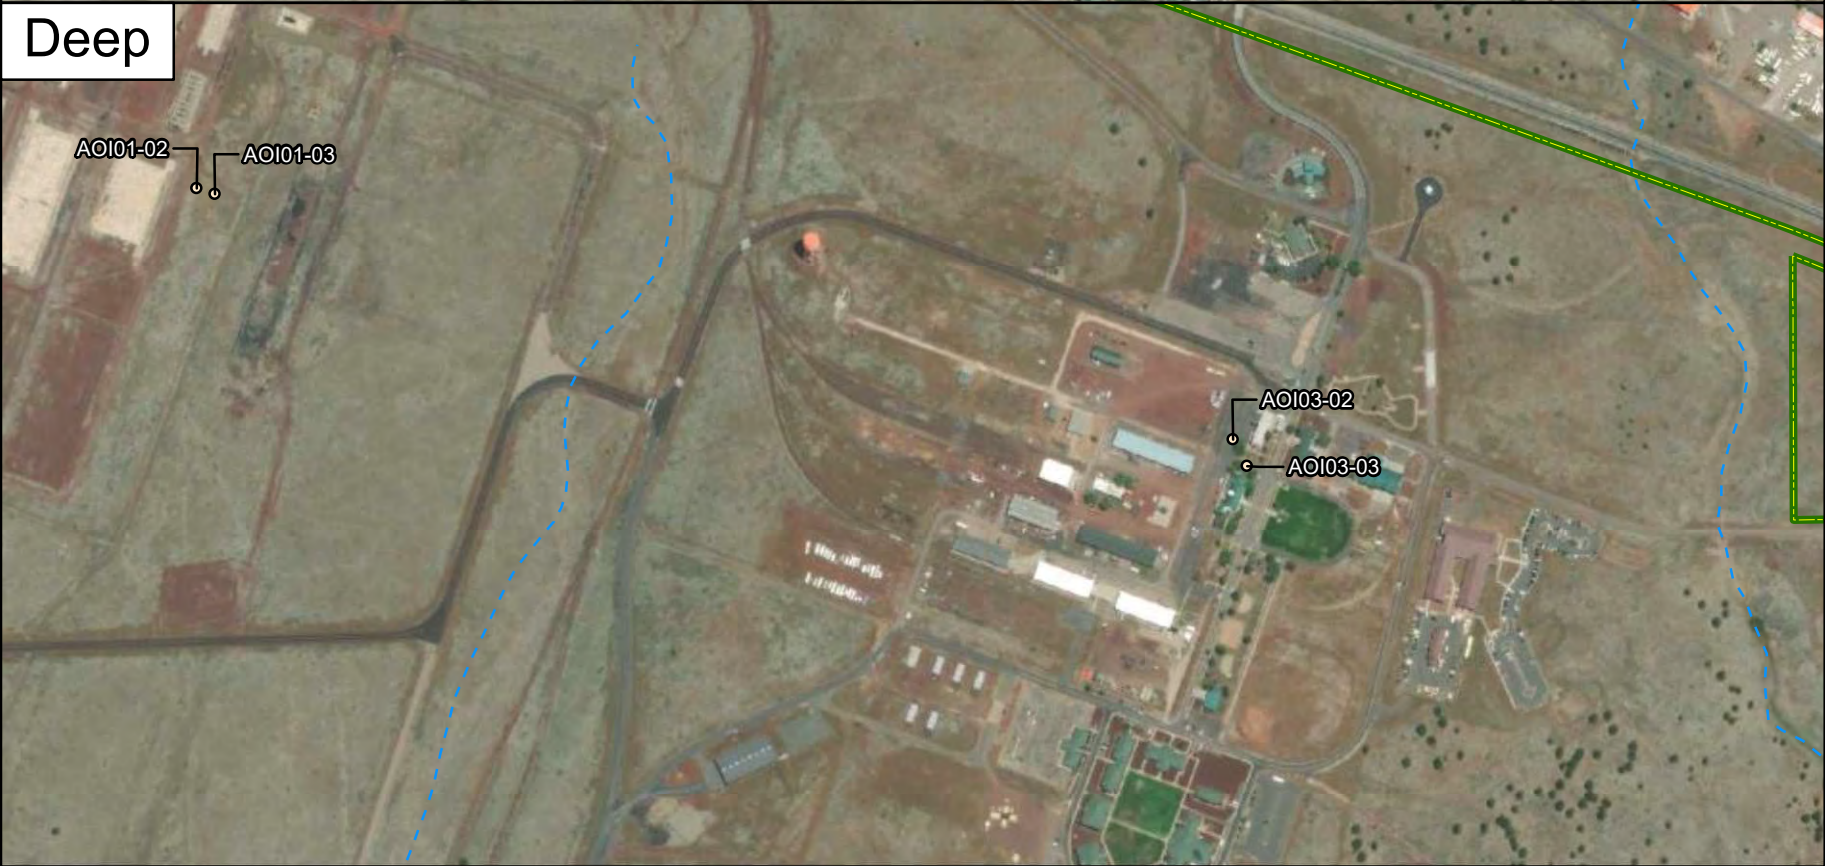
Figure 6-2

This section presents the analytical results for soil in comparison to SLs for AOI 2: Former Building LR200. Groundwater was not encountered in any of the borings drilled at AOI 2. The results in soil are presented in **Table 6-2** through **Table 6-4**. Soil results are presented on **Figure 6-2**, **Figure 6-4**, **Figure 6-6**, **Figure 6-8**, and **Figure 6-10**.

This section presents the analytical results for soil in comparison to SLs for AOI 4: WWTP Holding Ponds and Effluent Reuse Site. Groundwater was not encountered in any of the borings drilled at AOI 4. The results in soil are presented in **Table 6-2** through **Table 6-4**. Soil results are presented on **Figure 6-2**, **Figure 6-4**, **Figure 6-6**, **Figure 6-8**, and **Figure 6-10**.

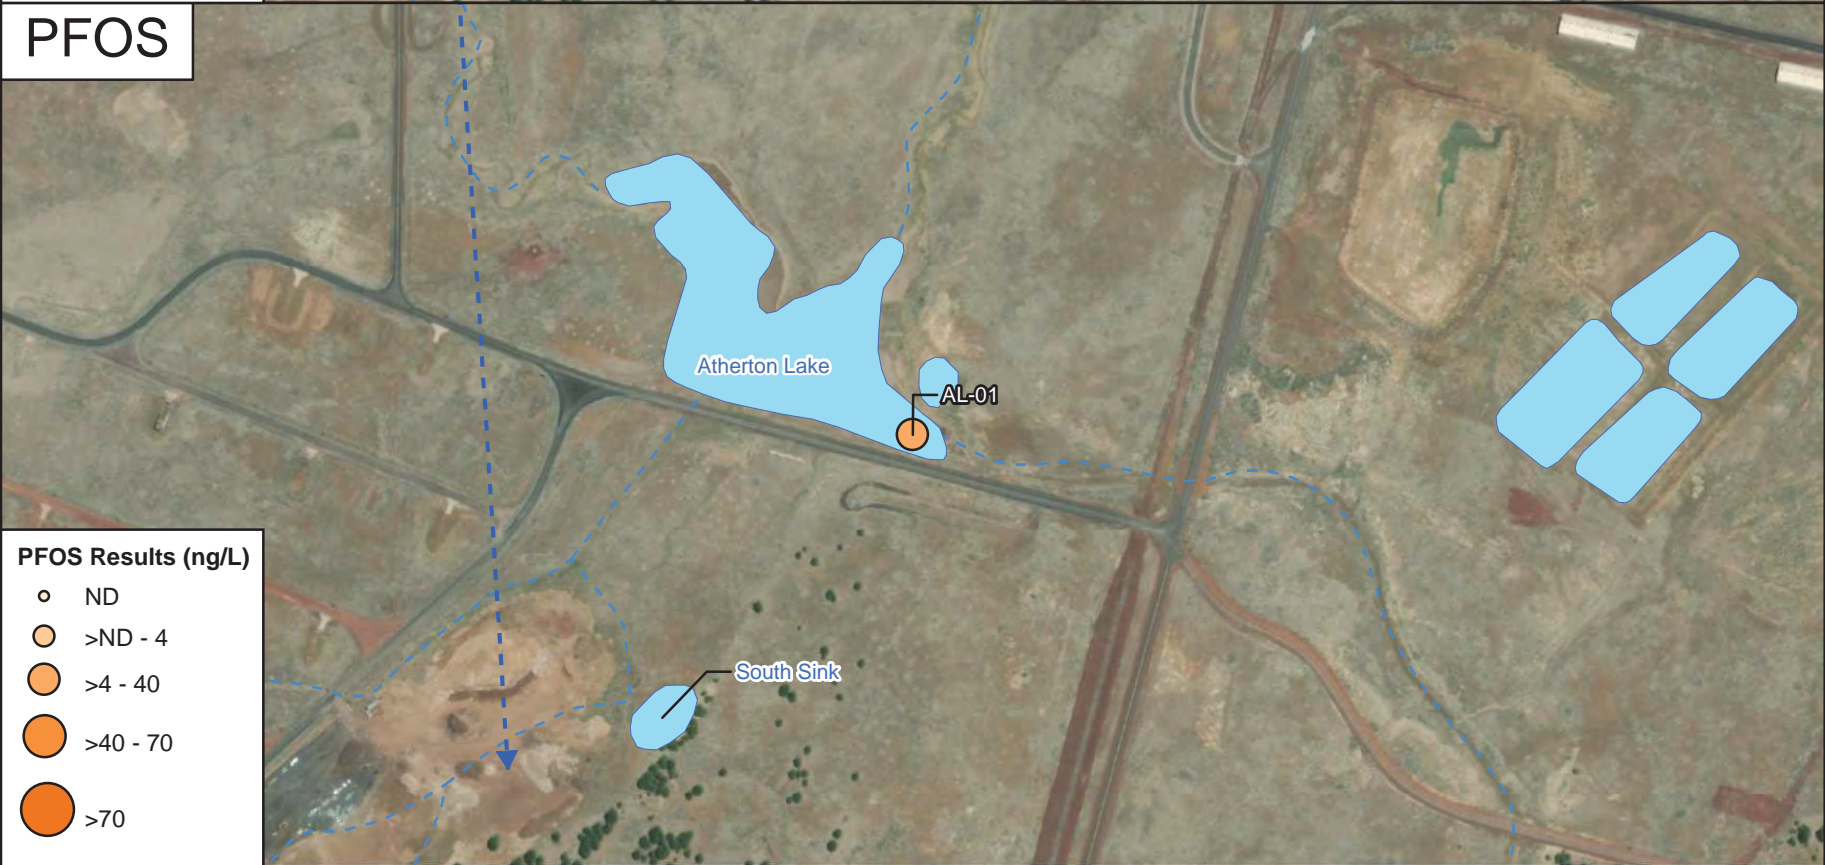
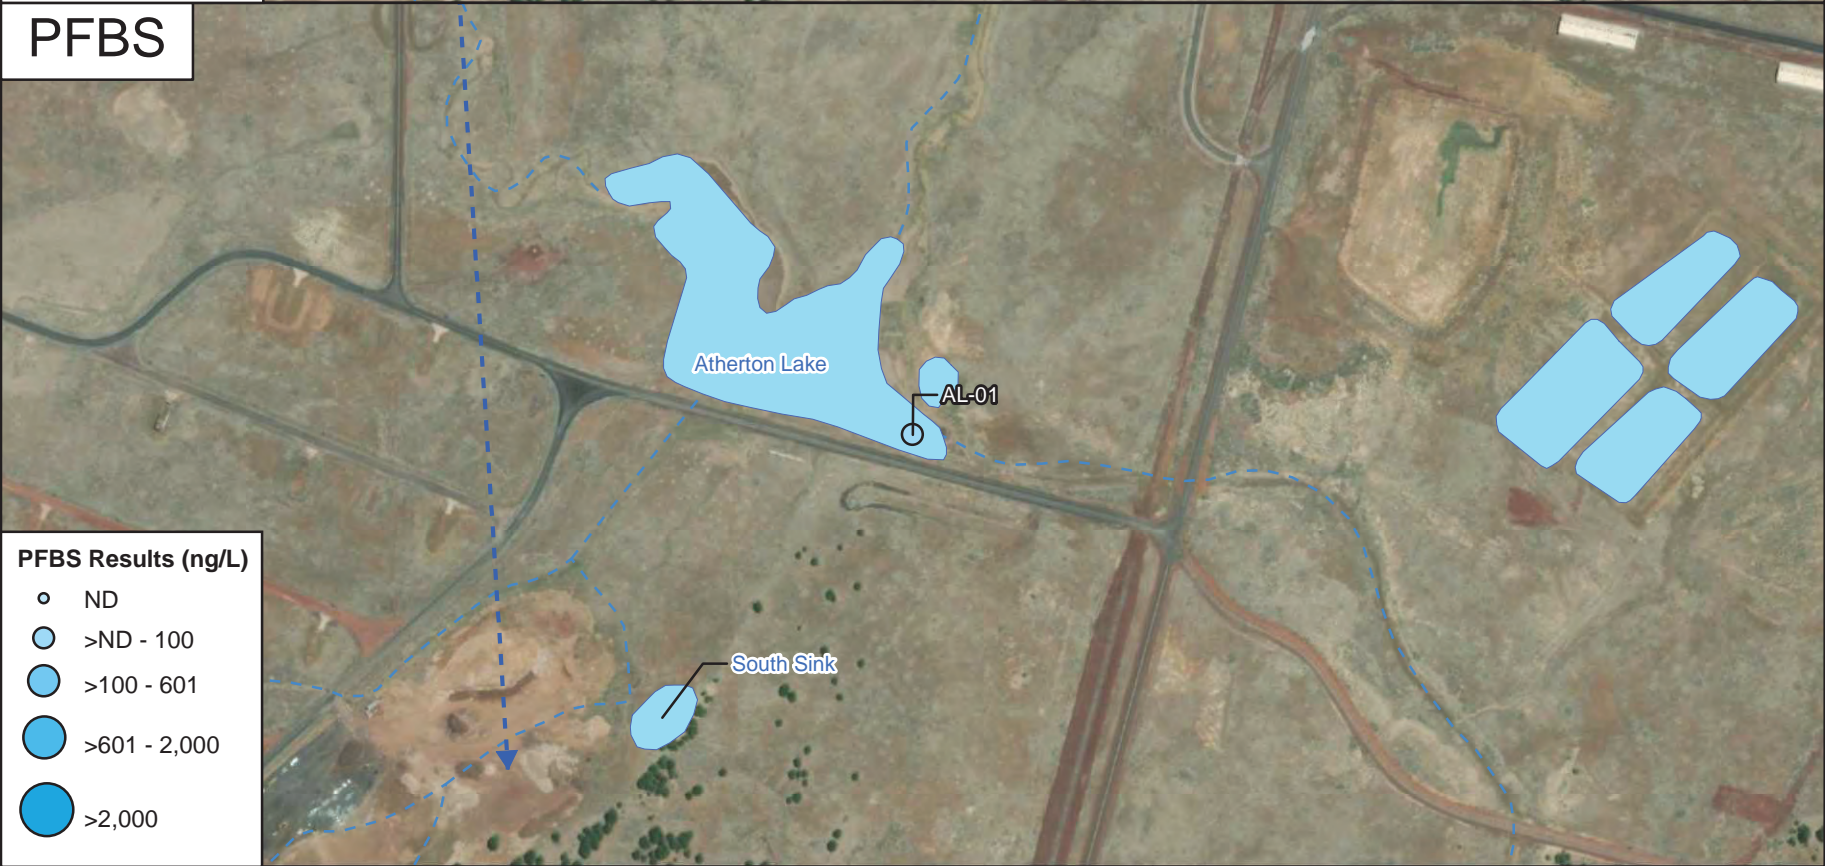
Figure 6-12

Figure 6-11 and **Figure 6-12** present the ranges of detections in groundwater. **Table 6-5** summarizes the groundwater results.

This section presents the analytical results for groundwater in comparison to SLs for AOI 5: NAAD-40. The results in groundwater are presented in **Table 6-5**. Groundwater results are presented on **Figure 6-11** and **Figure 6-12**.
