Preliminary Assessment Report

Roseville Armory, California

Perfluorooctane-Sulfonic Acid (PFOS) and Perfluorooctanoic Acid (PFOA) Impacted Sites
ARNG Installations, Nationwide

January 2020

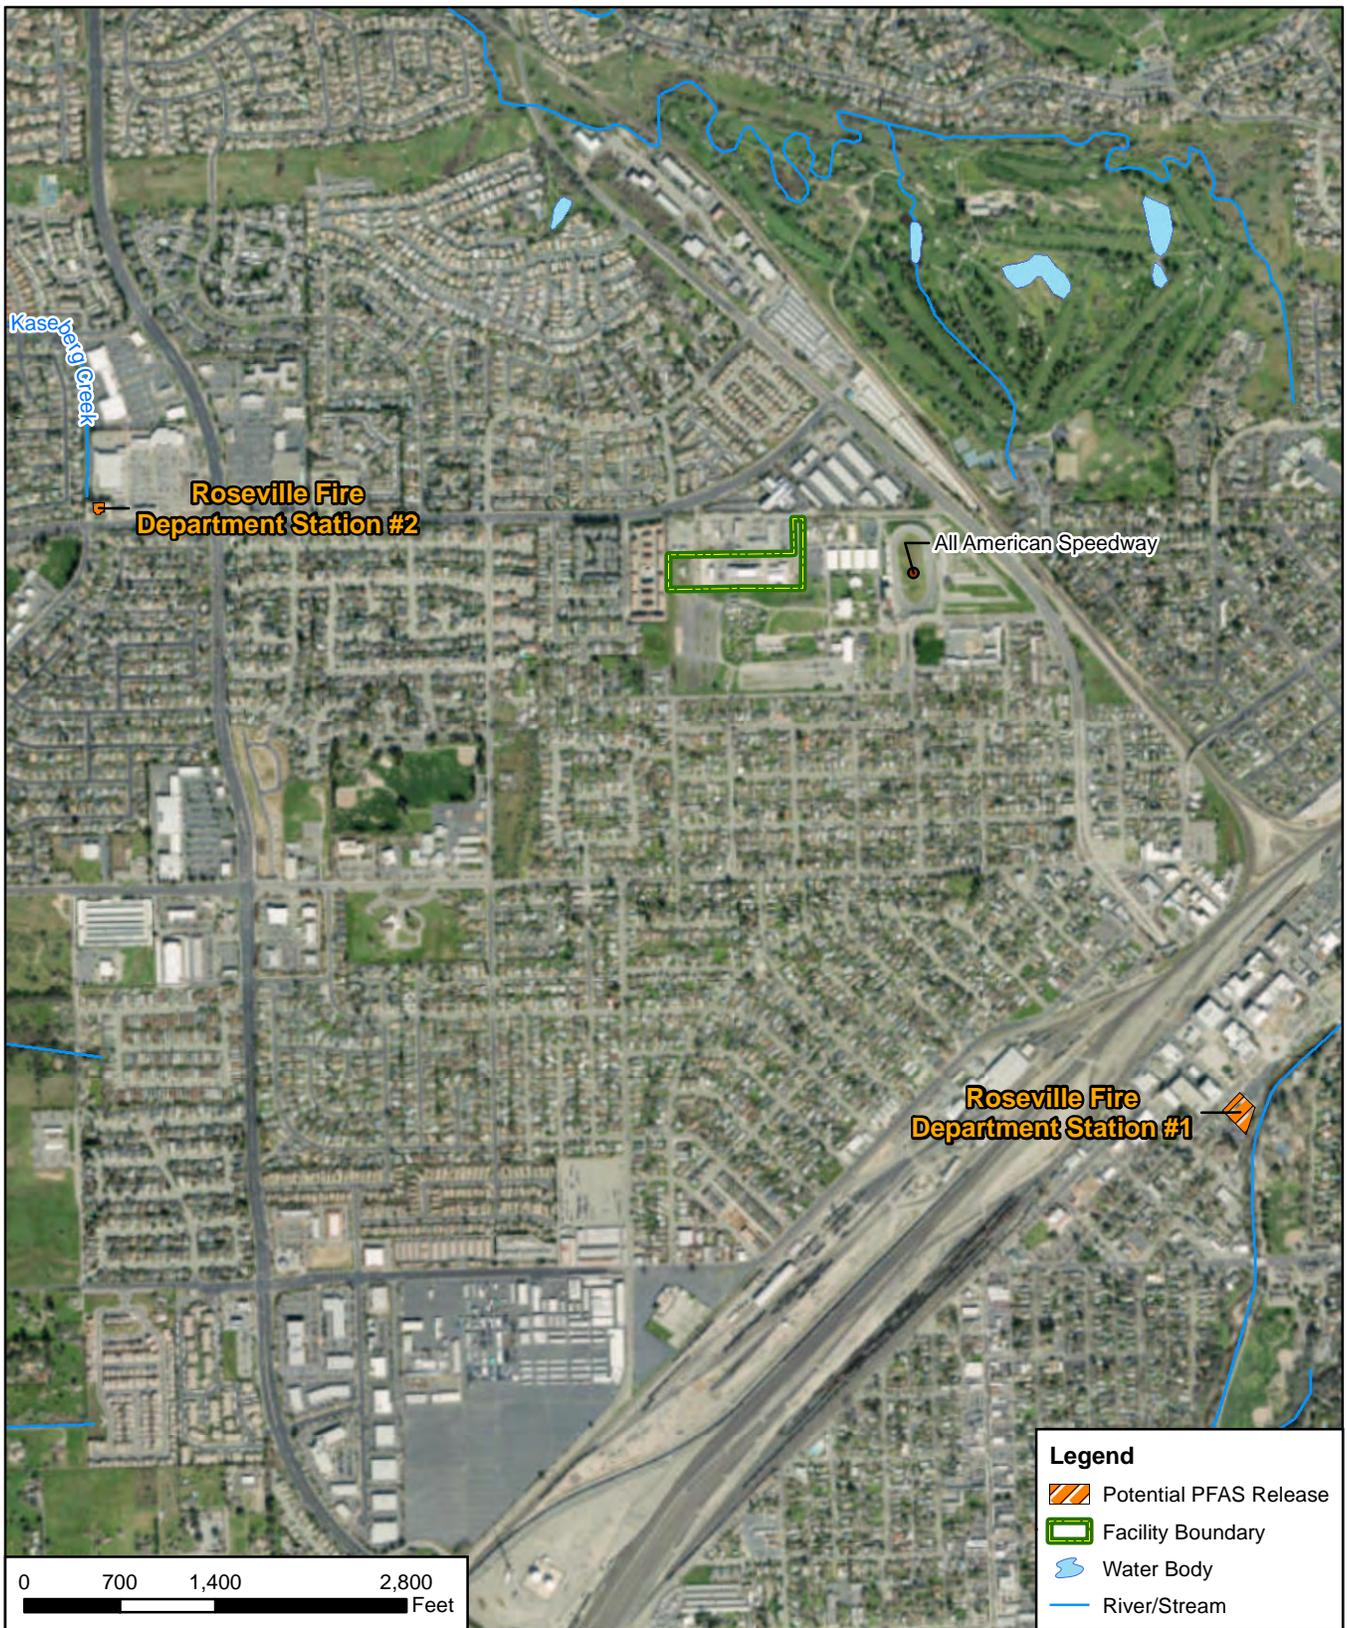
Figure 5-1

Two potential off-facility sources of PFAS adjacent to the Roseville Armory, not under the control of the CAARNG, were identified during the PA. A description of each adjacent source is presented below, and the adjacent sources are shown on **Figure 5-1**.

A PA interview was conducted with two City of Roseville Fire Department Chiefs, who confirmed the usage and storage of AFFF by the City of Roseville Fire Department. However, specific training and incident response areas could not be identified, and the Fire Chiefs were unaware of any fire training agreements with the ARNG. Two City of Roseville Fire Department Stations (#1 and #2) are located within a one mile radius of the Roseville Armory and were identified as potential adjacent sources. Fire Stations #1 and #2 are located at addresses 401 Oak Street and 1398 Junction Boulevard, respectively.

All American Speedway is located at address 800 All America City Boulevard, bordering the Roseville Armory to the east. All American Speedway is a 1/3-mile car racing track sanctioned by National Association for Stock Car Auto Racing (NASCAR). Vehicle crash accidents have occurred at the racetrack, but it is unknown if incident responses required the use of AFFF.

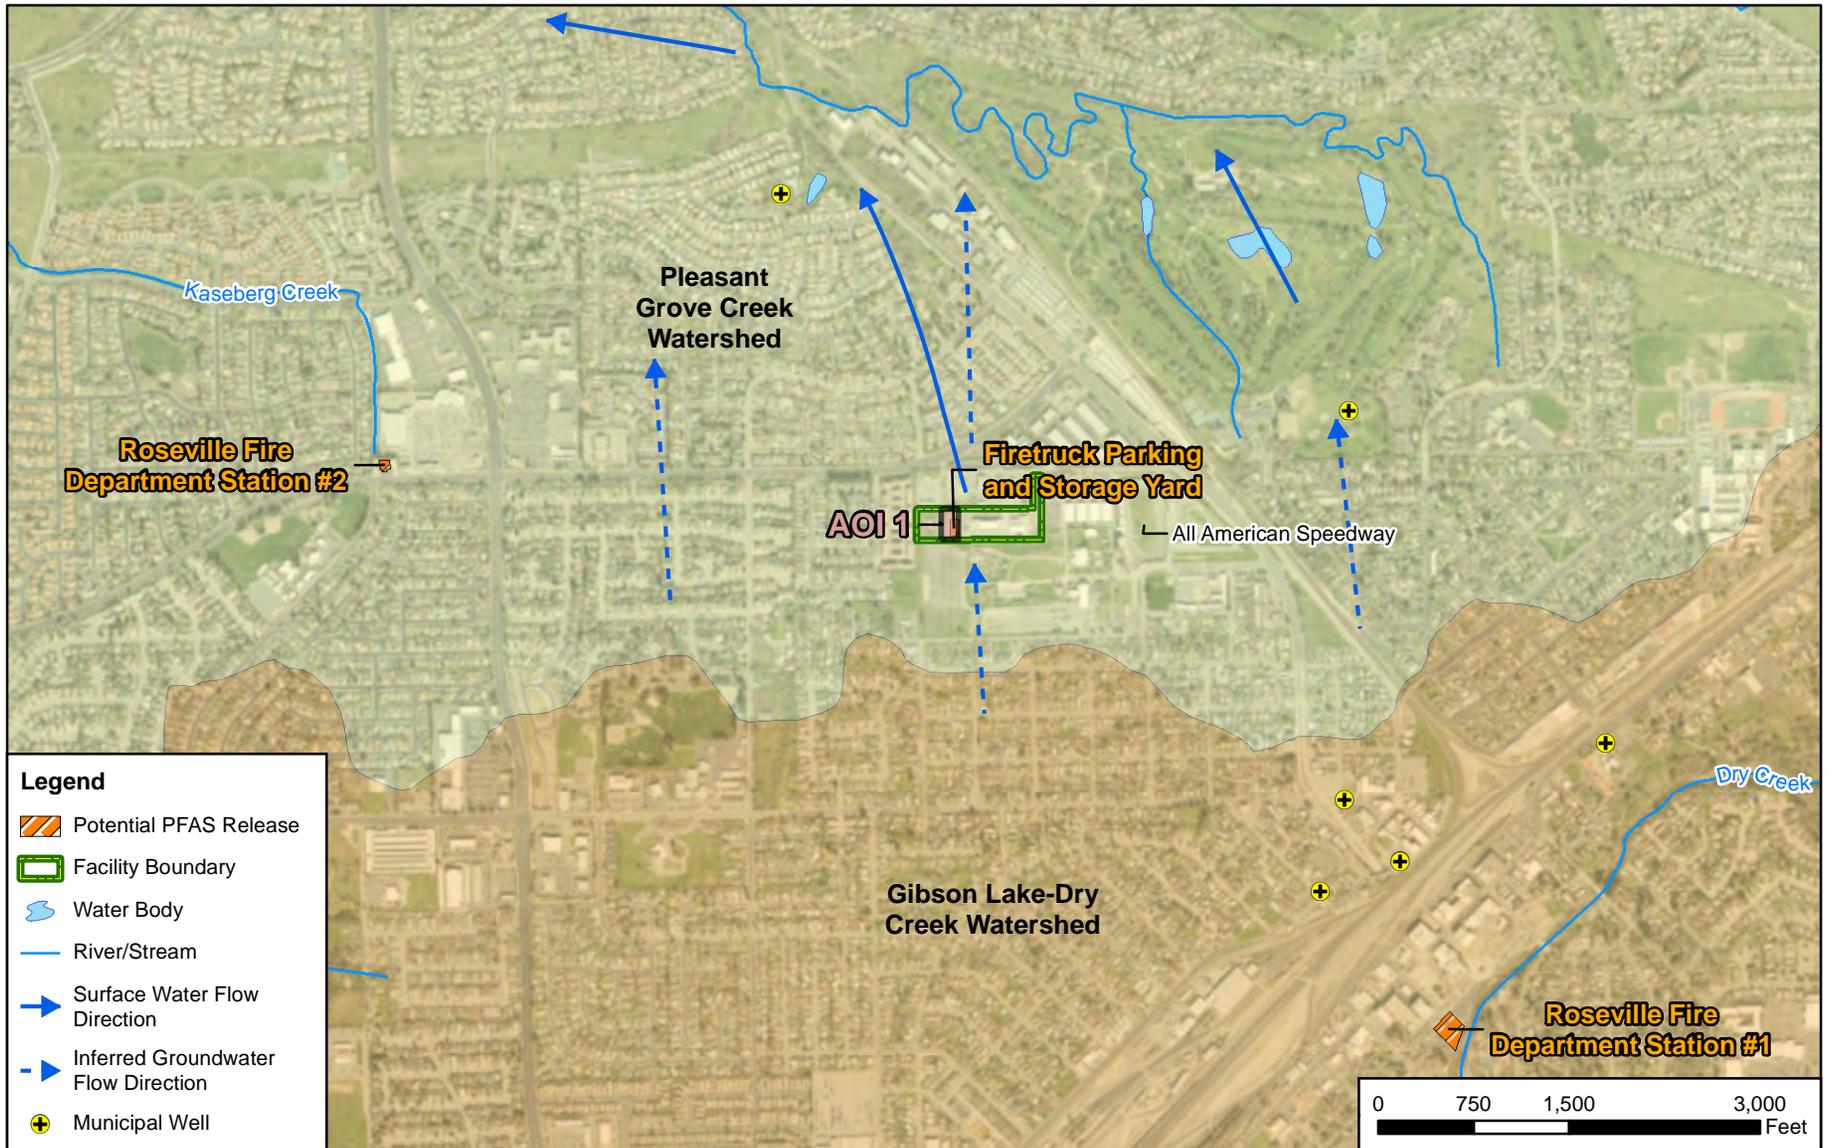
TITLE	Area of Interest	
AECOM	12420 Milestone Center Drive Germantown, MD 20876	Figure 6-1

Based on the PA findings, there was one area where AFFF may have been incidentally spilled to the ground surface. As such, this AOI may be potential PFAS source area. The AOI and preliminary CSM for this AOI is shown on **Figure 6-1** and **Figure 6-2**, respectively, and summarized below.

AOI 1 is the area containing parking for a firetruck, a storage building, and a yard. Potential AFFF releases are possible due to the historical storage of AFFF and parking of an AFFF-containing firetruck within AOI 1.

The area west of the paved lot within AOI 1 is unpaved soil. Ground-disturbing activities to soil at AOI 1 could result in site and construction worker exposure to potential PFAS contamination via inhalation of dust from surface soil or ingestion of surface or subsurface soil. Therefore, the inhalation and ingestion pathways for these receptors are considered potentially complete.

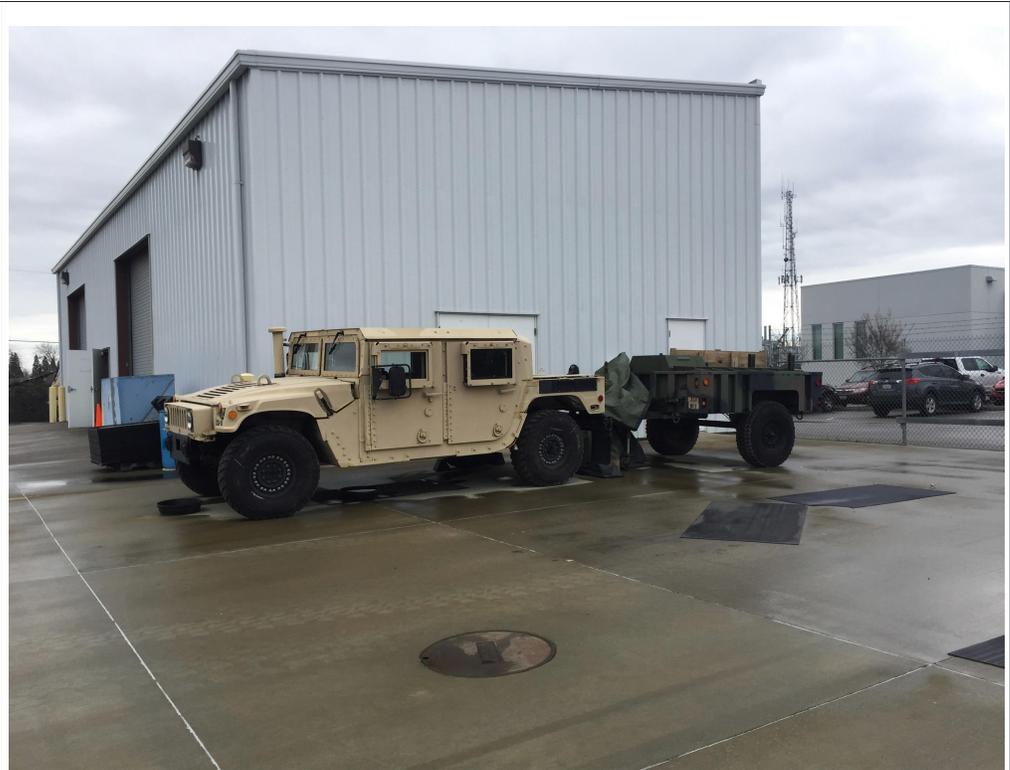
Area shown where Roseville Armory fire truck is typically parked; the door to the fire unit storage shed is shown beyond the vehicle
