Site Inspection Report

Camp San Luis Obispo

Site Inspection for Perfluorooctanoic acid (PFOA),
Perfluorooctanesulfonic acid (PFOS), Perfluorohexanesulfonic
acid (PFHxS), Perfluorononanoic acid (PFNA),
Hexafluoropropylene oxide dimer acid (HFPO-DA), and
Perfluorobutanesulfonic acid (PFBS) at ARNG Installations,
Nationwide

September 2023

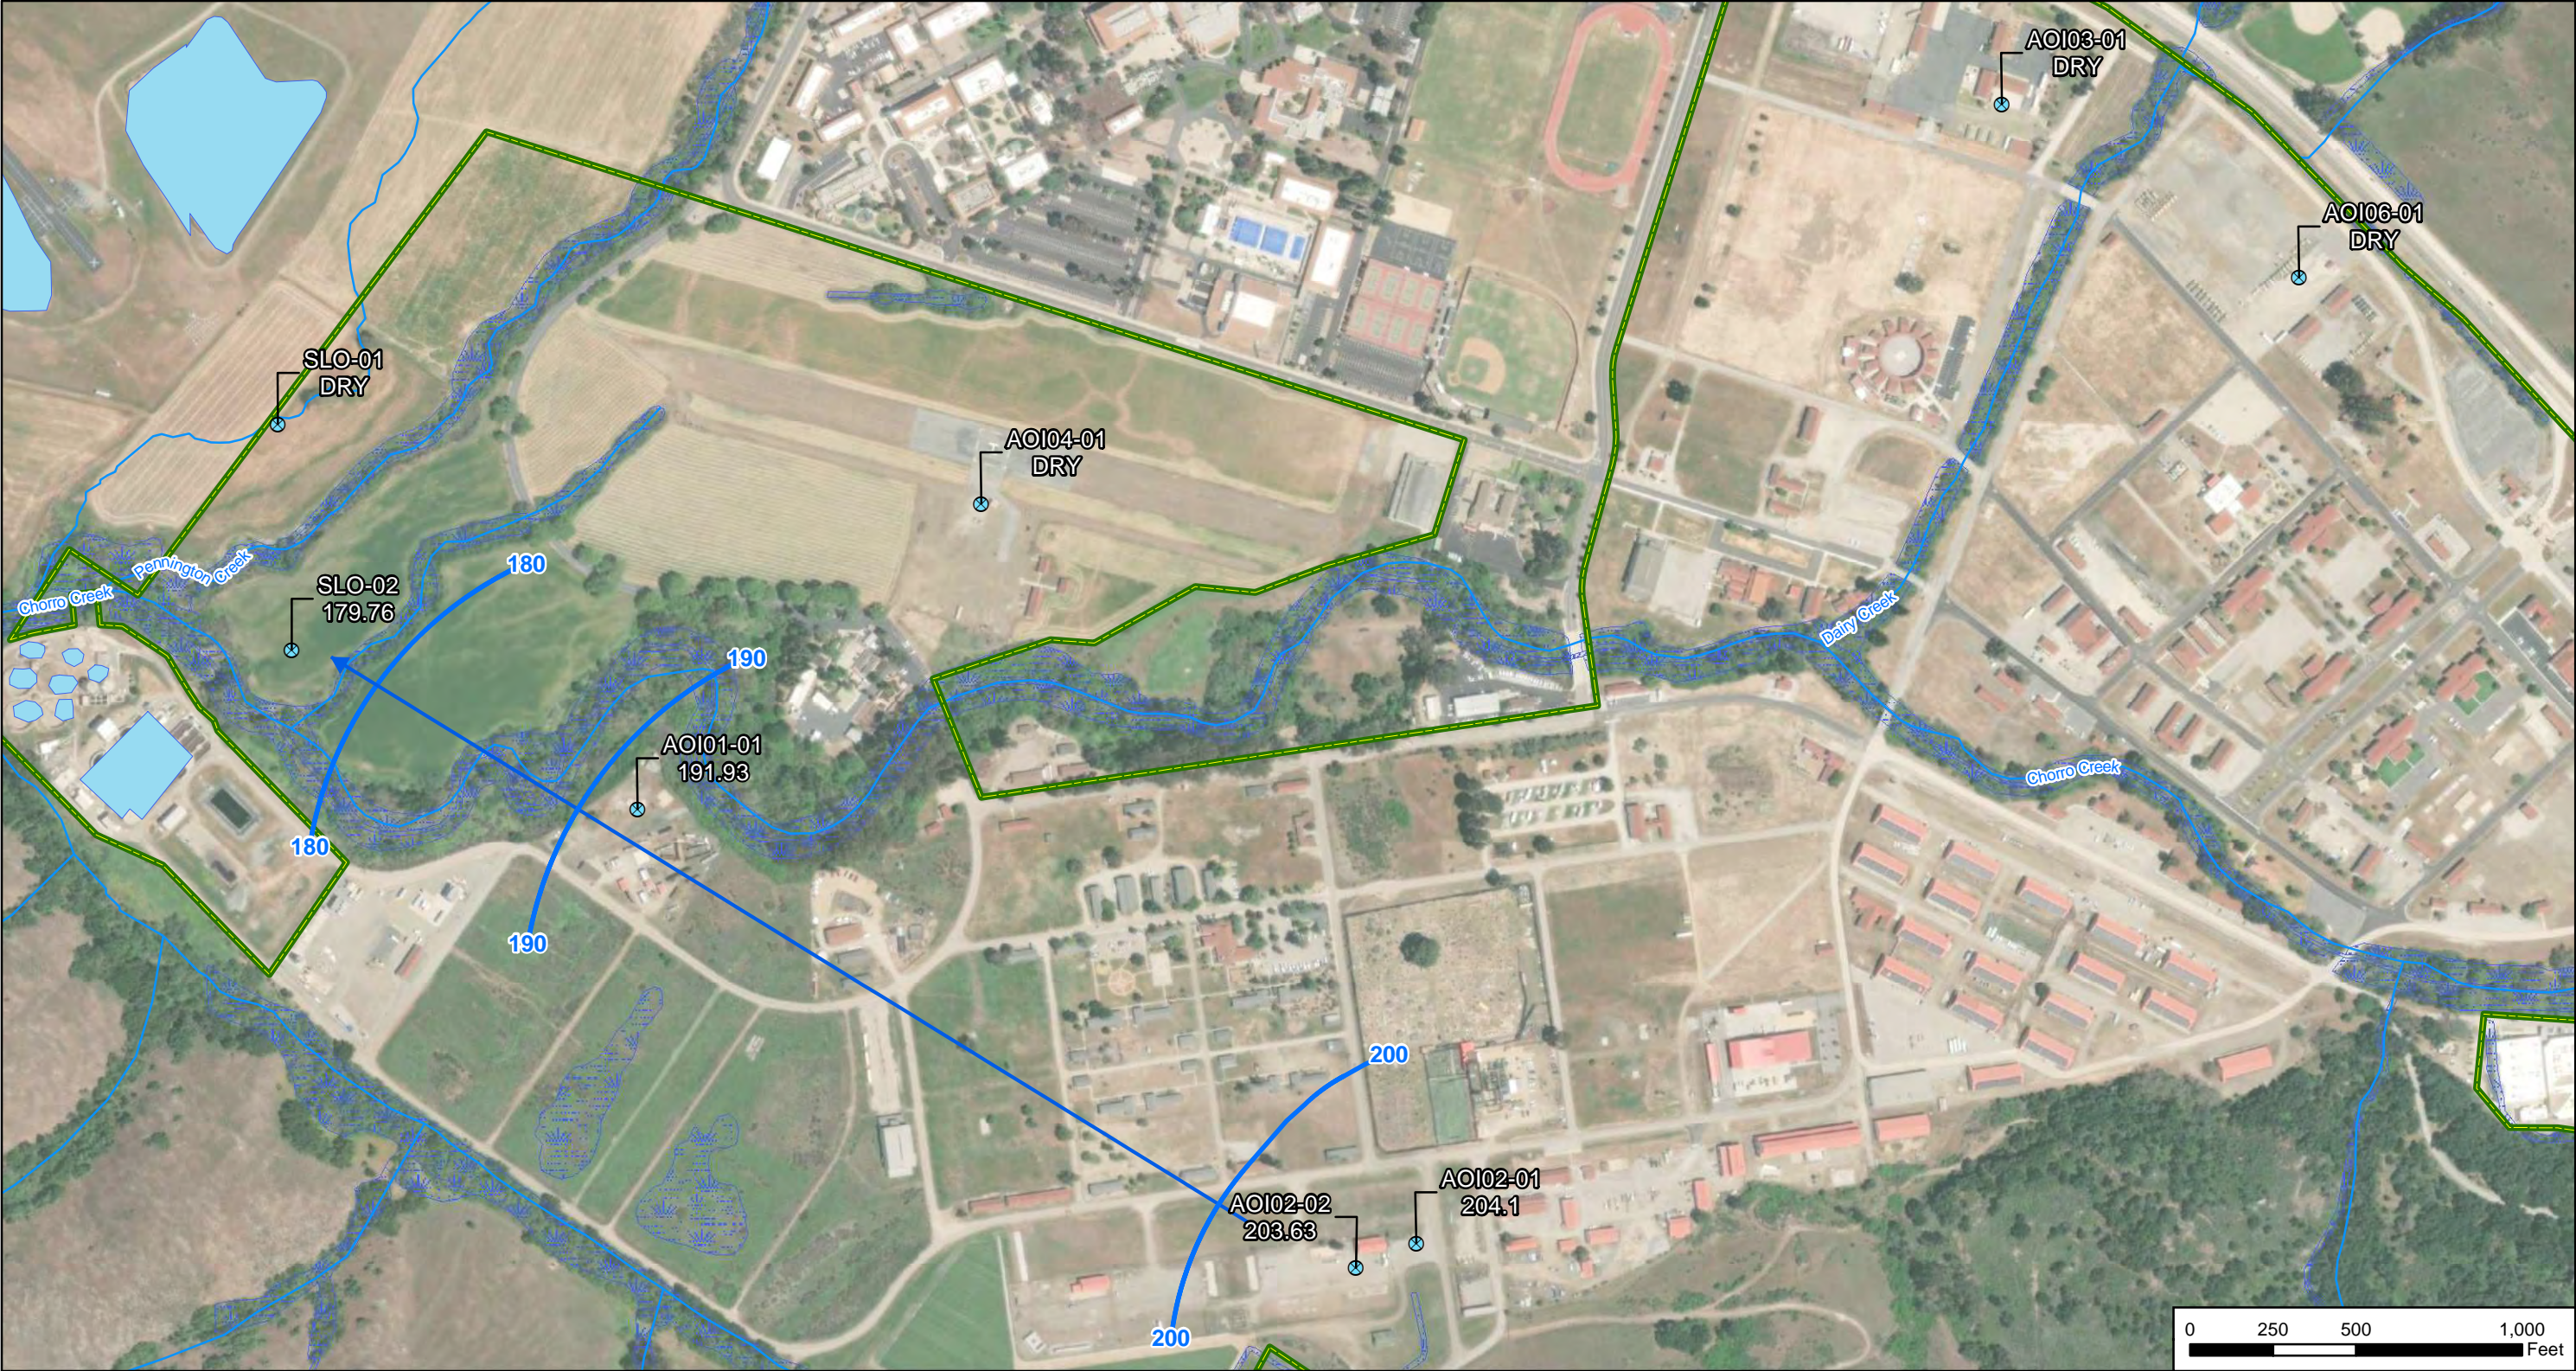
Facility Topography	
AECOM 12420 Milestone Center Drive Germantown, MD 20876	Figure 2-2

Camp SLO is located on the western slopes of the Santa Lucia Range, approximately 4.5 miles and 6.5 miles east of Morro Bay and the Pacific Ocean, respectively. The terrain in and around the facility is primarily the foothills of the Santa Lucia Range, which exhibits high relief with grasslands, rolling hills, and canyons. The facility is bounded to the north by Los Padres National Forest in the Santa Lucia Mountains and to the south by Cerro Romualdo and Chumash Peak, two hills that are a part of the Nine Sisters Peaks. The elevation of the facility ranges from approximately 190 feet to 2,440 feet above mean sea level, with elevation increasing from west to east (**Figure 2-2**).

The scope of the SI was bounded by the property limits of the facility (**Figure 2-2**). Off-facility sampling was not included in the scope of this SI. If future off-facility sampling is required, the proper stakeholders will be notified, and necessary rights of entry will be obtained by ARNG with property owner(s). The SI scope was bounded vertically by the observed depths of the surficial groundwater table. Temporal boundaries were limited to the spring and fall, which was the earliest available time field resources were available to complete the study.

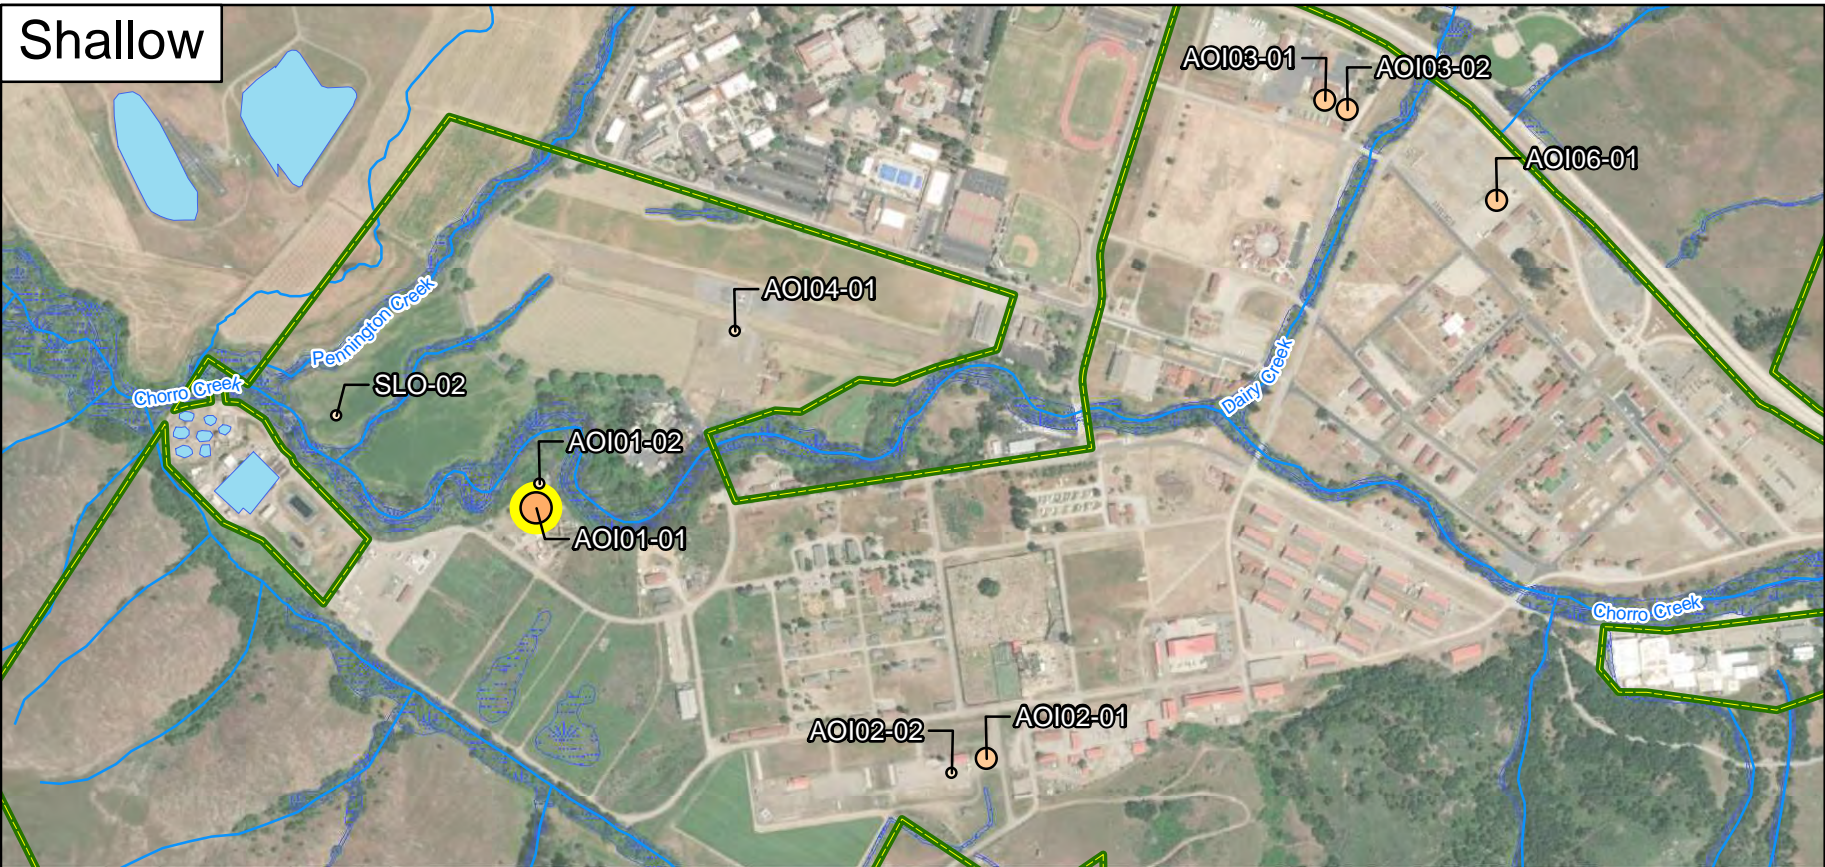
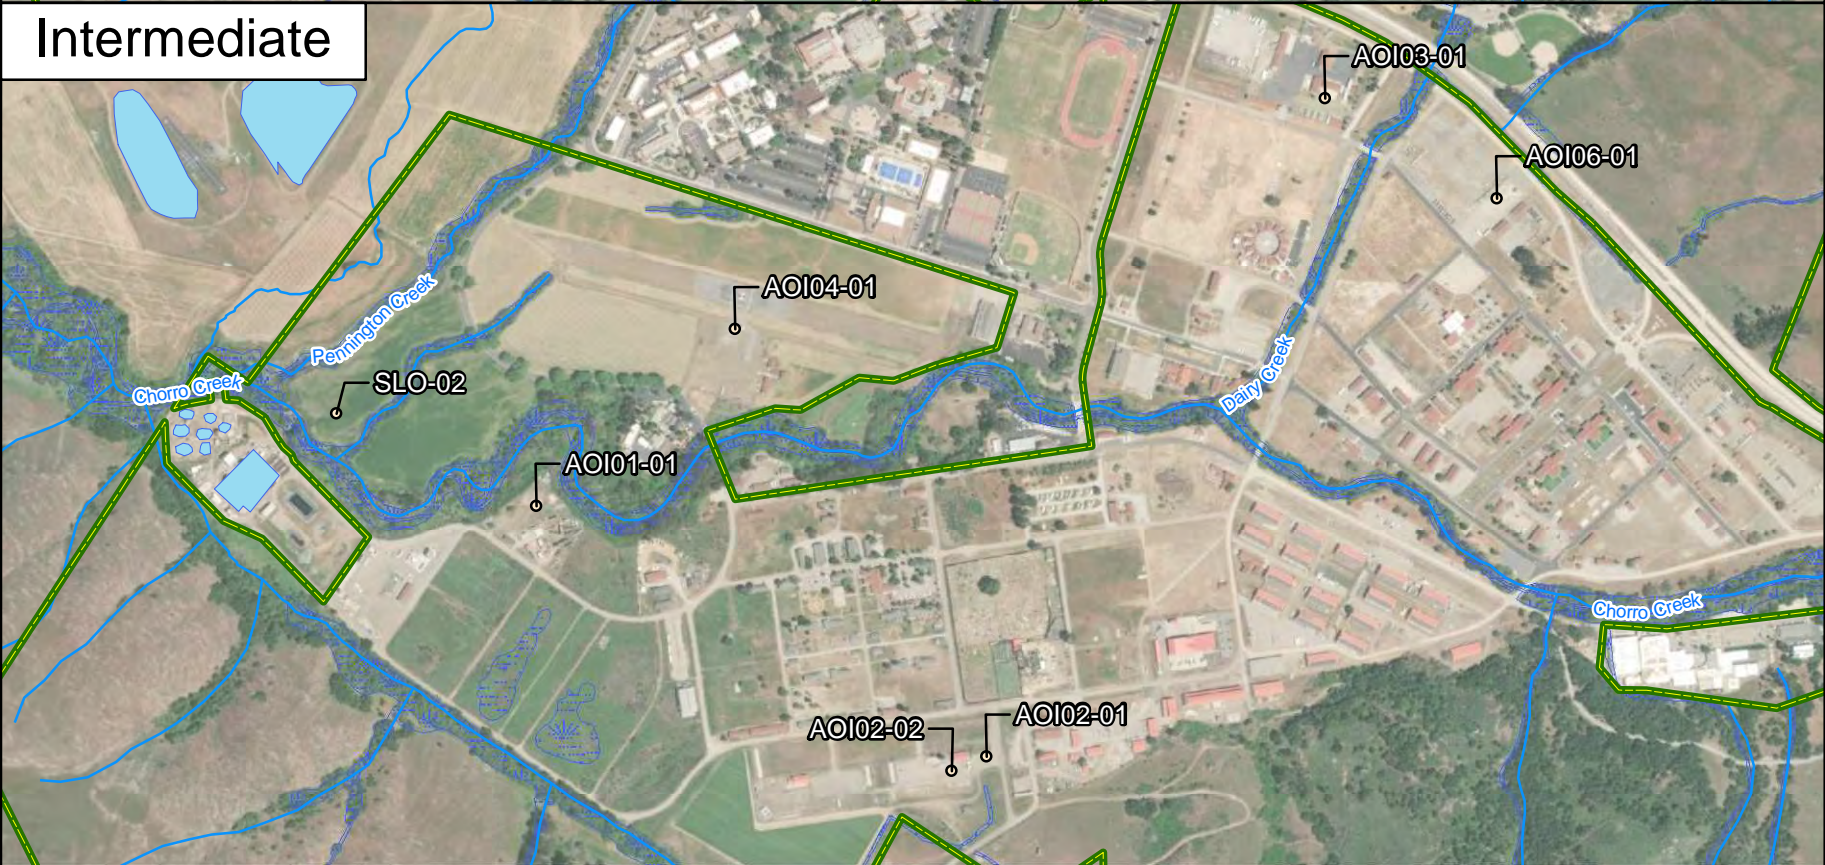
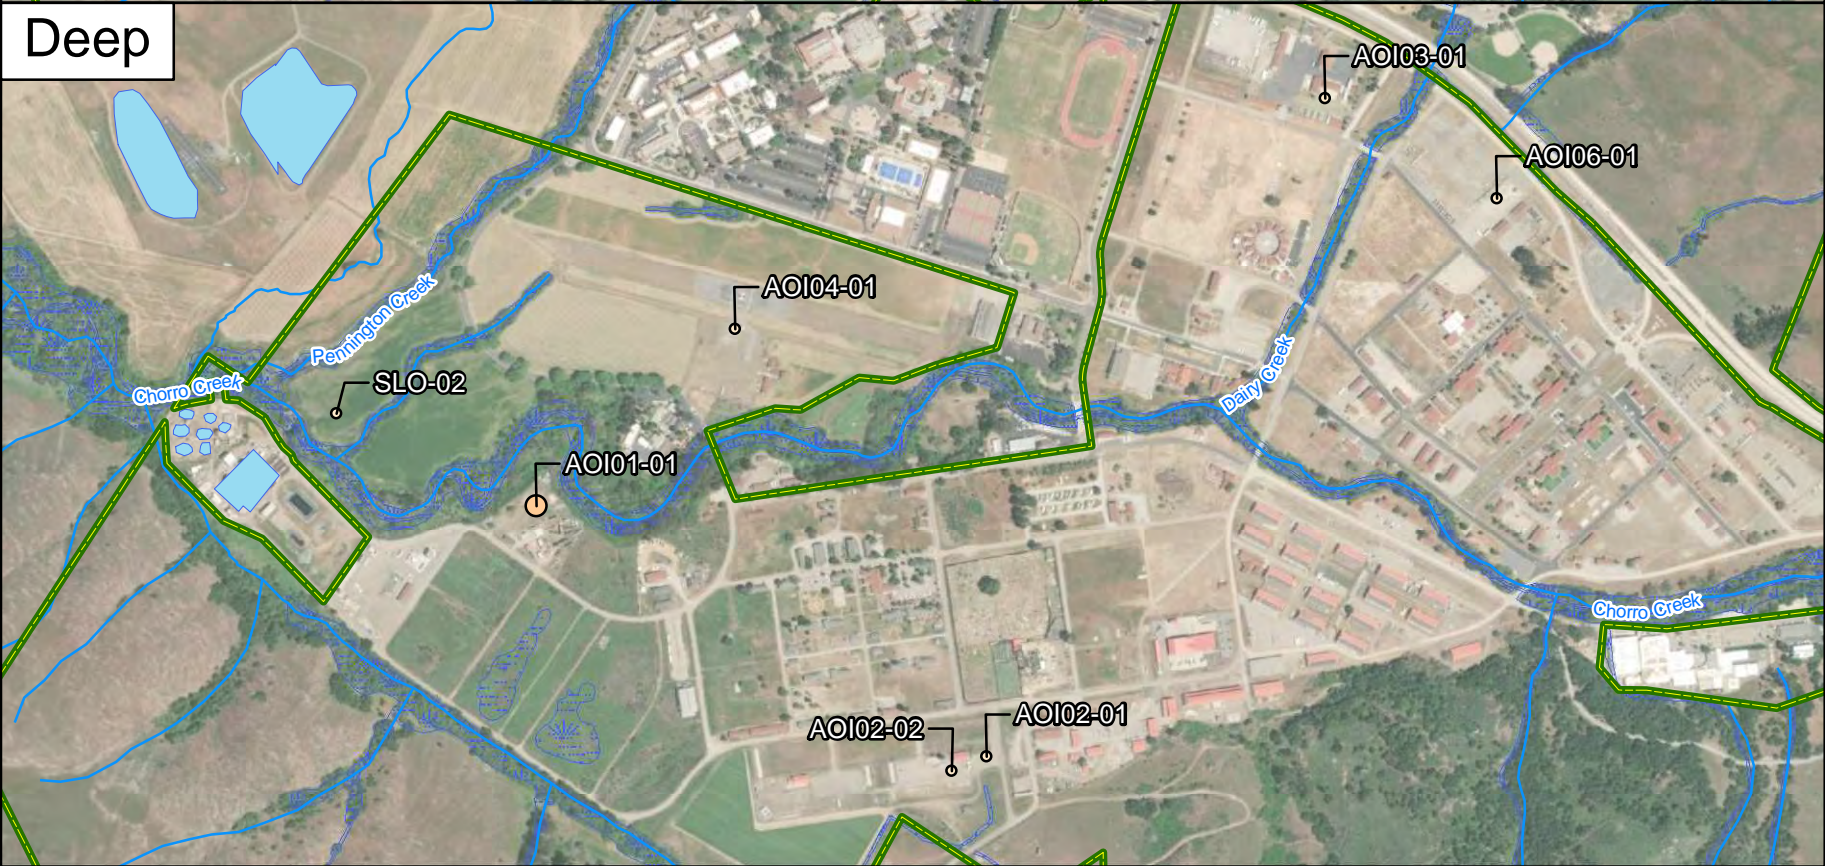
Figure 6-2

Exceedances of the OSD SL are depicted with a yellow halo.
Depth intervals shown represent respective sampling position within a given soil boring location.

PFOS Detections in Soil

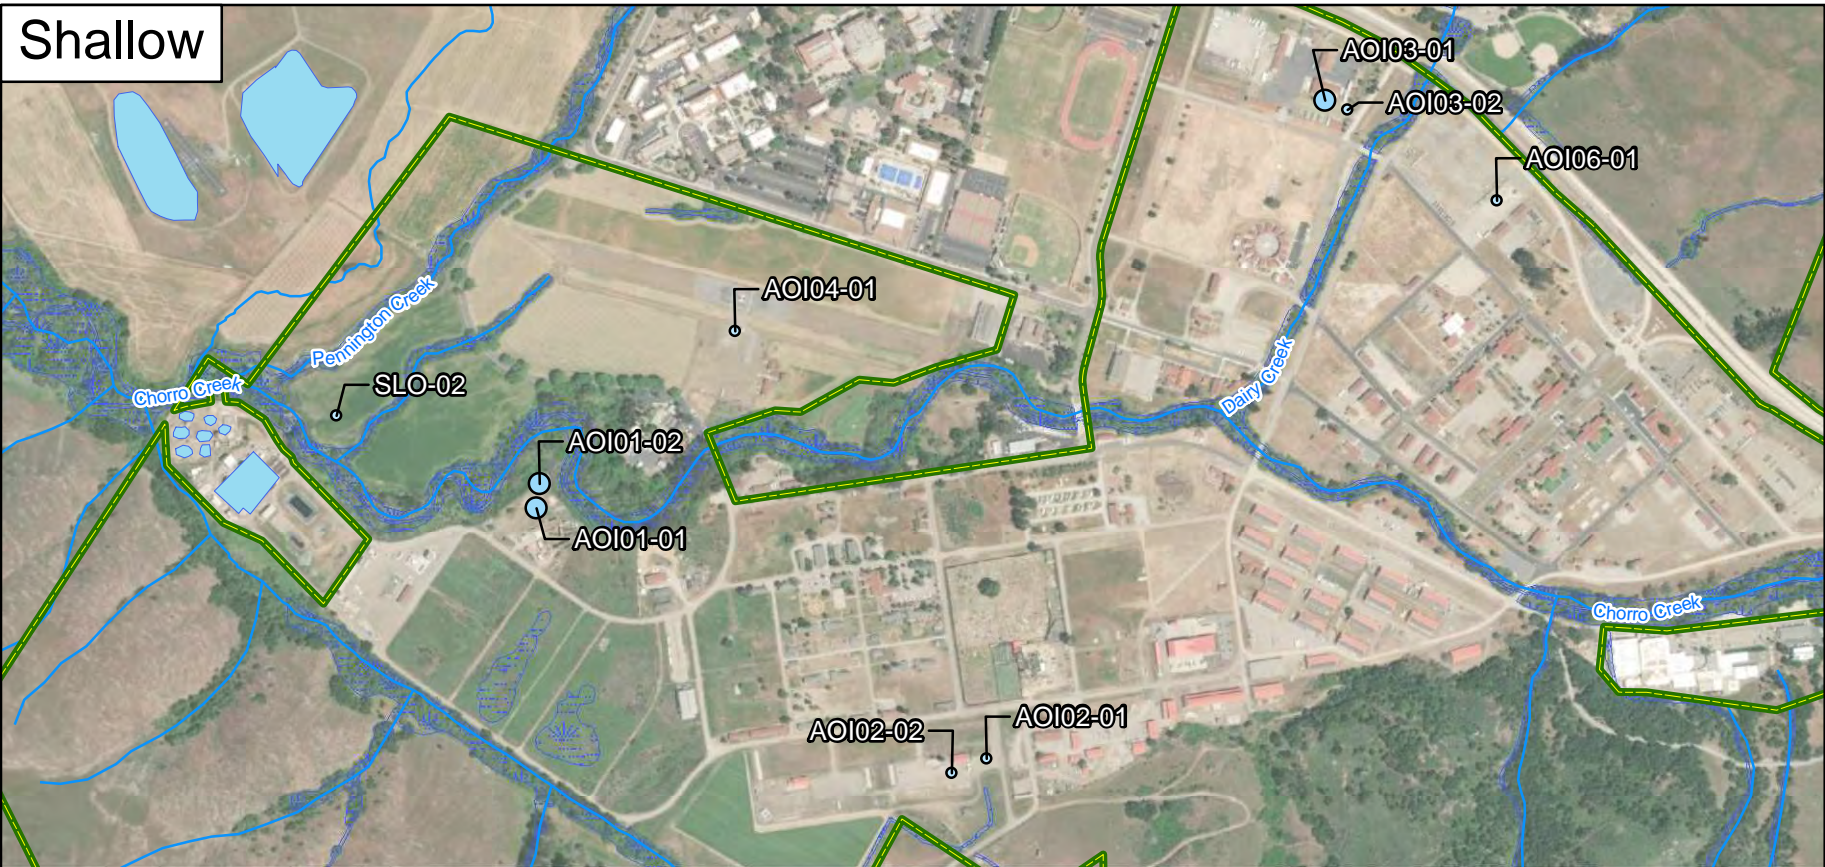
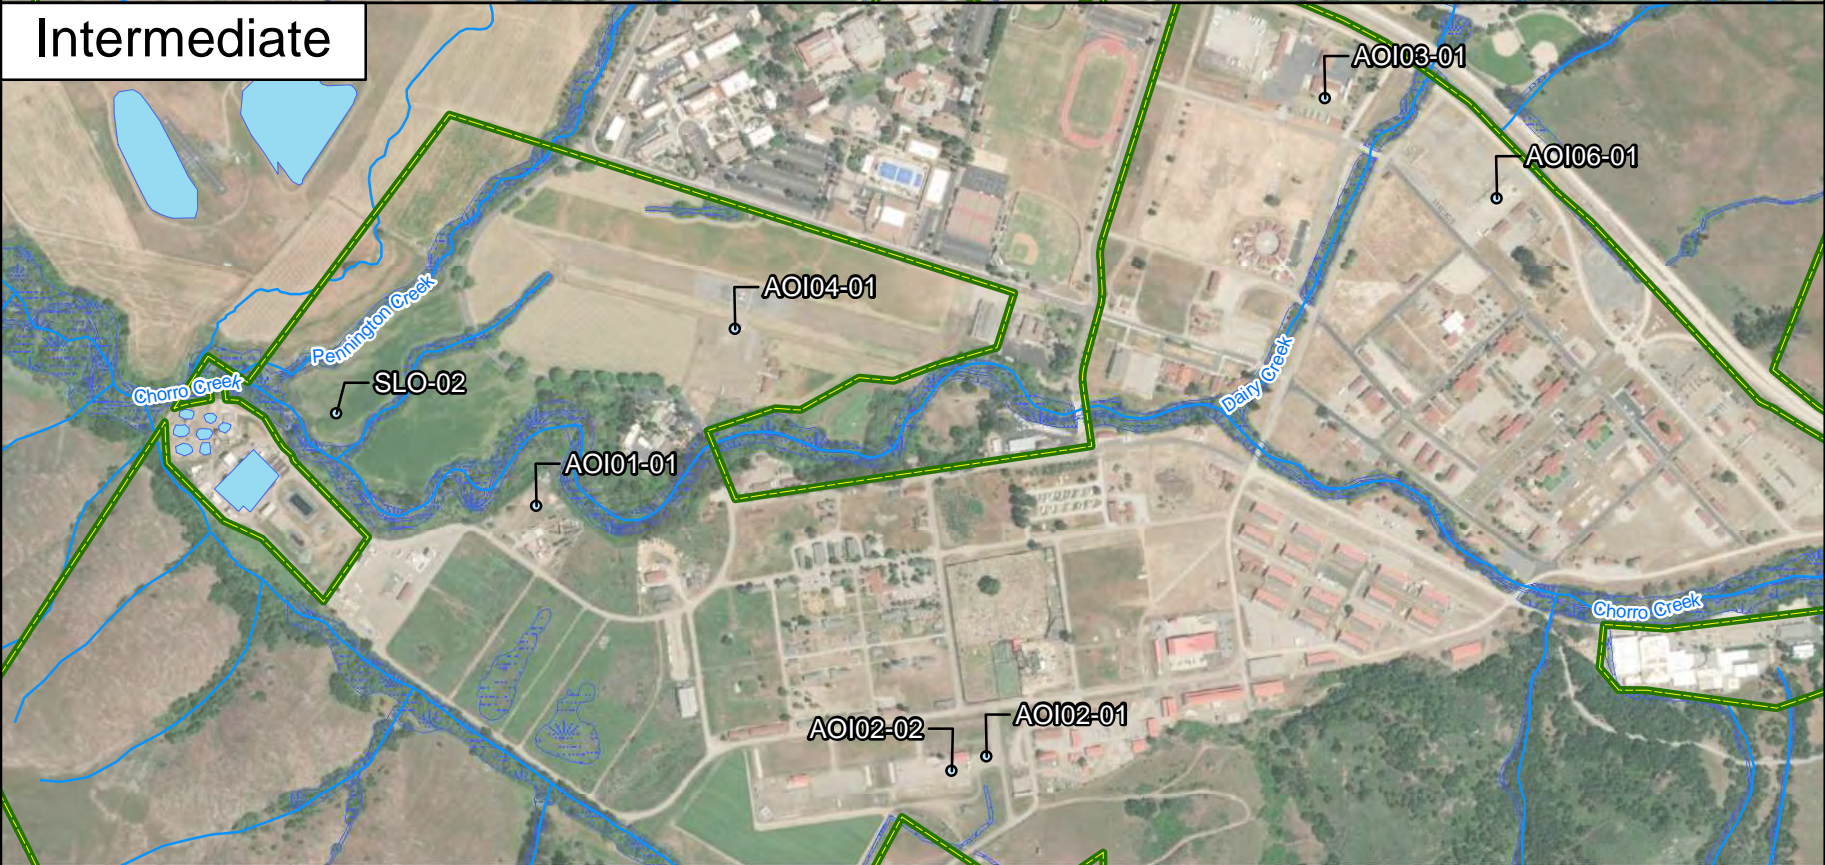
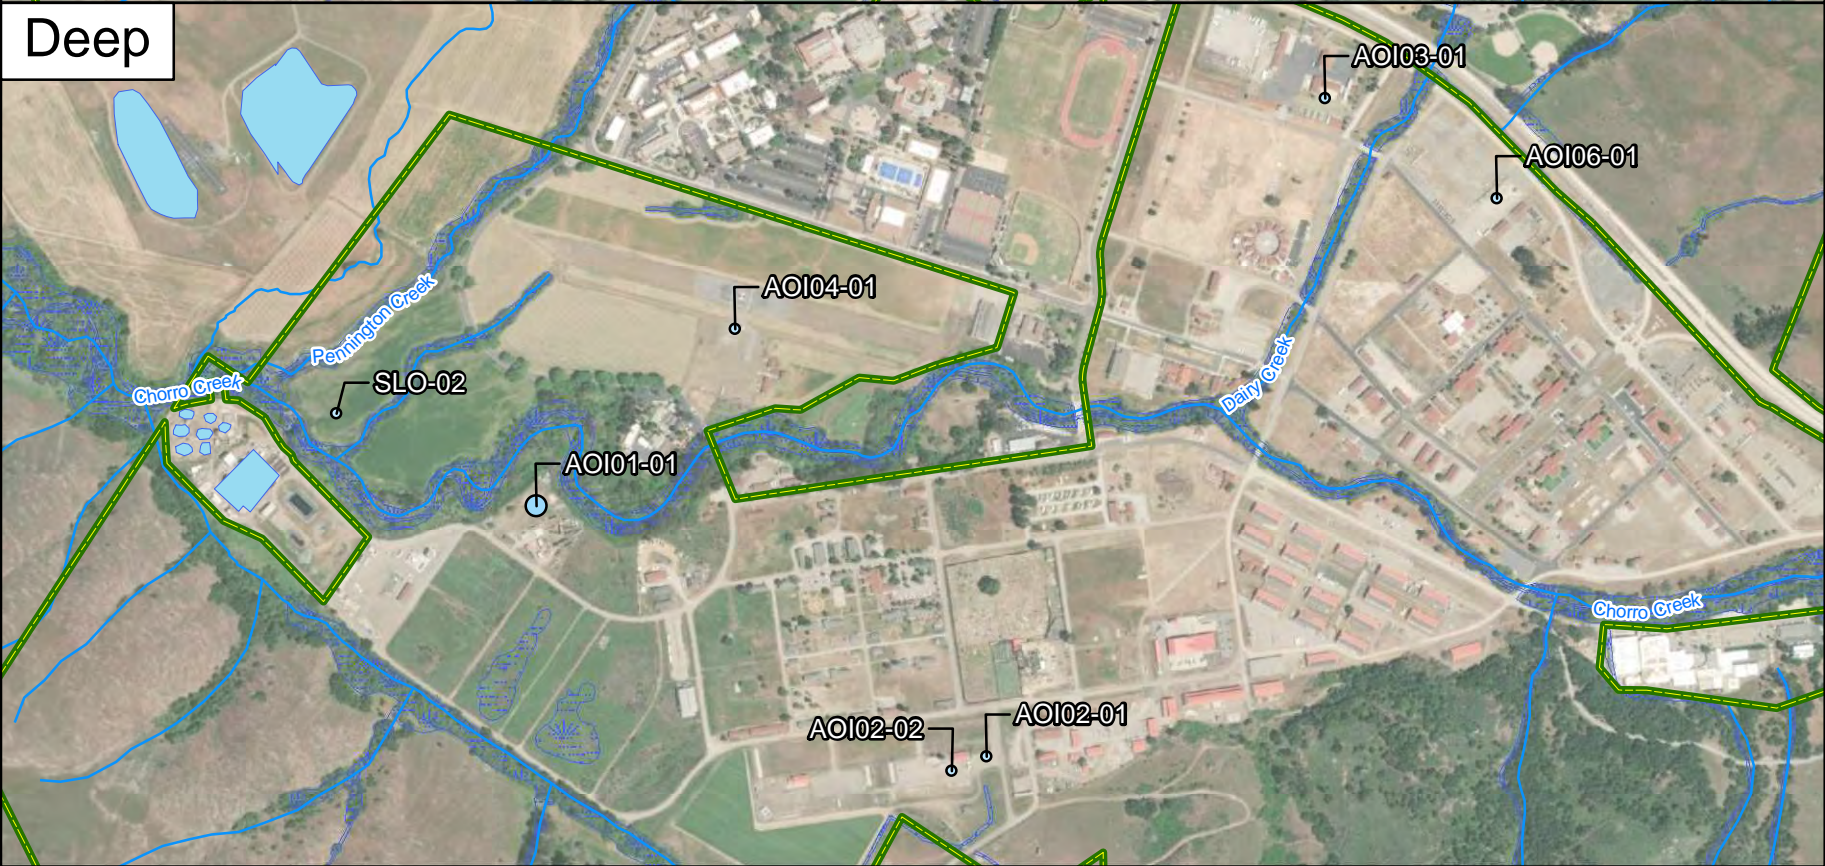
Figure 6-3

Exceedances of the OSD SL are depicted with a yellow halo.
Depth intervals shown represent respective sampling position within a given soil boring location.

PFBS Detections in Soil

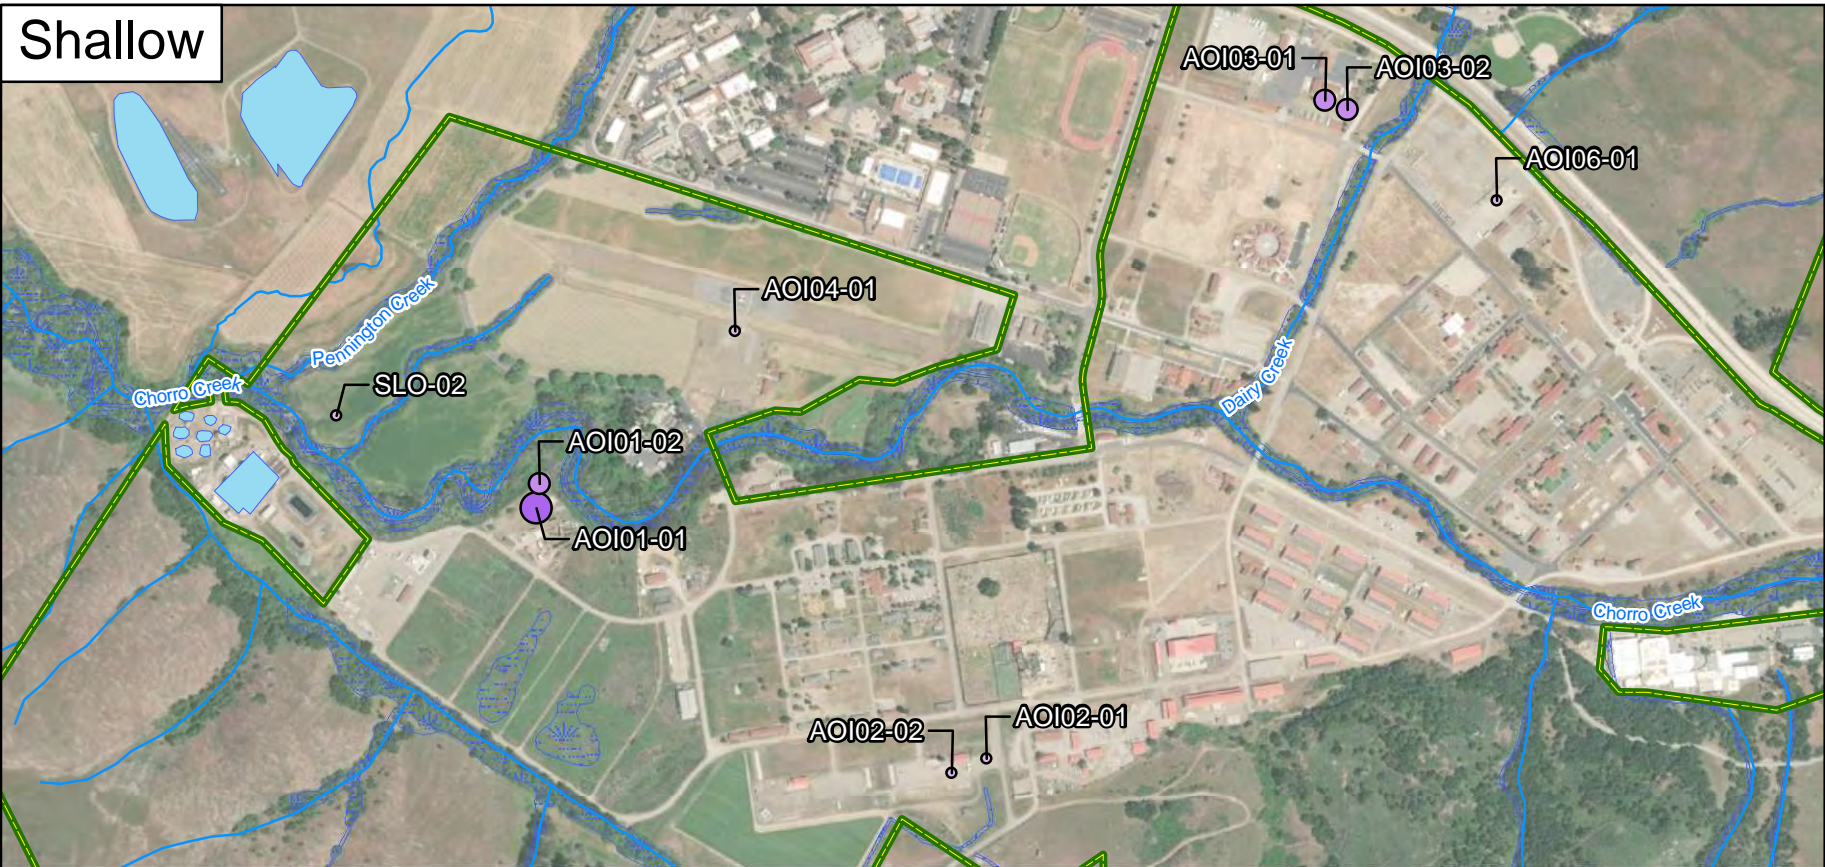
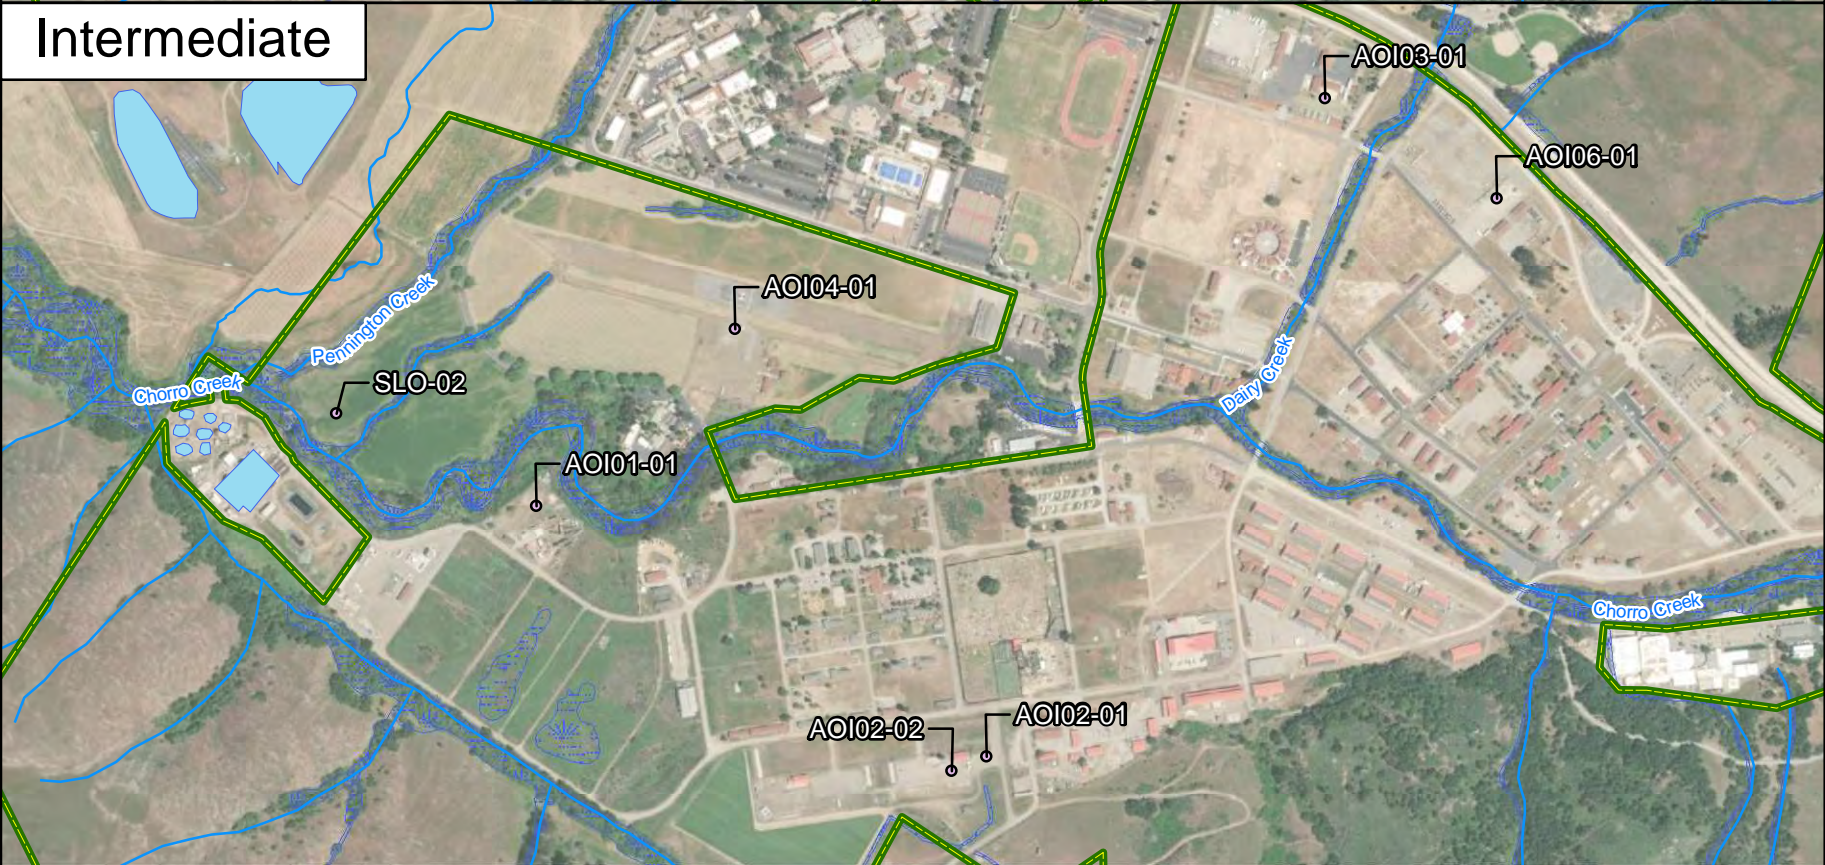
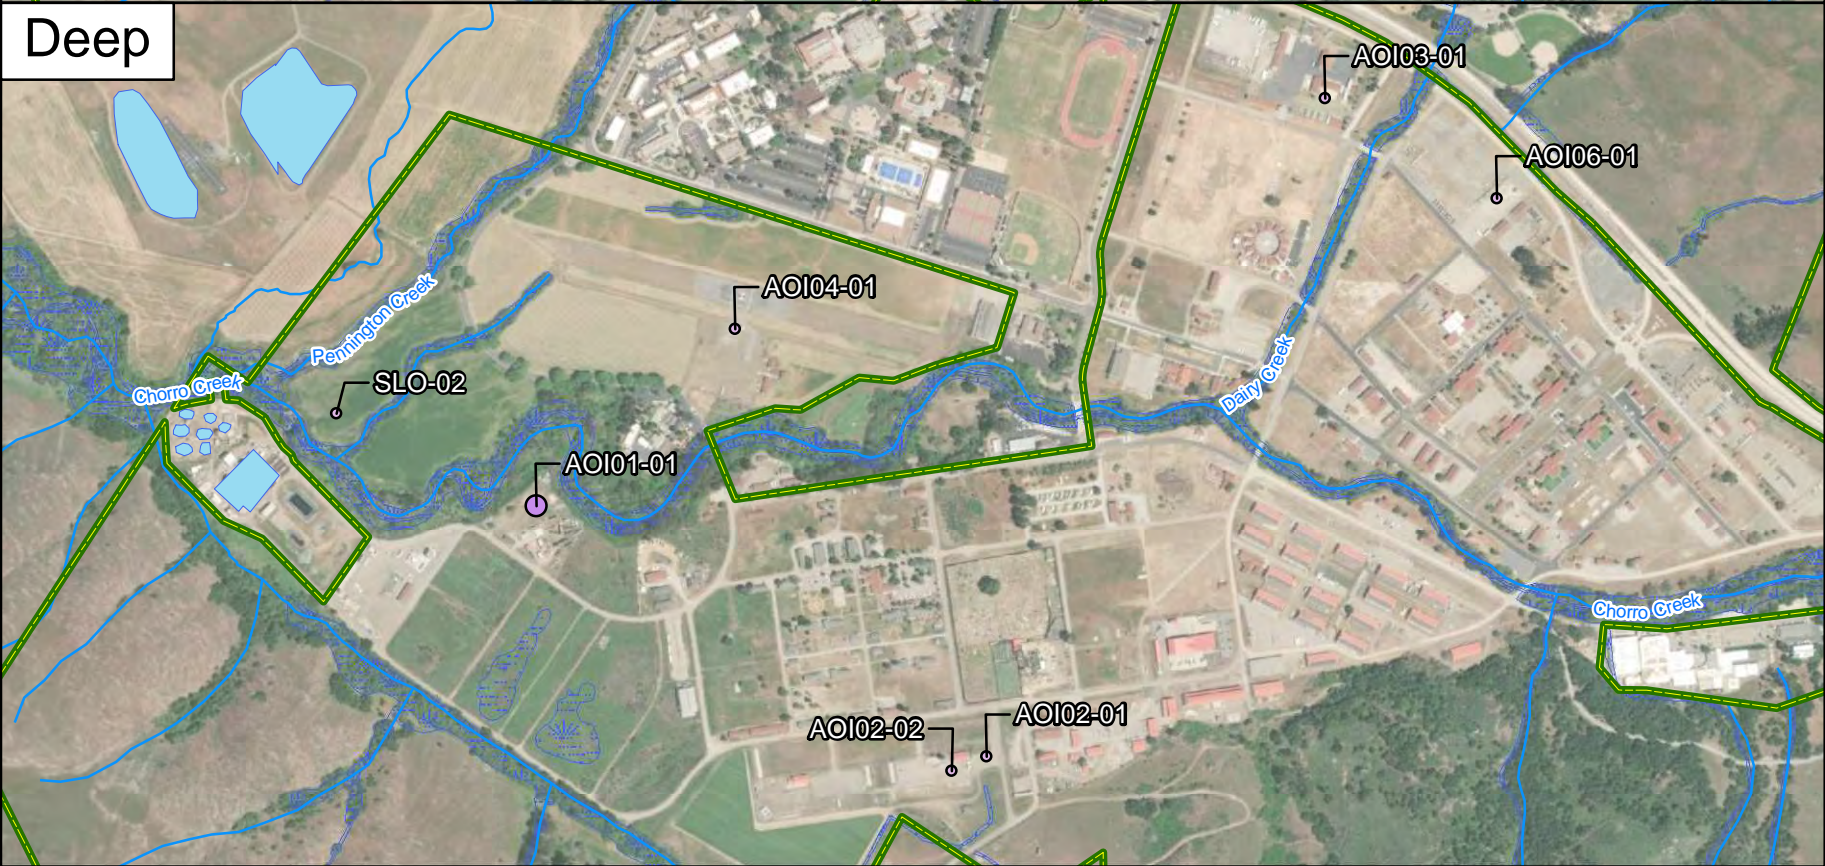
Figure 6-4

Exceedances of the OSD SL are depicted with a yellow halo.
Depth intervals shown represent respective sampling position within a given soil boring location.

PFHxS Detections in Soil

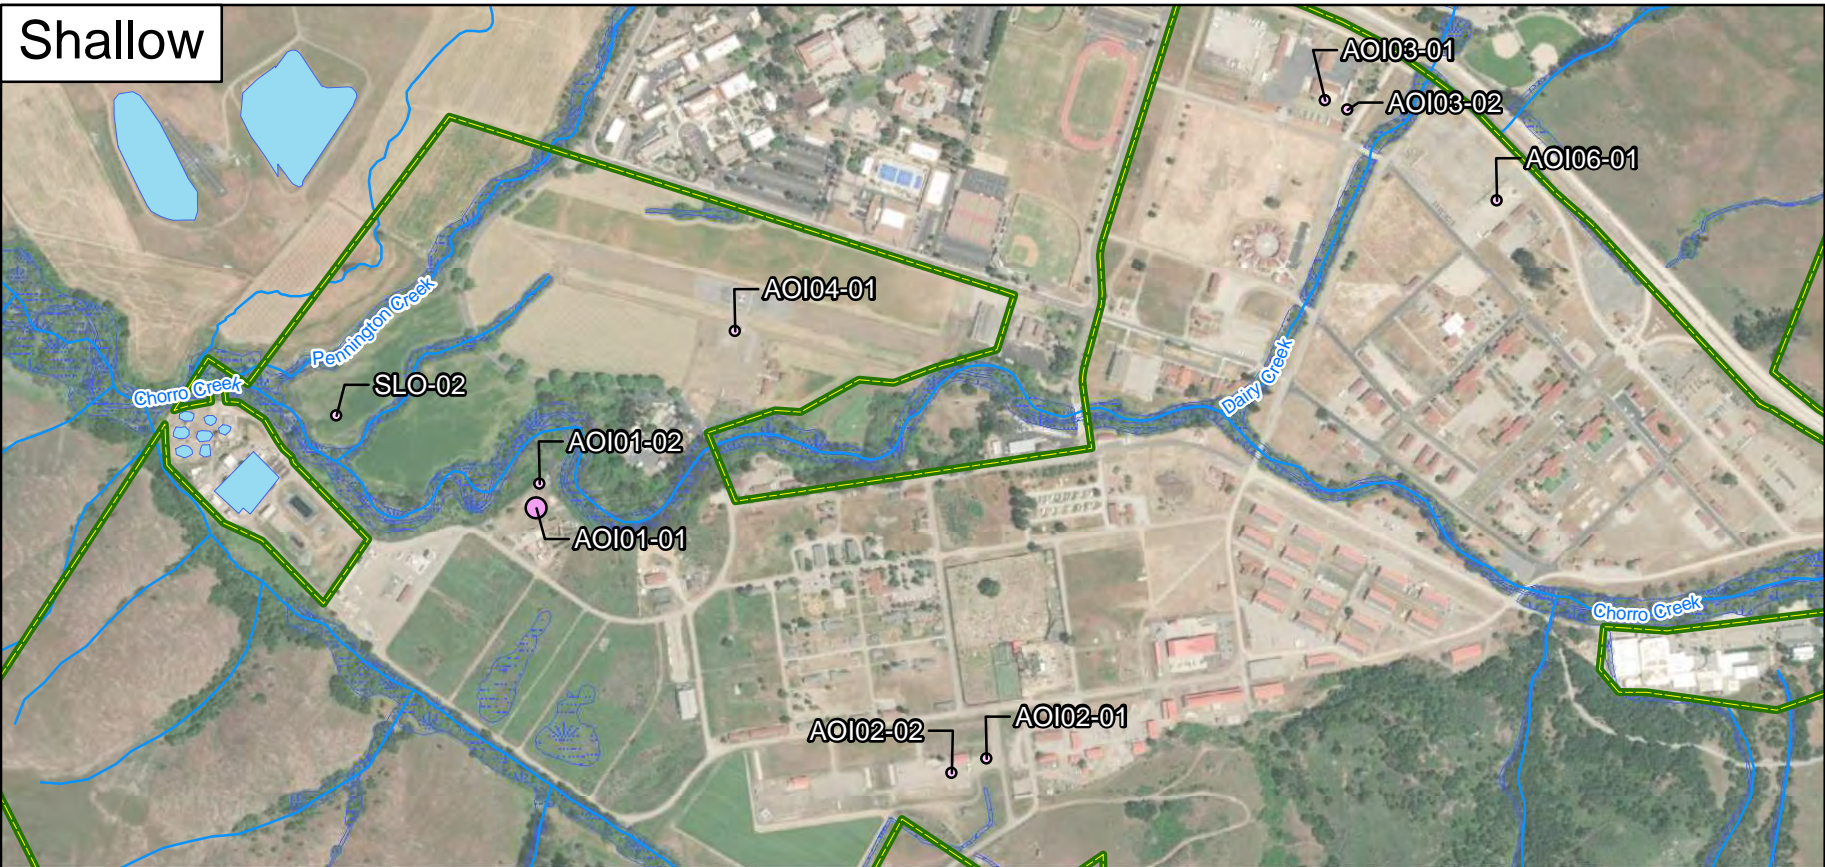
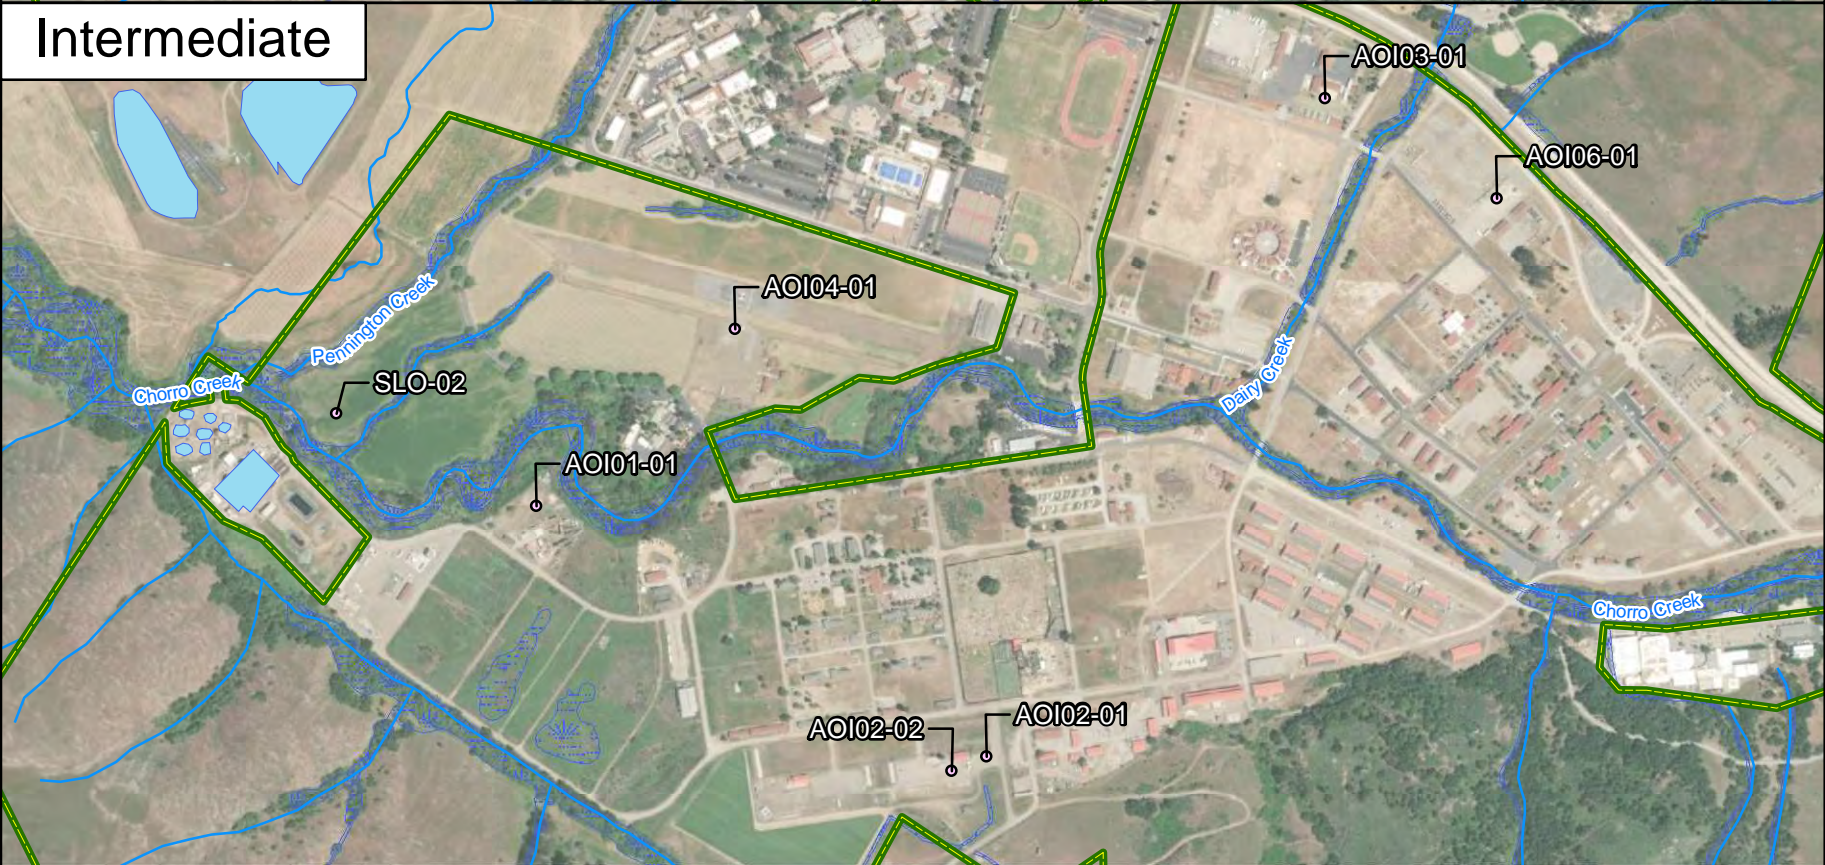
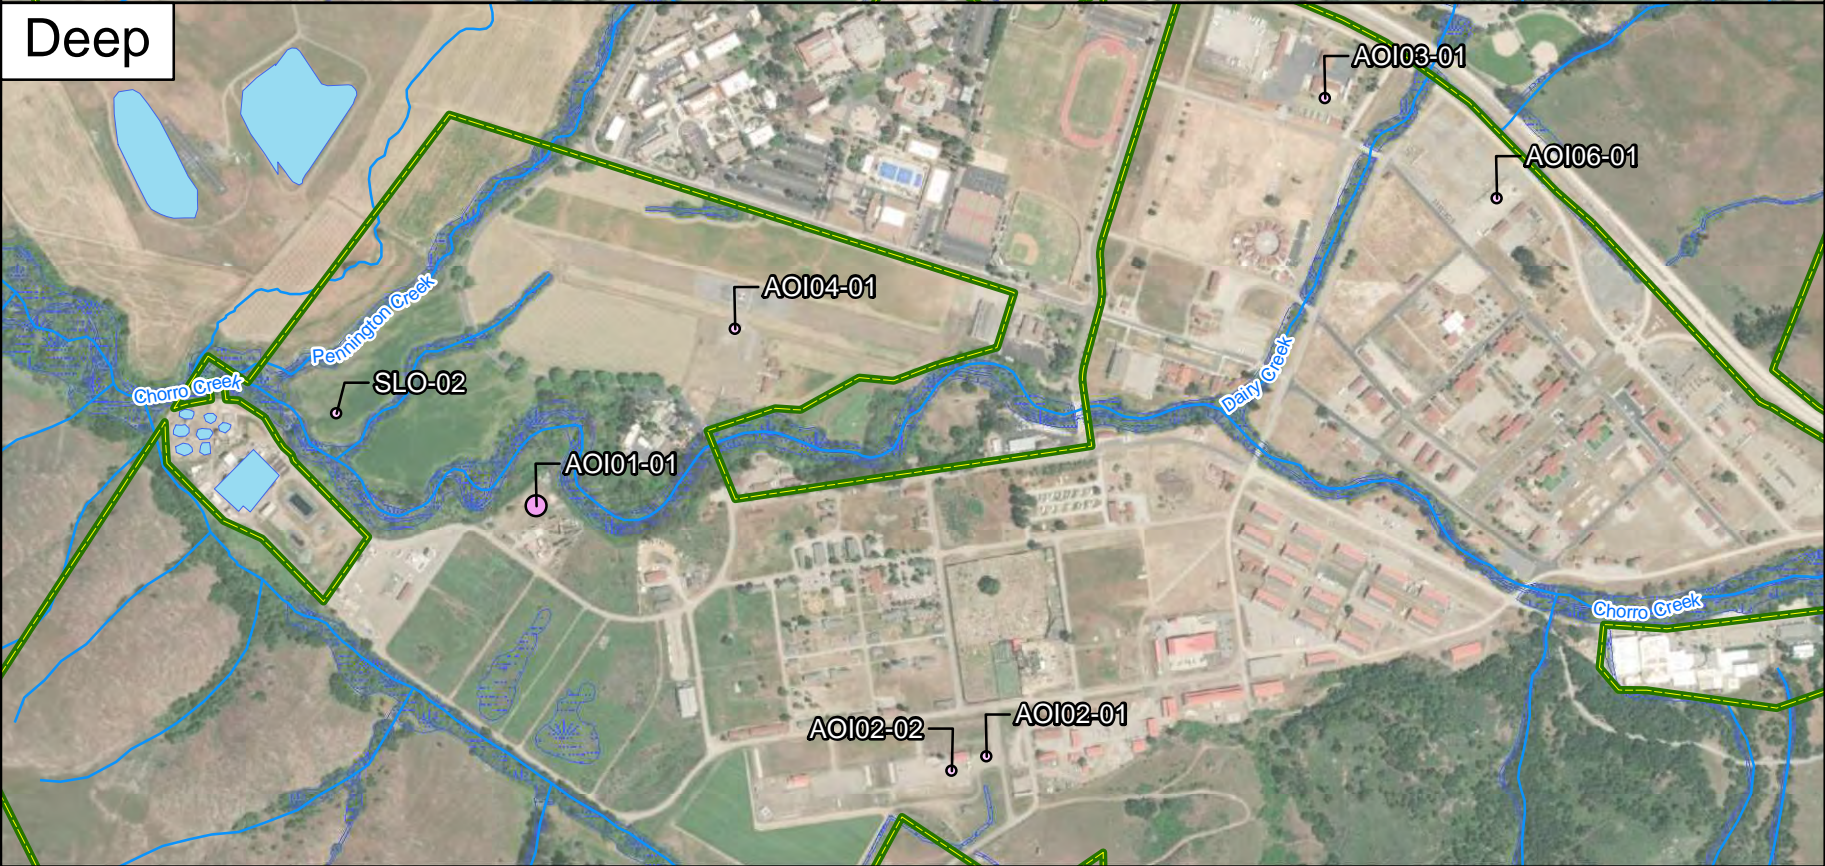
PFNA Results ($\mu\text{g}/\text{Kg}$)
