Site Inspection Report

Camp San Luis Obispo

Site Inspection for Perfluorooctanoic acid (PFOA),
Perfluorooctanesulfonic acid (PFOS), Perfluorohexanesulfonic
acid (PFHxS), Perfluorononanoic acid (PFNA),
Hexafluoropropylene oxide dimer acid (HFPO-DA), and
Perfluorobutanesulfonic acid (PFBS) at ARNG Installations,
Nationwide

September 2023

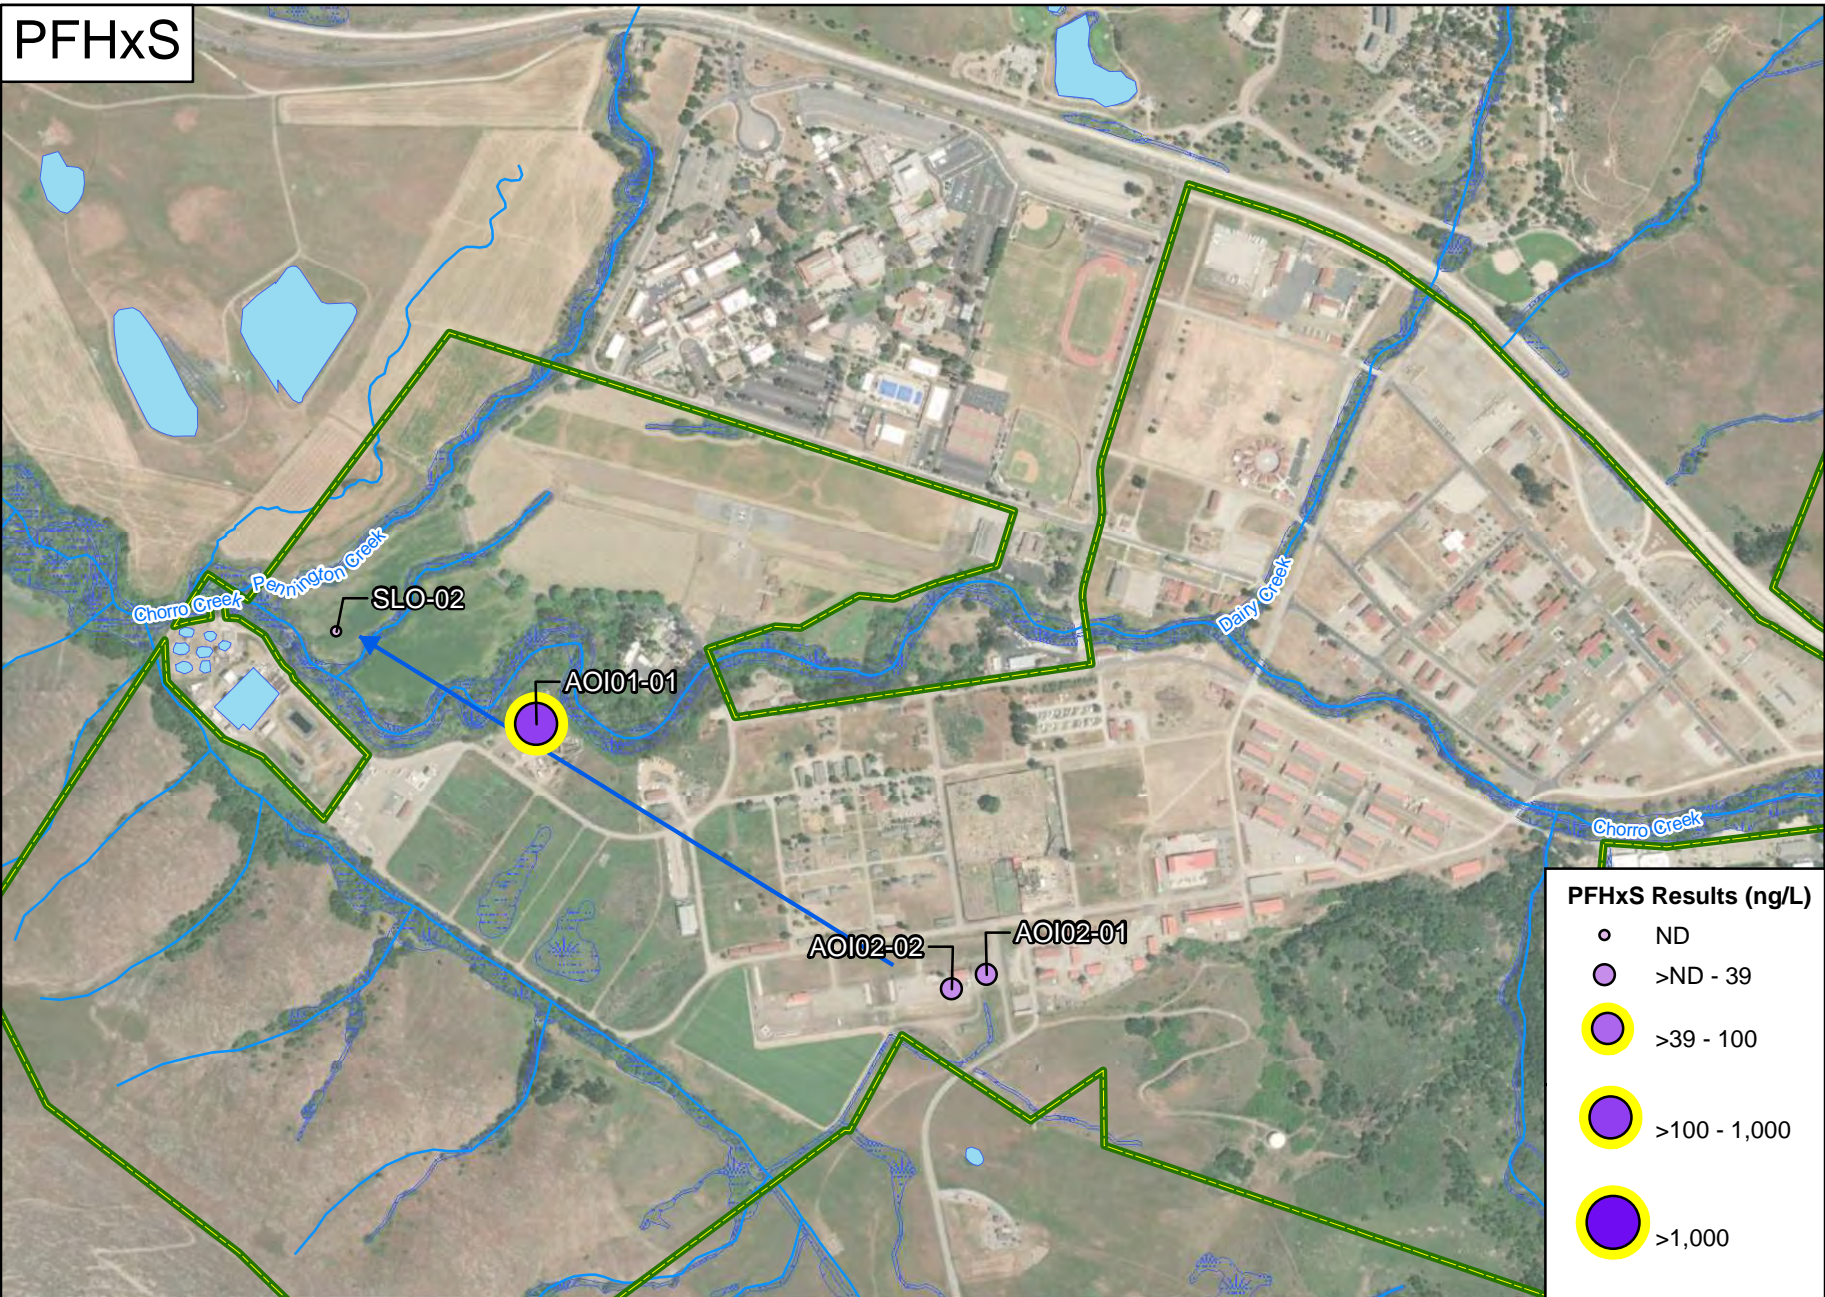
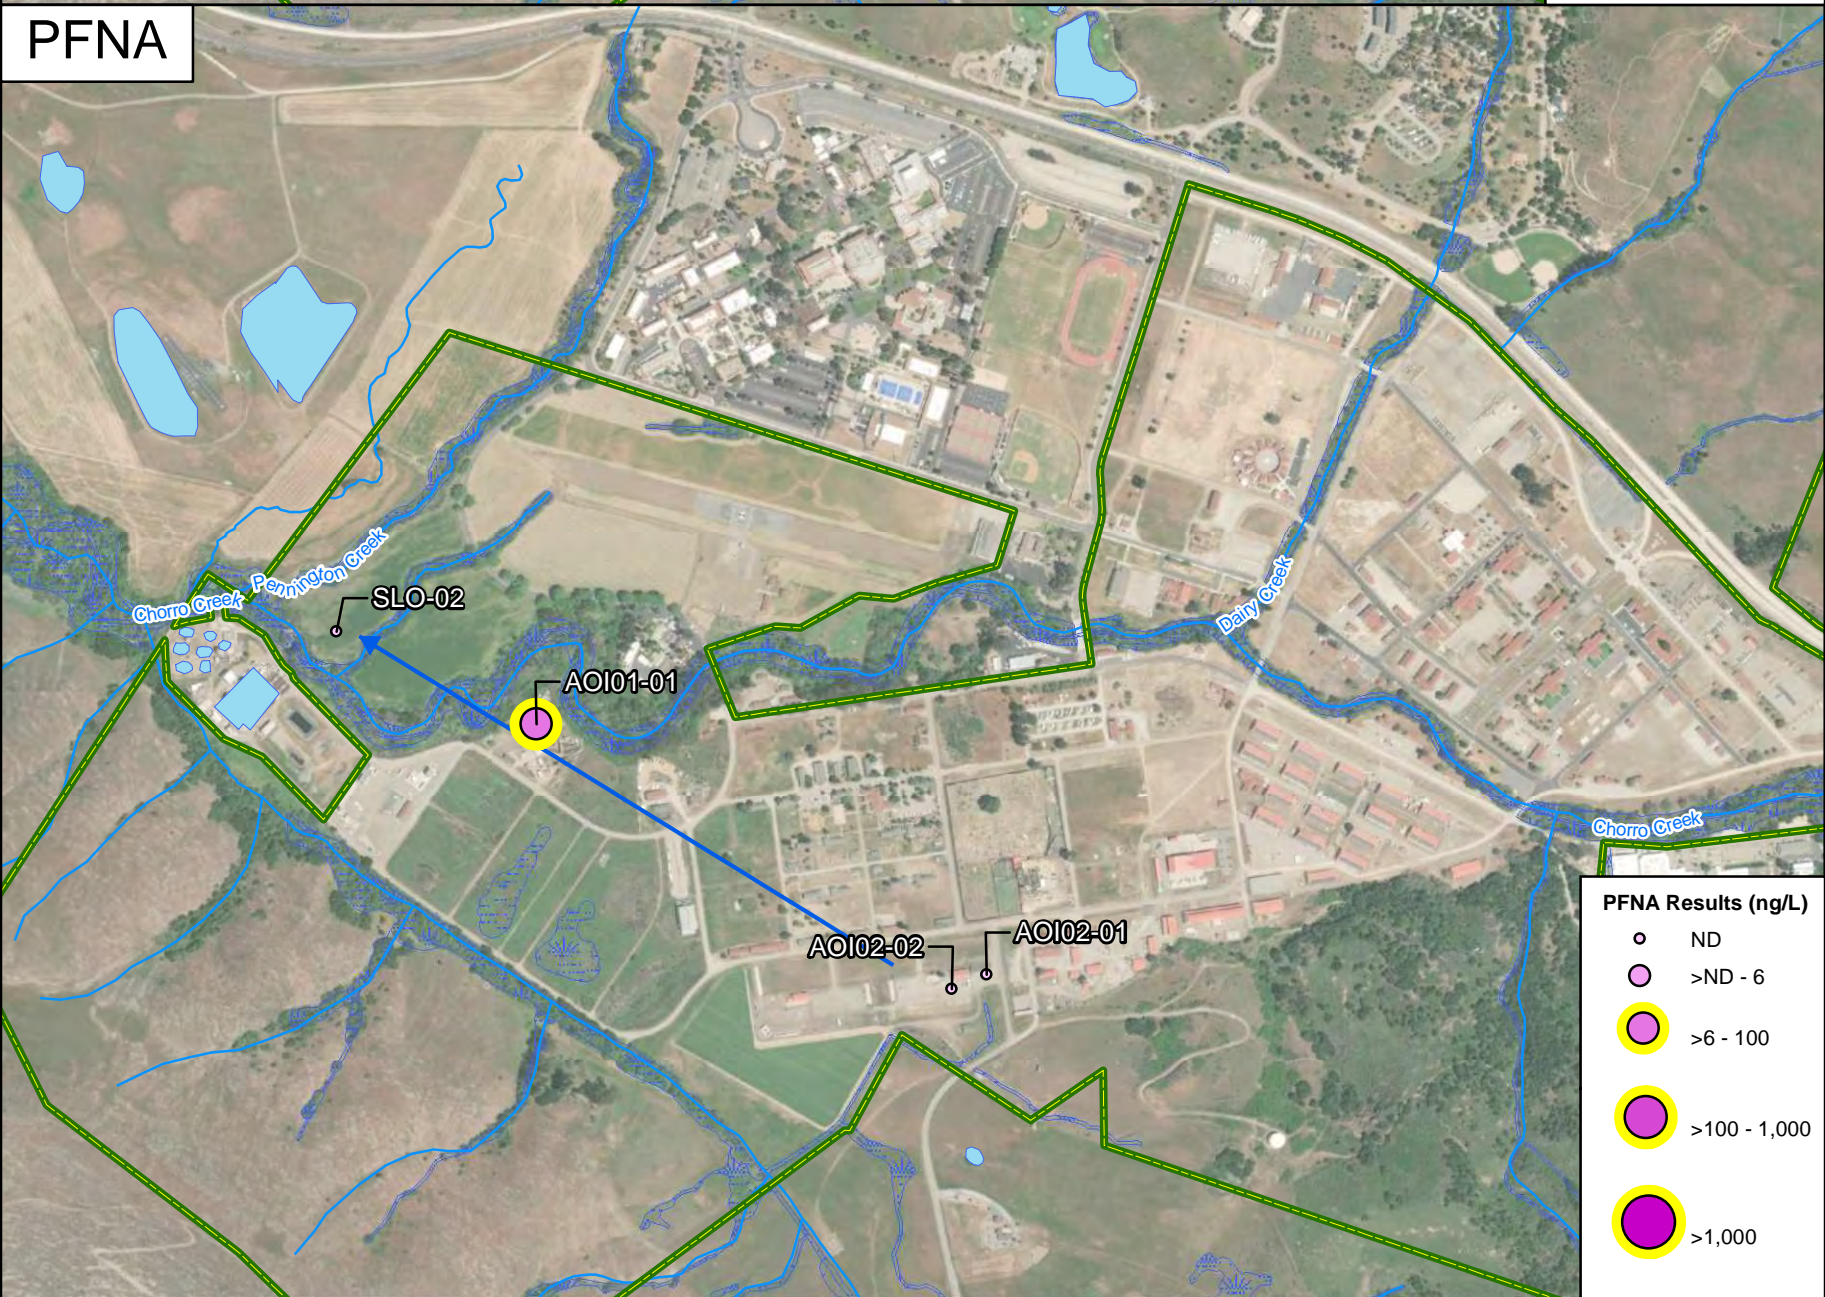
Exceedances of the OSD SL are depicted with a yellow halo.

PFHxS

PFNA
