FINAL Site Inspection Report Fresno Aviation Classification Repair Activity Depot (AVCRAD) Fresno, California

Site Inspection for Perfluorooctanoic acid (PFOA),
Perfluorooctanesulfonic acid (PFOS), Perfluorohexanesulfonic
acid (PFHxS), Perfluorononanoic acid (PFNA),
Hexafluoropropylene oxide dimer acid (HFPO-DA), and
Perfluorobutanesulfonic acid (PFBS) at ARNG Installations,
Nationwide

September 2023

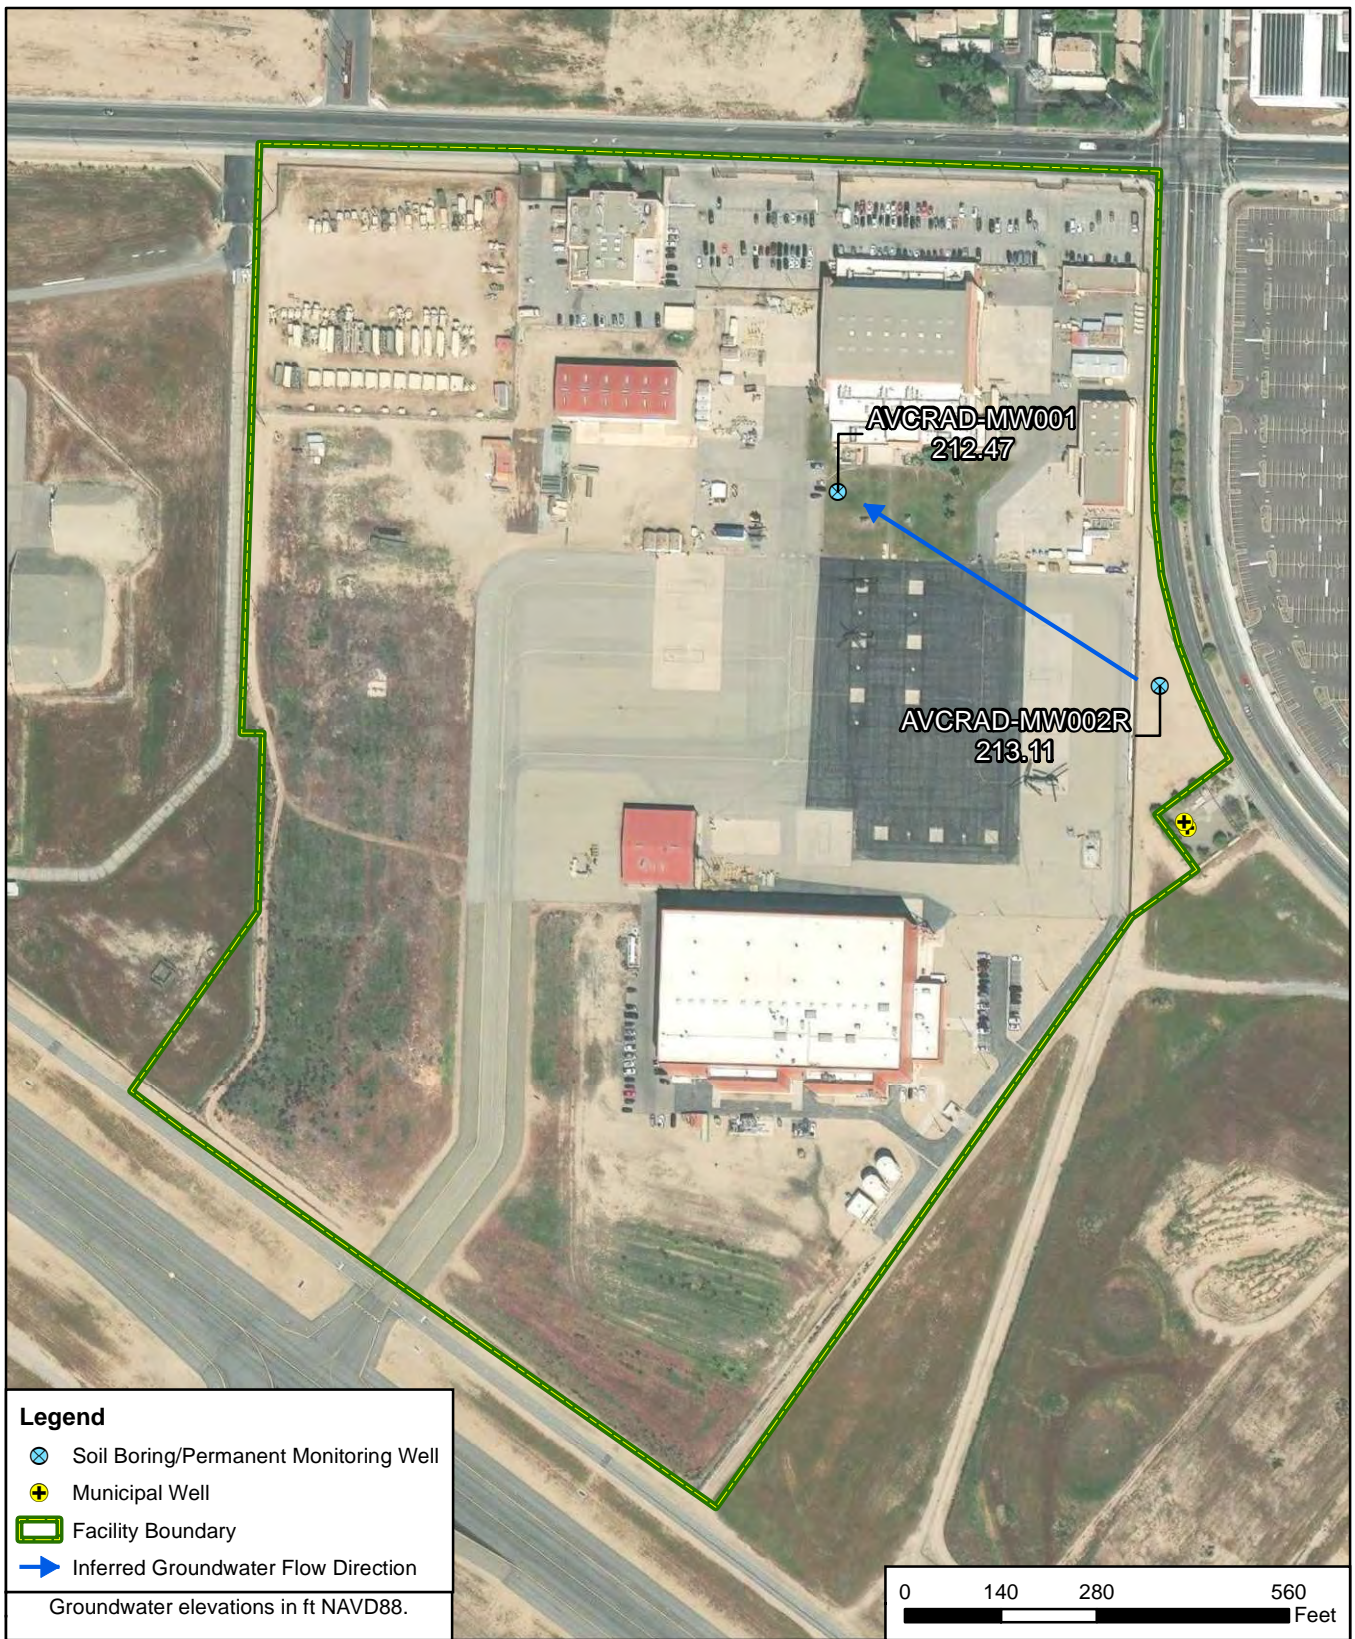
Figure 2-3

Fresno AVCRAD lies within the Kings Sub-basin of the San Joaquin Valley Groundwater Basin. Groundwater is found in the unconfined or semi-confined conditions within alluvial fan deposits in the eastern portion of the Central Valley, where Fresno AVCRAD is located. Seven water-bearing zones have been identified in the vicinity of the AVCRAD.

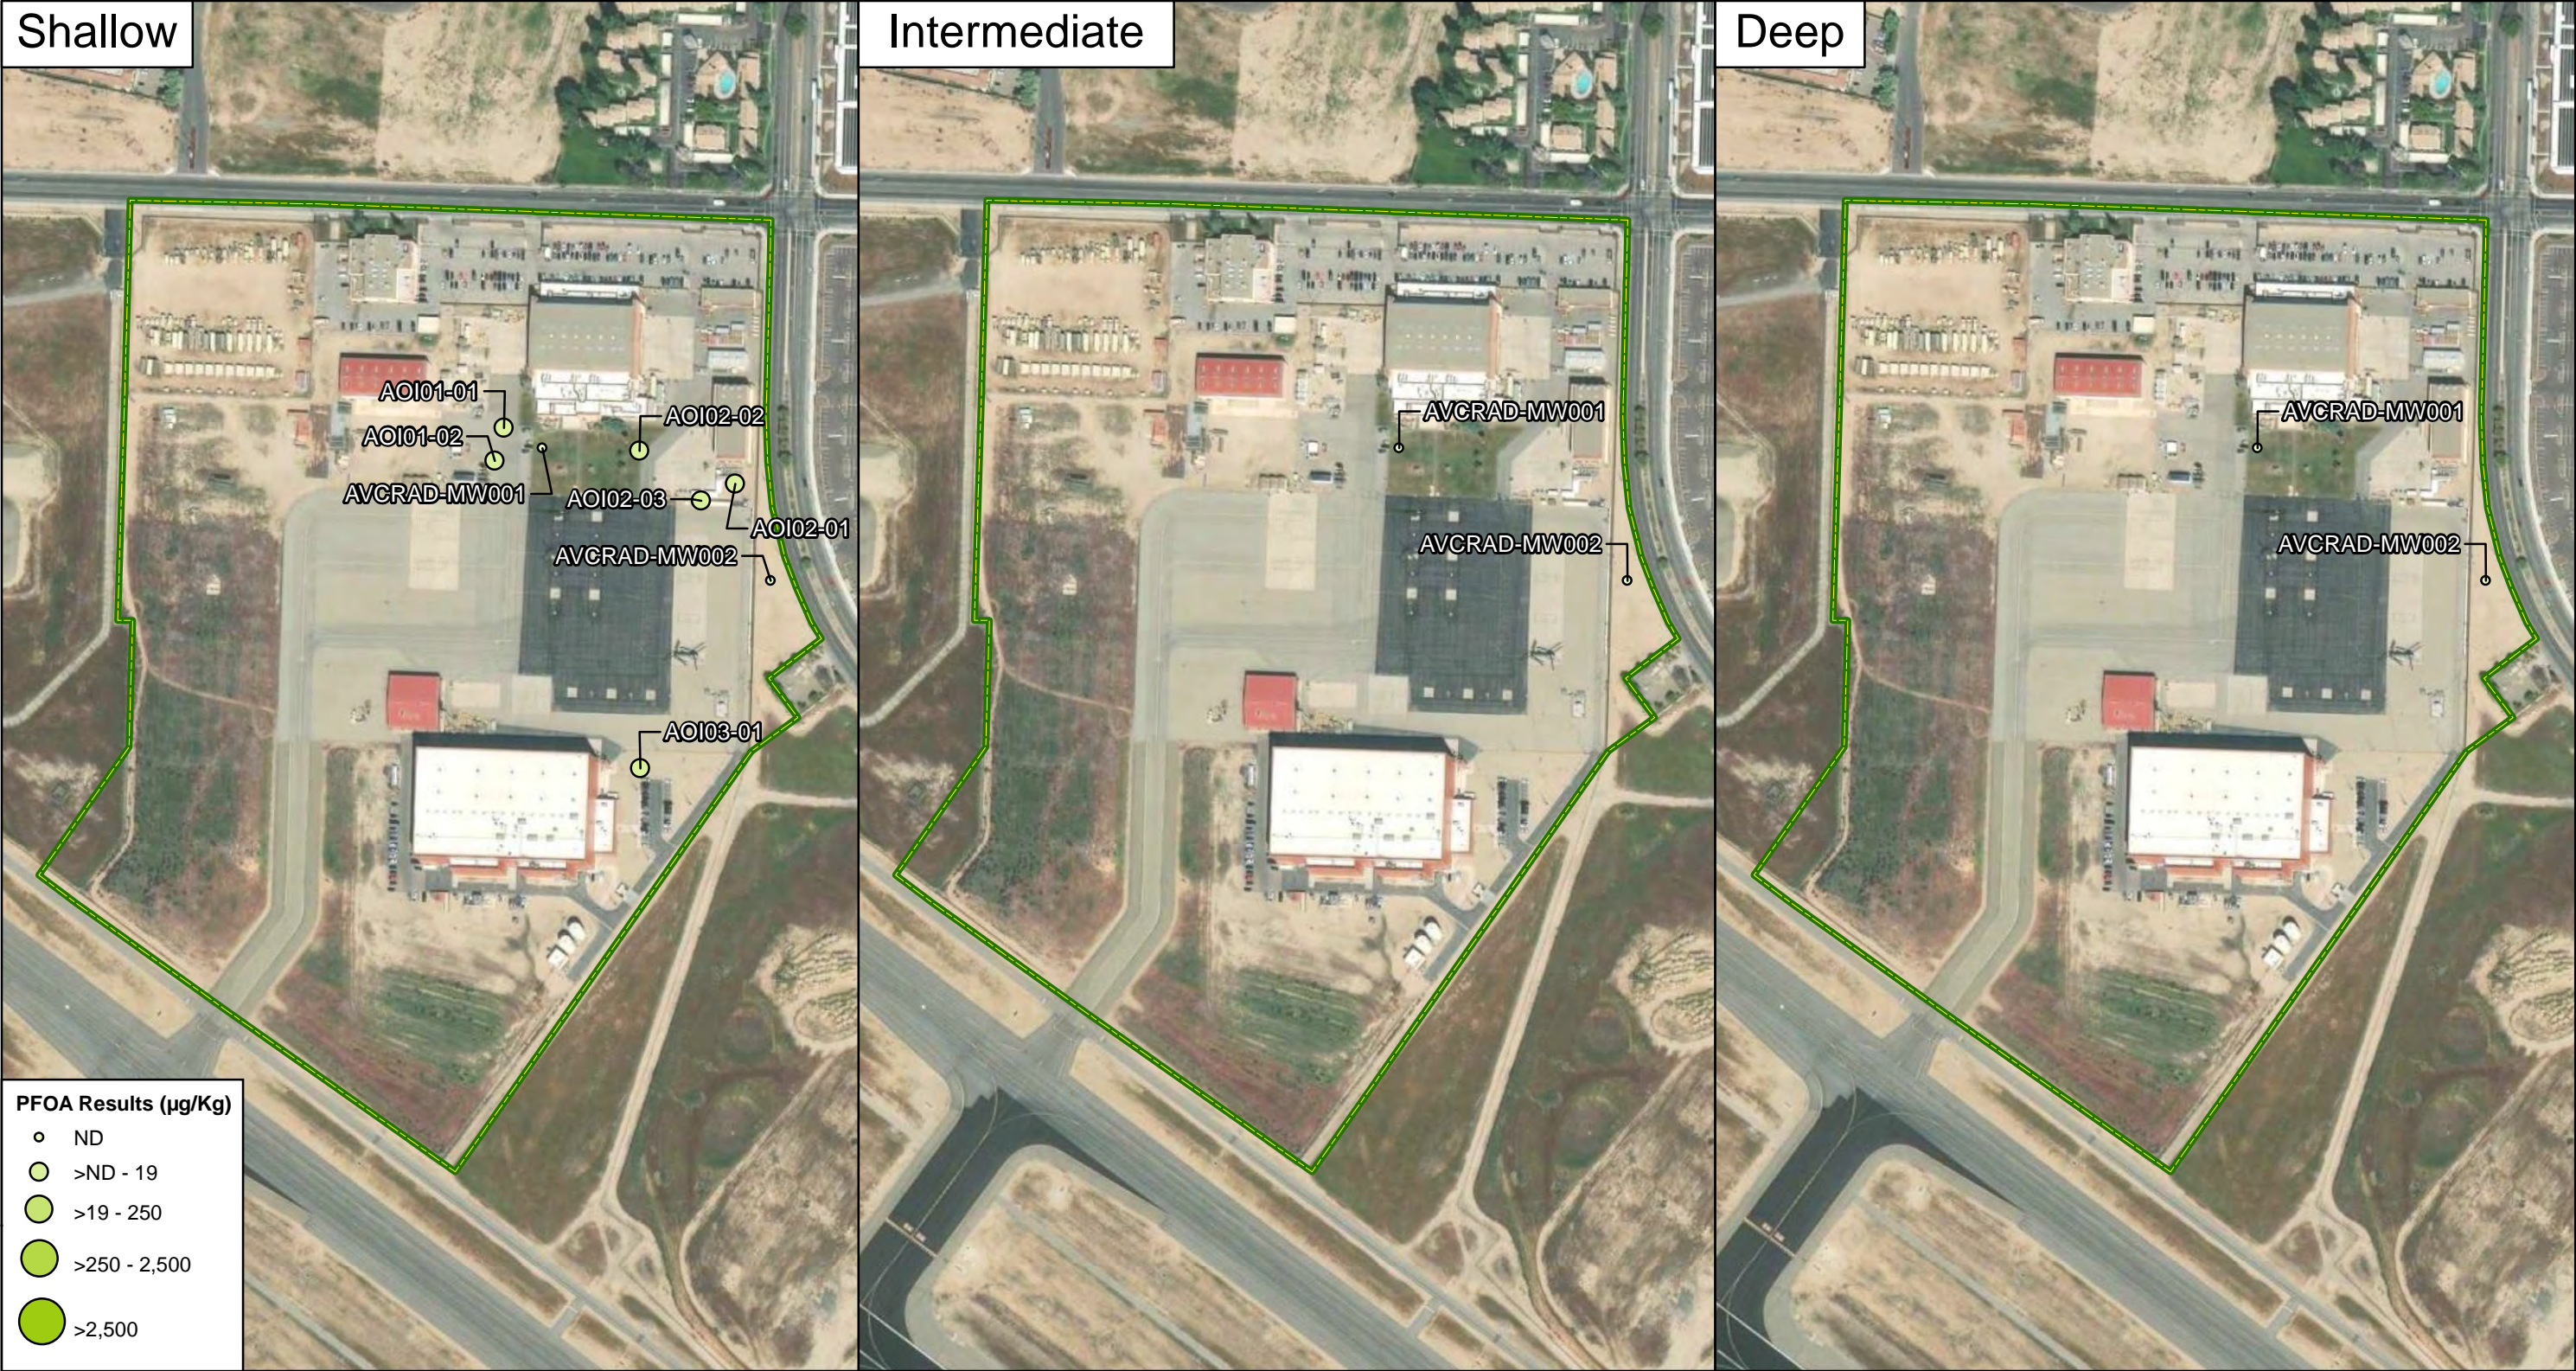
Figure 6-1

Exceedances of the OSD SL are depicted with a yellow halo.
Depth intervals shown represent respective sampling position within a given soil boring location.

This section presents the analytical results for soil in comparison to SLs for AOI 3, which includes one potential release area: the Corrosion Control Facility. No wells were installed at AOI 3; thus, groundwater was not sampled. The results in soil are presented in **Table 6-2**. Soil results are presented on **Figure 6-1** through **Figure 6-5**.

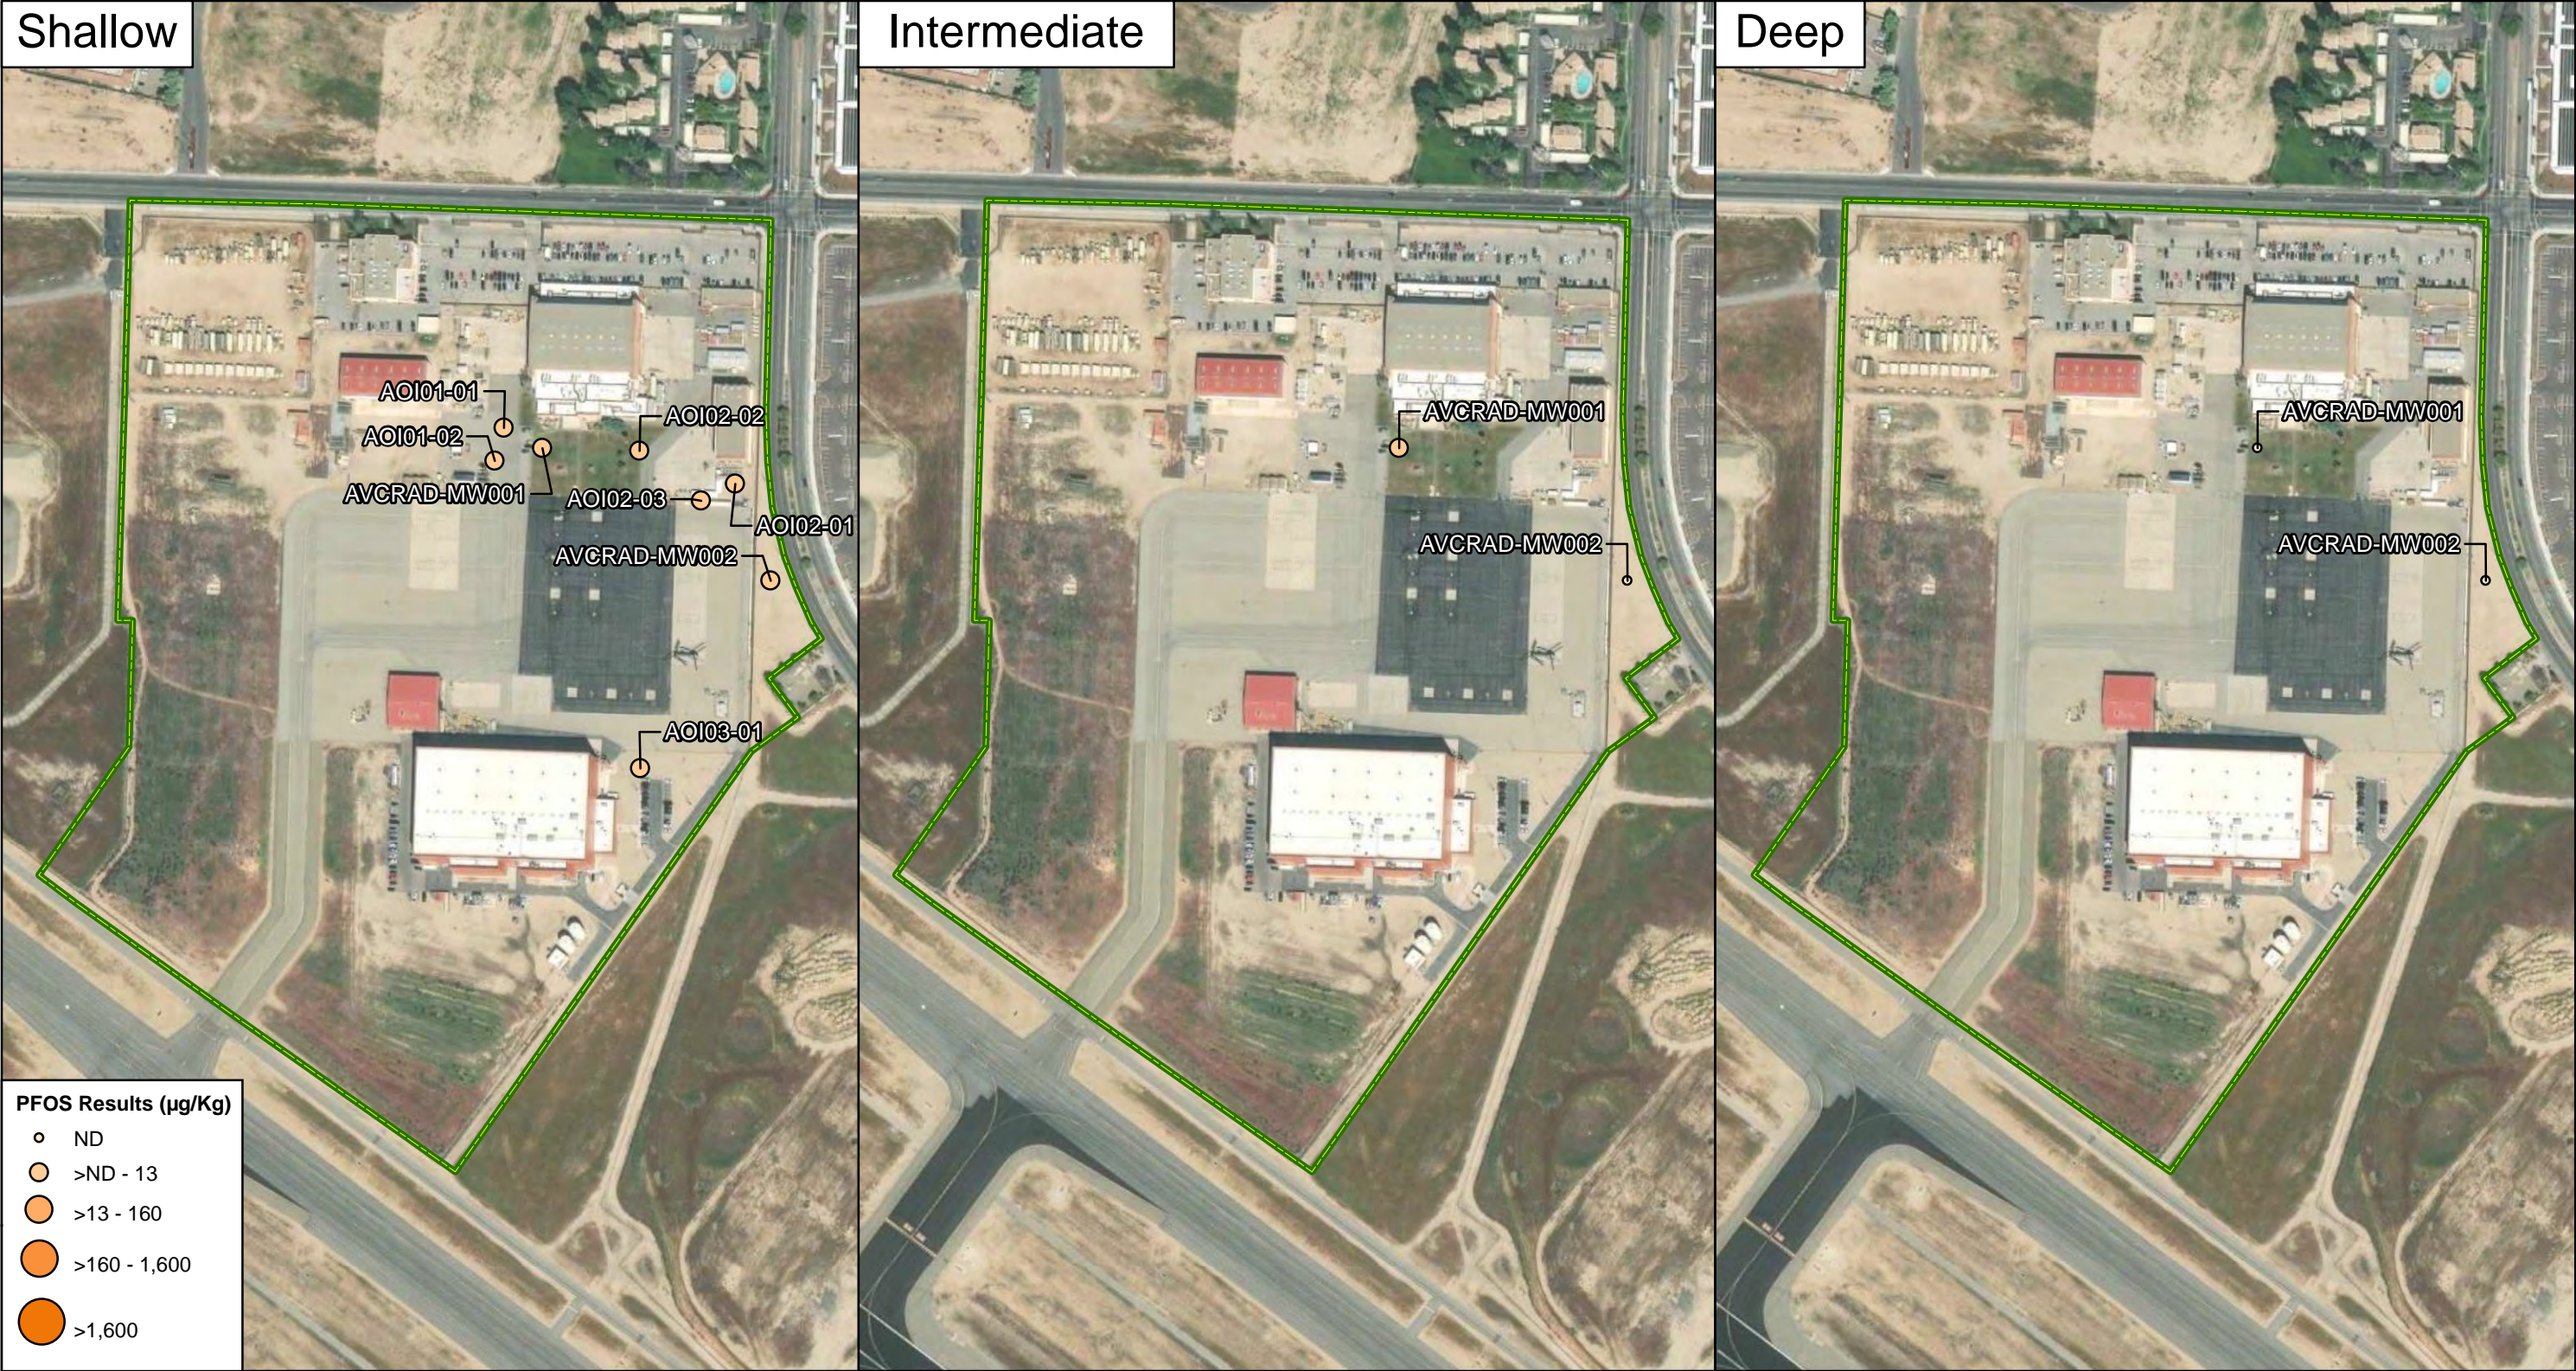
Figure 6-2

Exceedances of the OSD SL are depicted with a yellow halo.
Depth intervals shown represent respective sampling position within a given soil boring location.

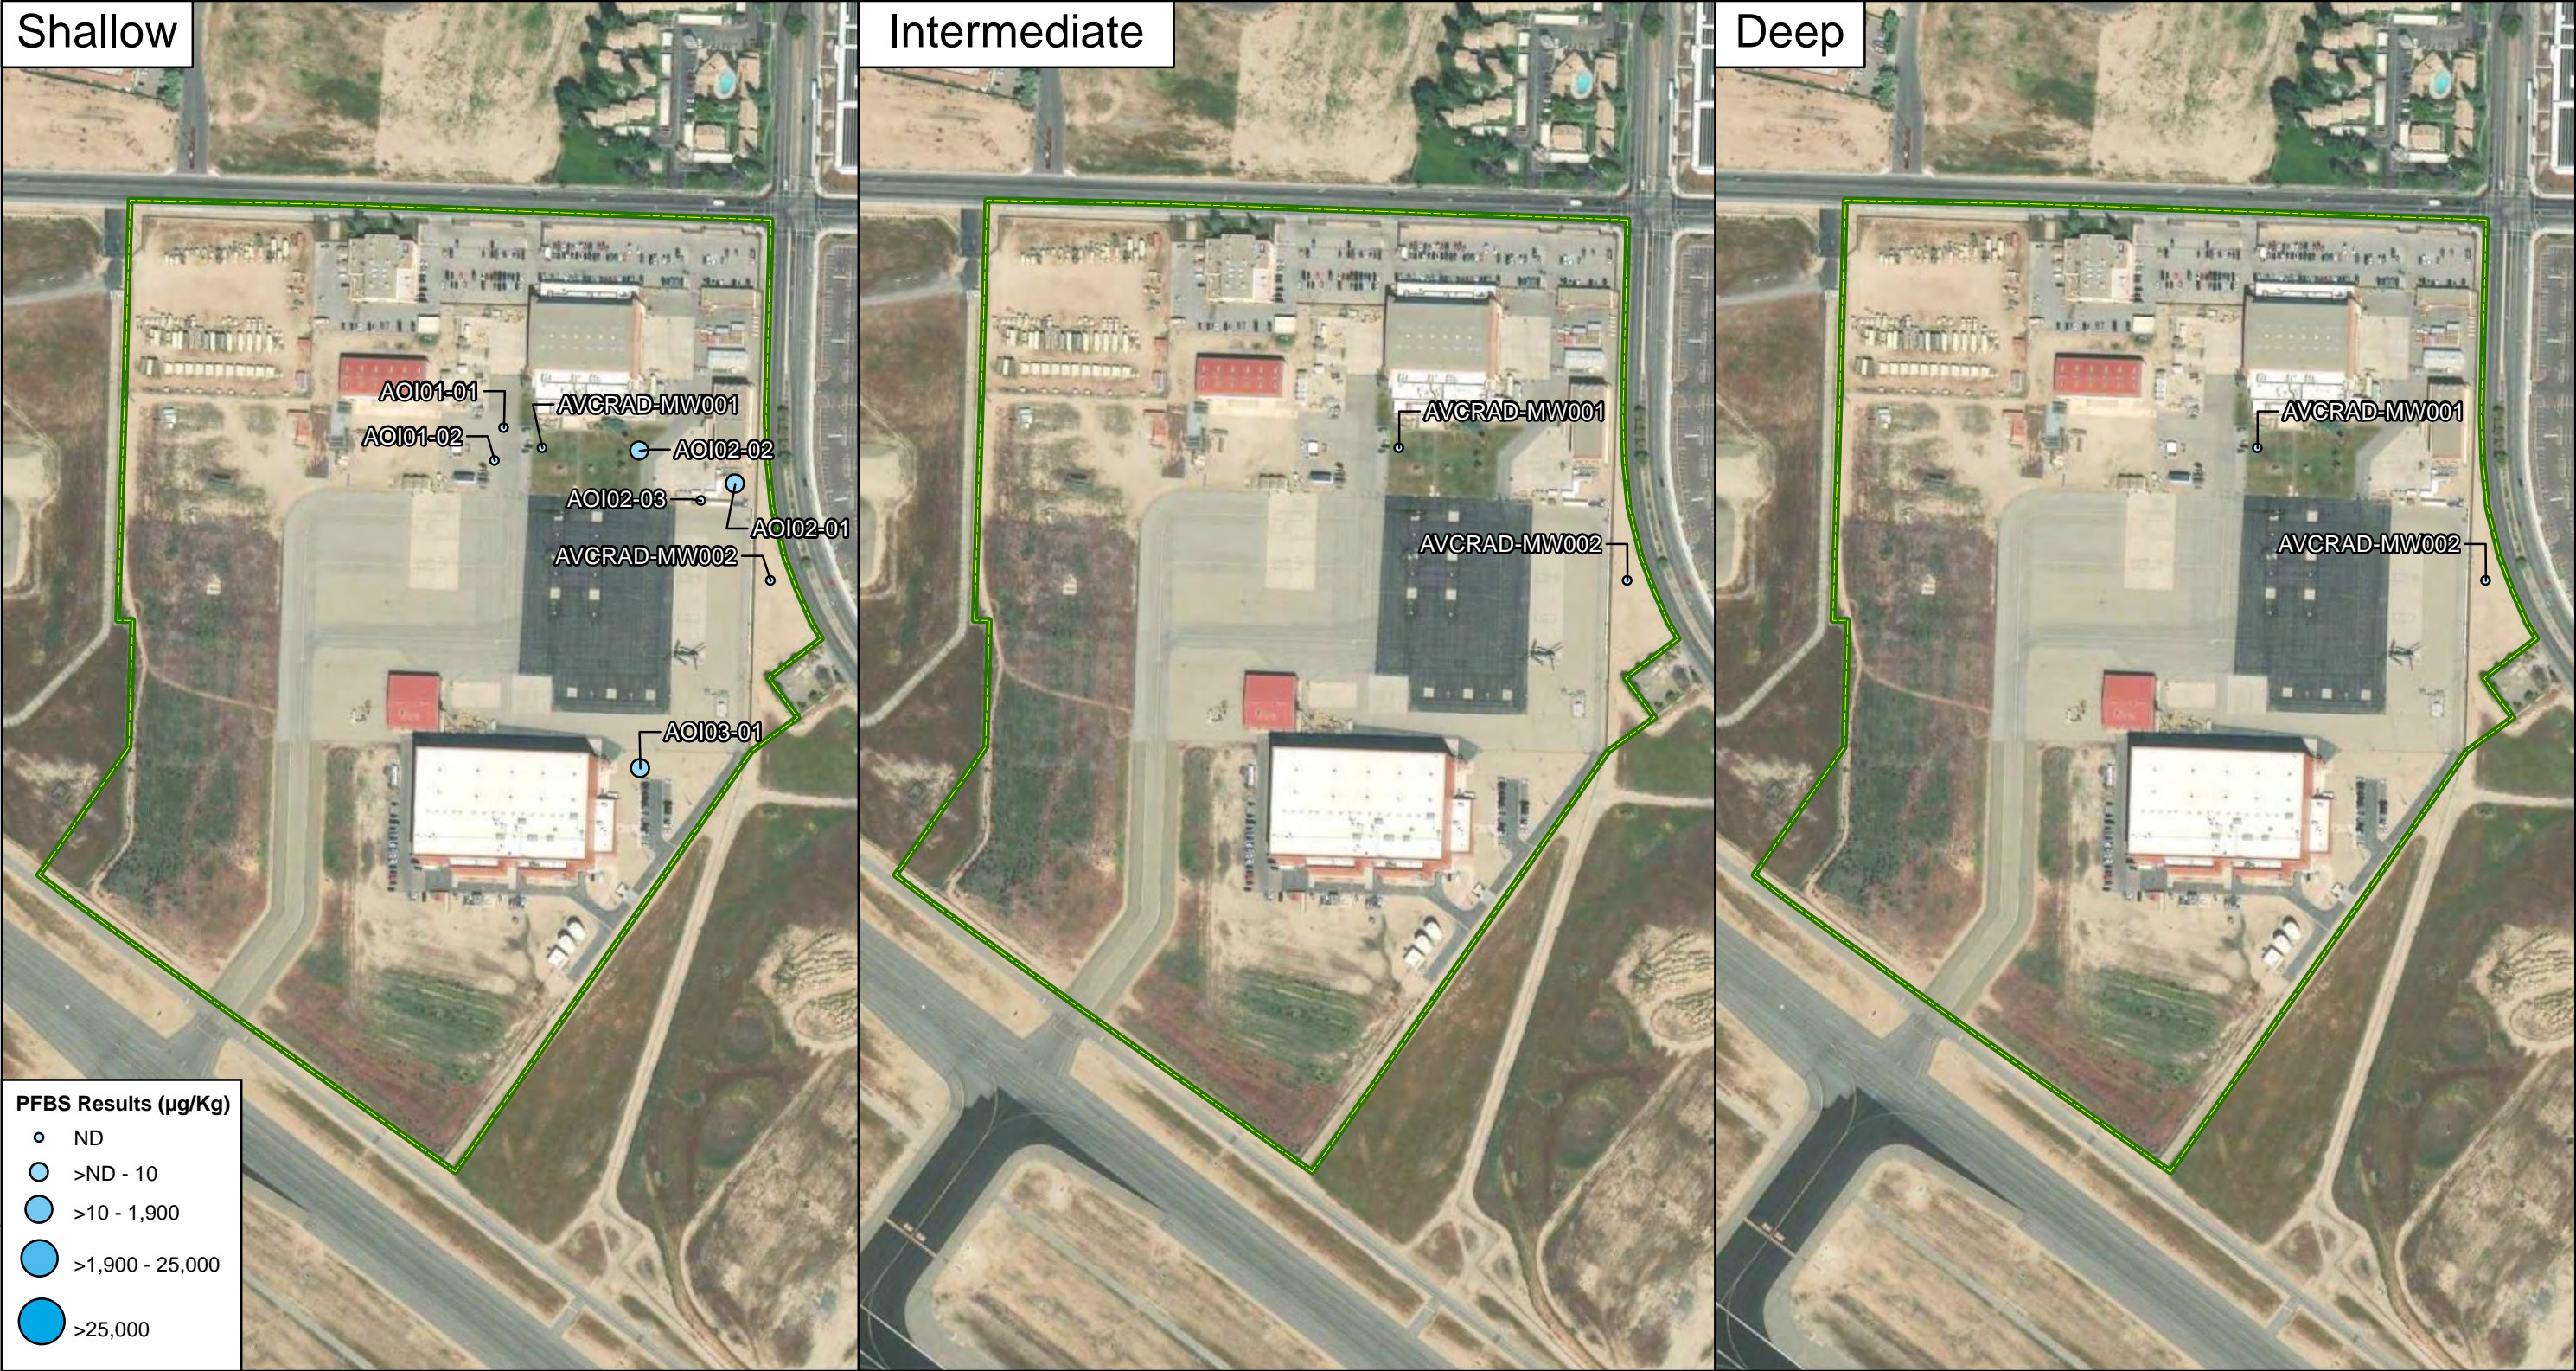
Figure 6-3

Exceedances of the OSD SL are depicted with a yellow halo.
Depth intervals shown represent respective sampling position within a given soil boring location.

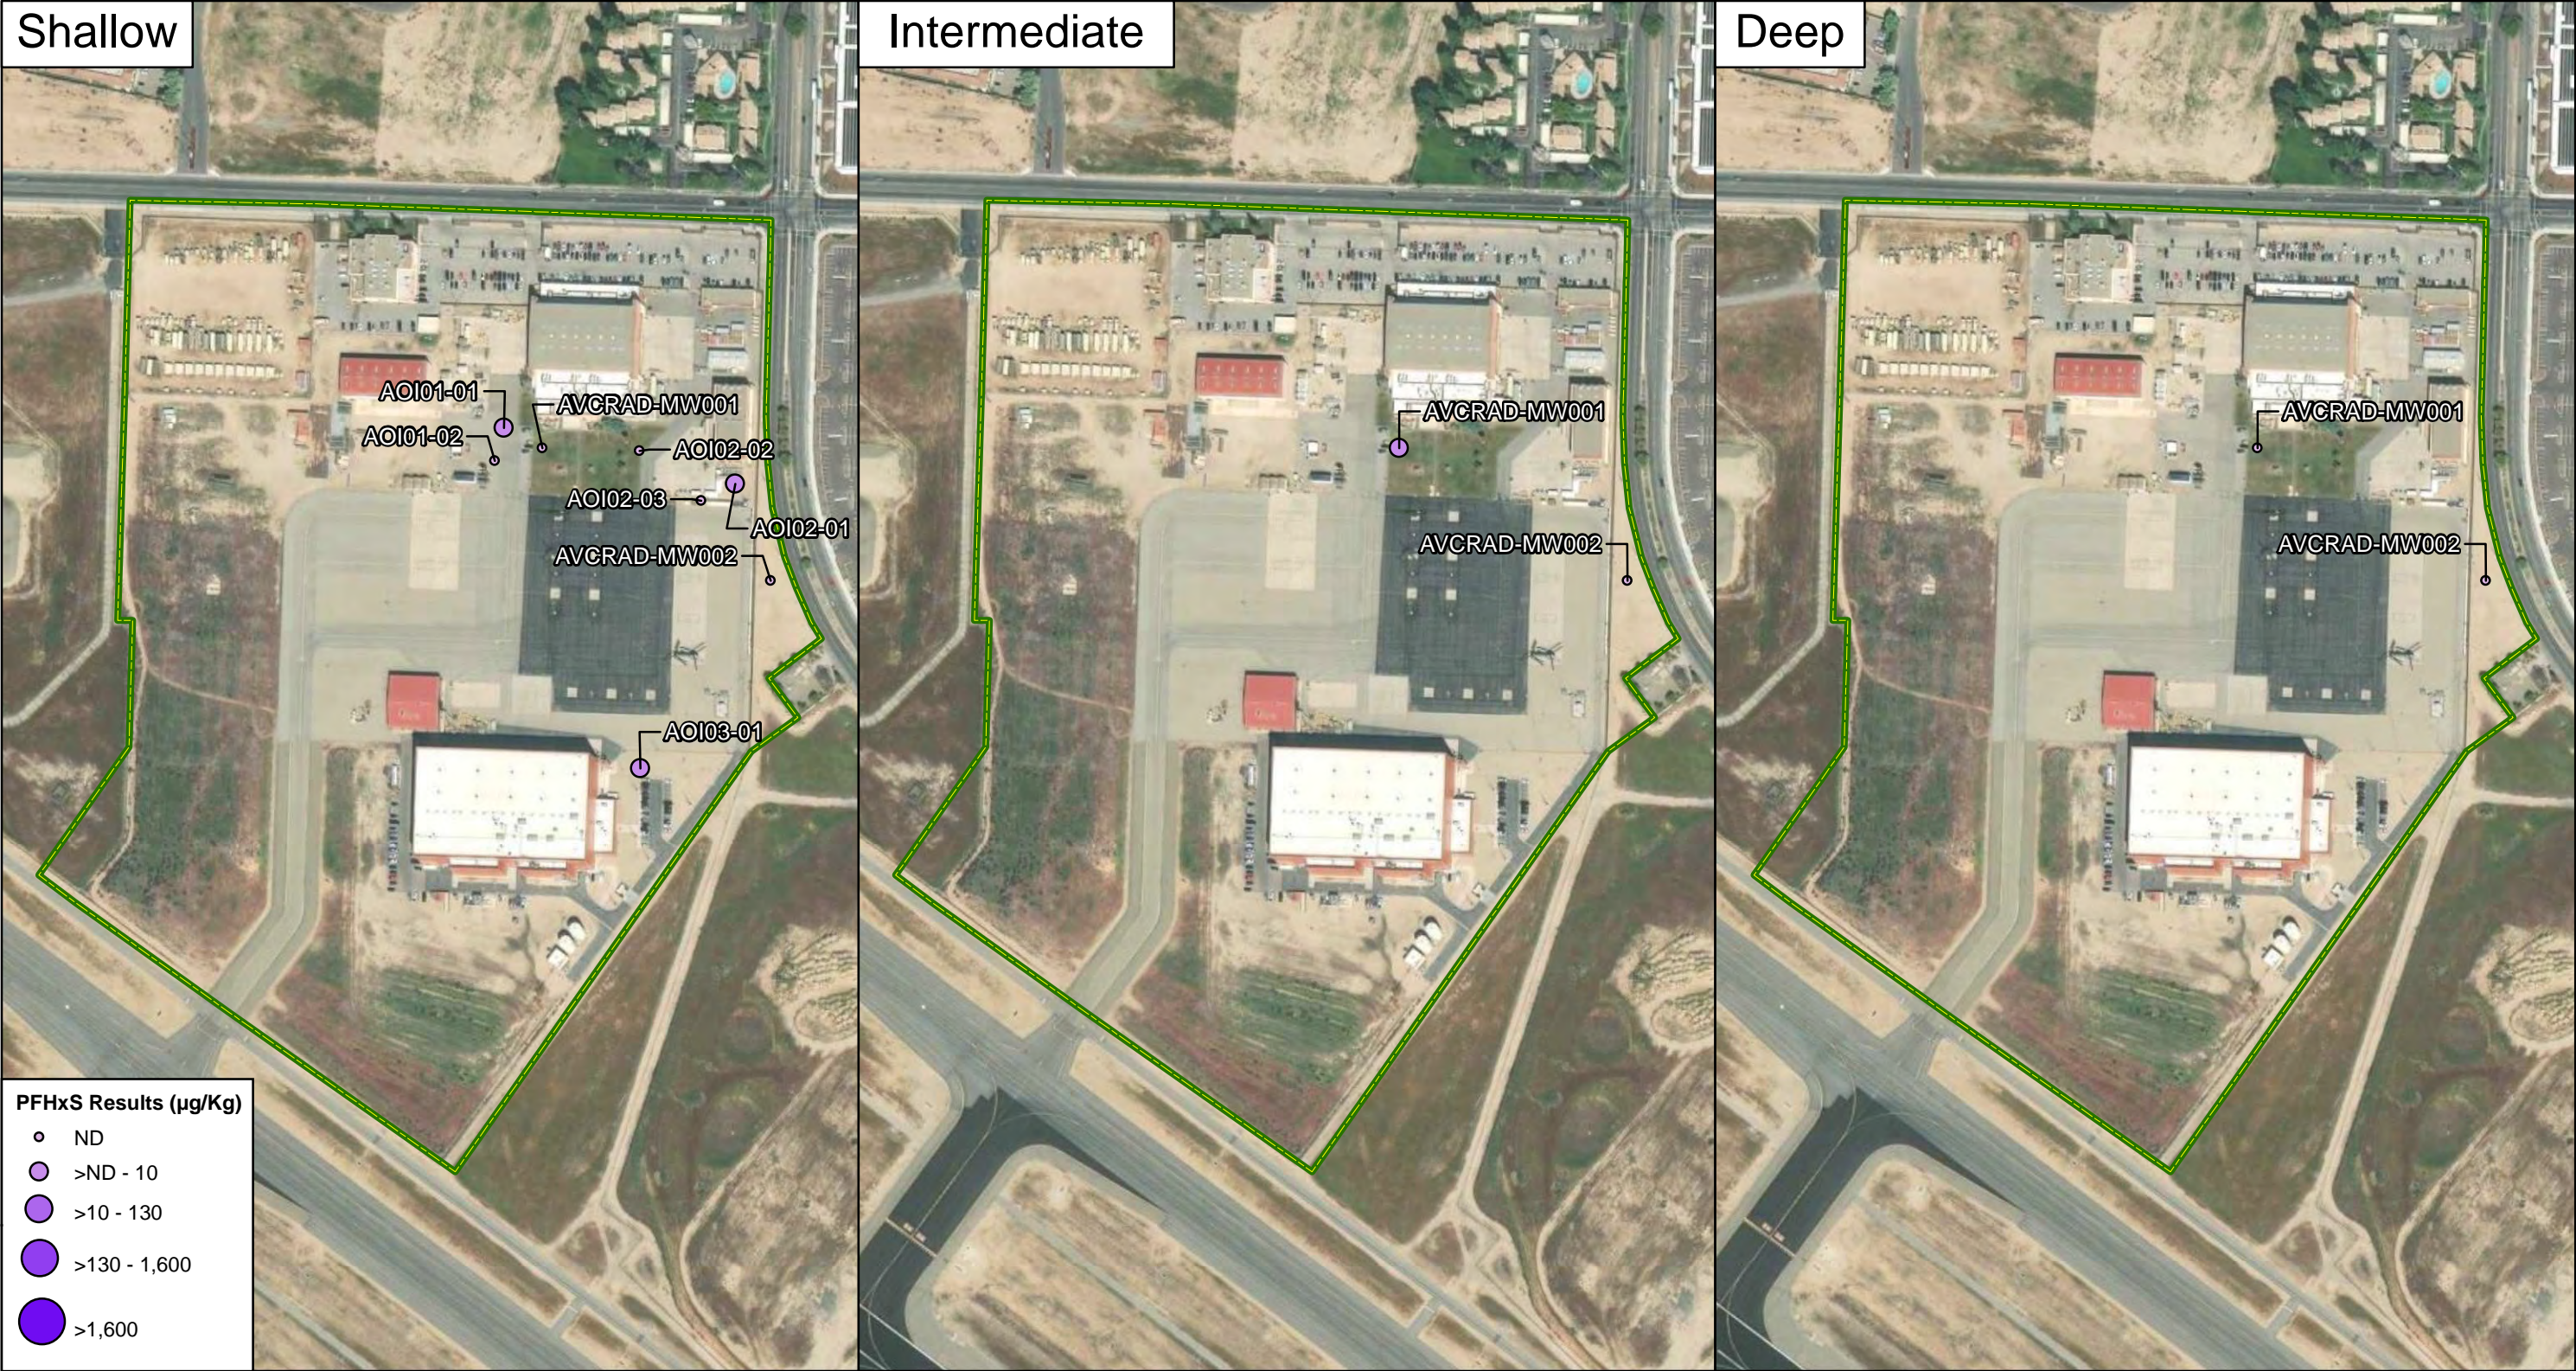
Figure 6-4

Exceedances of the OSD SL are depicted with a yellow halo.
Depth intervals shown represent respective sampling position within a given soil boring location.

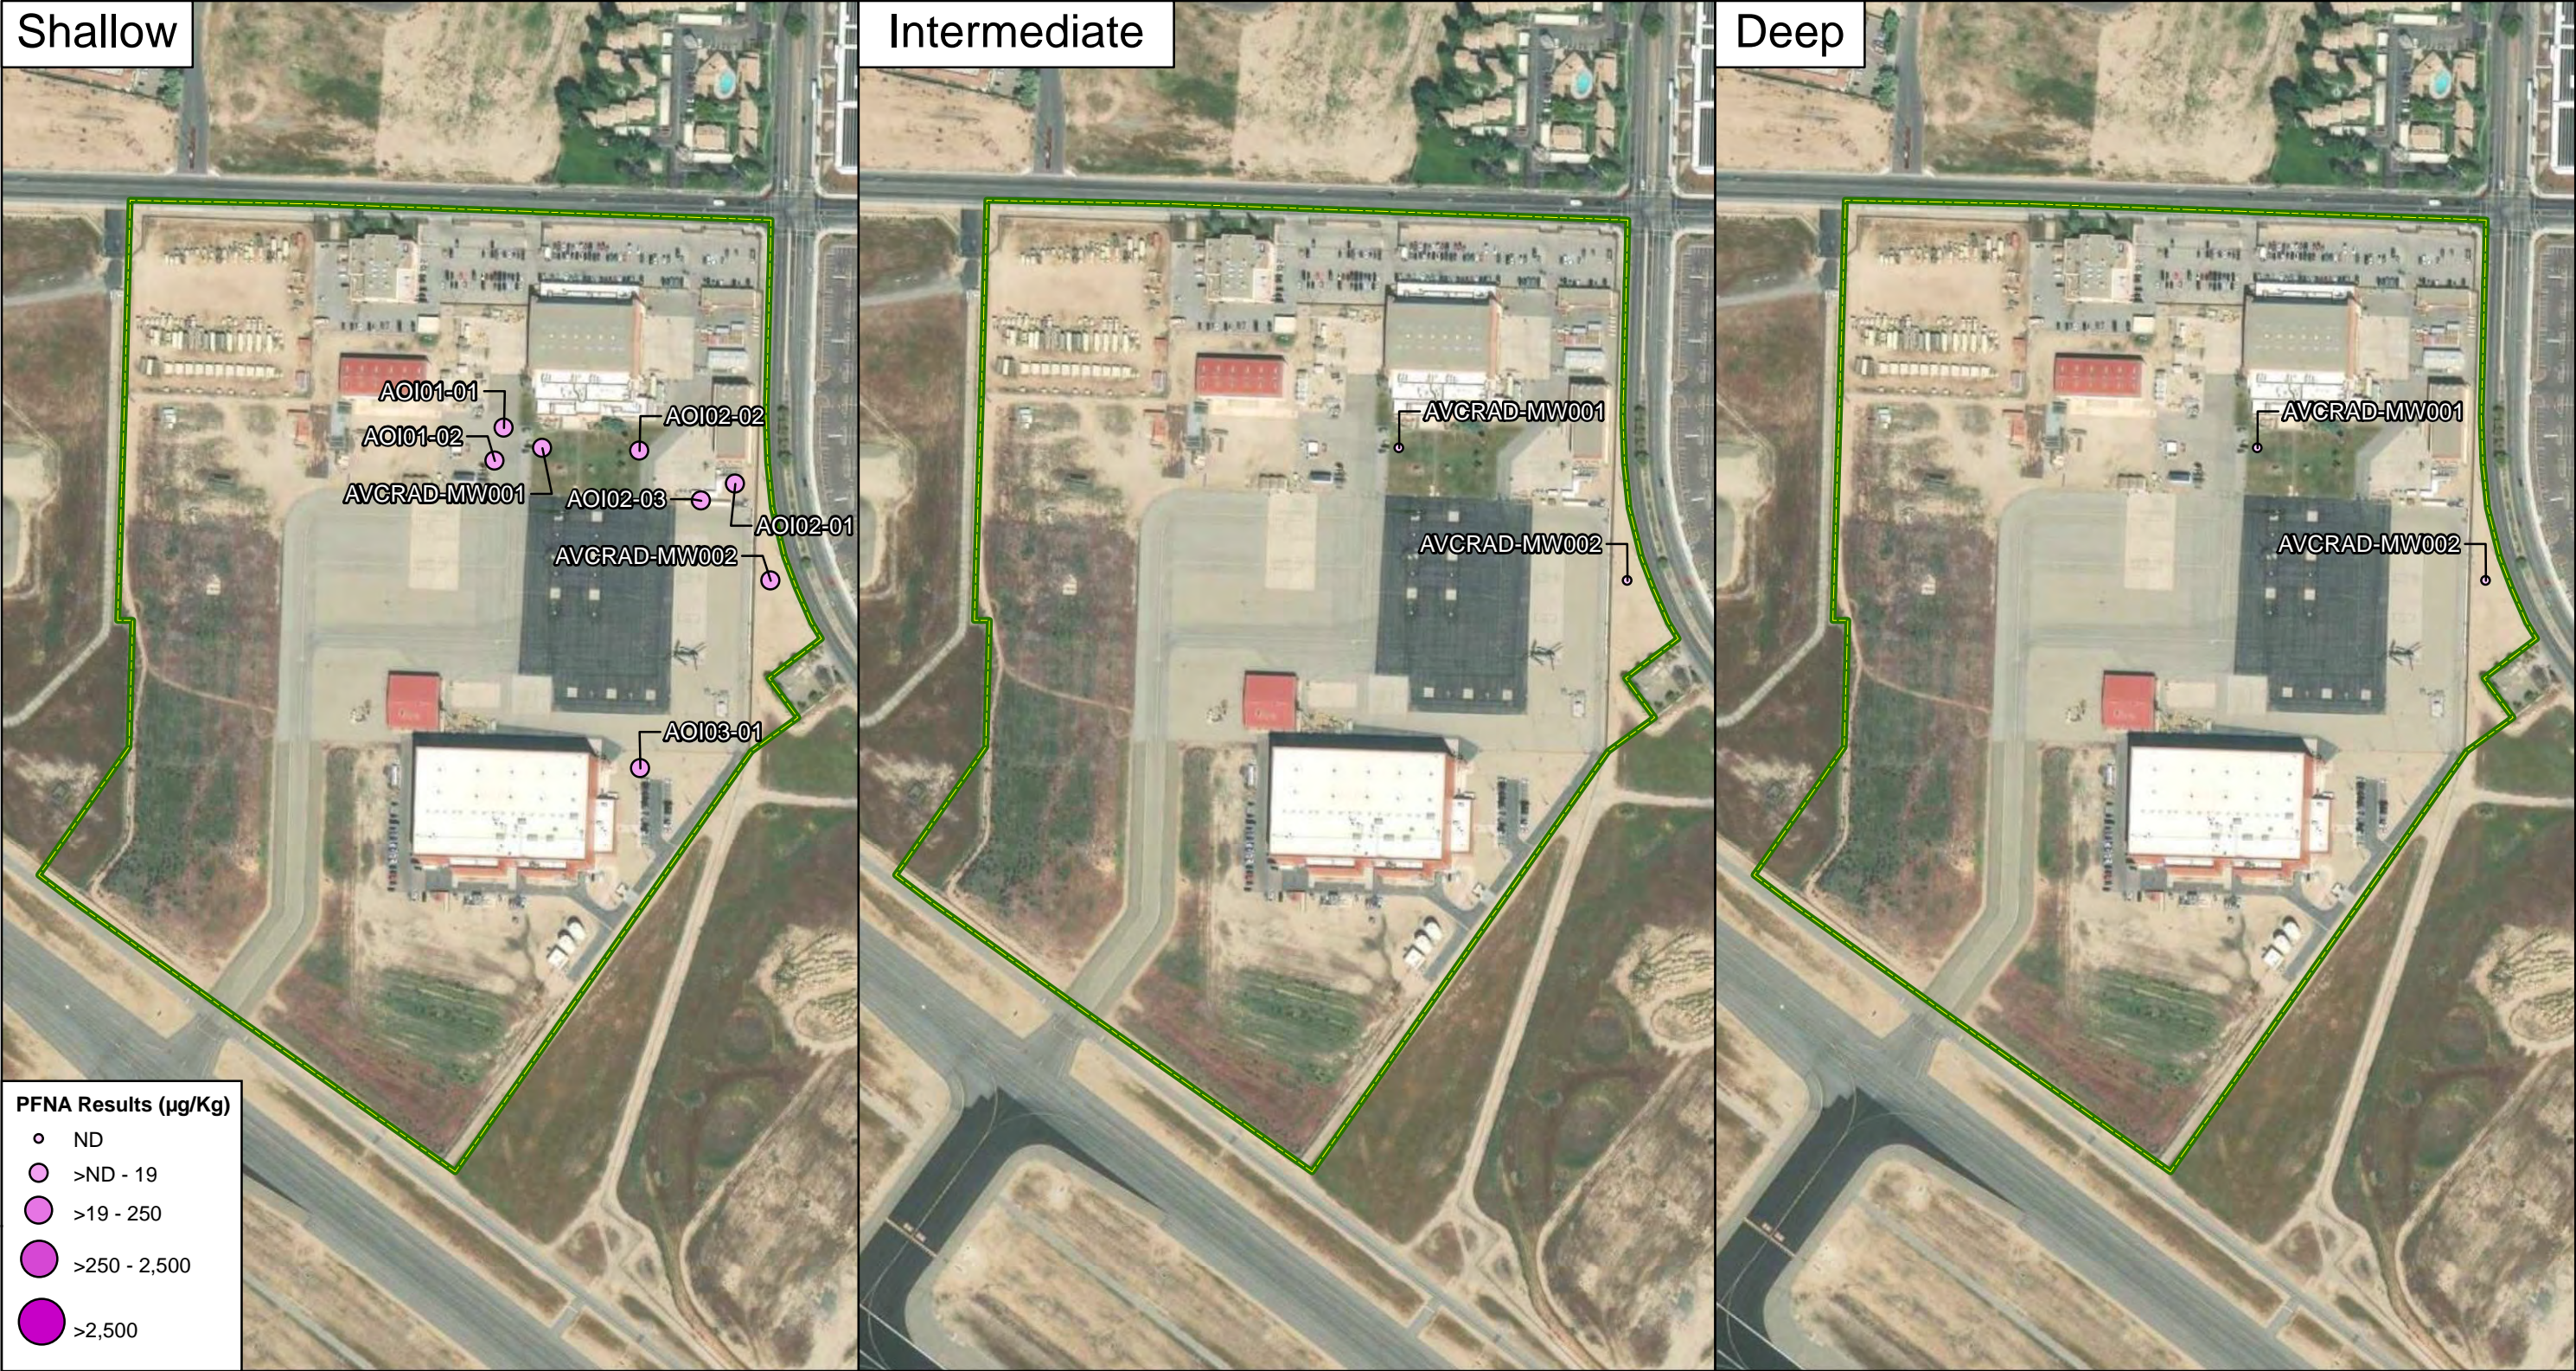
Figure 6-5

Exceedances of the OSD SL are depicted with a yellow halo.
Depth intervals shown represent respective sampling position within a given soil boring location.
