# FINAL Site Inspection Report Army Aviation Support Facility Stockton, California

Site Inspection for Perfluorooctanoic acid (PFOA),  
Perfluorooctanesulfonic acid (PFOS), Perfluorohexanesulfonic  
acid (PFHxS), Perfluorononanoic acid (PFNA),  
Hexafluoropropylene oxide dimer acid (HFPO-DA), and  
Perfluorobutanesulfonic acid (PFBS) at ARNG Installations,  
Nationwide

November 2023

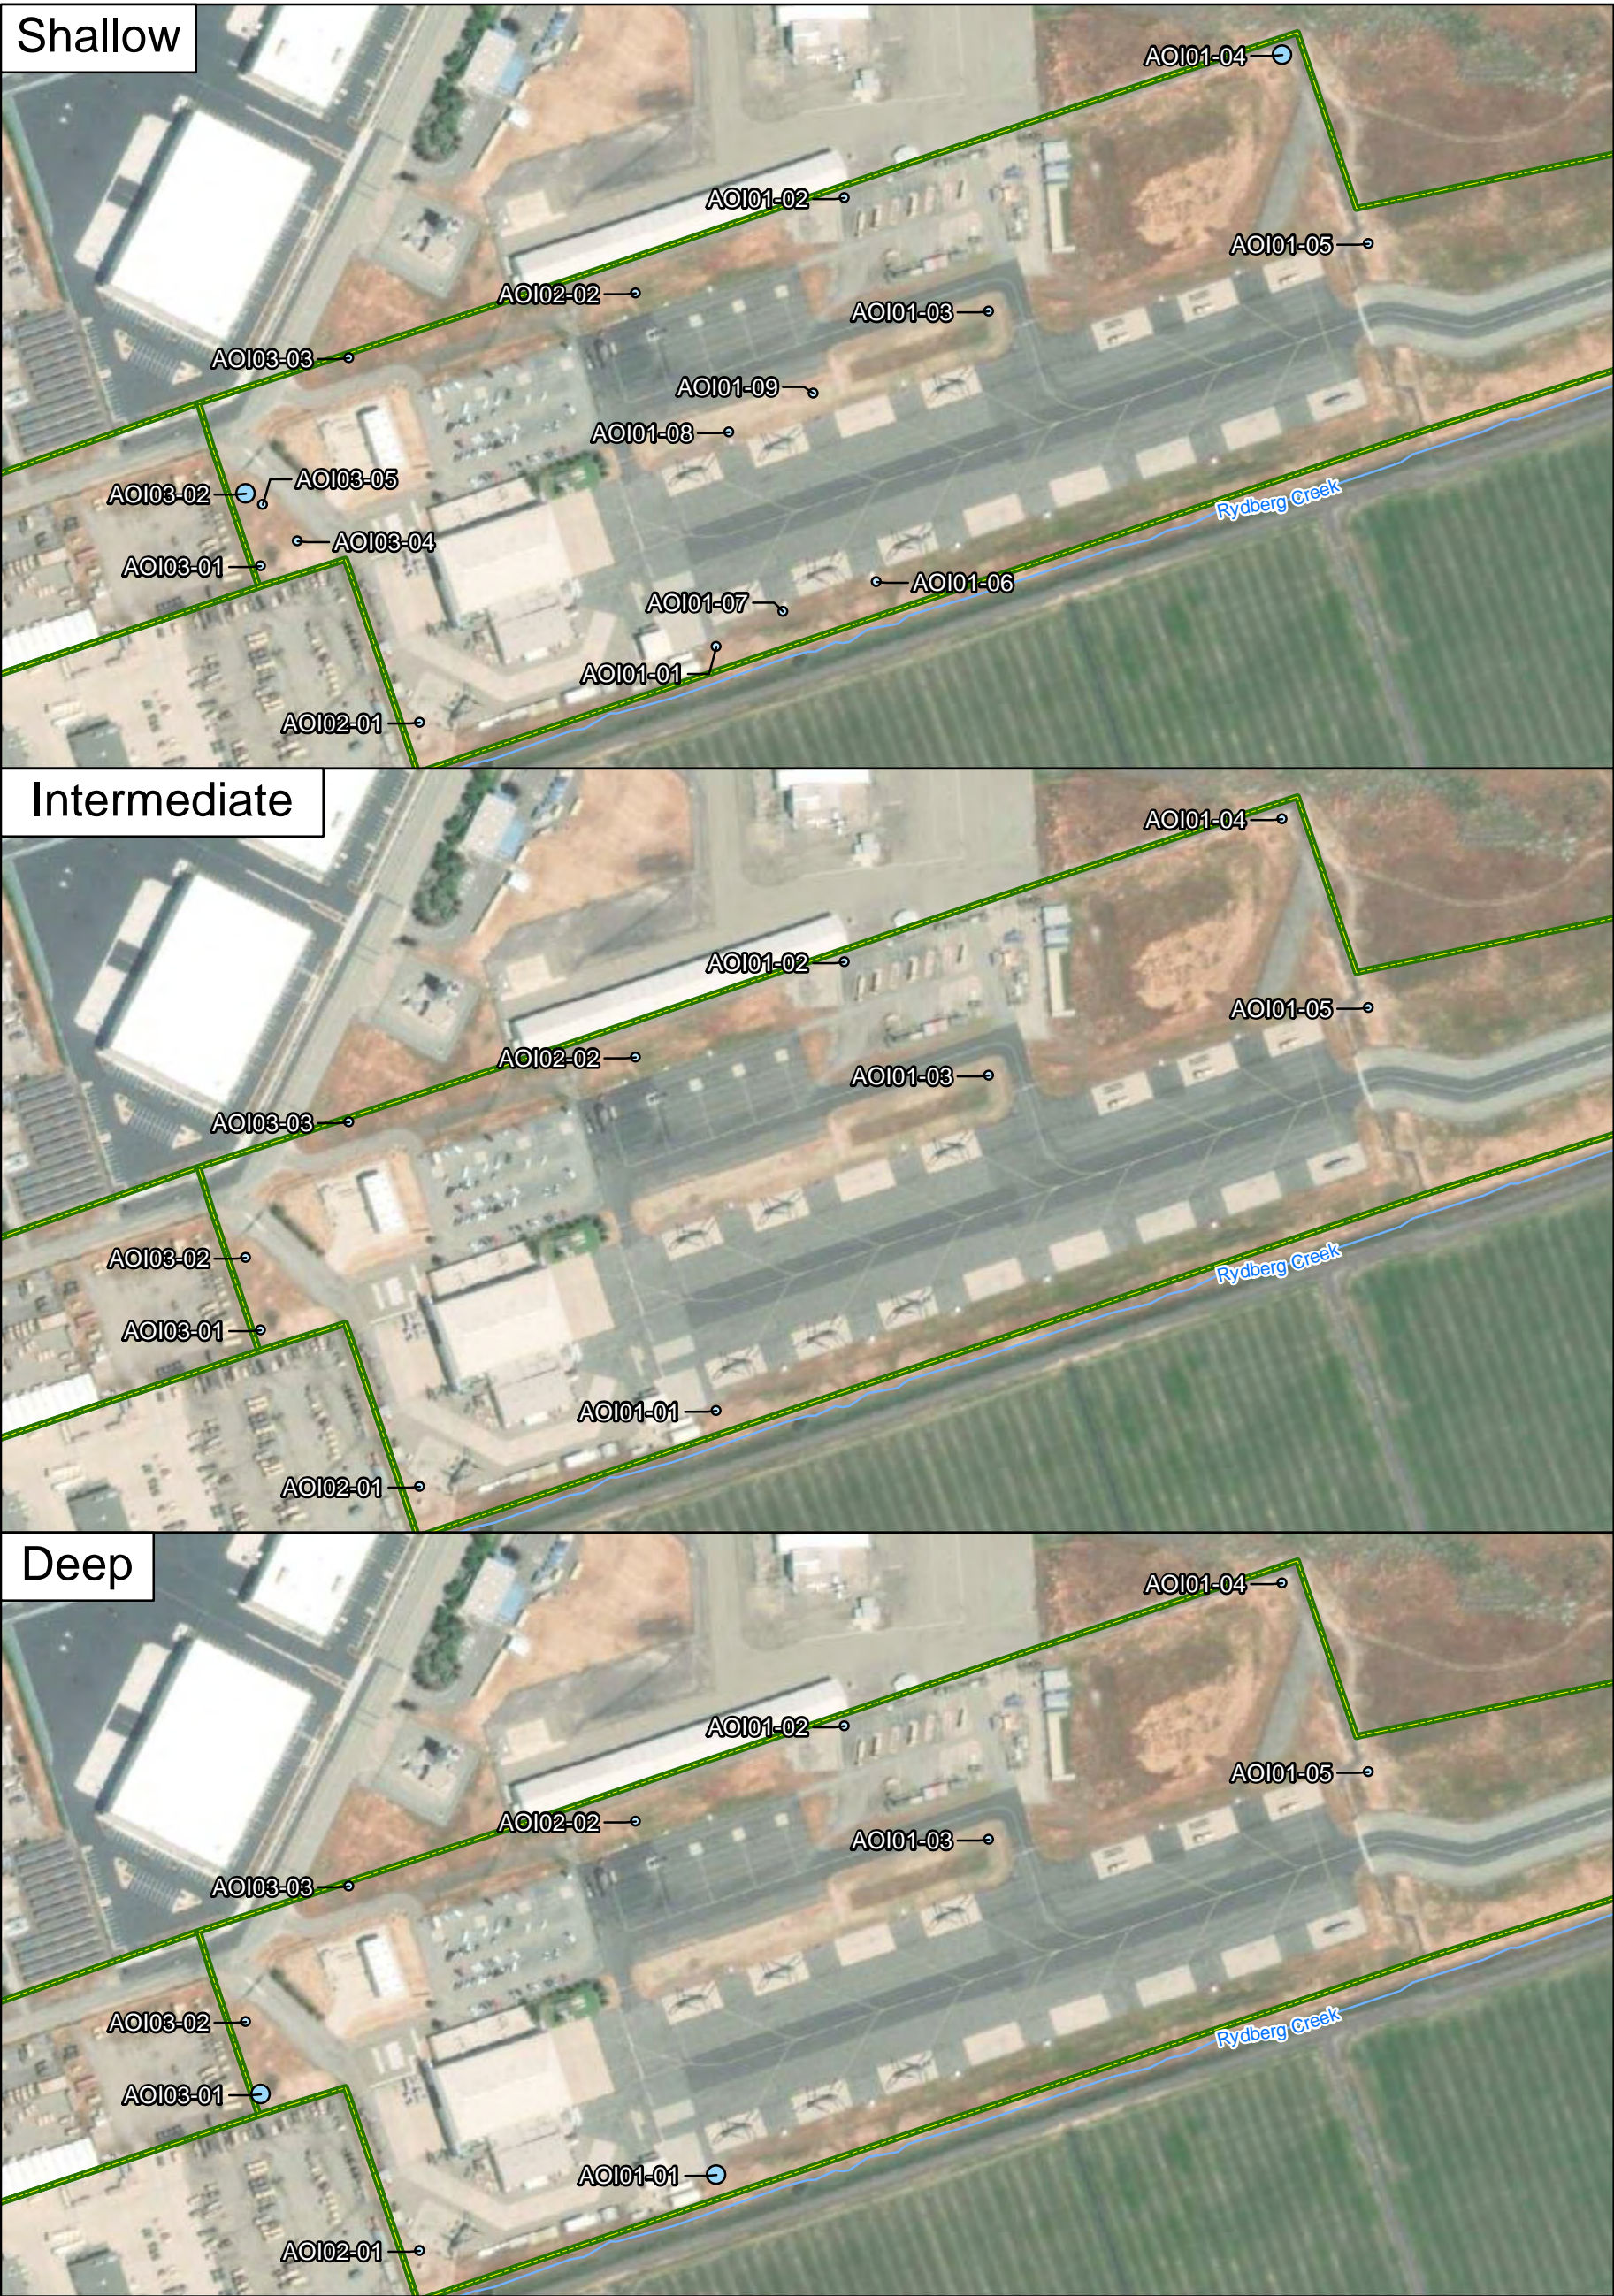
**Figure 6-3**

**Depth Intervals\***  
Shallow = 0-2 ft bgs  
Intermediate = 18-22 ft bgs  
Deep = 38-44 ft bgs

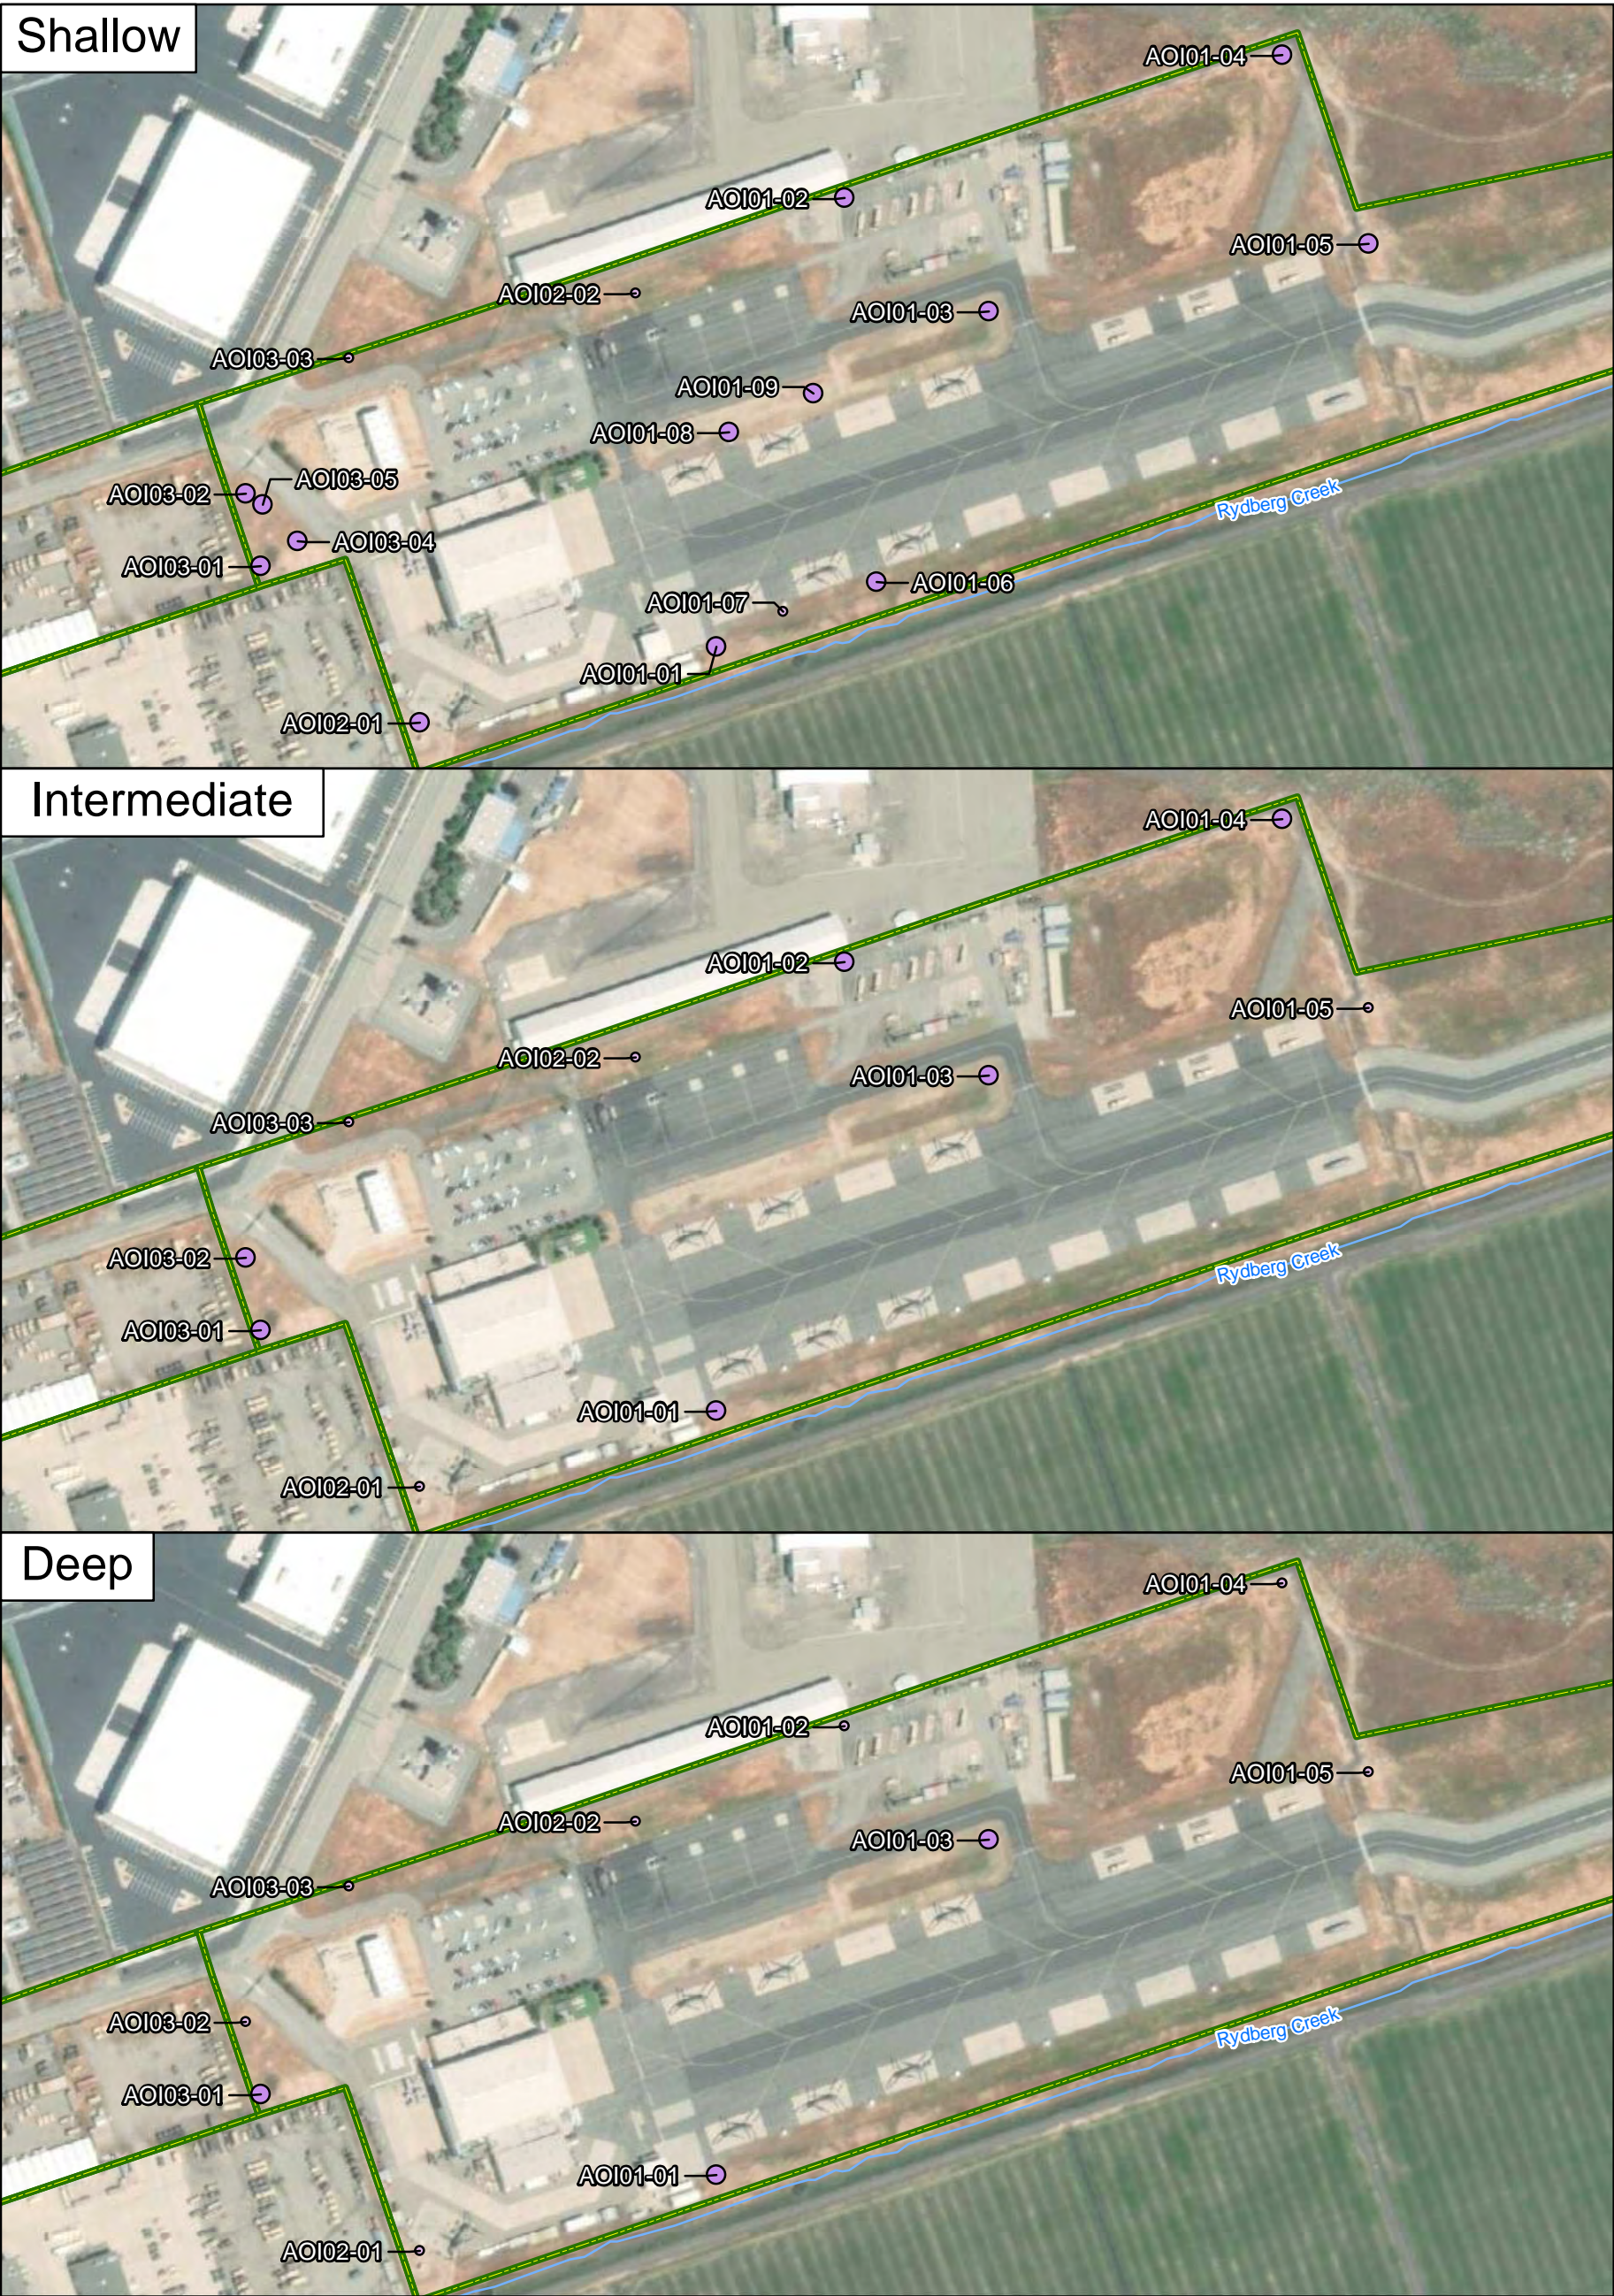
**Figure 6-4**

**Depth Intervals\***  
Shallow = 0-2 ft bgs  
Intermediate = 18-22 ft bgs  
Deep = 38-44 ft bgs

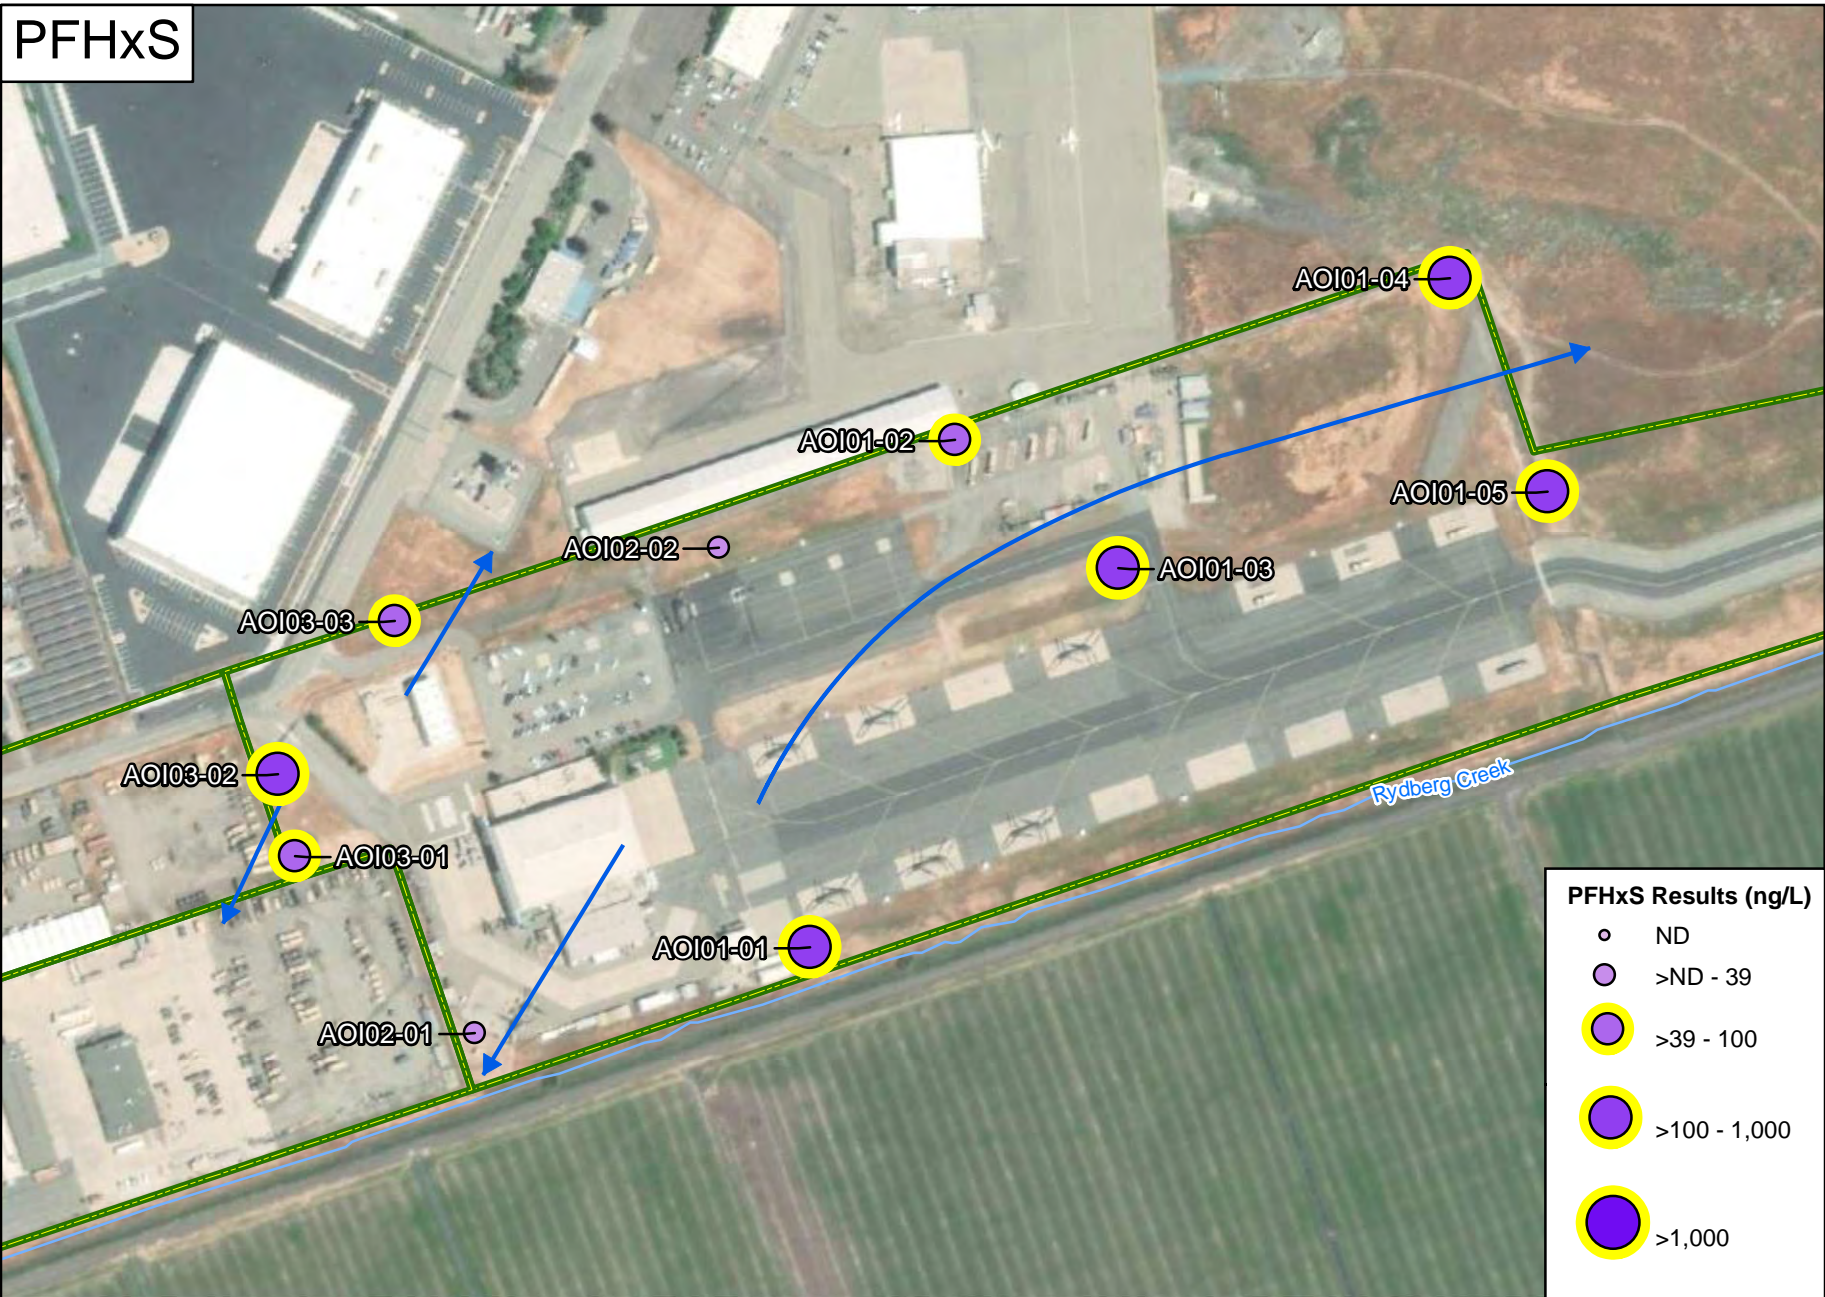
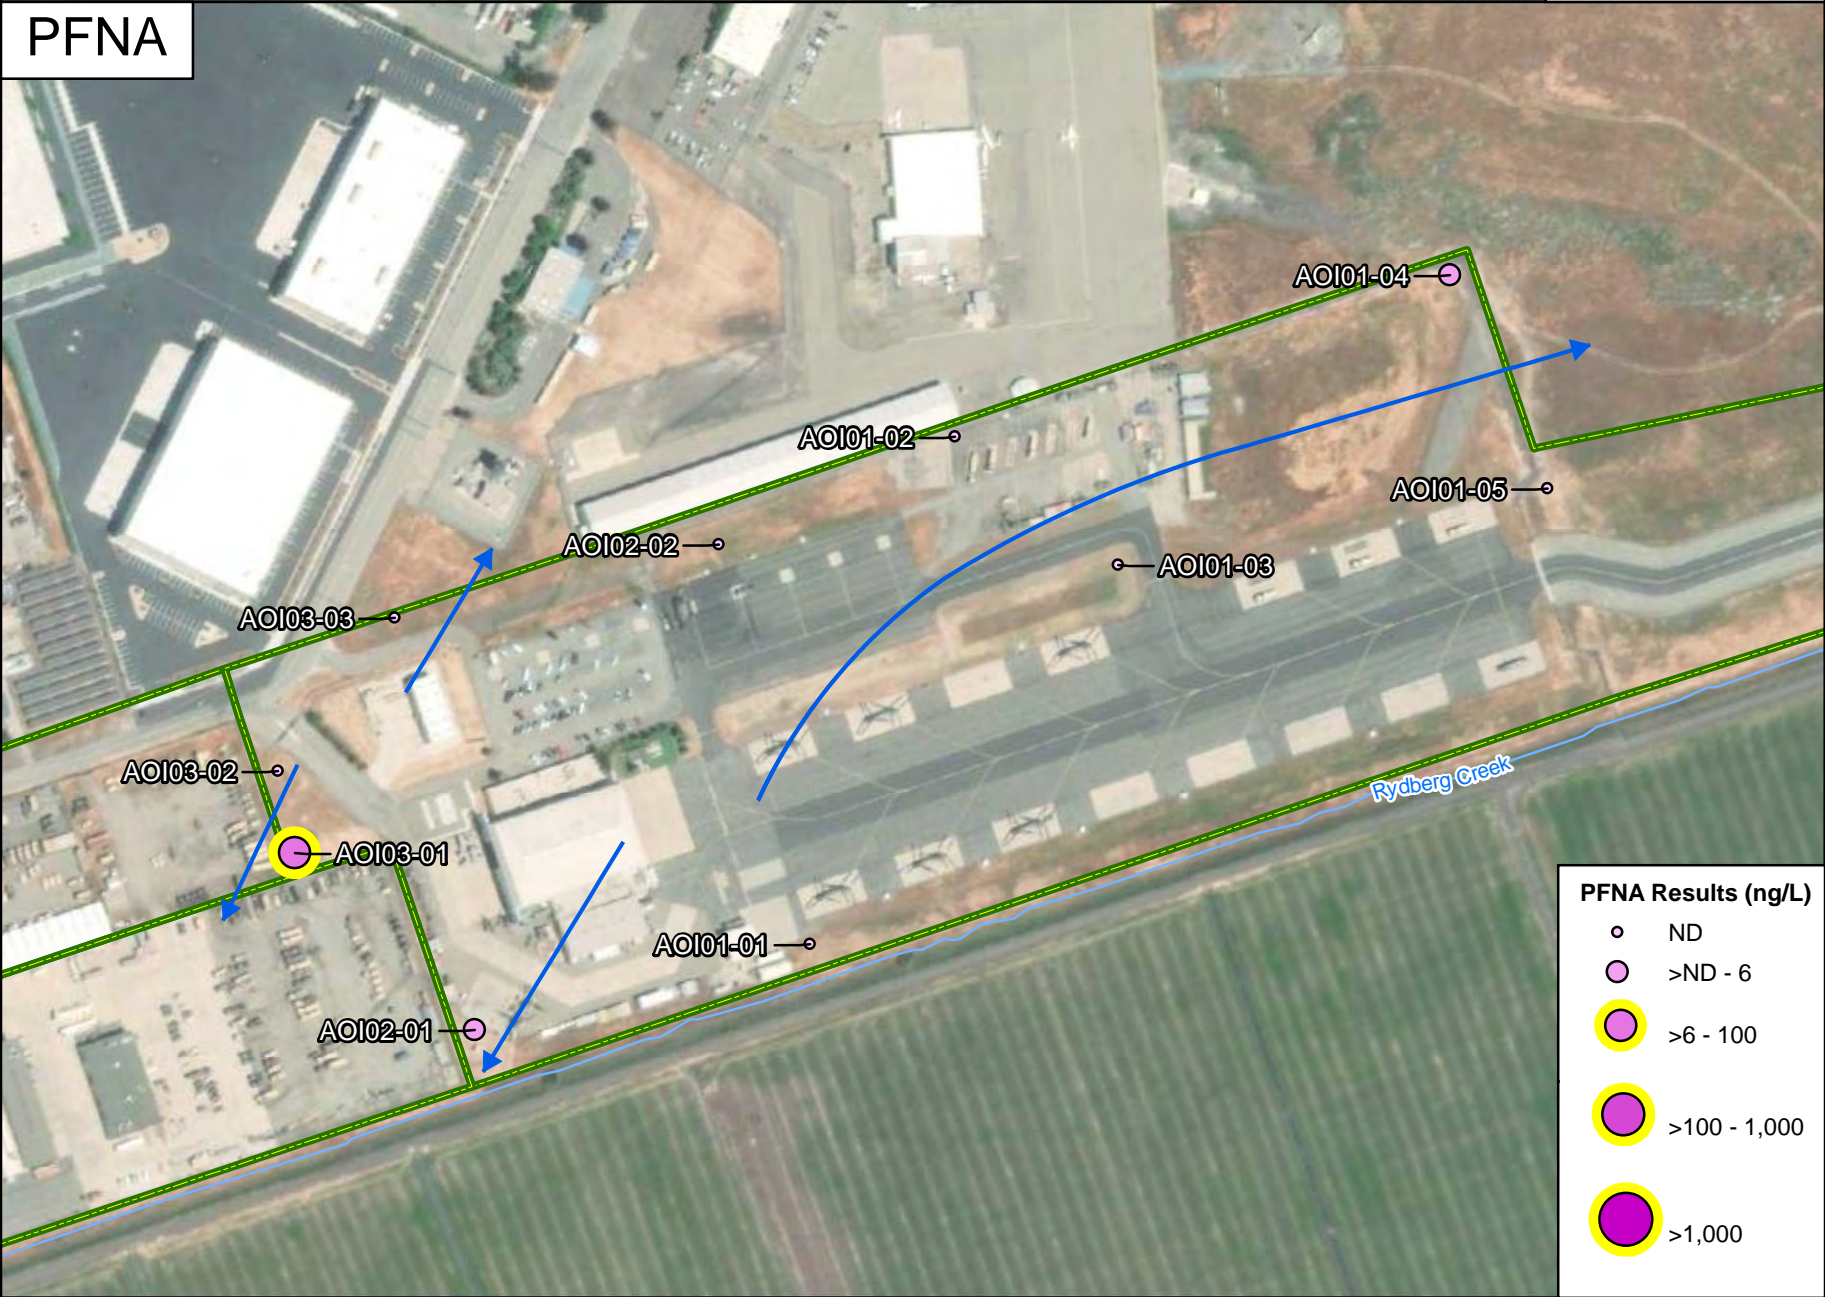
**Figure 6-6** and **Figure 6-7** present the ranges of detections in groundwater. **Table 6-4** summarizes the groundwater results.

PFHxS

PFNA
