Final Preliminary Assessment Report 1109th TASMG-Groton, Groton, Connecticut

Perfluorooctanesulfonic Acid (PFOS) and Perfluorooctanoic Acid
(PFOA) Impacted Sites
ARNG Installations, Nationwide

June 2020

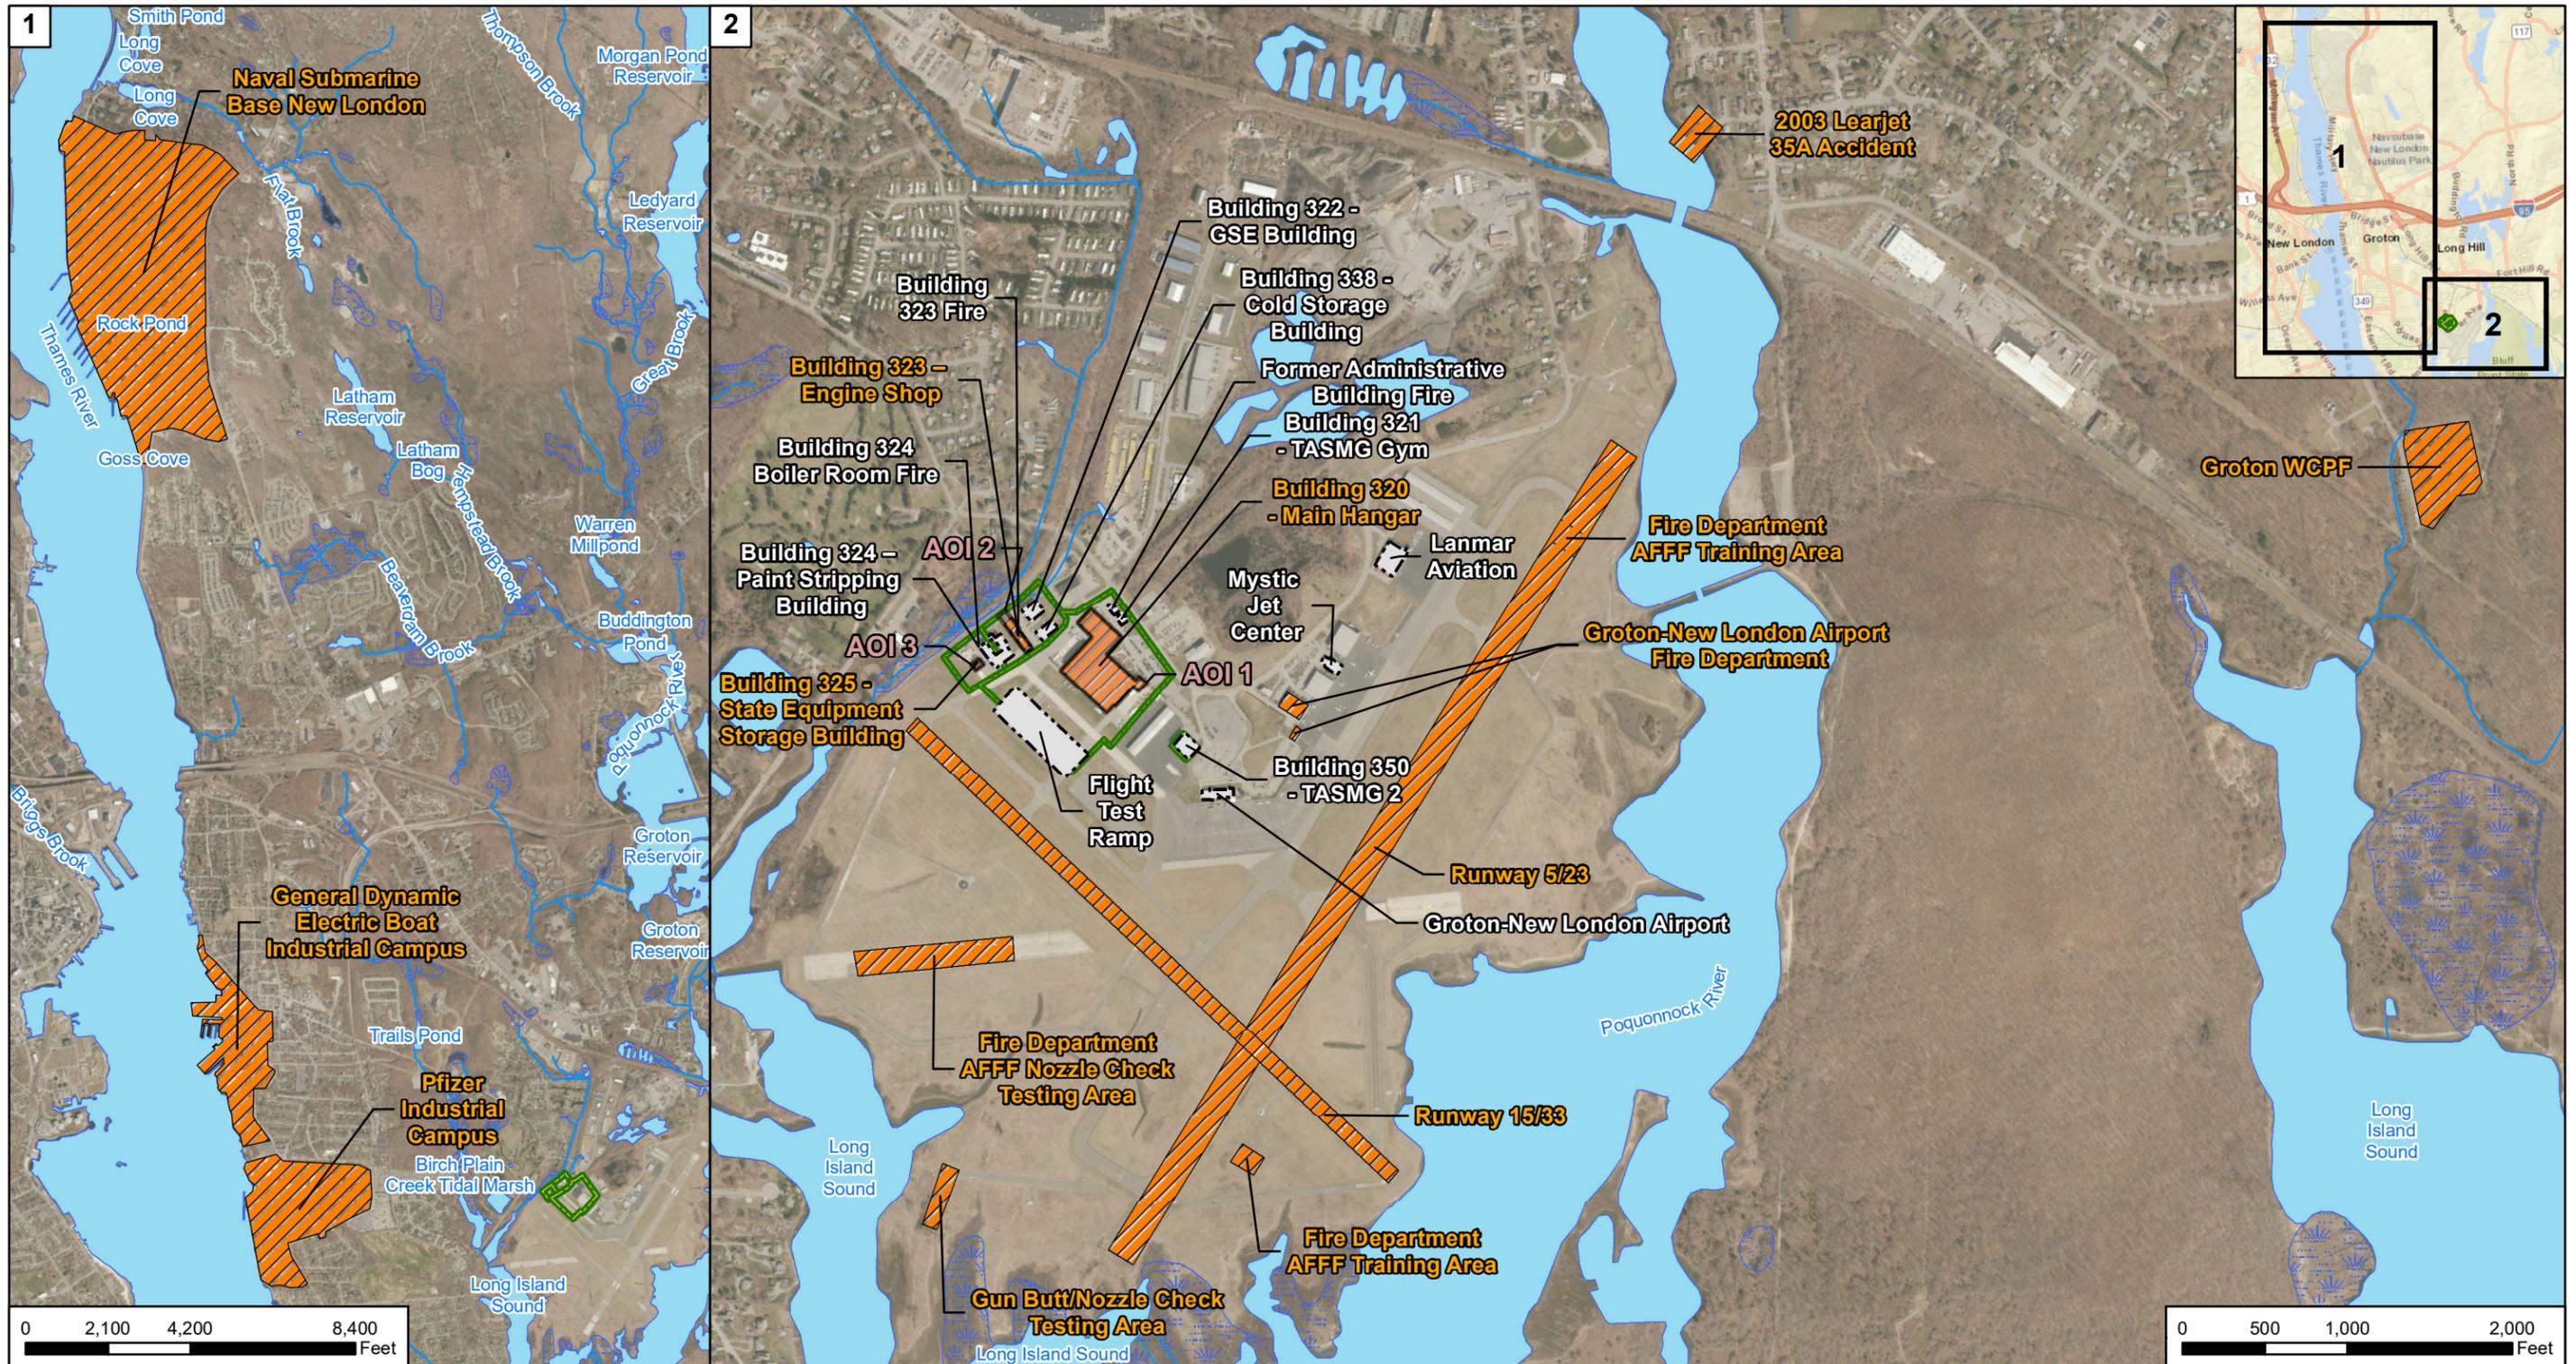
Figure ES-1

Three AOIs related to potential PFAS release were identified at TASMG-Groton based on PA data (**Figure ES-1**) and are summarized in **Table ES-1** below:

Summary of Findings

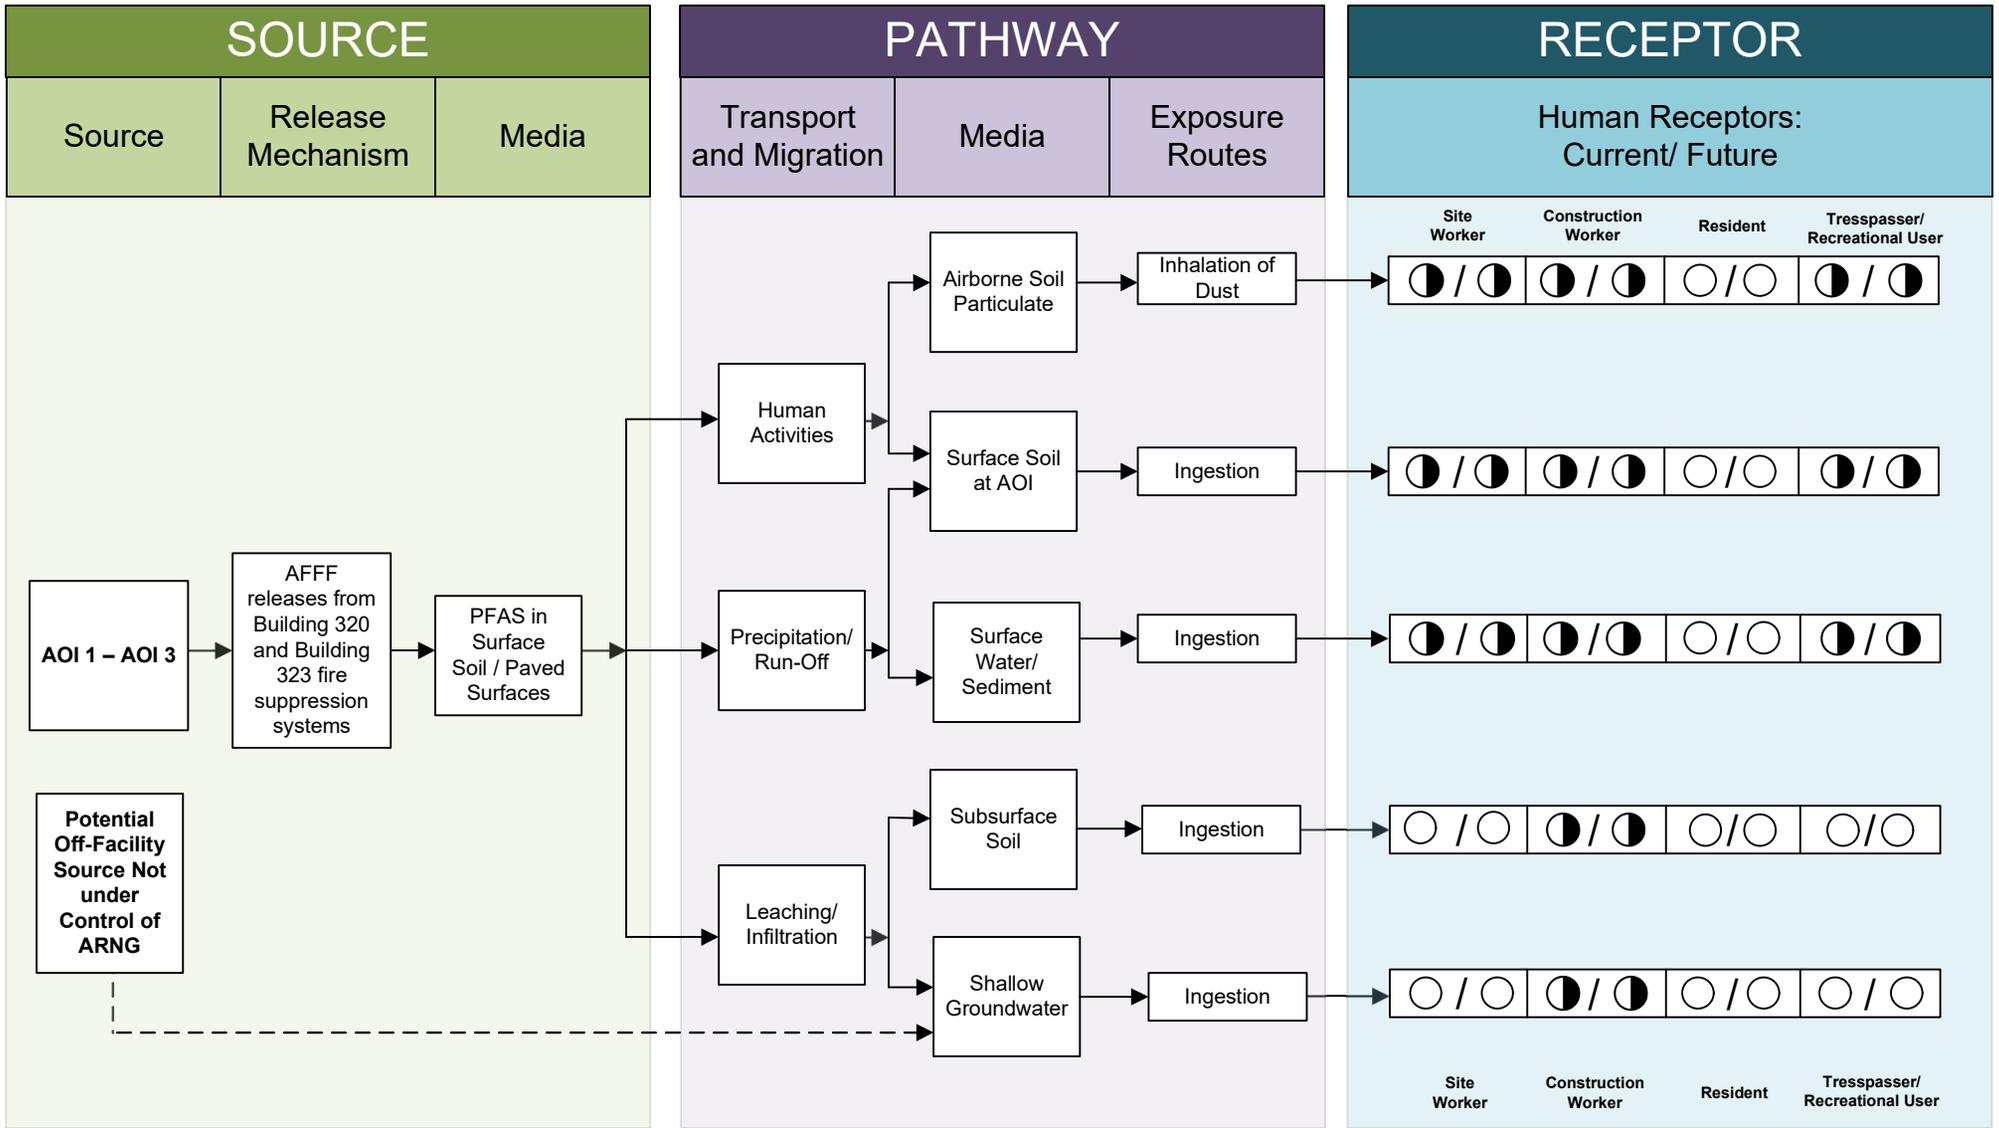
Figure ES-2
 Preliminary Conceptual Site Model
 TASMG-Groton, CT

Based on the possible PFAS releases at the AOIs, there is potential for exposure to PFAS contamination in environmental media at the facility to site workers, construction workers, trespassers and off-facility recreational users of the surrounding water bodies. The preliminary CSM for TASMG-Groton, which presents the potential receptors and media impacted, is shown on **Figure ES-2**.

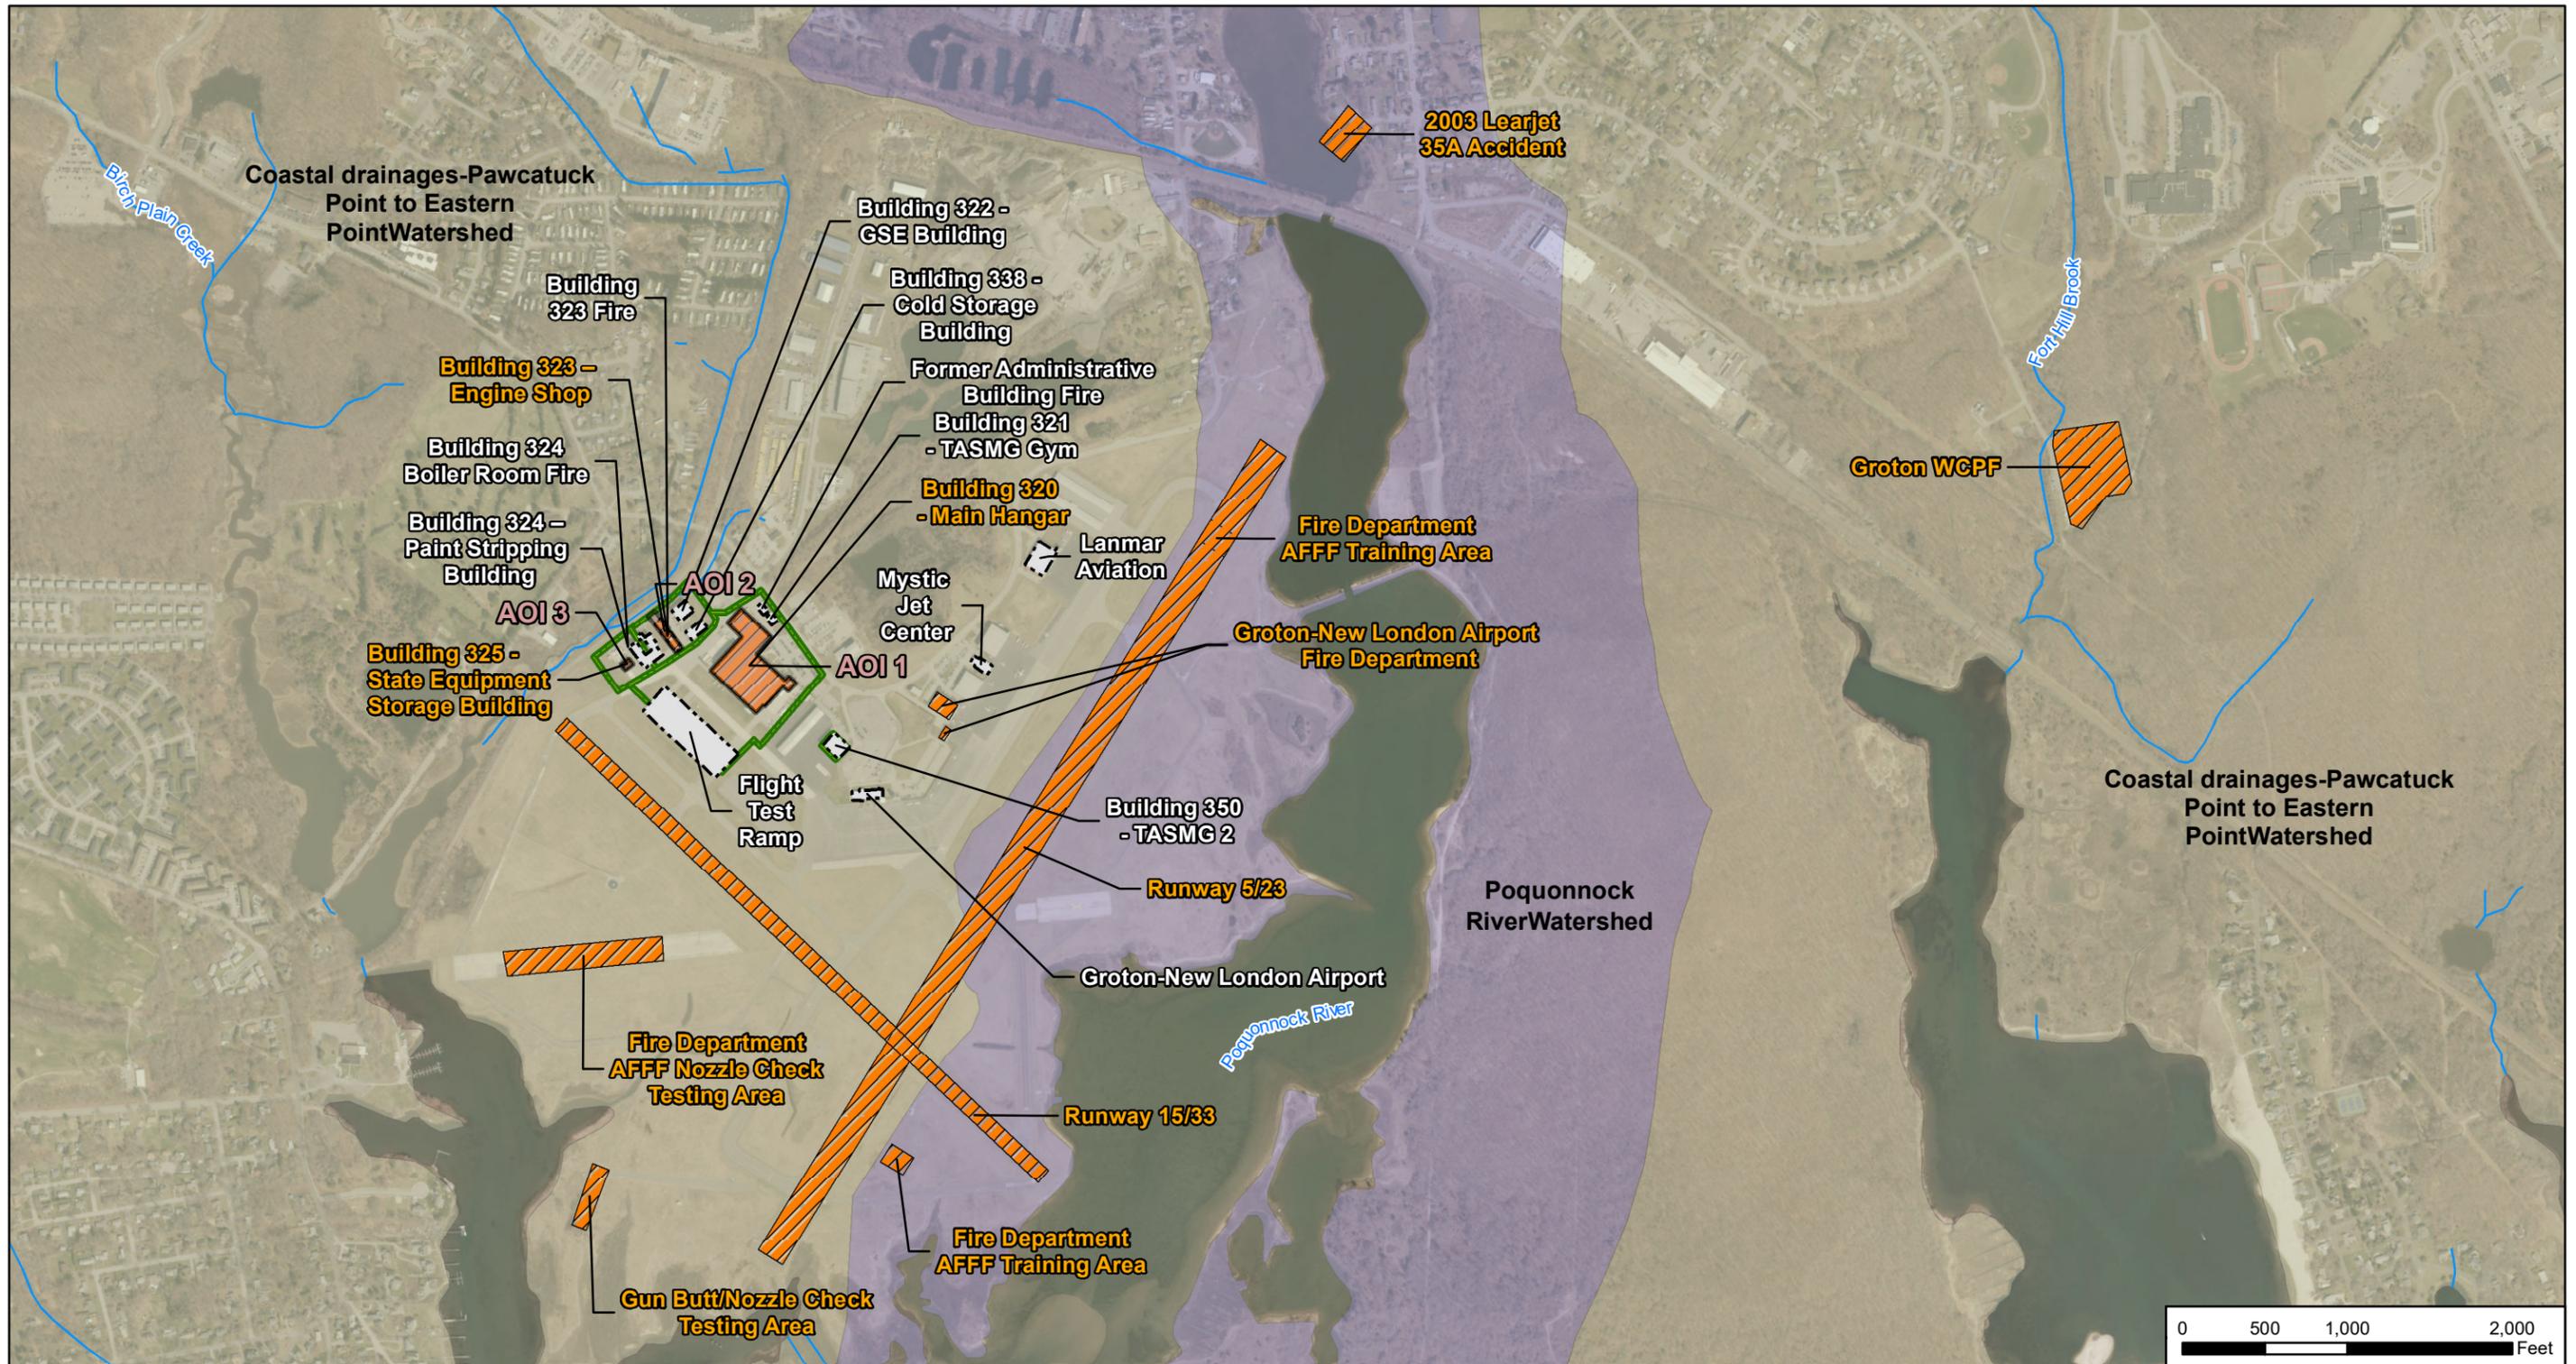
Figure 6-1

Based on the PA findings, two AOIs were identified at TASMG-Groton: AOI 1 Building 320 and AOI 2 Building 323. The AOI locations are shown on **Figure 6-1**. The following sections describe the CSM components and the specific preliminary CSM developed for each AOI. The CSM identifies the three components necessary for a potentially complete exposure pathway: (1) source, (2) pathway, (3) receptor. If any of these elements are missing, the pathway is considered incomplete.

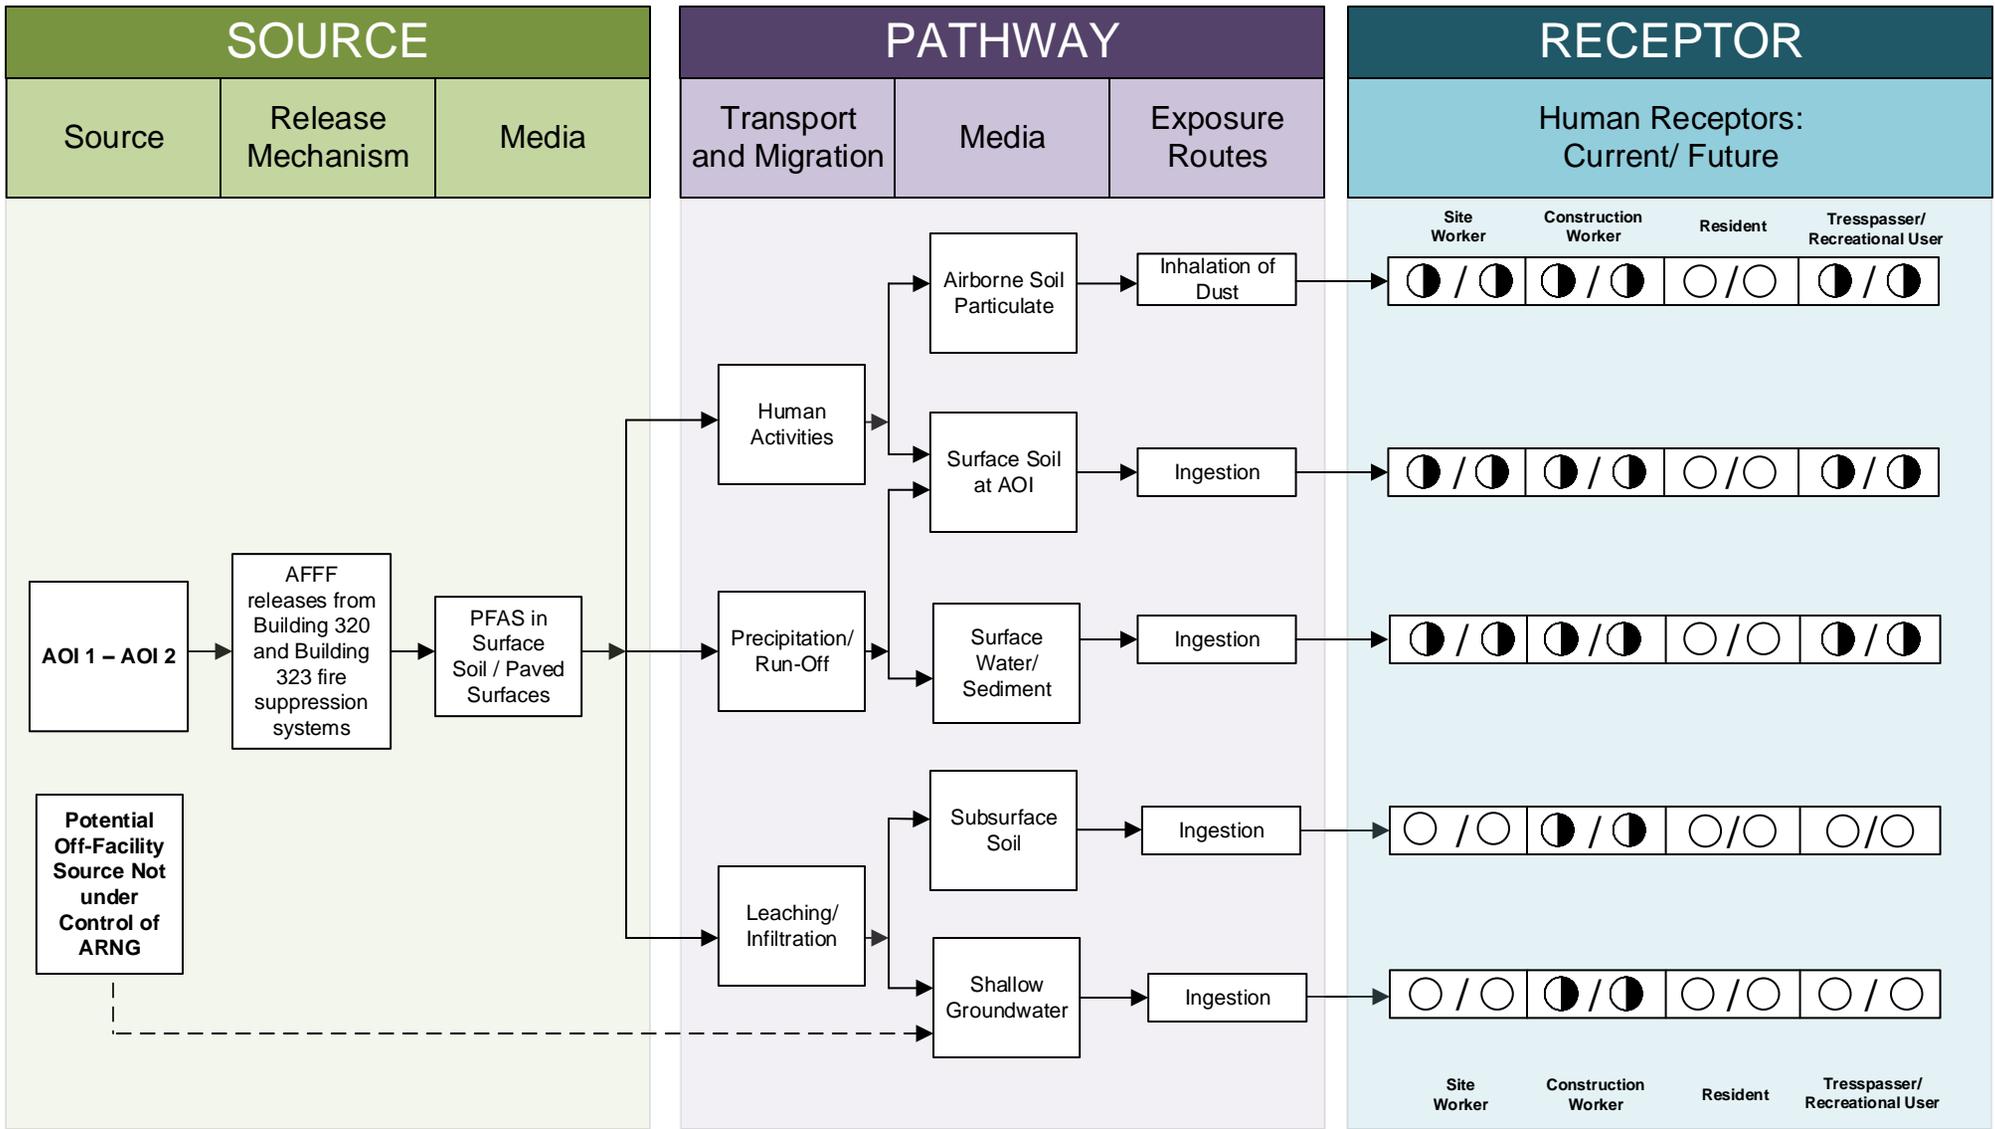
Figure 6-2
 Preliminary Conceptual Site Model
 AOI 1 (Building 320) – AOI 2 (Building 323)

AFFF releases at AOI 1 may also have infiltrated subsurface soil via cracks in pavement, joints between areas that are paved with different materials, and the nearby landscaped areas. If AFFF released at the AOI infiltrated the subsurface, then ground-disturbing activities may result in PFAS exposure to construction workers via ingestion and inhalation. Accidental ingestion of groundwater is also considered a potentially complete pathway for exposure to PFAS during construction activities due to the presumed 8- to 9-foot depth to groundwater. The preliminary CSM diagram for AOI 1 is shown in **Figure 6-2**.

AFFF releases at AOI 2 may also have infiltrated subsurface soil in the landscaped and wooded areas. As such, ground-disturbing activities may result in PFAS exposure to construction workers via ingestion and inhalation. Accidental ingestion of groundwater during construction is also considered a potentially complete pathway. The preliminary CSM diagram for AOI 2 is shown in **Figure 6-2**.

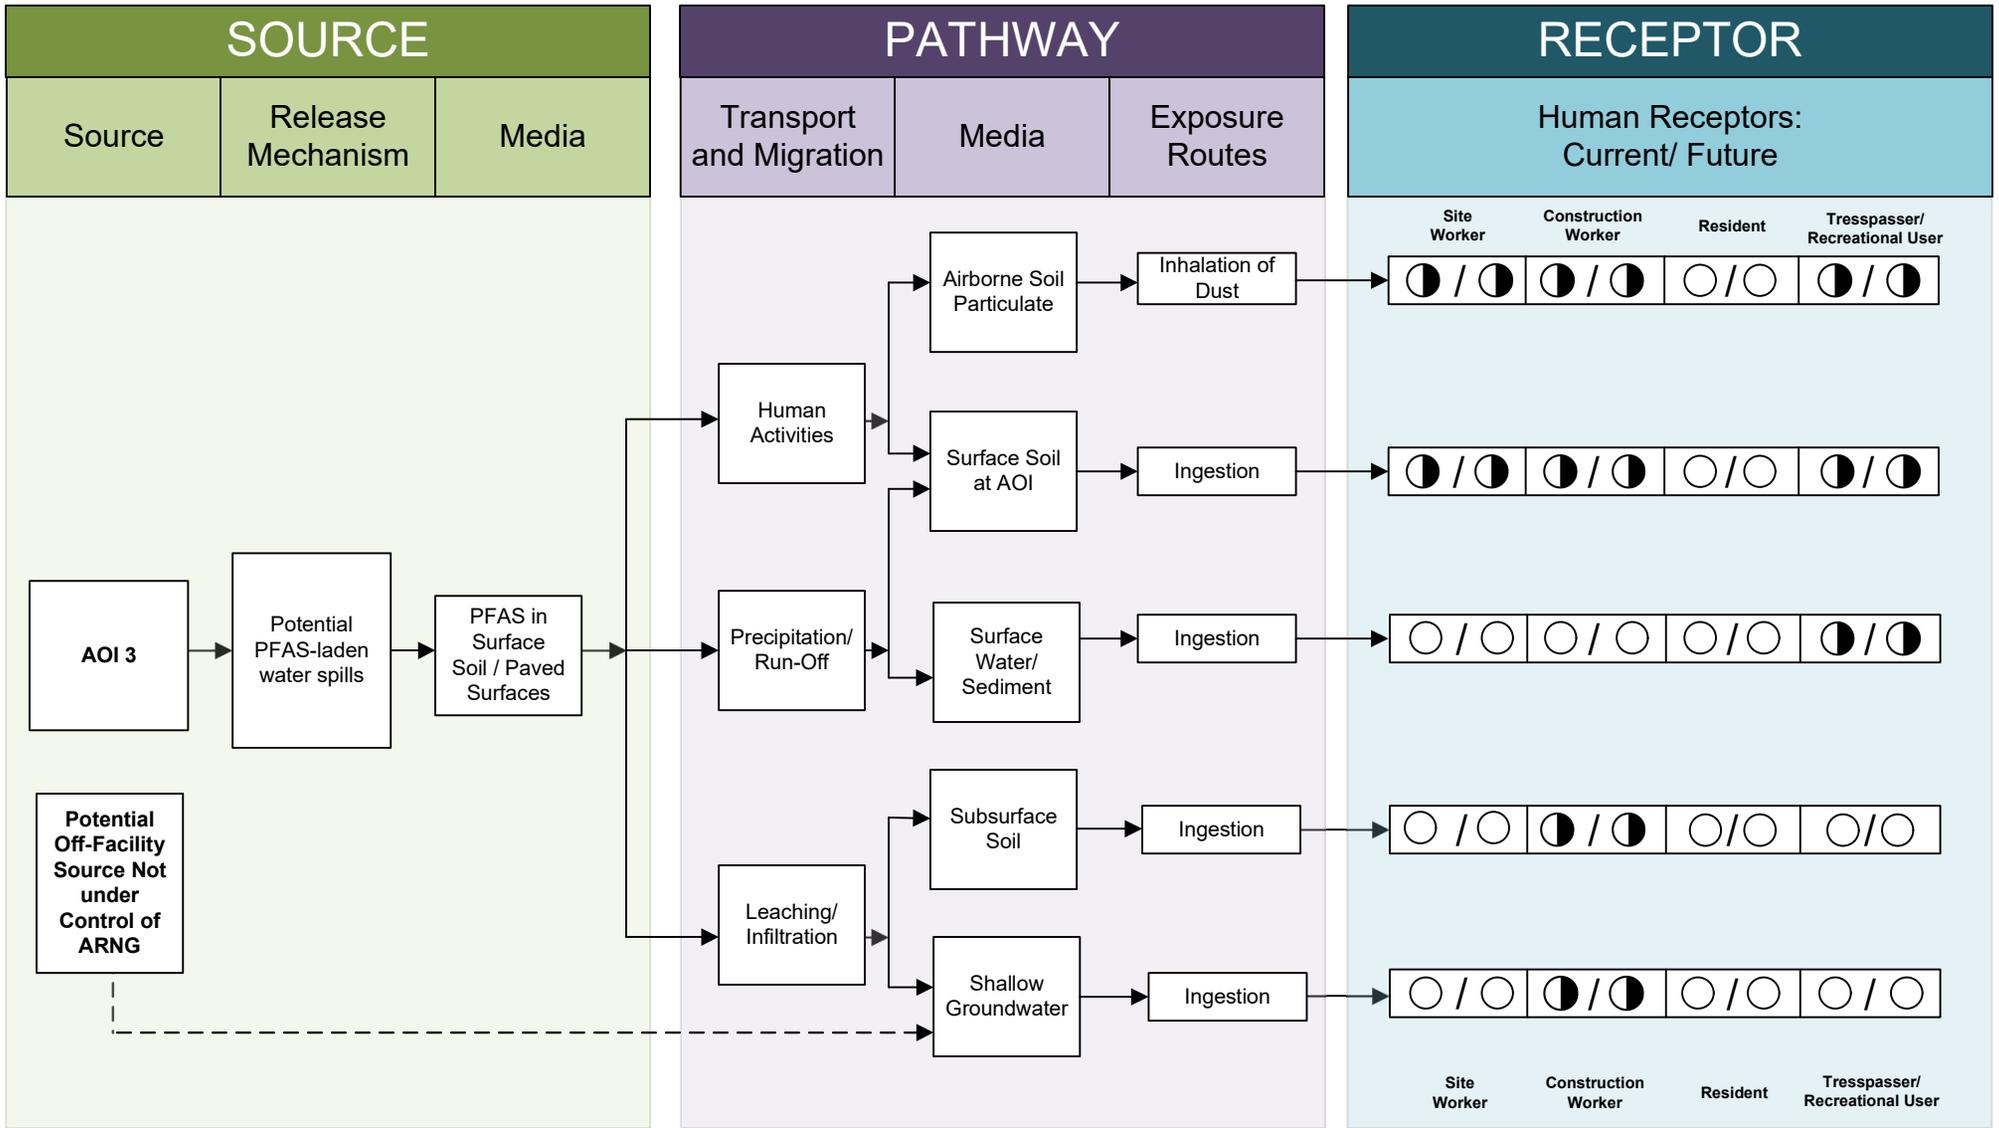
Surface soil surrounding AOI3 may have received surface water runoff containing PFAS. As such, it is considered a potentially complete pathway for PFAS exposure to site workers, construction workers, and trespassers via ingestion and inhalation. Additionally, ground-disturbing activities may result in PFAS exposure to construction workers via ingestion and inhalation of subsurface soil, and ingestion of groundwater. The preliminary CSM diagram for AOI 3 is shown in **Figure 6-3**.

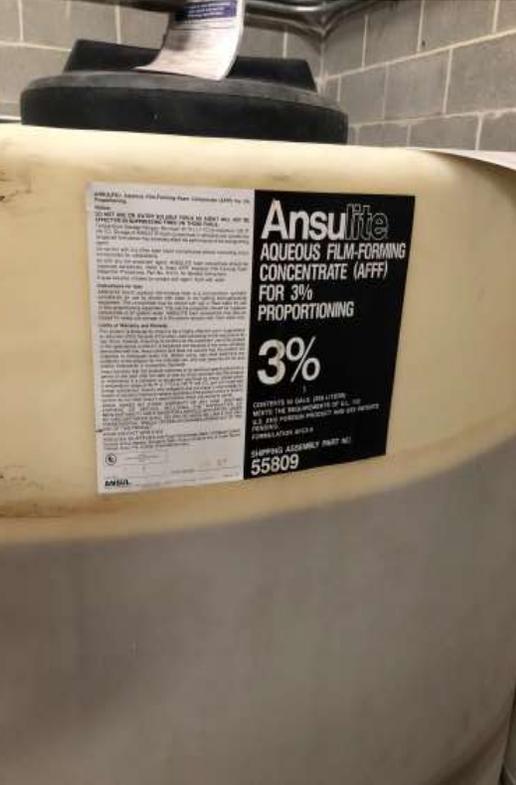
Photograph No. 1

Date 12/10/2019 Time 11:10	
Description: 5,000-gallon tank of Ansu-lite 3% AFFF concentrate stored in the tank room within Building 320.	
Orientation: NA

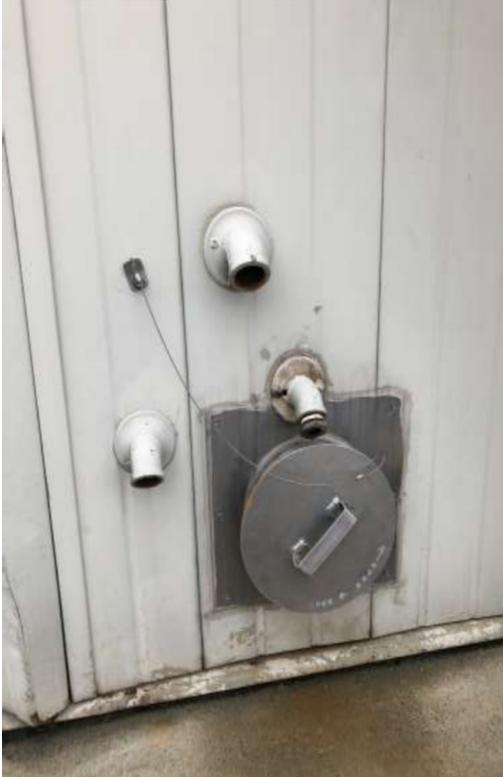
Photograph No. 2

Date 12/10/2019 Time 11:37	
Description: Nested AFFF system test ports used during the quarterly system testing of Building 320.	
Orientation: Northwest

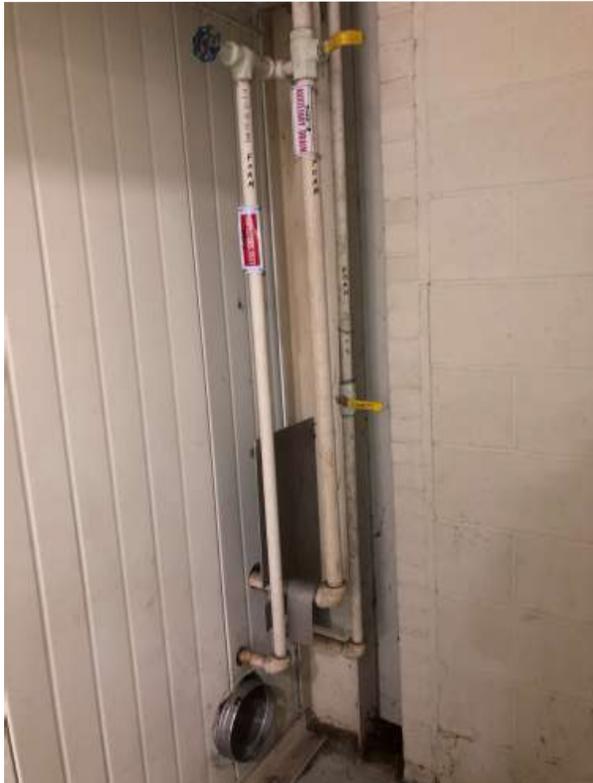
Army National Guard, Preliminary Assessment for PFAS	TASMG-Groton	Groton, Connecticut
<p>Photograph No. 3</p> <p>Date 12/10/2019 Time 11:39</p> <p>Description: Piping supporting AFFF system test ports at Building 320 used during the quarterly system testing. "Foam" labels visible on system piping.</p> <p>Orientation: East</p>

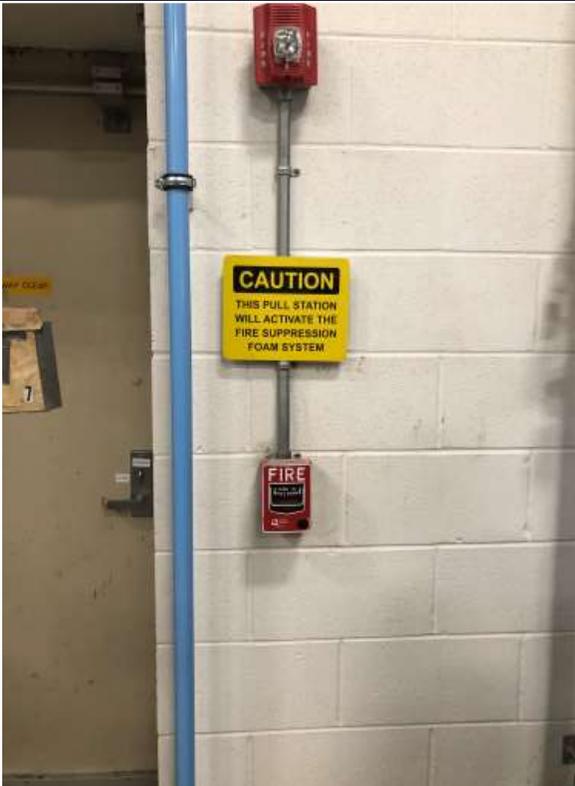
The first AFFF system release occurred between 2010 and 2012, when a contractor accidentally triggered the water suppression system, covering the building interior in rust-colored water. During cleanup, a contractor power washing the walls accidentally sprayed the AFFF system trigger and released the full 270-gallon AFFF system tank. According to staff present during the release, all of the building doors were closed, and the foam was guided towards the sanitary system drain at the center of the engine shop. The drain connects to an OWS that flows off-facility to the Groton WPCF and is located adjacent to the building. AFFF in the OWS was vacuumed out by a contractor and disposed of off-facility.

<p>Photograph No. 4</p> <p>Date 12/10/2019 Time 12:01</p> <p>Description: AFFF system release button in Building 323. This was accidentally triggered during the known AFFF system releases within the Engine Room.</p> <p>Orientation: Southwest</p>

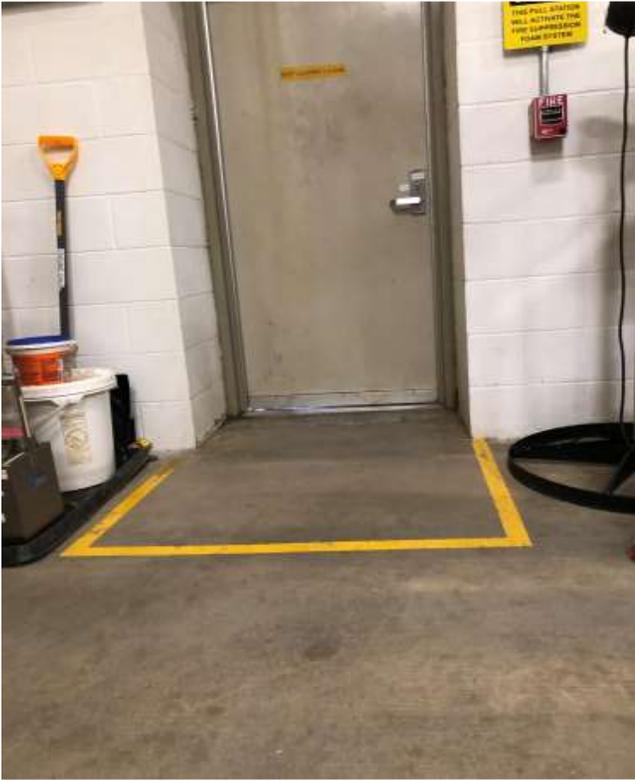
Army National Guard, Preliminary Assessment for PFAS	TASMG-Groton	Groton, Connecticut
<p>Photograph No. 5</p> <p>Date 12/10/2019 Time 12:09</p> <p>Description: Space visible between the floor and the bottom of the door in Engine Room in Building 323.</p> <p>Orientation: Northeast</p>

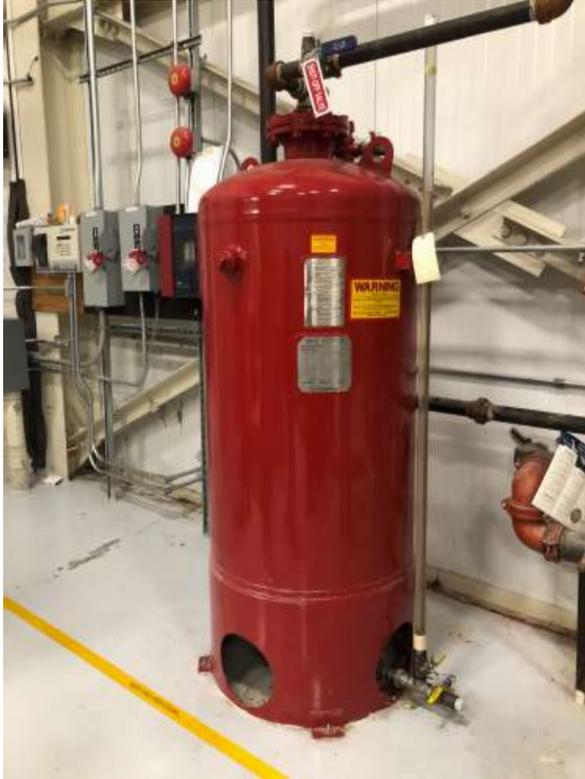
<p>A photograph showing a white door set in a white cinder block wall. The floor is concrete with a yellow rectangular safety line painted around the base of the door. There is a noticeable gap between the bottom of the door and the floor. To the left of the door, there are some white buckets and a blue-handled tool. To the right, there is a red fire alarm pull station and a yellow sign that reads 'THIS PULL STATION WILL ACTIVATE THE FIRE SUPPRESSION FOAM SYSTEM'.</p>	
<p>Photograph No. 6</p> <p>Date 12/10/2019 Time 12:10</p> <p>Description: 270-gallon AFFF concentrate tank stored in the Engine Room - Building 323.</p> <p>Orientation: Northeast</p>

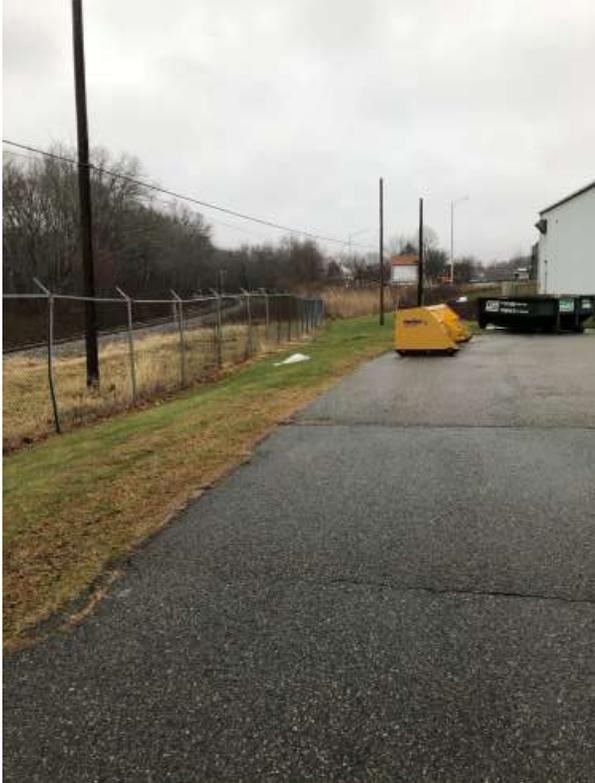
Photograph No. 7

Date 12/10/2019 Time 12:15	
Description: TASMG-Groton fence north of Building 323. Wetland visible in the foreground within the fenced area.	
Orientation: Northeast

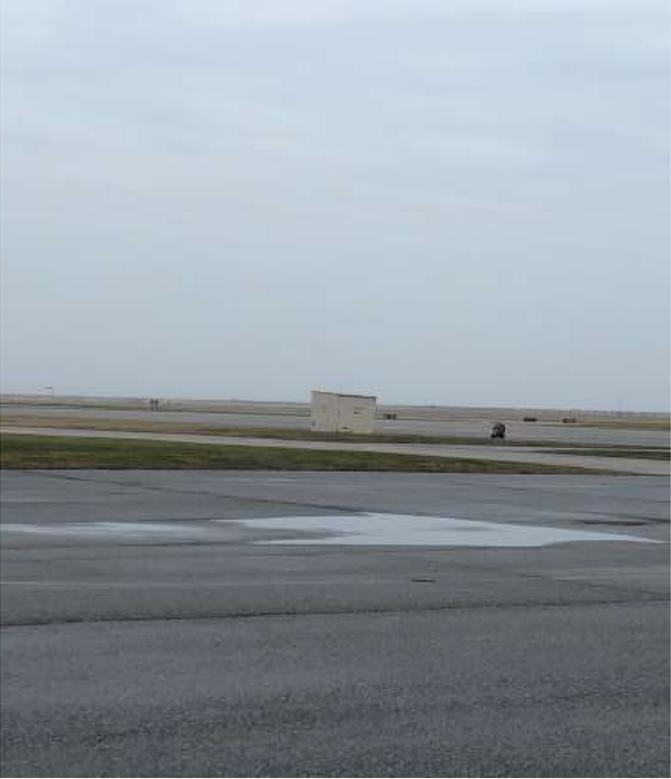
Photograph No. 8

A total of six to eight wheeled mobile fire extinguishers are staged between the Flight Test Ramp and a shed located on the ramp. The fire extinguishers contain Purple K extinguishant, which does not contain PFAS. According to interviewees, the Purple K fire extinguishers replaced extinguishers that contained Halon. It is unknown whether mobile fire extinguishers stored at TASMG-Groton have ever stored AFFF. No evidence indicates that any activities that may have resulted in PFAS releases to the environment have occurred at the Flight Test Ramp; the ramp is not considered a potential PFOS/PFOA release area.

Date 12/10/2019 Time 12:29	
Description: Mobile fire extinguisher staged on the Flight Ramp adjacent to a storage shed which is sometimes used to store more mobile fire extinguishers.	
Orientation: Southwest

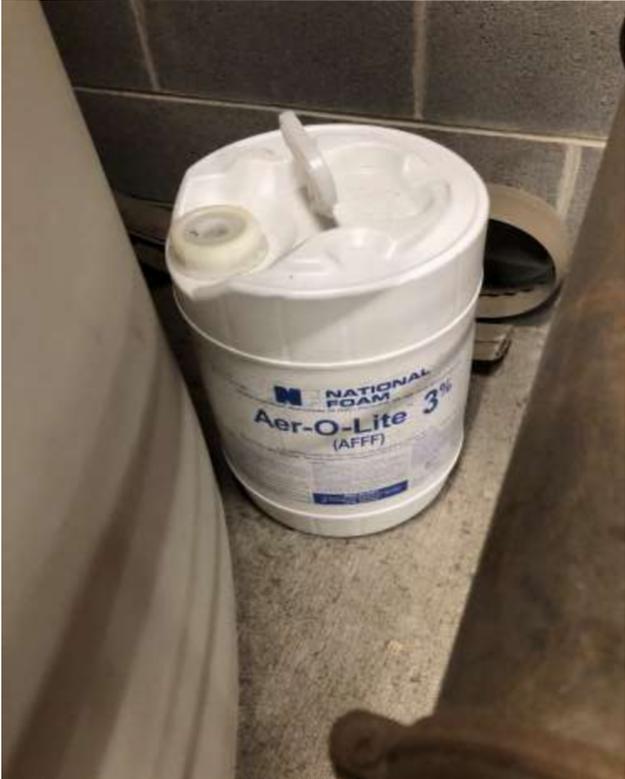
Army National Guard, Preliminary Assessment for PFAS	TASMG-Groton	Groton, Connecticut
<p>Photograph No. 9</p> <p>Date 12/10/2019 Time 11:10</p> <p>Description: 5-gallon bucket of National Foam Aer-O-Lite 3% AFFF concentrate stored within the Building 320 tank room.</p> <p>Orientation: NA</p>

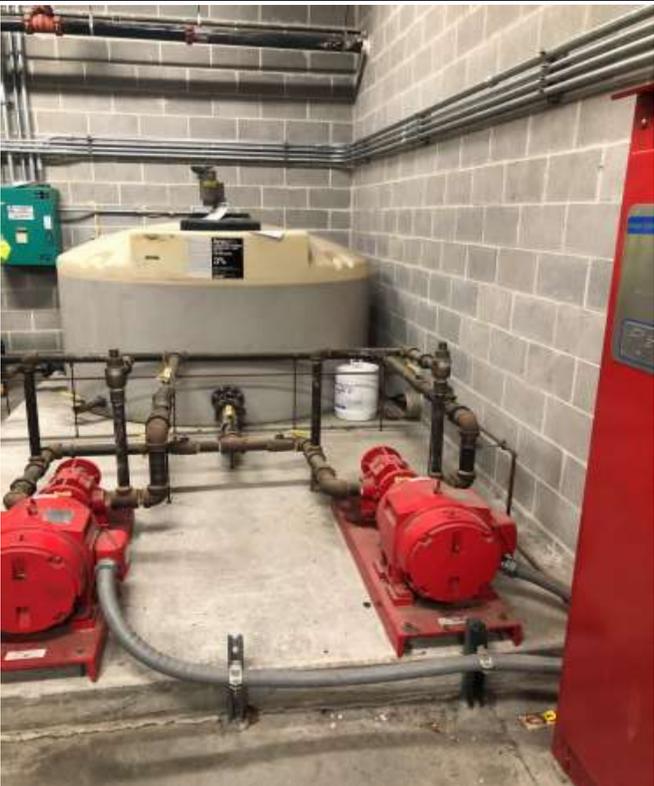
<p>Photograph No. 10</p> <p>Date 12/10/2019 Time 11:11</p> <p>Description: 5,000-gallon AFFF concentrate tank and 5-gallon bucket of AFFF concentrate stored within the Building 320 tank room.</p> <p>Orientation: NA</p>

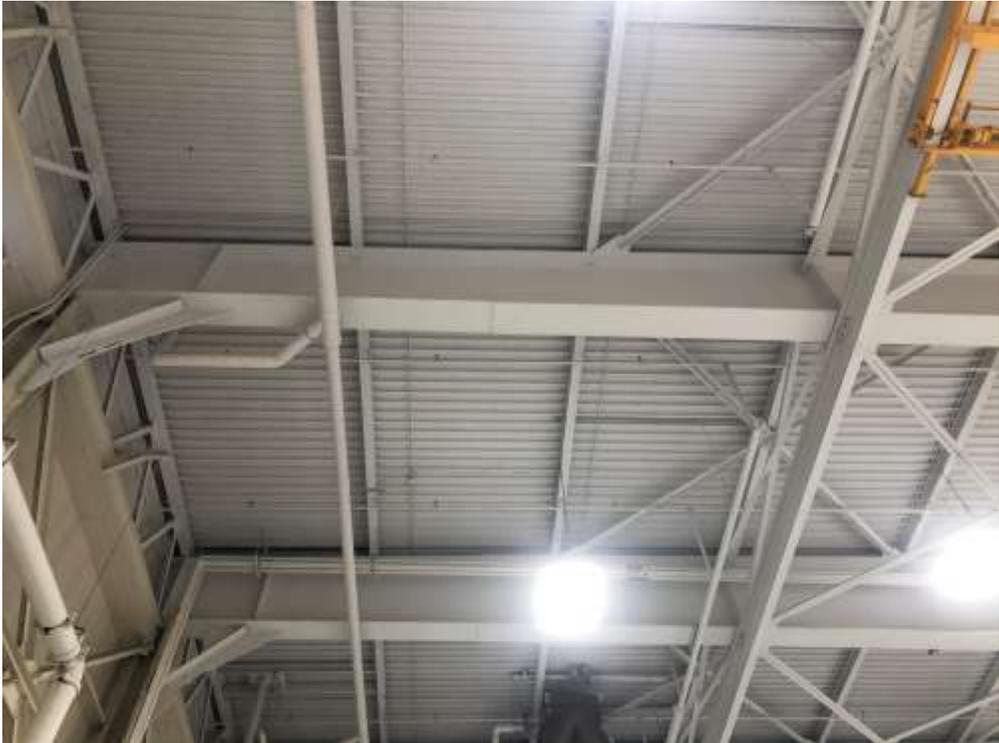
Photograph No. 11

Date 12/10/2019 Time 11:18	
Description: Ceiling sprinklers connected to the AFFF fire suppression system in the Building 320 hangar.	
Orientation: NA

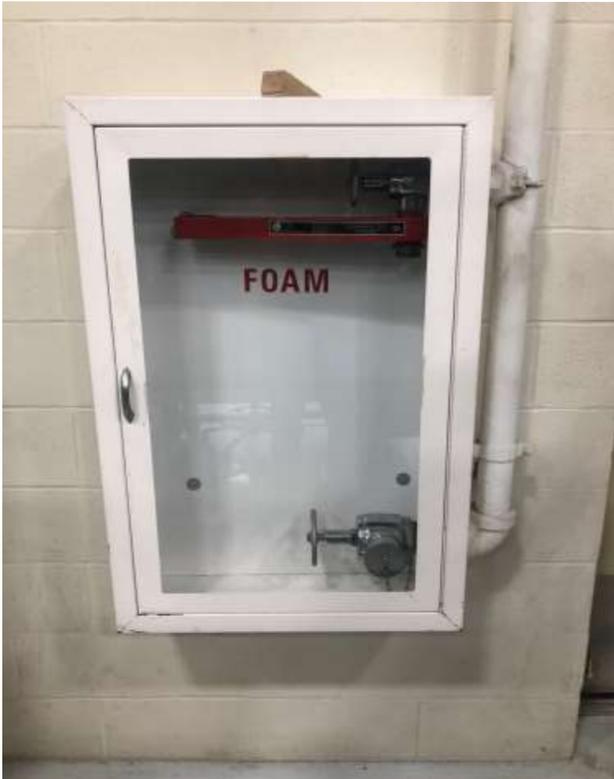
Photograph No. 12

Date 12/10/2019 Time 11:22	
Description: Building 320 AFFF suppression system hose that was used during the 2008 system test to discharge AFFF straight into the vac-truck of a private contractor.	
Orientation: NA

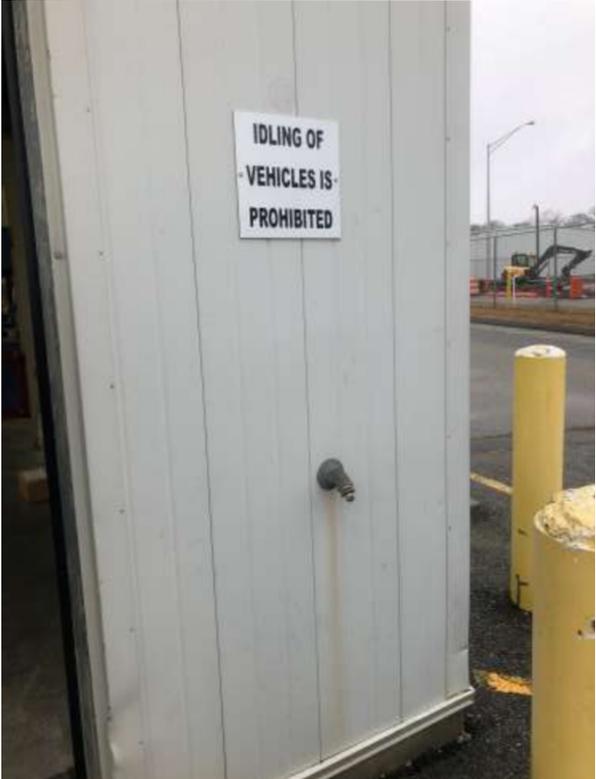
Army National Guard, Preliminary Assessment for PFAS	TASMG-Groton	Groton, Connecticut
<p>Photograph No. 13</p> <p>Date 12/10/2019 Time 11:25</p> <p>Description: AFFF system test port used during the quarterly system testing of Building 320. During testing, a barrel is placed beneath the port to catch potentially PFAS-laden water.</p> <p>Orientation: Northwest</p>

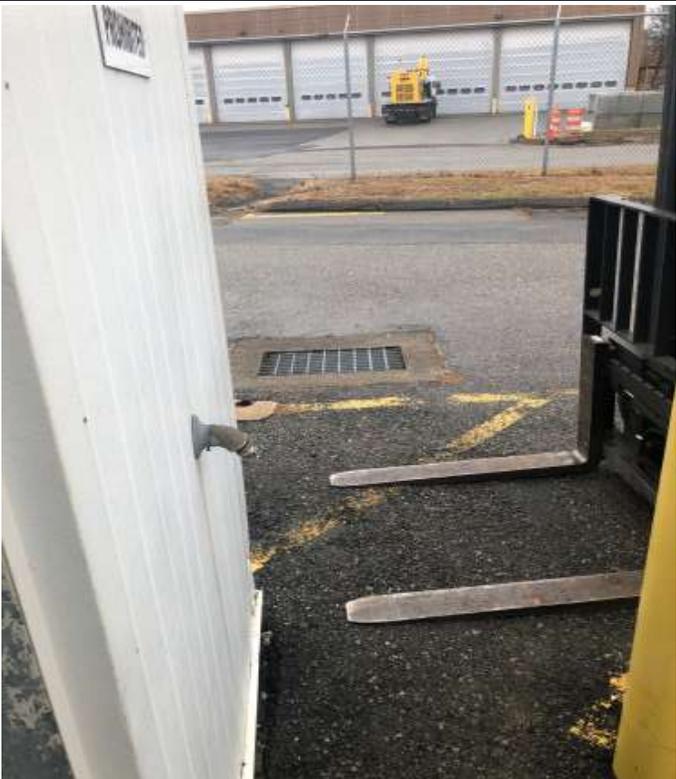
PFAS-laden water released from the test ports is collected in barrels; however, it is possible that water has been spilled during the many test events. Test ports are located over paved surfaces, but trench drains and catch basins were observed near the test ports during the VSI. The trench drains and catch basins connect to municipal sanitary sewers that discharge to the WPCF. Additionally, surface runoff at the facility generally drains from east to west. Stormwater catch basins channel flow west towards a small intermittent stream that enters Baker Cove and ultimately the Long Island Sound. Although surface water catch basins are not located immediately beneath or adjacent to the building test ports, it is possible that runoff transported PFAS-laden water into the surface water bodies described. As such, surface water and sediment are considered a potentially complete pathway for recreational users of the surface water bodies surrounding TASMG-Groton, and for site workers/construction workers entering the small wetland area within the facility.

<p>Photograph No. 14</p> <p>Date 12/10/2019 Time 11:27</p> <p>Description: AFFF system test port used during the quarterly system testing at Building 320. Sanitary drain visible beyond the test port.</p> <p>Orientation: Northwest</p>
