FINAL Preliminary Assessment Report Duncan Armory AASF, New Castle, Delaware

Perfluorooctanesulfonic Acid (PFOS) and Perfluorooctanoic
Acid (PFOA) Impacted Sites
ARNG Installations, Nationwide

June 2020

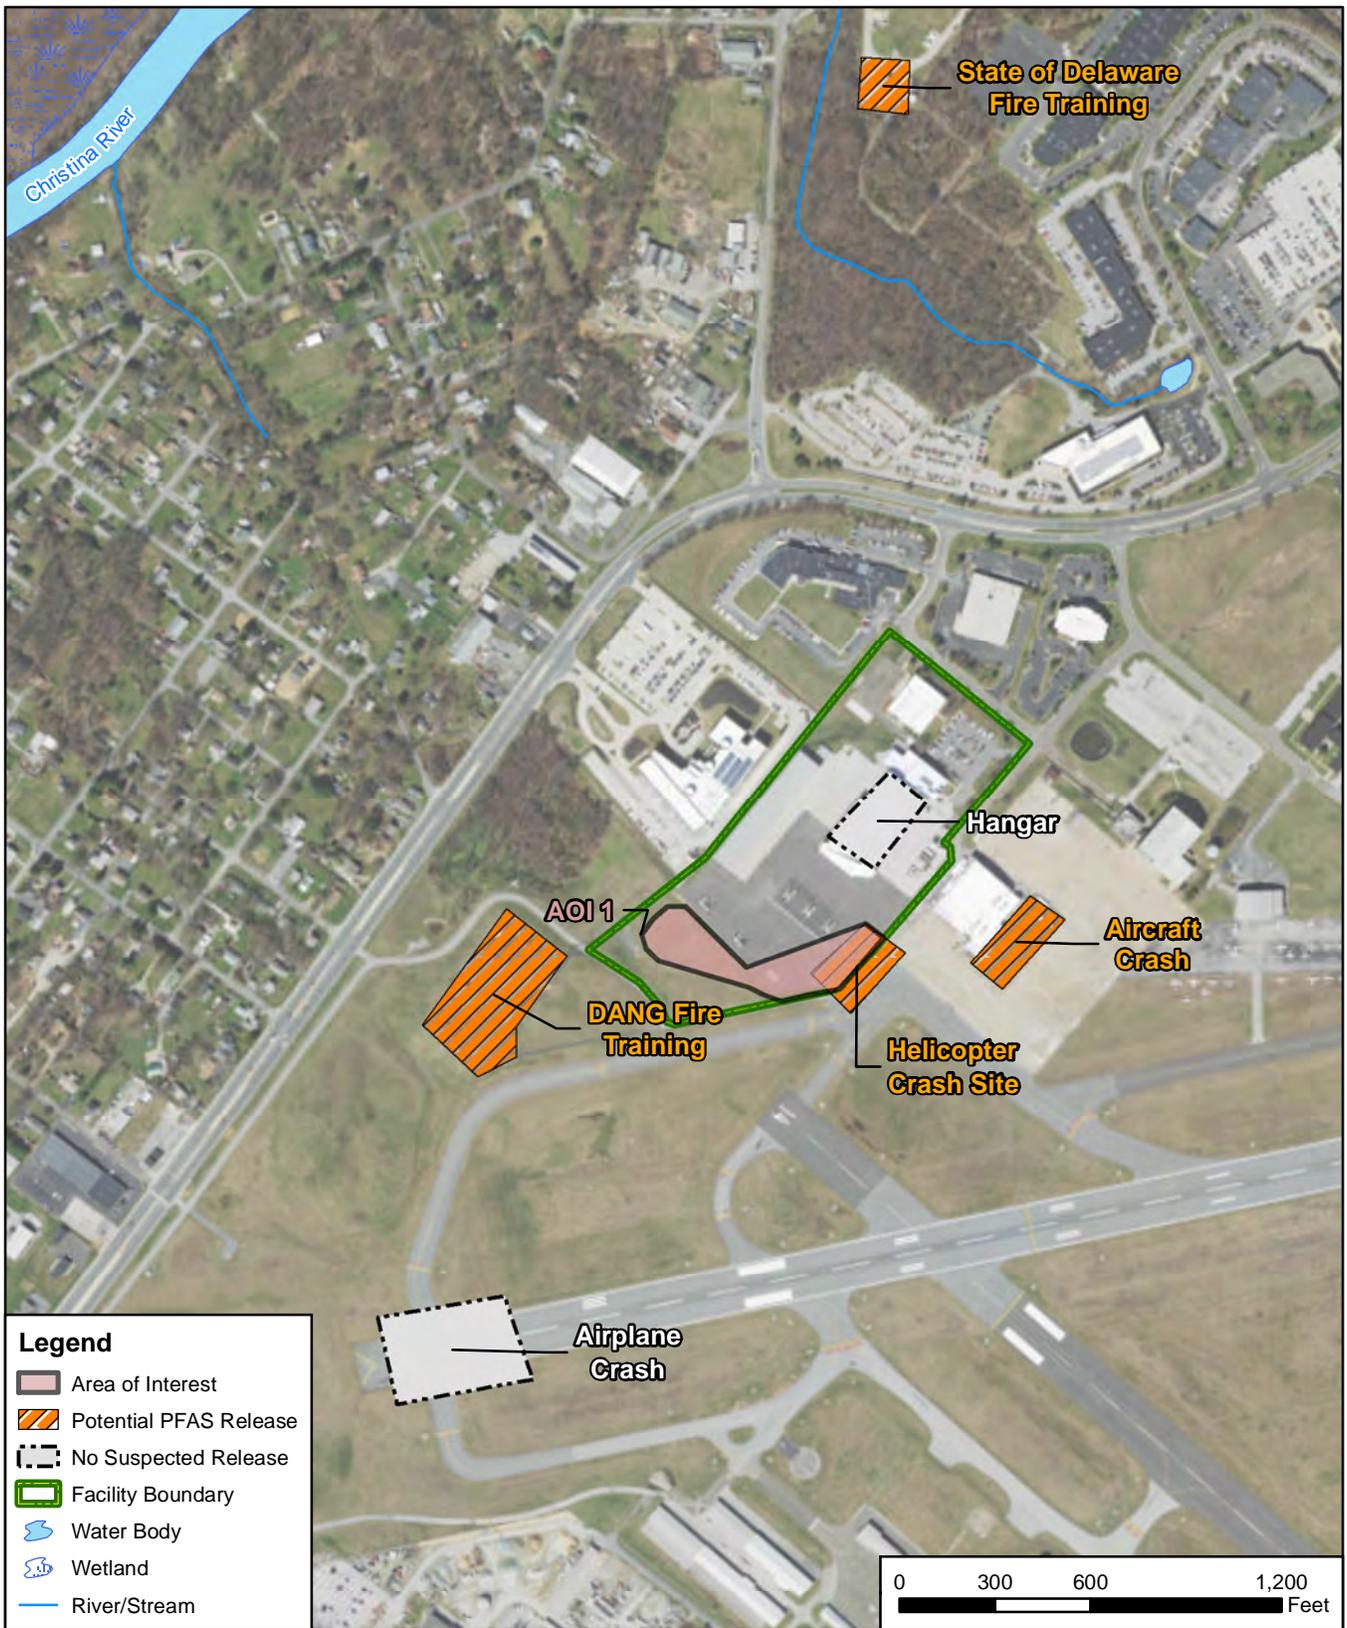
Summary of Findings	
AECOM 12420 Milestone Center Drive Germantown, MD 20876	Figure ES-1

One AOI (referred to as “AOI 1”) related to potential PFAS release was identified at DAASF during the PA. Aqueous film forming foam (AFFF) may have been used to extinguish a fire at an emergency response location. AOI 1 comprises the location at DAASF where a helicopter crashed, and the resultant fire was extinguished using foam. It is unknown if the foam utilized were AFFF, as firsthand interviewee knowledge begins in 1991. The AOI is shown on **Figure ES-1** and described in **Table ES-1** below. The preliminary CSM for DAASF is presented in **Figure ES-2**.

The area where the aircraft crashed and caught fire is located at the southern border of DAASF, near adjacent airport taxiways. Municipal fire response reportedly used firefighting foam to control and extinguish the fire at DAASF. It is unknown what types of foam were used by the FD. Potential PFAS contamination that may have resulted from fire response at the accident location (AOI 1) may have traveled across paved and unpaved ground to a retention basin in the southwest corner of the facility.

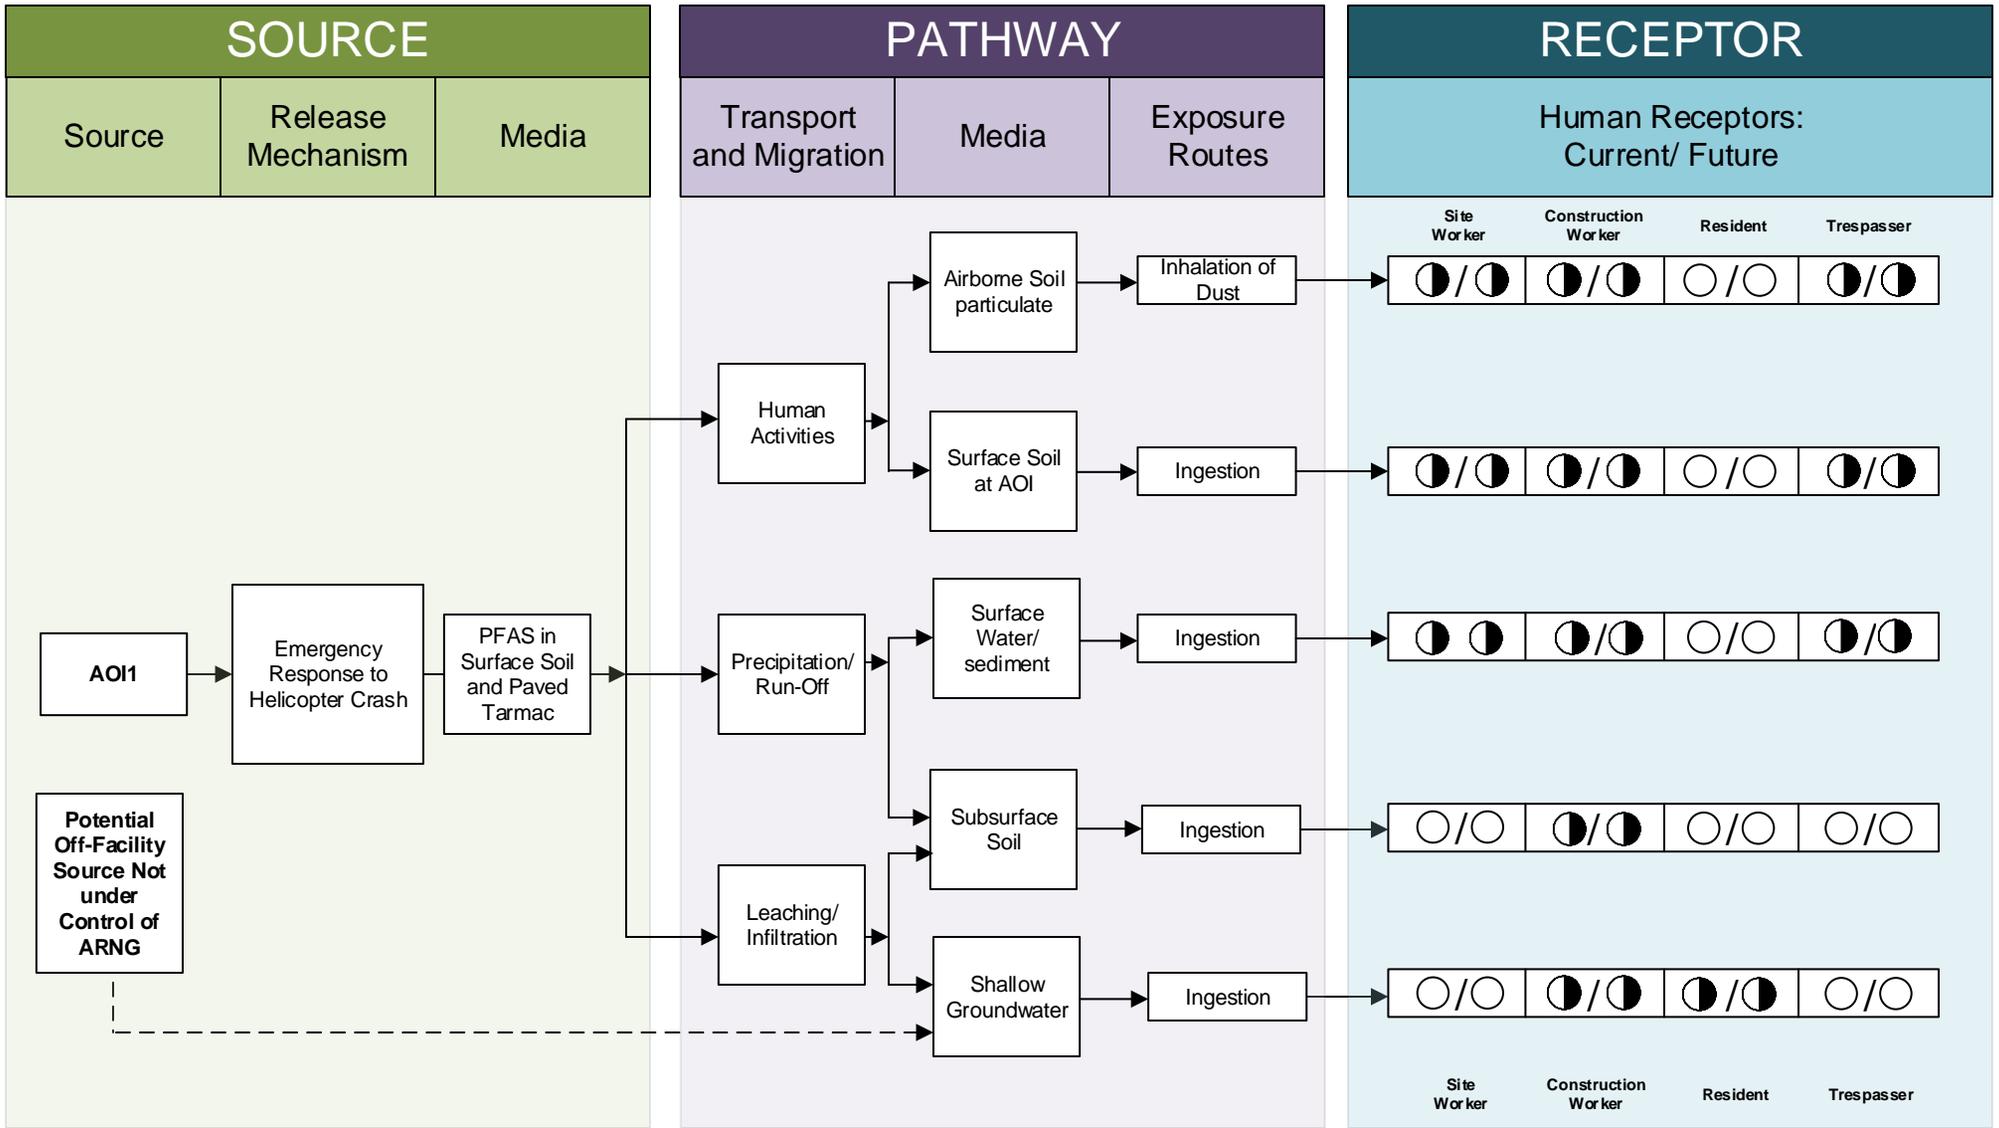
Figure ES-2
 Preliminary Conceptual Site Model
 Duncan Armory AASF, Delaware

Based on a potential PFAS release at the AOI, there is potential for exposure to PFAS contamination in airborne soil particulates, surface soil, surface water and sediments to site workers, construction workers, and trespassers via ingestion and inhalation; subsurface soil to construction workers via ingestion; and groundwater to construction workers and off-facility residents.

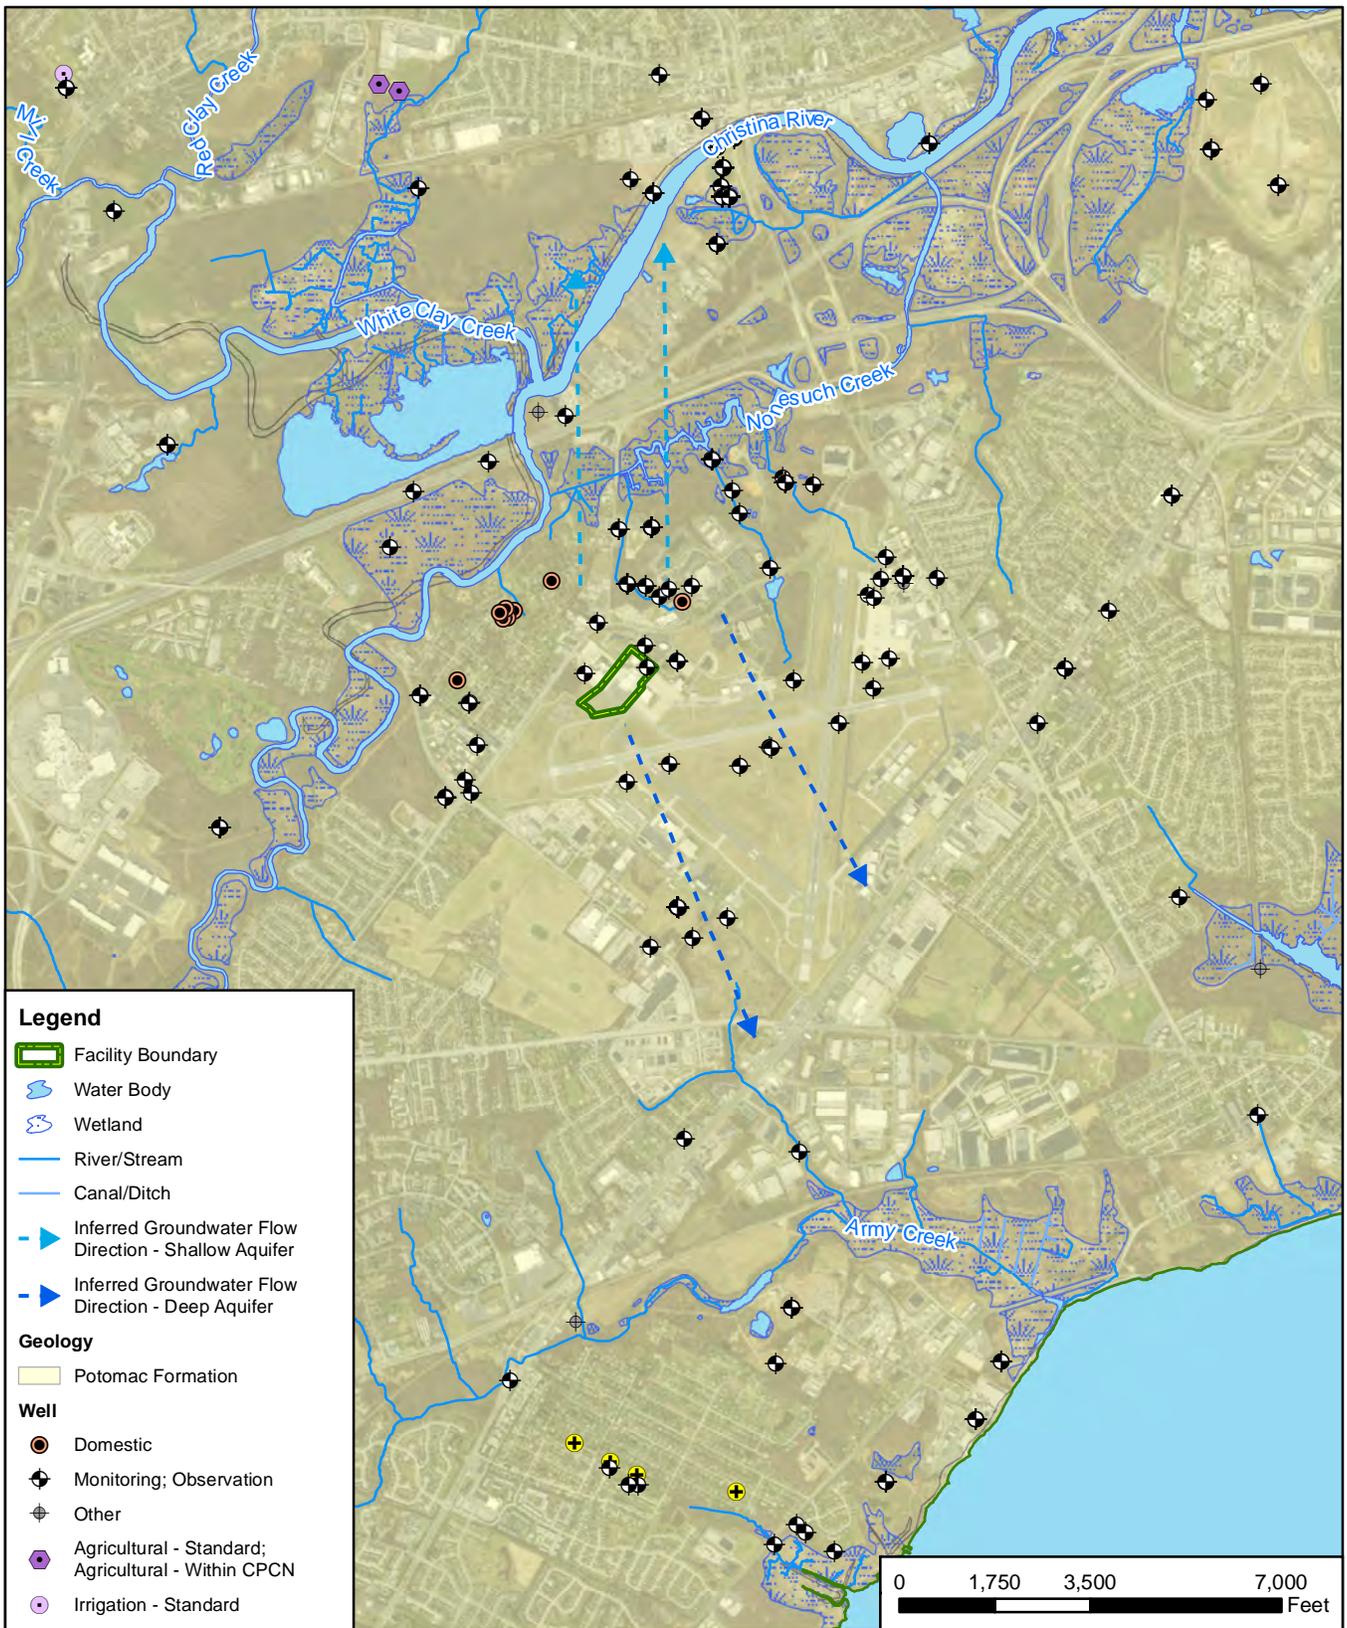
Figure 1-2

The Upper Potomac Aquifer lies in both the shallow and intermediate groundwater-bearing zones. The shallow zone extends from 0 to 30 feet amsl, and there is no clear distinction between the surficial Columbia aquifer and the Upper Potomac Aquifer. Separated from the shallow zone by a semi-confining layer of clay, the intermediate groundwater-bearing zone ranges from 1 to 20 feet thick, extends approximately 50 feet below mean sea level (bmsl), and is considered to be part of the Upper Potomac aquifer. Results of groundwater elevation data from a previous investigation at the adjacent ANG facility suggest that the shallow and intermediate zones are interconnected, as they show similar trends. The ANG groundwater gauging also determined that groundwater in both zones of the Upper Potomac Aquifer as well as the Columbia Aquifer is inferred to flow generally to the north (**Figure 1-2**).

The Middle Potomac Aquifer is considered the deep groundwater-bearing zone and is separated from the Upper Potomac Aquifer by a layer of clay 60 to 80 feet thick; it does not vertically transmit water. Below the clay layer, the aquifer's water-bearing sands extend from 120 to 130 feet bmsl. Groundwater levels are about 5 to 10 feet bmsl, suggesting that the groundwater is confined, and there is little transmission of water vertically between the Upper and Middle Potomac Aquifers. Groundwater in the Middle Potomac Aquifer flows to the south-southeast (**Figure 1-2**).

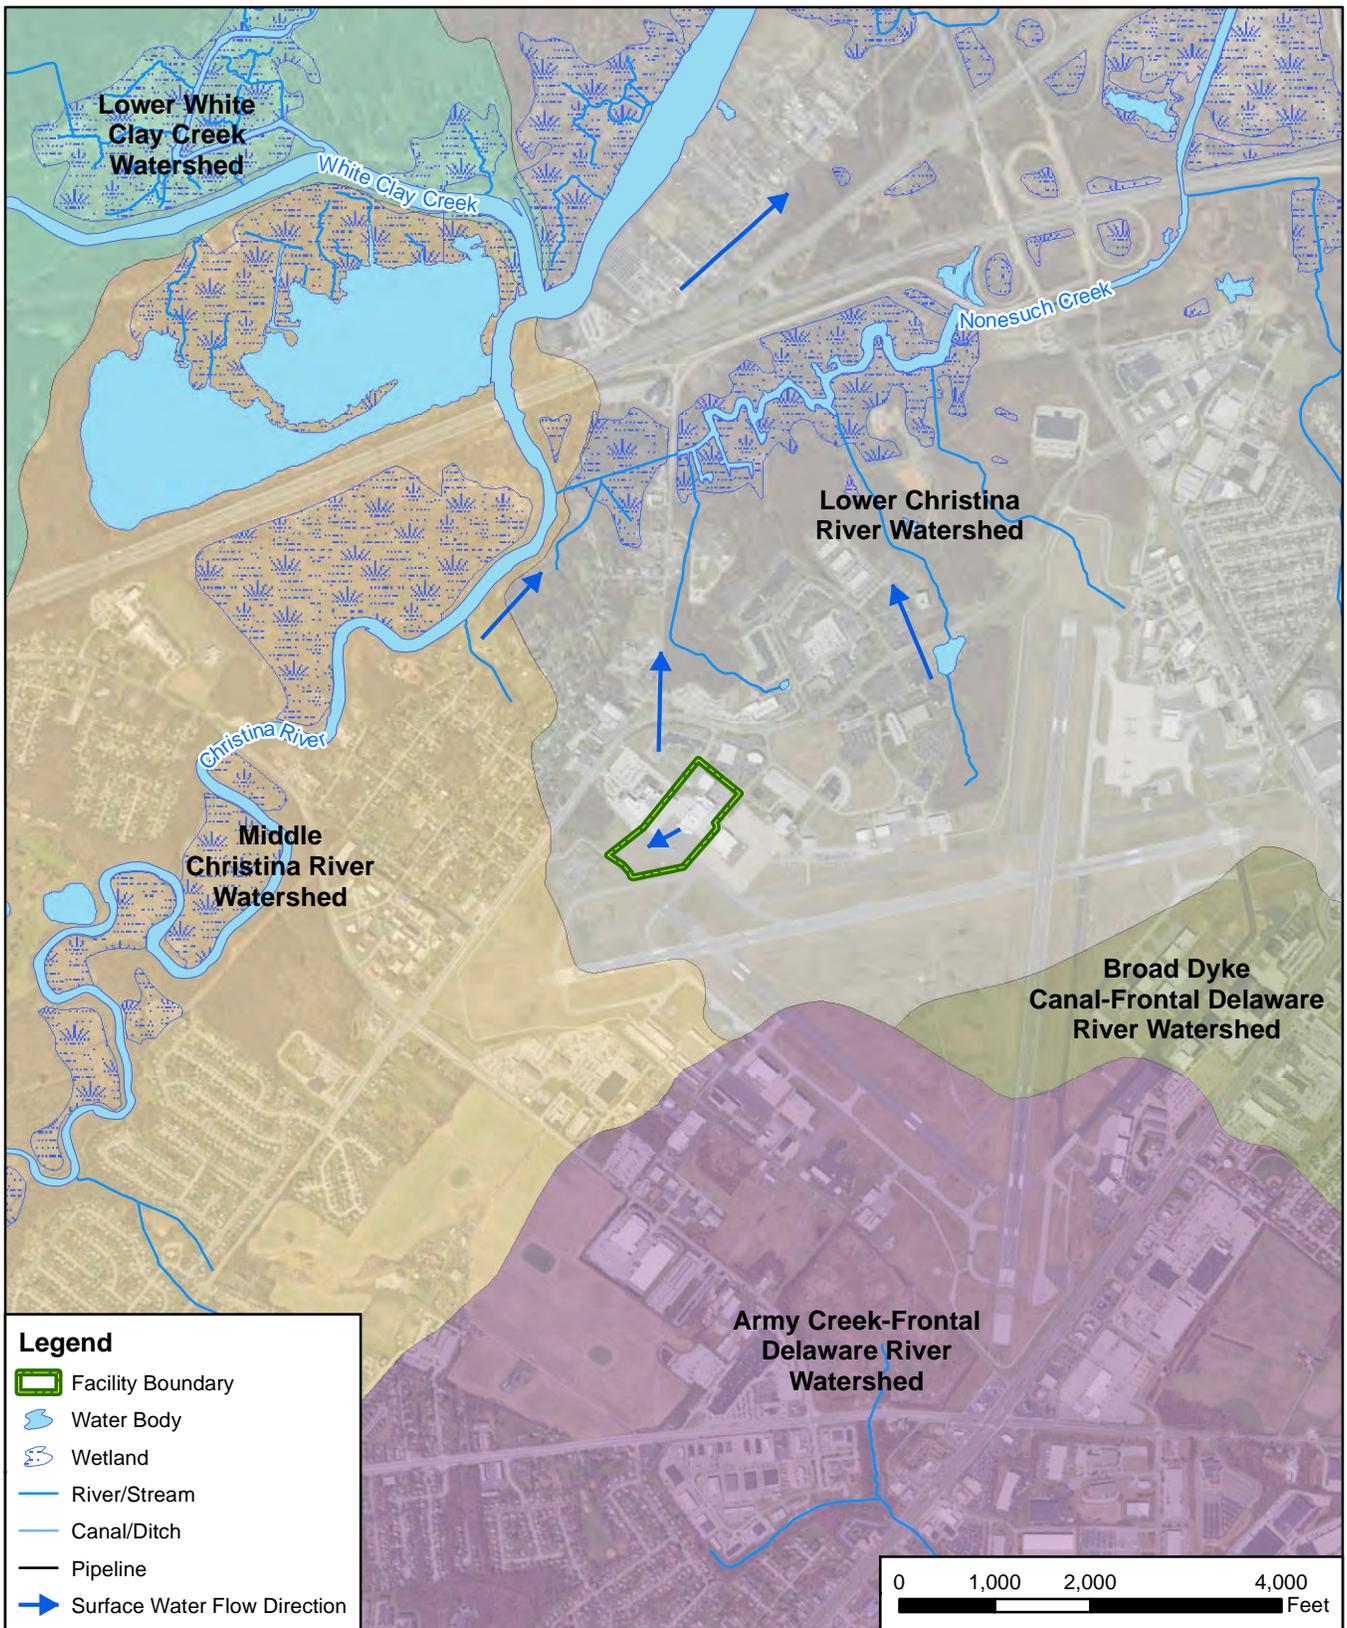
Surface Water Features	
AECOM 12420 Milestone Center Drive Germantown, MD 20876	Figure 1-3

DAASF sits on the Lower Christina River Watershed, at the edge of the Christina Basin, with wetlands lying north of the facility. On facility grounds, runoff flows away from the paved areas and structures into a retention basin on the southern end of the property, where runoff will infiltrate or evaporate. However, surrounding the facility, general surface water flow is north into the Christina River and Nonesuch Creek, which converge downstream and continue northeast to the Delaware River (**Figure 1-3**).

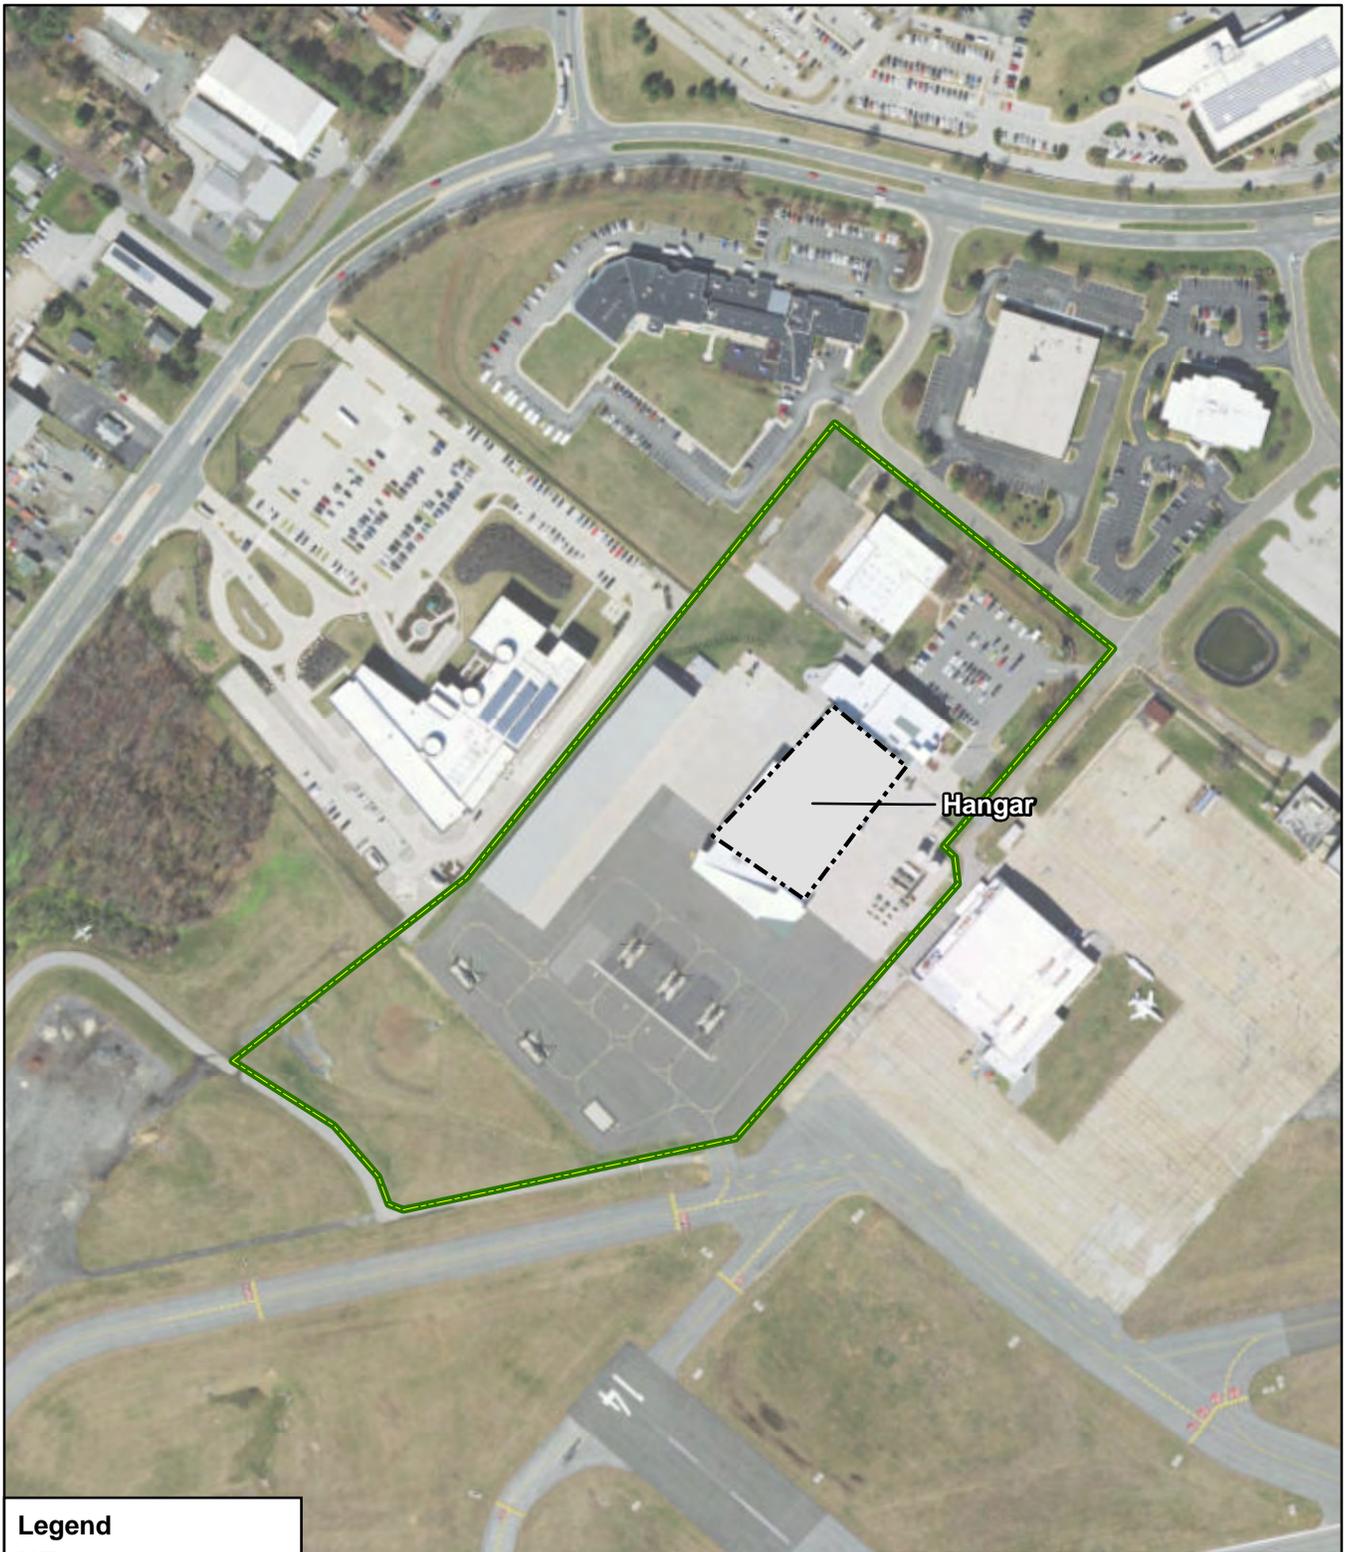
Figure 3-1

The hangar is located in the center of the DAASF facility; the geographic coordinates are 39°40'57.095"N; 75°39'56.959"W (**Figure 3-1**). According to interviewees, at the completion of construction of the new hangar and administrative wing in 2011, the existing fire suppression system in the hangar was retrofitted with a Jet-X 2% high expansion foam concentrate system. During retrofitting, the previous system was discharged with an aqueous soap and water solution to test functionality before Jet-X was placed in the system. Prior to the installation of the Jet-X deluge system, the fire suppression system was equipped with a non-PFAS foam, though interviewees do not remember the type, and firsthand interviewee knowledge only extends back to 1991. The storage tank for the current deluge system is located inside the fire suppression equipment room, which is accessible from outside of the building. The foam deluge system, automatic sprinkler system, and dry pipe sprinkler system are all checked on a quarterly basis by Allegiant Fire Protection. Though PFAS are not included in the Hazardous Materials Identification System Information for Jet-X, the full contents are a trade secret and not disclosed. As a result, the ARNG is conservatively operating under the potential for Jet-X to be PFAS-containing. There is no suspected release at this location on the DAASF facility.

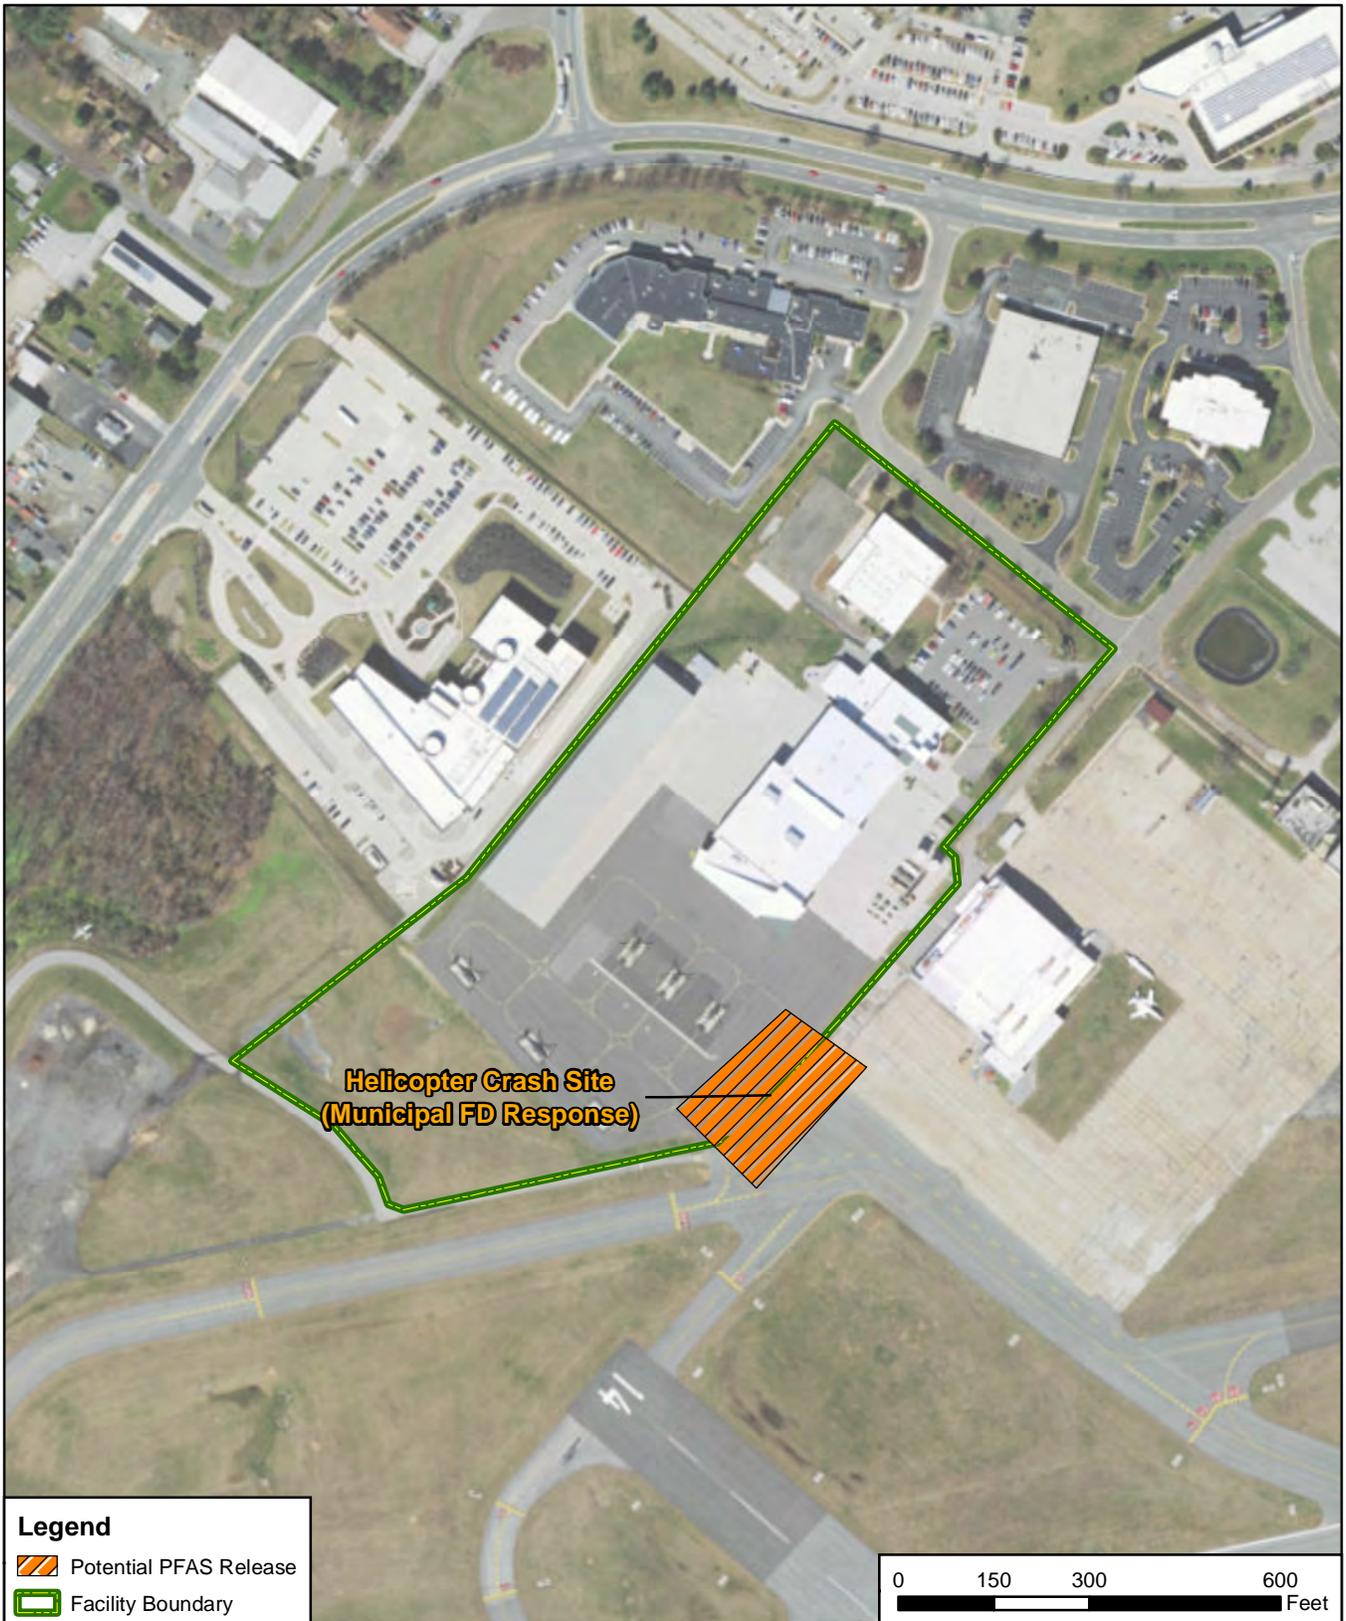
Emergency Response Area	
AECOM 12420 Milestone Center Drive Germantown, MD 20876	Figure 4-1

In the 1970s, an ARNG helicopter crashed on the boundary between the DAASF facility and New Castle Airport properties; the geographic coordinates are 39°40'53.789"N; 75°36'56.487"W (**Figure 4-1**). Interviewees with secondhand knowledge of the event indicated that the municipal fire department (FD) responded to the scene using a foam fire suppressant. It is unknown whether the aqueous foam used was AFFF. The released foam likely followed on-site surface water pathways to the retention basin at the southern end of the facility. Surface water runoff from the facility collects in this basin until it evaporates or infiltrates the subsurface. The crash location is a potential PFAS release.

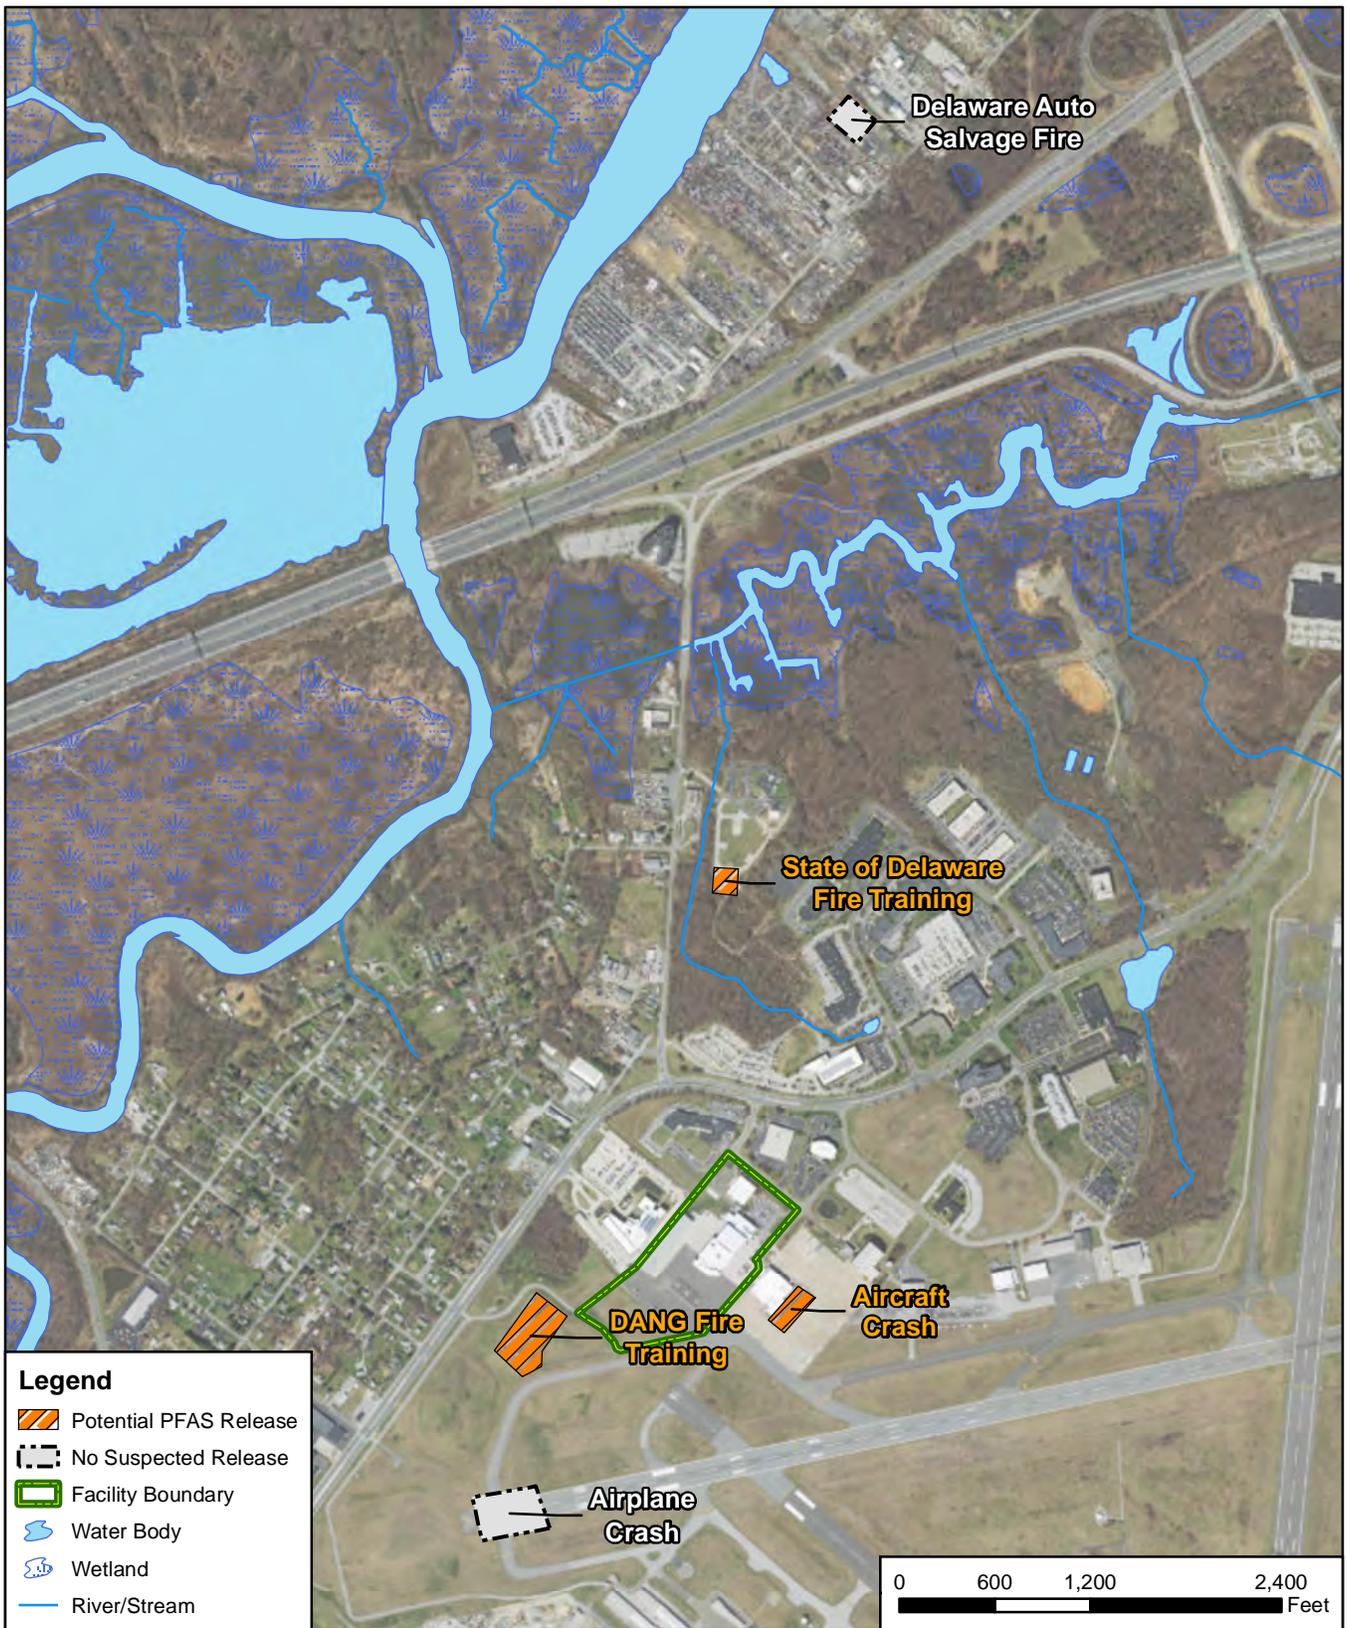
Adjacent Sources	
AECOM 12420 Milestone Center Drive Germantown, MD 20876	Figure 5-1

In July 2018, a fire of unknown origin broke out at Delaware Auto Salvage, located approximately 1.3 miles from DAASF. Emergency response units were called from surrounding cities to assist in controlling the fire. It was estimated that nearly 400 vehicles ignited, and news agencies reported that water was used to control the flames. This location has no suspected PFAS release because there are no reports or interviewee accounts of foam being used to control the fire (ABC, 2018). Emergency response personnel were not interviewed during the PA because the focus of the assessment was to evaluate potential PFAS related activities and sources at Delaware ARNG (DEARNG) properties. **Figure 5-1** shows the location of the Delaware Auto Salvage Fire.

Approximately 0.5 miles north of the facility is the Delaware State Fire School New Castle. Activities on this campus include exercises with live fires and firefighting foam. The type of foam used is uncertain, but there is a potential for PFAS release at this location. Delaware State Fire School personnel were not interviewed during the PA because the focus of the assessment was to evaluate potential PFAS related activities and sources at DEARNG properties. **Figure 5-1** shows the location of the Delaware State Fire School.

In June 1991, a military aircraft tilted while on a test flight, and its wing hit the ground, igniting a small fire which was then extinguished by the DANG FD. It is unknown whether AFFF were used to extinguish the fire; however, the DANG FD is known to use AFFF for fire suppression. Because the use of AFFF at the crash site cannot be confirmed, the crash site has been identified as a potential PFAS release area. DANG personnel were not interviewed during the PA because the focus of the assessment was to evaluate potential PFAS related activities and sources at DEARNG properties. **Figure 5-1** shows the location of the Aircraft Crash.

Approximately 80 feet southwest of the southwestern corner of DAASF property is the location of DANG's FTA. This location is DANG's current operational FTA. Interviewees noted training with fire suppressing foam does occur on this site, but they are unsure whether the foam is AFFF. Because of this uncertainty, the DANG FTA has been identified as a potential PFAS release area. DANG personnel were not interviewed during the PA because the focus of the assessment was to evaluate potential PFAS related activities and sources at DEARNG properties. **Figure 5-1** shows the location of the DANG FTA.

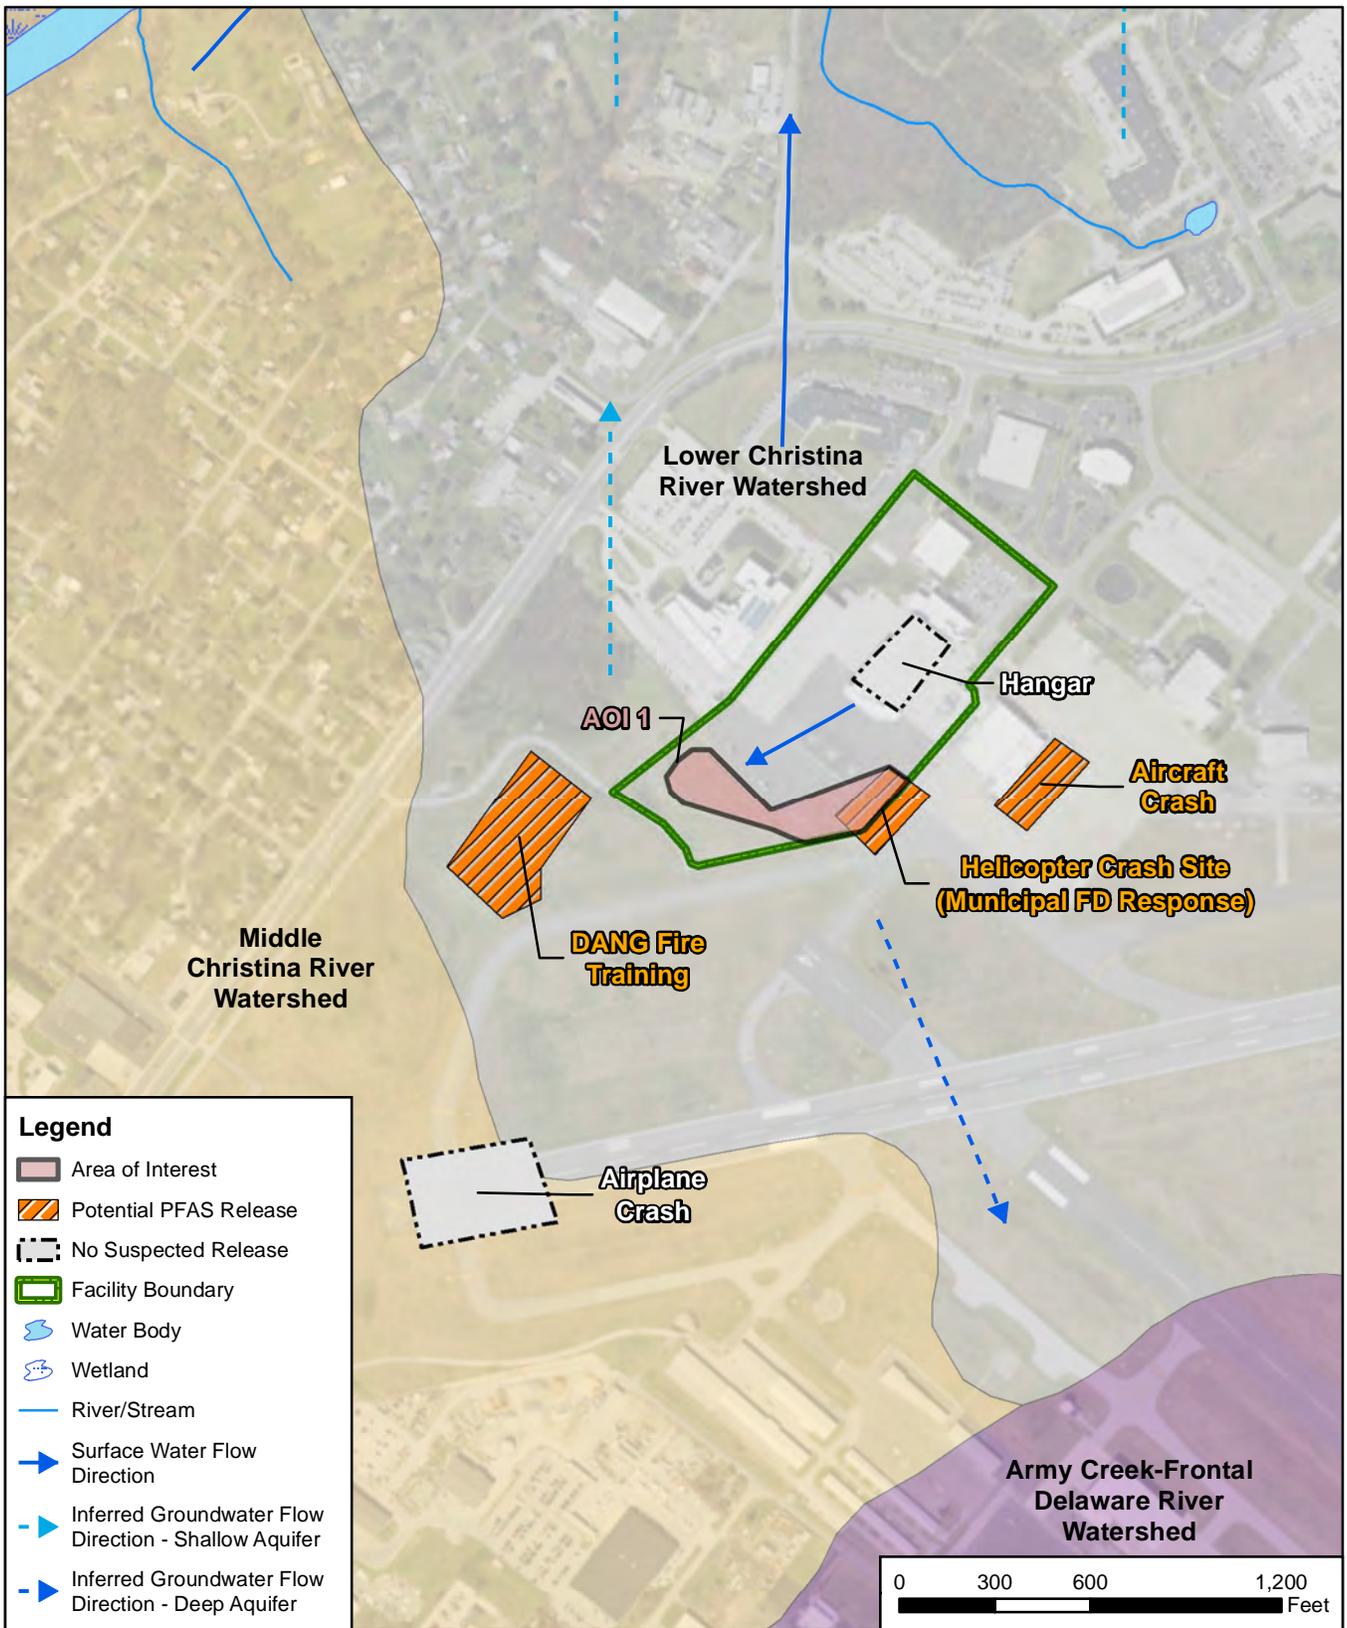
Area of Interest	
AECOM 12420 Milestone Center Drive Germantown, MD 20876	Figure 6-1

Based on the PA findings, one AOI was identified at DAASF: AOI 1 is the helicopter crash site and foam drainage pathway. The AOI location is shown on **Figure 6-1**. The following sections describe the CSM components and the specific preliminary CSM developed for AOI 1. The CSM identifies the three components necessary for a potentially complete exposure pathway: (1) source, (2) pathway, (3) receptor. If any of these elements are missing, the pathway is considered incomplete.

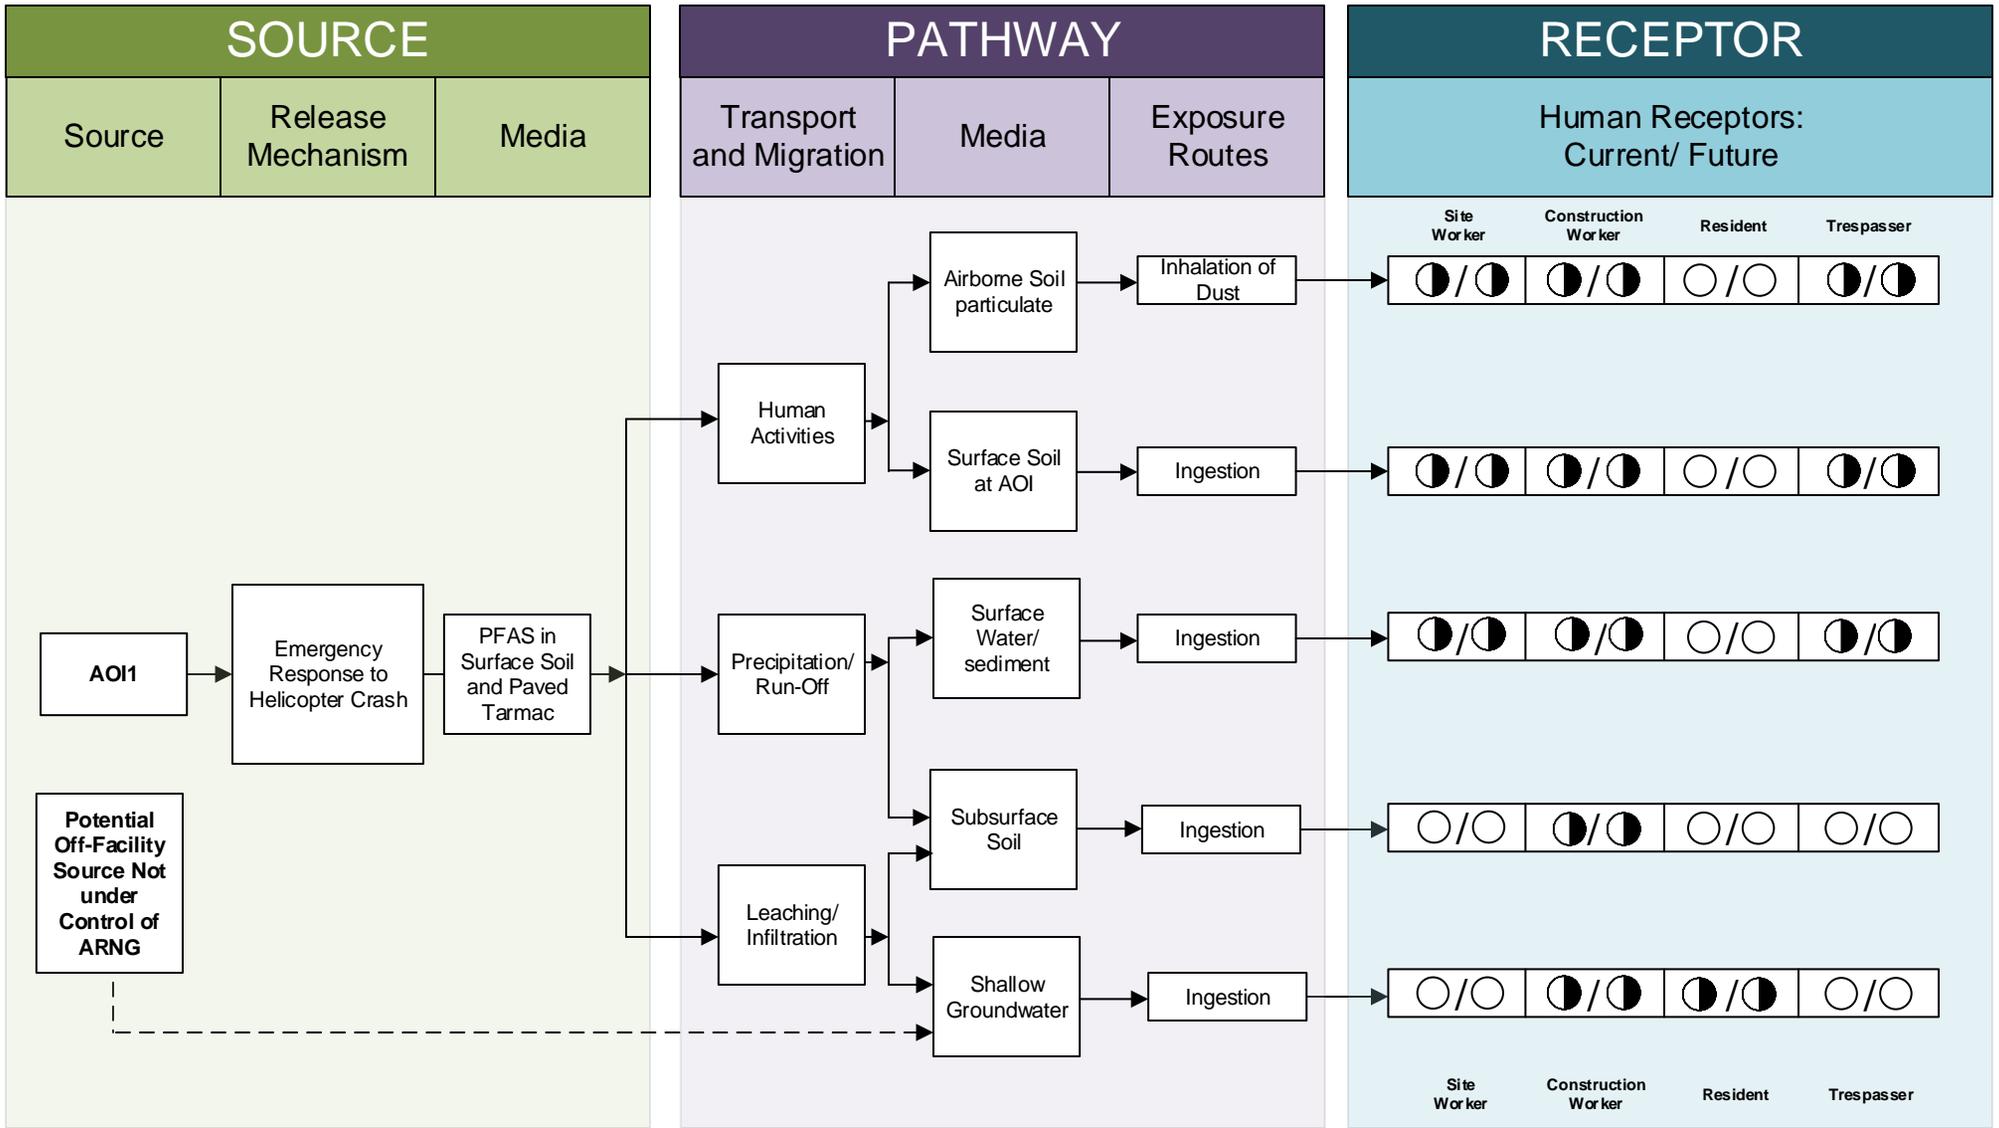
In general, the potential PFAS exposure pathways are ingestion and inhalation. Human exposure via the dermal contact pathway may occur, and current risk practice suggests it is an insignificant pathway compared to ingestion; however, exposure data for dermal pathways is sparse and continues to be the subject of PFAS toxicological study. Receptors at DAASF include site workers, construction workers, trespassers, and off-site residents. The preliminary CSM for DAASF indicates which specific receptors could potentially be exposed to PFAS (**Figure 6-2**).

PFAS contamination from the potential source area may have infiltrated to groundwater from the retention basin and along the path of foam migration from the crash site. Shallow groundwater is inferred to flow north, towards the Christina River, and deep groundwater is inferred to flow southeast, towards the Delaware River. While no potable water wells are located within DAASF, there are public water supply wells within 3.5 miles of the facility, located in the Public Wells Groundwater Plume Site. The approximate locations of the public wells were included in a 2019 EPA report and found to be south of the facility. DNREC's community fact sheet in **Appendix A** provides an outlined area of the Public Wells Groundwater Plume Site that encompasses the area of these four public wells. This public well plume site, as described previously, encompasses the New Castle County Airport, DAASF property, and surrounding residential areas (DNREC, 2019). These public wells are treated for PFAS contamination by Artesian Water Company, Inc.

The EDR™ report indicates there are also eight domestic, private wells that are located within 1 mile of the facility (EDR™, 2019). A potentially complete groundwater ingestion pathway exists for off-facility residents using these private wells. The ingestion pathway for groundwater to construction workers is also potentially complete. The preliminary CSM for AOI 1 is shown on **Figure 6-2**.
