FINAL Preliminary Assessment Report Duncan Armory AASF, New Castle, Delaware

Perfluorooctanesulfonic Acid (PFOS) and Perfluorooctanoic
Acid (PFOA) Impacted Sites
ARNG Installations, Nationwide

June 2020

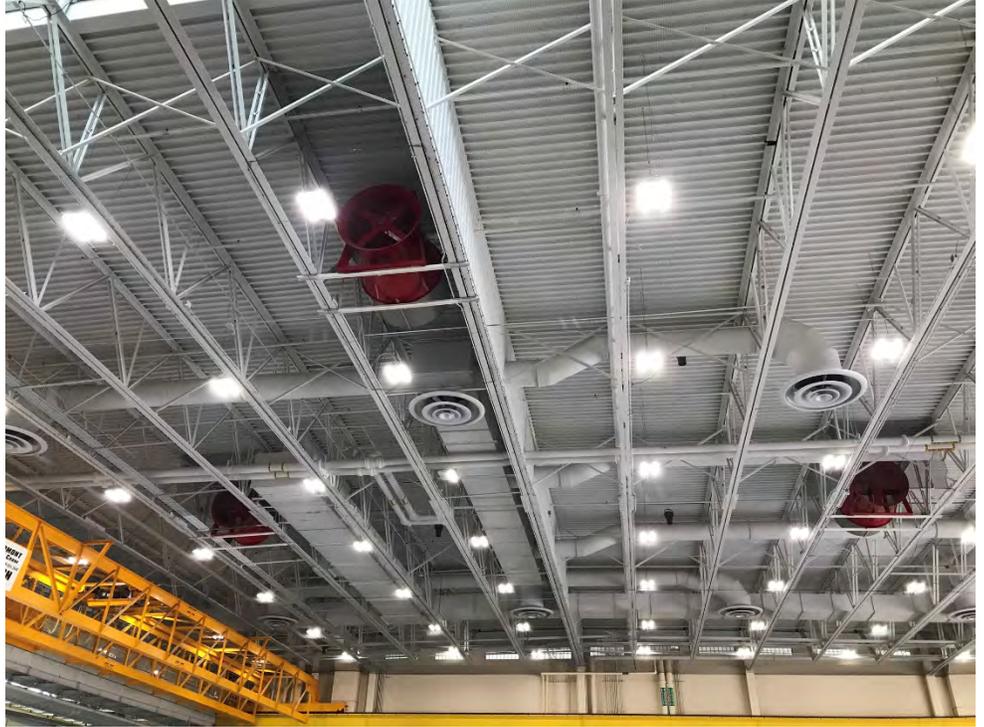
Photograph No. 2

AFFF foam suppression
system activation switch.

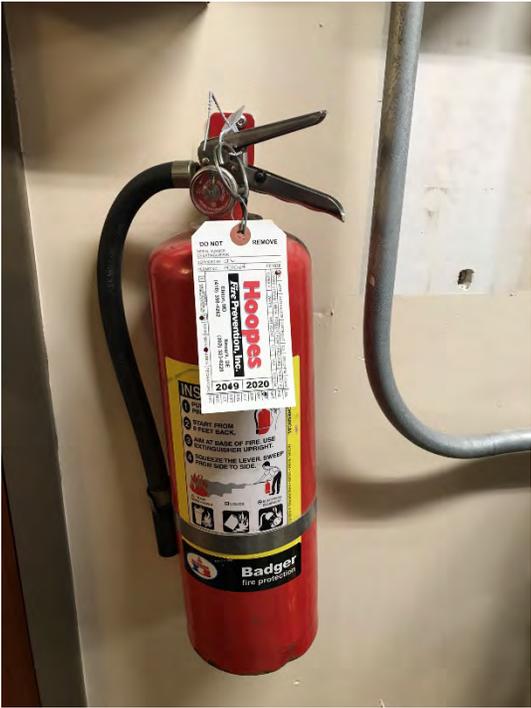
<p>Photograph No. 6</p> <p>Description:</p> <p>Image of handheld ABC fire extinguisher identical to others posted throughout the installation.</p> <p>Photo Date: 8/6/2019</p>

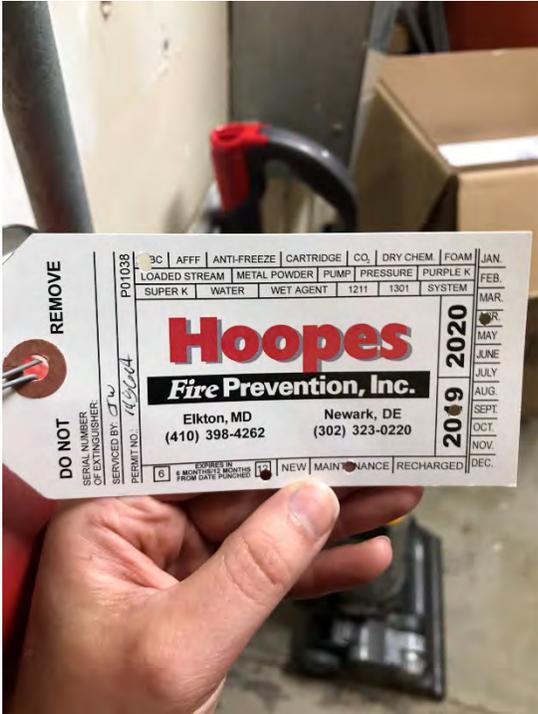
Army National Guard, Preliminary Assessment for PFAS	Duncan Armory AASF	New Castle, Delaware
<p>Photograph No. 7</p>

<p>Description:</p>		
<p>Inspection tag from handheld ABC fire extinguisher in facility. Photo Date: 8/6/2019</p>
