FINAL Preliminary Assessment Report Wilmington Readiness Center, Wilmington, Delaware

Perfluorooctanesulfonic Acid (PFOS) and Perfluorooctanoic
Acid (PFOA) Impacted Sites
ARNG Installations, Nationwide

June 2020

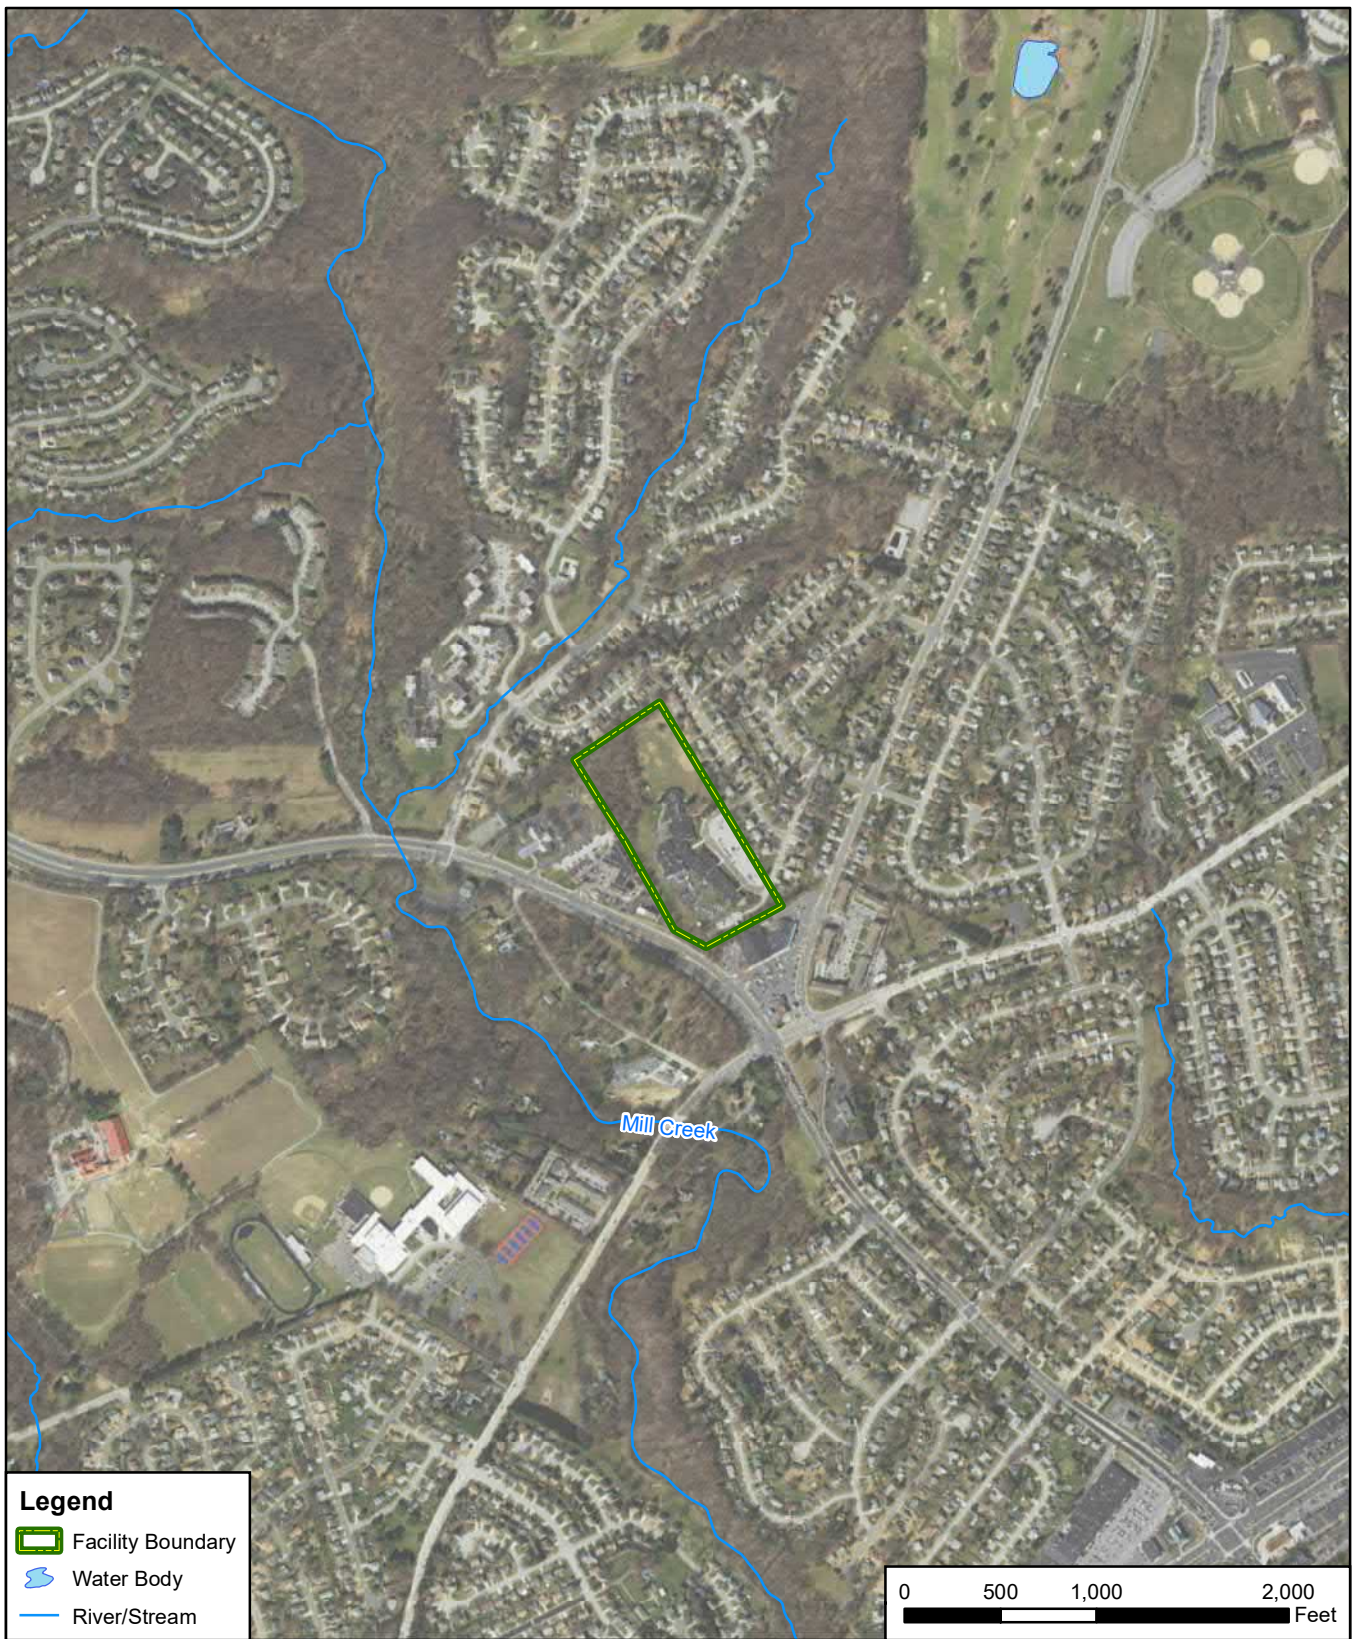
Summary of Findings	
 12420 Milestone Center Drive Germantown, MD 20876	Figure ES-1

No AOIs related to potential PFAS use, release, or storage were identified at Wilmington Readiness Center during the PA (**Figure ES-1**). One potential adjacent source of PFAS was identified downgradient of the facility. Based on facility history and interviews with various personnel, there is no potential for exposure to PFAS contamination in media at or near the facility.

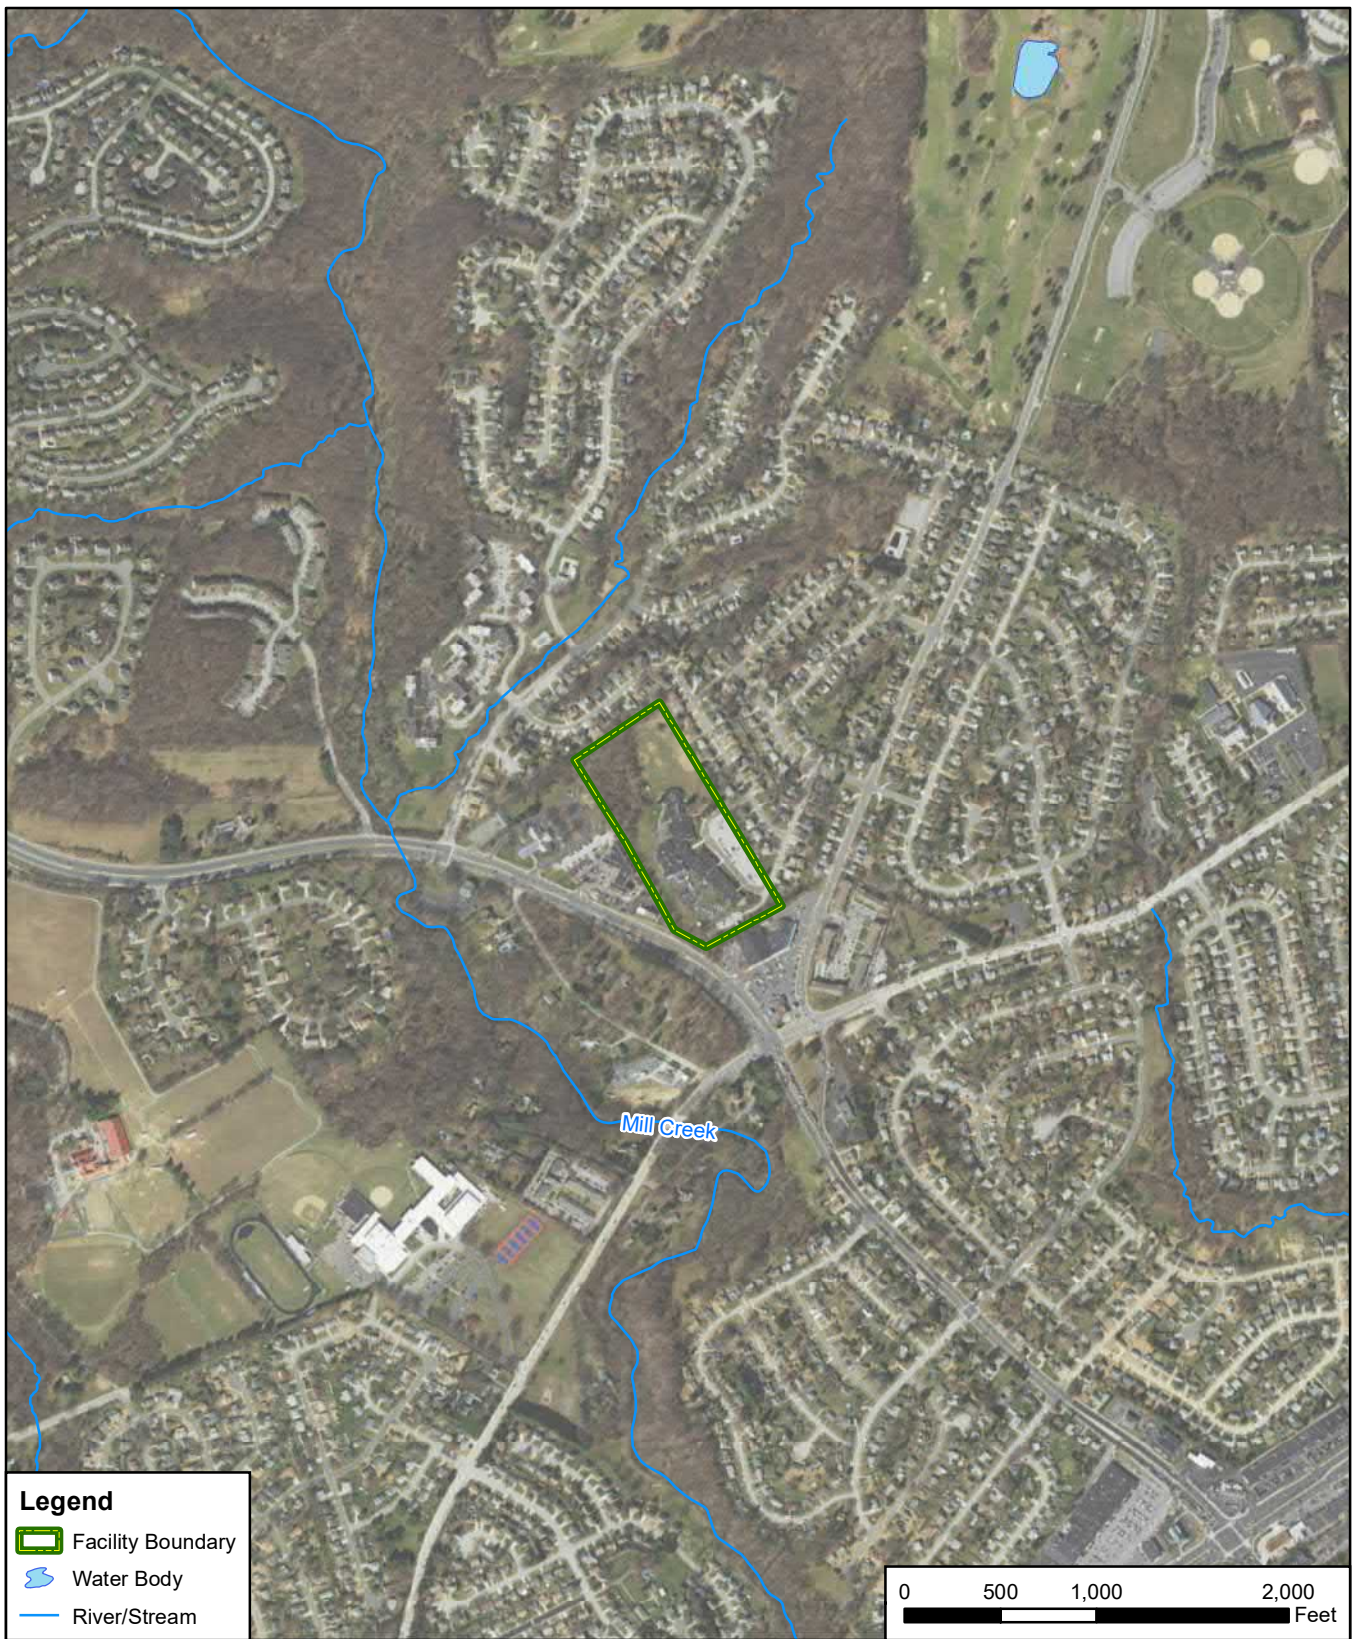
Summary of Findings	
 12420 Milestone Center Drive Germantown, MD 20876	Figure 7-1

Based on information obtained during interviews conducted with facility personnel, facility observations, and reviewed documentation, it is confirmed that AFFF has not been stored, used, or released at Wilmington Readiness Center; therefore, no AOIs related to PFAS release were identified at Wilmington Readiness Center.

Based on the absence (1982-present) of the use, storage, or release of PFAS-containing materials at Wilmington Readiness Center, no AOIs were identified during the PA. Evidence does not indicate that current or former ARNG activities contributed PFAS contamination to media at or near the facility. Wilmington Readiness Center will not move forward in the CERCLA process.

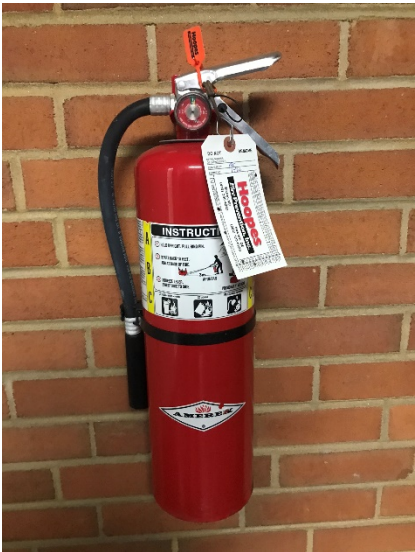
Army National Guard, Preliminary Assessment for PFAS	Wilmington Readiness Center	Wilmington, Delaware
<p>Photograph No. 1</p> <p>Description:</p> <p>AB fire extinguisher mounted on the wall inside the facility.</p> <p>Photo Date: 8/5/2019</p>

<p>Photograph No. 2</p> <p>Description:</p> <p>Tag from the AB fire extinguisher above. This is the only type of extinguisher at the facility.</p> <p>Photo Date: 8/5/2019</p>
