Preliminary Assessment Report Army Aviation Support Facility #1, Cecil Field, Jacksonville, Florida

Perfluorooctanesulfonic Acid (PFOS) and Perfluorooctanoic
Acid (PFOA) Impacted Sites
ARNG Installations, Nationwide

June 2020

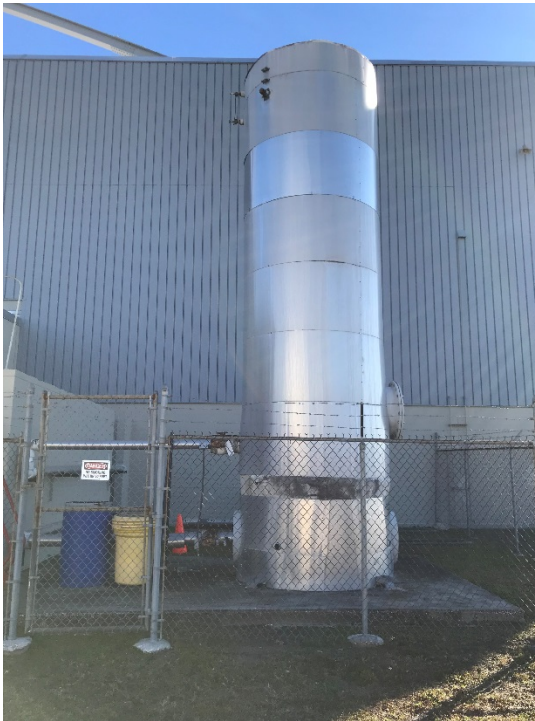
Army National Guard, Preliminary Assessment for PFAS		Cecil Field AASF #1	Jacksonville, Florida
Photograph No. 1 Description: Looking east General view of the 4,000-gallon concentrate tank Photo date 1/29/19

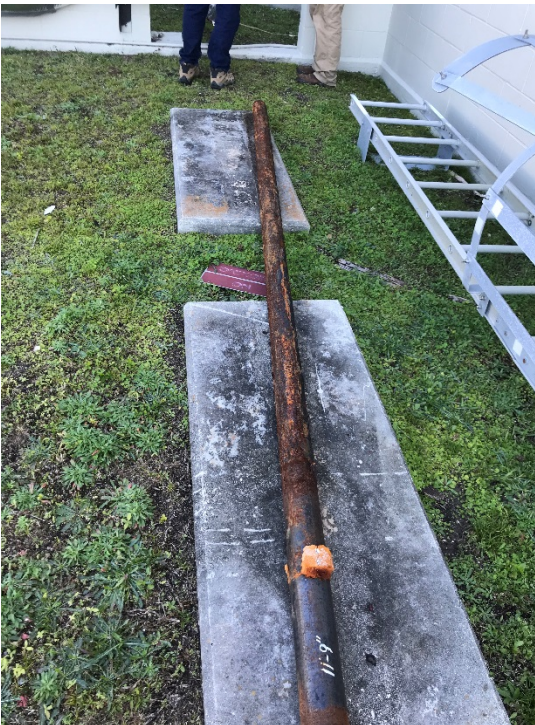
During the PA site visit, FLARNG personnel noted three areas where seepage of AFFF may have occurred. Near AFFF concentrate tank, FLARNG personnel identified where corrosion of one section of conduit between the AFFF concentrate tank and the pump room had occurred outside Hangar 860, along the westernmost wall. The corroded section of pipe was removed and replaced. Another section of conduit outside Hangar 860 appeared to have been patched due to a leak. Evidence of historical seepage of AFFF was also noted in the deluge room at the shut-off valve and overhead conduits. Photographs of these areas are provided in **Appendix C**.

Conduit replaced due to corrosion. Another line was noted to have been patched. FLARNG noted that may have been response issues in the past.

Photograph No. 2 Description: Looking north. Conduit replaced due to corrosion. Photo Date: 1/29/19

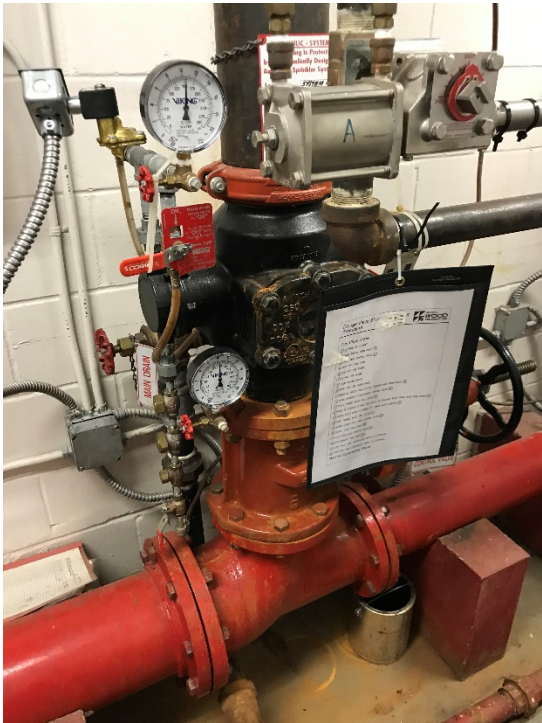
Corrosion from concentrated seepage noted in Deluge Room

Photo ID/Name	Date & Location	Description	Photograph
5	1/29/19 Ceil Frieze AREA	unknown direction	Shutoff valve with rust staining
6	1/29/19 Ceil Frieze AREA	unknown direction	Corroded conduit in deluge room.

Army National Guard, Preliminary Assessment for PFAS	Cecil Field AASF #1	Jacksonville, Florida
<p>Photograph No. 5</p> <p>Description:</p> <p>Unknown direction</p> <p>Shutoff valve with rust staining in deluge room</p> <p>Photo Date: 1/29/19</p>

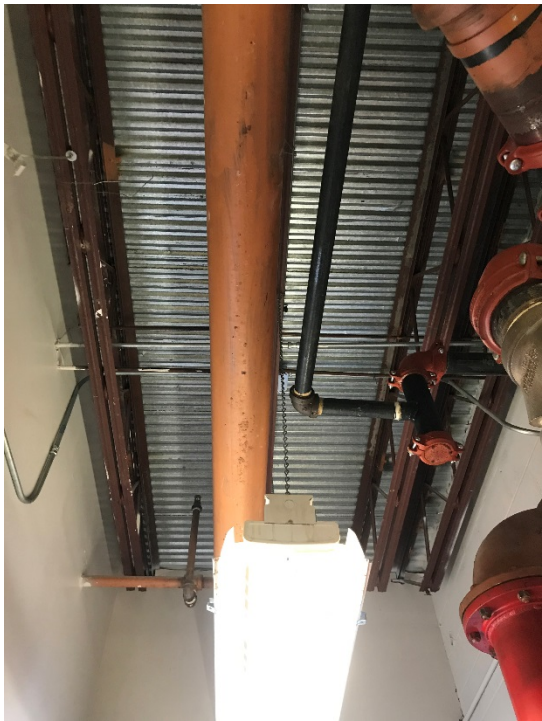
<p>Photograph No. 6</p> <p>Description:</p> <p>Unknown direction</p> <p>Conduit in deluge room with rust staining</p> <p>Photo Date: 1/29/19</p>

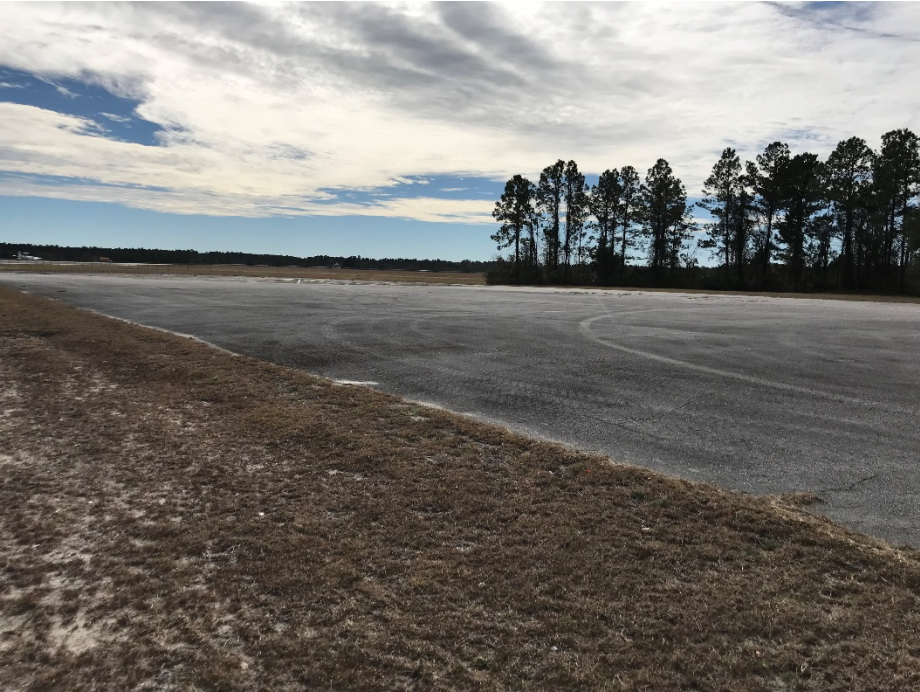
APPENDIX C – Photographic Log		
Army National Guard, Preliminary Assessment for PFAS		Cecil Field AASF #1
		Jacksonville, Florida
Photograph No. 9

The former FTA (Site 7) was used by the Navy to train aircraft firefighting techniques in one pit and two pads. The approximate geographic coordinates for the two pads are 30° 13' 15.1" N; 81° 53' 40.8" W and 30° 13' 14.3" N; 81° 53' 40.0" W. Approximate geographic coordinates for the pit are 30° 13' 16.6" N; 81° 53' 39.6" W. Site 7 was active from the 1950s, until fire-fighting activities ceased in 1975, and was most active during the Vietnam conflict (ABB Environmental Services, Inc., 1994). The two burn pads can be seen in the two aerial photographs from 1963 and 1975 in the environmental data resource report (EDR)TM provided in **Appendix A**. However, the burn pit is not distinguishable in aerial photographs provided in the EDRTM report.

Description:		
Looking southwest		
General view of suspected Navy FTA Photo Date: 1/29/19
