FINAL Preliminary Assessment Report Fort Pierce Readiness Center Fort Pierce, Florida

Perfluorooctanesulfonic Acid (PFOS) and Perfluorooctanoic
Acid (PFOA) Impacted Sites
ARNG Installations, Nationwide

August 2020

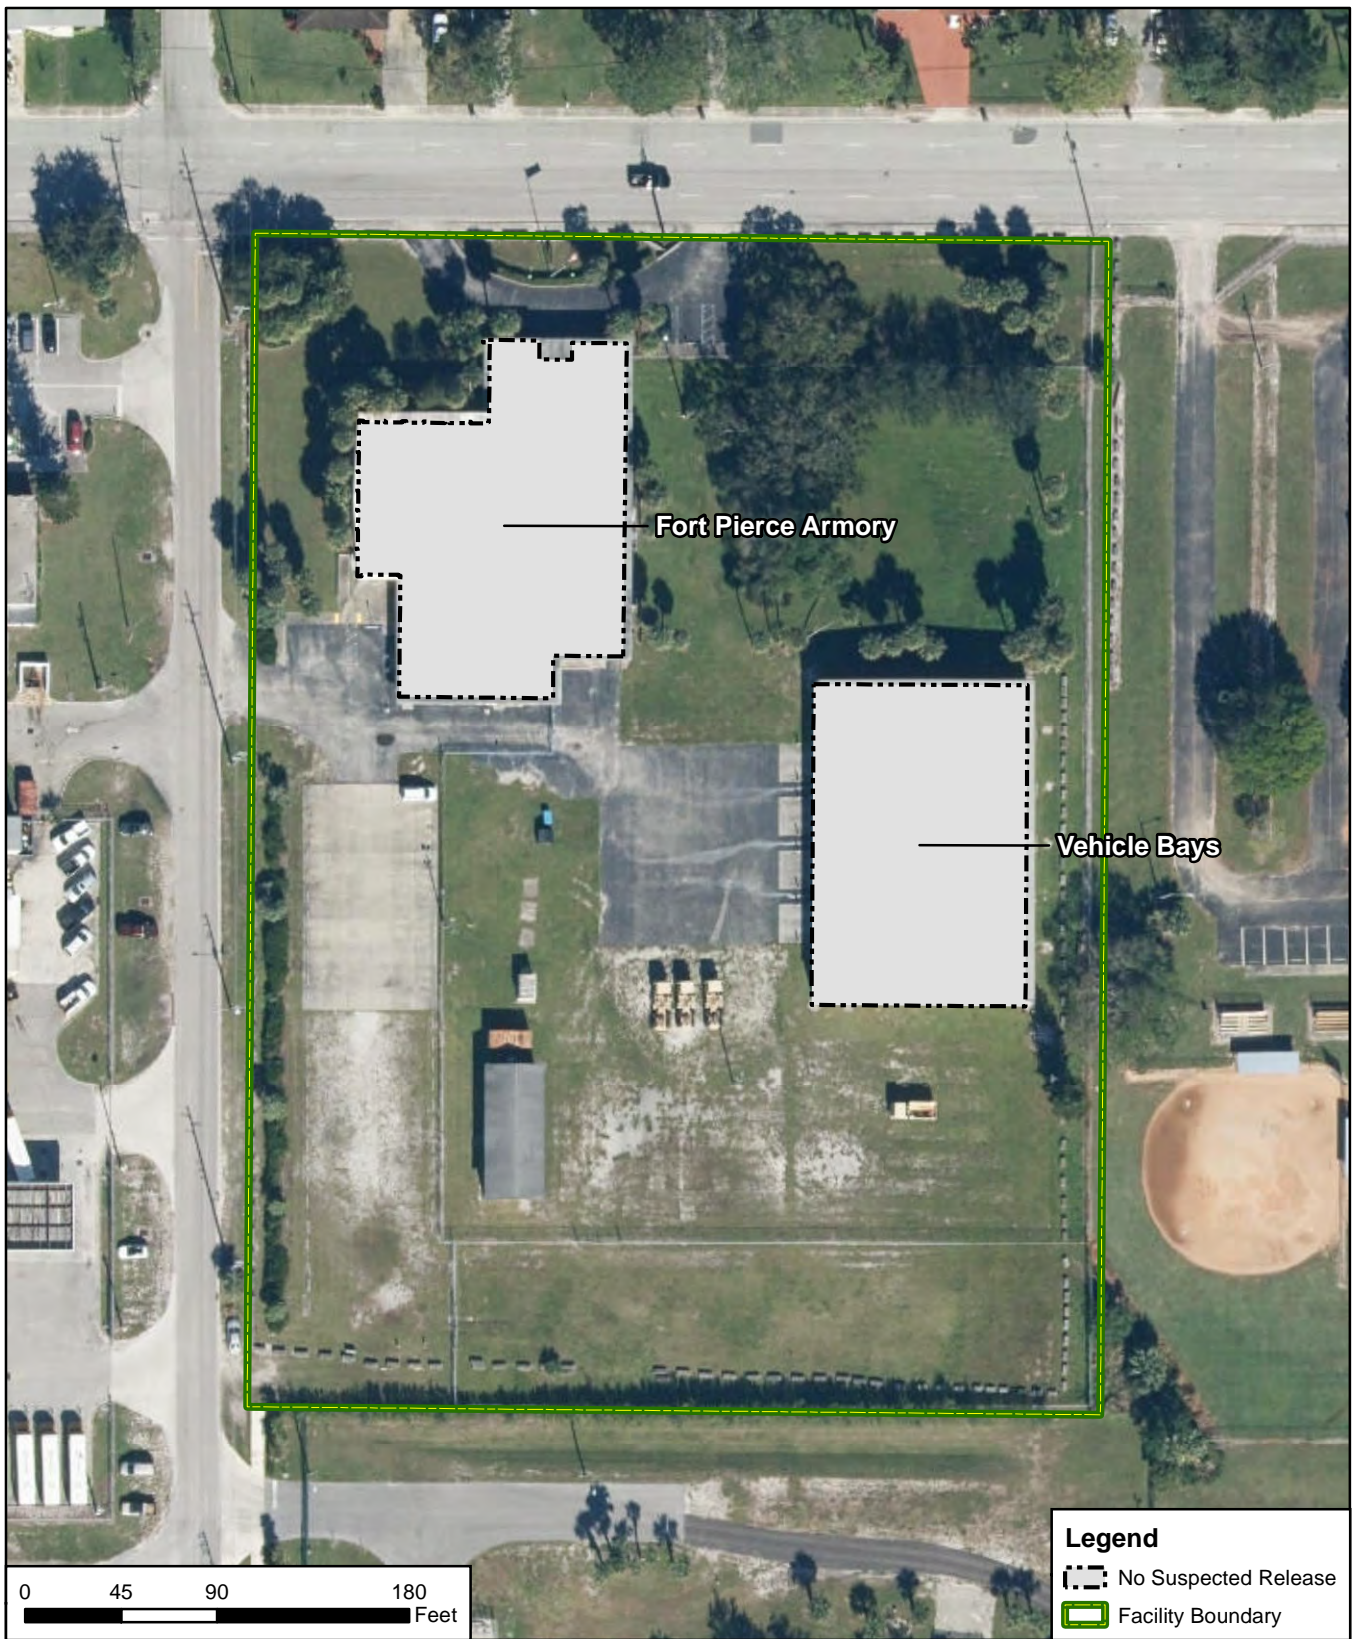
Summary of Findings	
AECOM 12420 Milestone Center Drive Germantown, MD 20876	Figure ES-1

Two areas, Fort Pierce RC Armory and the vehicle bays, have been identified as No Suspected Releases (**Figure ES-1**). Based on the documented absence (2017-present) of the use or release of PFAS-containing materials at Fort Pierce RC, no Areas of Interest (AOIs) were identified during the PA. Evidence does not indicate that current or former ARNG activities contributed PFAS contamination to soil, groundwater, surface water, or sediment at the facility or adjacent areas. Fort Pierce RC will not move forward in the Comprehensive Environmental Response, Compensation, and Liability Act (CERCLA) process.

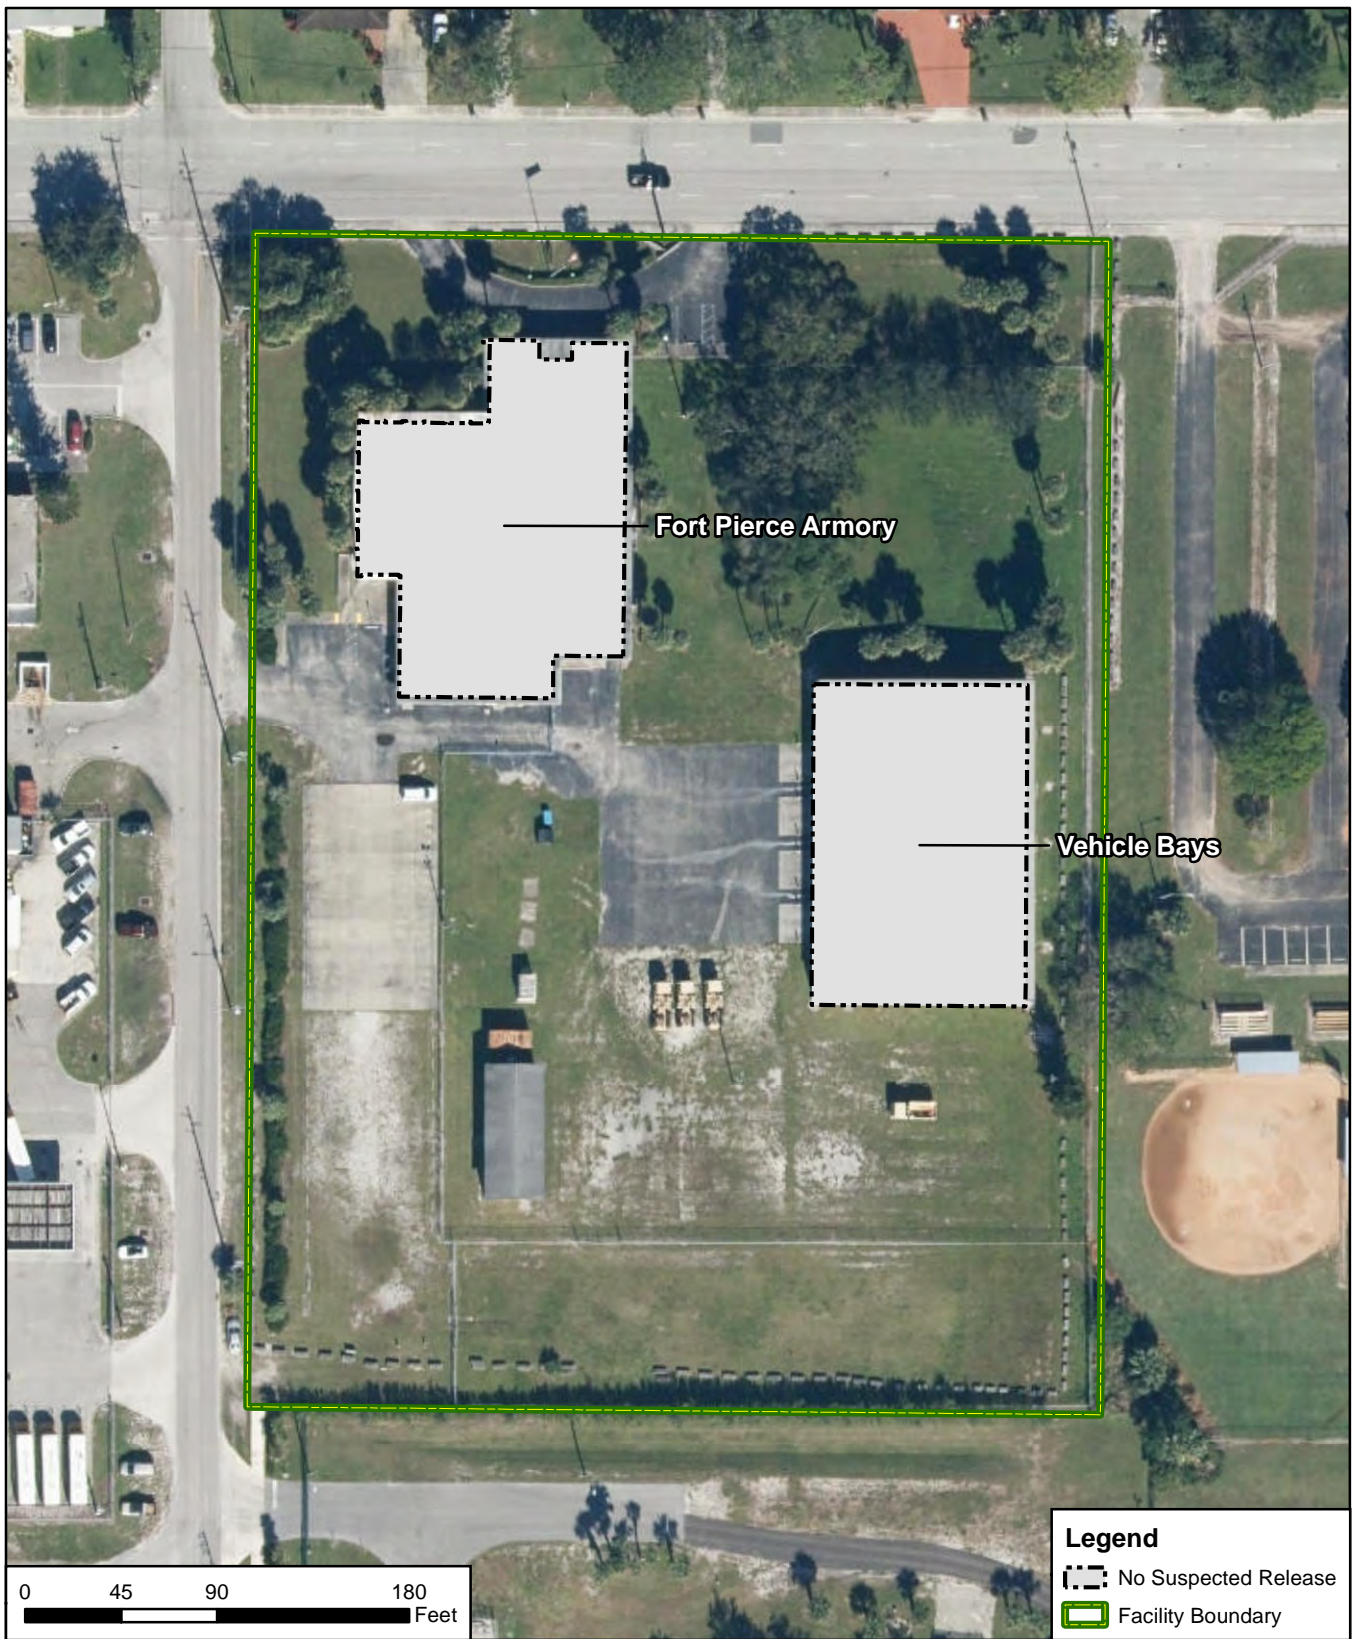
Non-Fire Training Area	
 12420 Milestone Center Drive Germantown, MD 20876	Figure 3-1

Two non-FTAs where PFAS were potentially released were identified during the PA. Descriptions of the non-FTAs are presented below, and the non-FTAs are shown on **Figure 3-1**. Interview records appear in **Appendix B**, and photographs appear in **Appendix C**.

The Armory is located in the northwest portion of the facility property (**Figure 3-1**). The geographic coordinates are 27°26'36.37"N; 80°21'13.13"W. The armory is used for drills and is not outfitted with a fire suppression system. During the site visit, ABC Dry chemical extinguishers were found throughout the facility. The kitchen portion of the armory is outfitted with a fire suppression system. At the time of the visit and to interviewee knowledge dating back to 2017, the fire suppression system contained potassium alkaline base solution. The kitchen also contained K-class fire extinguishers, which do not contain PFAS. A potential PFAS release to the environment at the armory is not suspected.

The vehicle bays are located on the eastern portion of the facility property (**Figure 3-1**). The geographic coordinates are 27°26'34.66"N; 80°21'10.70"W. The vehicle bays were used to store vehicles from the military police unit and is not outfitted with a fire suppression system or floor drains. The military police unit vehicles were mounted with missile pods. These vehicles were stored and maintained in the vehicle bays. It is unknown if AFFF may have been present when these vehicles were stored at the facility. Currently, the vehicle bays serve as a multipurpose area used for vehicle storage, light vehicle maintenance, and leisure activities area. During the site visit, extinguishers were not observed in the vehicle bays. At the time of the visit and to interviewee knowledge dating back to 2017, there were no vehicle fires at the facility. A potential PFAS release to the environment at the armory is not suspected.

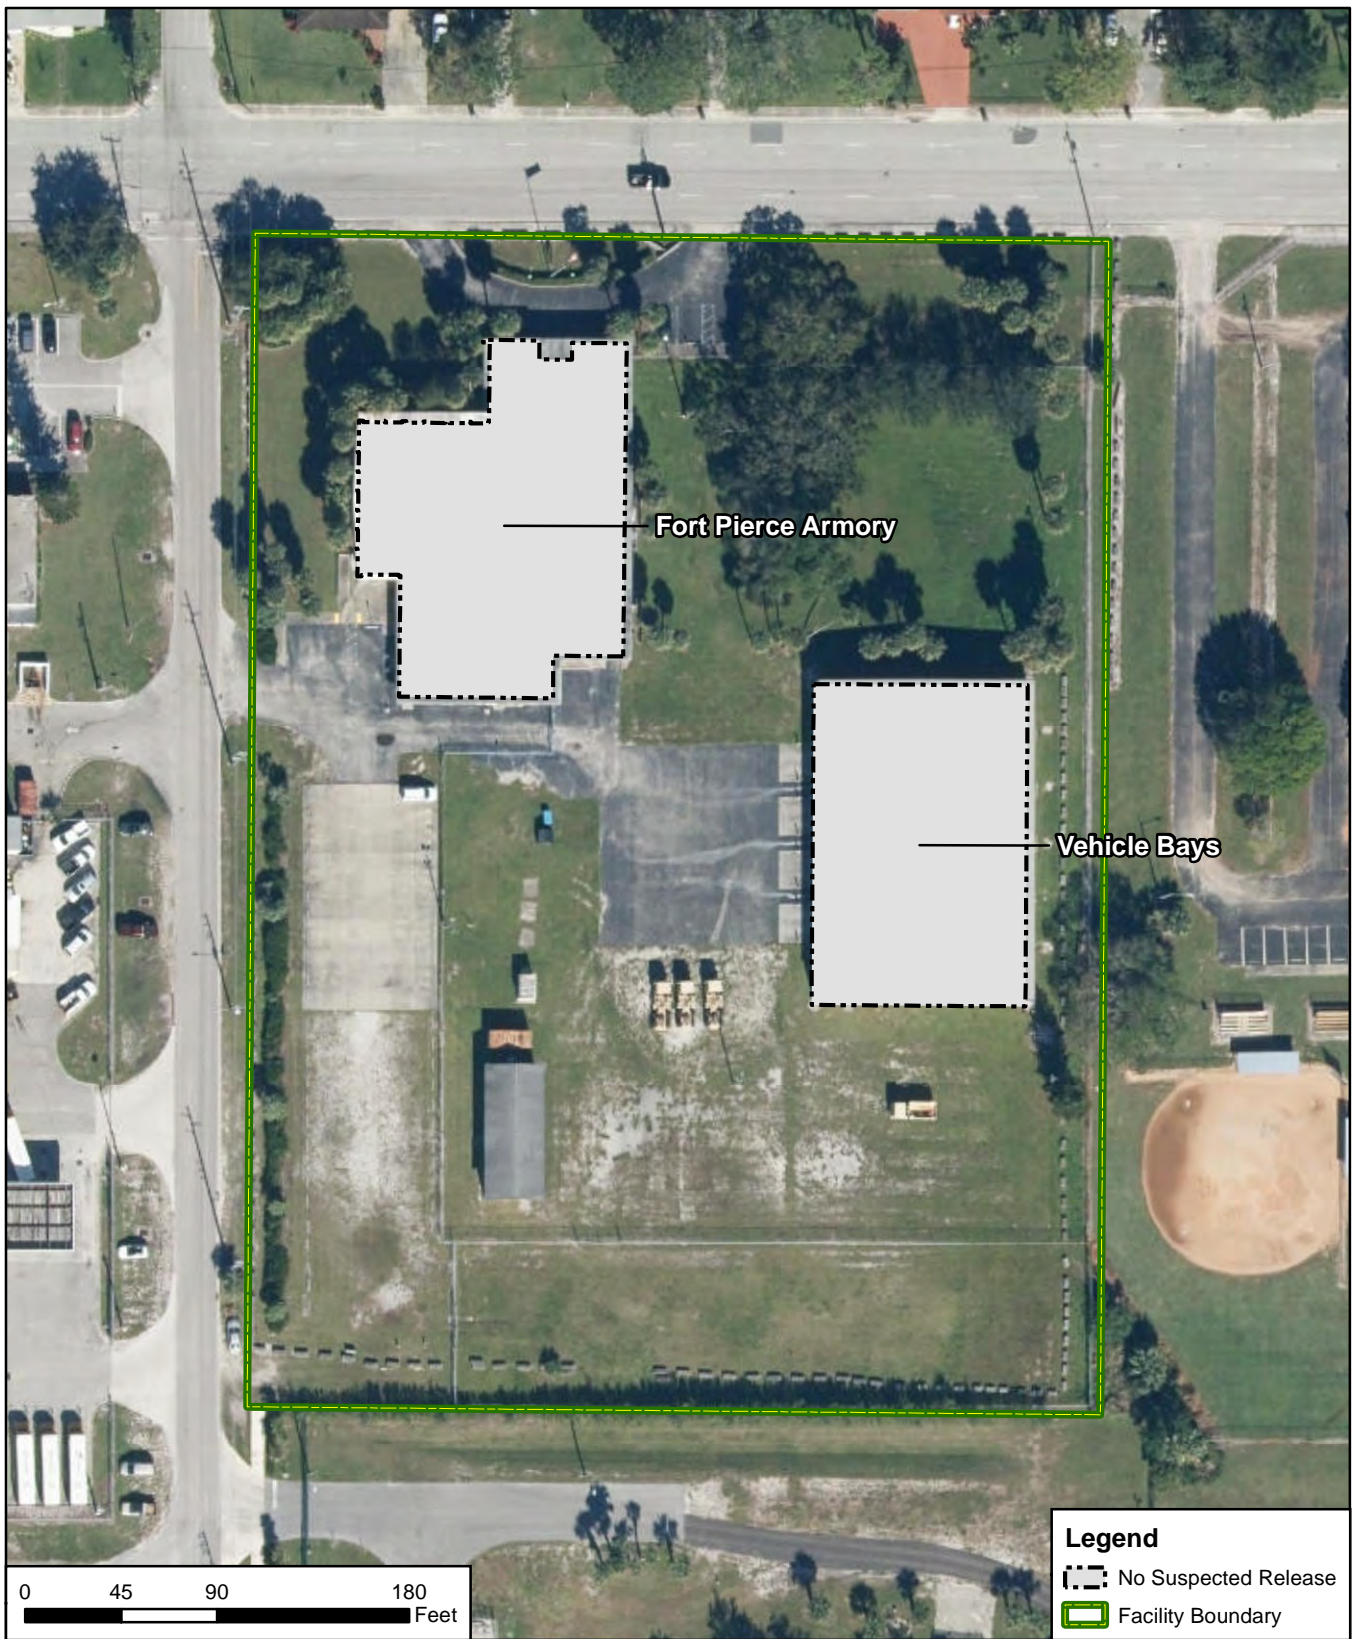
Summary of Findings	
AECOM 12420 Milestone Center Drive Germantown, MD 20876	Figure 7-1

No PFAS releases relating to current or historical activities at Fort Pierce RC were identified during this PA. The following areas discussed in **Section 3 (Figure 7-1)** and presented in **Table 7-1** below were determined to have no suspected release:

Based on the documented absence (2017-present) of the use or release of PFAS-containing materials at Fort Pierce RC, no AOIs were identified during the PA. Evidence does not indicate that current or former ARNG activities (if past activities were consistent with current operational procedures) contributed PFAS contamination to soil, groundwater, surface water, or sediment at the facility or adjacent areas. Fort Pierce RC will not move forward in the CERCLA process.
