FINAL Preliminary Assessment Report Lakeland Readiness Center Lakeland, Florida

Perfluorooctanesulfonic Acid (PFOS) and Perfluorooctanoic
Acid (PFOA) Impacted Sites
ARNG Installations, Nationwide

August 2020

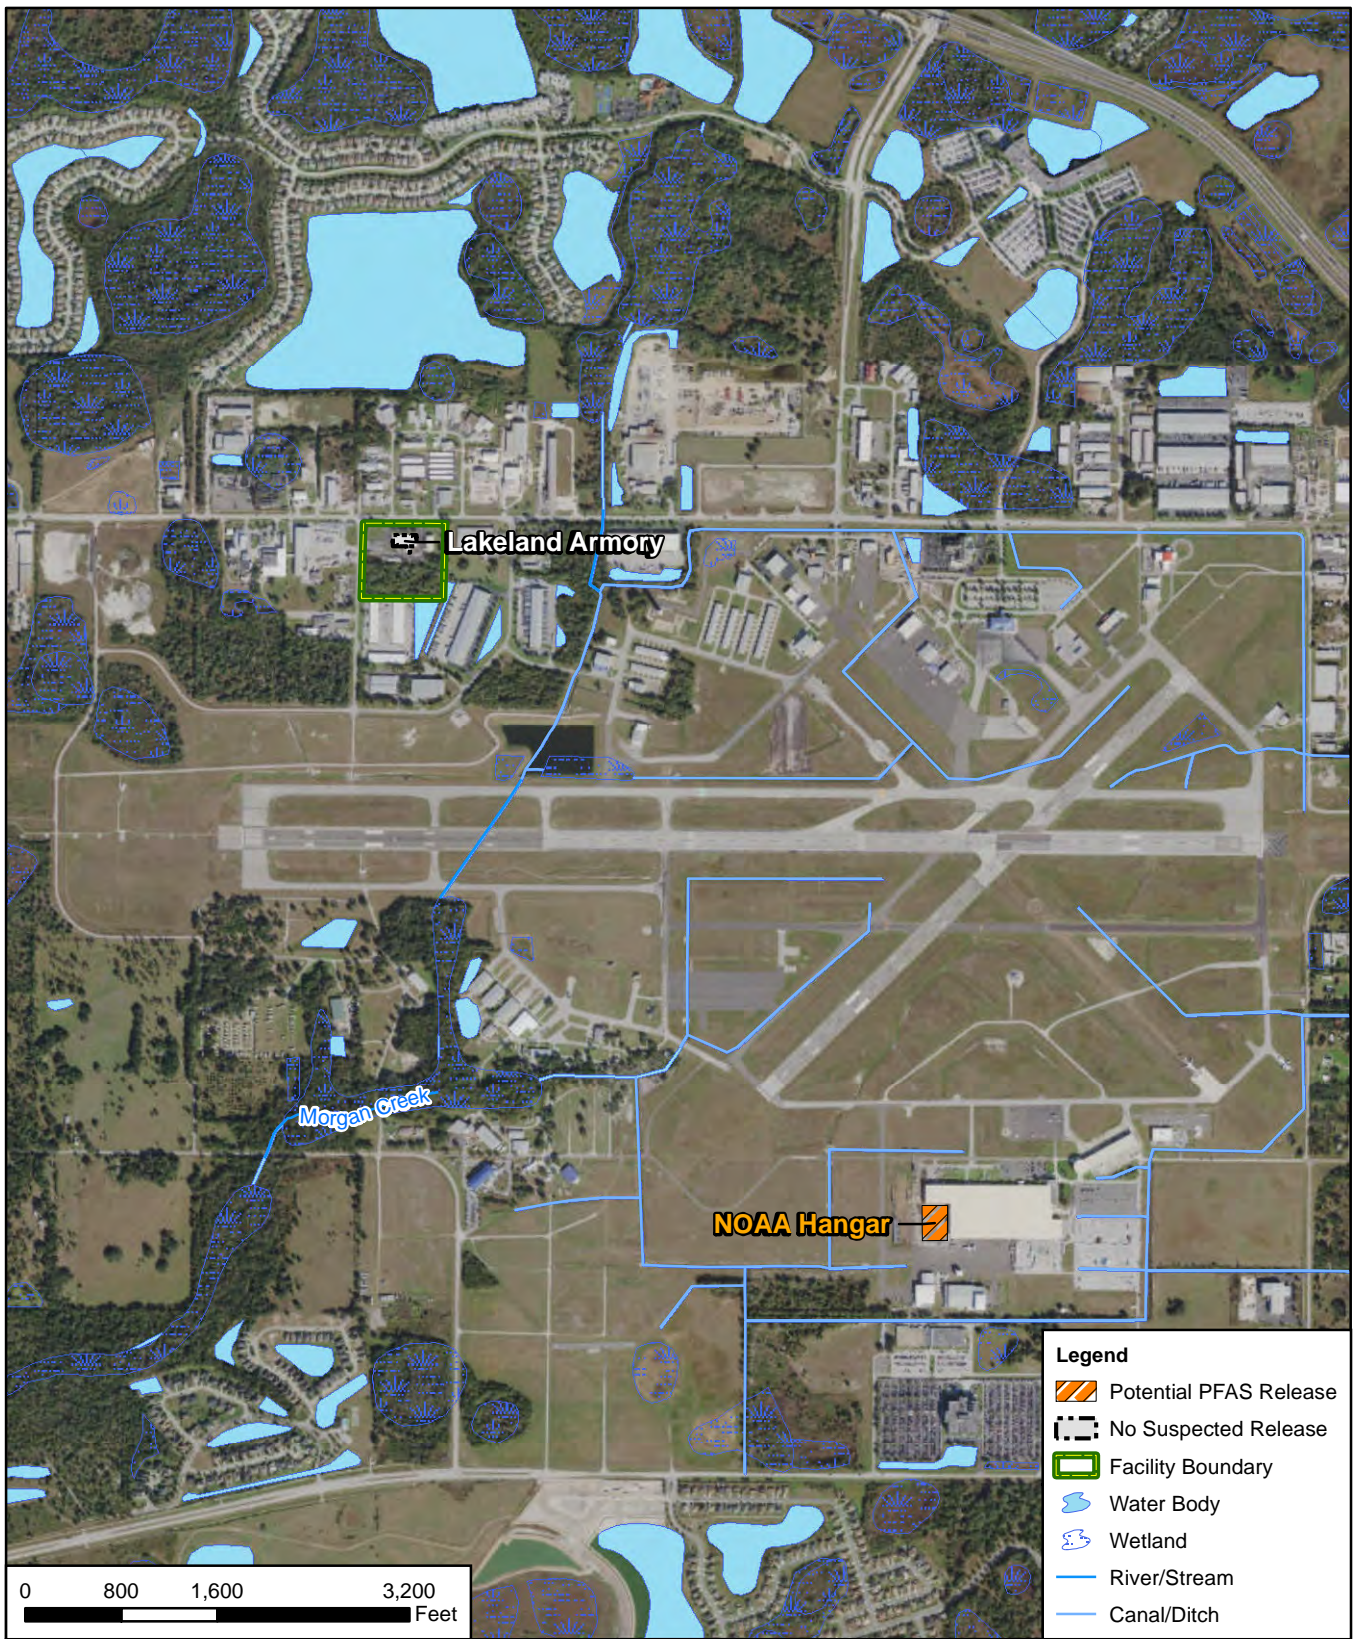
Summary of Findings	
AECOM 12420 Milestone Center Drive Germantown, MD 20876	Figure ES-1

One area, Lakeland RC Armory, has been identified as No Suspected Release (**Figure ES-1**). Based on the documented absence (2000-present) of the use or release of PFAS-containing materials at Lakeland RC, no Areas of Interest (AOIs) were identified during the PA. Evidence does not indicate that current or former ARNG activities contributed PFAS contamination to soil, groundwater, surface water, or sediment at the facility or adjacent areas. Lakeland RC will not move forward in the Comprehensive Environmental Response, Compensation, and Liability Act (CERCLA) process.

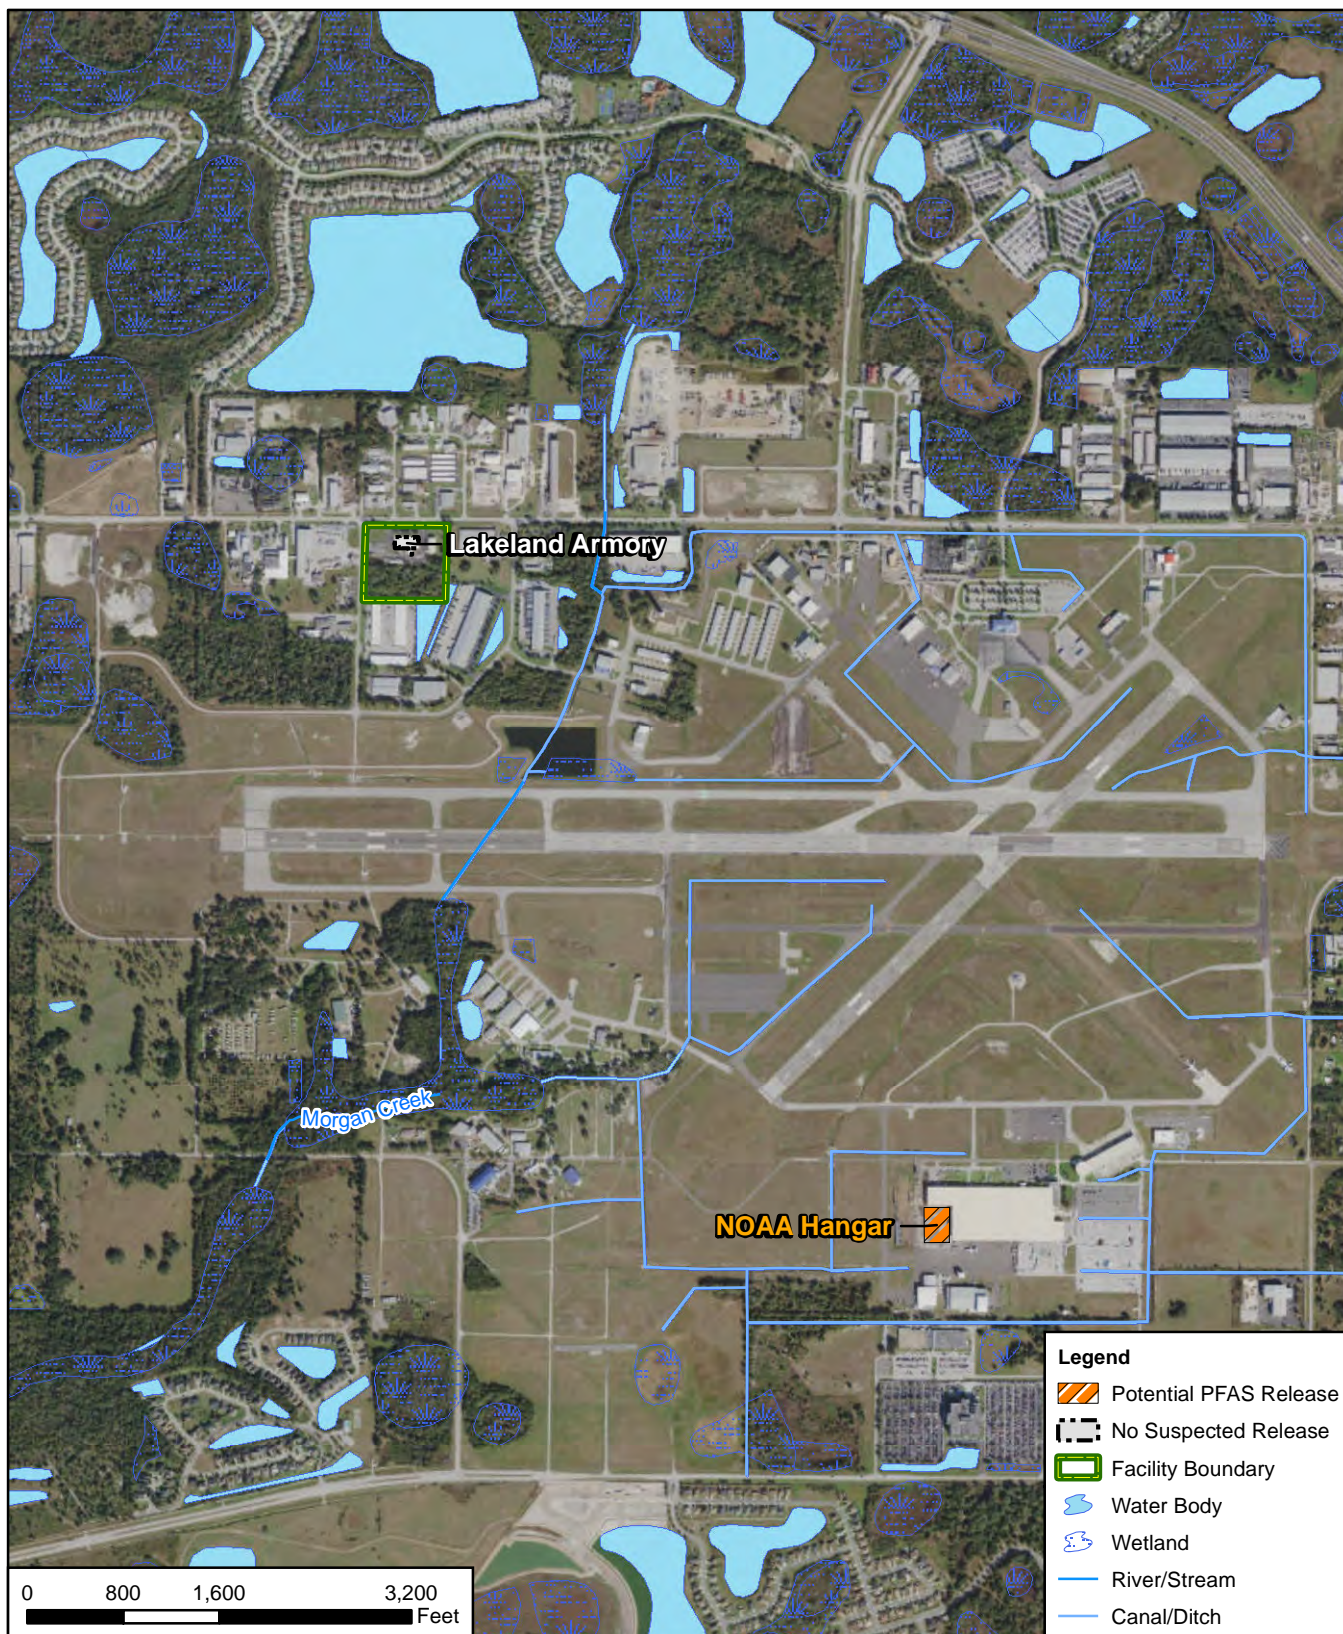
Summary of Findings				
NOTES Preliminary Assessment for PFAS at Lakeland Readiness Center, FL								<div>

No PFAS releases relating to current or historical activities at Lakeland RC were identified during this PA. The following areas, which were discussed in **Section 3 (Figure 7-1)** and are presented in **Table 7-1** below, were determined to have no suspected release:

Based on the documented absence (2000-present) of the use or release of PFAS-containing materials at Lakeland RC, no AOIs were identified during the PA. Evidence does not indicate that current or former ARNG activities contributed PFAS contamination to soil, groundwater, surface water, or sediment at the facility or adjacent areas. Lakeland RC will not move forward in the CERCLA process.
