FINAL Site Inspection Report Brooksville Readiness Center, Spring Hill, Florida

Site Inspection for Perfluorooctanoic acid (PFOA),
Perfluorooctanesulfonic acid (PFOS), Perfluorohexanesulfonic
acid (PFHxS), Perfluorononanoic acid (PFNA),
Hexafluoropropylene oxide dimer acid (HFPO-DA), and
Perfluorobutanesulfonic acid (PFBS) at ARNG Installations,
Nationwide

September 2023

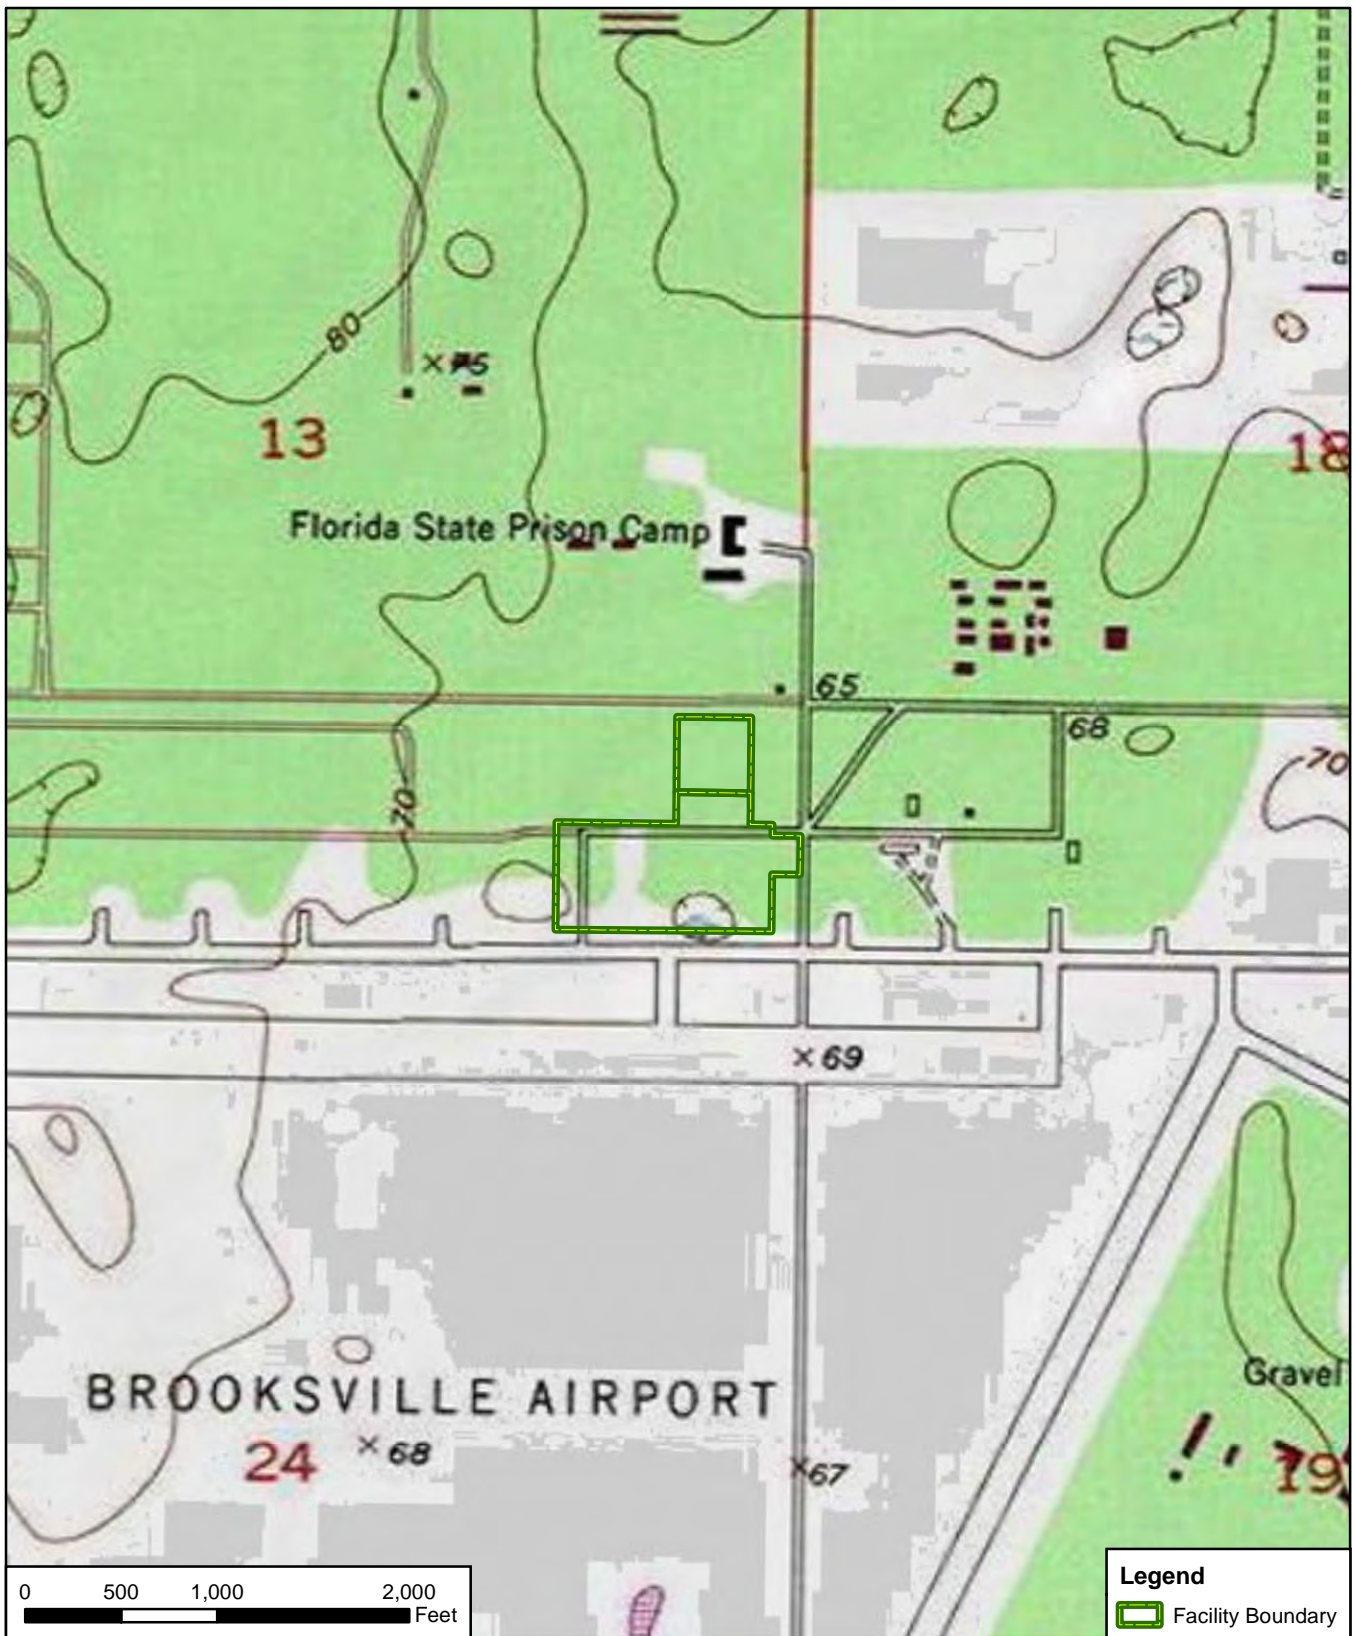
Figure 2-2

Facility Topography

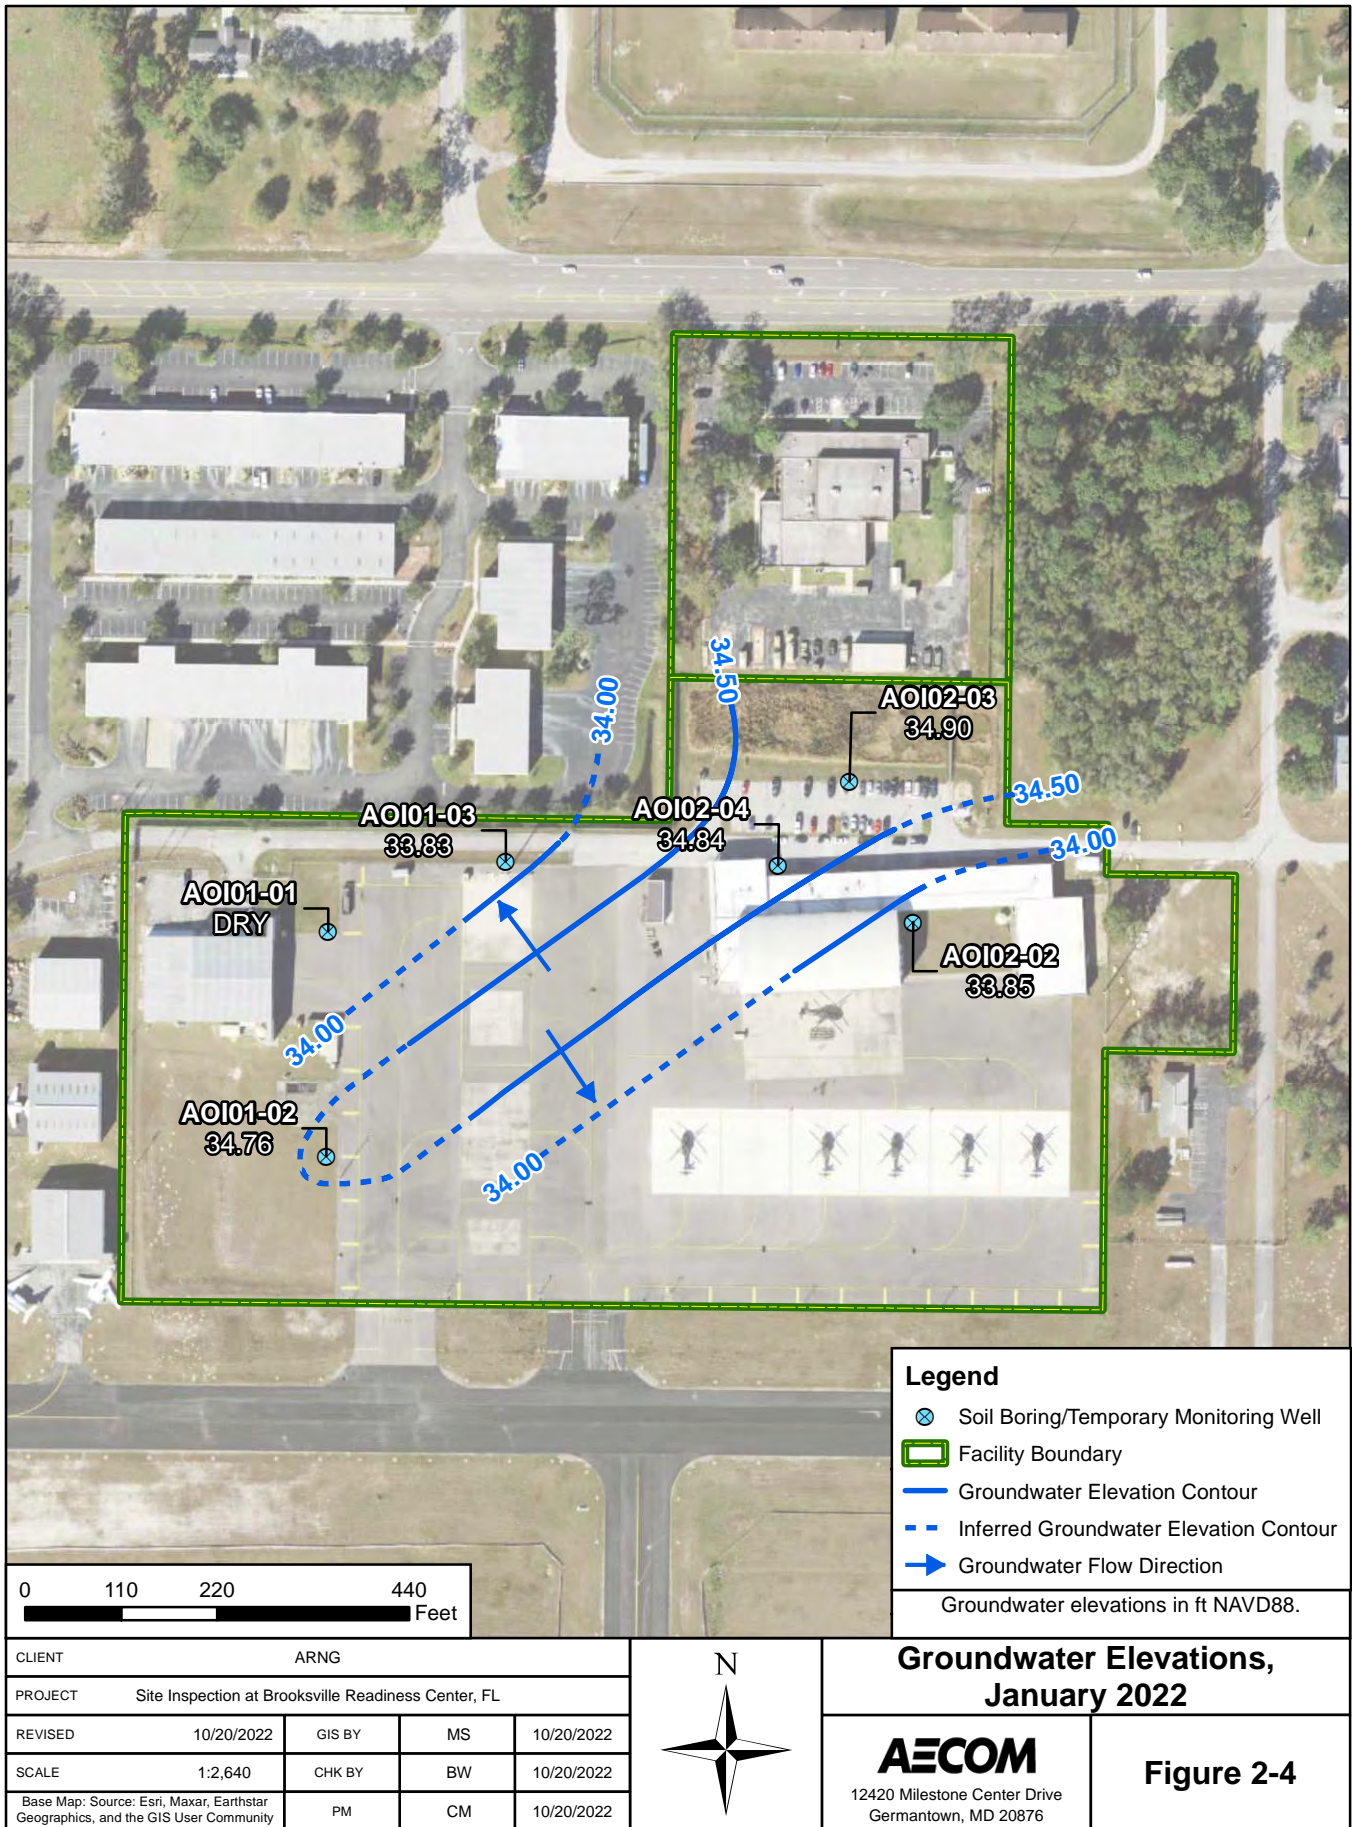
Depths to water measured in January 2022 during the SI ranged from 31.20 to 34.85 feet bgs. Groundwater elevation contours from the SI are presented on **Figure 2-4** and suggest a groundwater flow divide at the facility, with groundwater in the northwestern portion of the facility flowing to the northwest and groundwater in the southeastern half of the facility flowing to the southeast.

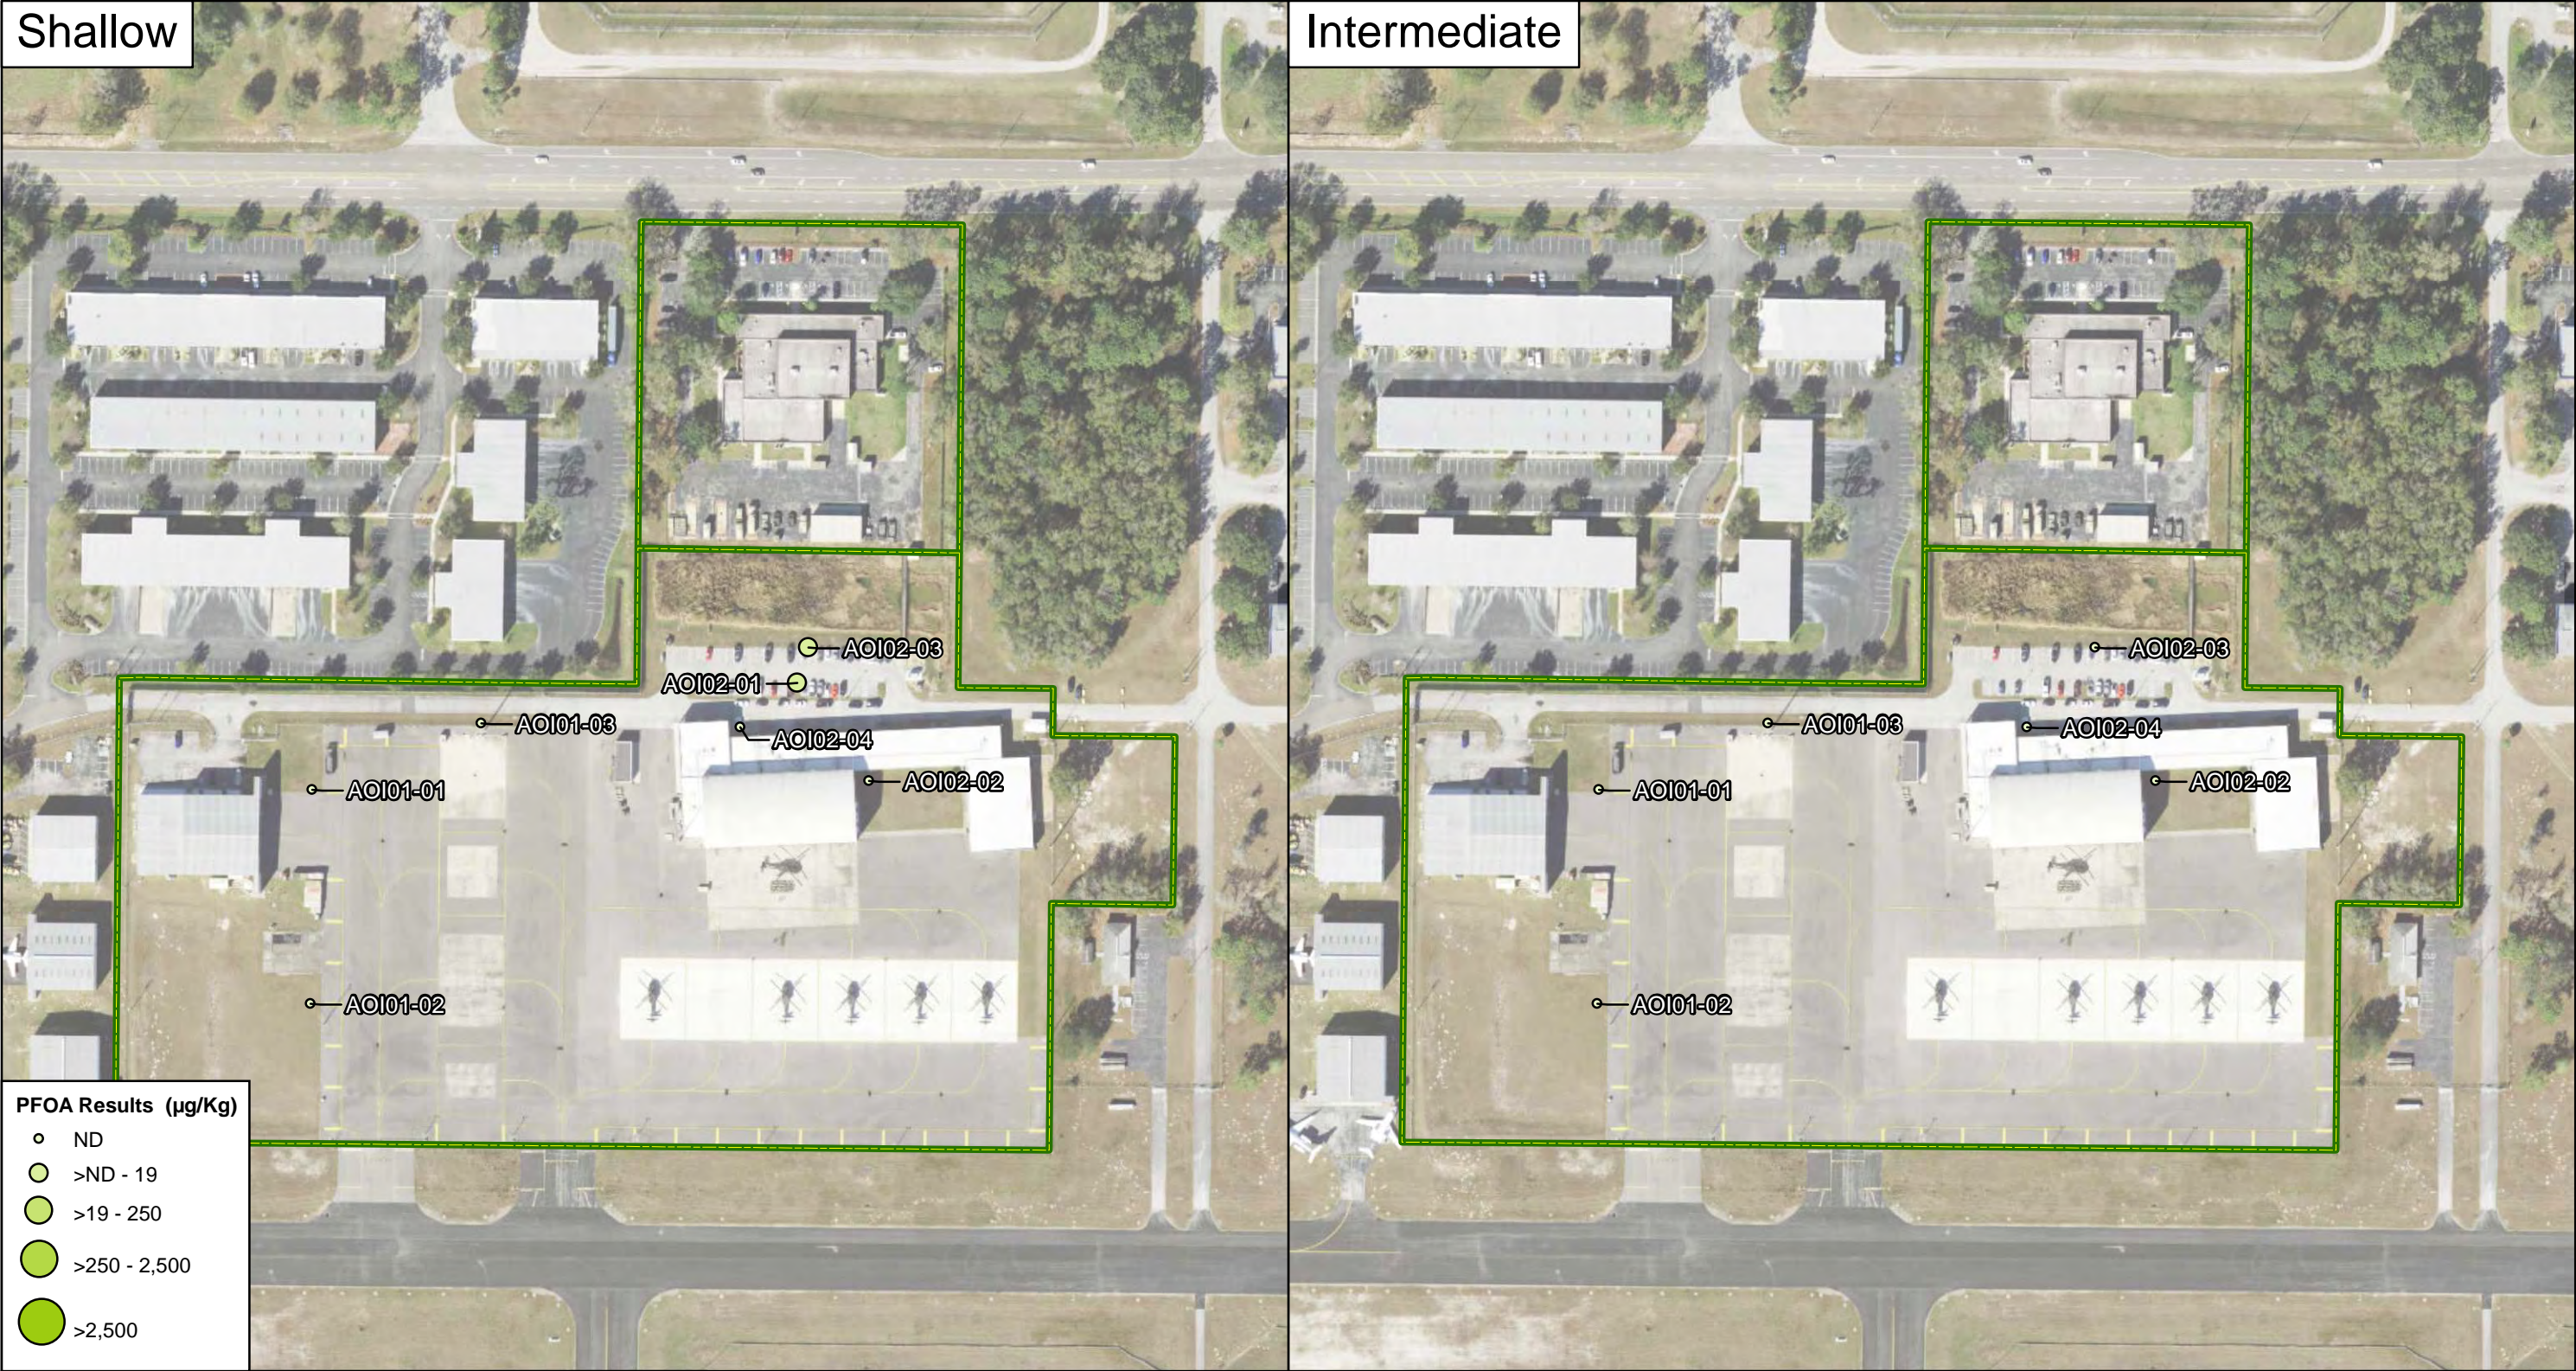
PFOA Detections in Soil		
12420 Milestone Center Drive Germantown, MD 20876		Figure 6-1

PFOA Results (µg/Kg)

- ND
- >ND - 19
- >19 - 250
- >250 - 2,500
- >2,500

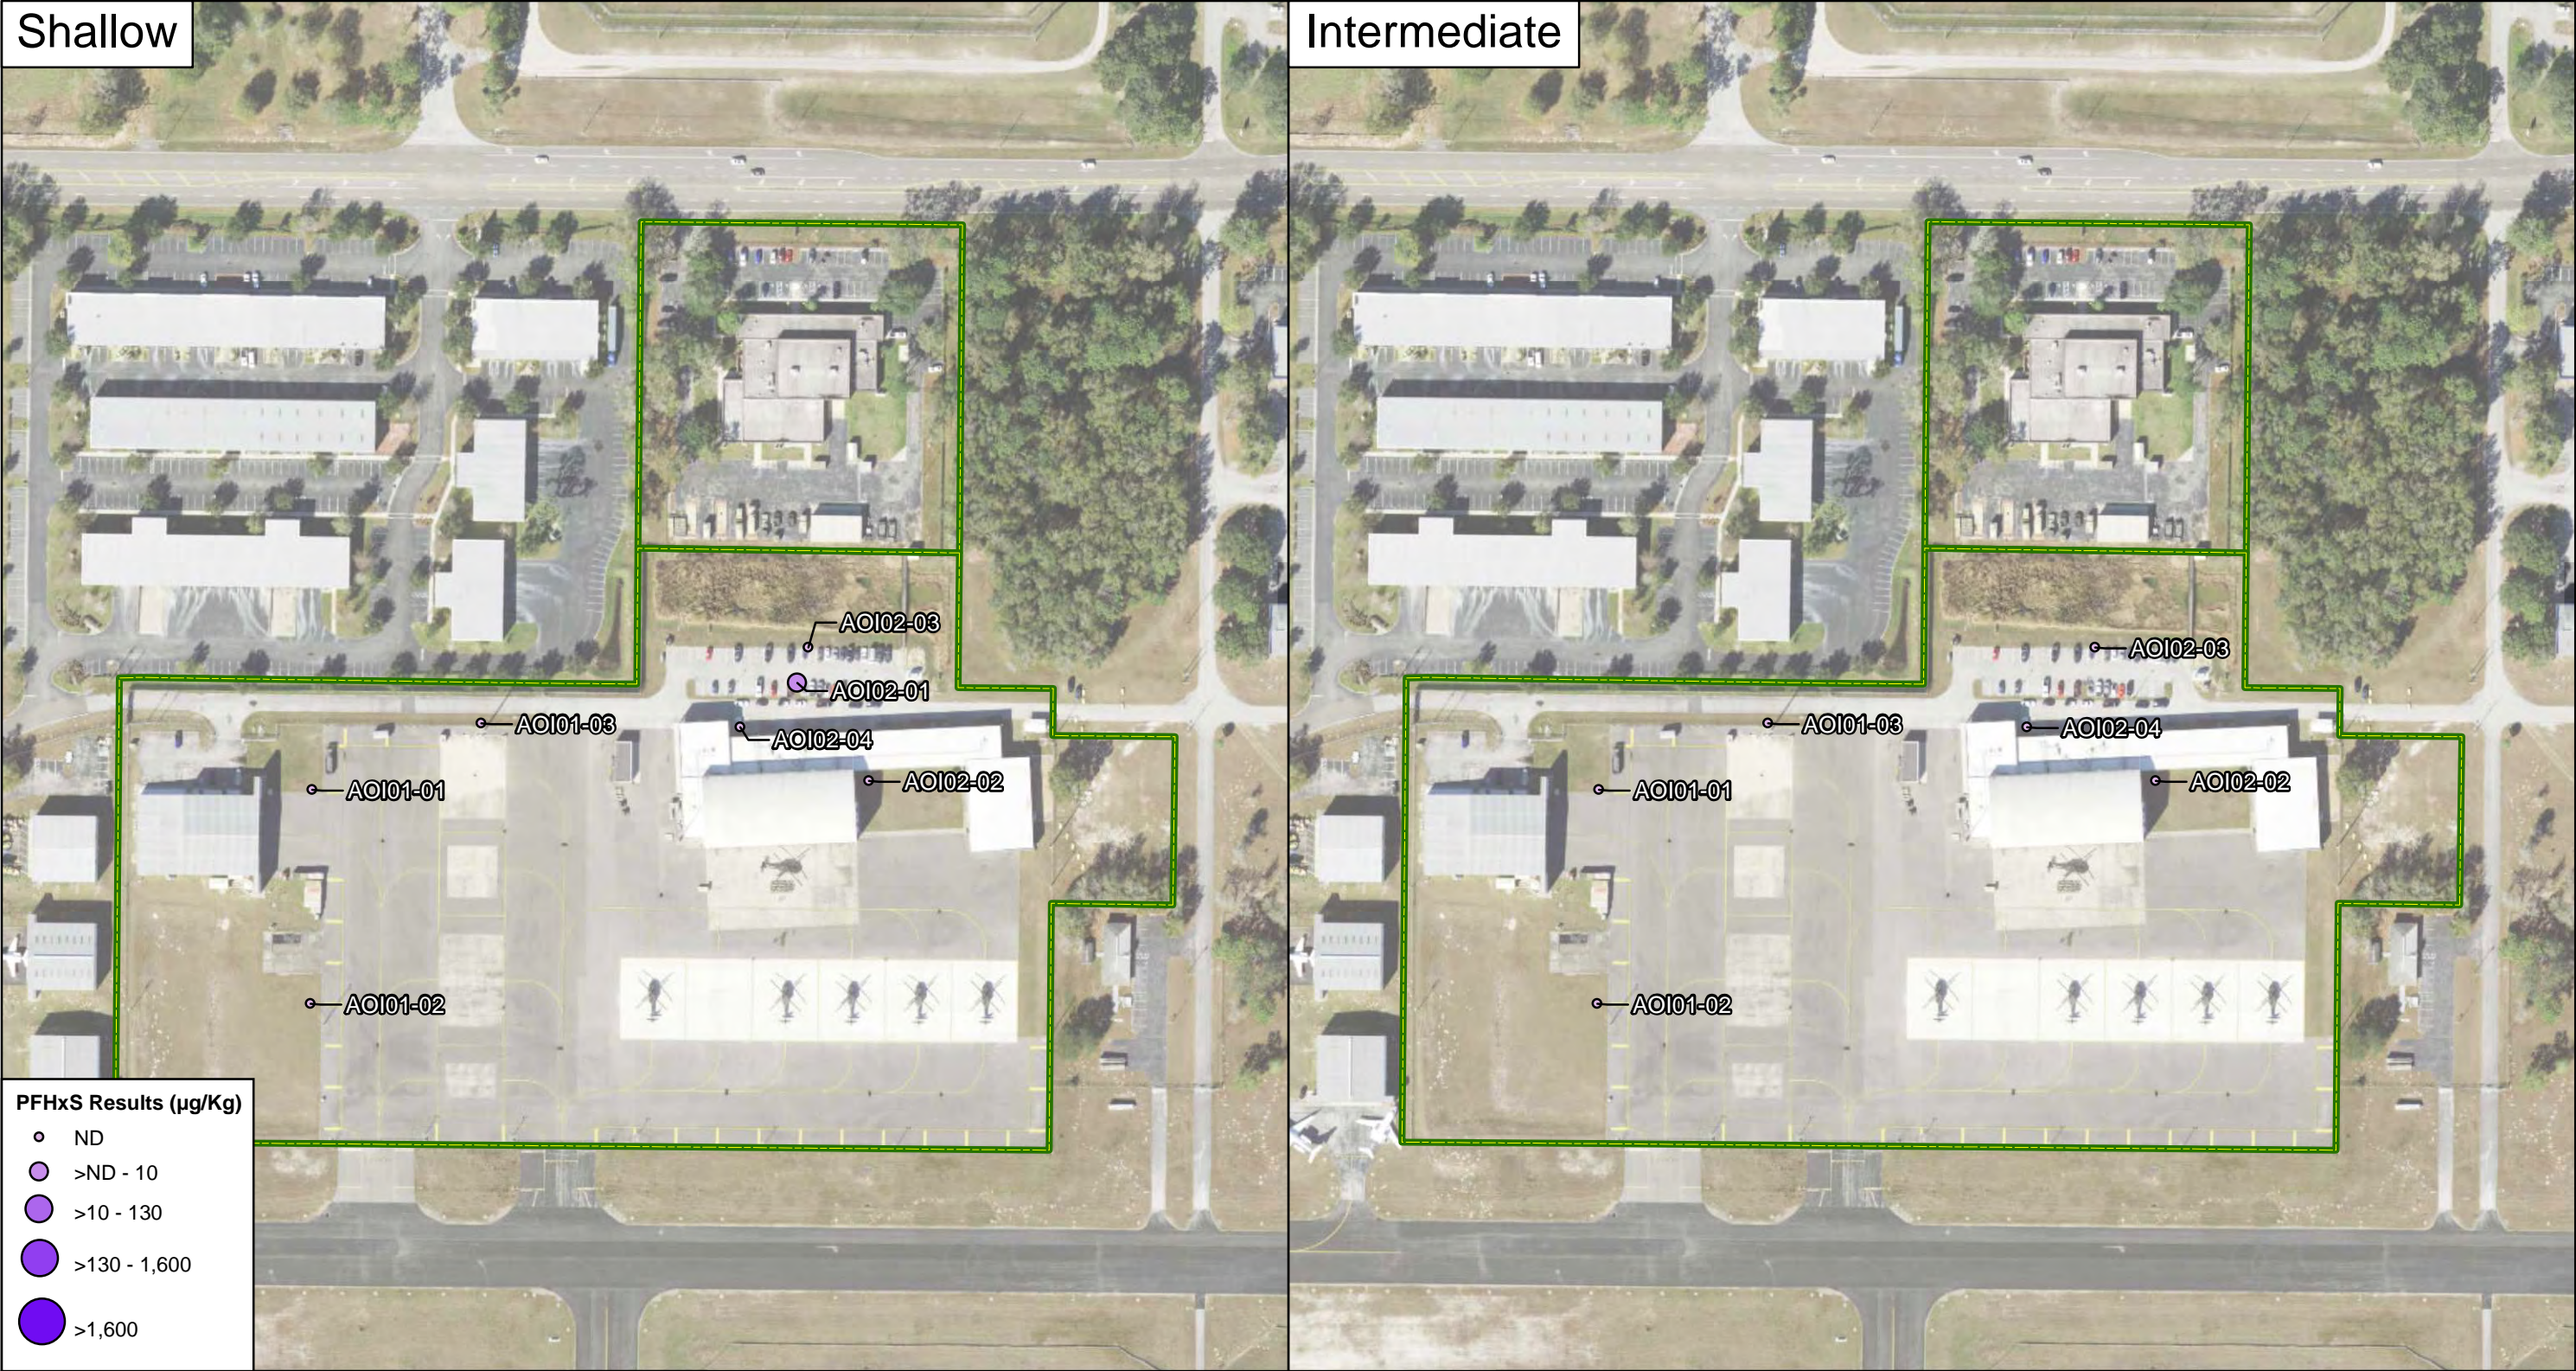
Figure 6-4

PFHxS Results (µg/Kg)

- ND
- >ND - 10
- >10 - 130
- >130 - 1,600
- >1,600

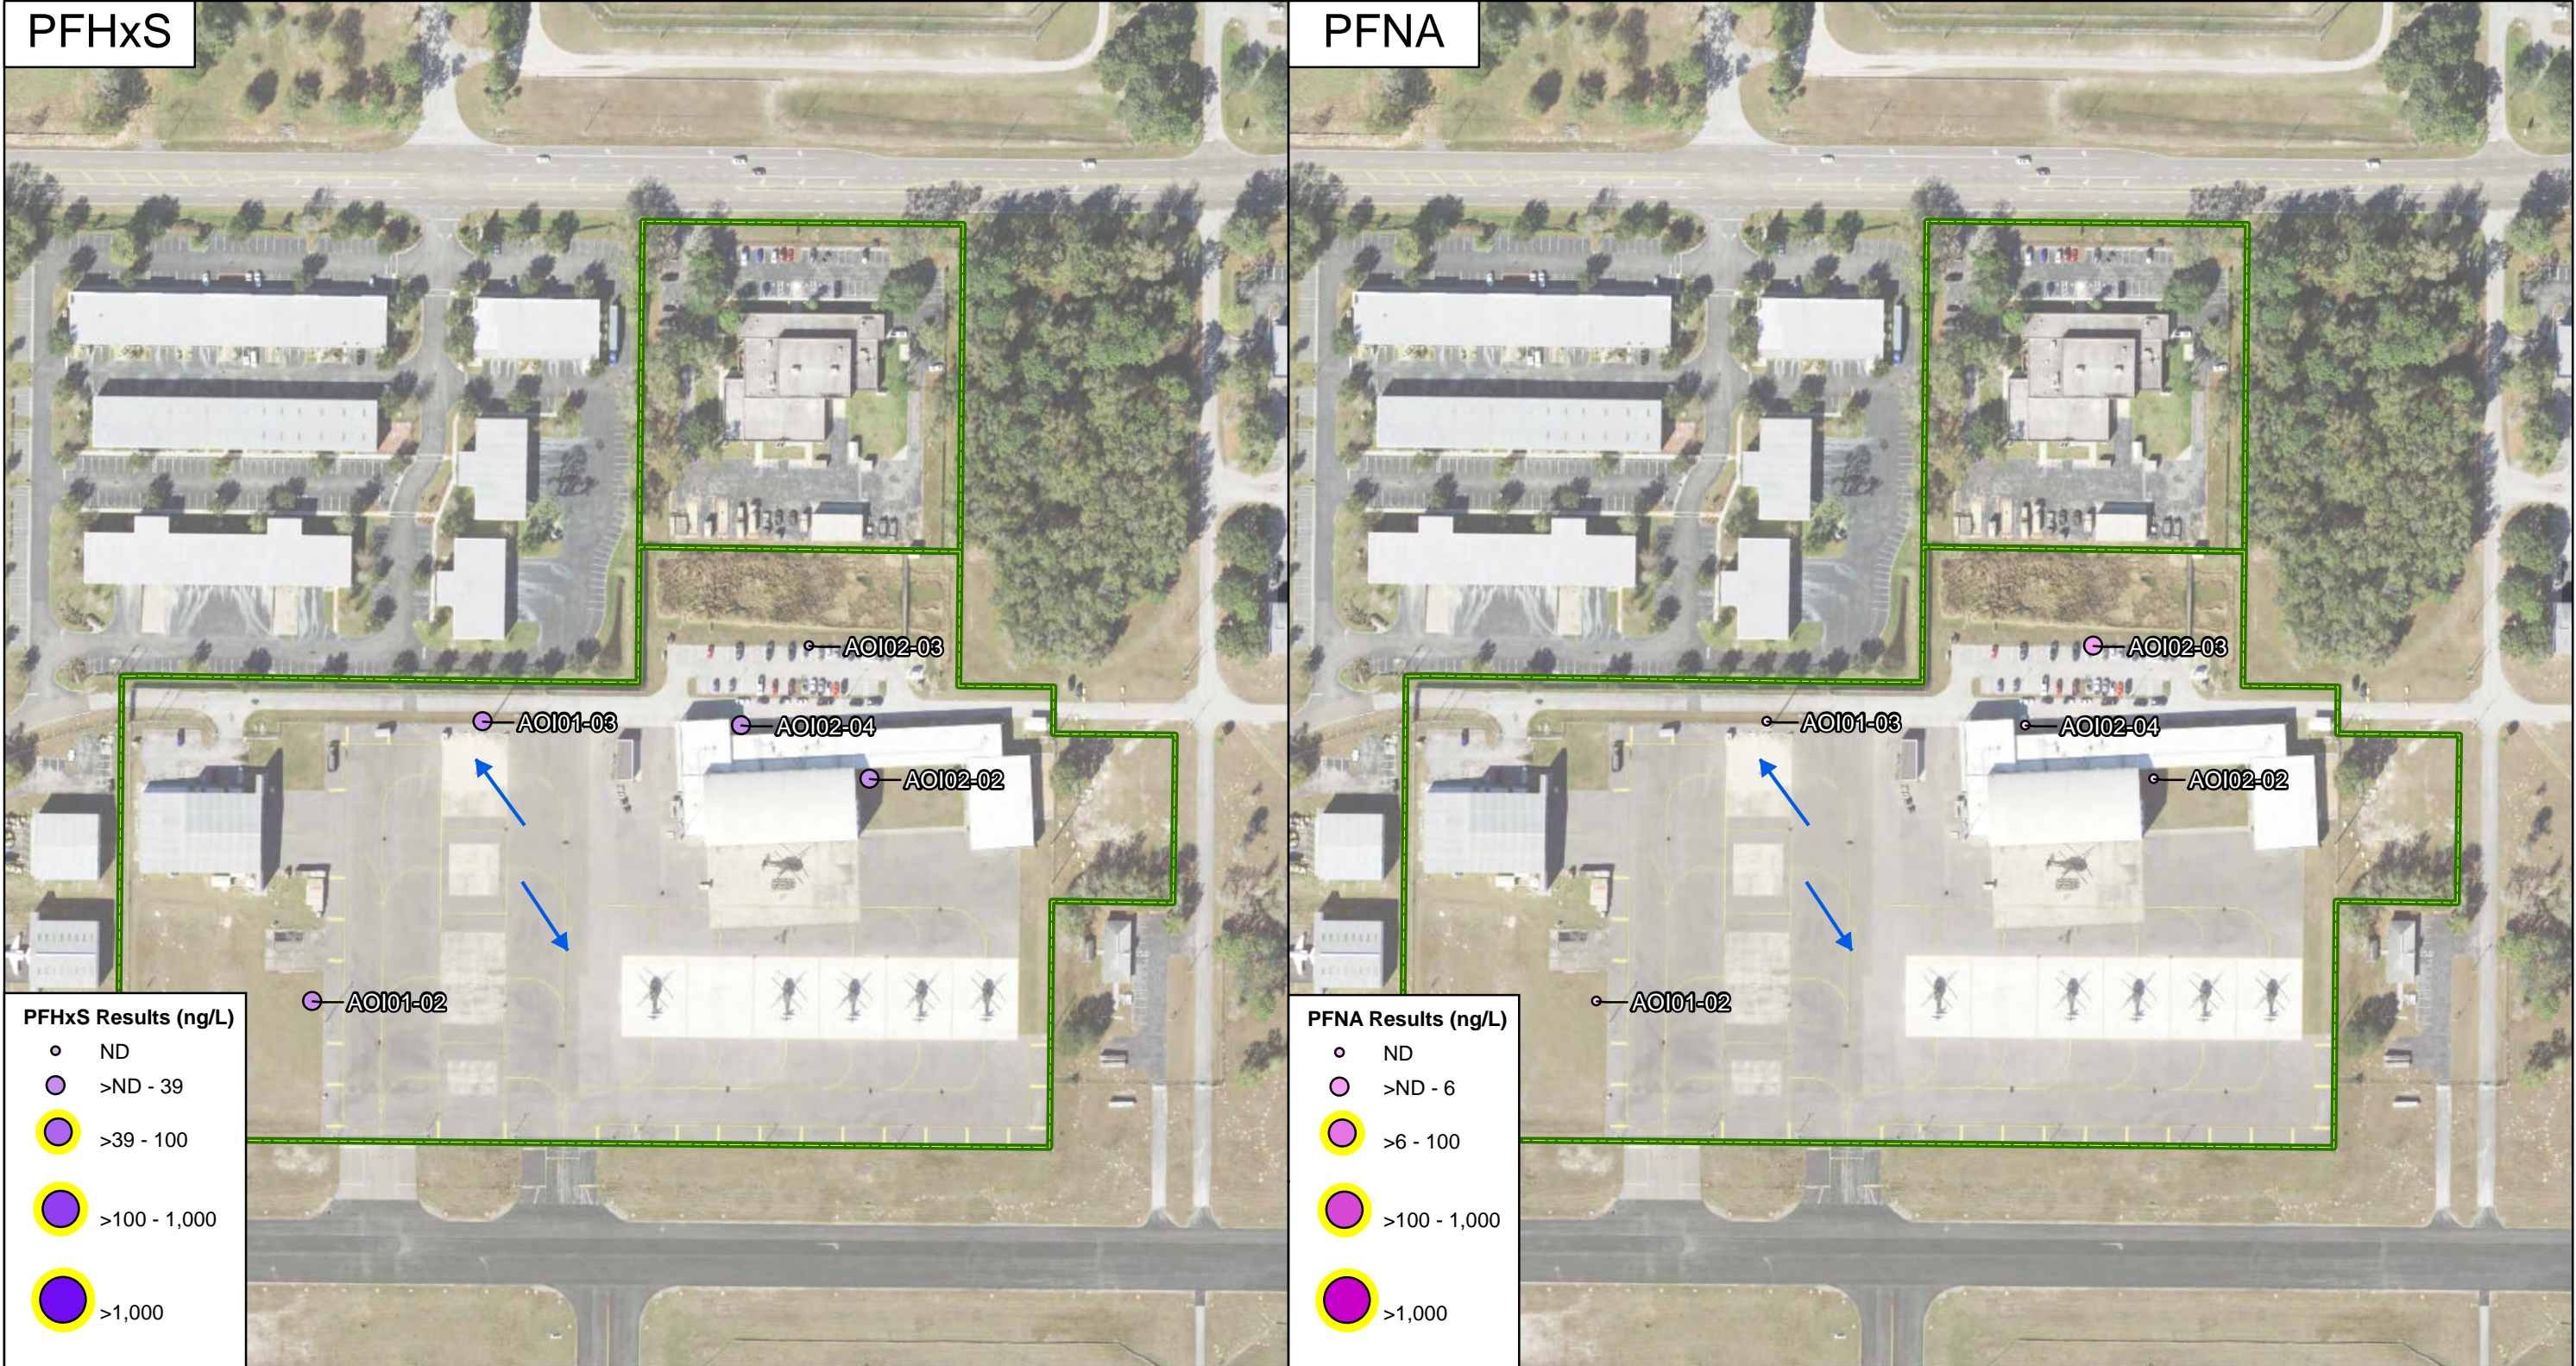
CLIENTARNG					Legend Facility Boundary Groundwater Flow Direction	<div>0100200400 Feet</div>	<div>N</div>	PFHxS and PFNA Detections in Groundwater	
PROJECTSite Inspection at Brooksville Readiness Center, FL								<div>AECOM 12420 Milestone Center Drive Germantown, MD 20876</div>	Figure 6-7
REVISED	8/9/2022	GIS BY	MS	8/9/2022					
SCALE	1:2,400	CHK BY	BW	8/9/2022					
Base Map: Source: Esri, Maxar, Earthstar Geographics, and the GIS User Community					PM	CM	8/9/2022	Exceedances of the OSD SL are depicted with a yellow halo.
