Final Preliminary Assessment Report Gowen Field, Boise, Idaho

Perfluorooctane-Sulfonic Acid (PFOS) and Perfluorooctanoic
Acid (PFOA) Impacted Sites
ARNG Installations, Nationwide

December 2019

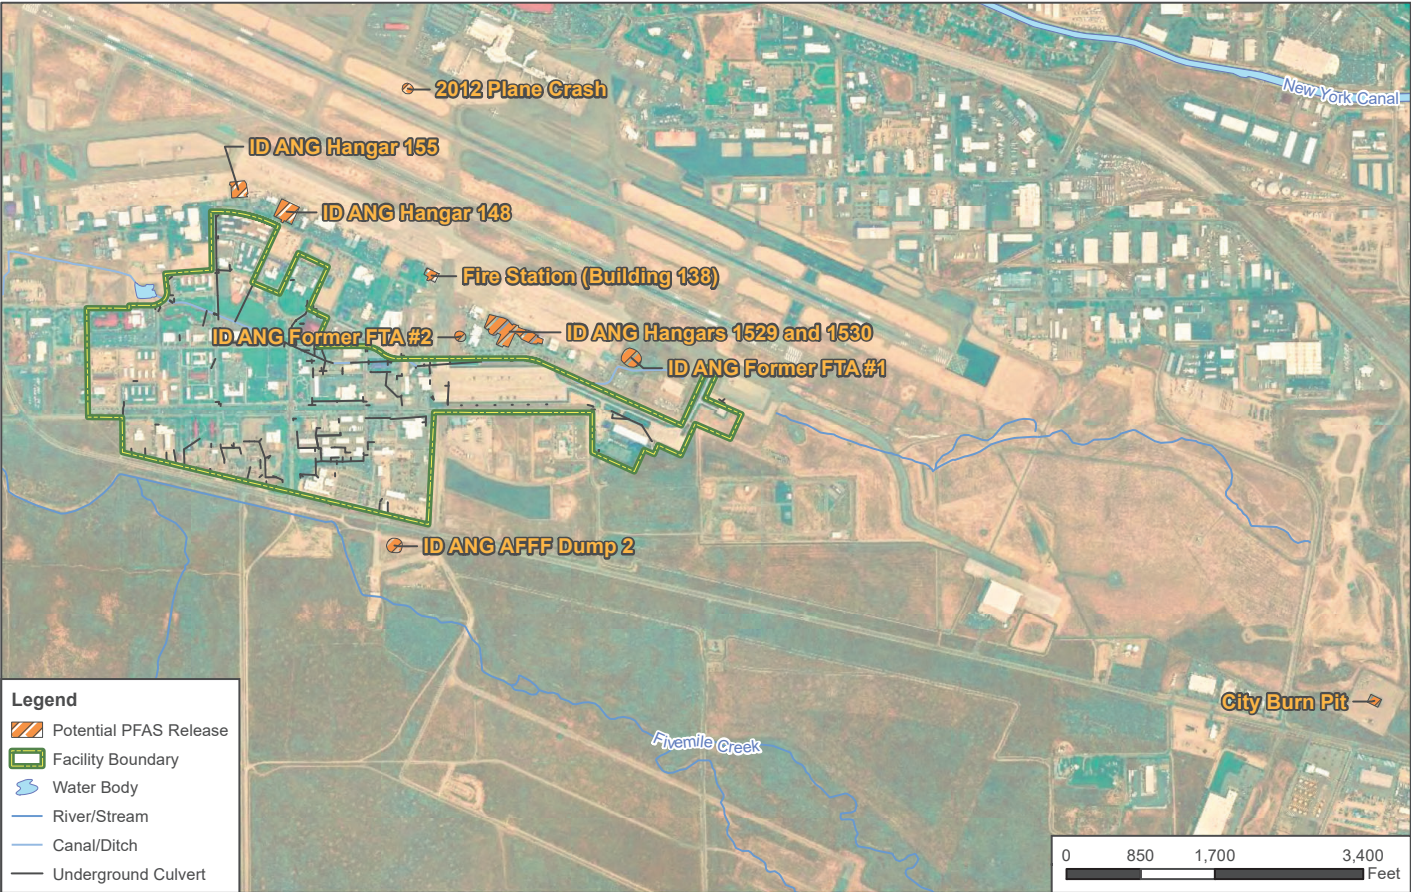
Adjacent Sources	
AECOM	12420 Milestone Center Drive Germantown, MD 20876
Figure 5-1

Nine potential off-facility sources of PFAS not under control of the IDARNG were identified during the PA. The sources are mentioned in the *Final Preliminary Assessment Report for Perfluorinated Compounds at Boise Air National Guard Boise, Idaho* which details the PFAS investigation conducted by the adjacent IDANG facility. A description of each potential off-facility source is presented below, and locations are shown on **Figure 5-1**.

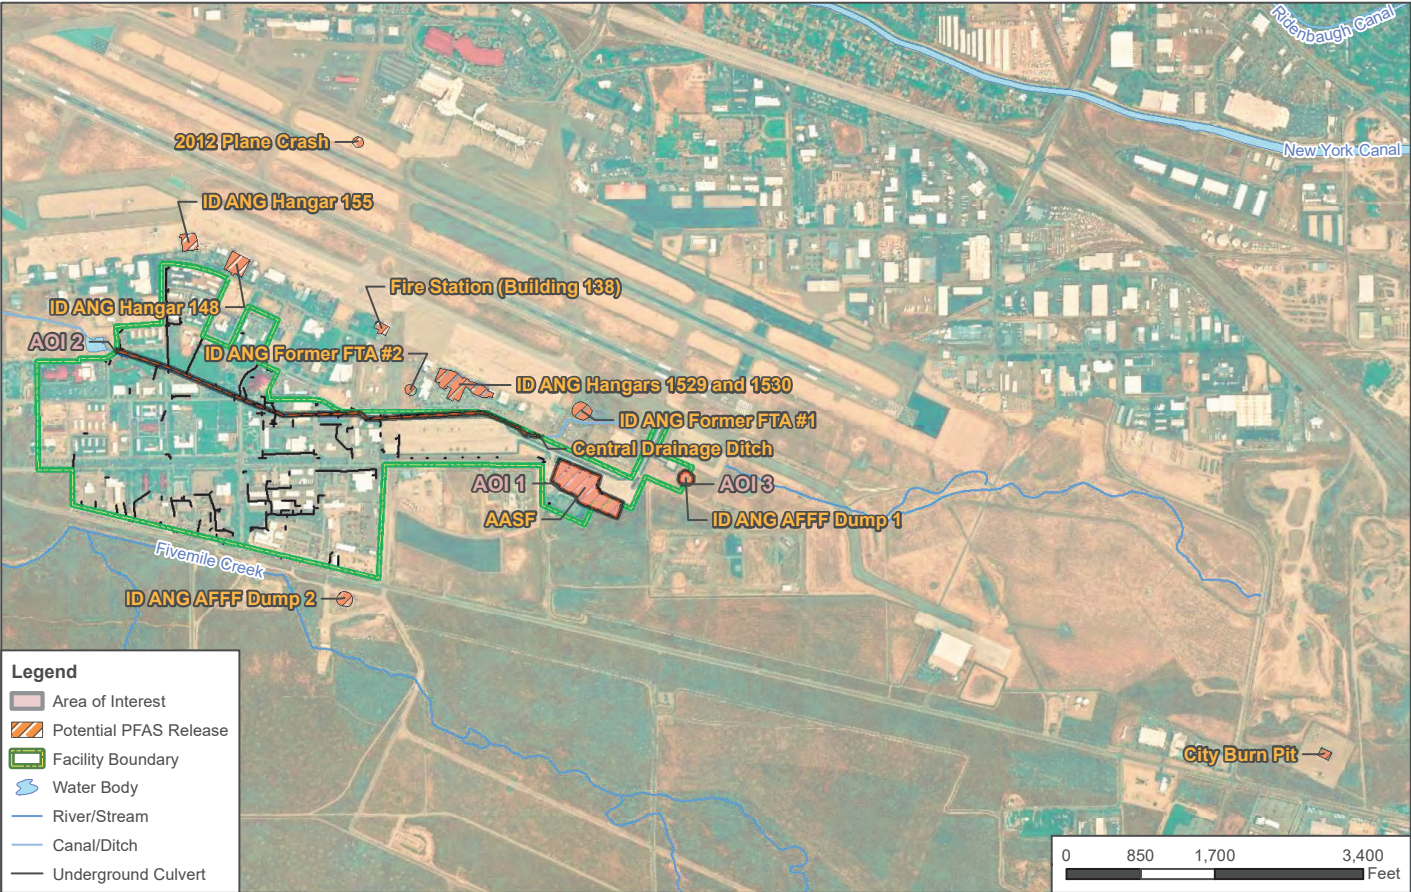
Three AOIs related to potential PFAS release were identified (**Table 7-1**) at Gowen Field during the PA (**Figure 7-1**).

Based on documented potential PFAS releases at AOI 1 and the documented PFAS presence at AOI 2 and AOI 3, there is potential for exposure to PFAS contamination in media at or near the facility. The preliminary CSM for Gowen Field is shown on **Figure 6-2**, which presents the potential receptors and media impacted.

ARNG will evaluate the need for an SI at AOI 1 at Gowen Field based on the potential receptors, the potential migration of PFAS contamination off the facility, and the availability of resources. ARNG and ANG will evaluate the need for an SI at AOI 2 and AOI 3 pending a decision on which entity will conduct future investigations at these locations.
