FINAL Preliminary Assessment Report Kankakee Army Aviation Support Facility #2 Kankakee, Illinois

Perfluorooctane-Sulfonic Acid (PFOS) and Perfluorooctanoic
Acid (PFOA) Impacted Sites
ARNG Installations, Nationwide

February 2021

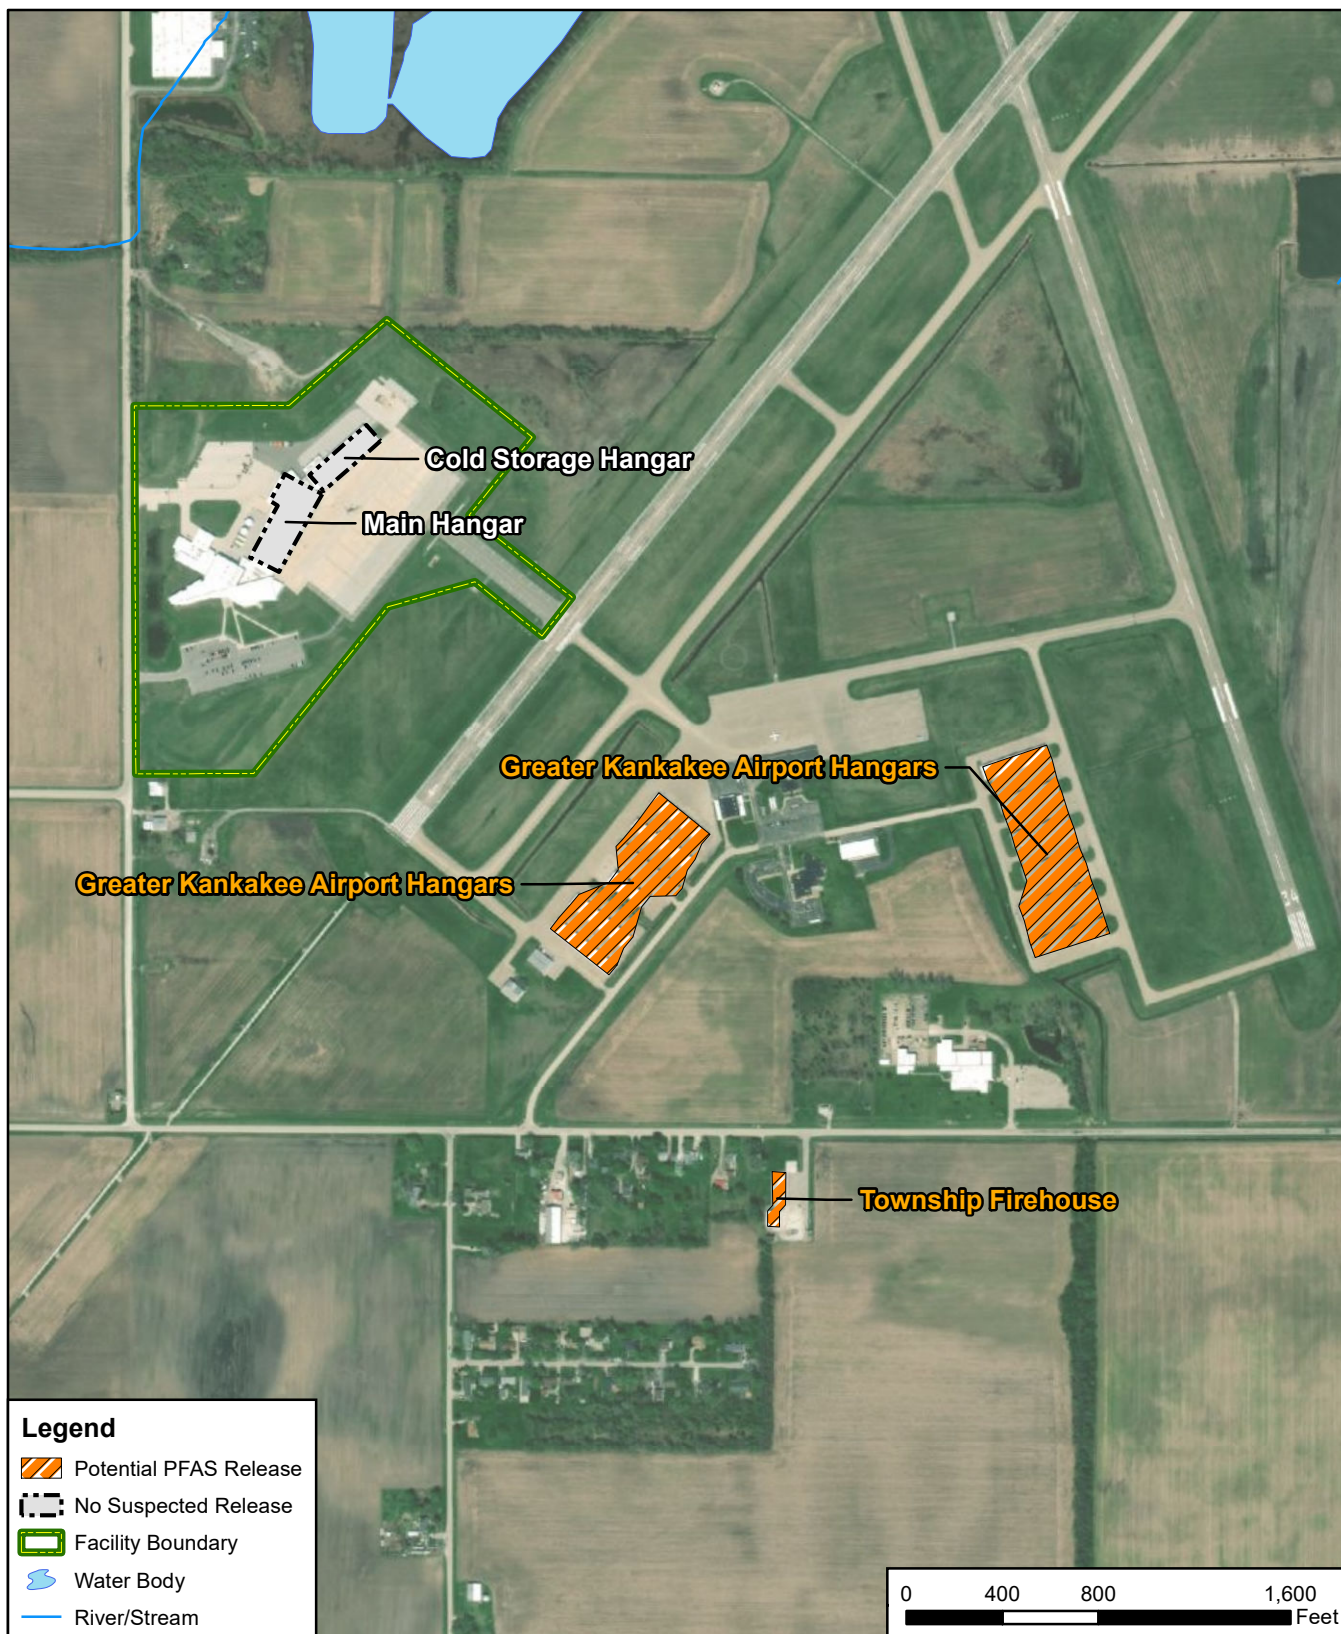
12420 Milestone Center Drive Germantown, MD 20876		Figure ES-1

No Areas of Interest related to potential PFAS releases were identified at the AASF during the PA. The summary of PA findings is shown on **Figure ES-1**.

Summary of Findings			
NOTES					Preliminary Assessment for PFAS at Kankakee AASF, IL						
REVISED		1/11/2021		GIS BY		MS		1/11/2021			
SCALE		1:9,600		CHK BY		JW		1/11/2021			
Base Map: Source: Esri, Maxar, GeoEye, Earthstar Geographics, CNES/Airbus DS, USDA, USGS,				PM		RG		1/11/2021

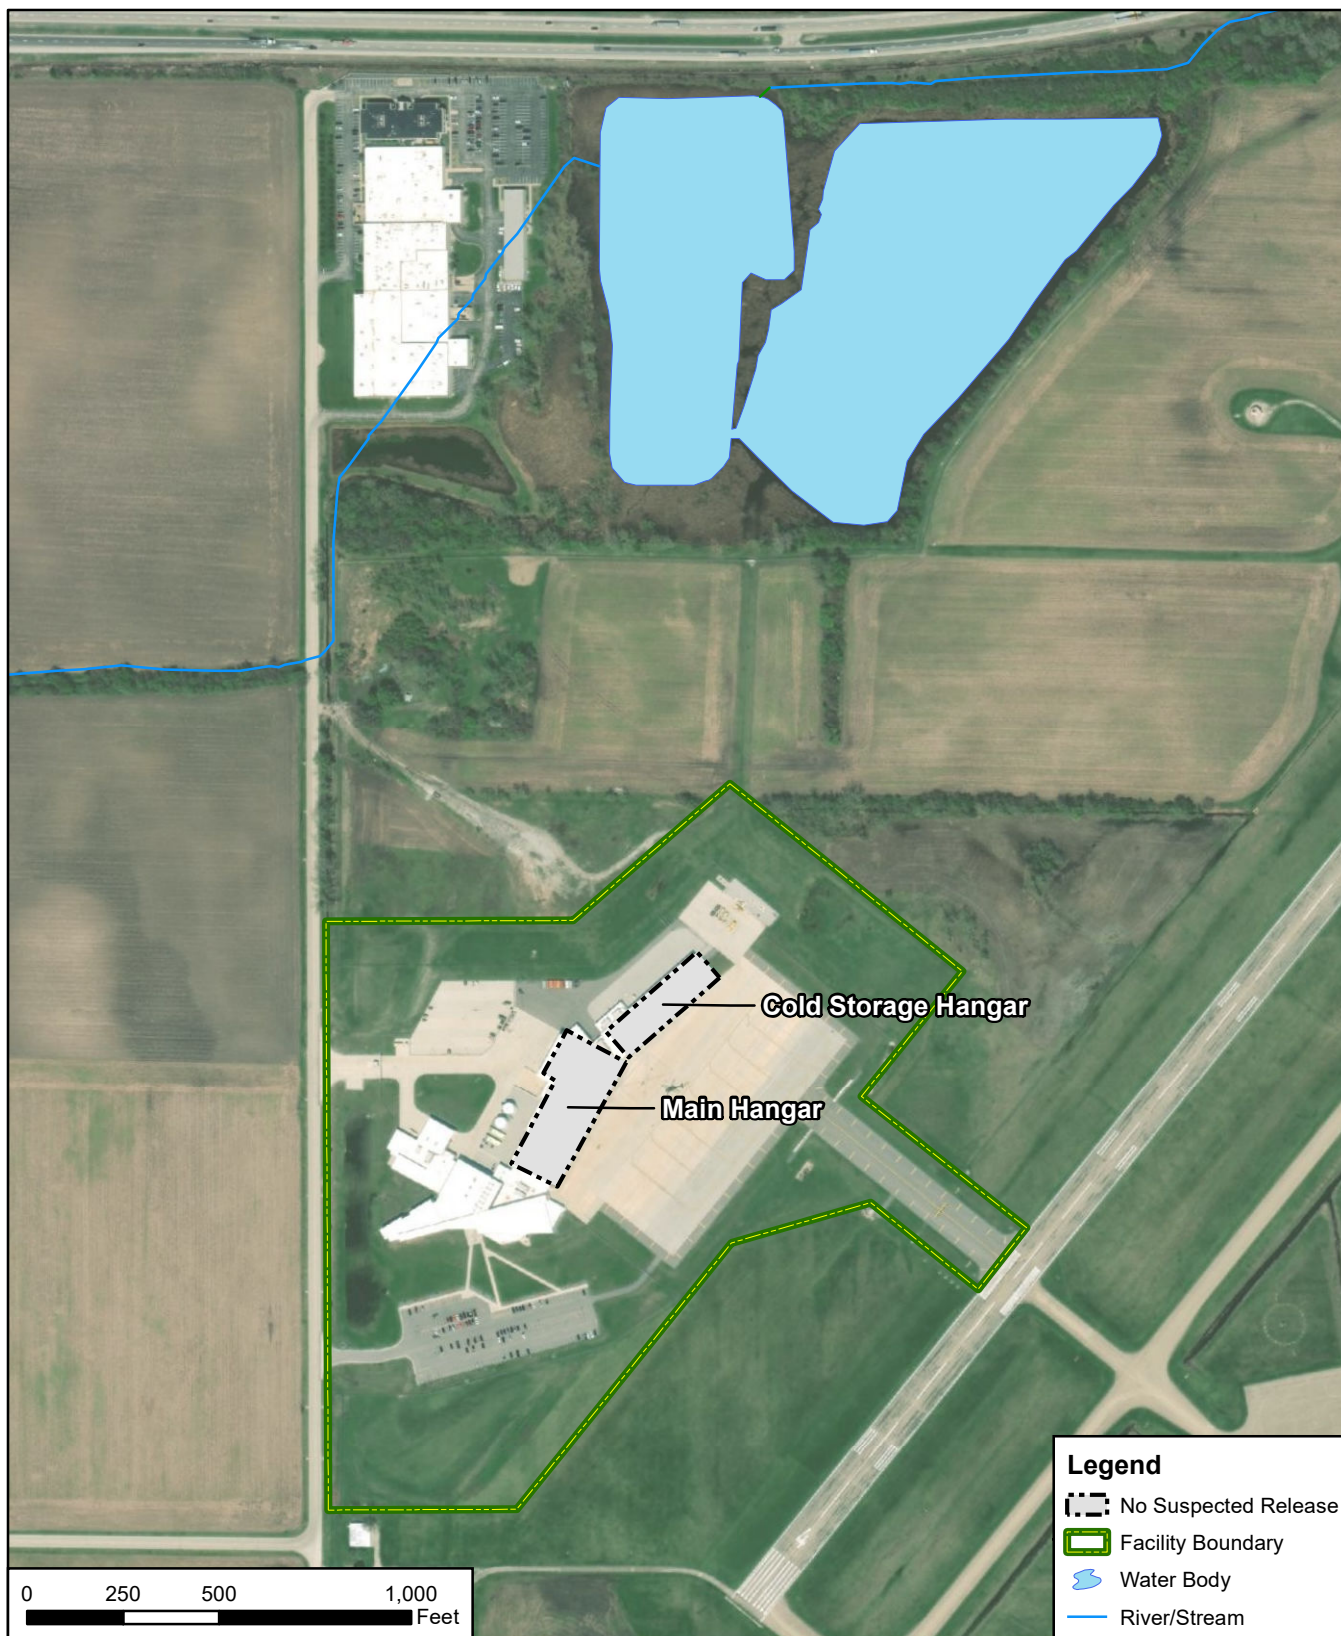
12420 Milestone Center Drive Germantown, MD 20876	Figure 3-1
SCALE	1:6,000	CHK BY	JW	1/11/2021			
Base Map: Source: Esri, Maxar, GeoEye, Earthstar Geographics, CNES/Airbus DS, USDA, USGS,		PM	RG	1/11/2021

In 2017, the Main Hangar was built which contains a fire suppression system supplied by a 400-gallon tank filled with two percent Jet-X HEF. The geographic coordinates are 41°04'09.6"N and 87°51'23.4"W. Upon installation of the fire suppression system, there was one full hangar release suppression system test, conducted by a contractor. The hangar doors were closed during the test, and the HEF went down the trench drains, which flow to an oil/water separator at the north side of the facility boundary. Water from the oil/water separator drains to the stormwater conveyance system, which discharges to an existing pond approximately 500 feet north and off the facility. The pond is connected to a tributary that flows to the Kankakee River (**Figure 3-1**). There has been no additional maintenance of the fire suppression system since its original installation. There are currently three Purple K mobile fire extinguishers located at the facility around the ramp area.

In 2017, the Cold Storage Hangar was built which contains a fire suppression system supplied by a 300-gallon tank filled with two percent Jet-X HEF. This fire suppression system uses a separate fire suppression system than the Main Hangar. The Cold Storage Hangar is located northeast of the Main Hangar. The geographic coordinates are 41°04'12.3"N and 87°51'20.7"W. Upon installation of the fire suppression system, there was one full hangar release suppression system test conducted, by a contractor. The hangar doors were closed during the test, and the HEF went down the trench drains, which flow to an oil/water separator at the north side of the facility boundary. Water from the oil/water separator drains to the stormwater conveyance system, which discharges to an existing pond approximately 500 feet north and off the facility. The pond is connected to a tributary that flows to the Kankakee River (**Figure 3-1**).

Non-Fire Training Areas	
NOTES		Preliminary Assessment for PFAS at Kankakee AASF #2, IL					
REVISED	1/11/2021	GIS BY	MS	1/11/2021

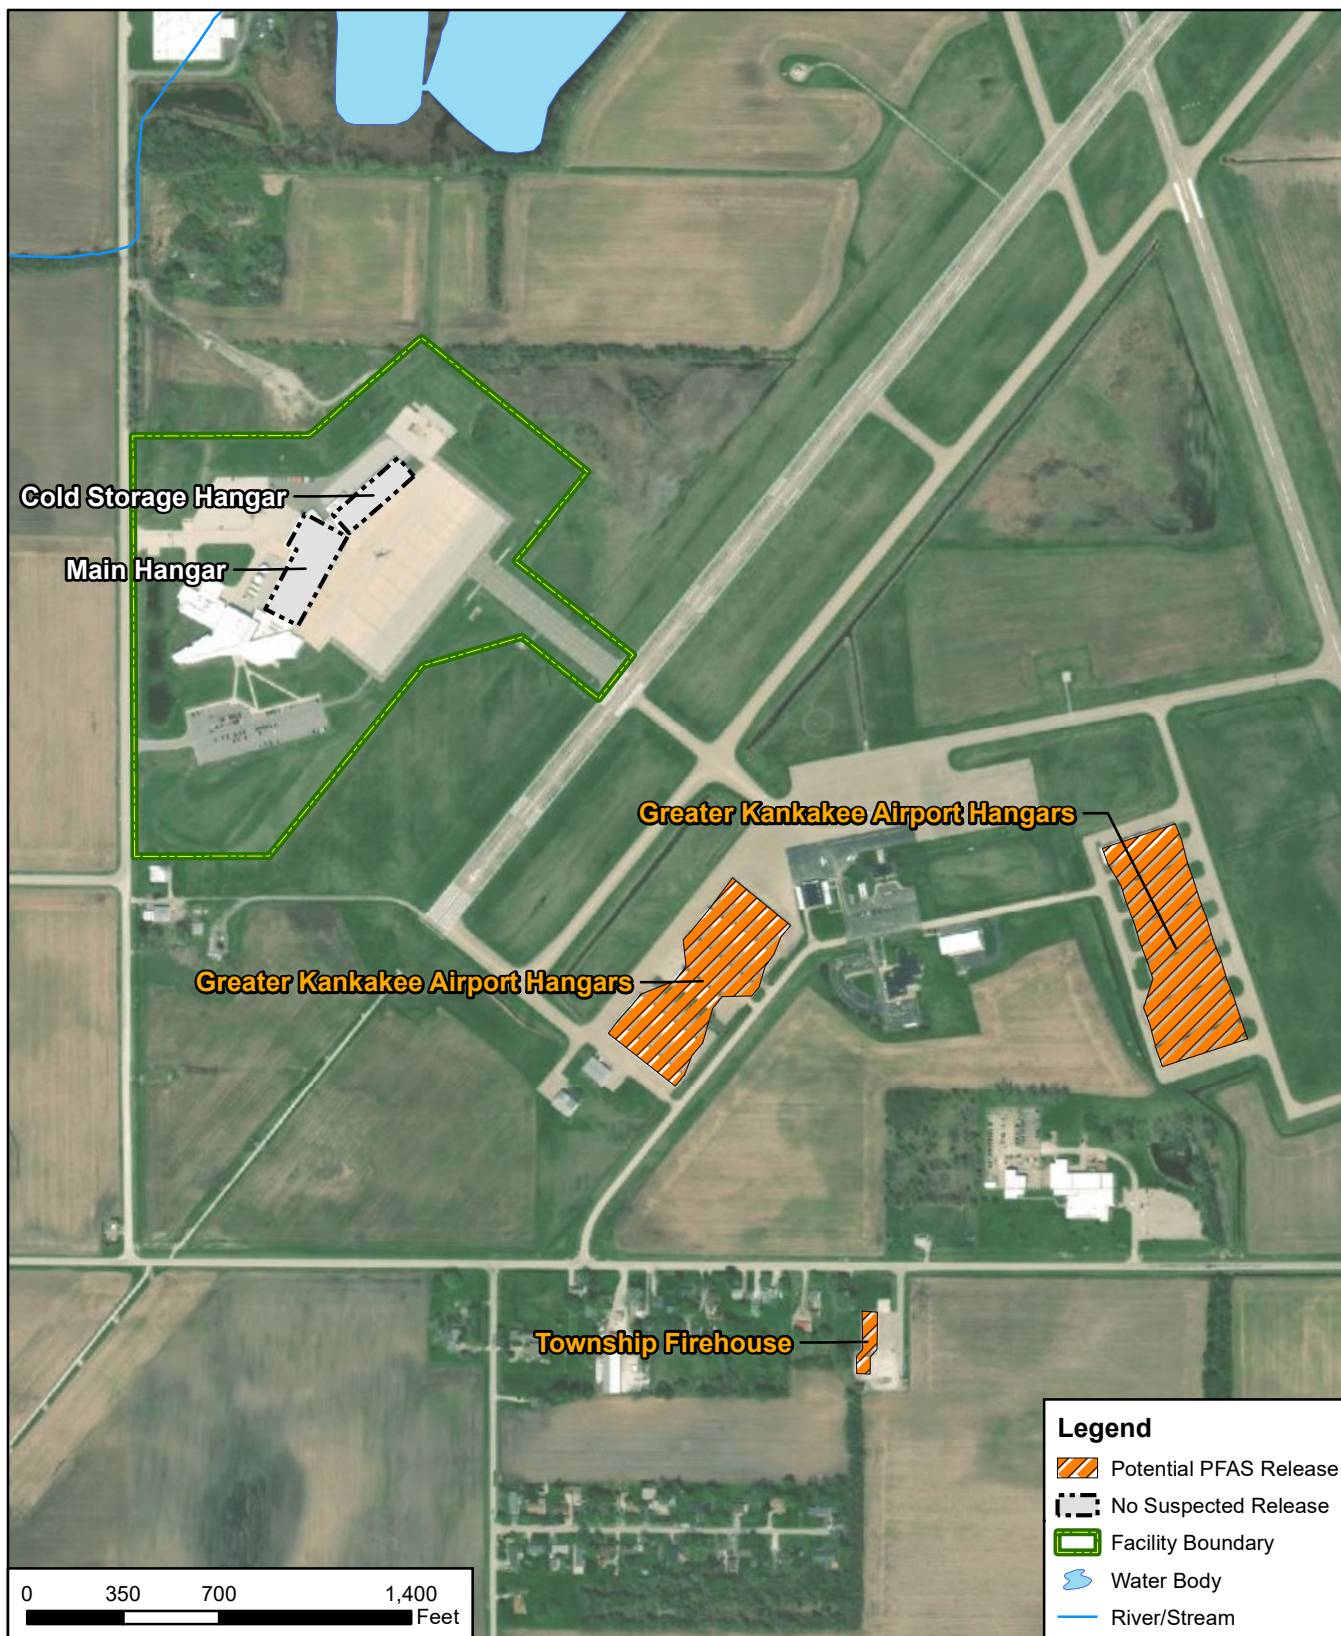
Figure 5-1

The Greater Kankakee Airport geographic coordinates are 41°03'55.0"N and 87°50'55.3"W. The current Greater Kankakee Airport has been officially serving the Kankakee community since 1962 and is owned and operated by the Kankakee Valley Airport Authority. The AASF is adjacent to the Greater Kankakee Airport. The airport is home to private hangars housing helicopter, single engine aircraft, ultralights, and turbine powered aircraft. The geographic coordinates of the areas where the Greater Kankakee Airport Hangars are located are 41° 3'55.12"N and 87°51'4.71"W; and 41° 3'56.24"N and 87°50'42.14"W. There is also an official Federal Aviation Administration (FAA) Light Sport Repair Station located at the Greater Kankakee Airport. The FAA Light Sport Repair Station offers services of sport pilot examinations for powered parachute, sport pilot training in fixed-wing aircraft and powered parachute as well as inspection, maintenance, and heavy maintenance and other engine services. Due to the unknown nature of whether the private hangars have fire suppression systems and the maintenance that is performed at the repair station; the Greater Kankakee Airport has been identified as an adjacent source.

There is a Township Firehouse located southeast of the AASF that is used by the volunteer fire department. The geographic coordinates are 41°3'42.60"N and 87°50'56.71"W. There was no information obtained through interviews or online research that described if firetrucks or firefighting equipment are stored at the firehouse. However, there is a potential that AFFF could be stored at the firehouse or on firetrucks; therefore, the Township Firehouse has been identified as an adjacent source.

Adjacent Sources

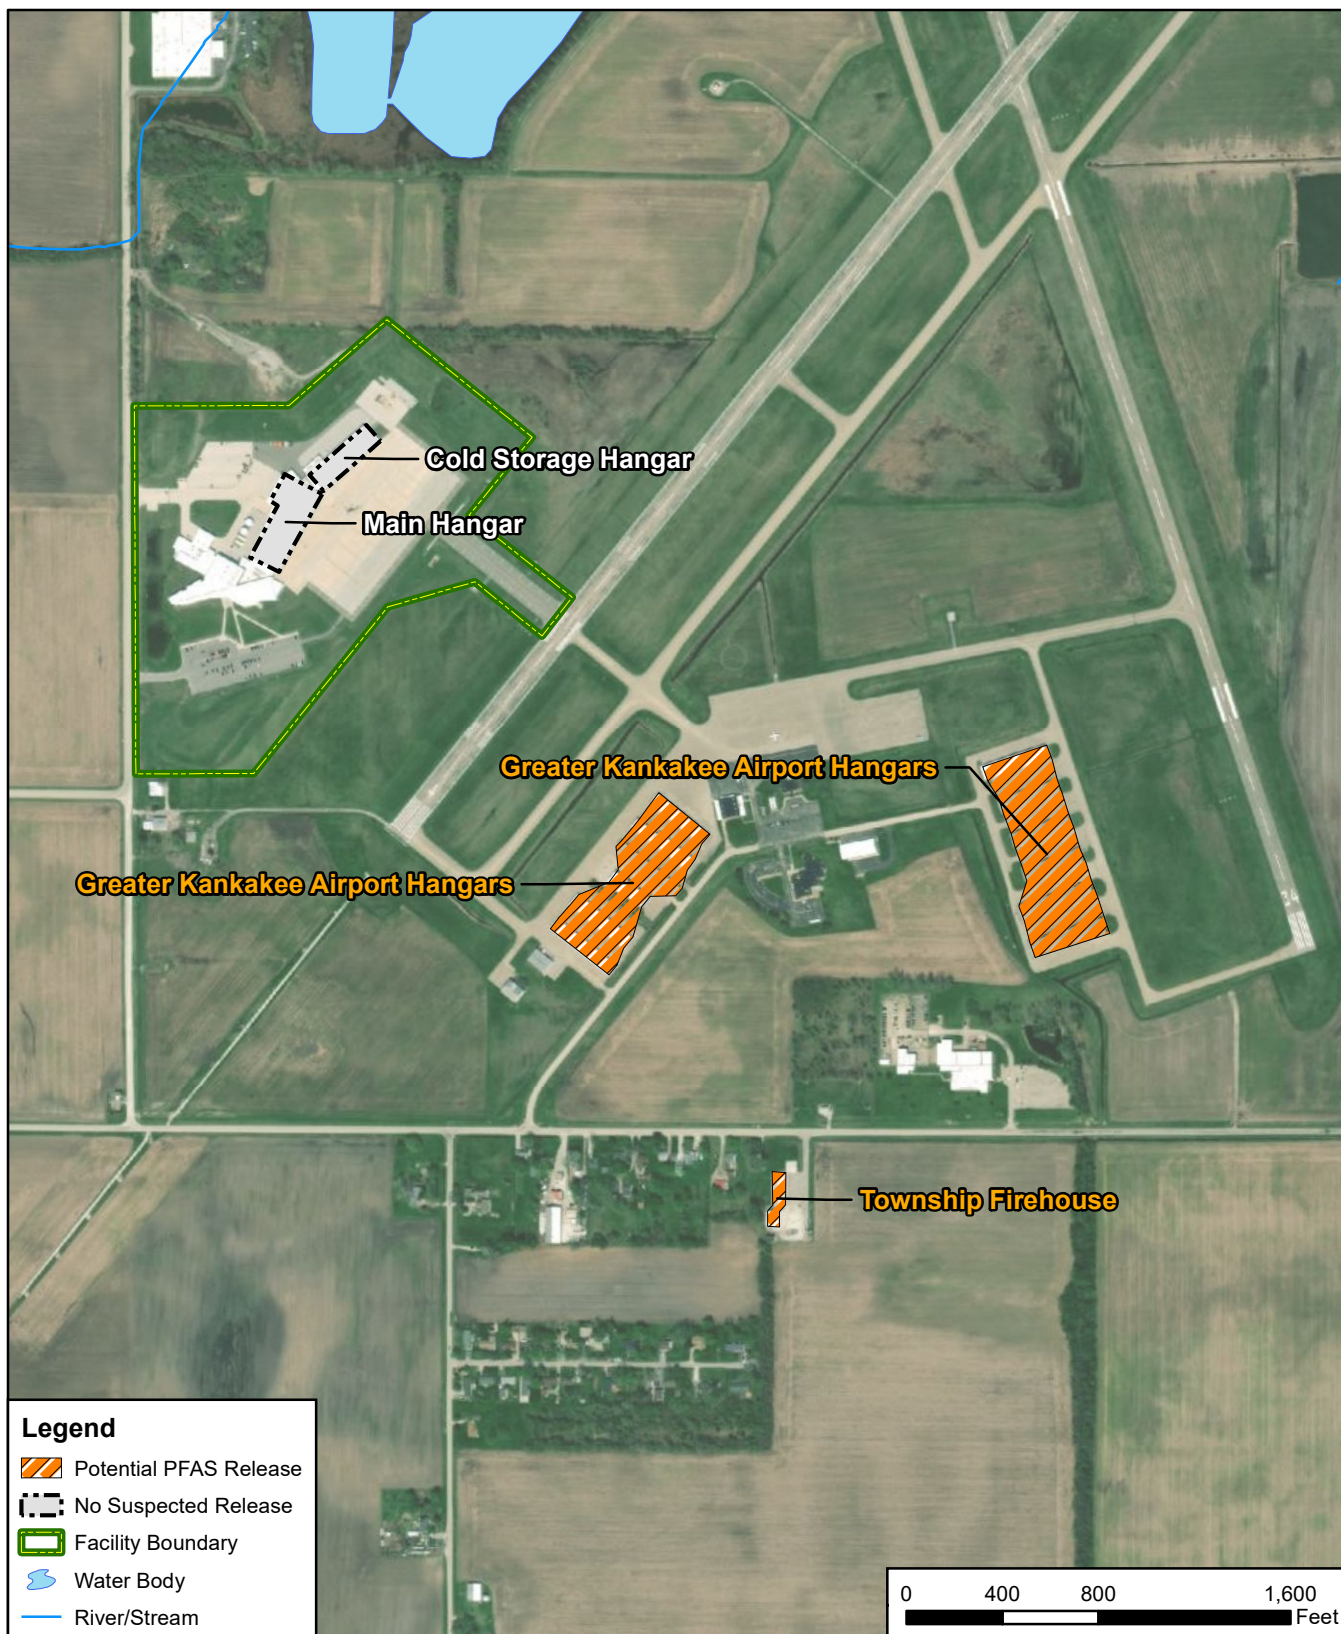
12420 Milestone Center Drive Germantown, MD 20876	Figure 7-1	
SCALE	1:9,600	CHK BY	JW	1/11/2021				
Base Map: Source: Esri, Maxar, GeoEye, Earthstar Geographics, CNES/Airbus DS, USDA, USGS,		PM	RG	1/11/2021

Based on information obtained during interviews conducted with facility personnel who have been familiar with the facility since 2017 and reviewed documentation, no AOIs related PFAS releases were identified at the AASF. While adjacent sources were identified, evidence obtained during the PA does not support that current or former ARNG facility activities have contributed to PFAS contamination in soil, groundwater, surface water, or sediment. Therefore, the pathways to all human receptors are incomplete. A summary of the PA findings is presented on **Figure 7-1**.

Summary of Findings		
NOTES		Preliminary Assessment for PFAS at Kankakee AASF, IL						
REVISED	1/11/2021	GIS BY	MS	1/11/2021

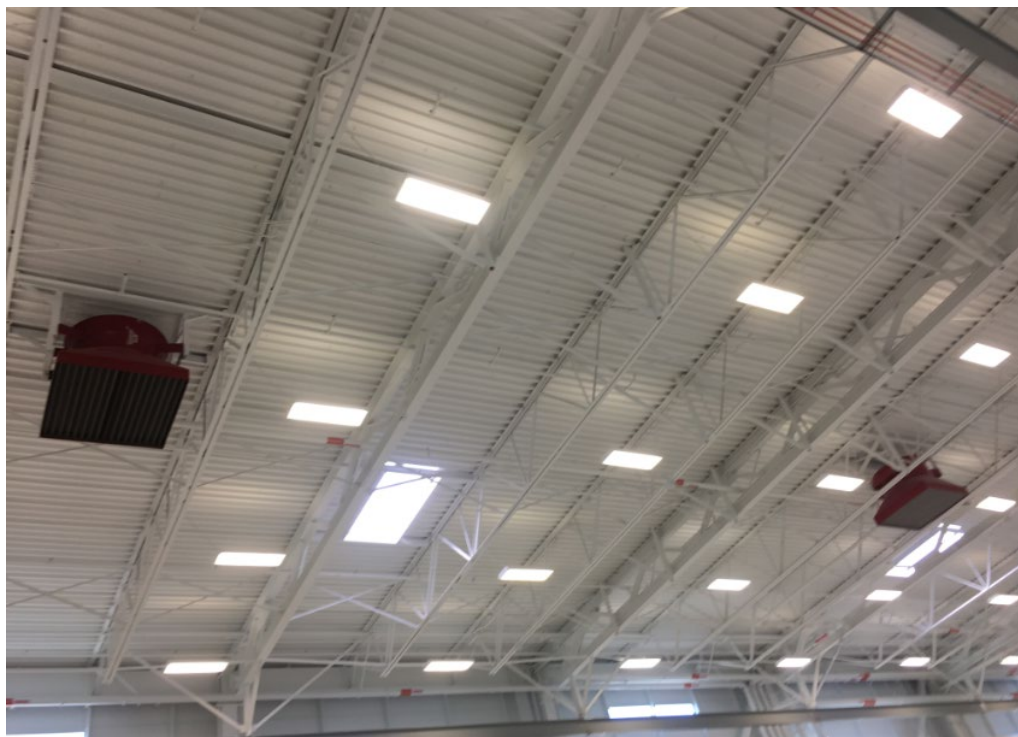
Fire suppression system
sprinkler heads in the Main
Hangar.

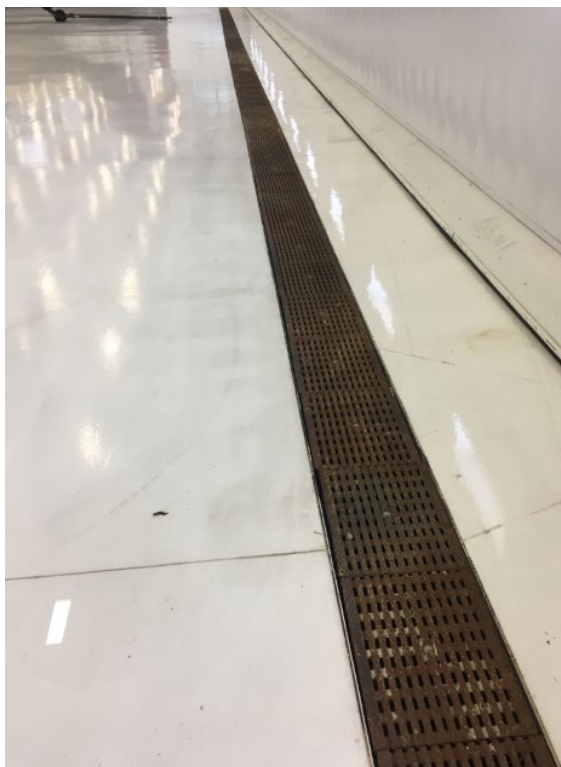
Photograph No. 2

Trench drains in the Main
Hangar that lead to an
oil/water separator then to the
stormwater system.

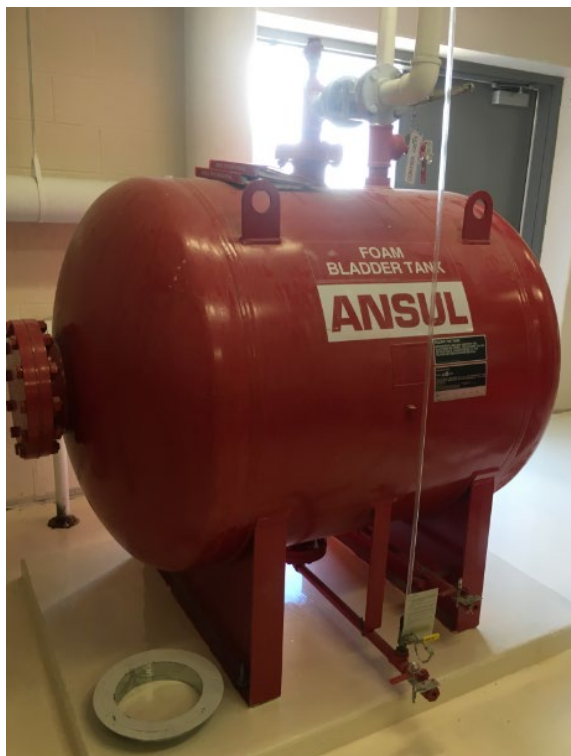
The fire suppression system
foam bladder tank that
supplies the Main Hangar.

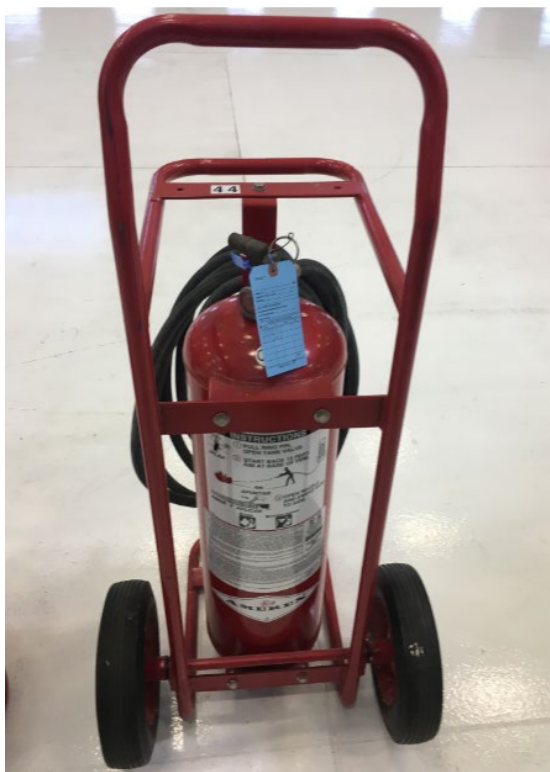
Photograph No. 4

Purple K fire extinguisher that
are found on the ramp areas at
the Kankakee AASF #2.

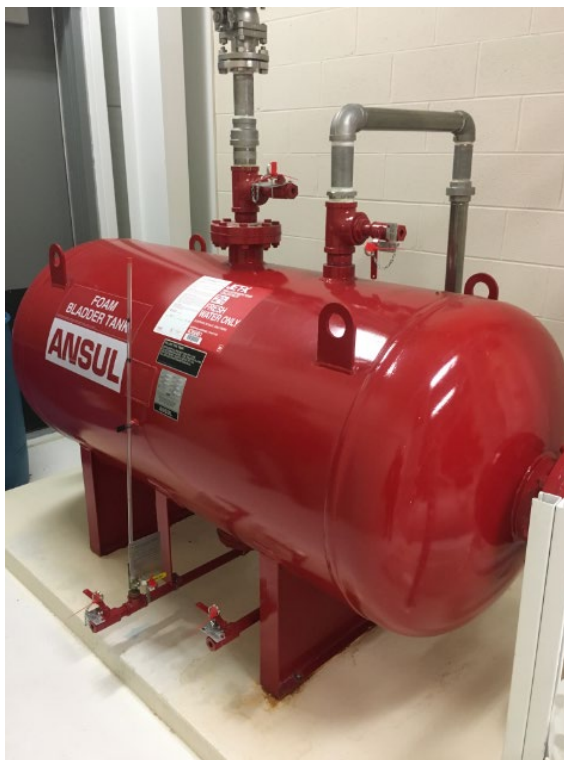
The fire suppression system
foam bladder tank that
supplies the Cold Storage
Hangar.

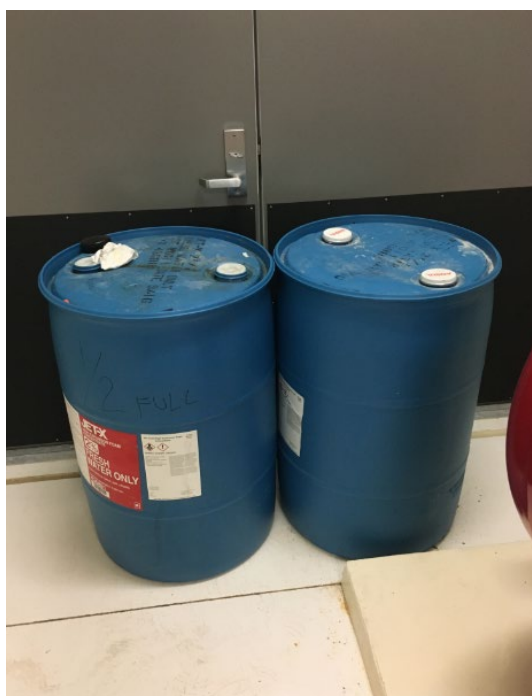
Photograph No. 6

In the Cold Storage Hangar fire suppression system room, two 55-gallon drums of two percent Jet-X HEF were present; one of the drums was half full and the other drum was completely full. There was no visible leaking or discoloration on the concrete.

Two 55-gallon drums of
2% Jet-X High Expansion
Foam found in the Cold
Storage Hangar fire
suppression system room.
There was no visible
leaking or corrosion on the
floor.

Area of Interest	Source of Uncertainty
AOI 2	One of the 55-gallon drums of two percent Jet-X HEF was half-full. Personnel did not know where or when the HEF was used.
