FINAL Preliminary Assessment Report Camp Atterbury Edinburgh, Indiana

Perfluorooctane-Sulfonic Acid (PFOS) and Perfluorooctanoic
Acid (PFOA) Impacted Sites
ARNG Installations, Nationwide

September 2020

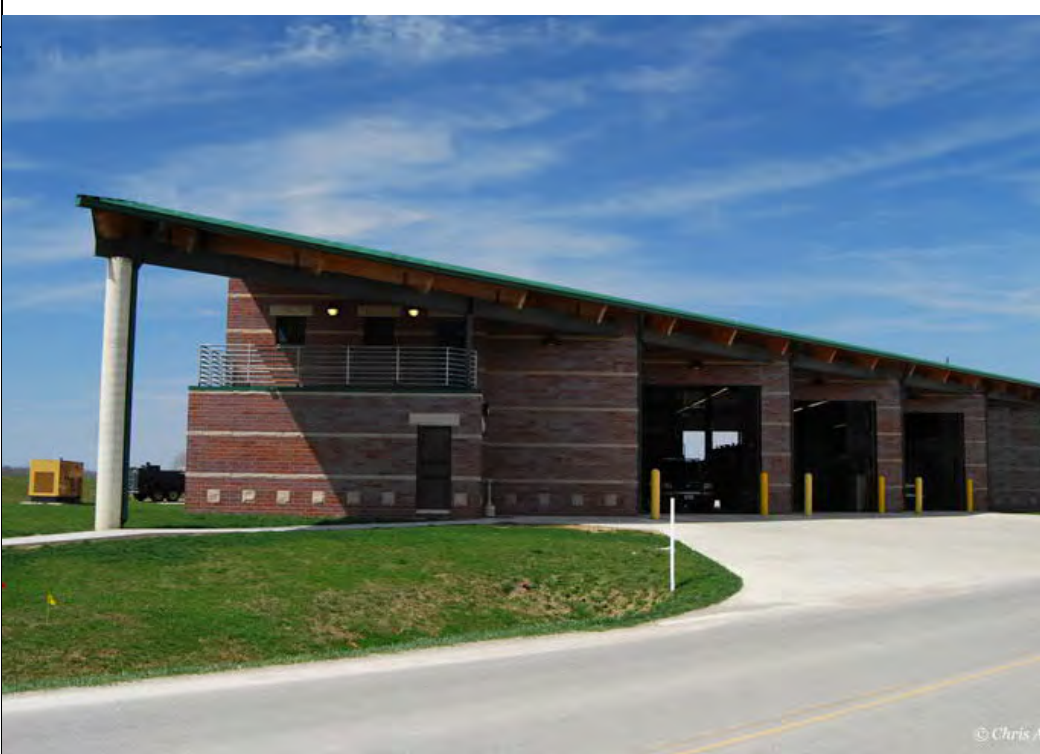
Army National Guard, Preliminary Assessment for PFAS	Camp Atterbury	Edinburgh, Indiana
<p>Photograph No. 1</p> <p>Description:</p> <p>Looking west at the current Camp Atterbury fire station.</p> <p>Date Taken:</p> <p>27 August 2018</p>

<p>A wide-angle photograph of the Camp Atterbury fire station. The building is constructed of red brick with a green metal roof. It features a prominent overhang on the left side supported by a concrete pillar. Several large garage doors are visible on the right side. The station is situated on a grassy area next to a paved road. The sky is blue with some light clouds.</p>	
<p>Photograph No. 2</p> <p>Description:</p> <p>Looking south inside the current fire station. 2011 Oshkosh firetruck equipped with a 420 gallon AFFF tank, currently filled with 3% AFFF.</p> <p>Date Taken:</p> <p>27 August 2018</p>

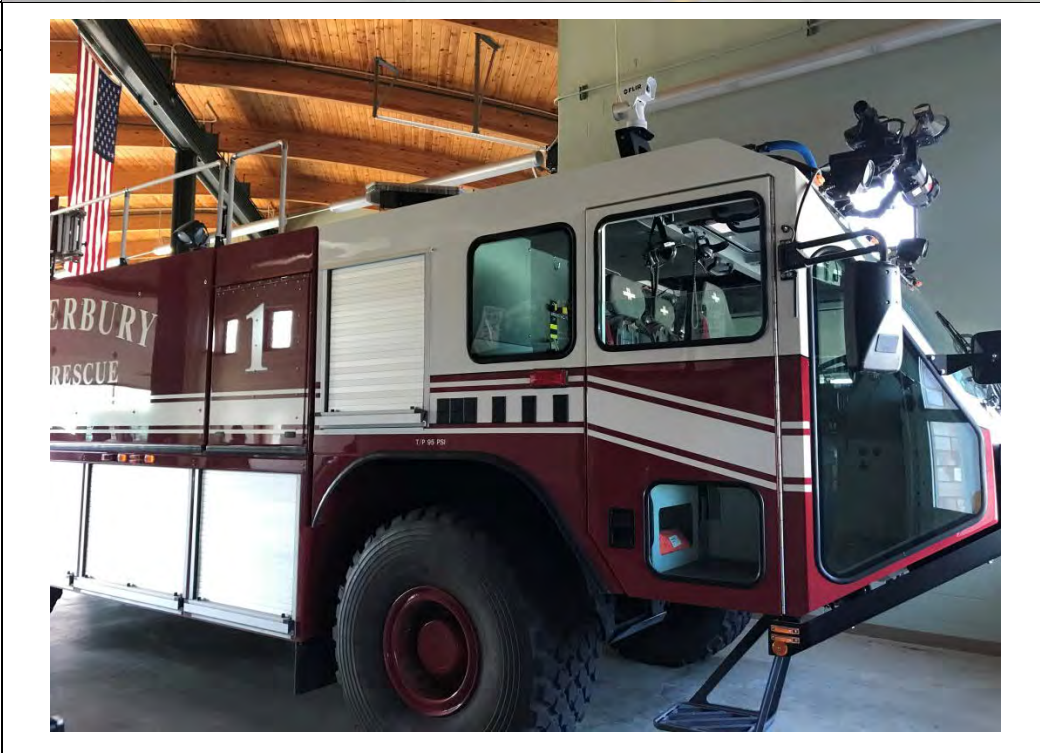
<p>A photograph taken from inside the fire station looking south. A red and white 2011 Oshkosh firetruck is parked. The side of the truck has "ATTERBURRY RESCUE" and the number "1" written on it. The truck is equipped with a large tank and various emergency lights. The interior of the station shows wooden beams and an American flag hanging on the wall.</p>

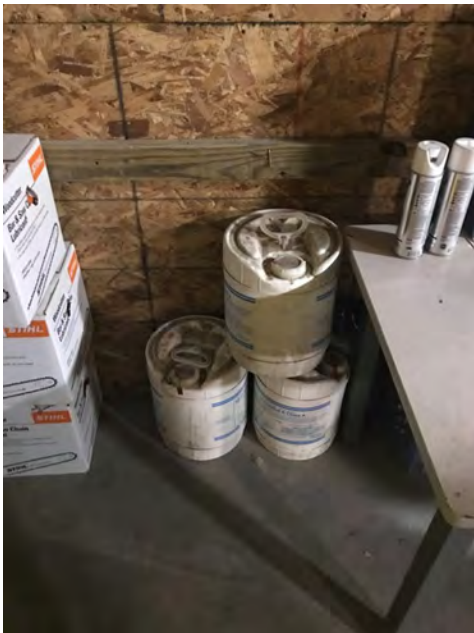
<p>Photograph No. 6</p> <p>Description:</p> <p>Looking west inside the natural resources barn. Three 5-gallon buckets of Phos-Chek Class A Firefighting foam used in the vehicles.</p> <p>Date Taken:</p> <p>28 August 2018</p>
