Preliminary Assessment Report Shelbyville AASF, Indiana

Perfluorooctanesulfonic Acid (PFOS) and Perfluorooctanoic
Acid (PFOA) Impacted Sites
ARNG Installations, Nationwide

July 2020

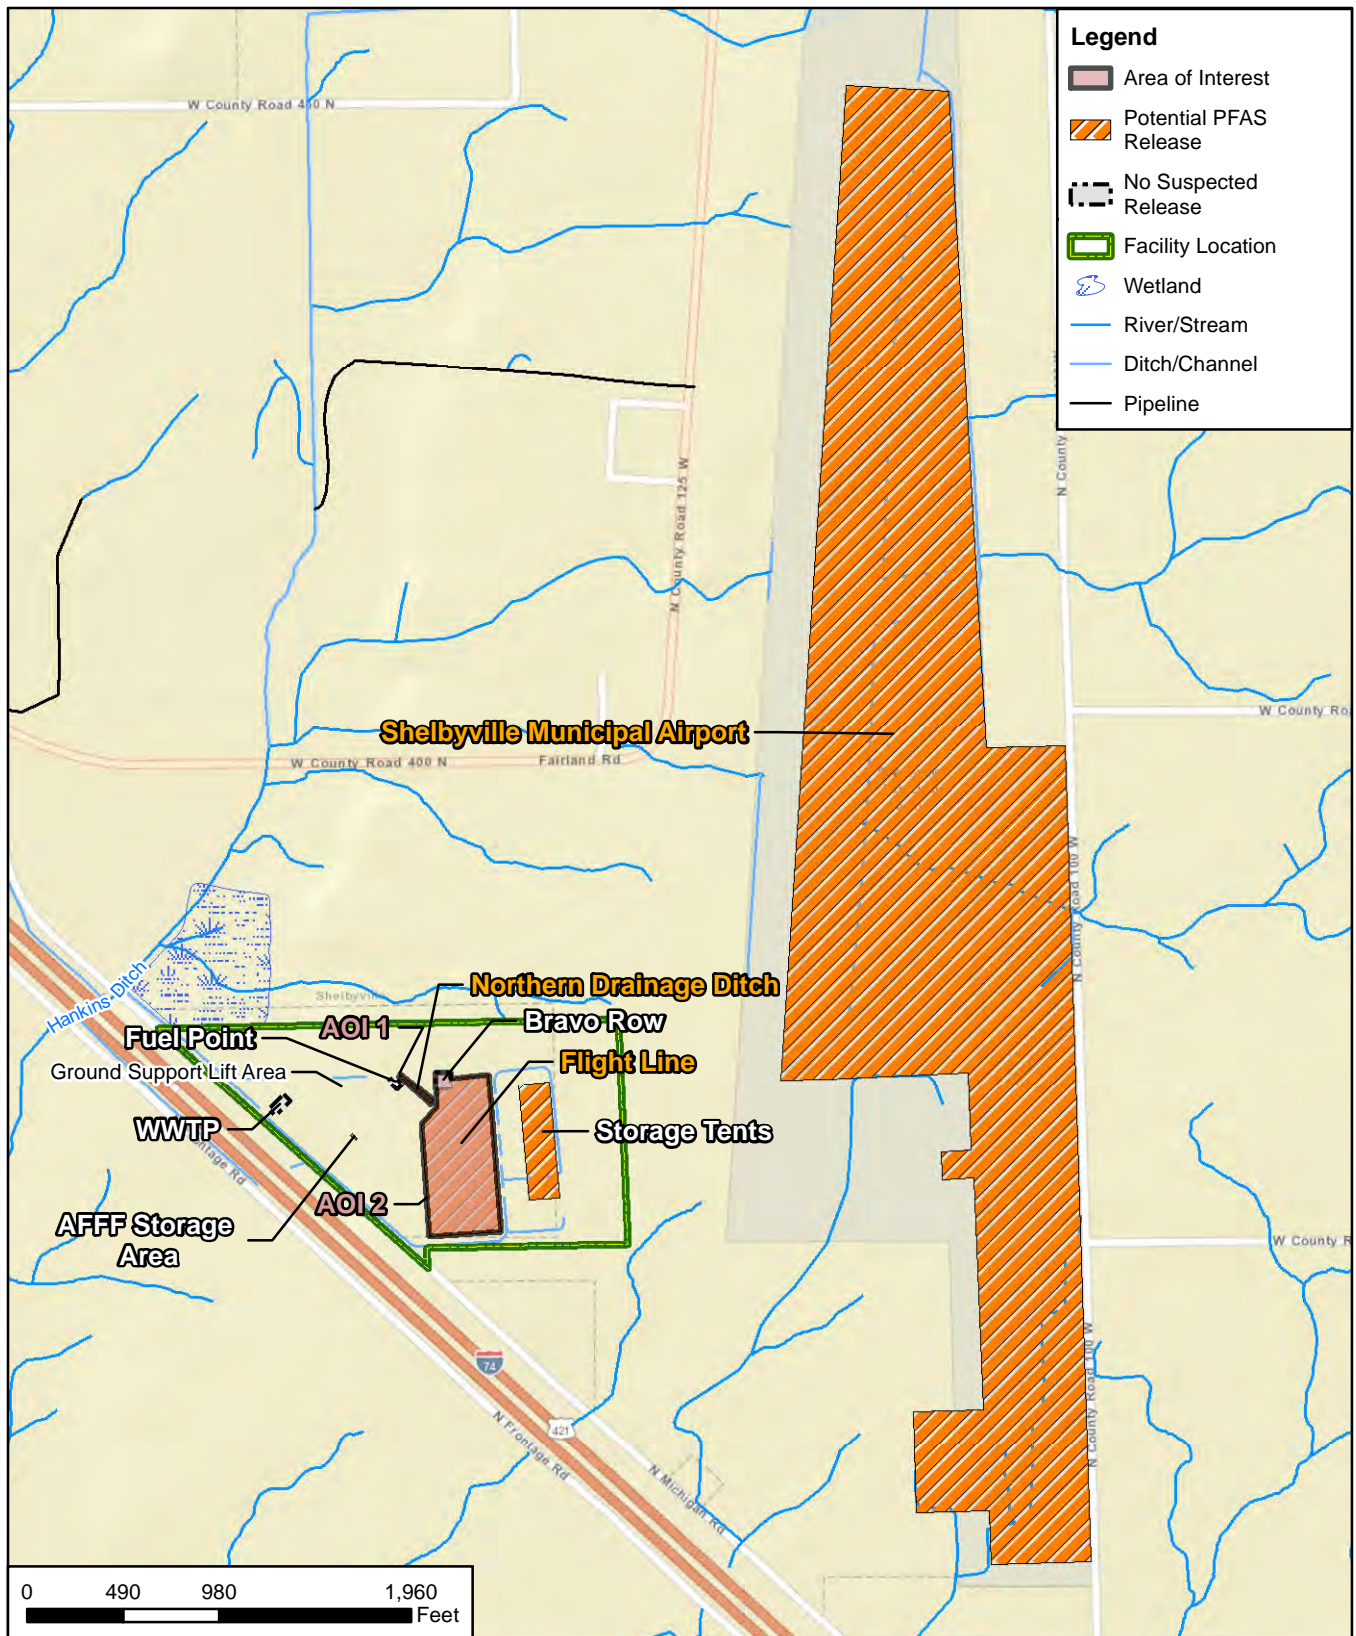
Figure ES-1
REVISED	5/29/2020	GIS BY	MS	5/29/2020				
SCALE	1:11,760	CHK BY	LC	5/29/2020				
Base Map: Sources: Esri, HERE, Garmin, USGS, Intermap, INCREMENT P, NRCan, Esri Japan, METI,		PM	RG	5/29/2020

One AOI related to a PFAS release, and one AOI related to a potential PFAS release, were identified at Shelbyville AASF, Indiana based on PA data. The AOIs are shown on **Figure ES-1** and described in **Table ES-1** below:

Summary of Findings	
NOTES					Preliminary Assessment for PFAS at Shelbyville AASF, IN

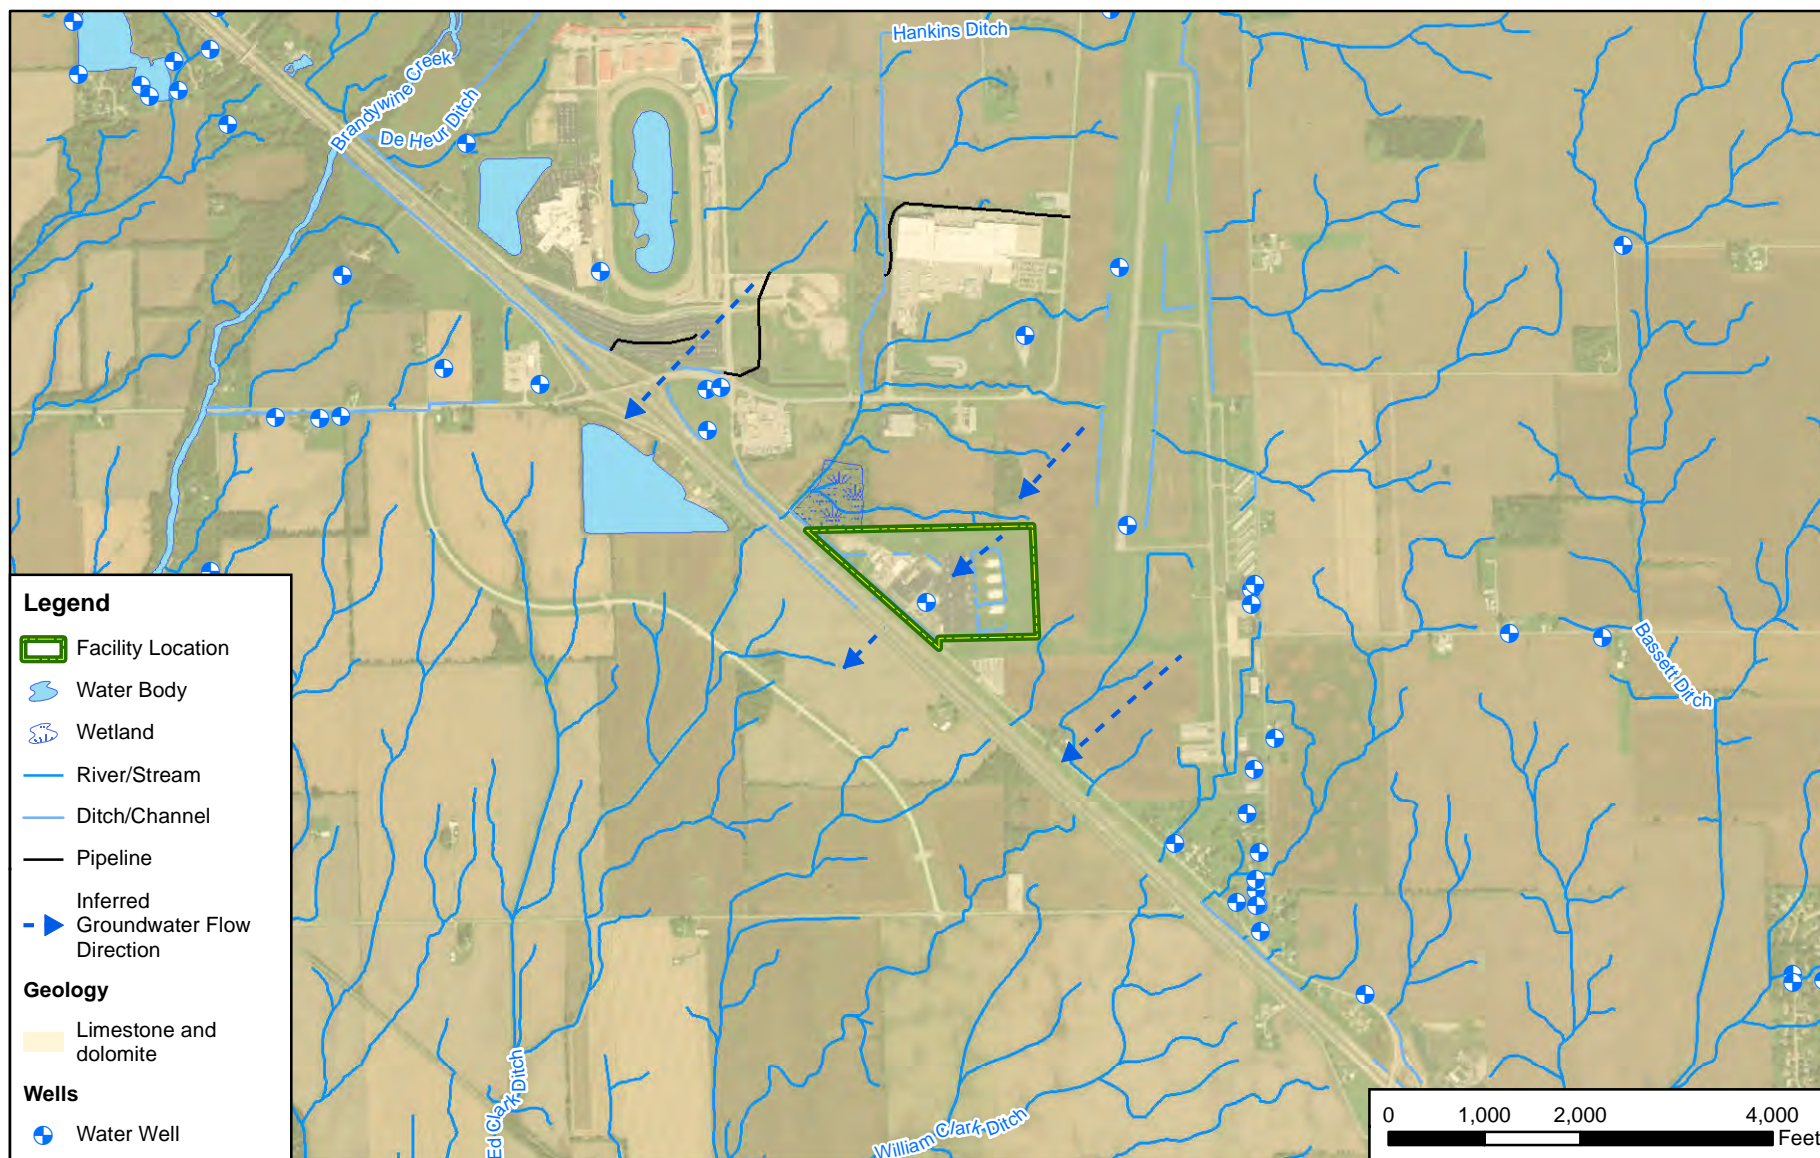
12420 Milestone Center Drive Germantown, MD 20876	Figure 1-2	
REVISED	4/22/2019	GIS BY	MS	4/22/2019					
SCALE	1:24,000	CHK BY	LC	4/22/2019					
Base Map: Source: Esri, DigitalGlobe, GeoEye, Earthstar Geographics, CNES/Airbus DS, USDA, USGS, AeroGRID, IGN, and the GIS User Community		PM	RG	4/22/2019

Most aquifers in the area draw from buried unconsolidated sand and gravel deposits within the New Castle Till Aquifer system (**Figure 1-2**). This system is characterized by thinner intertill sand and gravel layers, which differs from the northern and western parts of the county that are hydrologically separated from meteoric and surface infiltration by the overlying till. These horizontal layers of varying depth and thickness often cross surface drainage basin boundaries subterraneously (Fenelon et al., 1994). System recharge is generally from groundwater in overlying till layers.

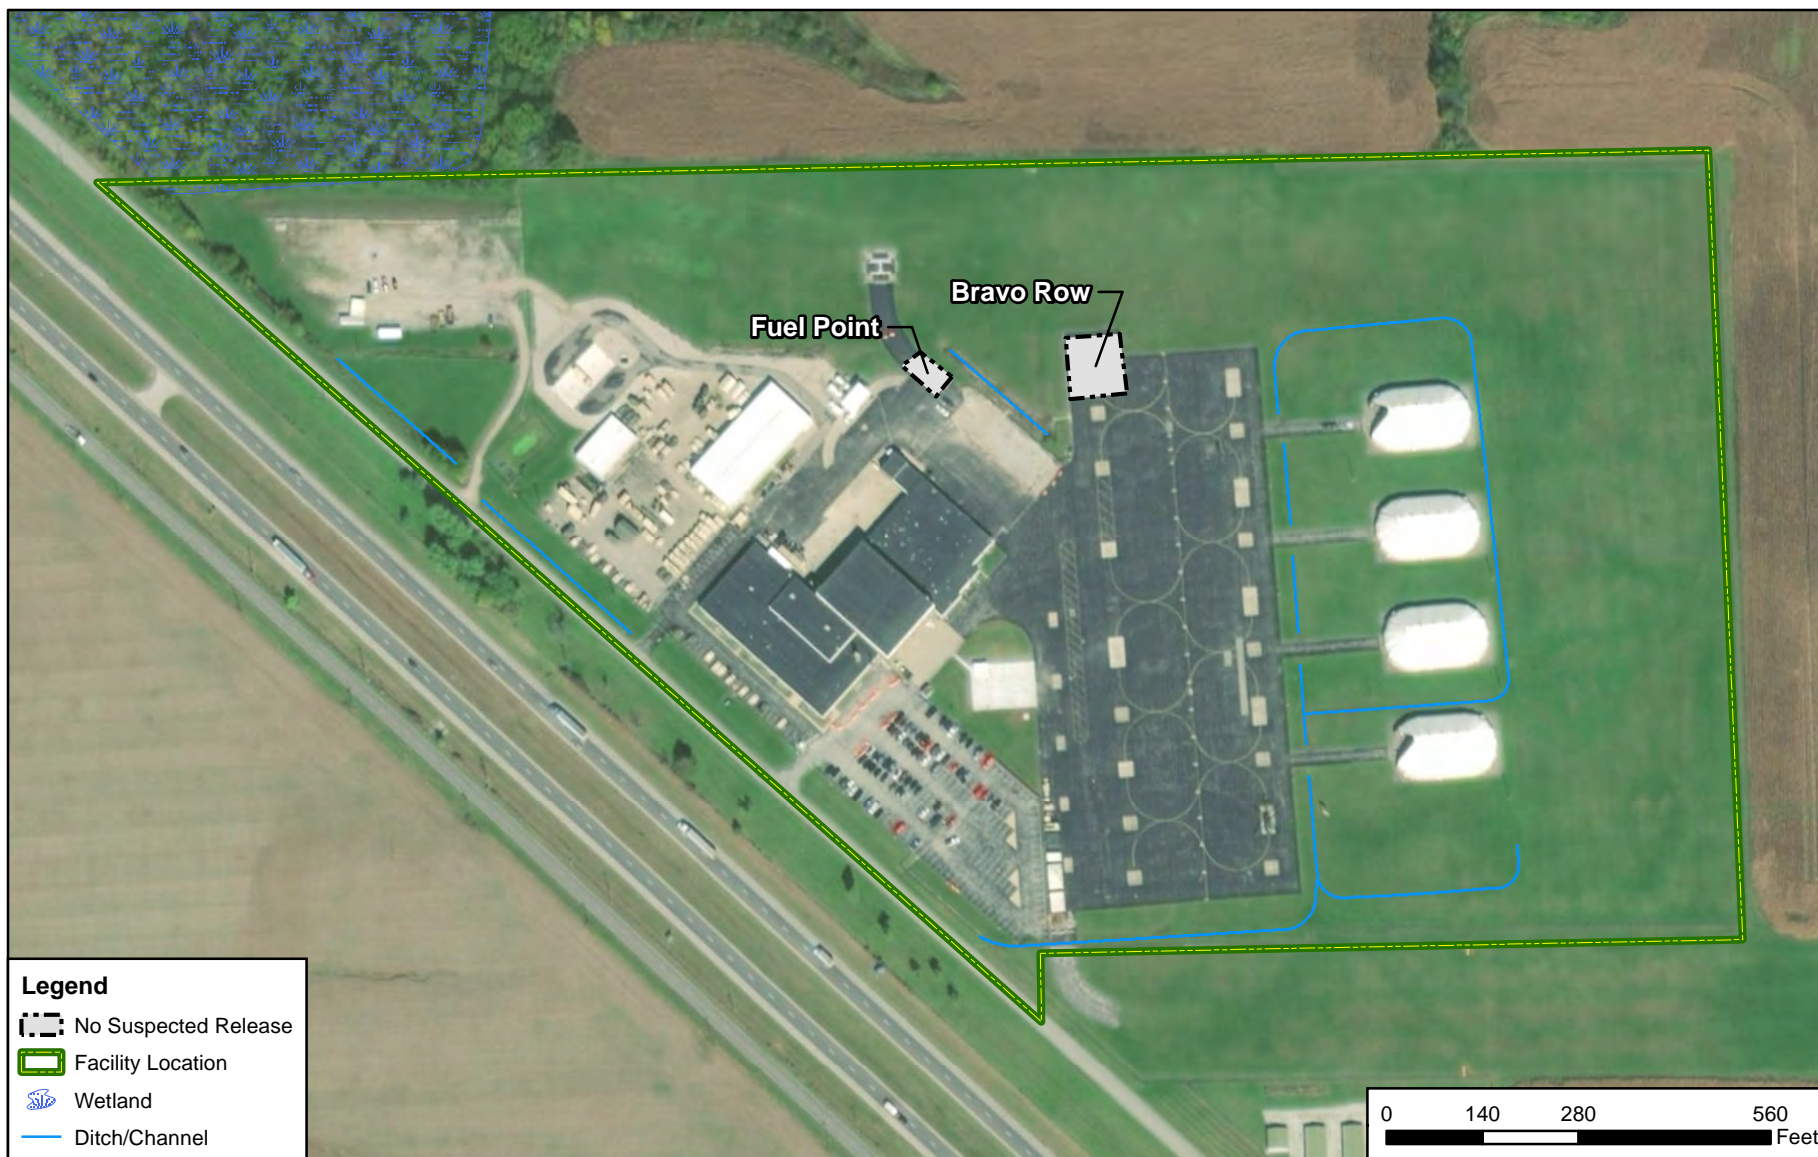
This FTA is located on Bravo row in the northwest corner of the flight line (39°34'46.31"N, 85°48'39.76"W). The FTA comprises concrete pads surrounded by asphalt. Crash carts containing sodium bicarbonate are located along the flight line. No training or use of AFFF is documented at this FTA per information collected during interviews.

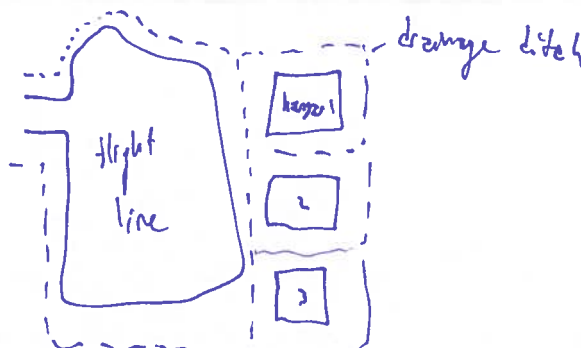
Area of interest (AOI) 1:
Drainage Ditch on north side
of facility. Approximately 50
gallons of AFFF solution was
sprayed here to reduce weed
growth and simultaneously
perform hydrostatic testing on
firefighting equipment. The
Fuel Point FTA is located just
off-frame to the left.
