# FINAL Site Inspection Report Muscatatuck Urban Training Center Butlerville, Indiana

Site Inspection for Perfluorooctanoic acid (PFOA),  
Perfluorooctanesulfonic acid (PFOS), Perfluorohexanesulfonic acid  
(PFHxS), Perfluorononanoic acid (PFNA), Hexafluoropropylene oxide  
dimer acid (HFPO-DA), and Perfluorobutanesulfonic acid (PFBS) at  
ARNG Installations, Nationwide

February 2023

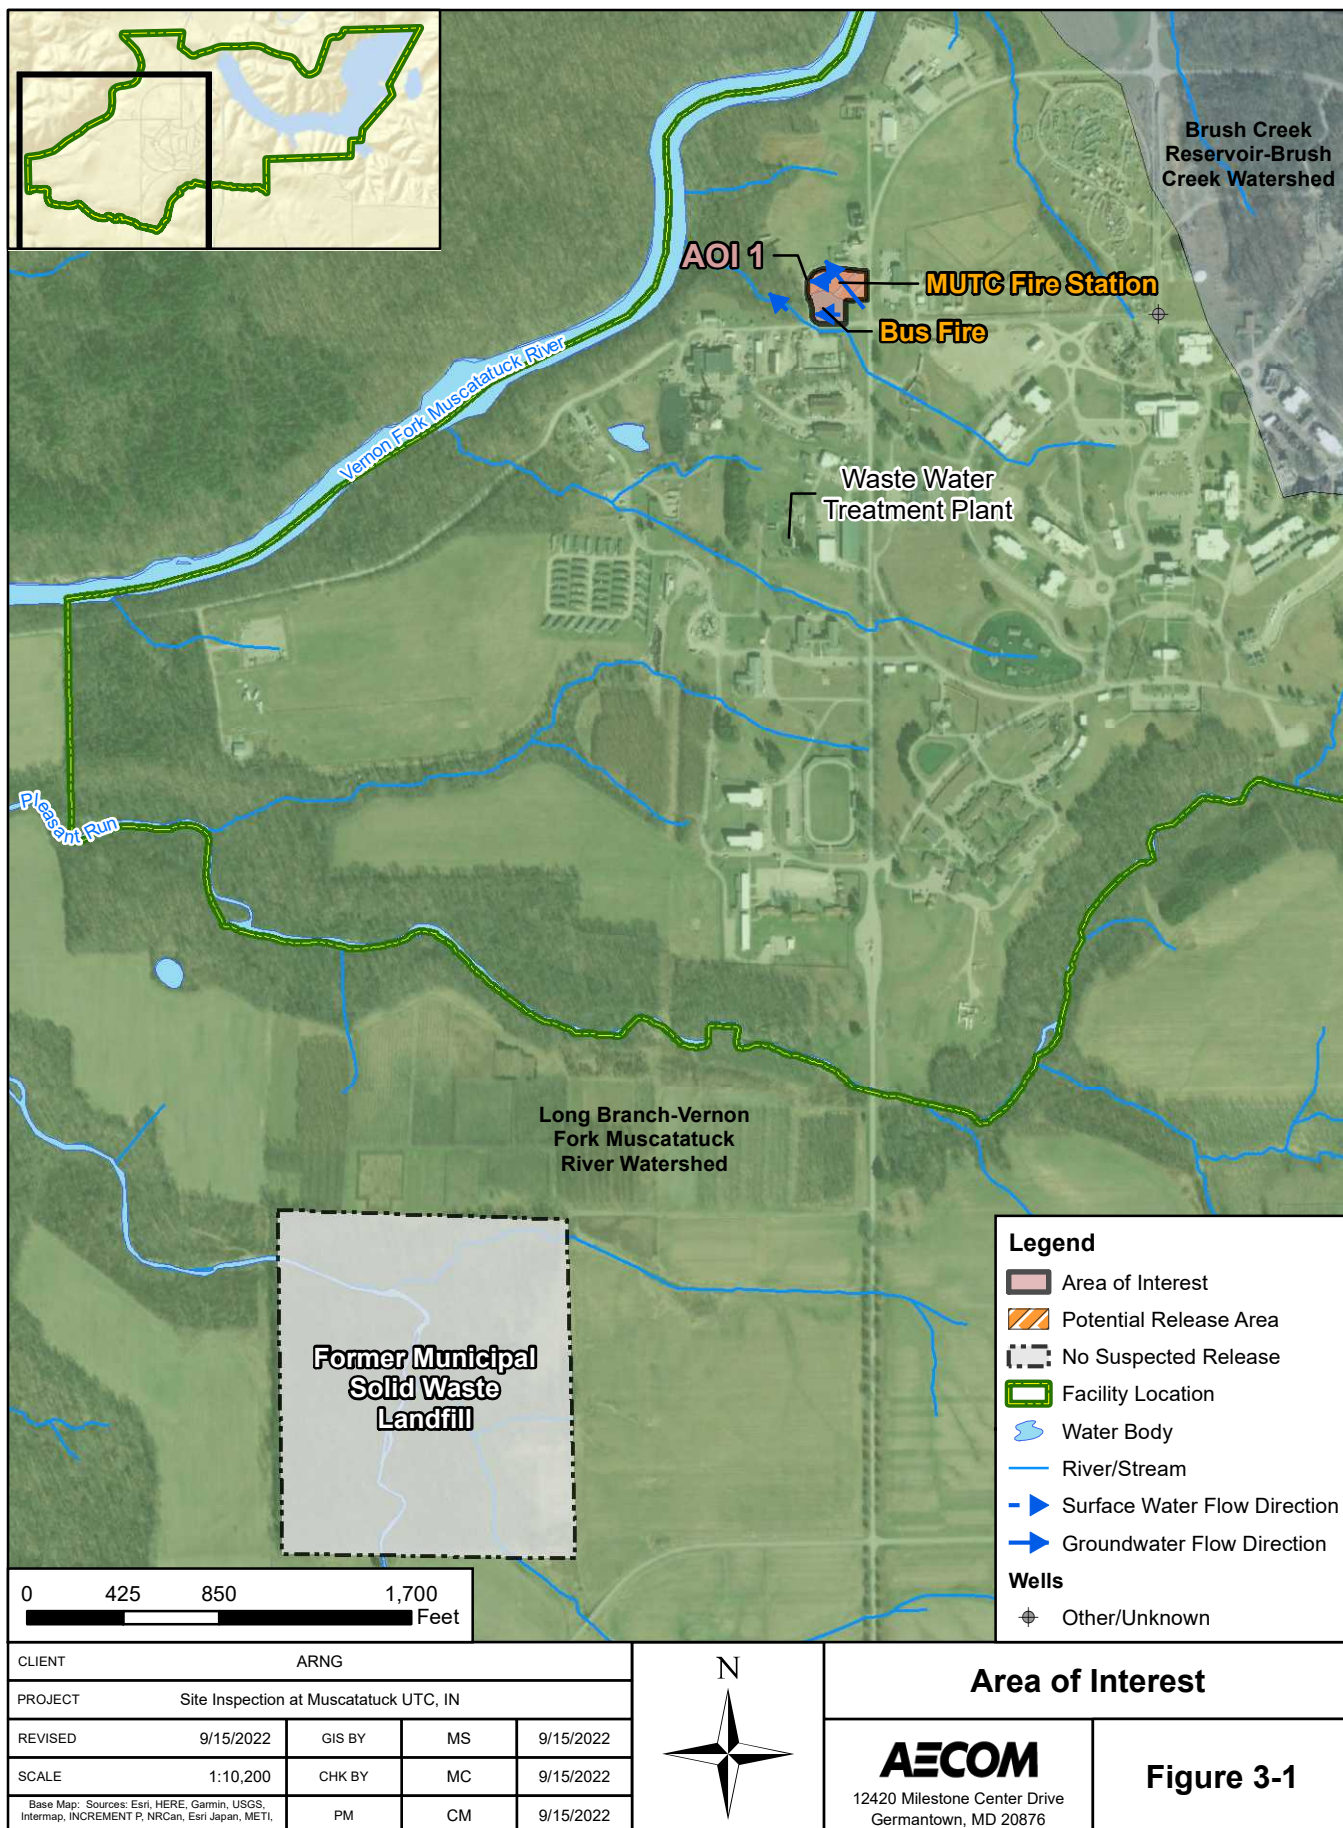
AOI 1 encompasses the Fire Station, the 0.25-acre gravel pad west of the Fire Station, and the 0.45-acre grass lot immediately southwest of the Fire Station. The emergency response activities associated with the April 2021 bus fire resulted in a known release of AFFF to the ground surface at the AOI. Although there are no documented releases of the AFFF stored at the Fire Station, because AFFF was stored within both the station and firetrucks within and around the buildings, it is possible that AFFF may have historically been spilled or released during routine activities or product handling. Firetrucks containing/equipped with AFFF also have the potential to leak due to corrosion of fittings and gaskets. Details of fire training or fire-fighting activities at the facility between the years 2005 and 2008 are not known.

The PA evaluated areas where PFAS-containing materials may have been used, stored, disposed, or released historically. Based on the PA findings, AFFF was stored at the facility and created the potential for it to have been incidentally released to the environment during handling or via leaks. Additionally, recent fire response activities resulted in the known release of AFFF to the ground surface. These areas were grouped into one AOI: MUTC Fire Station & Bus Fire (AECOM, 2021a). These potential release areas are shown on **Figure 3-1**.
