FINAL Preliminary Assessment Report Muscatatuck Urban Training Center, Indiana

Perfluorooctanesulfonic Acid (PFOS) and Perfluorooctanoic
Acid (PFOA) Impacted Sites
ARNG Installations, Nationwide

October 2020

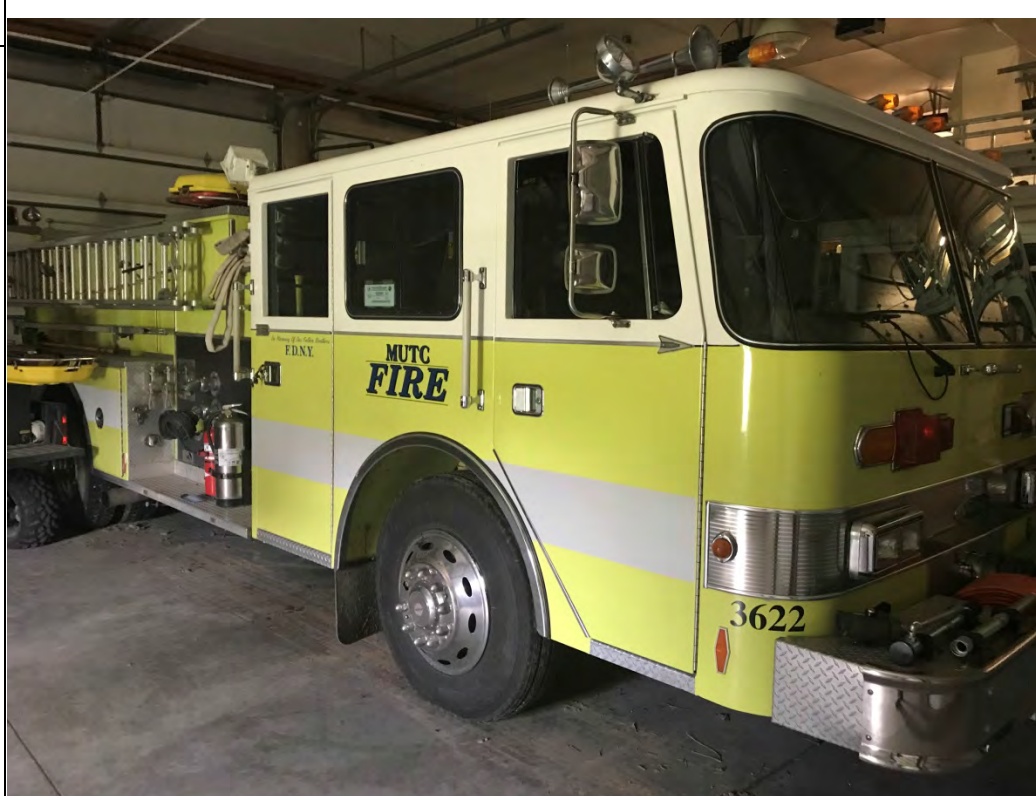
Photograph No. 2

Secondary Firetruck located in the fire station bay. Currently loaded with ~20 gallons of AFFF.

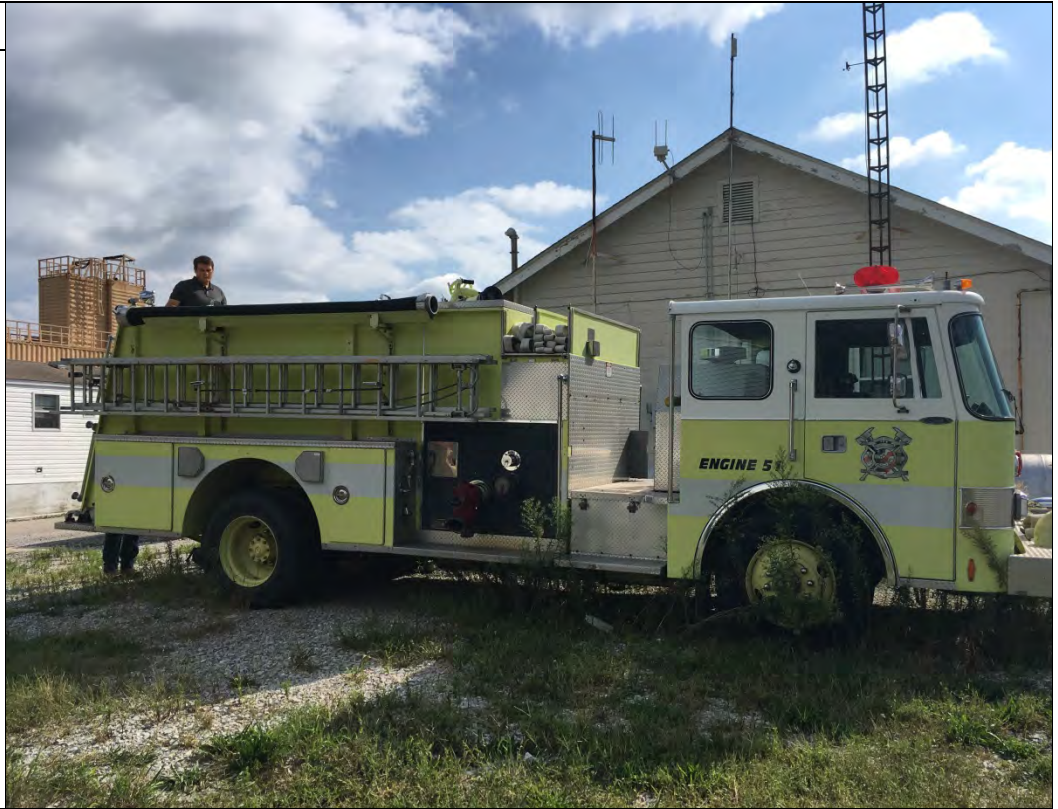
Tertiary reserve truck located in the rear of the fire station (building directly in back of photo). The truck is loaded with ~20 gallons of AFFF, but is currently out of commission. The single FTA at MUTC, the burn tower, can be seen in the back left of the photo.

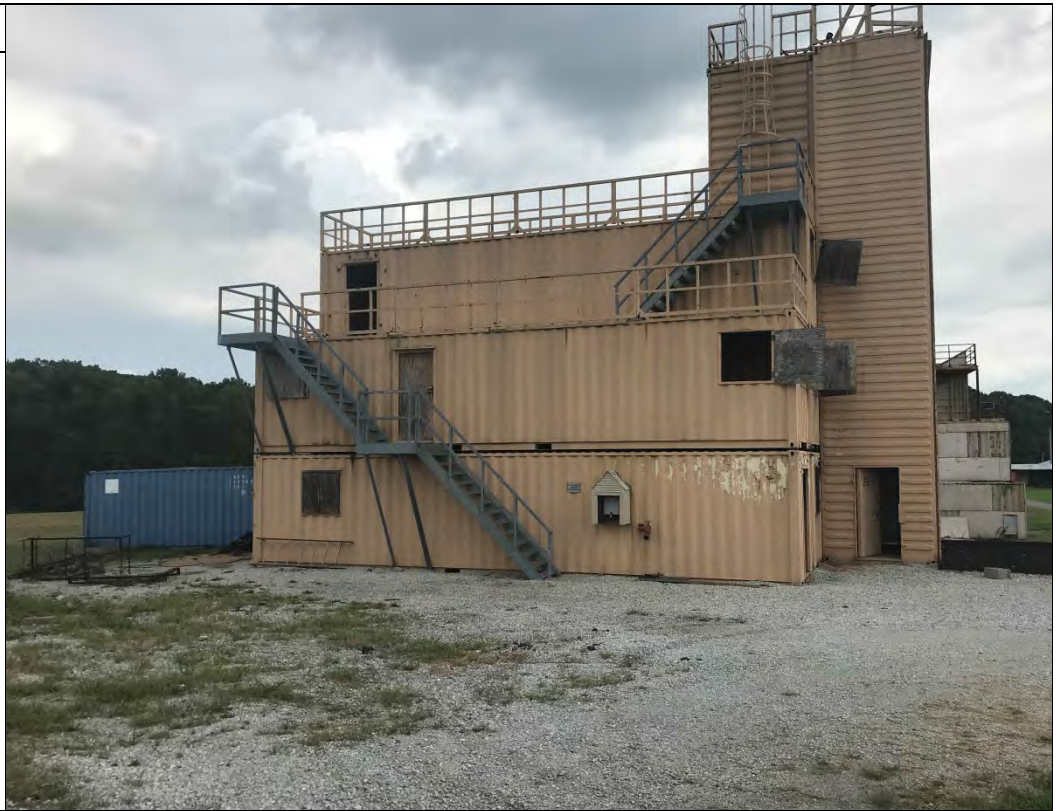
Burn Tower Fire Training Area. No historical or reported use of AFFF has occurred. Dry fuel (burnt pallets) can be seen in the lower left corner of the building, in front of the blue connex.
