# FINAL Preliminary Assessment Report Army Aviation Support Facility #1, Topeka, Kansas

Perfluorooctane-Sulfonic Acid (PFOS) and Perfluorooctanoic  
Acid (PFOA) Impacted Sites  
ARNG Installations, Nationwide

January 2020

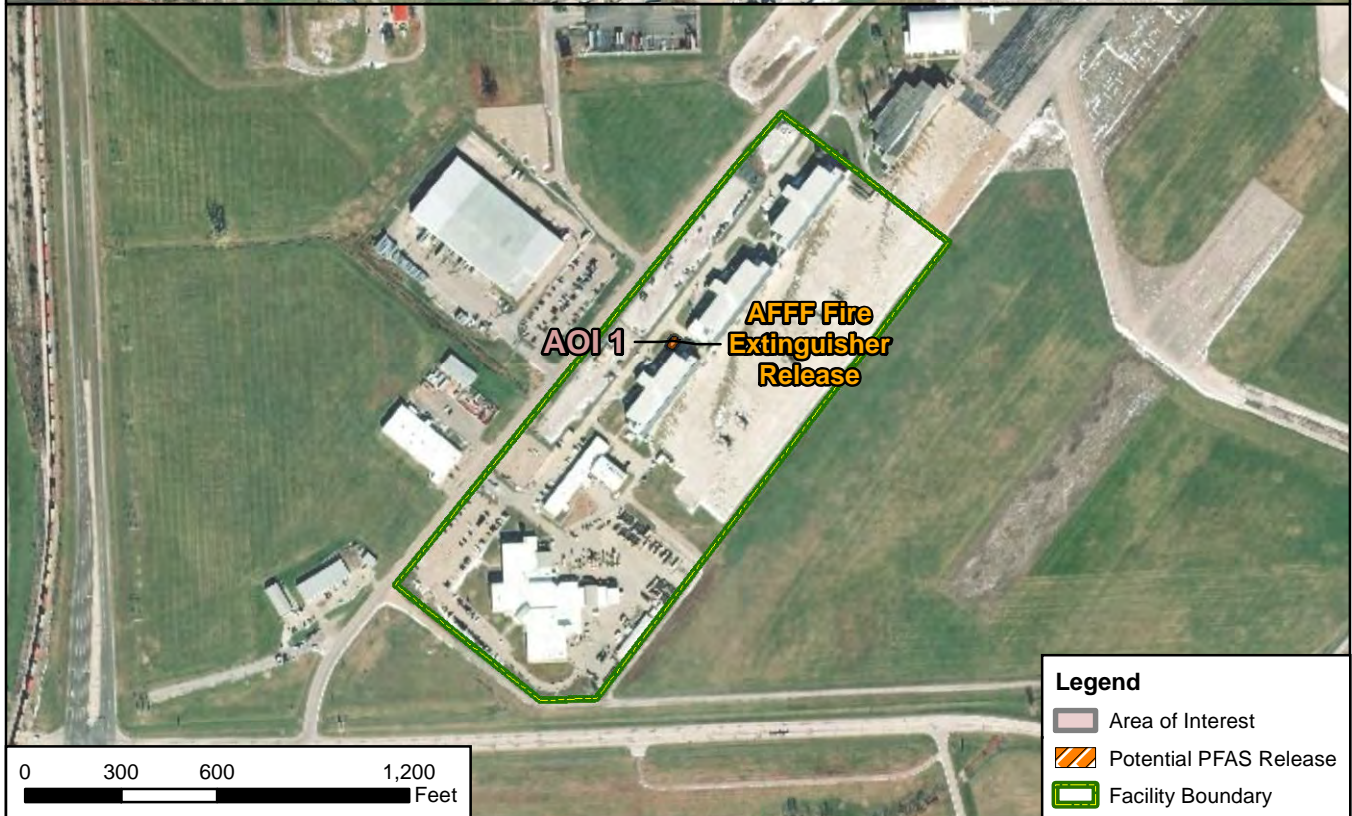
One AOI related to potential PFAS release was identified at AASF #1 during the PA. The AOI is shown on **Figure ES-1** and described in **Table ES-1** below:

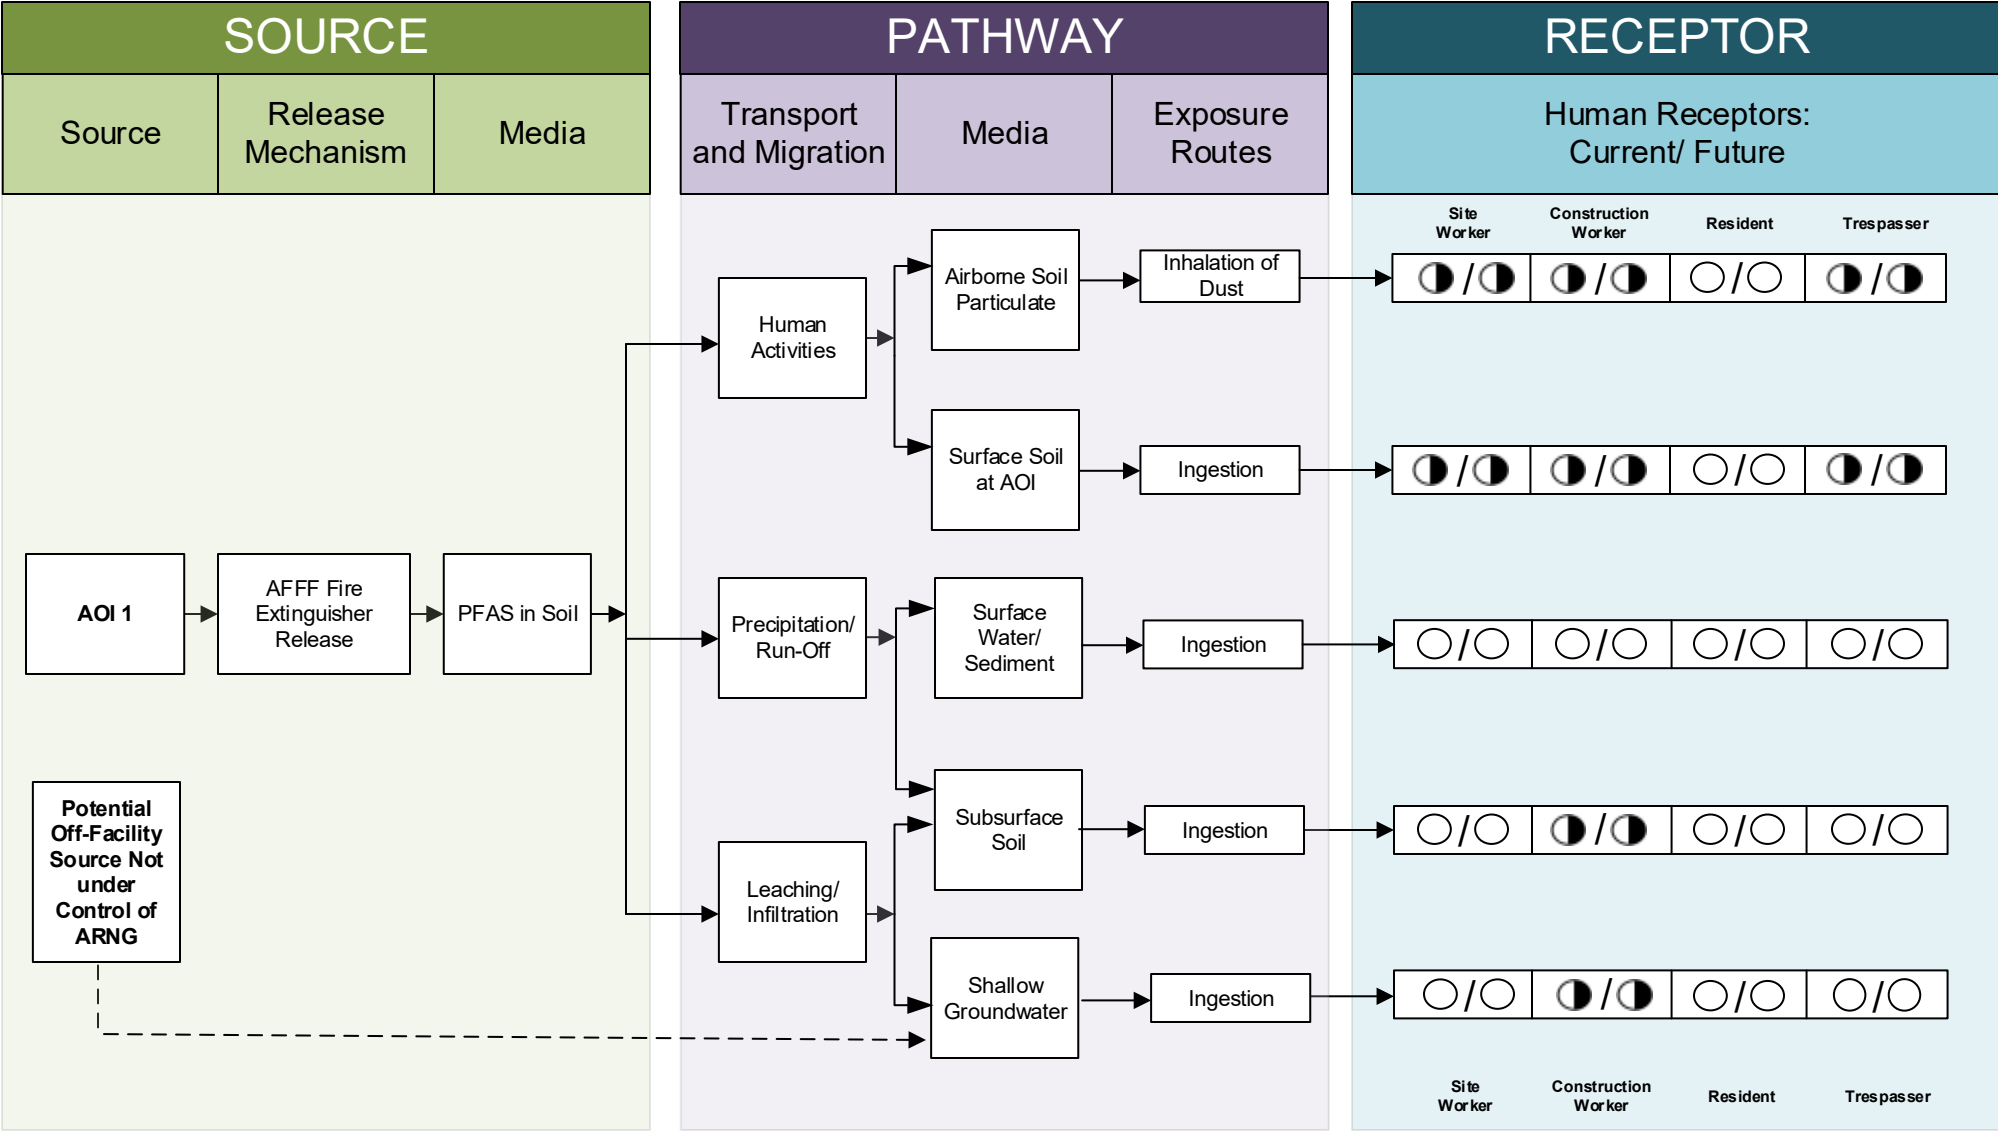
Figure ES-2  
Preliminary Conceptual Site Model  
Topeka AASF #1

Based on potential PFAS release at this AOI, there is potential for exposure to PFAS contamination in surface soil to site and construction workers; and subsurface soil to construction workers via ingestion and inhalation of dust. Because AASF #1 has been operated by the KSARNG since 1970, the uncertainty associated with potential PFAS use at the facility is relatively low. Based on the USEPA Unregulated Contaminant Monitoring Rule 3 data, it was indicated that no PFAS were detected in a public water system above the United States Environmental Protection Agency Lifetime Health Advisory level within 20 miles of the facility. The preliminary CSM for AASF #1 is shown on **Figure ES-2**.

Notes:  
1. Dermal contact exposure pathway is incomplete for PFAS.

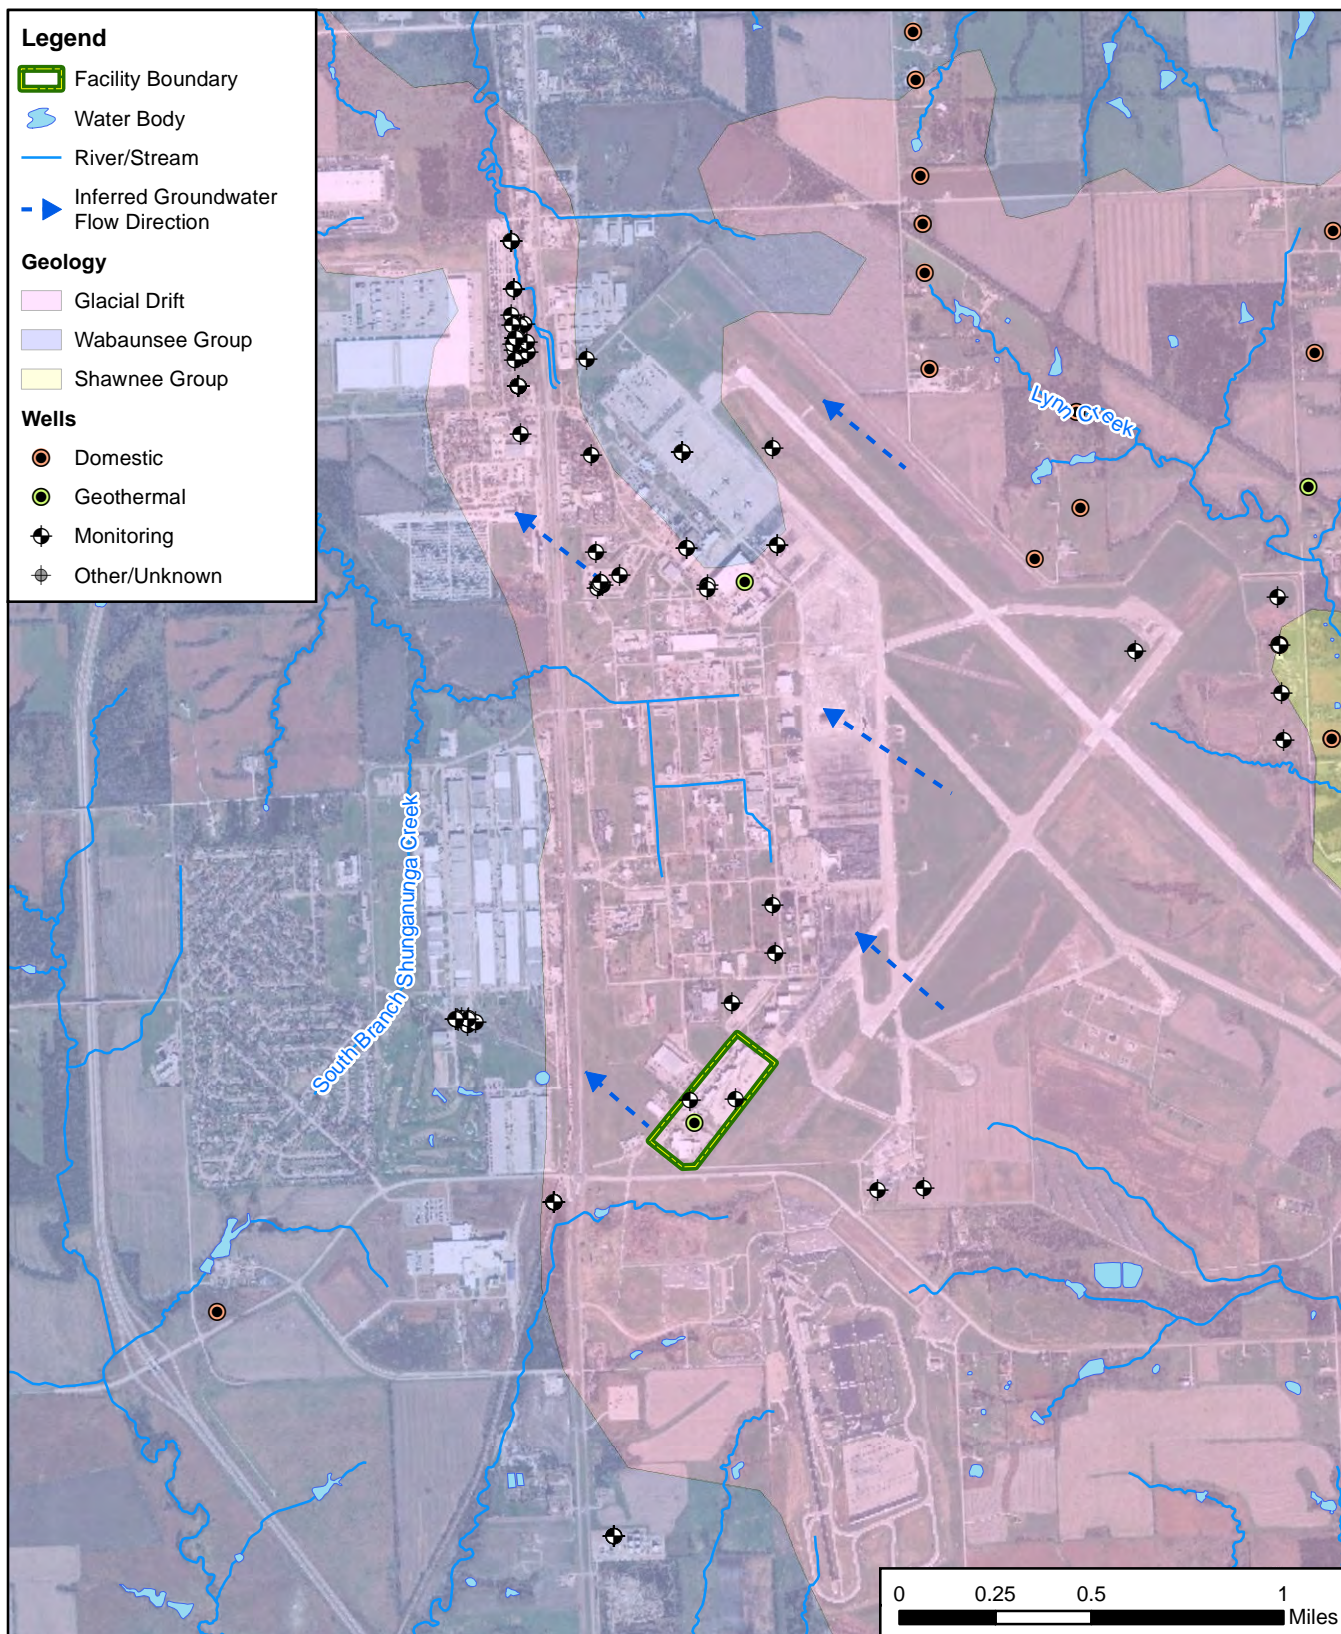
Figure 1-2	
REVISED	11/25/2019	GIS BY	MS	11/25/2019				
SCALE	1:31,680	CHK BY	SI	11/25/2019				
Base Map: Source: Esri, DigitalGlobe, GeoEye, Earthstar Geographics, CNES/Airbus DS, USDA, USGS,		PM	RG	11/25/2019				12420 Milestone Center Drive Germantown, MD 20876

Groundwater occurs in two aquifers at AASF #1: an unconfined aquifer within the shallow, unconsolidated material, and a confined aquifer within the Nodaway Coal formation of the bedrock. The water table is relatively shallow, at 10 feet below ground surface (bgs), on average, but can occur anywhere from 2 to 24 feet bgs. Groundwater flow is limited at AASF #1 because of a lack of hydraulic connectivity, but it generally flows northwest.

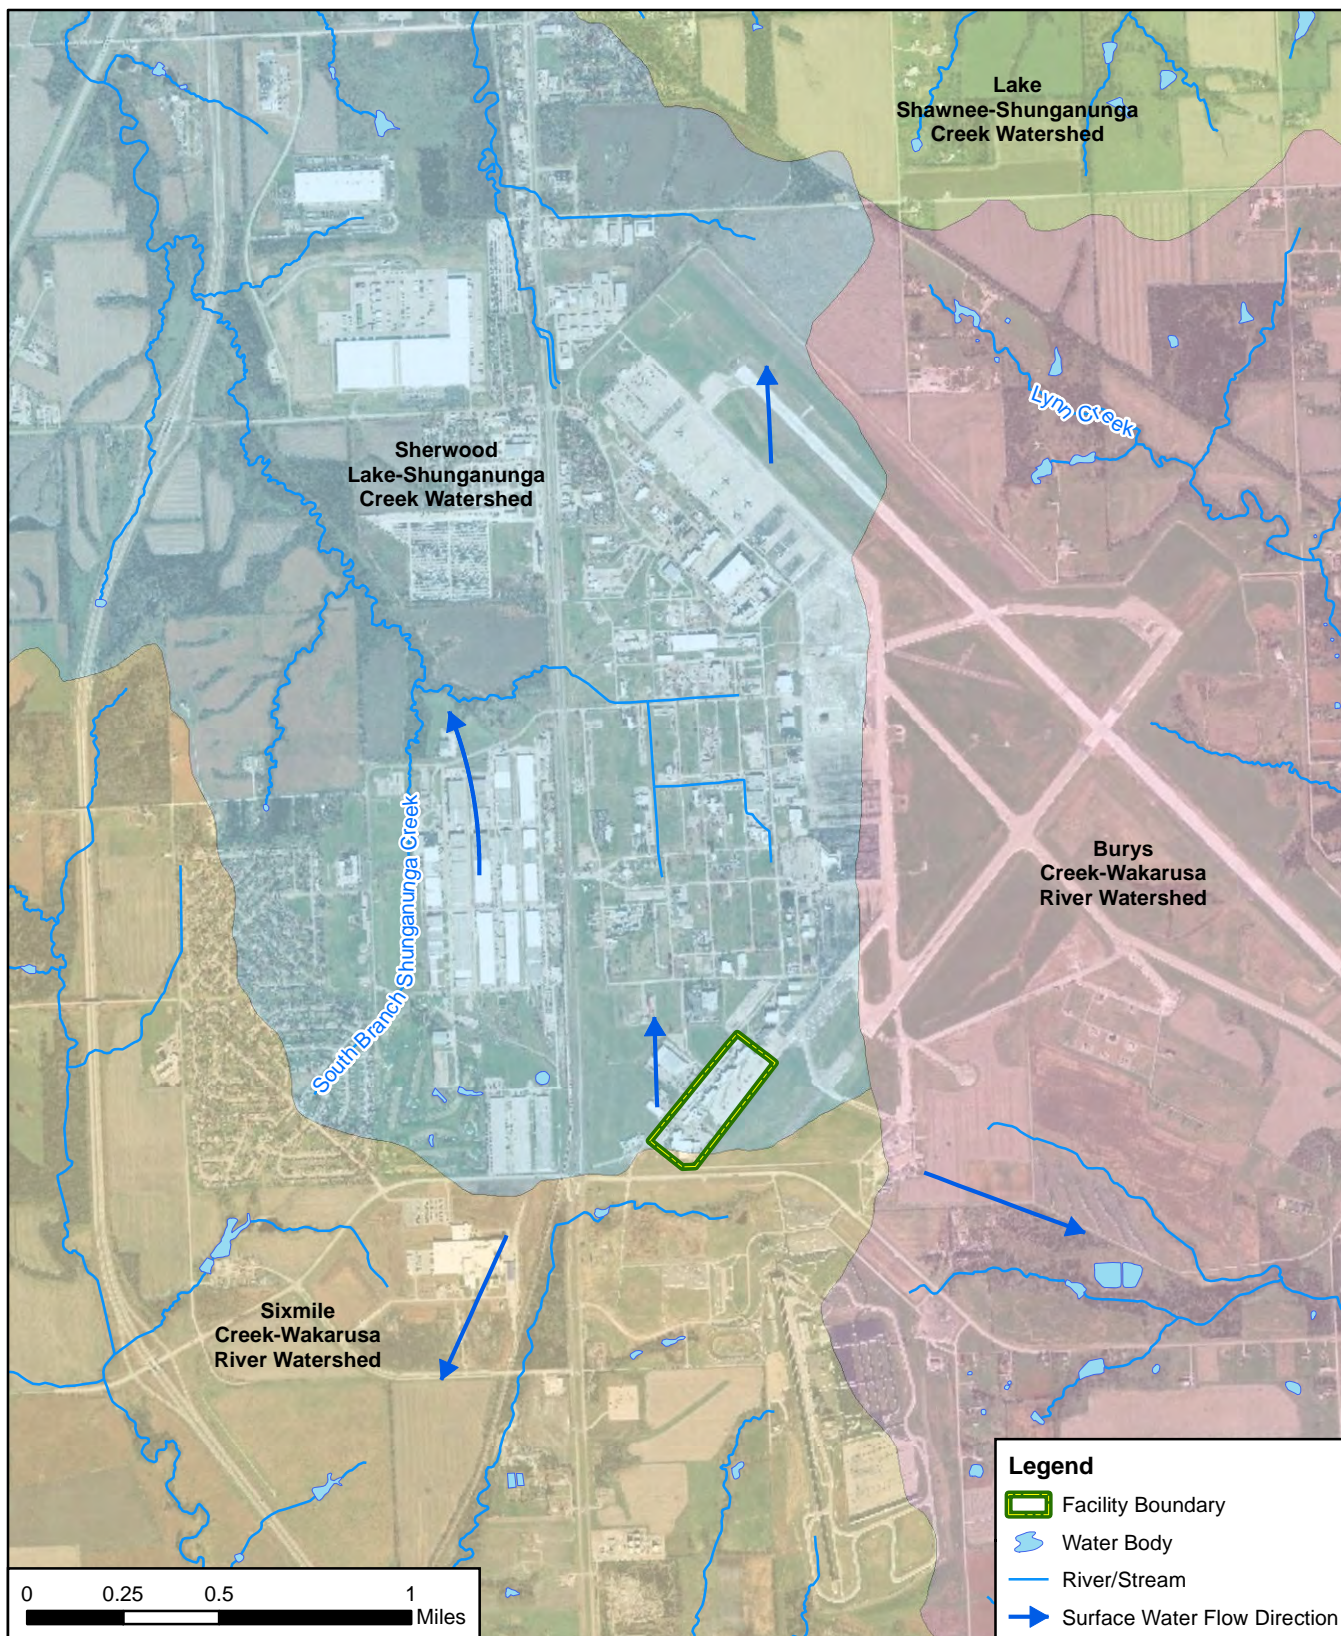
Surface Water Features	
<b>AECOM</b> 12420 Milestone Center Drive Germantown, MD 20876	Figure 1-3

AASF #1 is located between two creeks, Lynn Creek and the south branch of Shunganunga Creek, where there is a drainage divide that runs along the main runway (**Figure 1-3**). Lynn Creek drains southeast to the Wakarusa River, while Shunganunga Creek drains into the Kansas River to the north. At AASF #1, surface runoff is primarily in the form of sheet flow, but discharges in to the Wakarusa River via direct discharge or through the storm sewer (Leidos, 2014).

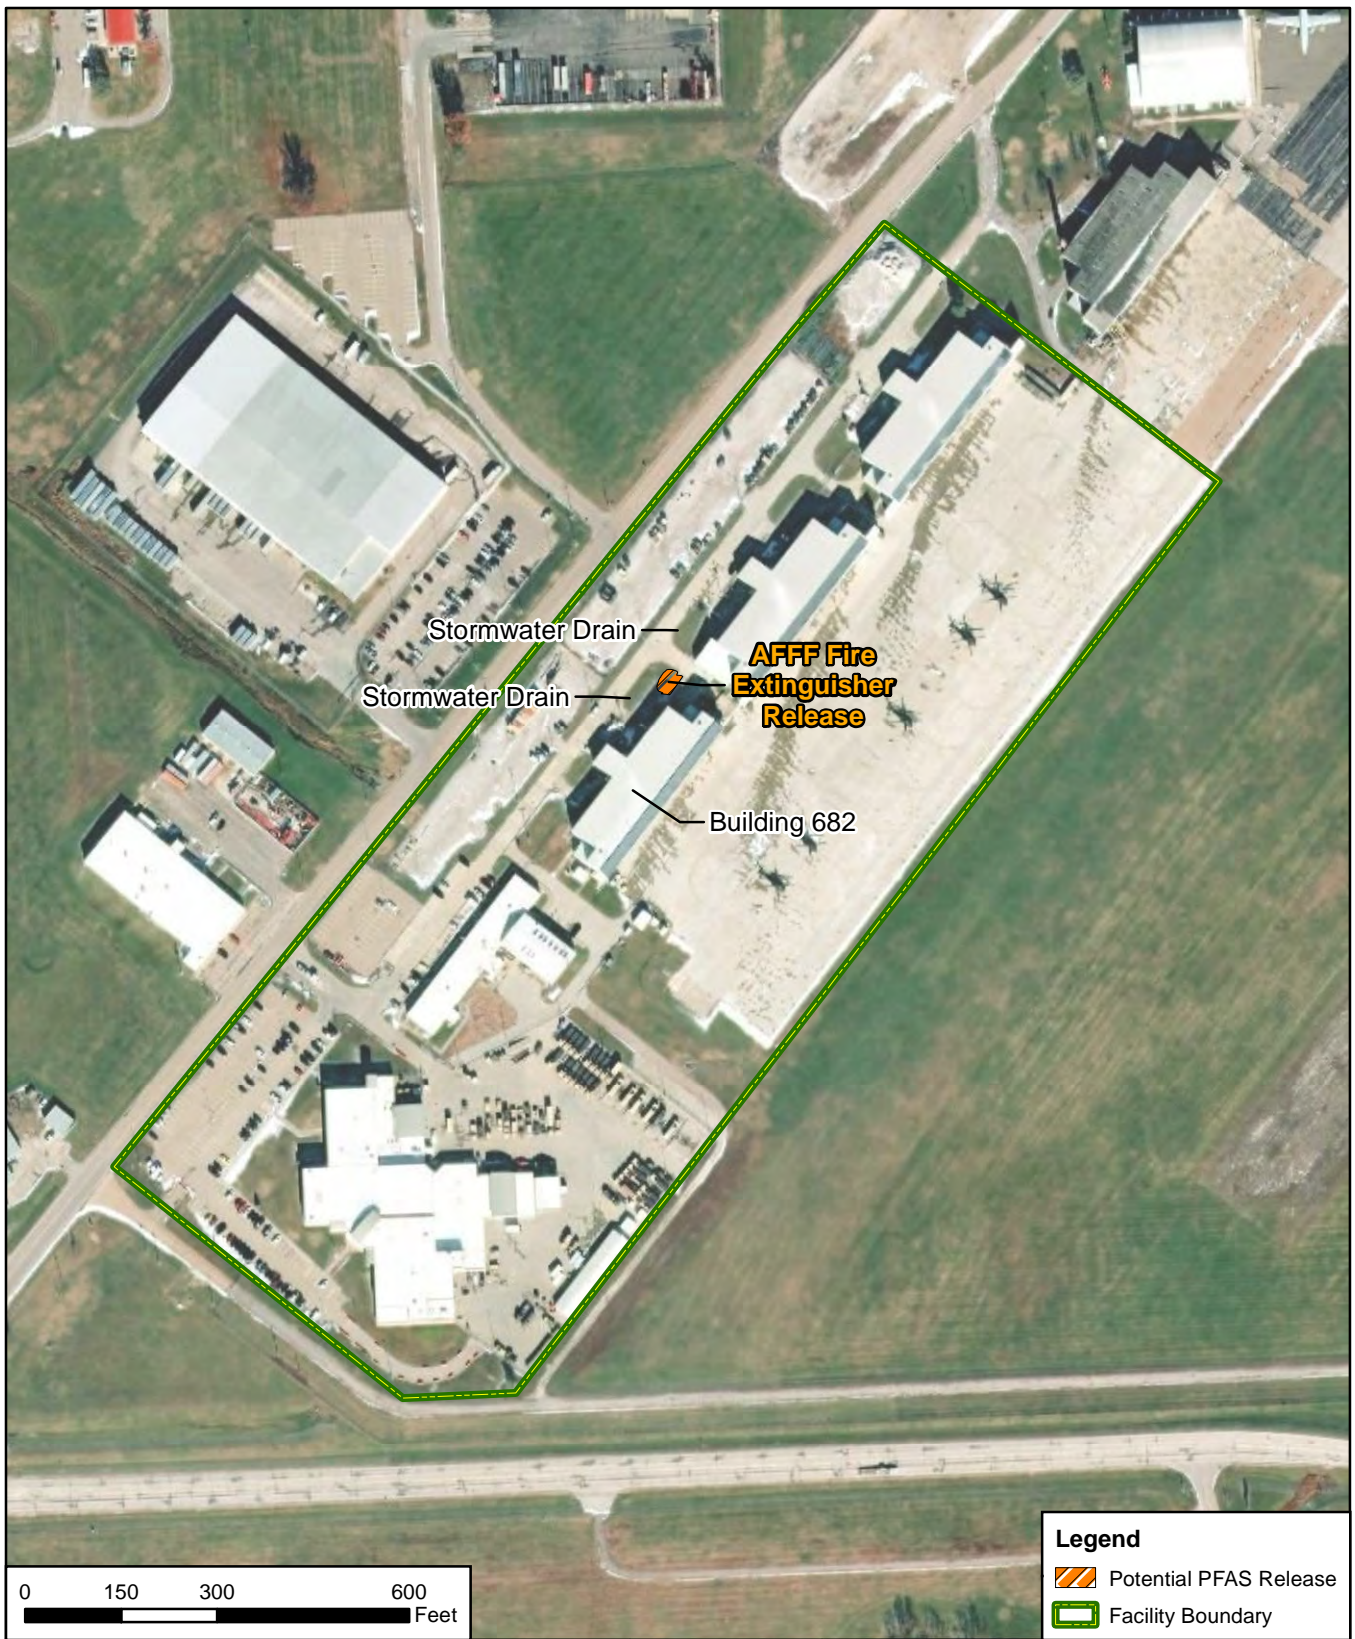
<b>Non-Fire Training Area</b>	
<b>AECOM</b> 12420 Milestone Center Drive Germantown, MD 20876	<b>Figure 3-1</b>

One non-FTA where AFFF was stored and/or potentially released was identified during the PA. A description of the non-FTA is presented below and shown on **Figure 3-1**. Interview records and photographs are included in **Appendix B** and **Appendix C**, respectively.

Since 1992, the AASF #1 facility housed six TriMax-30™ fire extinguishers that were placed on the ramp area. In 2008, the TriMax-30™ fire extinguishers were removed from the facility, and five Ansul Alcohol-Resistant AFFF fire extinguishers (Ansul AR-33-D) with a 15 percent (%) AFFF solution concentration were placed on the ramp area. In 2014, there was a one-time release of AFFF, when four Ansul AFFF fire extinguishers were emptied on gravel behind building 682 (**Figure 3-1**). The estimated total amount emptied onto the gravel area was 132 gallons of 15% AFFF solution. The geographic coordinates are 38°56'18.73"N; 95°40'50.50"W. One of the Ansul AFFF fire extinguishers was containerized in a 55-gallon drum during the time when the four Ansul AFFF fire extinguishers were emptied, and ultimately from the facility in August 2019 to be properly disposed of through the Defense Logistics Agency (DLA) contract. No bulk AFFF solution has been stored on the facility. The TriMax-30™ and Ansul fire extinguishers were tested annually by a contractor, and any release was containerized then removed by the contractor. Since 2014, the AASF #1 facility has housed six Purple K fire extinguishers that are placed on the ramp area.

There are two stormwater drains in the proximity of the release area. The closest stormwater drain is approximately 65 feet to the north, and the second is approximately 140 feet to the south. Both of the stormwater drains are elevated above the gravel release area; therefore, it is unlikely the release impacted the stormwater system. The two stormwater drains lead to two outfalls on the west boundary of the facility and ultimately discharge north to the South Branch Shunganunga Creek.

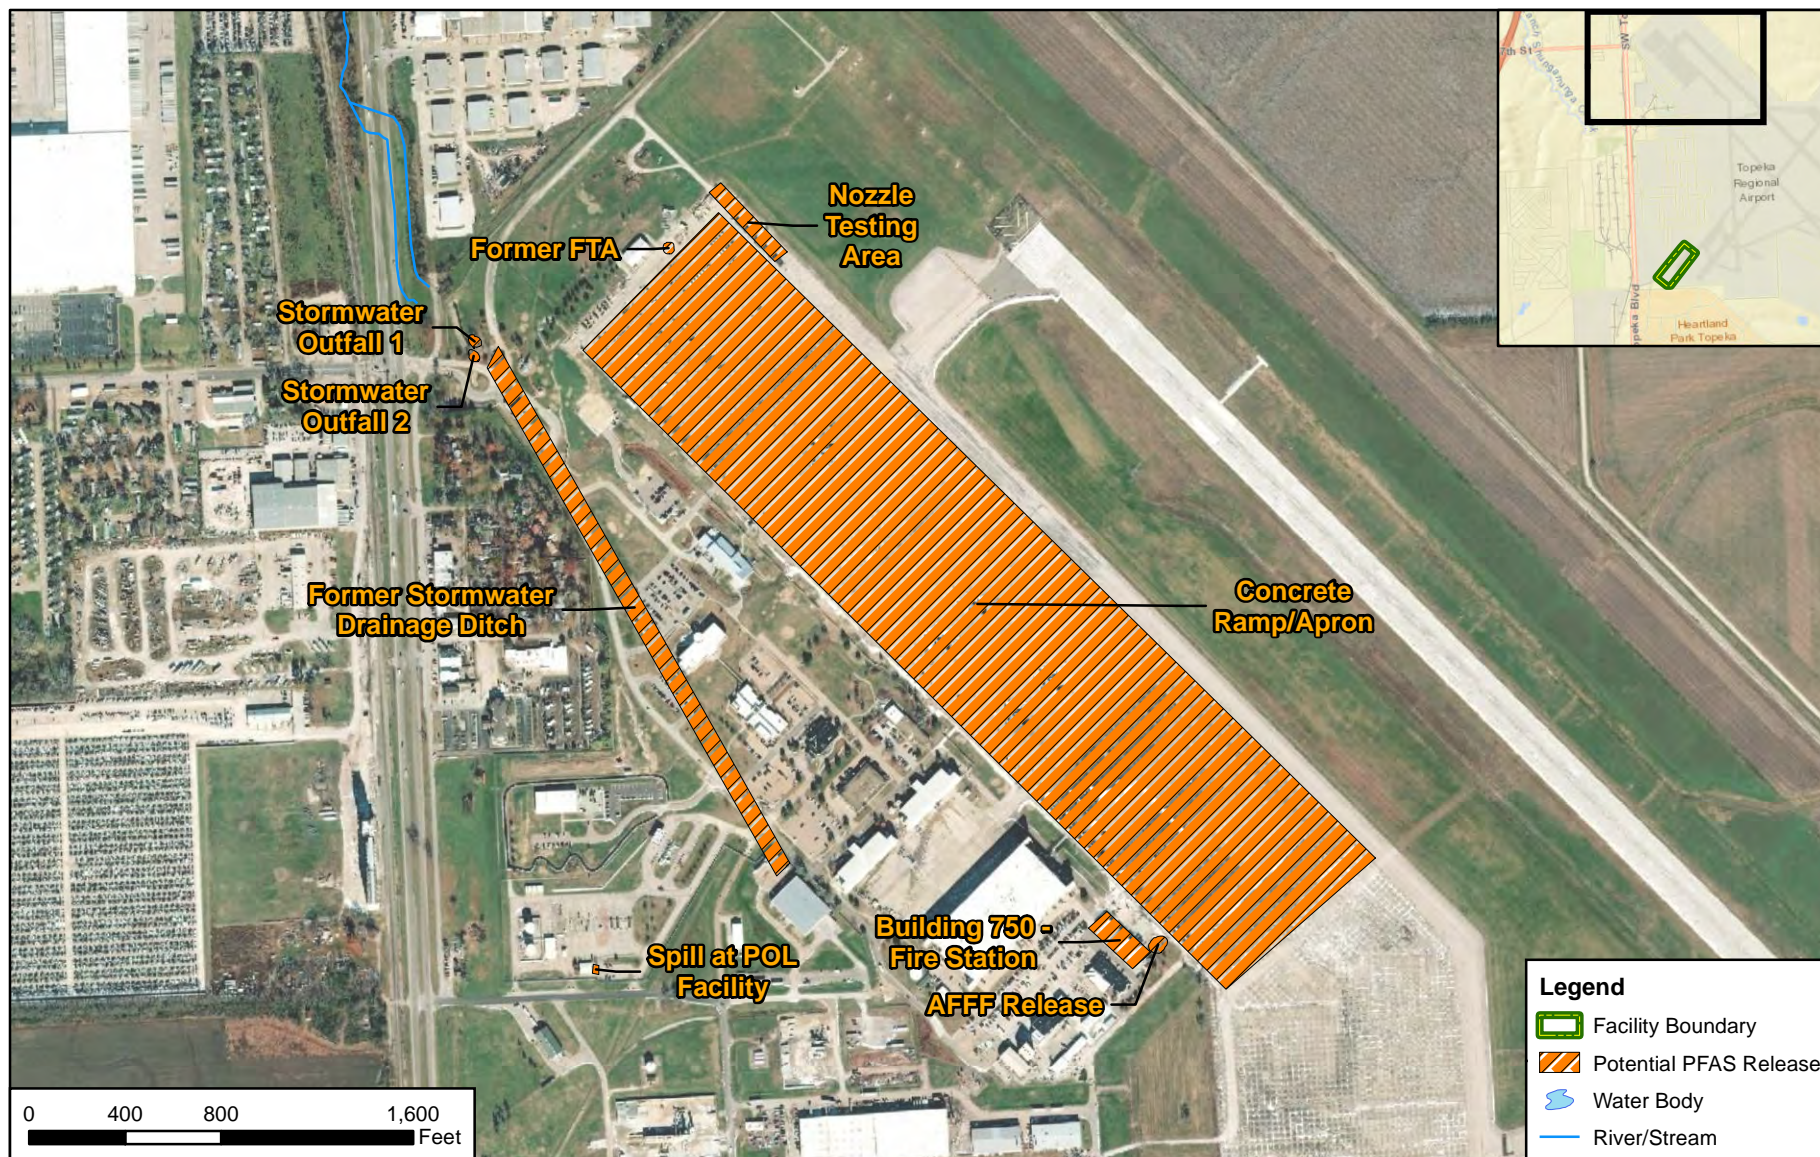
TITLE		Adjacent Sources	
		12420 Milestone Center Drive Germantown, MD 20876	Figure 5-1

Nine off-site potential PFAS source areas adjacent to AASF #1 were identified during the PA through interviews (**Appendix B**), online research, and the Environmental Data Resource Report (**Appendix A**). **Figure 5-1** presents the location of potential adjacent source areas.

Based on the SI findings, several potential areas of potential use, storage, or release of AFFF have historically occurred at the KSANG, Forbes Field (Amec Foster Wheeler, 2017). These locations are described below.

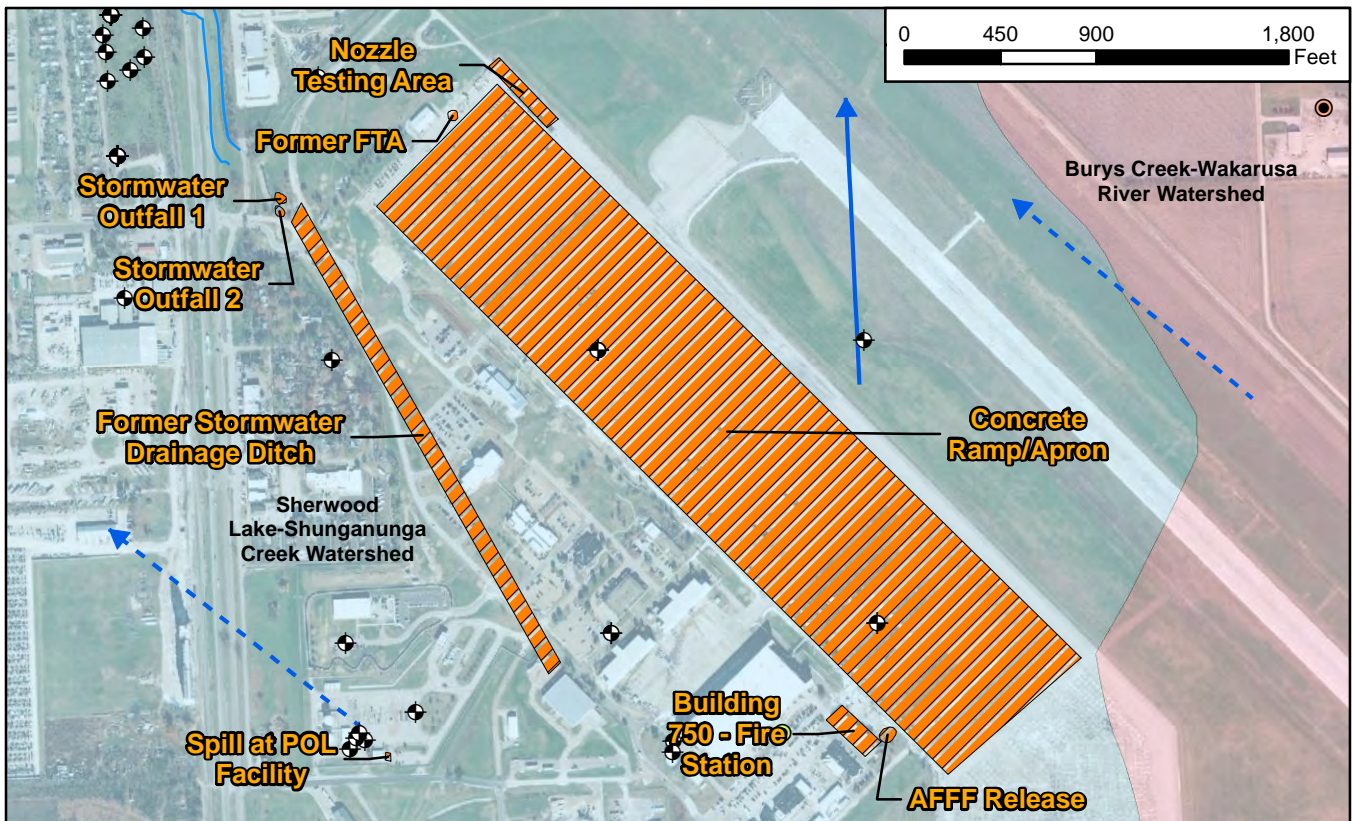
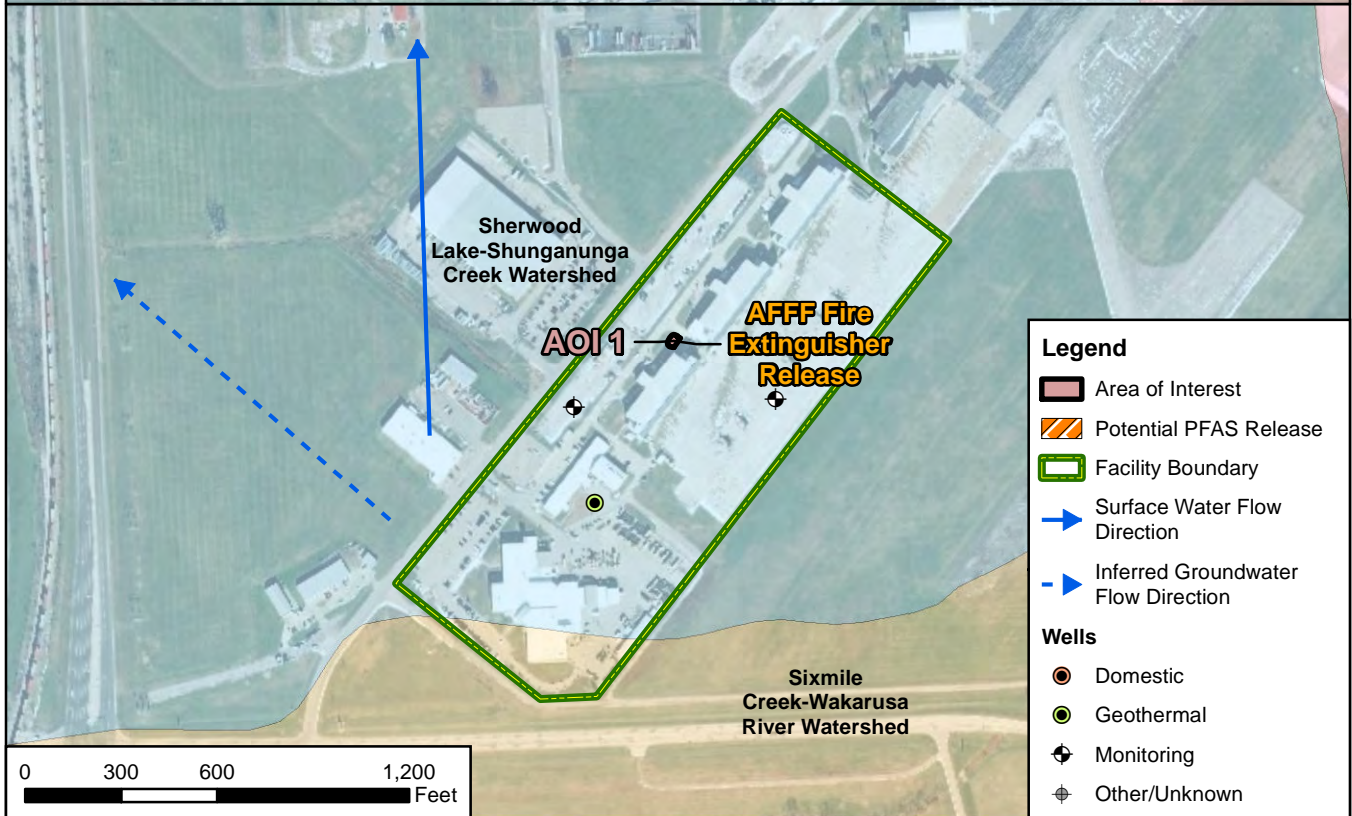
Based on the PA findings, one AOI was identified at AASF #1: AOI 1 AFFF Fire Extinguisher Release. The AOI is shown on **Figure 6-1**. The following sections describe the CSM components and the specific preliminary CSM developed for the AOI 1. The CSM identifies the three components necessary for a potentially complete exposure pathway: (1) source, (2) pathway, (3) receptor. If any of these elements are missing, the pathway is considered incomplete.

AOI 1 is the AFFF Fire Extinguisher Release area adjacent to building 682. PFAS releases to soil by the KSARNG occurred in 2014, when four Ansul AFFF fire extinguishers were fully emptied on gravel behind the building. The estimated total amount emptied was 132 gallons of 15% AFFF solution.

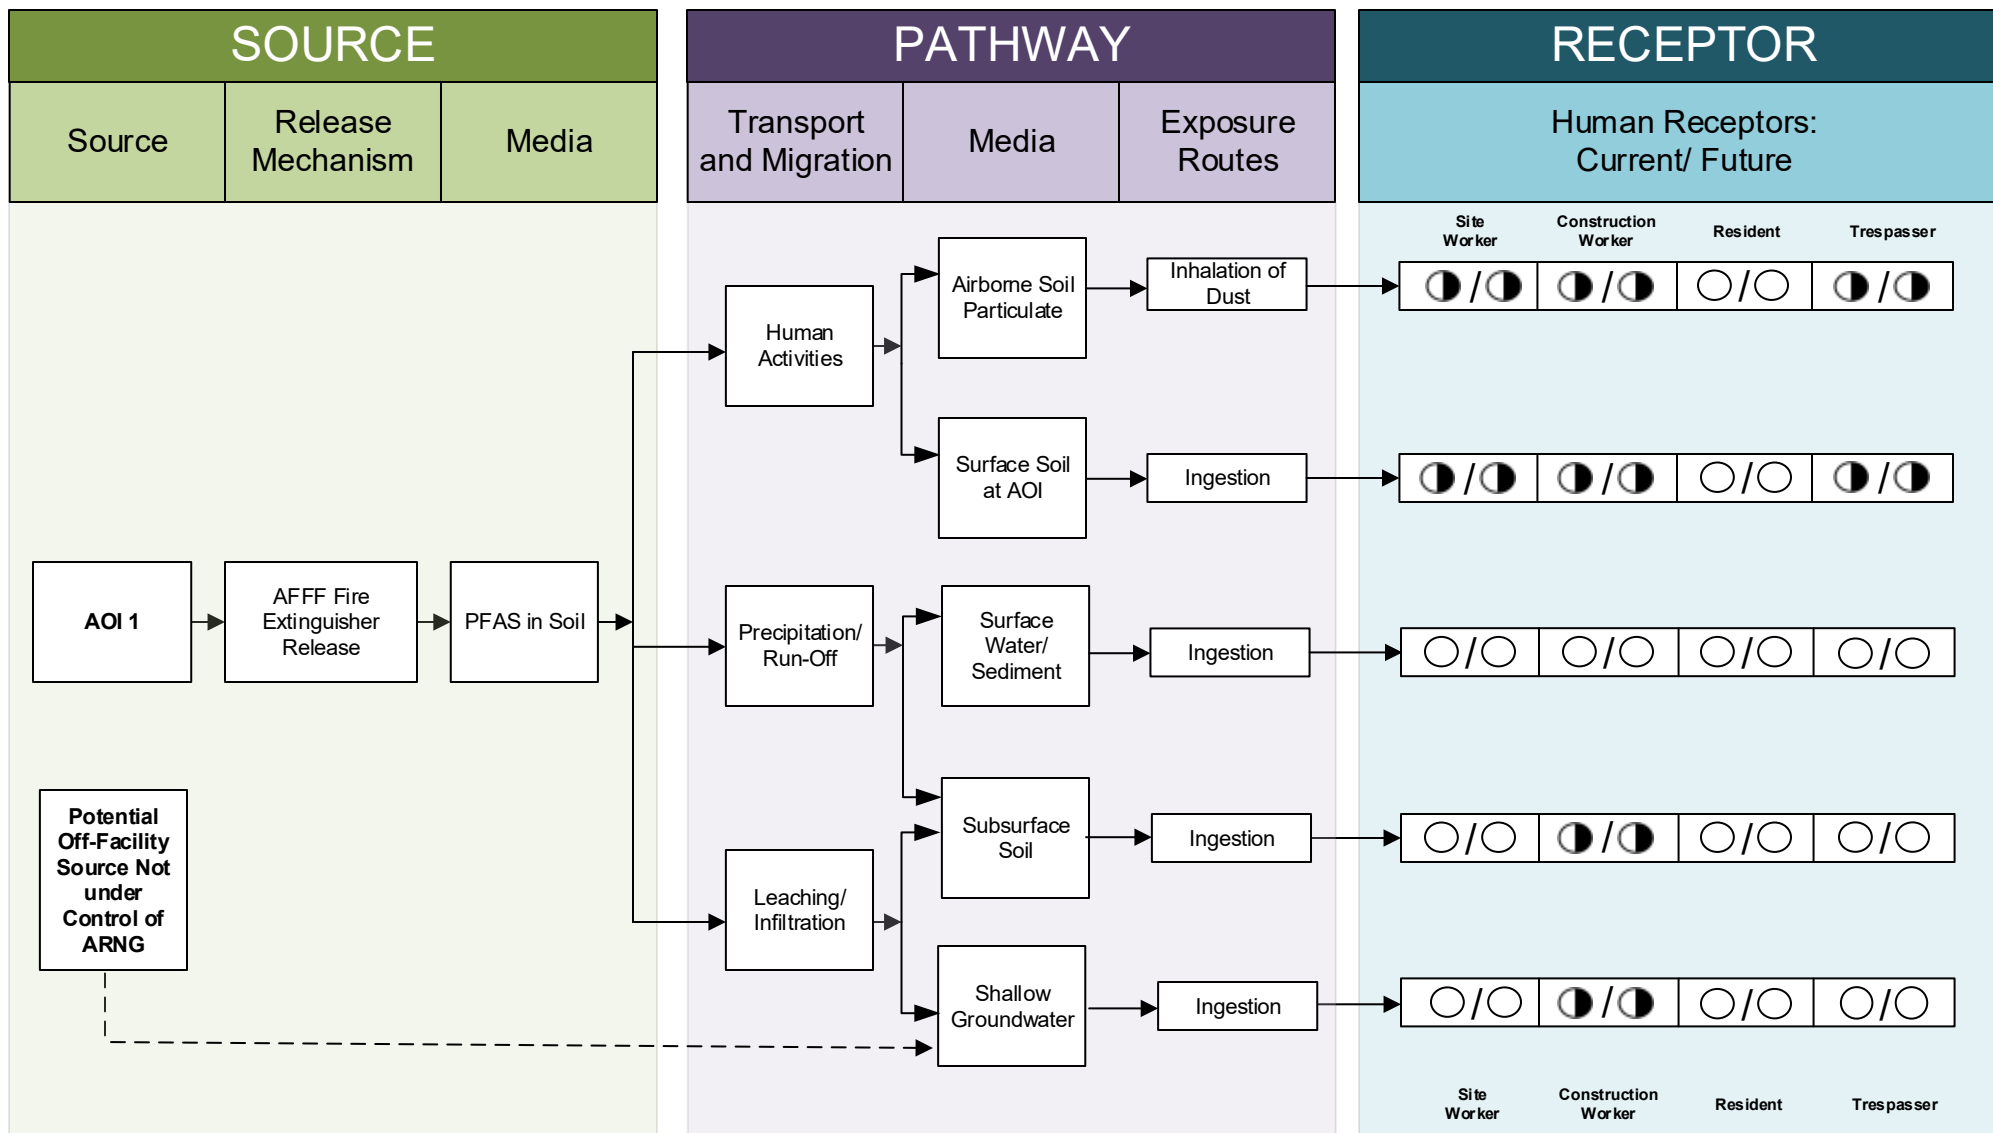
**Figure 6-2**  
Preliminary Conceptual Site Model  
AOI 1 AFFF Fire Extinguisher Release

Ground-disturbing activities to surface soil at AOI 1 could result in site worker, construction worker, and trespasser exposure to potential PFAS contamination. Therefore, the exposure pathways for inhalation of soil particles and ingestion of soil are potentially complete for these receptors. Ground-disturbing activities to subsurface soil could result in construction worker exposure via inhalation of soil particles and ingestion of subsurface soil. Therefore, the inhalation and ingestion pathways for these receptors are considered potentially complete.

No surface water features flow through AOI 1; therefore, surface water and sediment exposure pathways are incomplete for the site worker, construction worker, and trespasser. There are two stormwater drains in the proximity of the release area. The closest stormwater drain is approximately 65 feet to the north, and the second is approximately 140 feet to the south. Both of the stormwater drains are elevated above the gravel release area; therefore, it is unlikely the release impacted the stormwater system.

AOI 1 is located side gradient of five domestic wells within 2 miles of the facility; these wells are not likely to be impacted by potential PFAS releases at AOI 1. The AASF #1 drinking water is supplied by the City of Topeka; therefore, the exposure pathway for groundwater via ingestion to the site worker, trespasser, and off-facility resident is incomplete. Because PFAS are water soluble and can migrate readily from soil to groundwater, the exposure pathway via ingestion for the construction worker is considered potentially complete. The preliminary CSM for AASF #1 is shown on **Figure 6-2**.

1. Dermal contact exposure pathway is incomplete for PFAS.

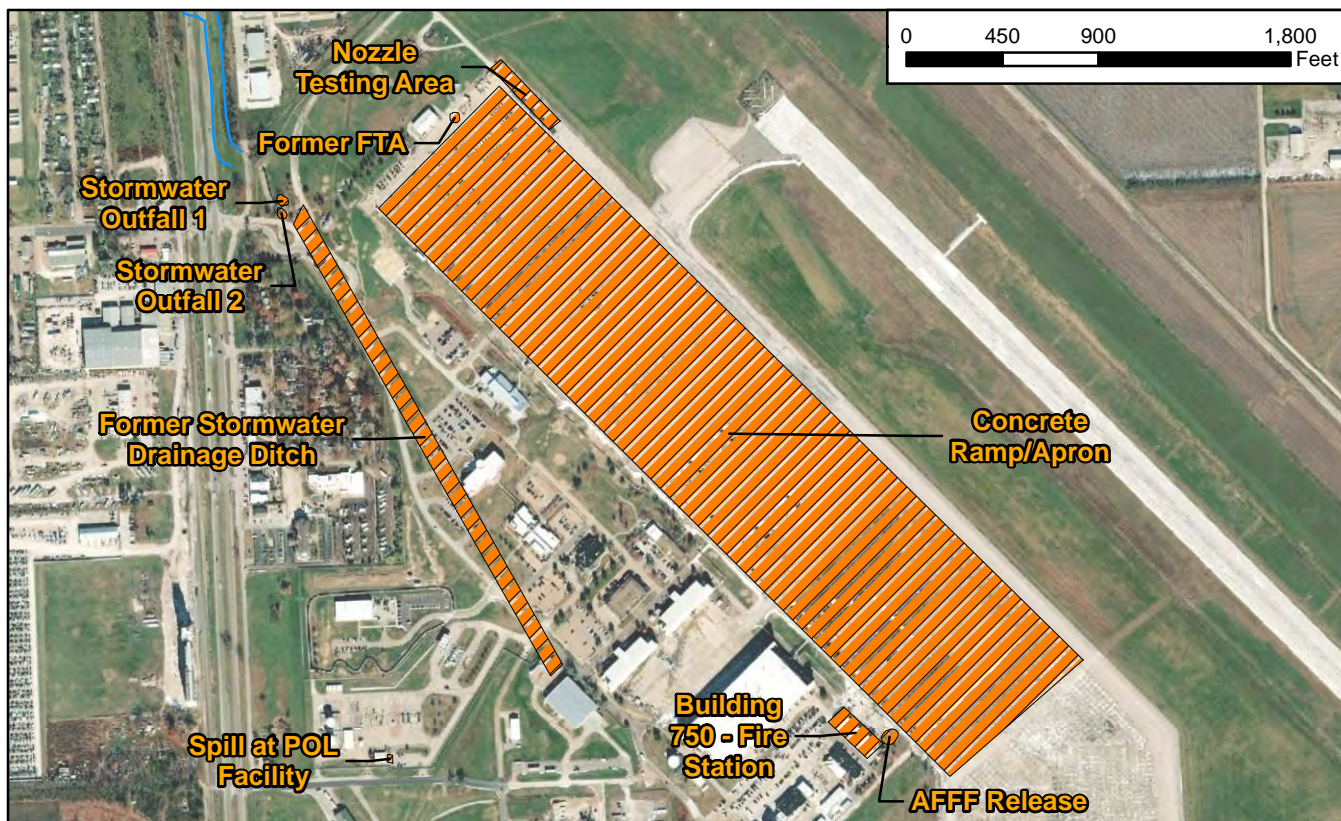
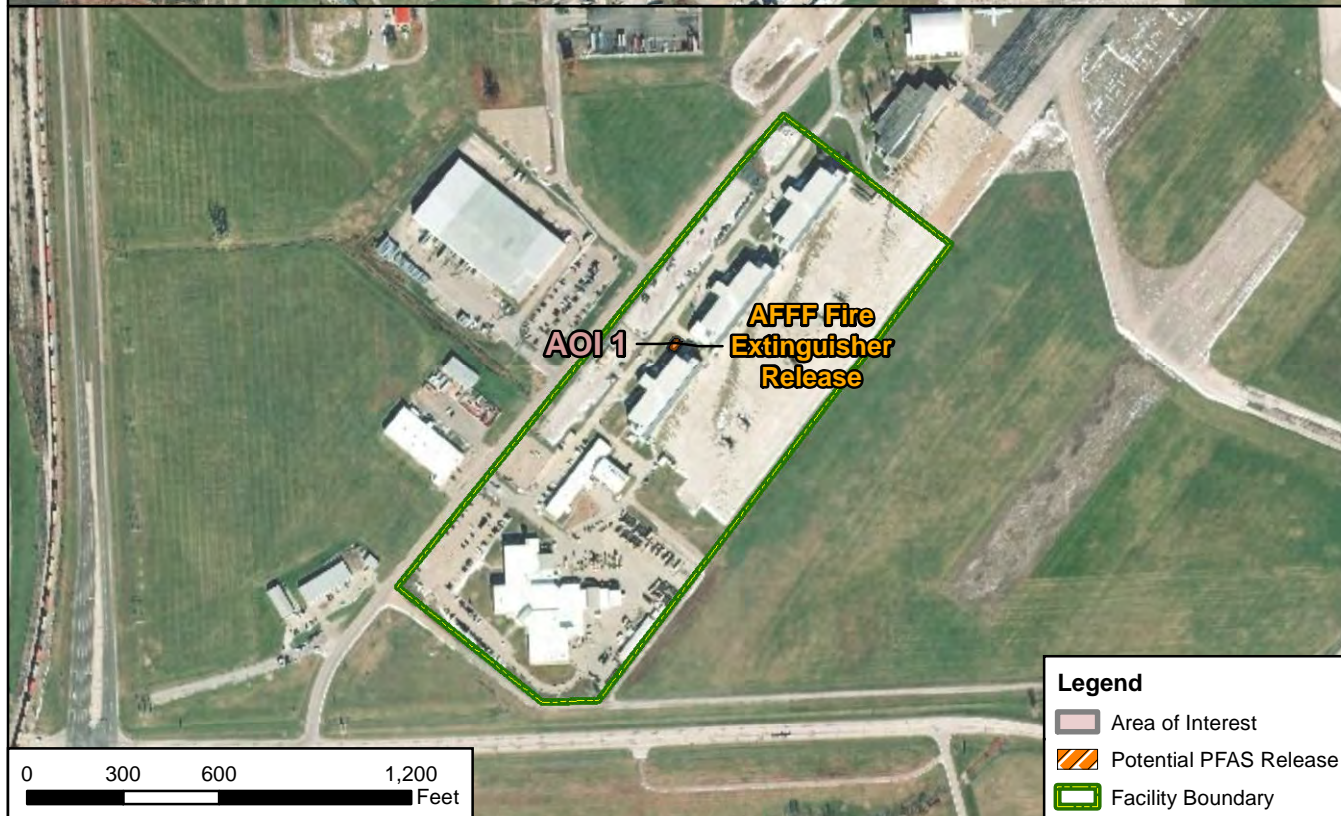
Summary of Findings		
NOTES		Preliminary Assessment for PFAS at Topkea AASF 1, KS						
REVISED	11/25/2019	GIS BY	MS	11/25/2019

One AOI related to potential PFAS releases was identified (**Table 7-1**) at AASF #1 during the PA (**Figure 7-1**).

Based on potential PFAS release at this AOI, there is potential for exposure to PFAS contamination in surface soil to site and construction workers; subsurface soil to construction workers via ingestion and inhalation of dust; and in groundwater to construction workers via ingestion.

Area of Interest	AOI Location	Rationale	Potential Future Action
AOI 1 AFFF Fire Extinguisher Release	45°25'22.39"N; 88°8'26.59"W	132-gallons of AFFF was released to the ground surface	Proceed to an SI for soil and groundwater

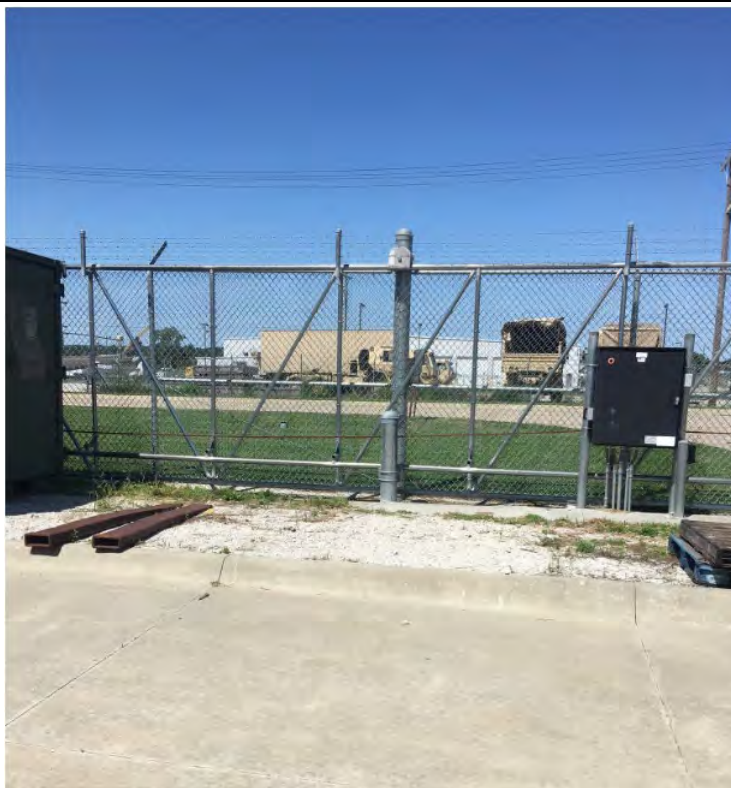
### Photograph No. 2

Stormwater drain that is situated slightly above gravel area. Surface water flow from AOI 1 would not reach this stormwater drain.
