# FINAL Preliminary Assessment Report Camp Beauregard, Louisiana

Perfluorooctanesulfonic Acid (PFOS) and Perfluorooctanoic  
Acid (PFOA) Impacted Sites  
ARNG Installations, Nationwide

July 2020

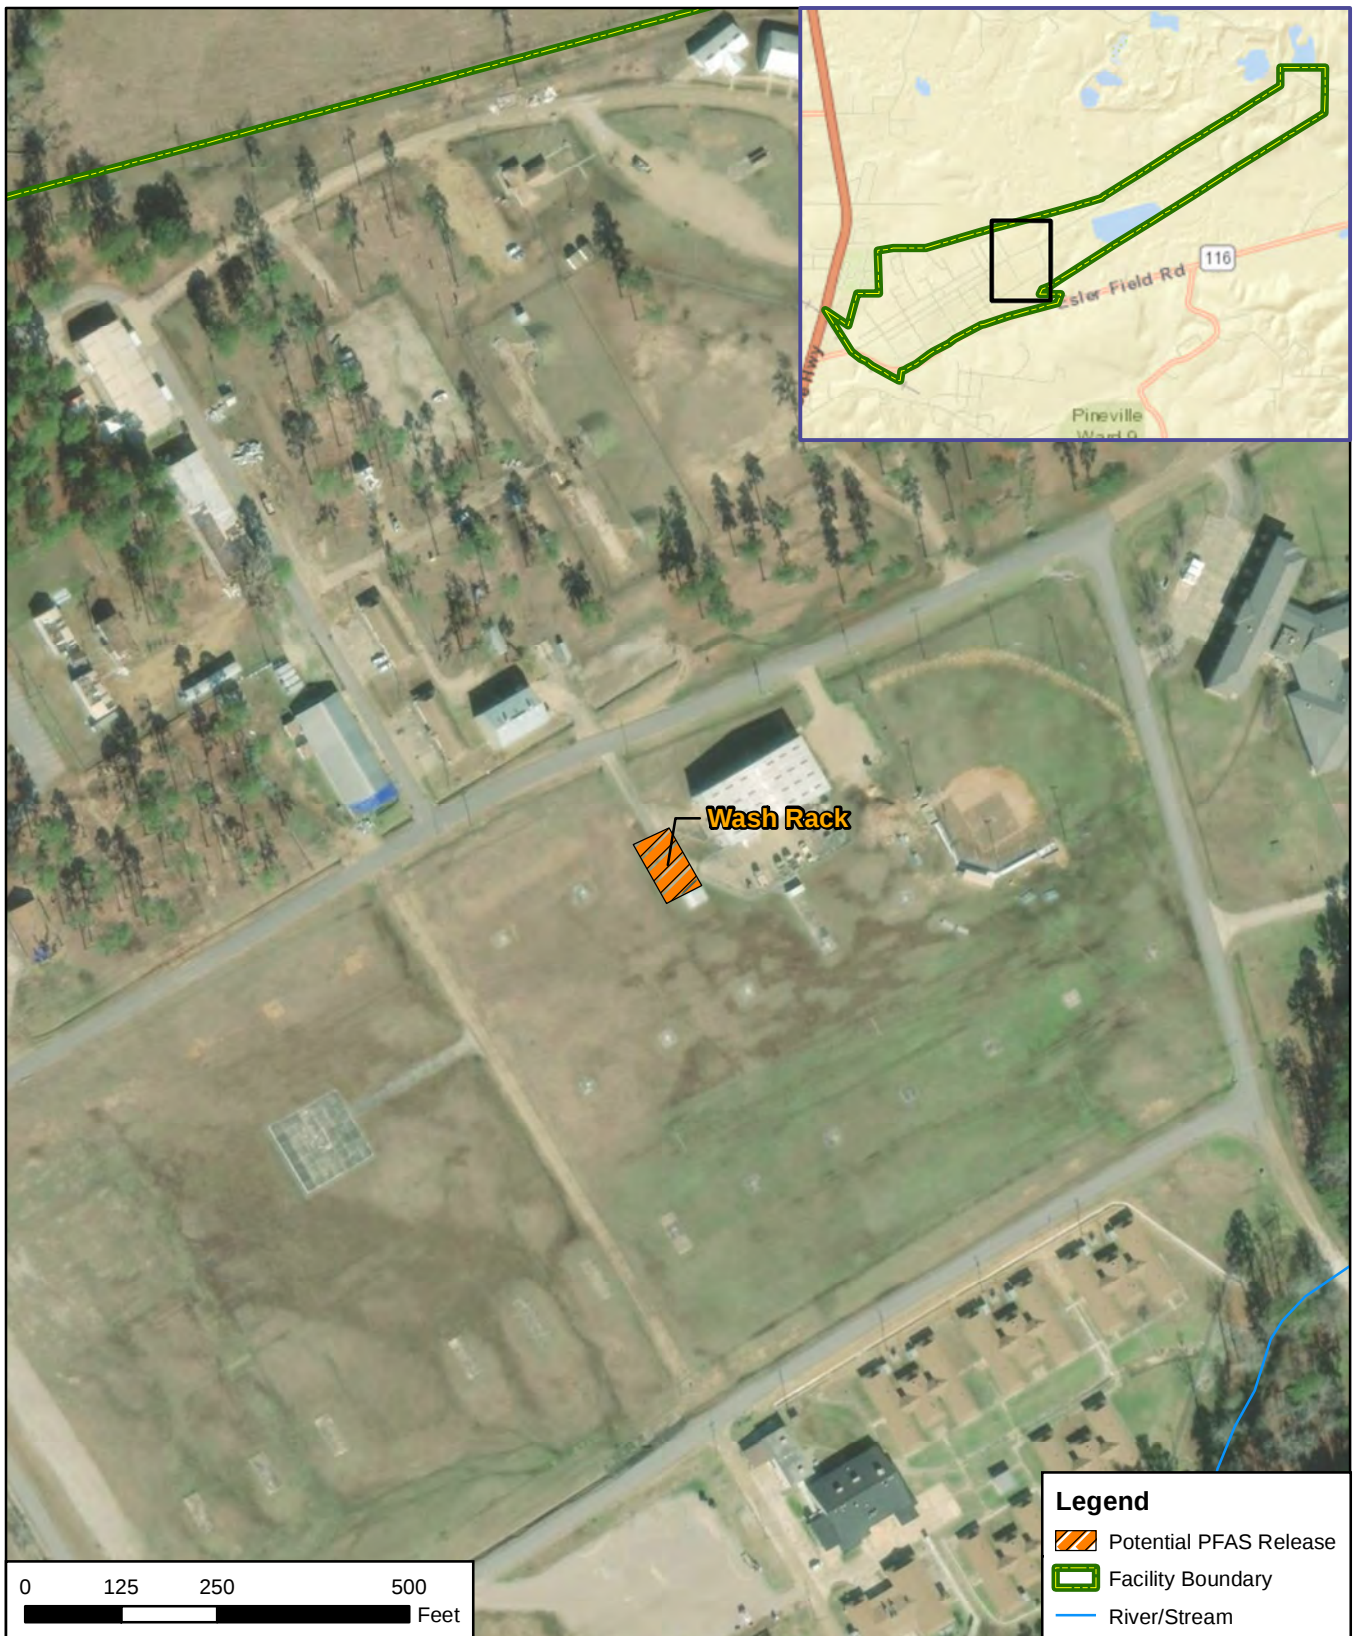
LAARNG personnel believe the Wash Rack was constructed sometime after the AASF was moved to Esler Field in 2000-2001. AFFF was possibly discharged at the Wash Rack near Building 1338 during fire training activities. The Wash Rack is located on a concrete surface with a drain to an oil/water separator (OWS). The OWS drained to the retention pond until 2003, when it was closed (**Section 3.1**). Since 2003, wastewater from the Wash Rack is conveyed to and treated by the wastewater treatment plant adjacent to Pinecrest School. Photos of the concrete surface and drains leading to the OWS can be seen in **Appendix C**. There are no documented instances of AFFF usage. The approximate coordinates of the Wash Rack are 31°22'32.8"N; 92°23'23.4"W.

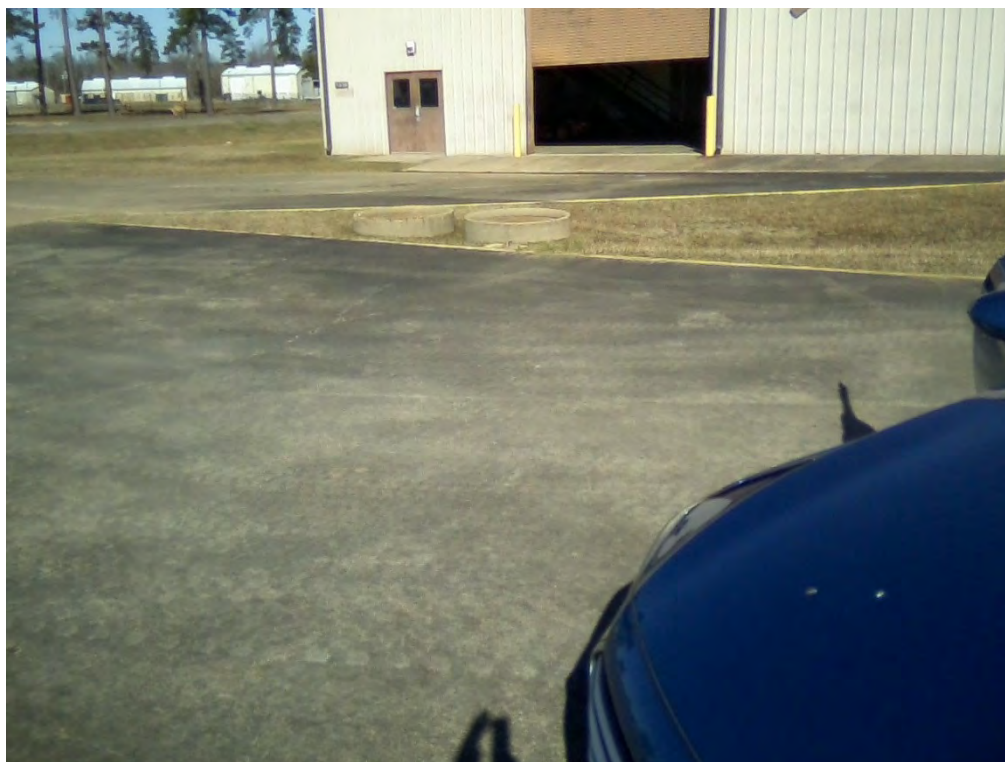
Photo of Wash Rack/MVC  
Rack near Bldg 1338 with  
oil/water separator manholes  
in grassy area.

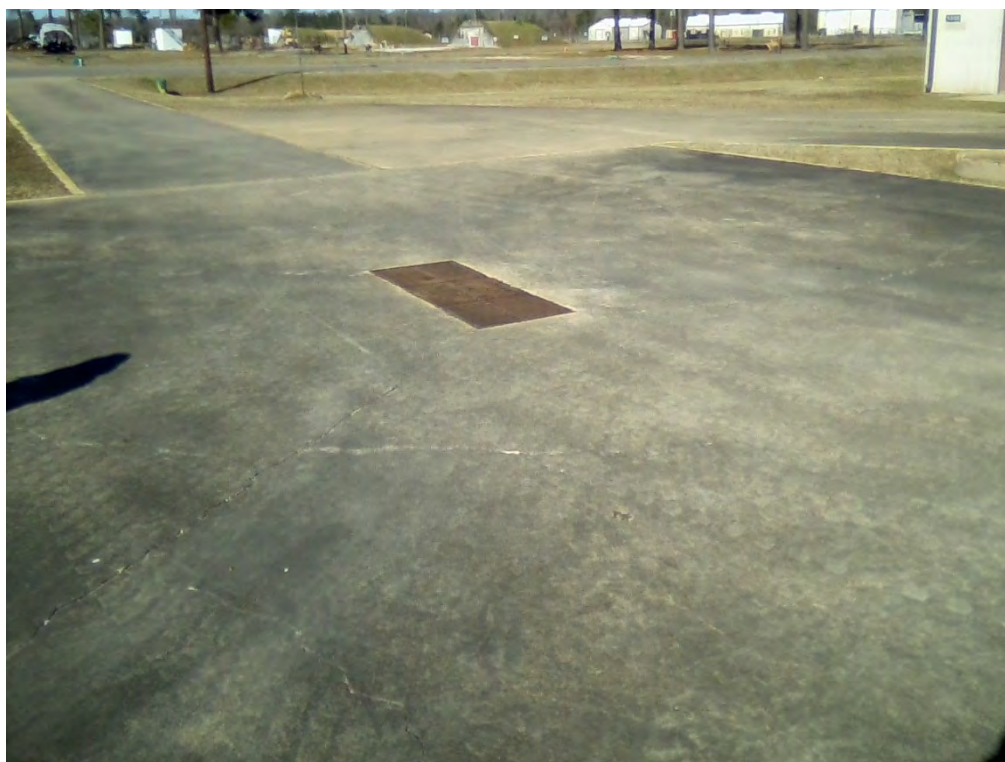
### Photograph No. 2

Photo of Wash Rack/MVC  
Rack near Bldg 1338 with  
drain to oil/water separator in  
concrete area.

| Area of Interest | AOI Location | Rational | Potential Future Action |
|---|---|---|---|
| AOI 2 Wash Rack | 31°22'32.8"N;<br>92°23'23.4"W | AFFF may have been used in unknown quantities for fire training exercises. | Proceed to an SI, focus on soil and groundwater. |

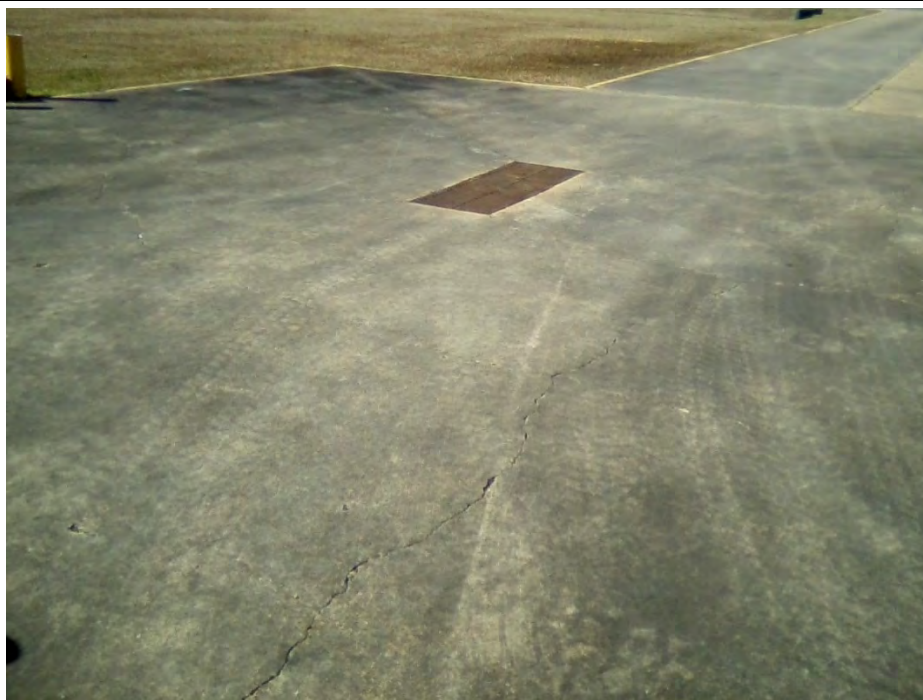
Photo of Wash Rack/MVC  
Rack near Bldg 1338 with  
oil/water separator manholes  
in grassy area.

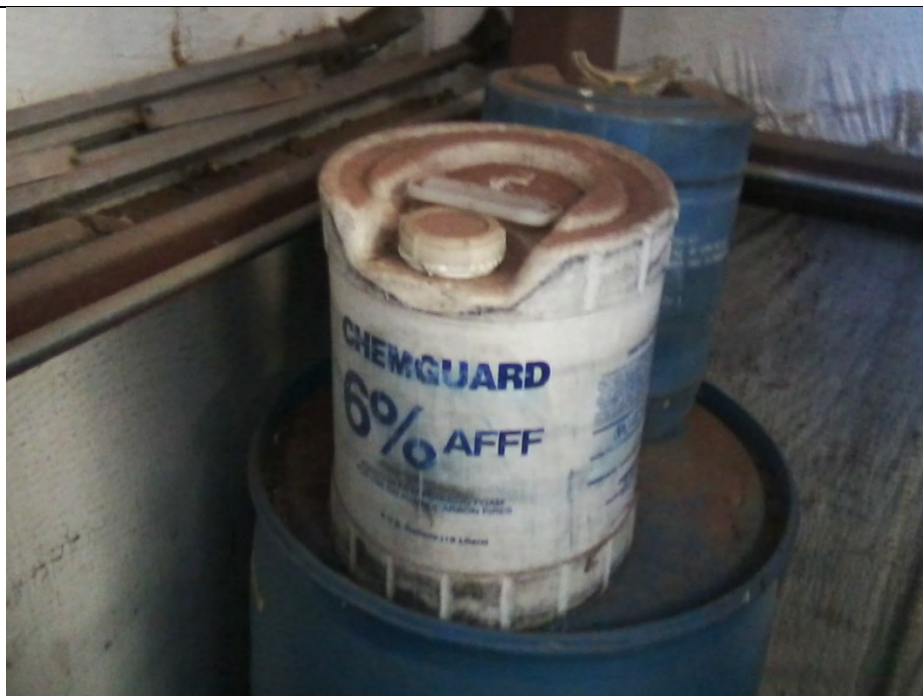
### Photograph No. 4

During the VSI, it was observed that the Firehouse Building 327 currently stores Chemguard® six percent AFFF in five 5-gallon containers near the emergency response vehicles. Firetrucks carried 5-gallon containers up until around 2017. Spray tests were performed with these vehicles; no foam was used on site but was used in training off-post. The interviewee had no recollection of any AFFF leaks. The geographic coordinates for the Firehouse Building 327 are 31°22'13.90"N; 92°24'10.89"W.

Photo of AFFF container in  
Fire Station (Bldg 327) at  
Camp Beauregard.

| Area of Interest | AOI Location | Rational | Potential Future Action |
|---|---|---|---|
| AOI 3 Firehouse Building 327 | 31°22'13.8"N;<br>92°24'10.9"W | AFFF was stored at this location and on firetrucks. No known onsite discharges are recorded. | Proceed to an SI, focus on soil and groundwater. |

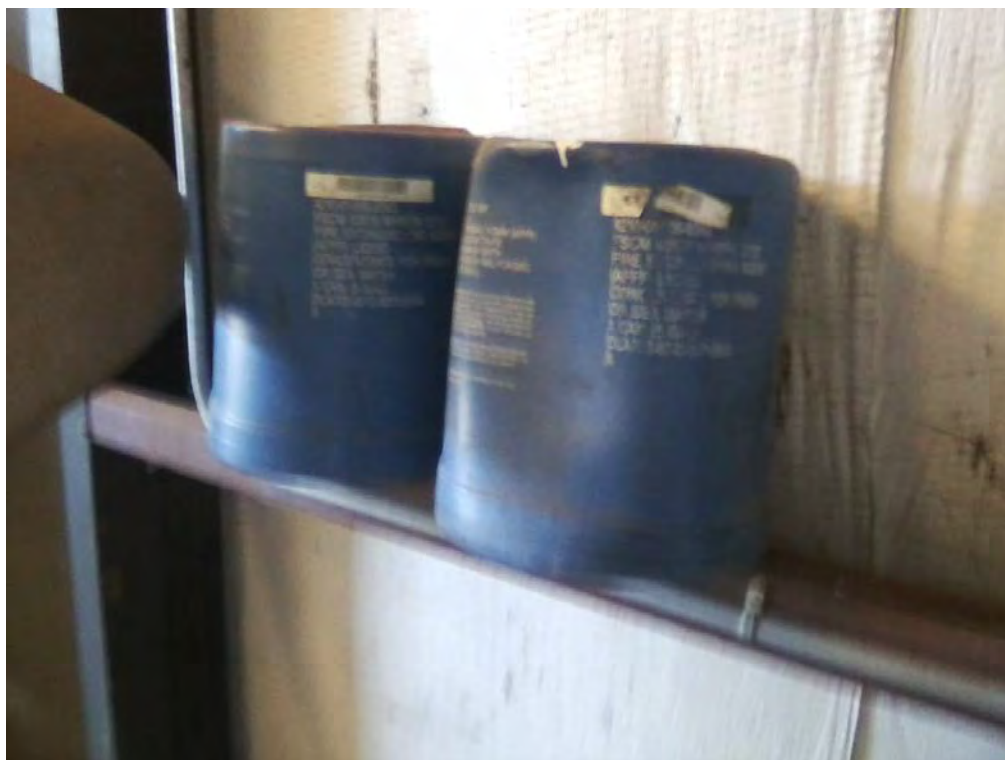
Photo of AFFF containers in  
 Fire Station (Bldg 327) at  
 Camp Beauregard.

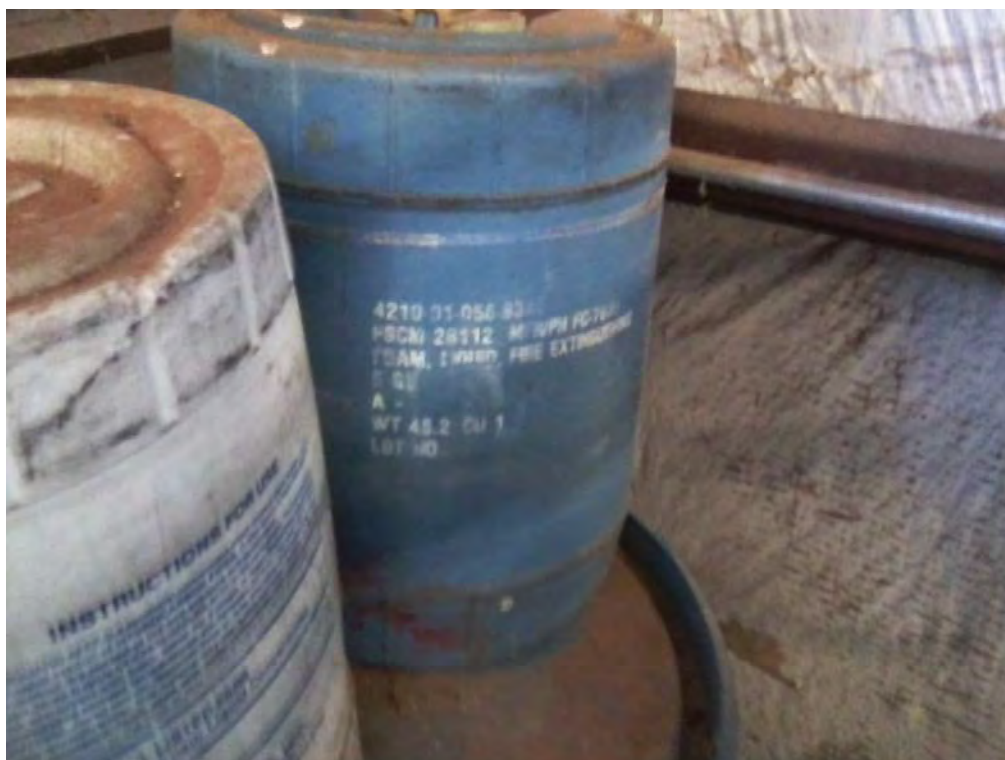
### Photograph No. 6

Photo of firefighting foam  
 container in Fire Station (Bldg  
 327) at Camp Beauregard.

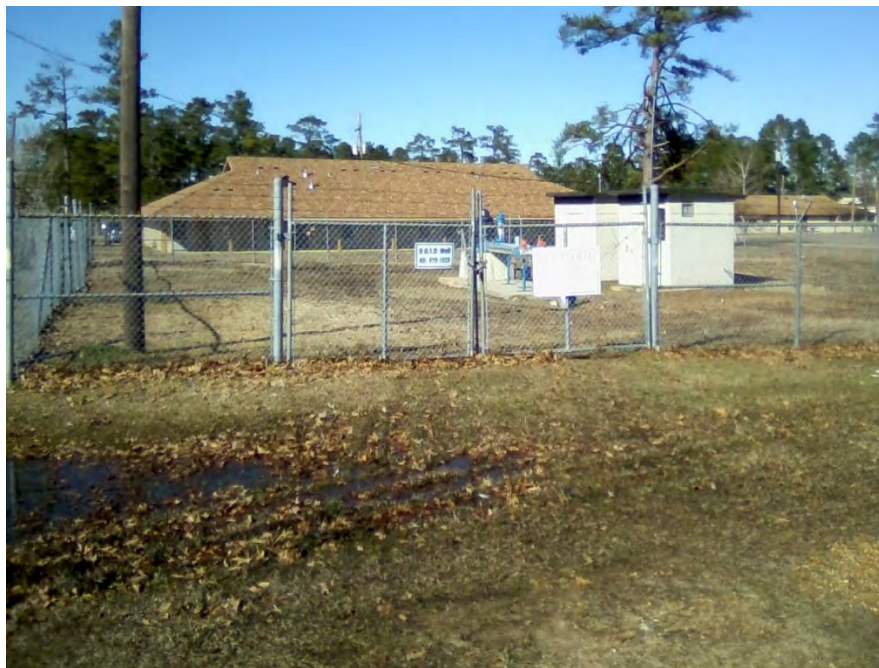
Photo of Waterworks No. 3  
water well.

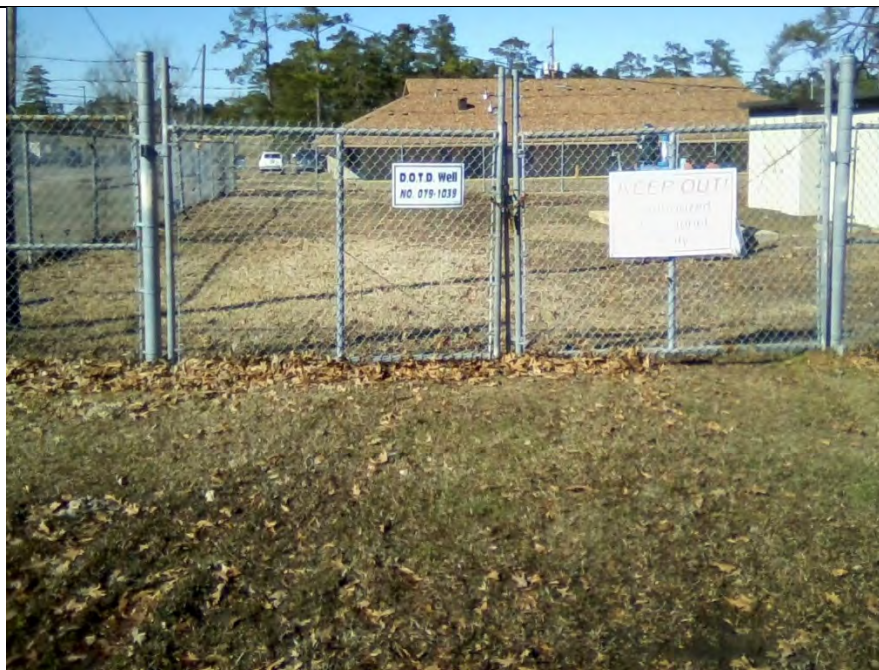
### Photograph No. 8

Photo of Waterworks No. 3  
water well.
