## Site Inspection Report

### Camp Beauregard, Louisiana

Site Inspection for Perfluorooctanoic acid (PFOA),  
Perfluorooctanesulfonic acid (PFOS), Perfluorohexanesulfonic  
acid (PFHxS), Perfluorononanoic acid (PFNA),  
Hexafluoropropylene oxide dimer acid (HFPO-DA), and  
Perfluorobutanesulfonic acid (PFBS) at ARNG Installations,  
Nationwide

February 2023

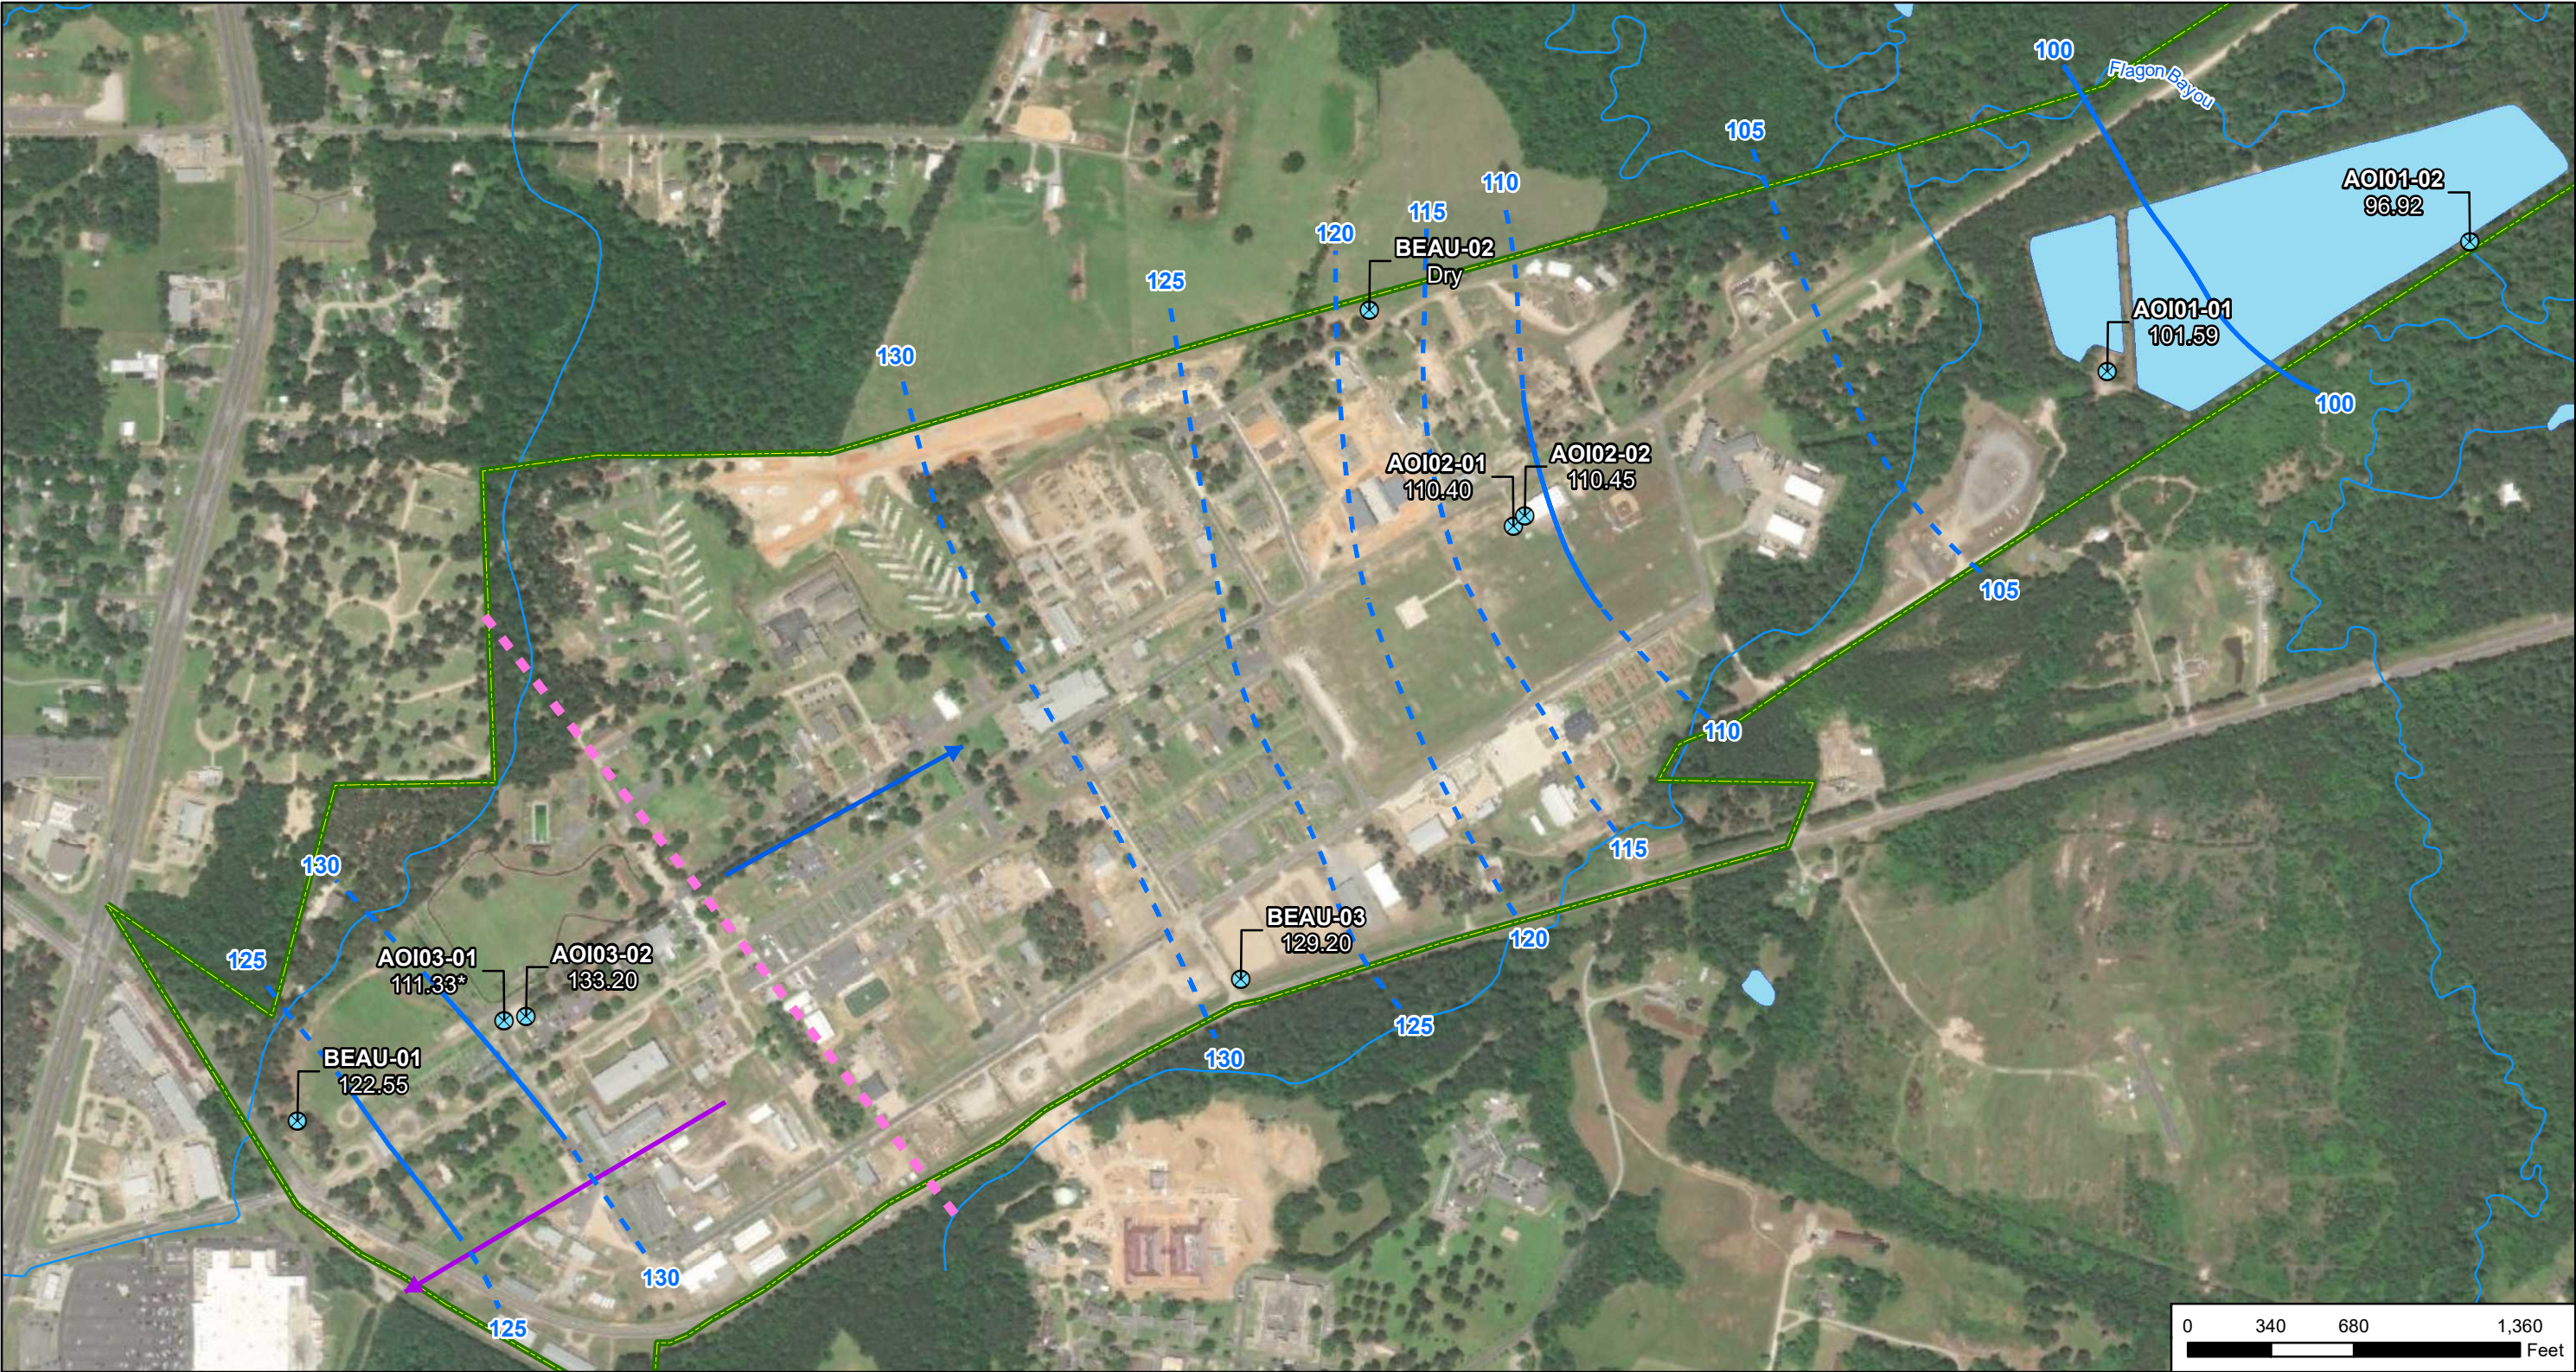
**Figure 2-3**

of the Flemings Formation are absent at the Training Site. The Williamson Creek member terminates at the southern part of the Cantonment Area, and the Dough Hills member terminates just north/northeast of the Cantonment Area and is therefore not present at the Training Site. Second, the sandy to gravelly facies of the Bentley and Williana formations predominate in the Training Site (USAEHA, 1994). The geology of Camp Beauregard Cantonment Area is shown on **Figure 2-3**.

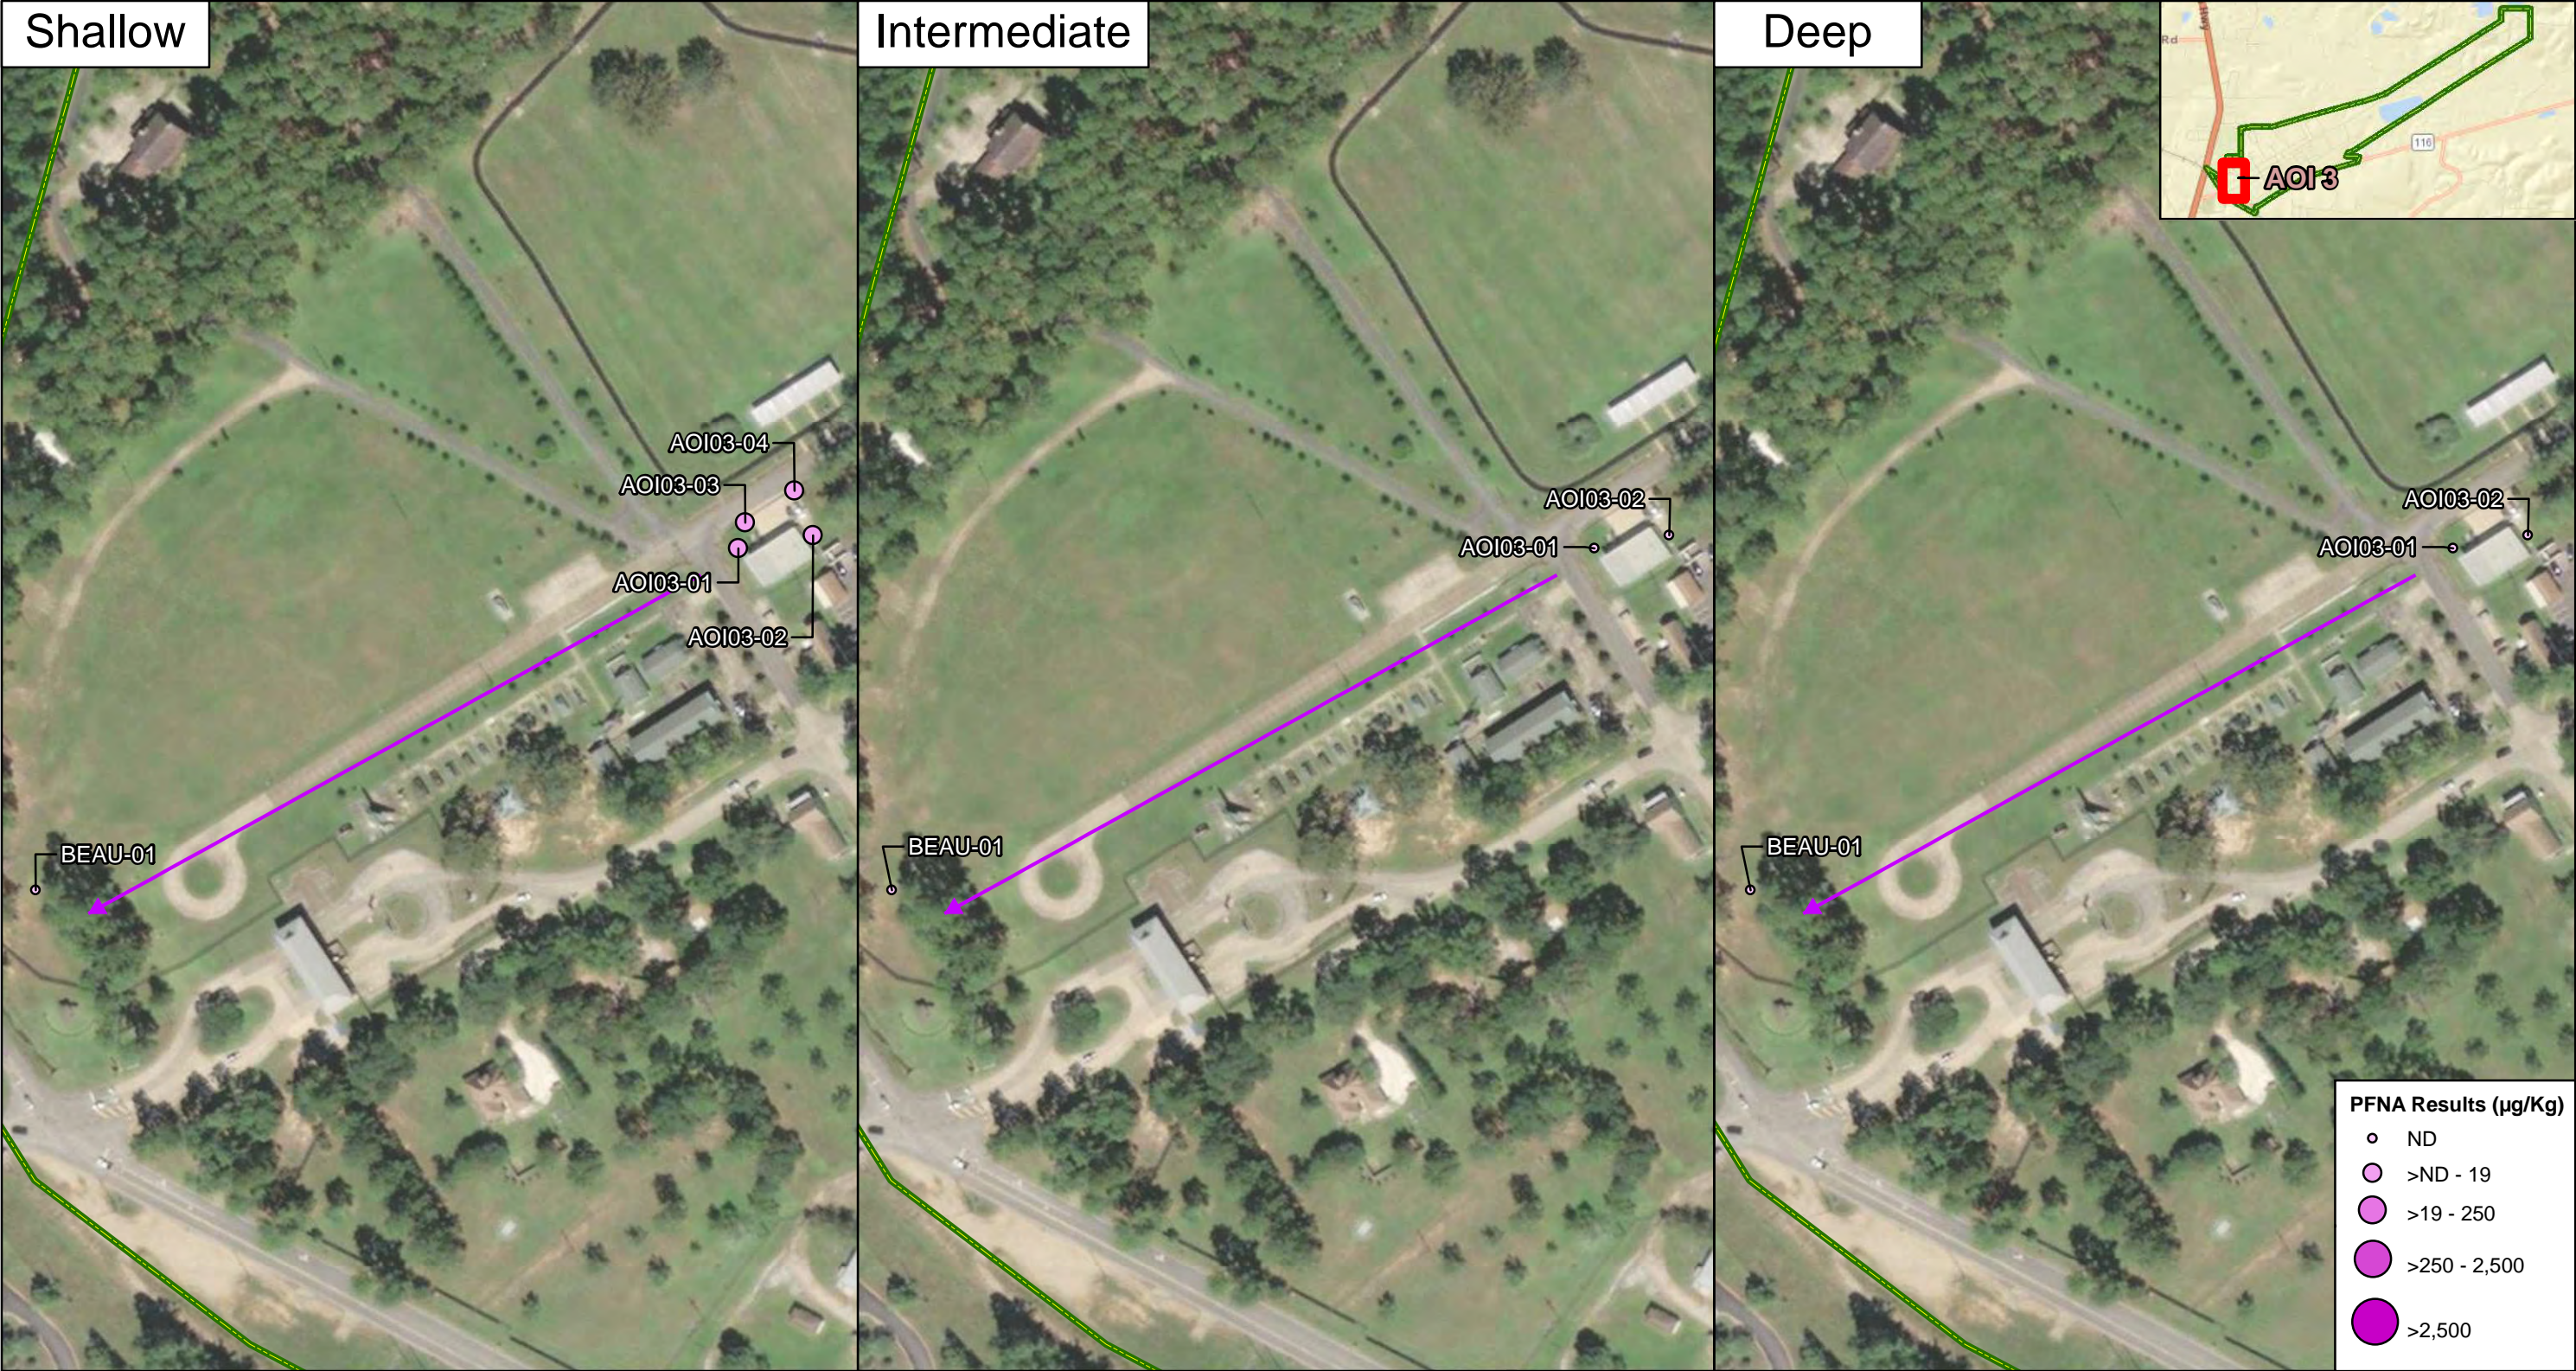
<div><div></div> Facility Boundary</div> <div><div></div> Groundwater Flow Direction</div> <div><div></div> Surface Water Flow Direction</div> <div>0180360720</div> <div>Feet</div> <div>Exceedances of the OSD SL are depicted with a yellow halo.</div> <div>Depth intervals shown represent respective sampling position within a given soil boring location.</div>		<div>N</div> <div></div>		PFNA Detections in Soil, AOI 2	
<div>AECOM</div> <div>12420 Milestone Center Drive</div> <div>Germantown, MD 20876</div>				Figure 6-14
