Final Preliminary Assessment Report Caswell Training Site Limestone, Maine

Perfluorooctane-Sulfonic Acid (PFOS) and Perfluorooctanoic
Acid (PFOA) Impacted Sites
ARNG Installations, Nationwide

November 2019

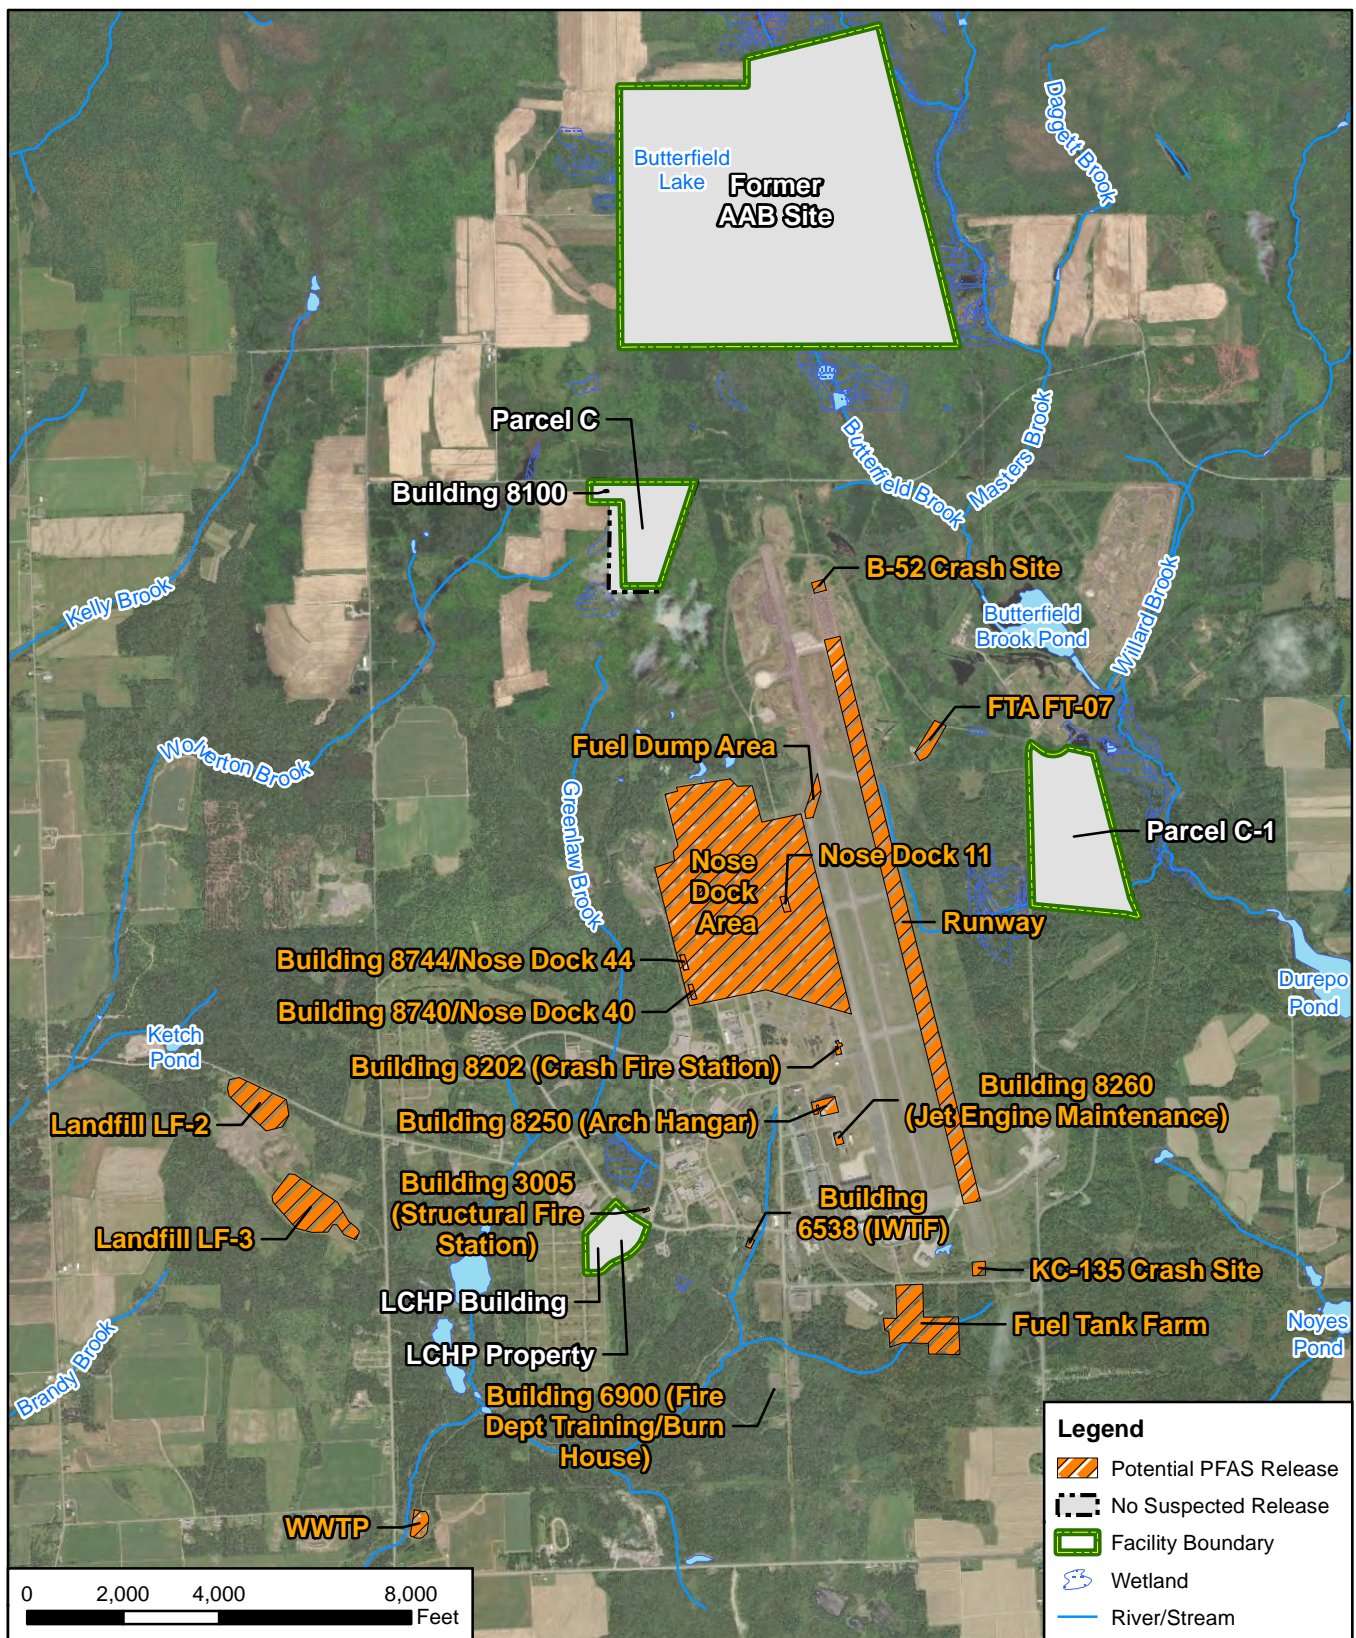
12420 Milestone Center Drive Germantown, MD 20876	Figure ES-1	
SCALE	1:48,000	CHK BY	LC	11/12/2019				
Base Map: Source: Esri, DigitalGlobe, GeoEye, Earthstar Geographics, CNES/Airbus DS, USDA, USGS,		PM	RG	11/12/2019

No Areas of Interest related to PFAS release were identified at CTS based on PA data. Based on the documented absence of the use/release of PFAS-containing materials at CTS, evidence does not support current or former ARNG activities at the facility having contributed to PFAS contamination in soil, groundwater, surface water, or sediment at the facility or adjacent areas. The summary of findings is presented in **Figure ES-1**.

Summary of Findings		
NOTES		Preliminary Assessment for PFAS at Caswell Training Site, ME						
REVISED	11/12/2019	GIS BY	MS	11/12/2019

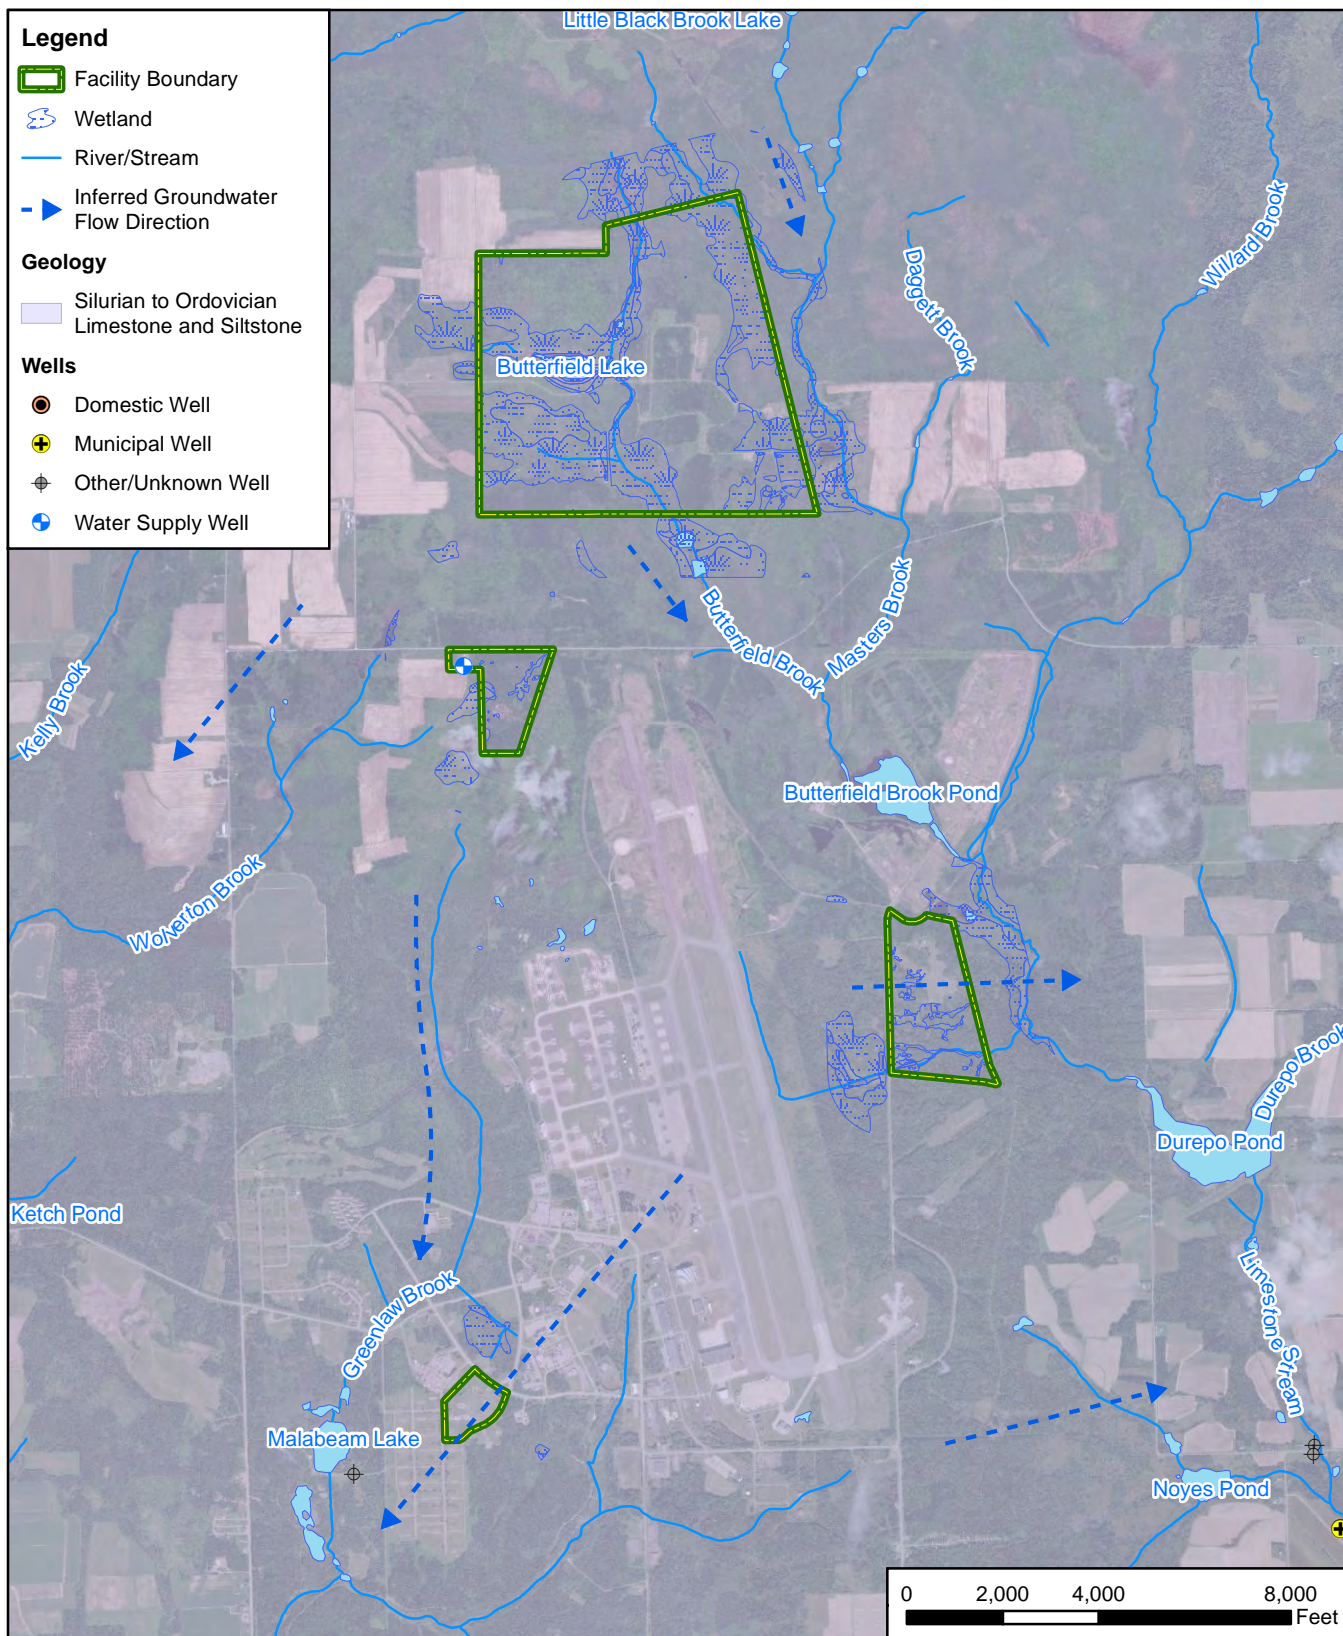
12420 Milestone Center Drive Germantown, MD 20876	Figure 1-2	
SCALE	1:48,000	CHK BY	LC	10/18/2019				
Base Map: Source: Esri, DigitalGlobe, GeoEye, Earthstar Geographics, CNES/Airbus DS, USDA, USGS,		PM	RG	10/18/2019

Bedrock in the vicinity of the former LAFB is comprised of the Carys Mills Formation of upper Ordovician to lower Silurian age (**Figure 1-2**). The Carys Mills Formation consists of up to 700 ft of grayish, extensively fractured limestone (AMEC Foster Wheeler, 2015). Within the MEARNG LCHP property, weathered bedrock was encountered at depths ranging from 2.8 to 6.5 ft below ground surface (bgs) (Summit Environmental Consultants, Inc., 2009). Parcel-specific bedrock depths for the remaining MEARNG CTS properties is unknown.

The fractured bedrock aquifer is a significant source of water and is reportedly stored in secondary bedrock openings including joints, faults and fracture zones (Prescott, 1972). Groundwater flows preferentially along bedrock bedding planes and areas of dissolution at the intersection of the bedding plane and fractures (ABB, 1995). The groundwater flow direction varies across the former LAFB based on the presence of a groundwater divide that is generally located along the flightline. East of the flightline, within the vicinity of MEARNG Parcel C-1, groundwater generally flows to the east. West of the flightline, within the vicinity of the MEARNG LCHP parcel and Parcel C, groundwater generally flows to the south and southwest (AMEC Foster Wheeler, 2015). Groundwater at the MEARNG Former AAB Site is expected to flow southeast, towards Butterfield Brook Pond. Generalized bedrock groundwater flow direction is shown on **Figure 1-2**.

Groundwater Features		
NOTES		Preliminary Assessment for PFAS at Caswell Training Site, ME						
REVISED	10/18/2019	GIS BY	MS	10/18/2019

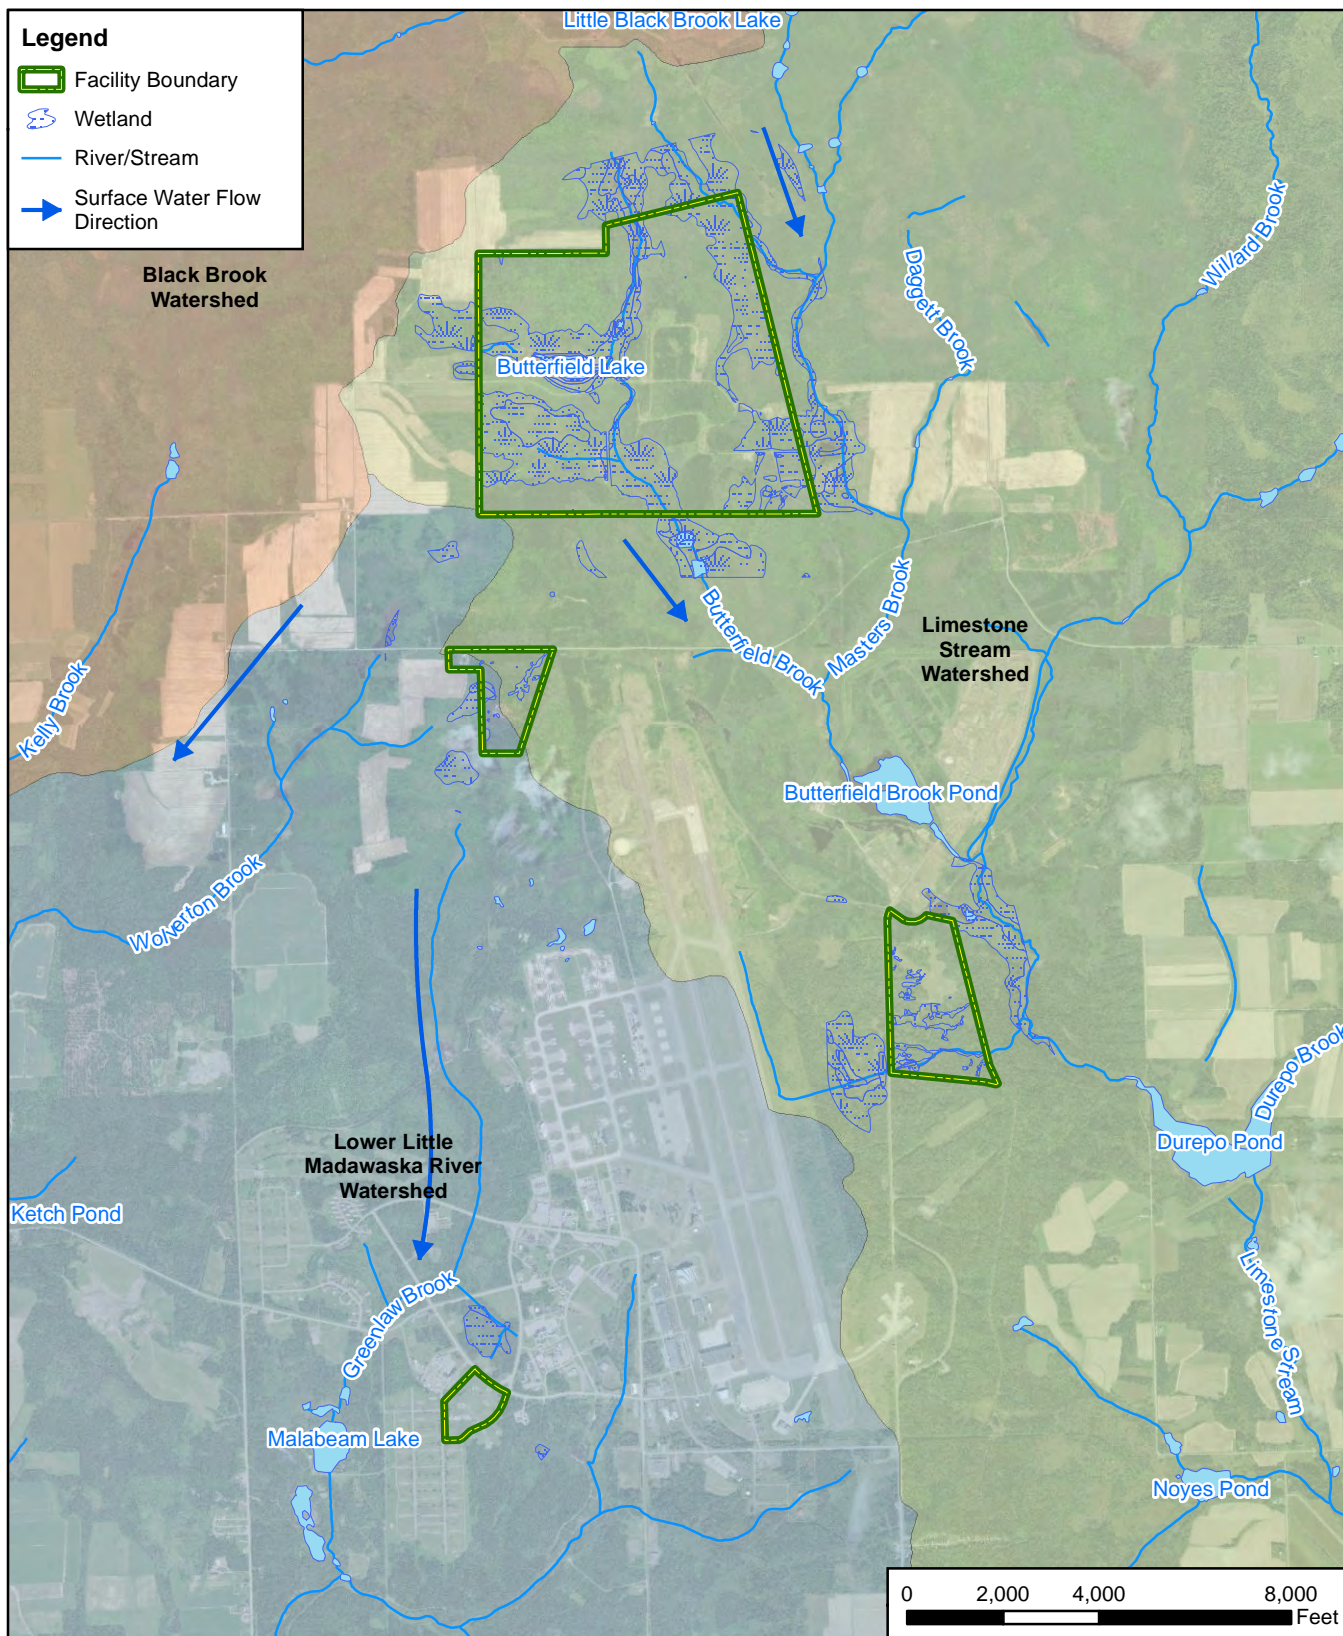
12420 Milestone Center Drive Germantown, MD 20876	Figure 1-3	
SCALE	1:48,000	CHK BY	LC	10/18/2019				
Base Map: Source: Esri, DigitalGlobe, GeoEye, Earthstar Geographics, CNES/Airbus DS, USDA, USGS,		PM	RG	10/18/2019

CTS is located on a drainage divide between tributaries of the Aroostook River, including Greenlaw Brook, Butterfield Brook, Masters Brook, and Willard Brook. The flightline at the former LAFB is located at the approximate center of the drainage divide, with drainage on the west side flowing to the west-southwest to Greenlaw Brook, and areas to the east flowing east-southeast towards Butterfield Brook (ERM, 1994). Butterfield Brook subsequently flows southeast, off-base, towards the Durepo Reservoir in the town of Limestone as seen in **Figure 1-3**.

Surface Water Features		
NOTES		Preliminary Assessment for PFAS at Caswell Training Site, ME						
REVISED	10/18/2019	GIS BY	MS	10/18/2019

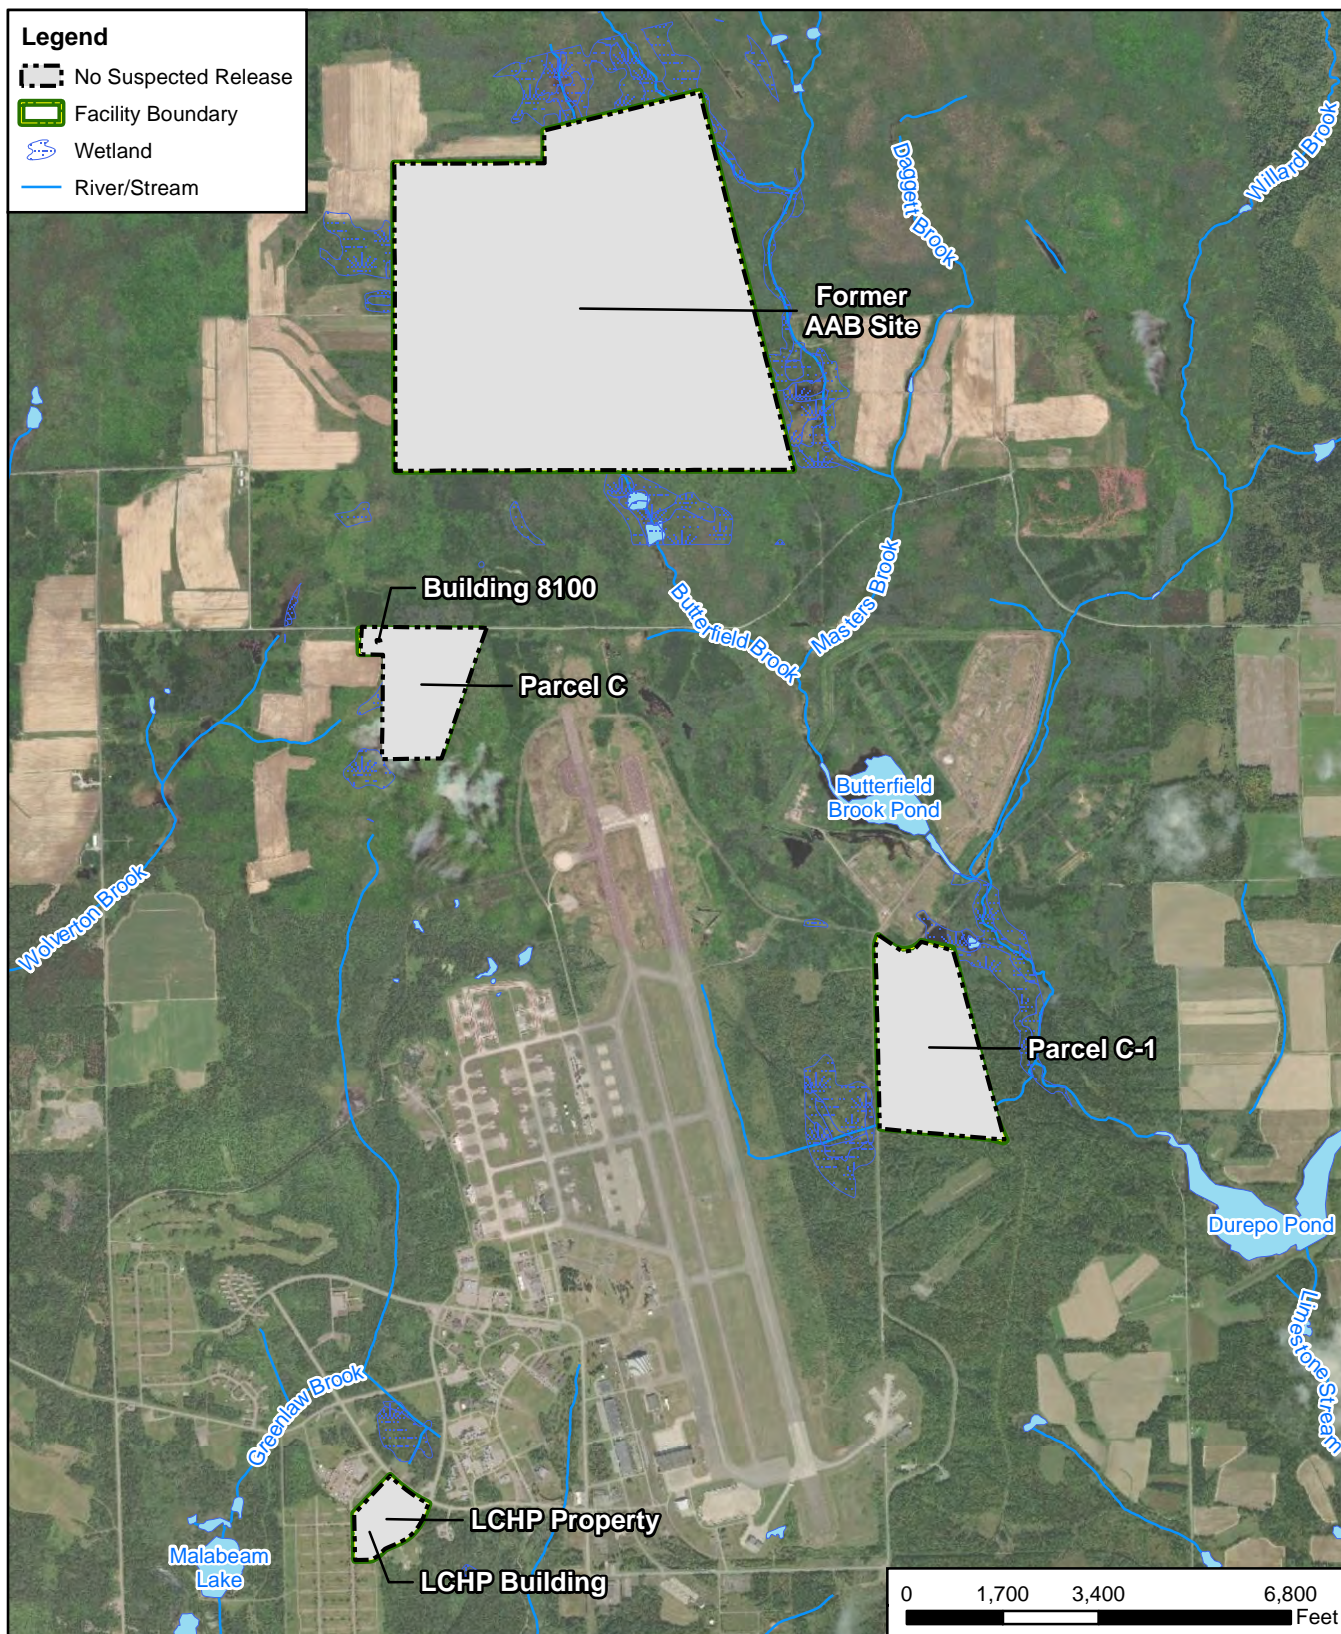
Figure 3-1

Several non-FTAs where AFFF could have been potentially stored and/or released were investigated during the PA. A description of each non-FTA is presented below, and the non-FTAs and are shown on **Figure 3-1**.

Non-Fire Training Areas

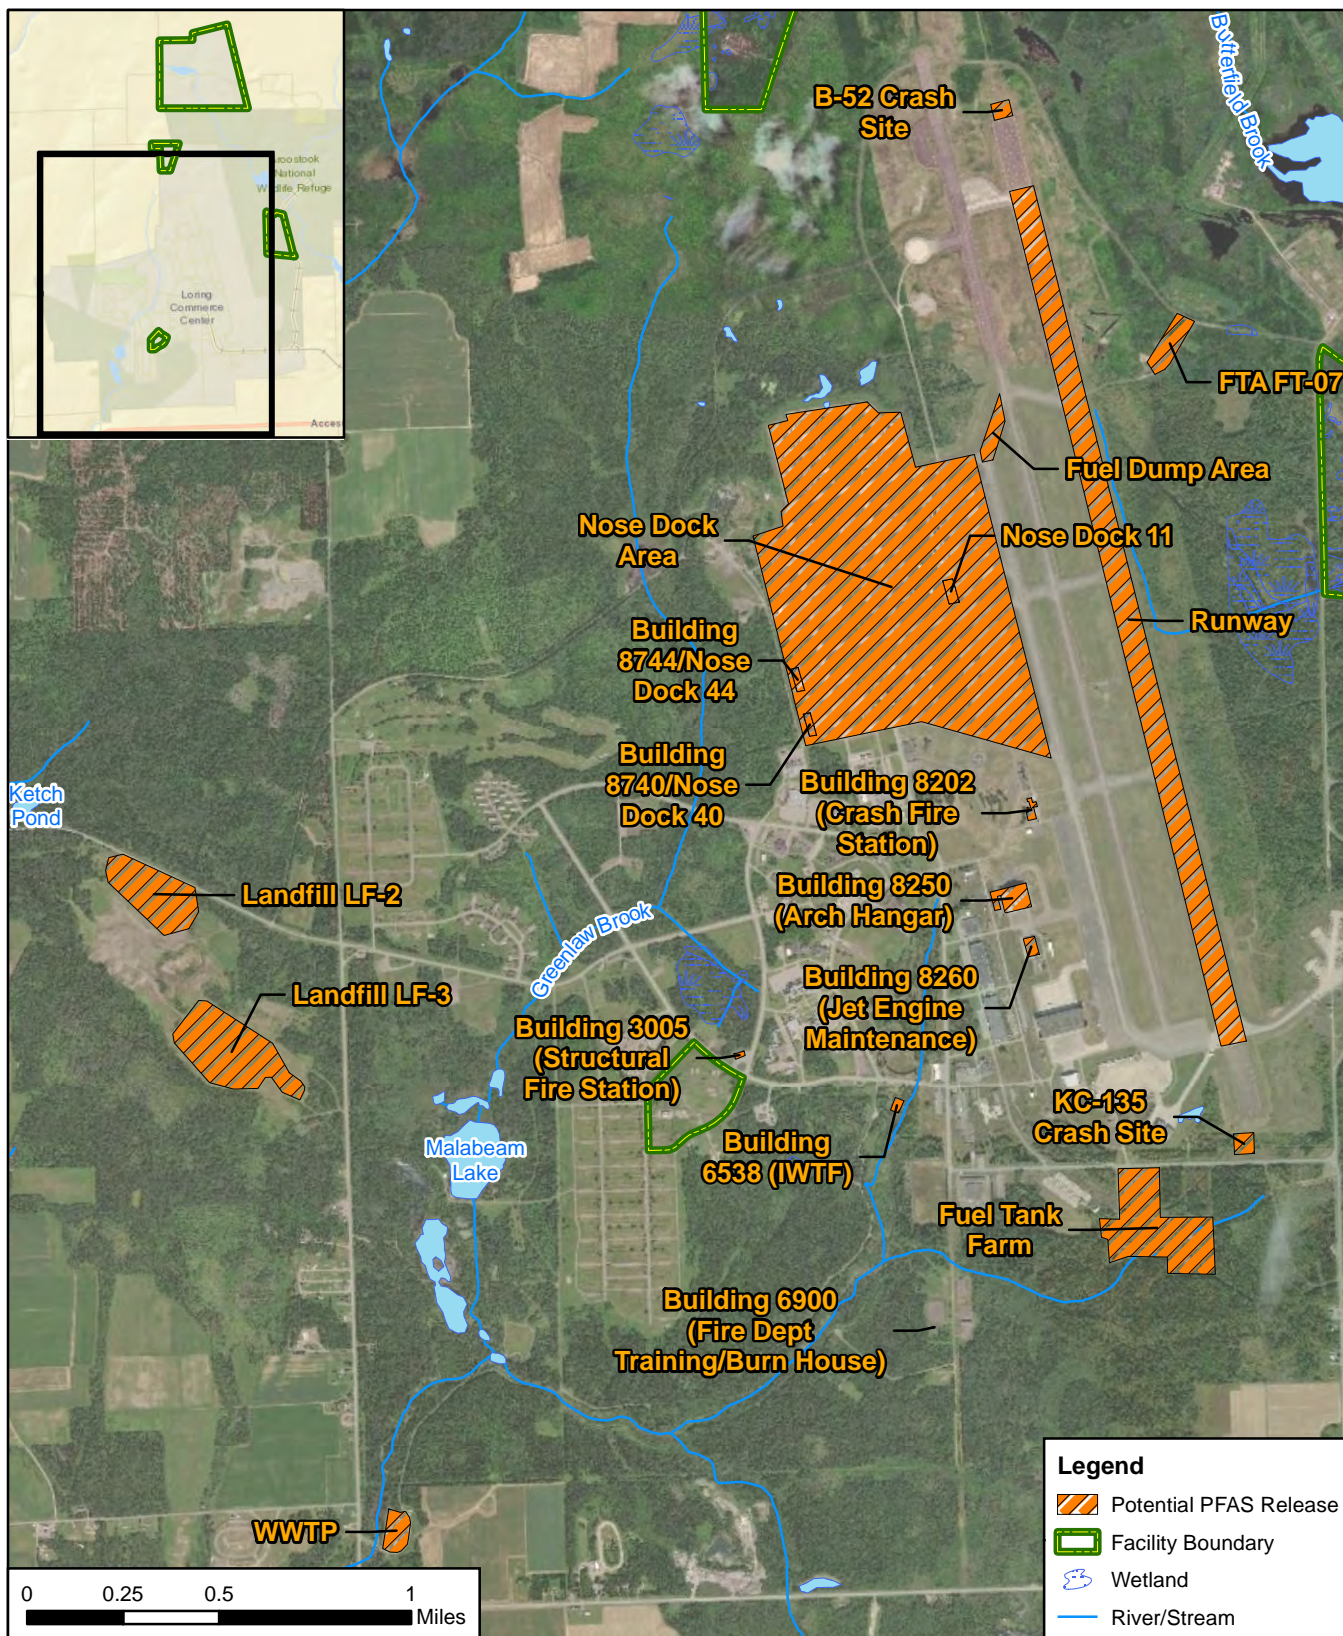
Several potential off-facility sources of PFAS adjacent to CTS, not under the control of MEARNG, were identified during the PA through interviews, review of the EDR report for a 1-mile radius surrounding CTS (**Appendix A**), and historical document review. A description of each potential adjacent source is presented below, and the sources are shown on **Figure 5-1**.

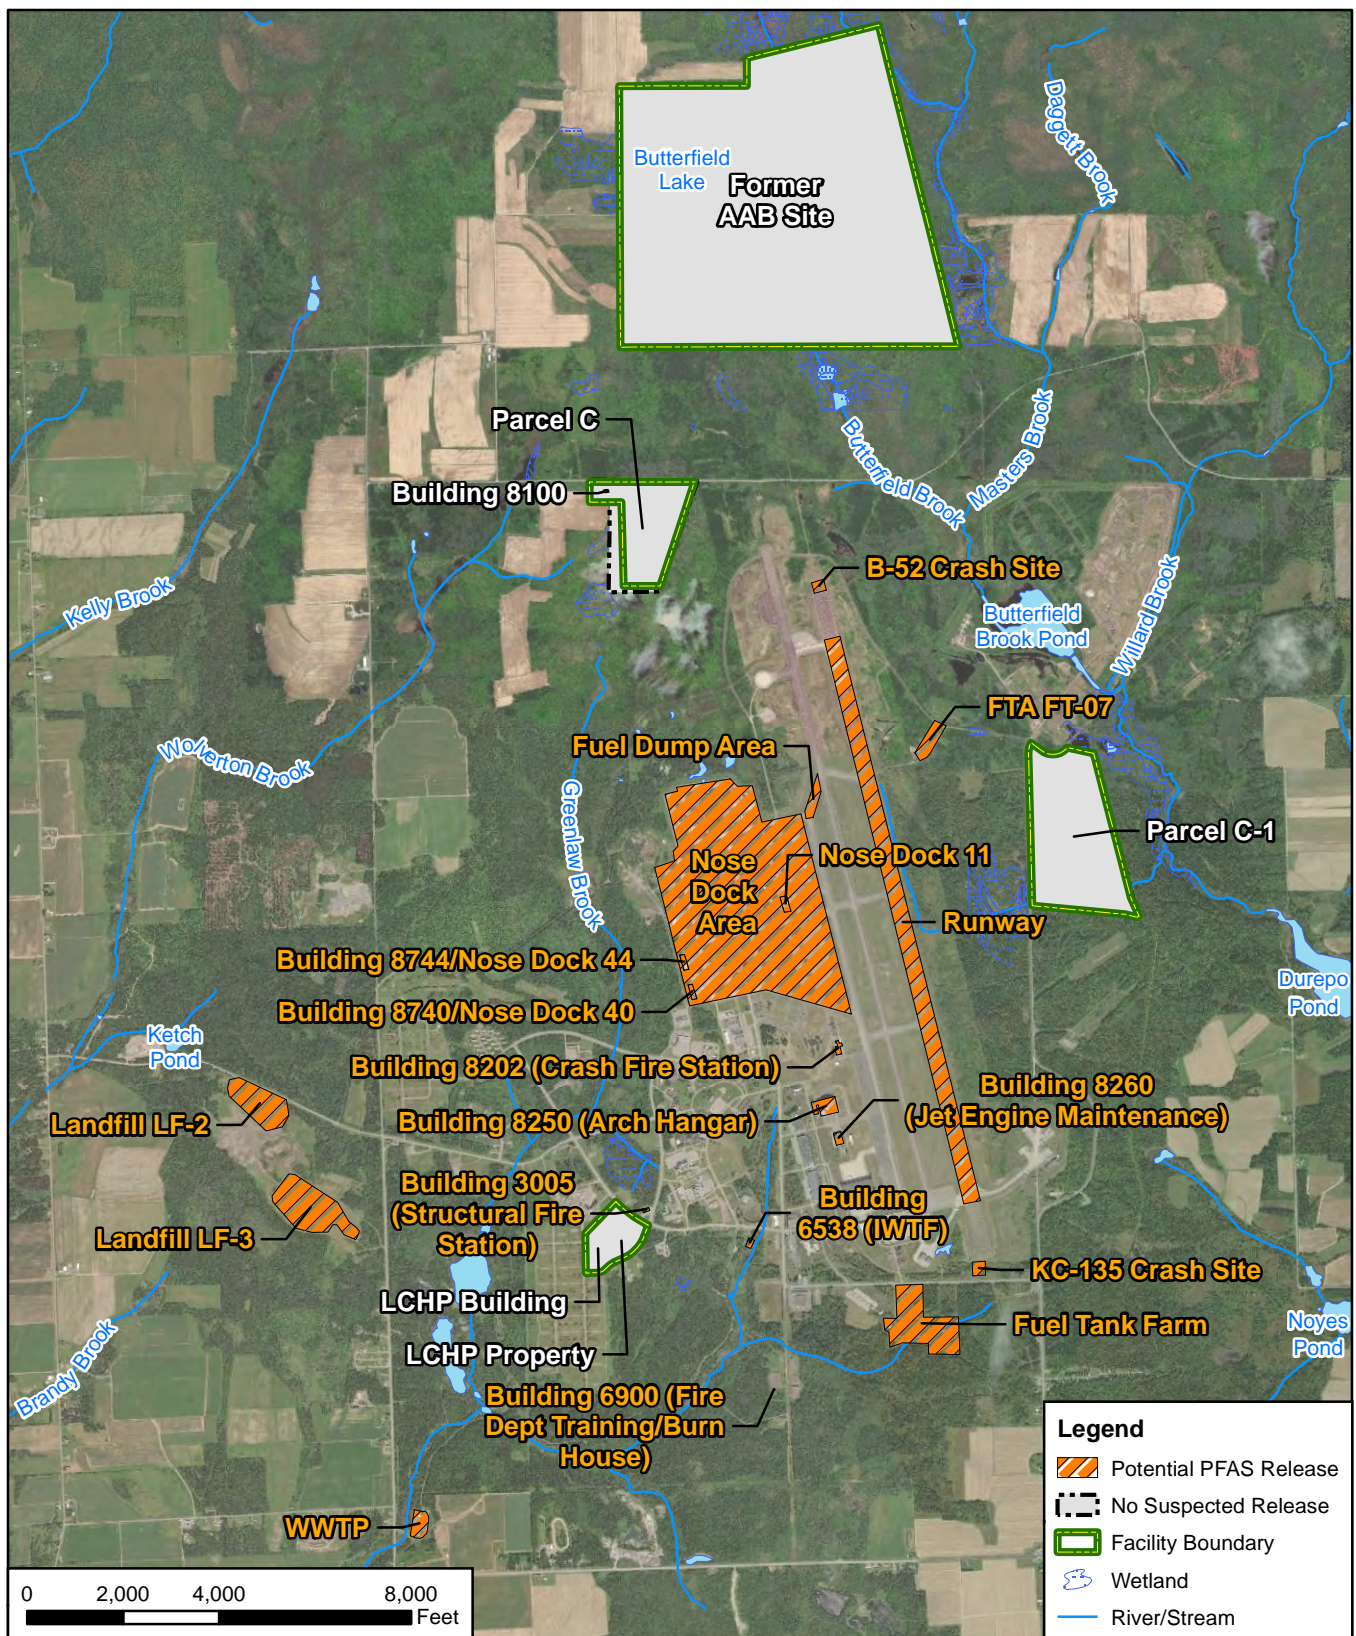
Interviews (with personnel whose tenure span the entire history of the MEARNG CTS parcels) and records indicate that current or former ARNG activities have not resulted in PFAS releases at the CTS. Based on the absence of the use or release of PFAS-containing materials at CTS, no AOIs were identified during the PA.

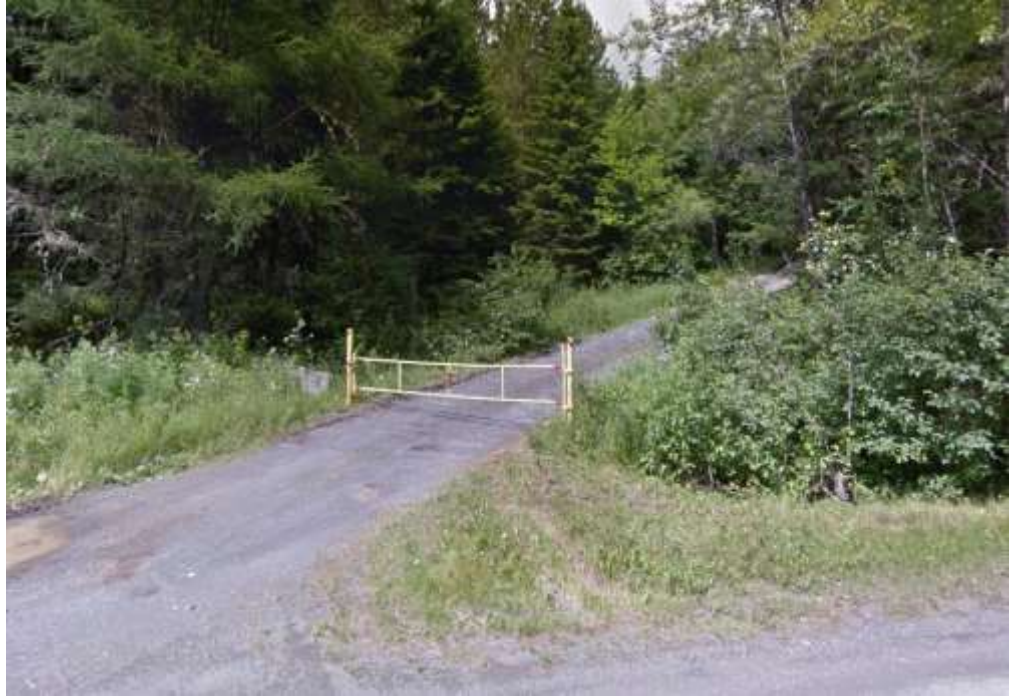
Access road to the MEARNG
former AAB Site restricted by
gate.

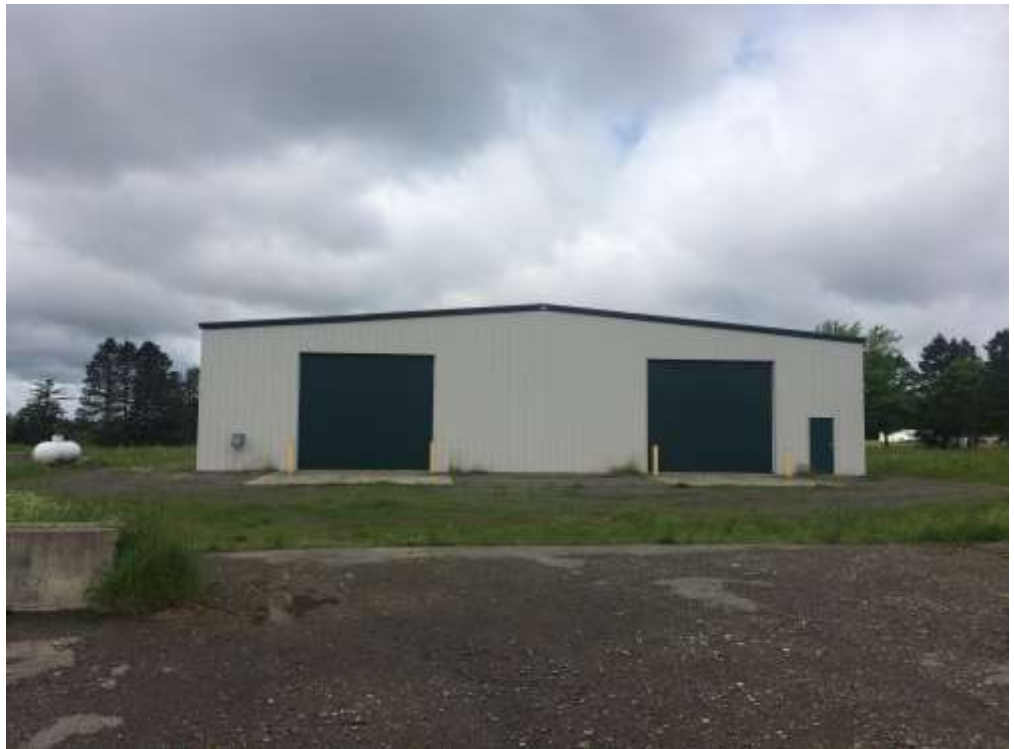
MEARNG LCHP building
located west of the southern
end of the former LAFB
runway
