Final Preliminary Assessment Report Brunswick Armed Forces Reserve Center, Maine

Perfluorooctane-Sulfonic Acid (PFOS) and Perfluorooctanoic Acid
(PFOA) Impacted Sites
ARNG Installations, Nationwide

November 2019

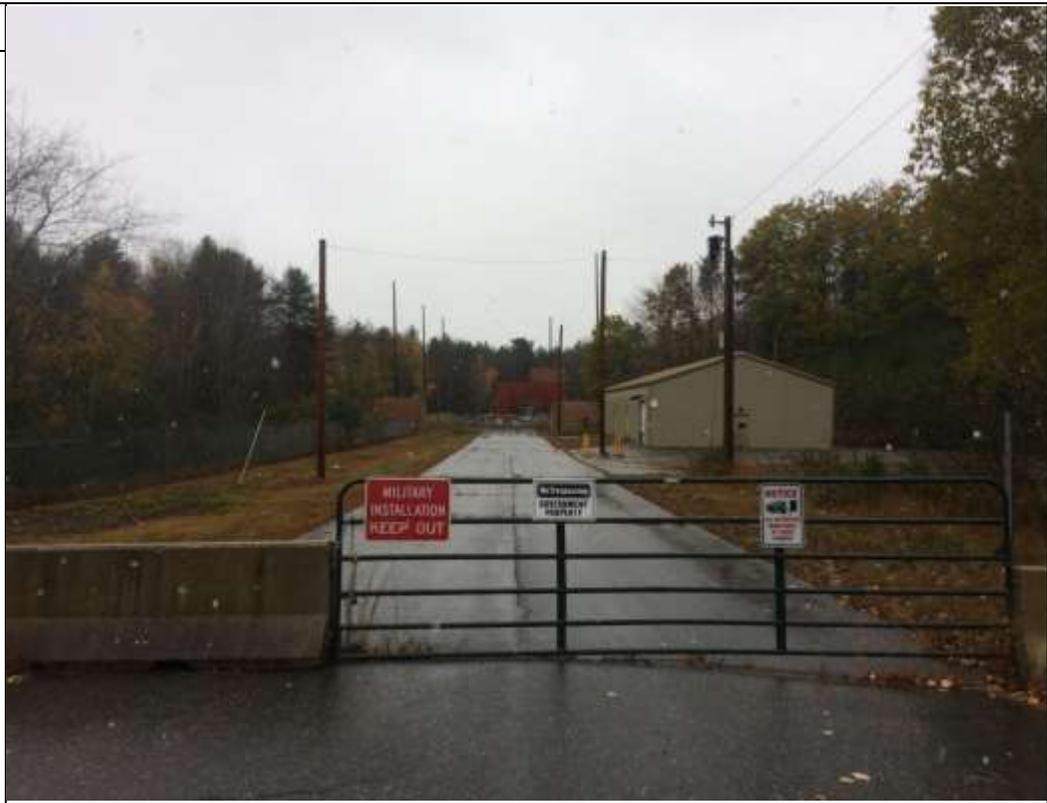
Training area on the western MEARNG Brunswick property (EDC-13), located west of the Brunswick AFRC. View facing southwest.

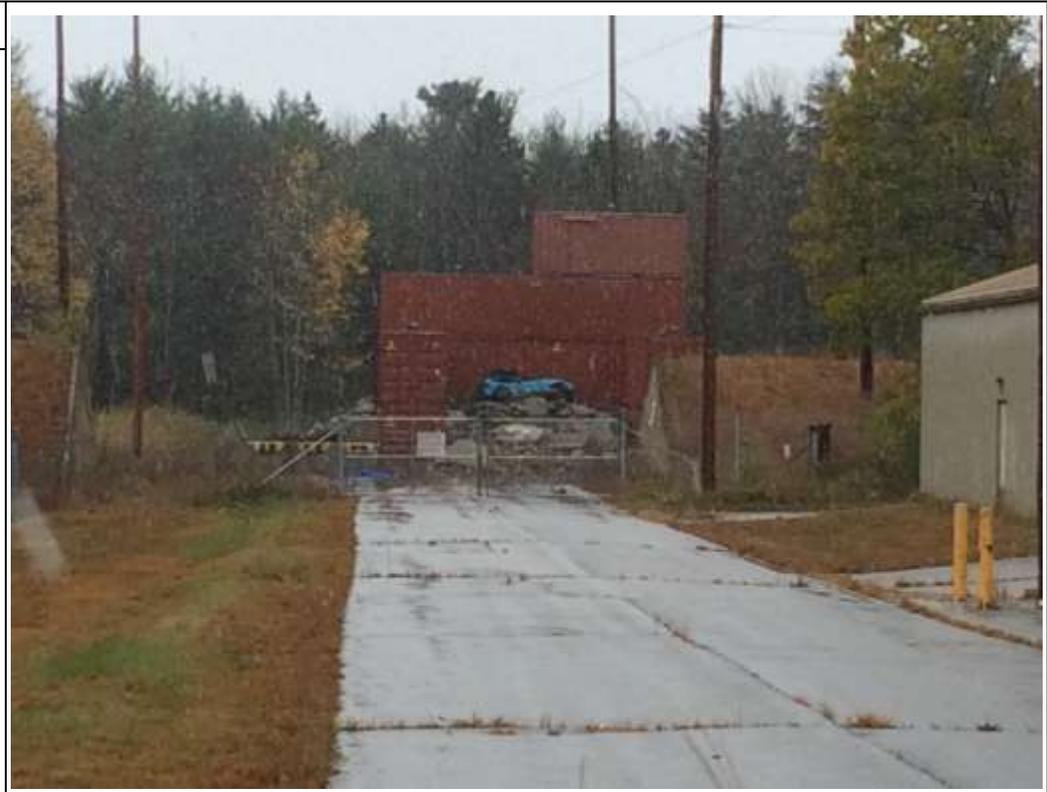
Photograph No. 4

Training area on the western MEARNG Brunswick property (EDC-13), located west of the Brunswick AFRC. View facing southwest.

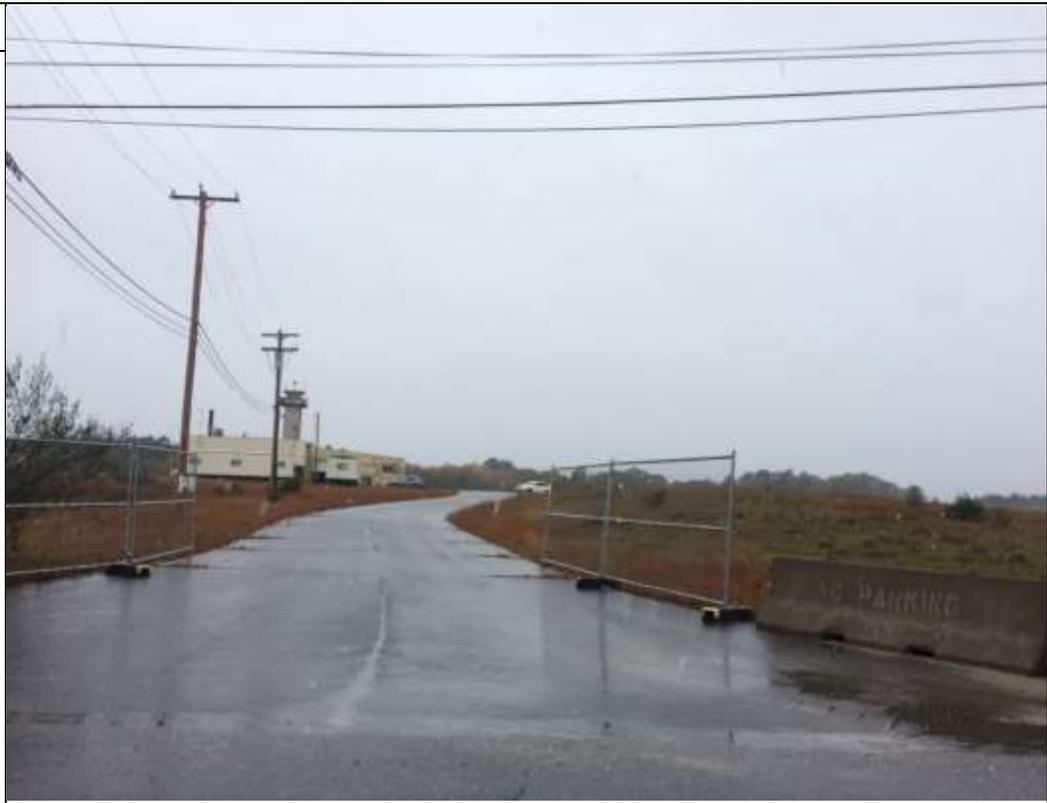
Entrance to landfill area on the Naval Air Station (NAS) Brunswick facility. Landfill located north of MEARNG Brunswick properties. View facing west.
