FINAL Preliminary Assessment Report Barnes Army Aviation Support Facility #2 Westfield, Massachusetts

Perfluorooctanesulfonic Acid (PFOS) and Perfluorooctanoic
Acid (PFOA) Impacted Sites
ARNG Installations, Nationwide

November 2020

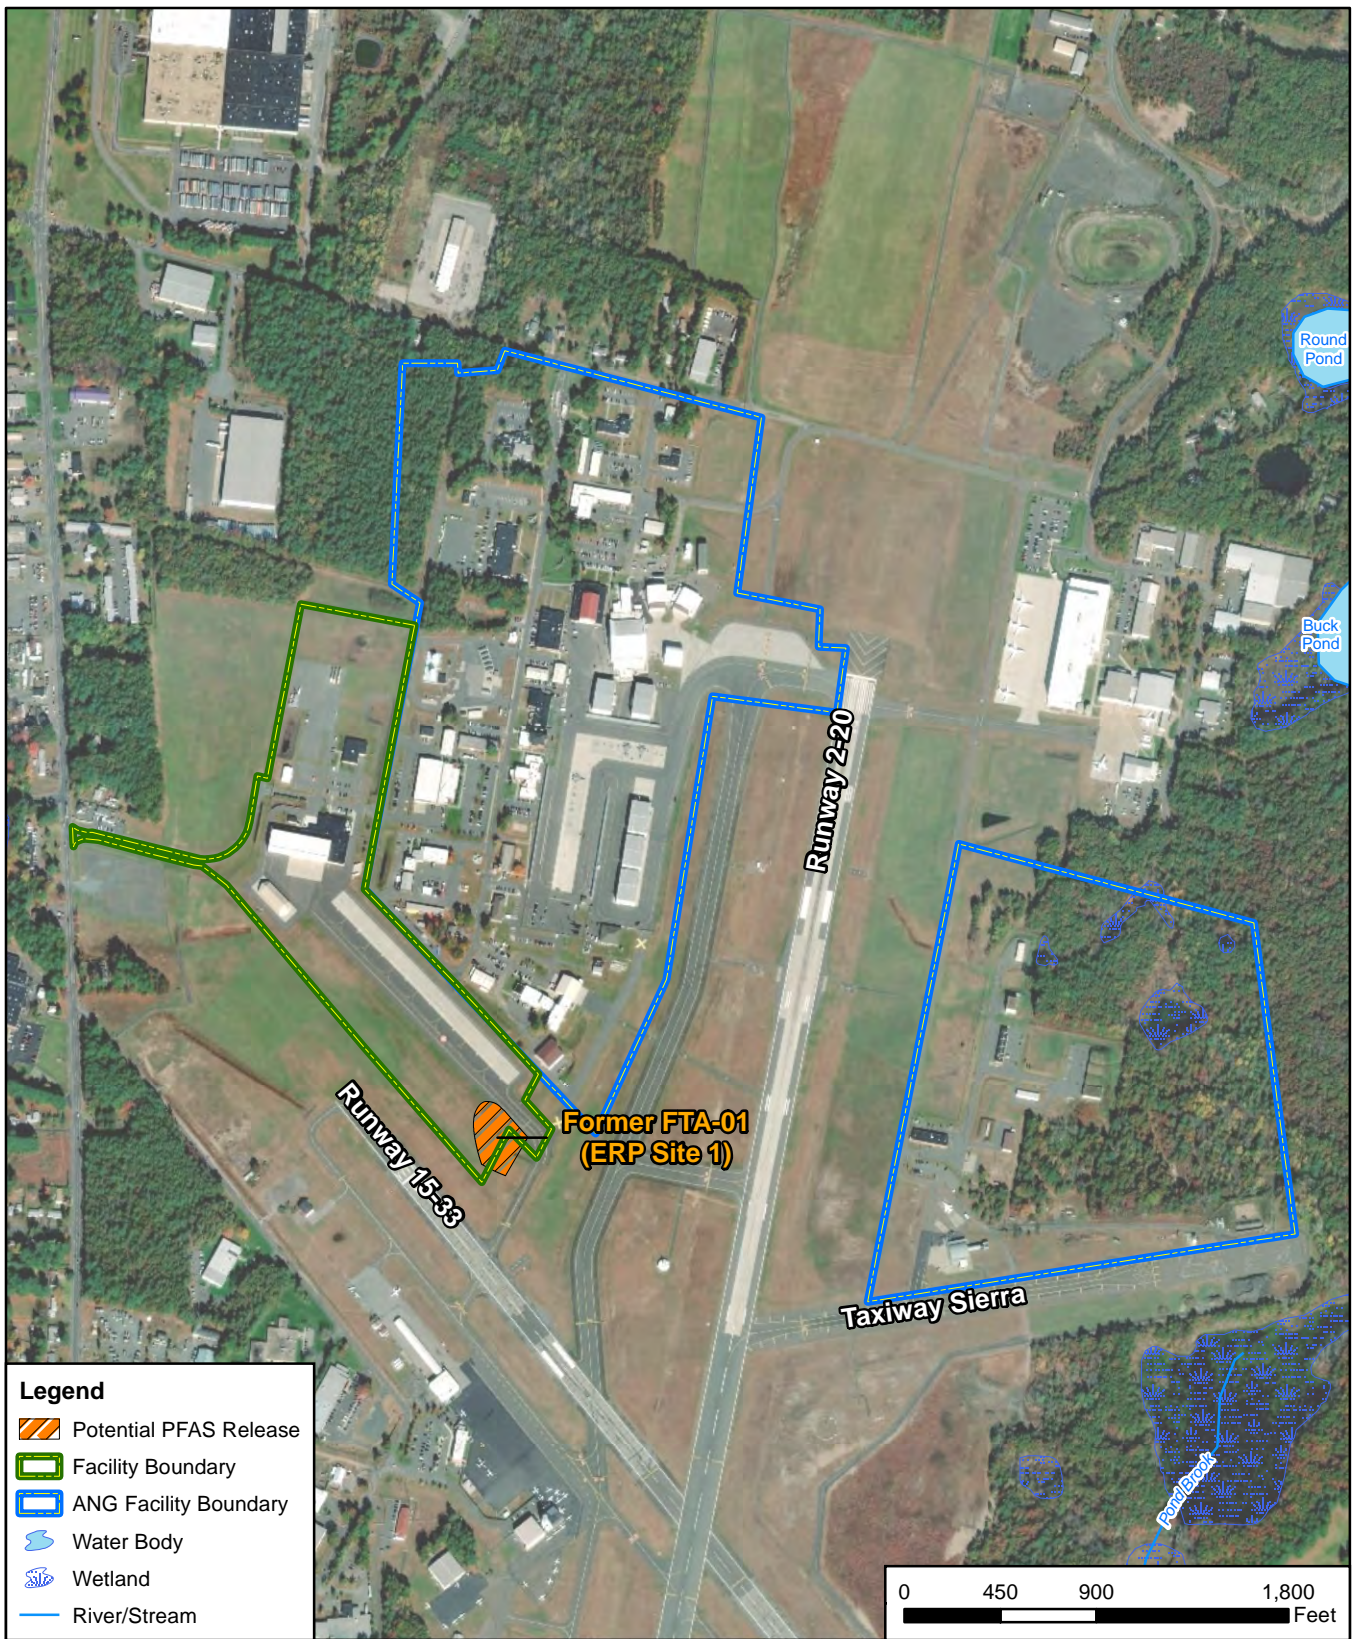
Fire Training Areas	
NOTES Preliminary Assessment for PFAS at Barnes AASF, MA

One former FTA was identified within the Barnes AASF #2 facility during the PA as an Area of Interest (AOI). A description of the FTA is presented below, and the FTA location is shown on **Figure 2-1**. Detailed photographs of the FTA appear in **Appendix C**.

Environmental investigations performed on behalf of the ANG in the Environmental Restoration Program (ERP) included Former FTA-01, also known as the ERP Site 1. The location of FTA-01, as seen on **Figure 2-1**, was determined in detail using historical aerial photographs from 1942-1997 (**Appendix A**) and observations made during the site visit at AASF #2. FTA-01 is located approximately 150 yards southwest of the current fire station (Building 040), northwest of the Sierra Taxiway. FTA-01 is currently located on flat lying land mostly consisting of grass with small patches of airfield pavement in the vicinity. This FTA was active from approximately 1950 until 1987 and consisted of a burn pit, a fire extinguisher training pit, a drum storage area, and an up-gradient bermed area (BB&E, 2016).

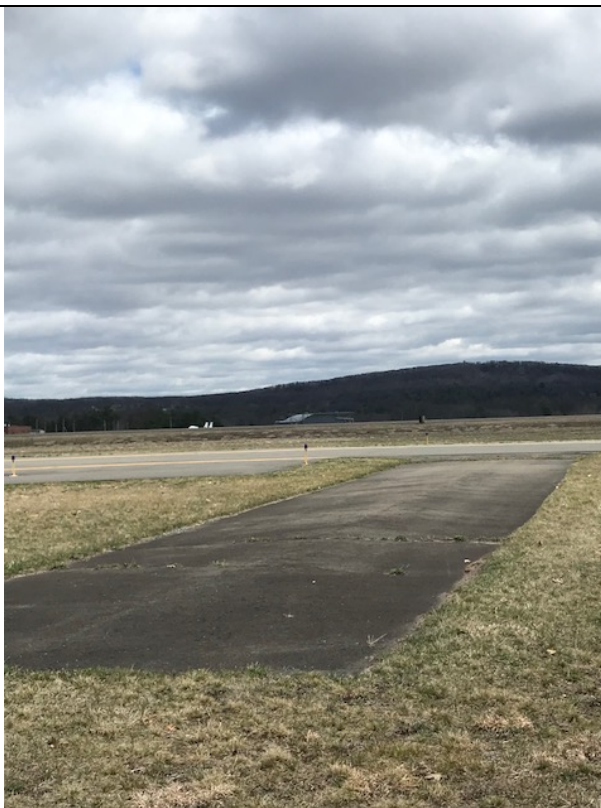
Northwest end of paved area
in Fire Training Area 1, facing
southeast.

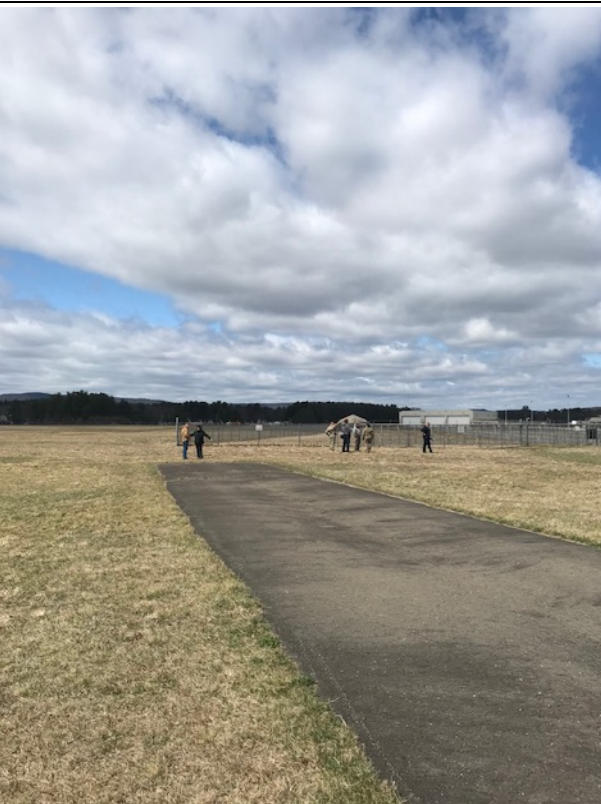
Photograph No. 2

Southeast end of Fire Training
Area 1, facing northwest.

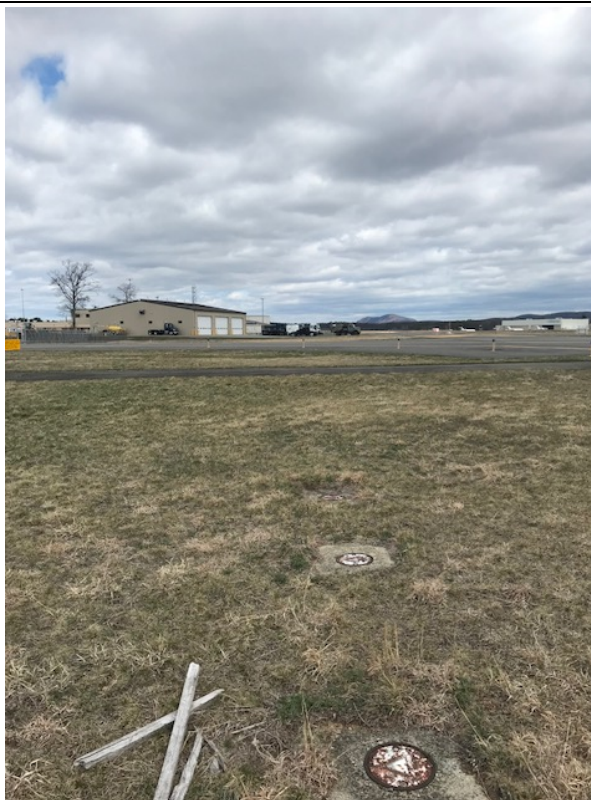
Monitoring wells on the southwest end of Fire Training Area 1, facing northeast.

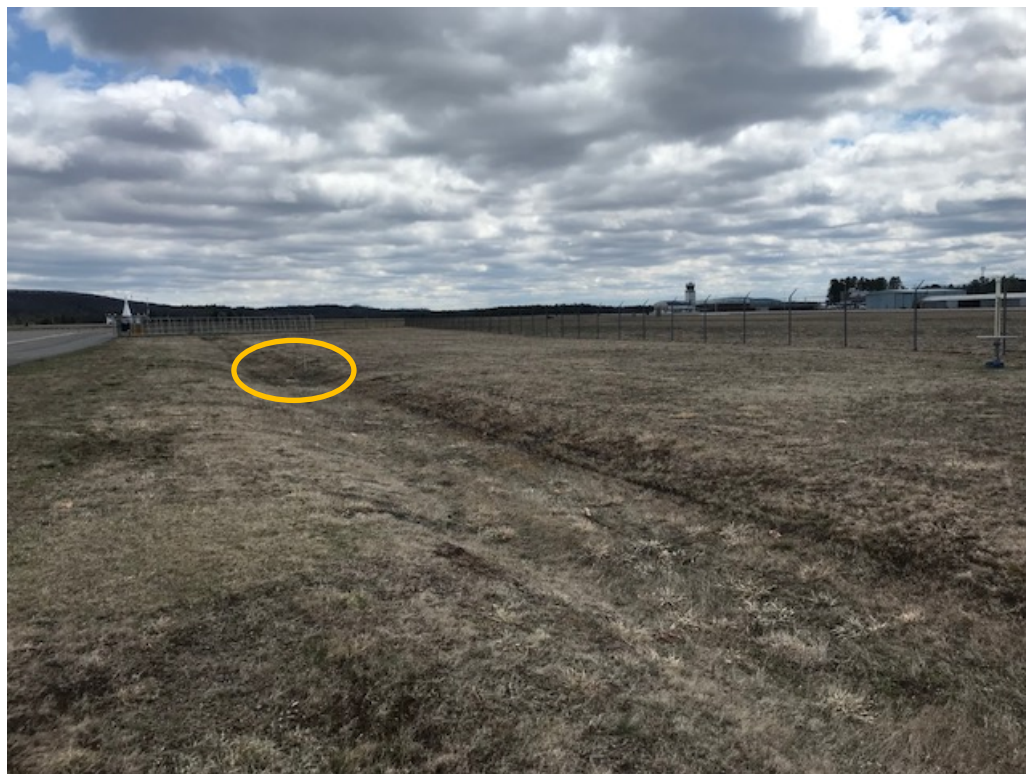
Photograph No. 4

West end of the apron, approximately 500 feet northwest of Fire Training Area 1. The circled area shows one of the various drains throughout the apron.

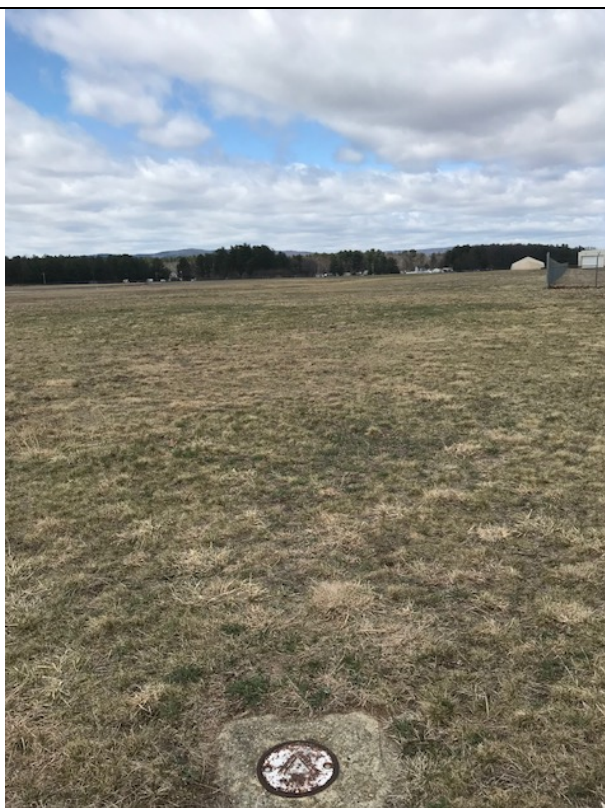
Southeast end of Fire Training Area 1, facing northwest towards tree-lined area where previous berm used to exist.
