FINAL Preliminary Assessment Report Camp Edwards Joint Base Cape Cod, Massachusetts

Perfluorooctanesulfonic Acid (PFOS)
and Perfluorooctanoic Acid (PFOA) Impacted Sites
ARNG Installations, Nationwide

November 2020

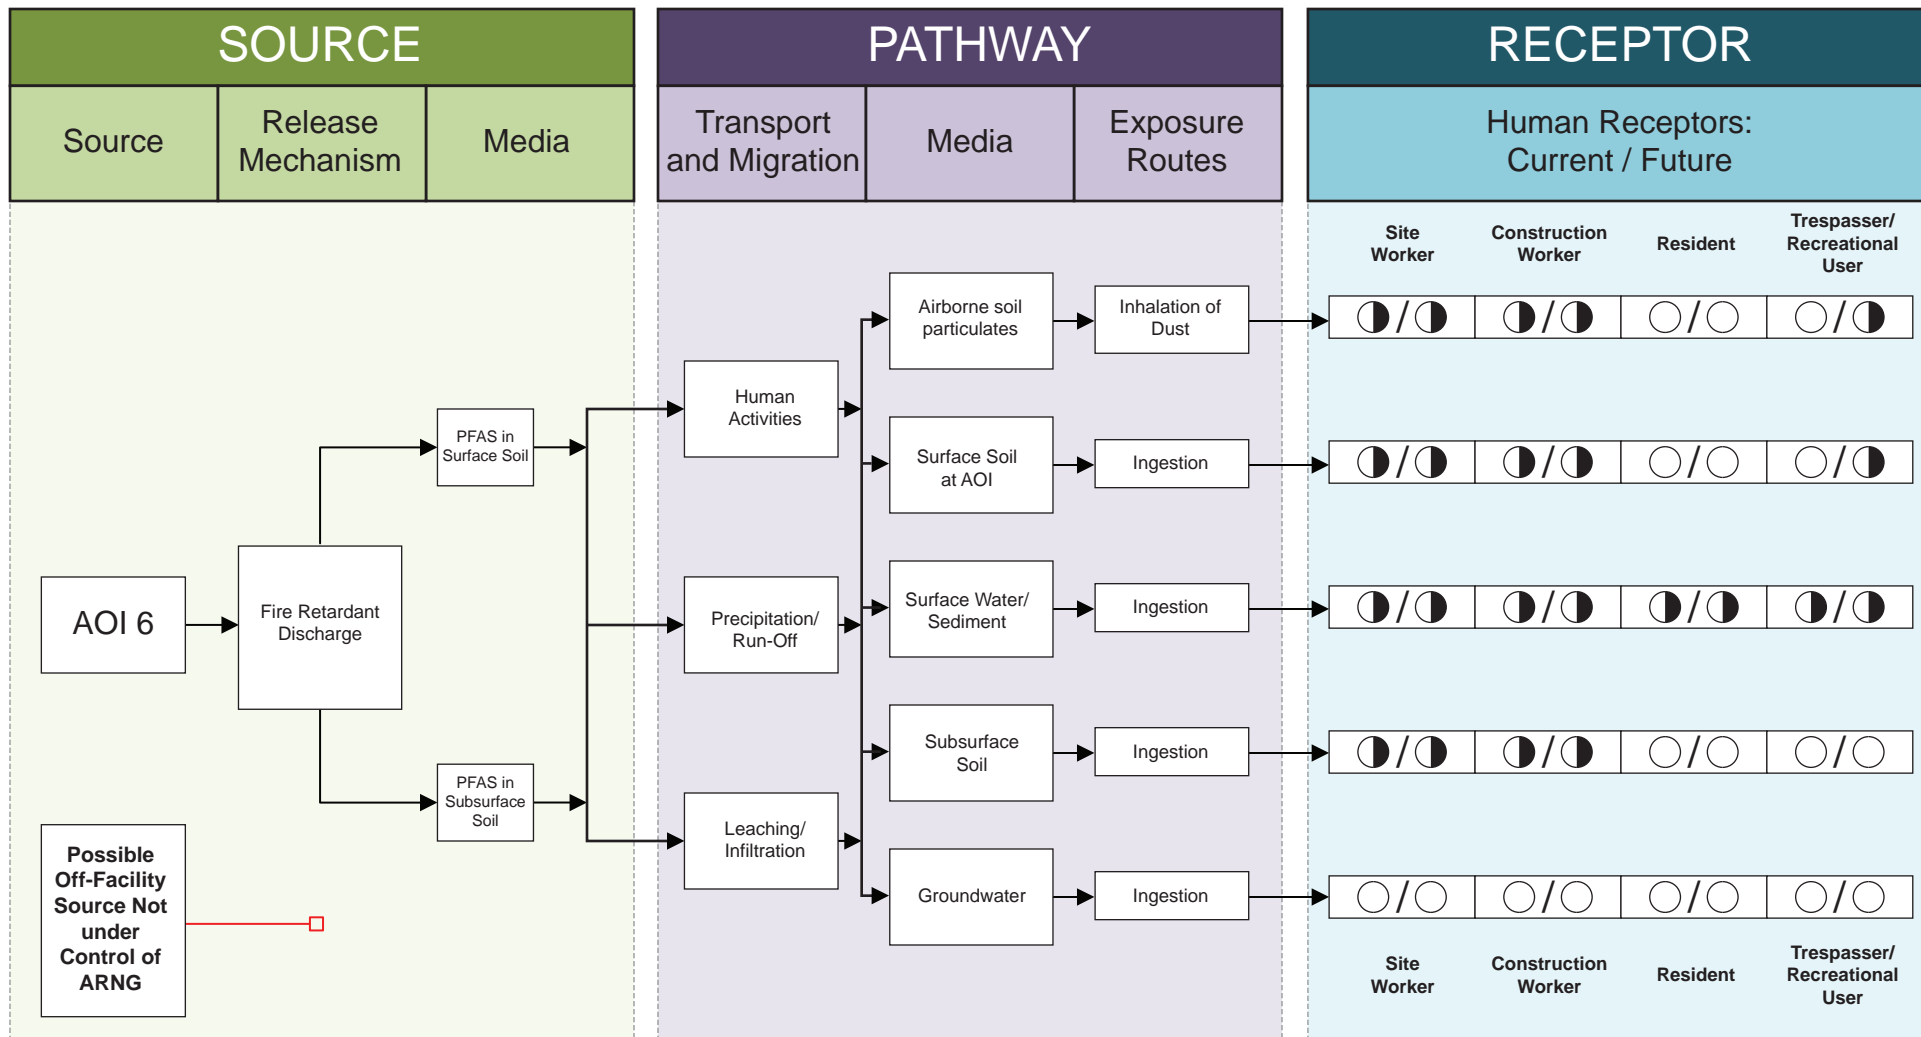
Though there is no direct evidence of AFFF usage documented. However, there has been suggested anecdotal evidence that if AFFF were used, it would have been used at an OB/OD Site (USACE, 2019). The Camp Edwards IAGWSP is conducting an ongoing PFAS investigation at the OB/OD Sites, which will evaluate the presence of PFAS compounds as well as potential exposure pathways. The preliminary CSM for Camp Edwards AOI 6 is presented on **Figure 6-8**.

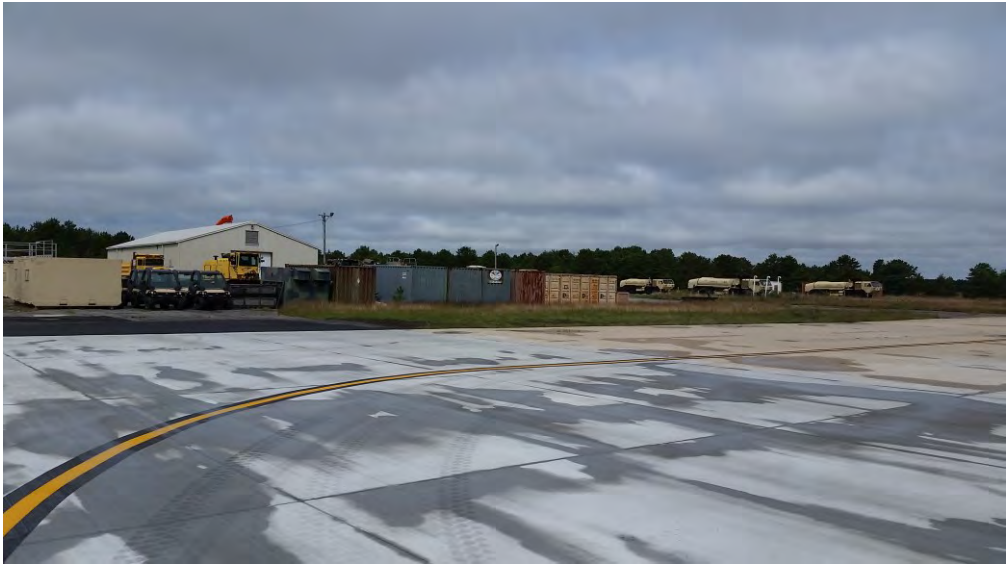
Army National Guard, Preliminary Assessment for PFAS	Camp Edwards	Joint Base Cape Cod, Massachusetts
<p>Photograph No. 01</p> <p>Description: Motor Pool area behind Building 2814 with cold storage building.</p> <p>Orientation: W/NW</p>

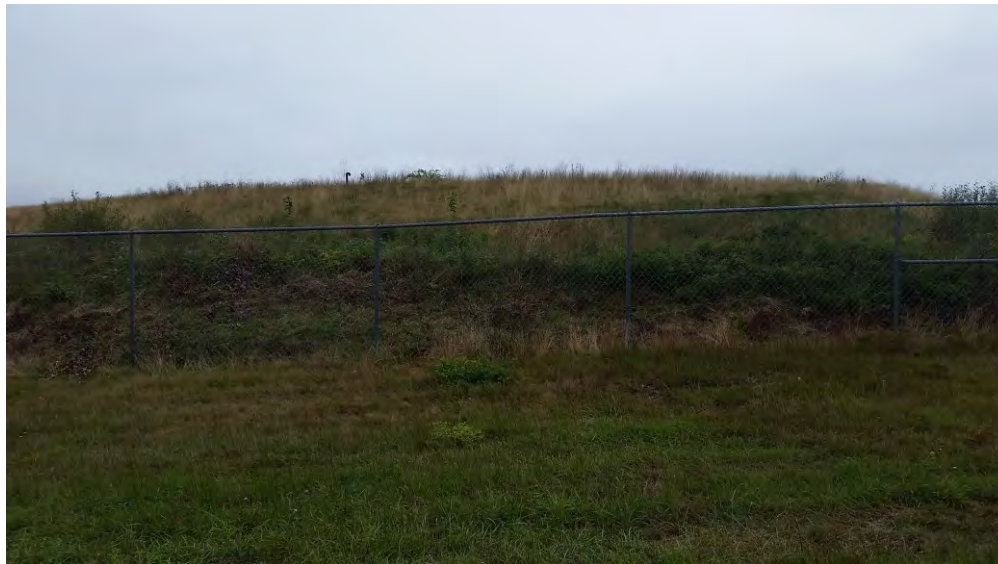
Entrance to Landfill #1
