FINAL Preliminary Assessment Report Camp Grayling, Michigan

Perfluorooctane-Sulfonic Acid (PFOS) and Perfluorooctanoic
Acid (PFOA) Impacted Sites
ARNG Installations, Nationwide

August 2018

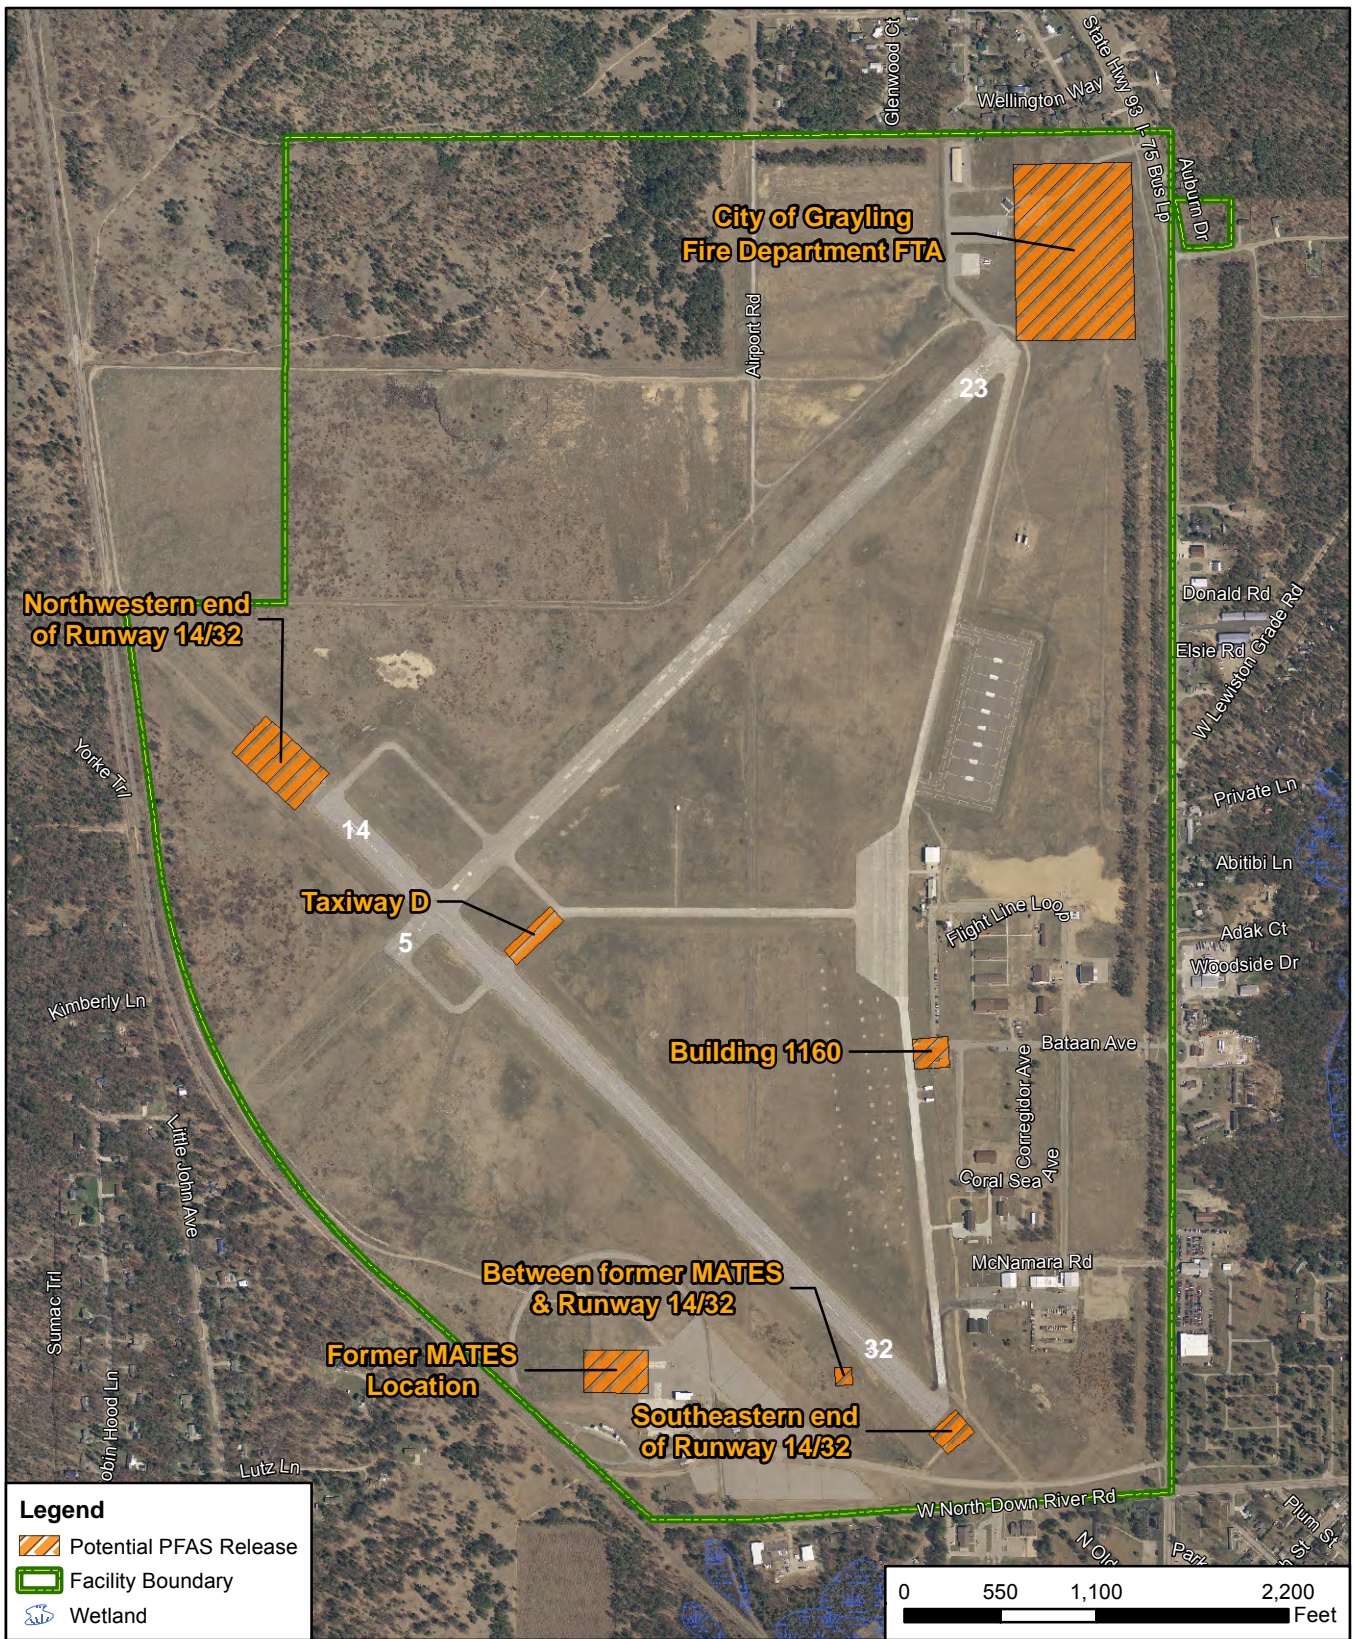
Howes Lake is located approximately 1.5 miles north of Lake Margrethe, within the boundaries of the South Post. The area surrounding the lake is largely rural and undeveloped with the exception of the Shawono Center, a State run juvenile treatment facility, located on the southeastern shore of the lake. During follow-on interviews, a former Camp Grayling firefighter recalled that training activities had historically been conducted at Howes Lake. Camp Grayling's Environmental Quality Specialist recalled such training including bridging activities on the lake. It was not known if activities included firefighting training or resulted in emergency response to wildfires. The exact location and dates of training within the area is uncertain. A review of historical aerial photographs revealed an area of frequent disturbance, located on the southwestern shore of the lake; this area may have been where training occurred. Approximate geographic coordinates for that area of disturbance are 44°41'11.05"N and 84°49'5.15"W. The potential FTA area is shown on **Figure 2-3**.

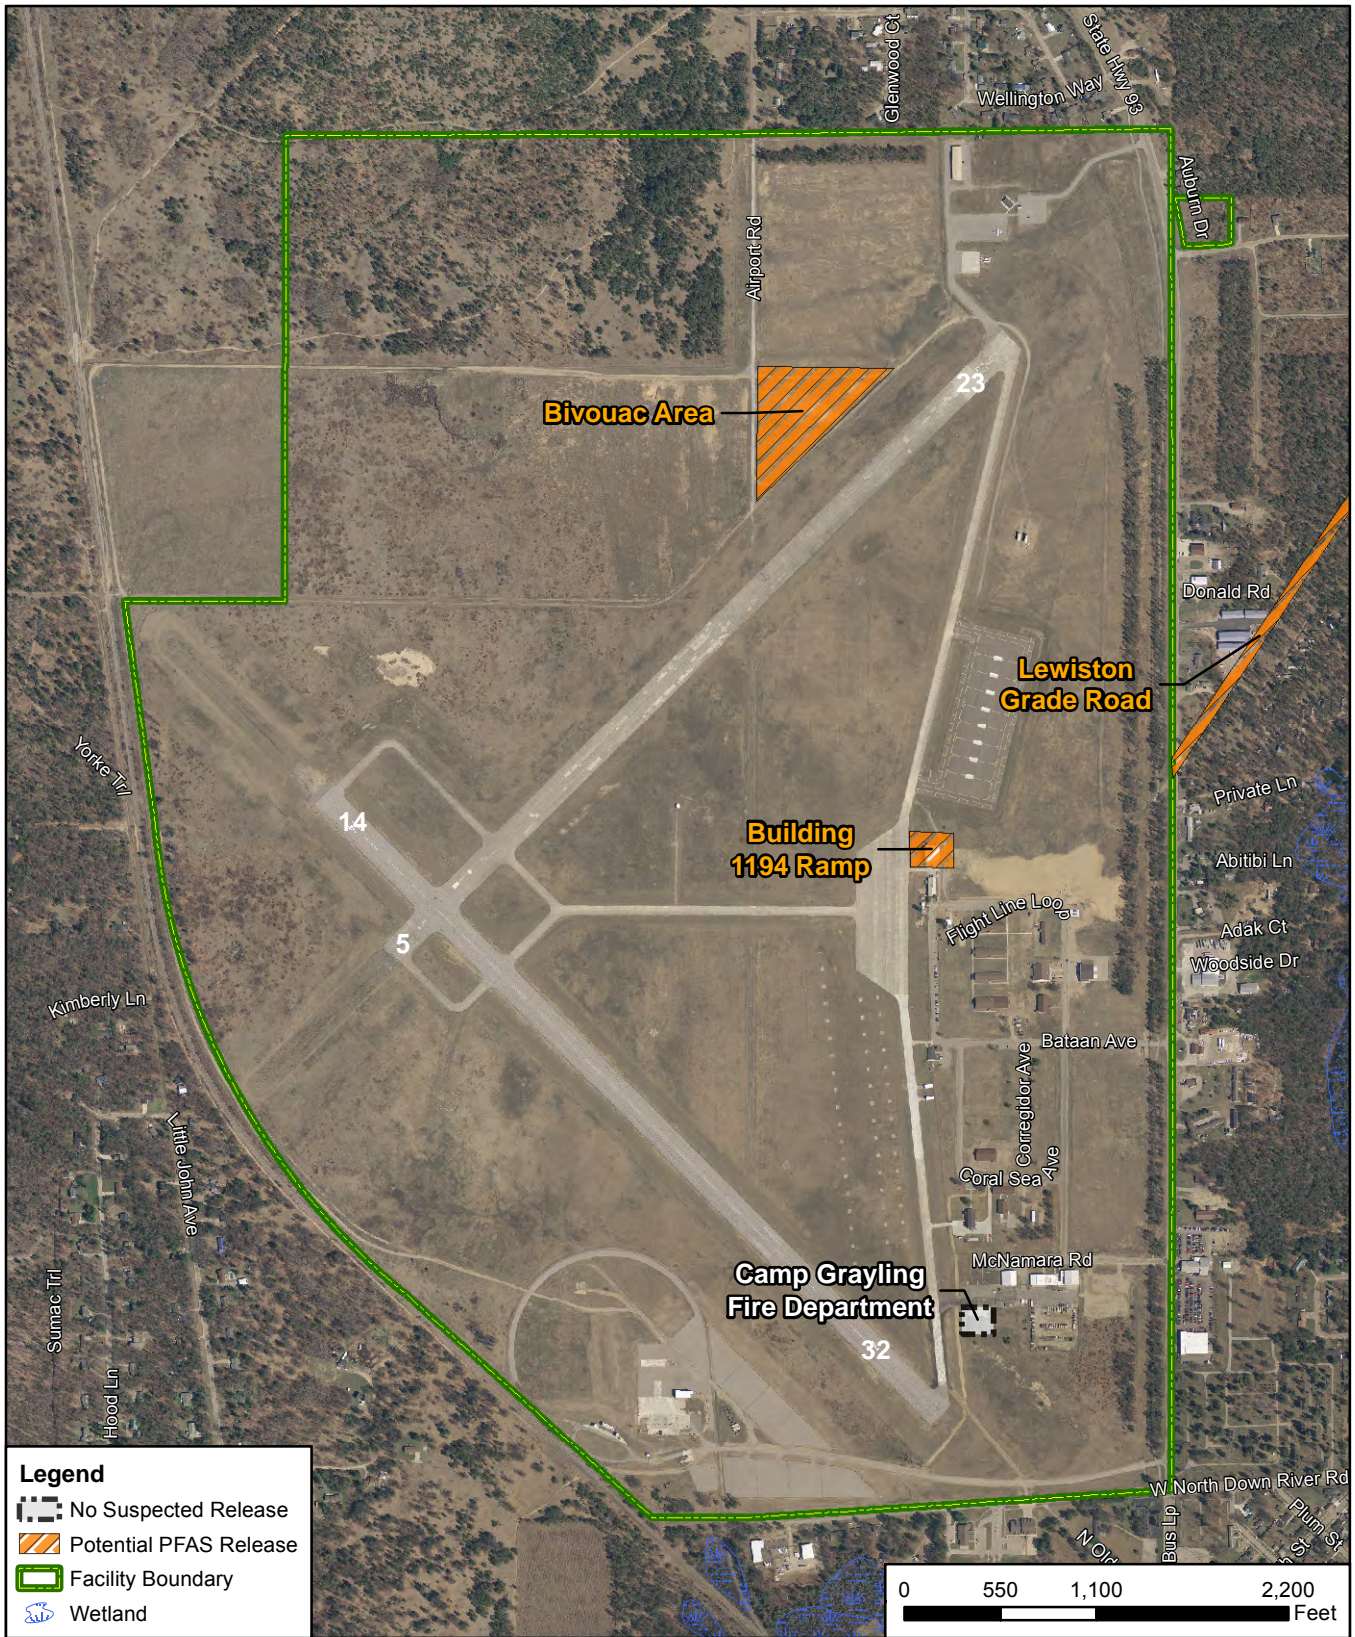
The Parade Grounds are located within the western central area of the cantonment. The grounds contain several athletic fields, a fitness center, and a helicopter landing pad. The approximate geographic coordinates are 44°37'28.49"N and 84°47'30.17"W. Camp Grayling unit capabilities were demonstrated more than once on the Parade Grounds during the period of active AFFF use (1970s and 1980s). Camp Grayling firefighting units (1439th and 1440th) reportedly used AFFF during these demonstrations. The exact number of demonstrations and concentration of AFFF is unknown. Several photographs of Camp Grayling firefighters using AFFF from tanker trucks were provided and included in **Appendix C**.

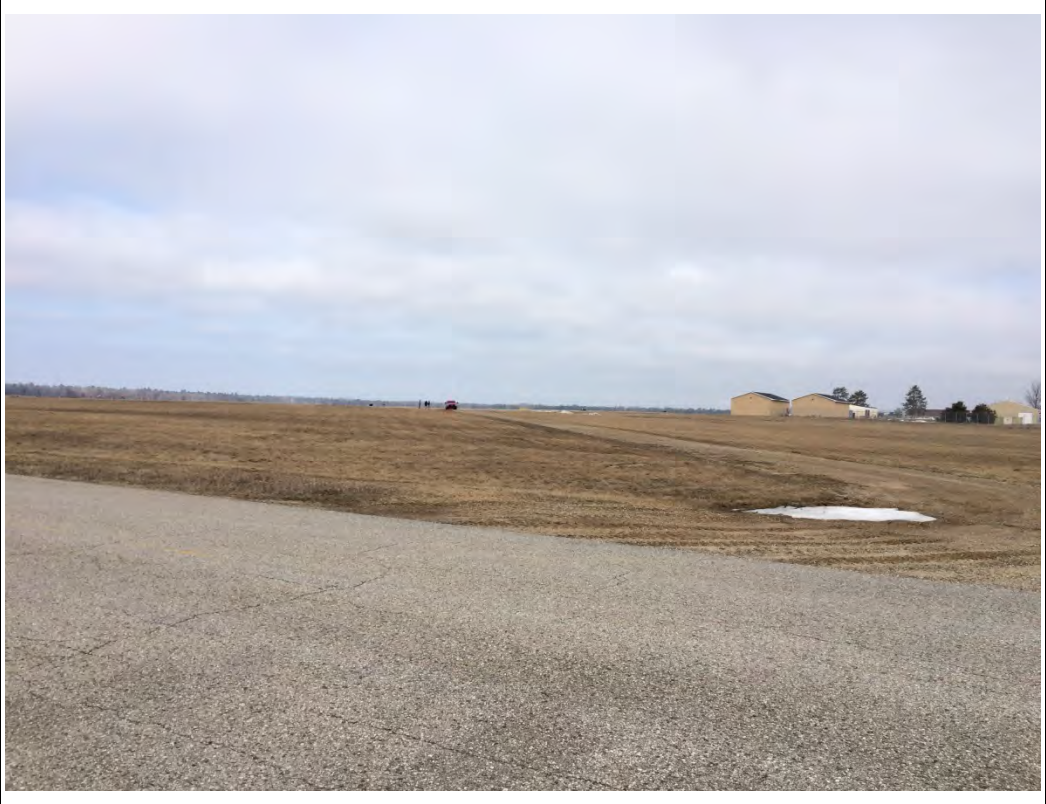
Photograph No. 1

Description:
Area of interest (AOI) 1: Grayling Army Airfield (GAAF); Standing on southern access road facing north towards the firefighting training area and Runway 32. Snow in foreground.

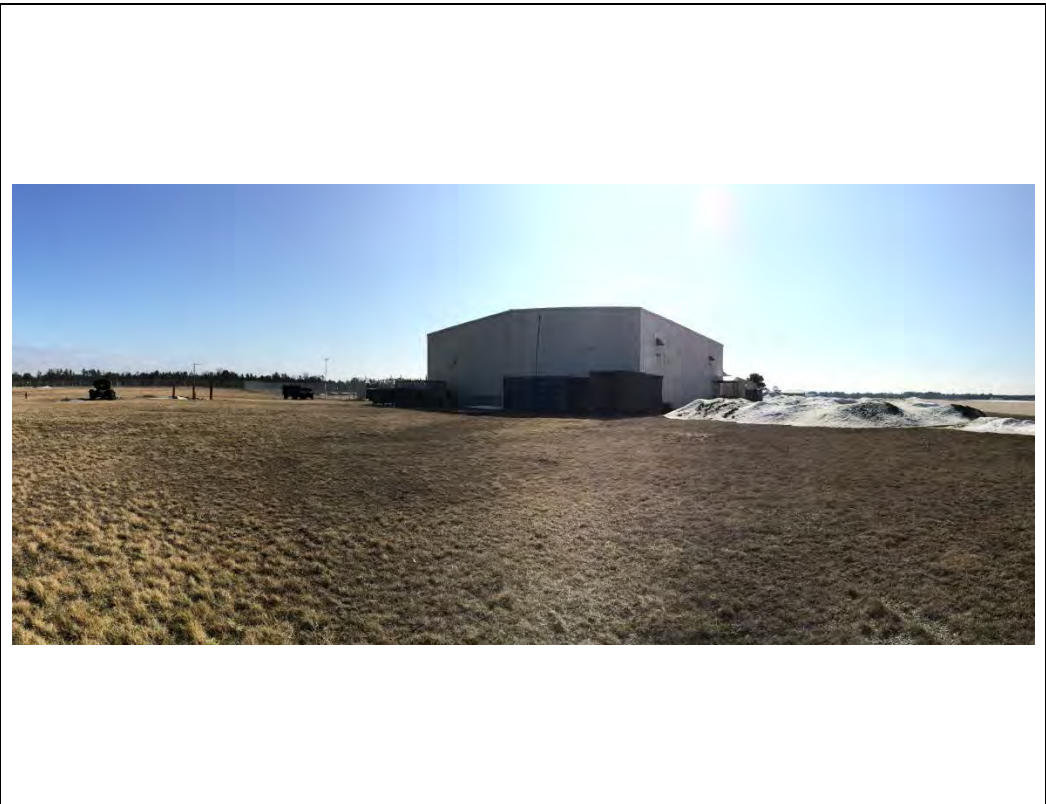
Photograph No. 2

Former Camp Grayling firefighters reported that during the 1970s and 1980s, Camp Grayling fire trucks routinely parked on standby on the ramp adjacent to Building 1194. Fire truck holding tanks reportedly leaked approximately 80 gallons of their contents each day and were topped off every night with AFFF (unknown concentration) and water. Although the capacity of the tanker trucks that leaked was not known, new trucks acquired in the late 1980's were reported to have 1,500 gallon capacity tanks. The frequency at which the trucks were parked in this area is unknown; however, since the Camp Grayling Fire Department building (Building 1150) was not built at the airfield until 2006, it is suspected that trucks containing AFFF were present in this area during all active training seasons from the early 1970's through approximately 1986.

Description:
AOI1: GAAF; Standing on northern side of Building 1194 facing southeast towards AOI1. Snow piles on right side of photograph. Leaking fire trucks were routinely parked near Building 1194.

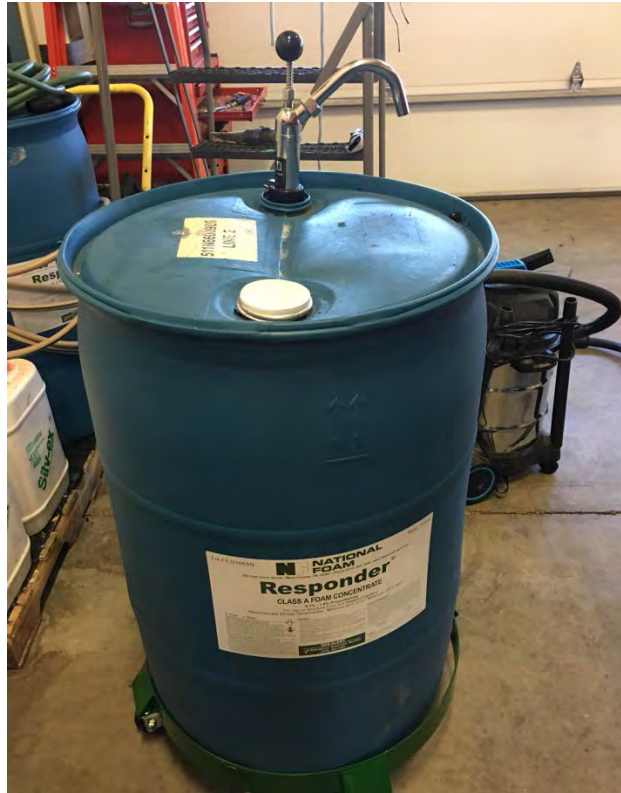
The Camp Grayling Fire Department is currently located at GAAF in Building 1150, which was built in 2006. Firefighting foam was reported to be currently stored in the building. During the PA site visit, multiple 5-gallon buckets and 55-gallon drums of Class A firefighting foam concentrate (0.1 to 1.0 percent proportioning) was observed. No AFFF was observed in the building during PA site visit activities.

Camp Grayling Fire Department (at GAAF): Class A firefighting foam concentrate stored in the Camp Grayling Fire Department building.

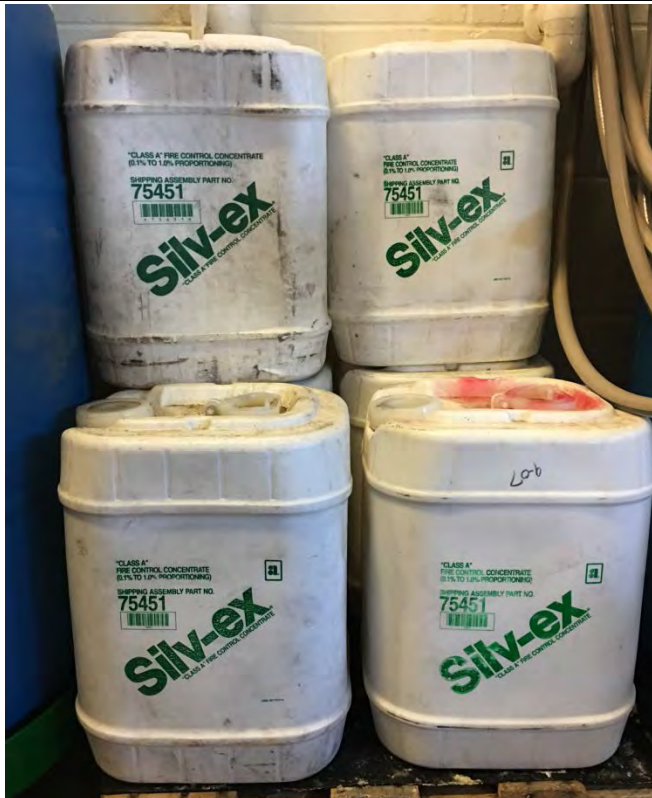
Photograph No. 4

Camp Grayling Fire Department (at GAAF): Class A firefighting foam concentrate stored in the Camp Grayling Fire Department building.

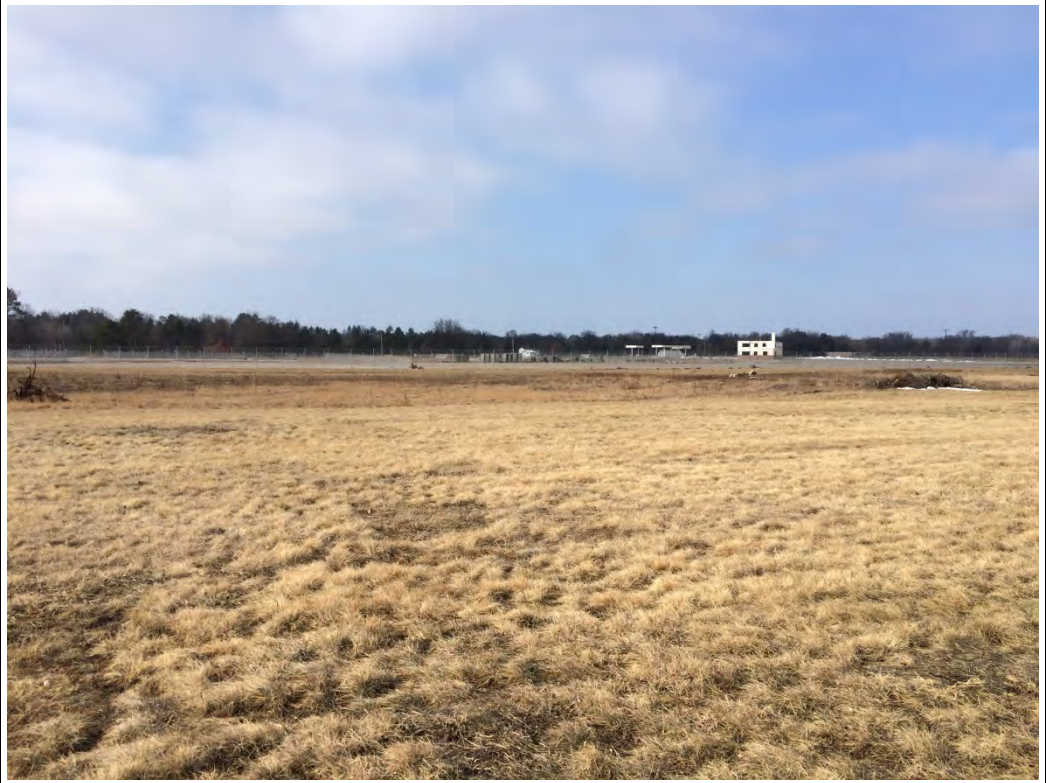
AOI2: GAAF; standing within AOI2 on west side of the southern portion of Runway 32, facing vehicle maintenance Building 1100 (former MATES; AOI3).

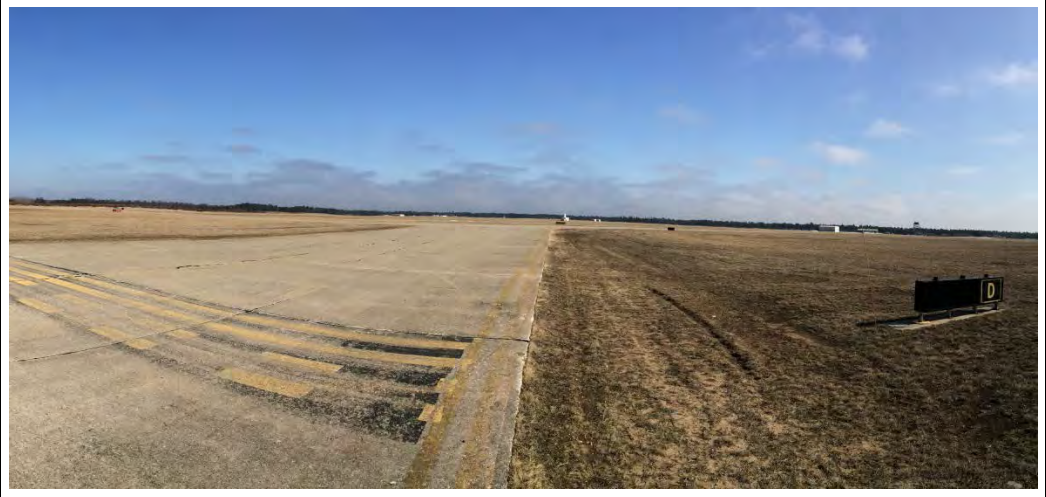
Photograph No. 6

AOI4: GAAF; Standing at intersection of Runway 32 and 23, looking northeast. Former fire training area

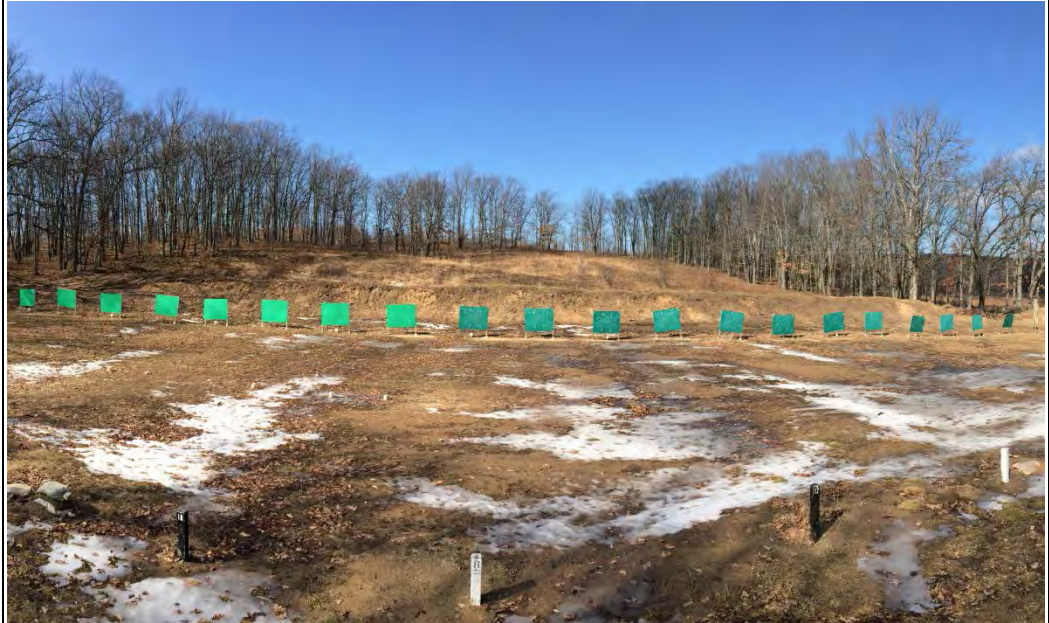
AOI11: South Post, Small Arms Range 3A Complex. Standing on southern end of range facing northwest. Snow seen on range floor.

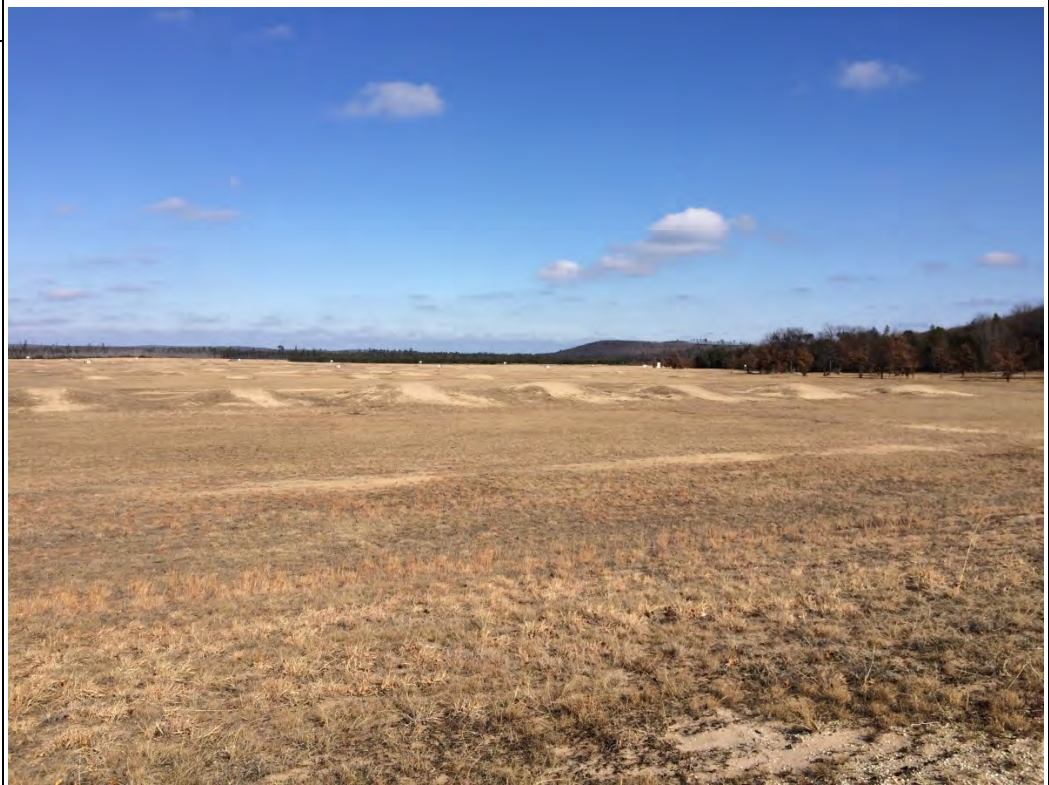
Photograph No. 8

AOI10: Range 8 – Multipurpose Machine Gun Range. Standing at firing line looking north-northeast.

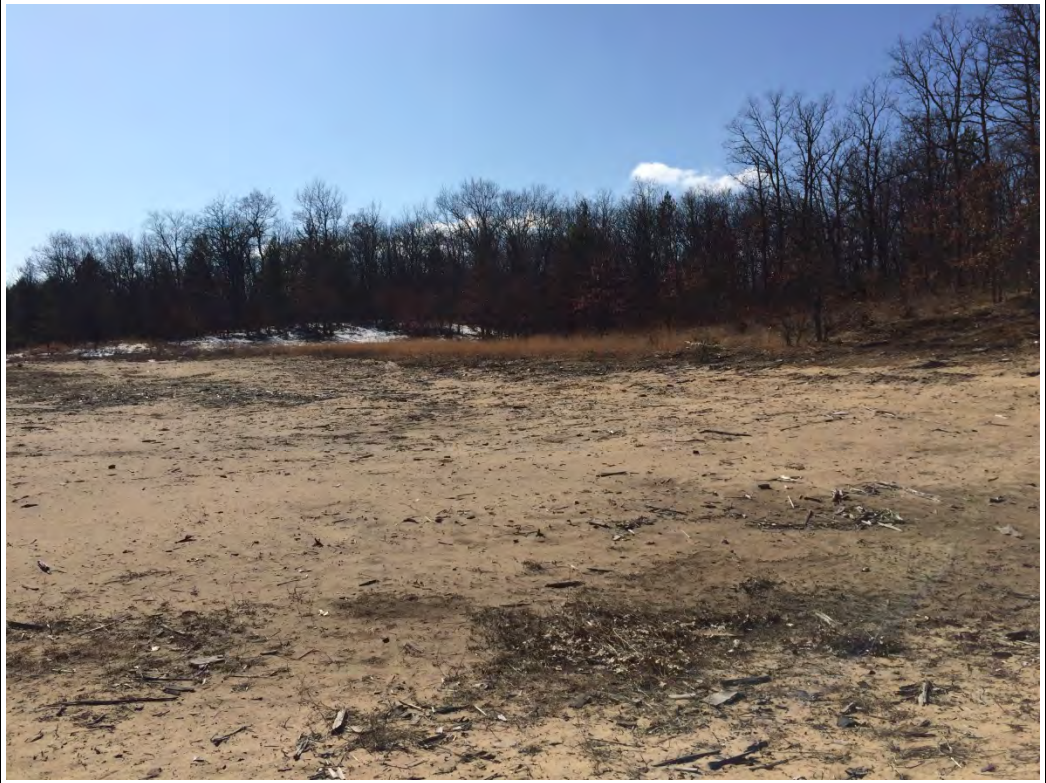
AOI12: Range 20 – light demolitions range. Range 21 not accessible due to icy roads. Standing on northeast end facing southwest towards range floor.

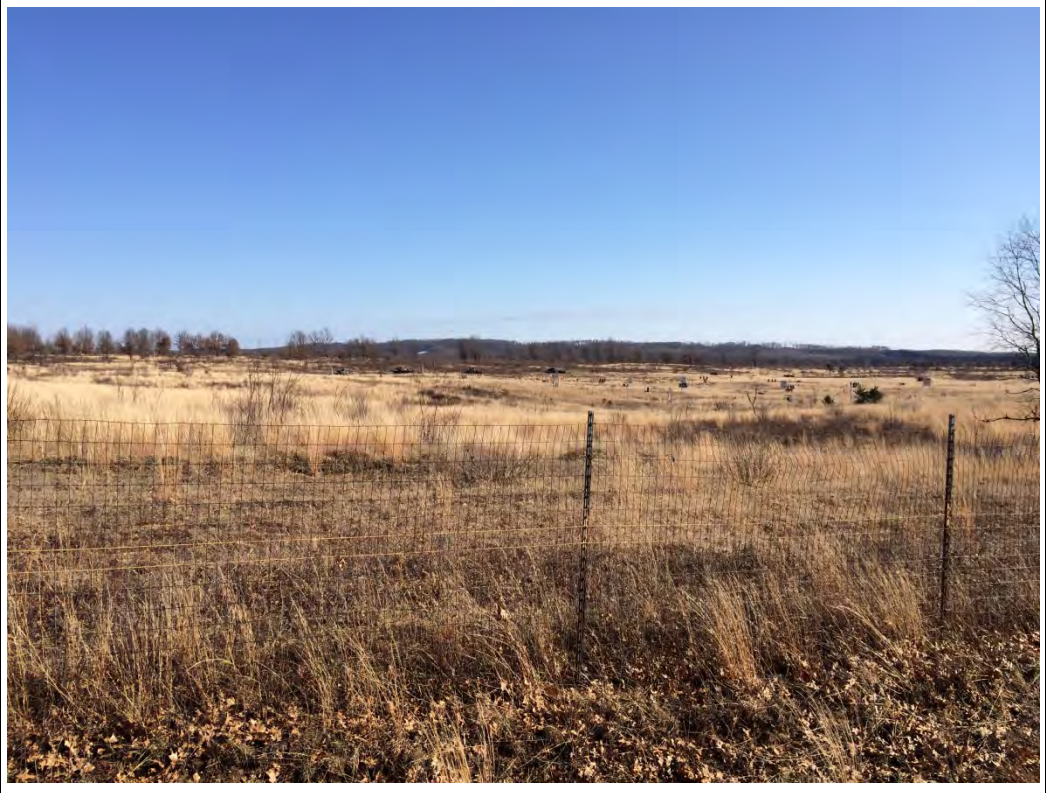
Photograph No. 10

AOI13: Range 15. Standing on northwest end facing southeast towards range. Fence seen in foreground.

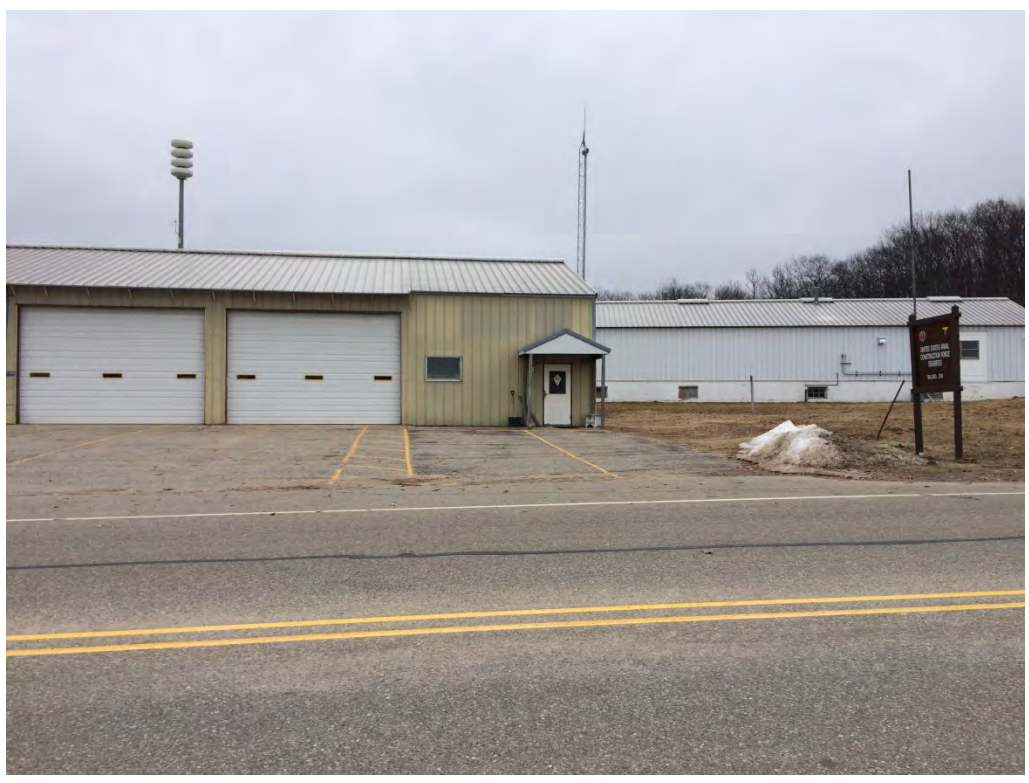
AOI14: Building 39 – Former Fire Barn. Standing on Howe Road facing east.

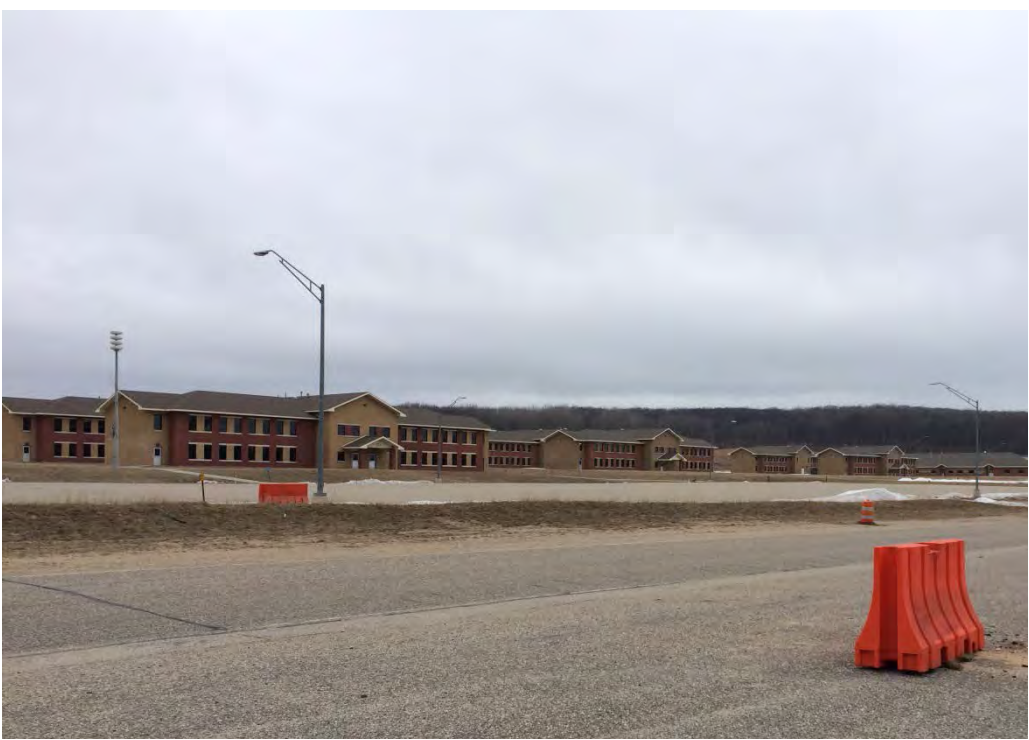
Photograph No. 12

AOI15: Building 600 area. Standing on east side of 8th Street facing northwest towards Building 600 area.

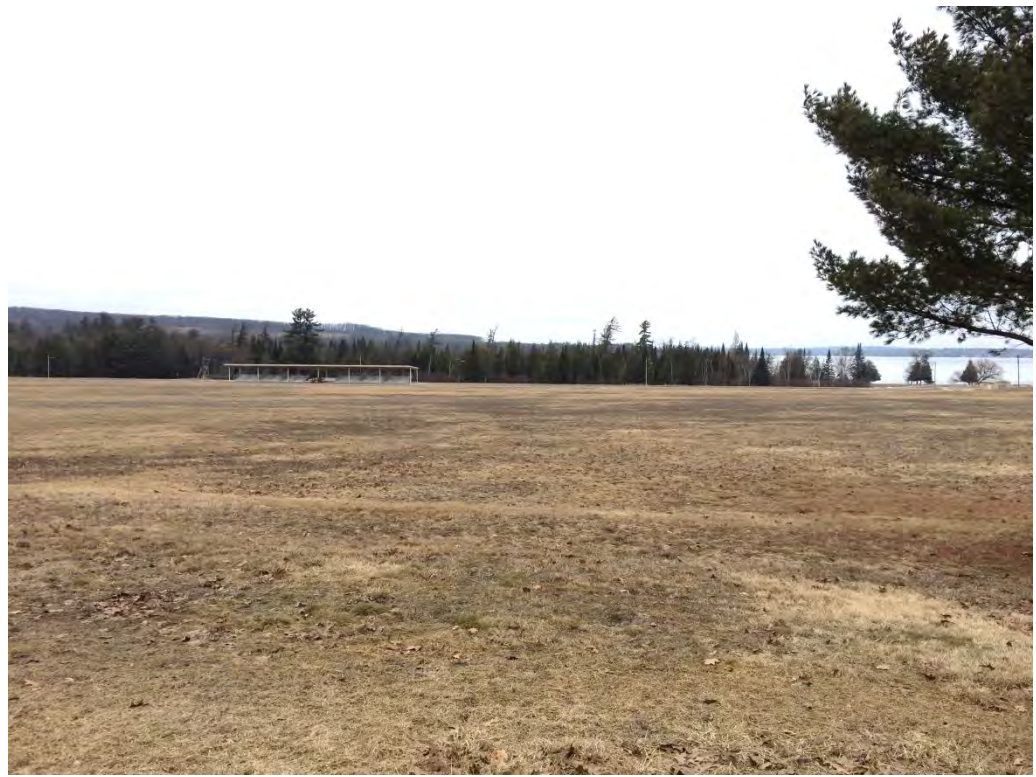
AOI15: Parade Grounds circa 2018. Standing on Howe Road facing north towards Lake Margrethe (seen in background).

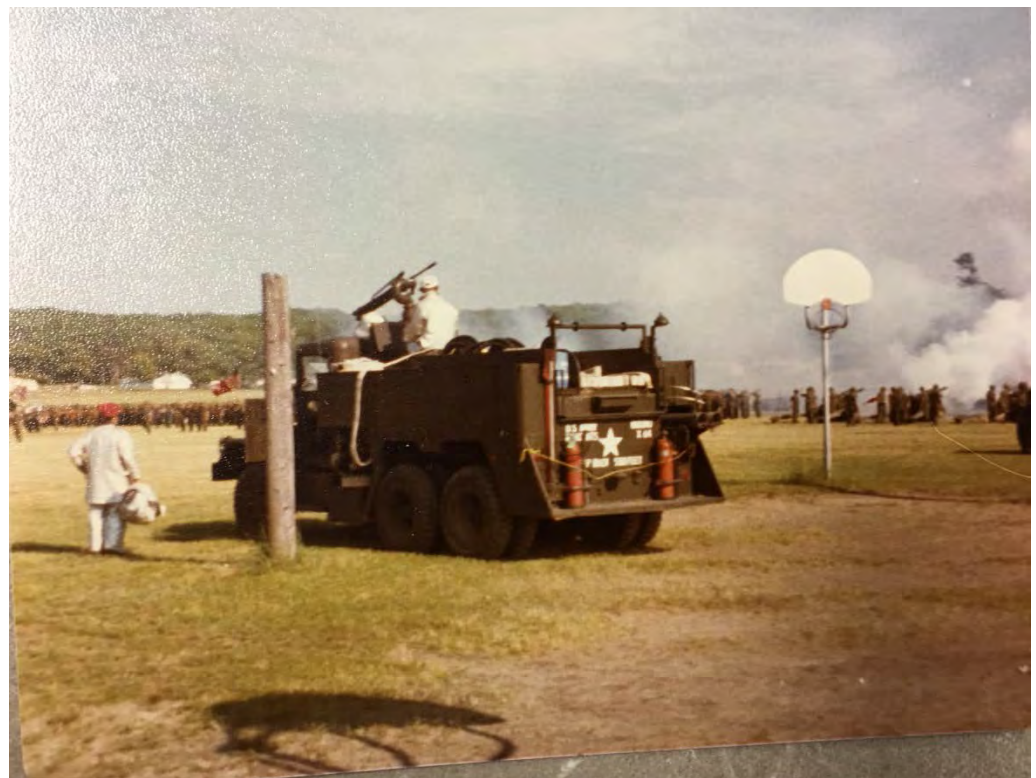
Photograph No. 14

AOI15: Parade Grounds circa 1970s – 1980s. Photograph provided by Kim Halstead. Camp Grayling fire truck parked on Parade Grounds. Blue AFFF bucket seen in back of truck.

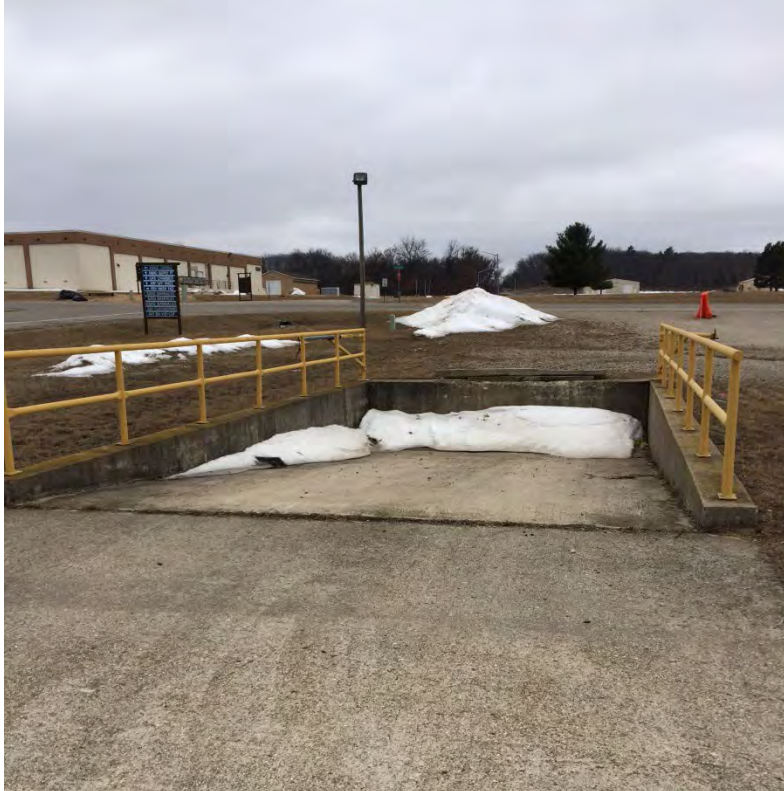
<p>Photograph No. 16</p> <p>Description:</p> <p>AOI15: Larger Wash Rack on corner of Parade Road and 8th Street. Standing on southern side of Wash Rack facing north. Wash Rack surrounded by large concrete pad.</p>

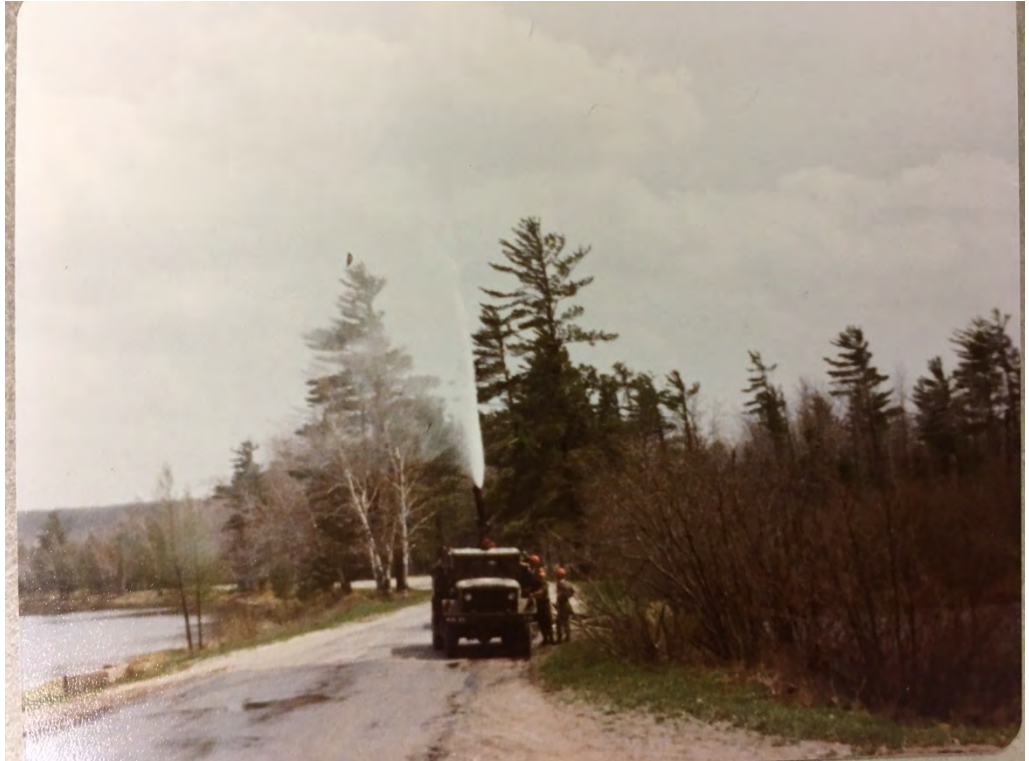
AFFF was potentially released into Lake Margrethe during check nozzle maintenance activities. Additionally, PFAS contamination, from other potential releases of AFFF within the cantonment, may have infiltrated shallow groundwater and migrated to Lake Margrethe.

<p>Photograph No. 20</p> <p>Description:</p> <p>AOI15: Check nozzle area (1970s - 1980s). Photograph provided by Kim Halstead. Camp Grayling Firefighters performing check nozzle maintenance on fire truck next to Lake Margrethe.</p>

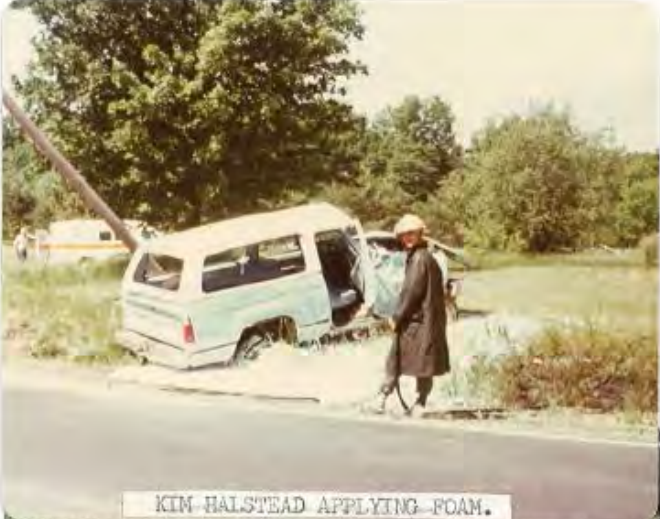
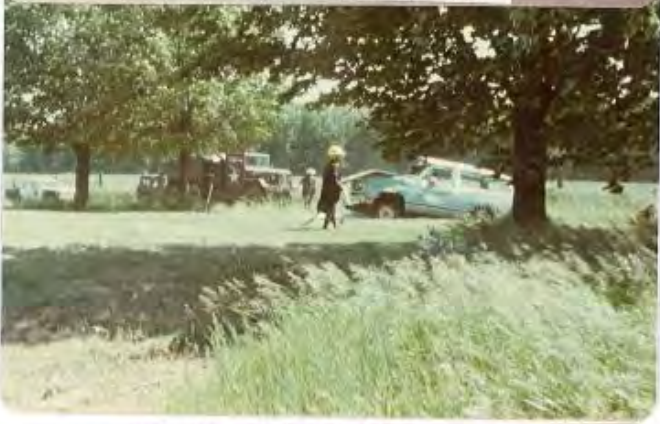
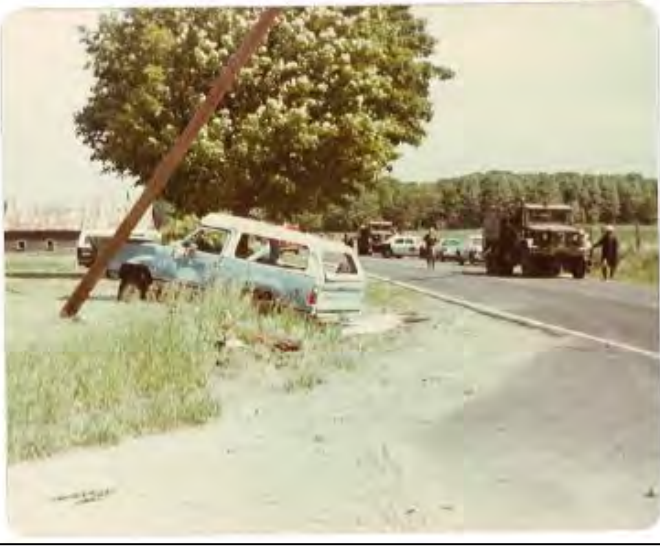
Army National Guard, Preliminary Assessment for PFAS	Camp Grayling	Grayling, Michigan
<p>Photograph No. 23</p> <p>Description:</p> <p>Single time emergency response to car accident.</p>	<p data-bbox="607 289 1344 403"><i>Military at Beaver Road Accident 1979</i></p>

<p data-bbox="727 890 1114 919">KIM-HALSTEAD APPLYING FOAM.</p>

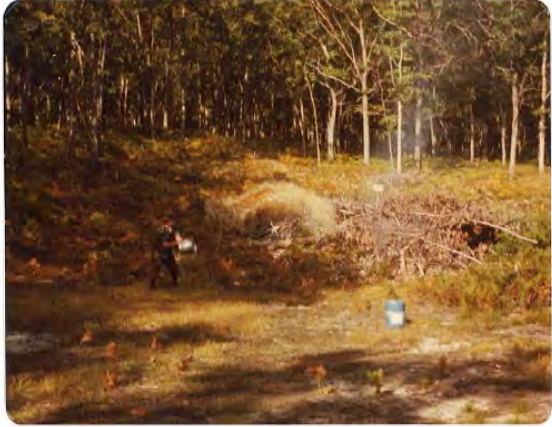
<p>Photograph No. 25</p> <p>Description: AOI18</p>	<p>Pre-Burn on Range 30 Complex in the Early 1980s. AFFF was Put into the water tank on the Fire truck and mixed with water to form wet water to Fight wild Land Fires</p>

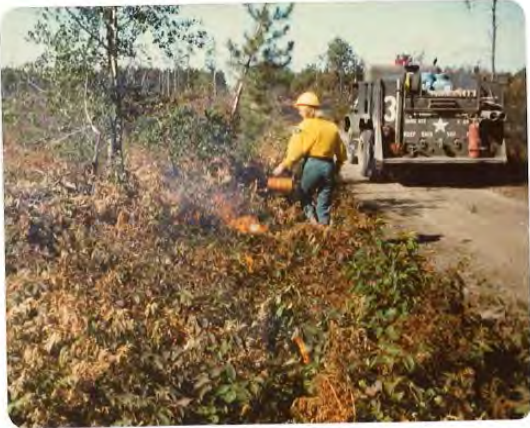
<p>← AFFF = Blue Containers on Back of fire truck.</p>	
--	--	--

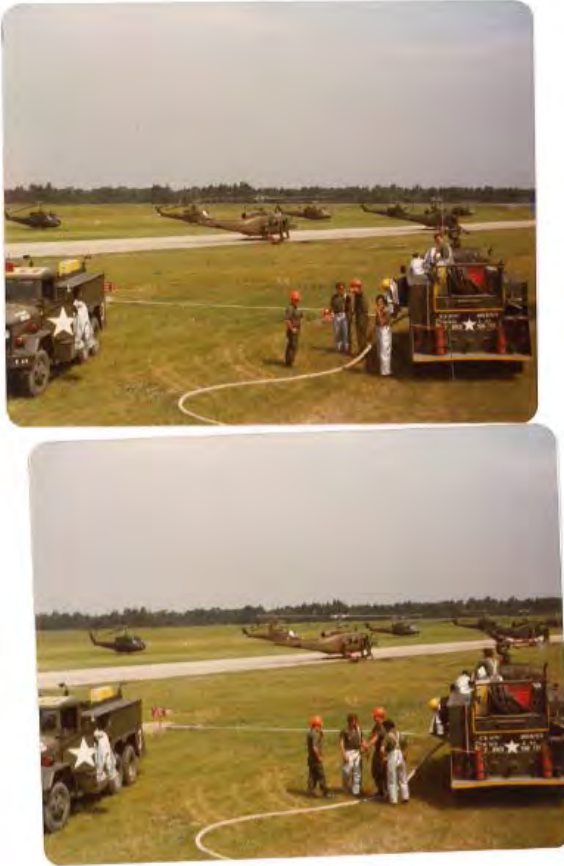
Army National Guard, Preliminary Assessment for PFAS	Camp Grayling	Grayling, Michigan
<p>Photograph No. 26</p> <p>Description:</p> <p>AOII</p>	<p>Fire trucks staged at CGAAF Near Ops Building Early 1980's</p>

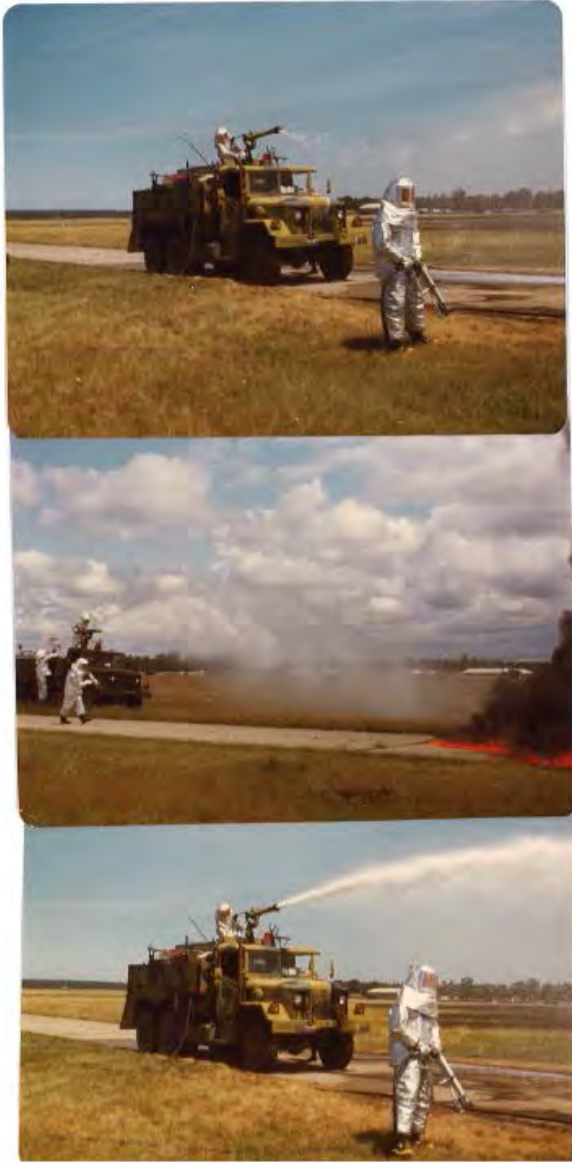
<p>The photograph log contains three vertically stacked images. The top image shows a green military truck with a foam cannon mounted on its back, parked on a grassy airfield. A person in a white hazmat suit stands next to the truck. The middle image shows the same truck and person, with a large plume of white foam being discharged from the cannon. The bottom image shows the truck and person again, with a high-pressure water hose being used to spray the ground.</p>

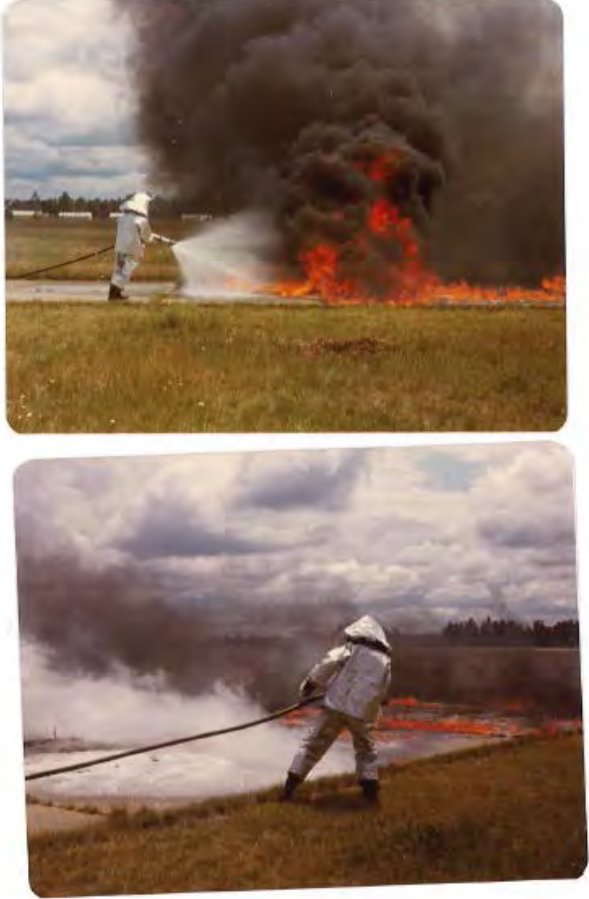
Army National Guard, Preliminary Assessment for PFAS	Camp Grayling	Grayling, Michigan
<p>Photograph No. 28</p> <p>Description: AOI4</p>	<p>Indiana National Guard Training Early 1980's (Page 2)</p>

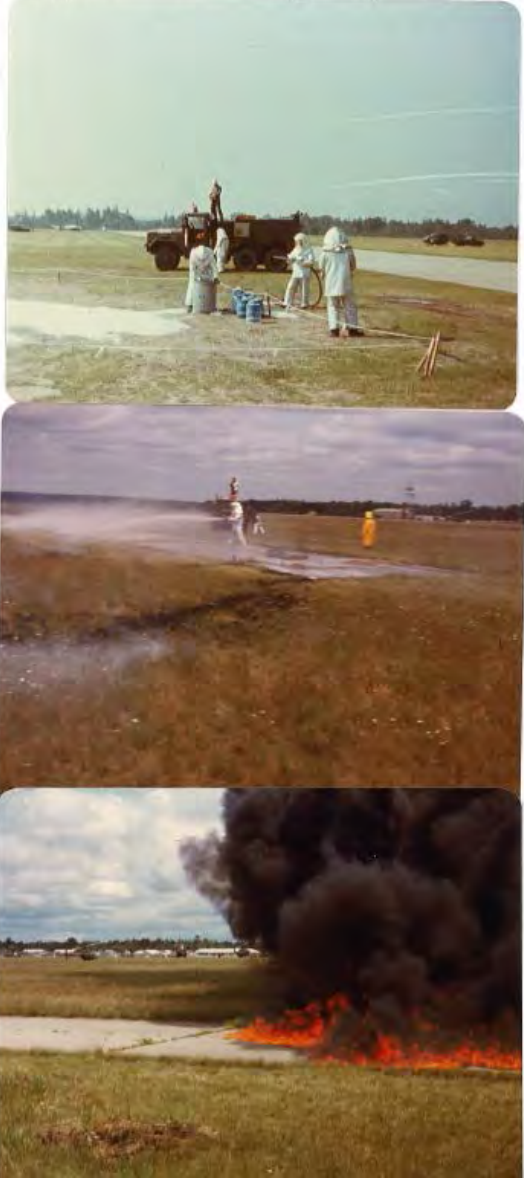
Army National Guard, Preliminary Assessment for PFAS	Camp Grayling	Grayling, Michigan
<p>Photograph No. 29</p> <p>Description:</p> <p>AOI4</p>	<p>Michigan National Guard CGATS (Fire Detachment) TRAINING mid 1980's (Page 1) AIRFIELD</p>
