Preliminary Assessment Report

Lansing Hangar, Michigan

Perfluorooctanesulfonic Acid (PFOS) and Perfluorooctanoic Acid (PFOA) Impacted Sites
ARNG Installations, Nationwide

September 2020

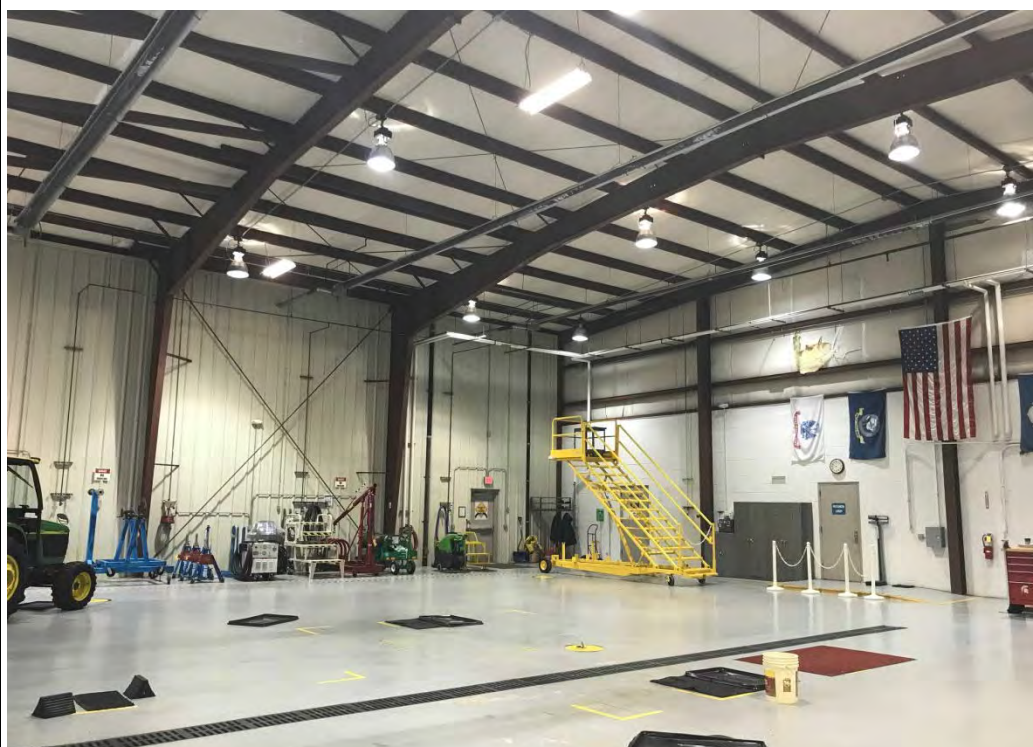
Inside hangar; no fire suppression system. Photo taken on 7 June 2018.

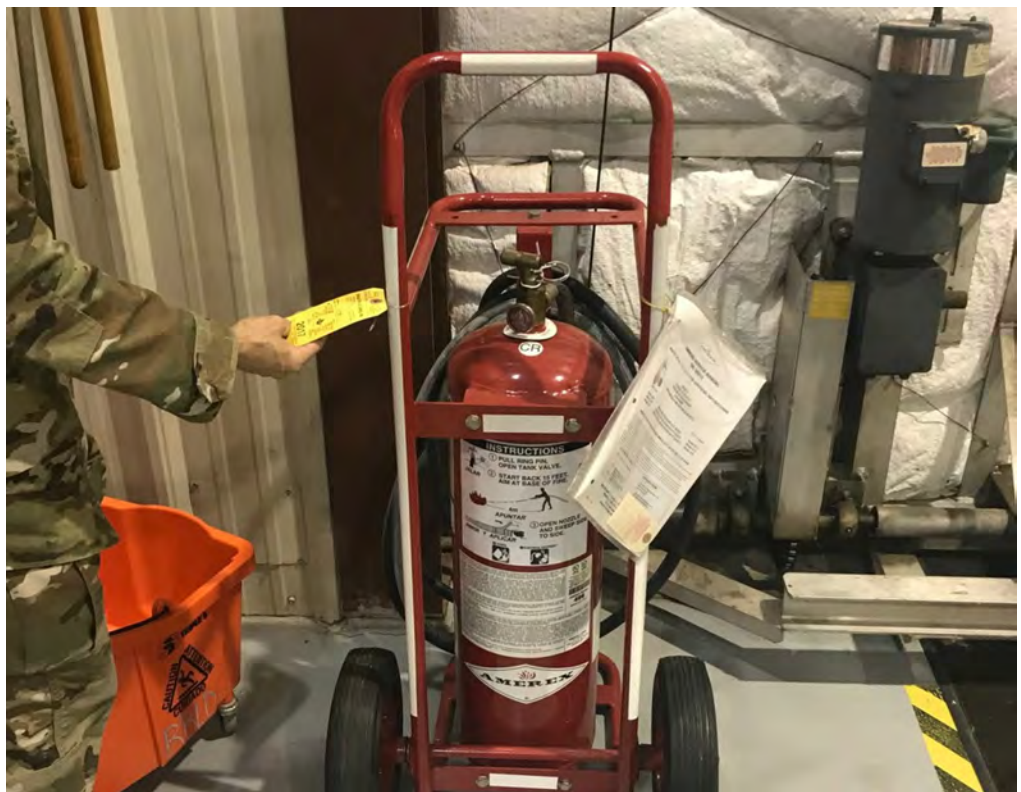
Photograph No. 2

Example of 150lb BC (dry chemical) fire extinguisher available at the hangar. Photo taken on 7 June 2018.

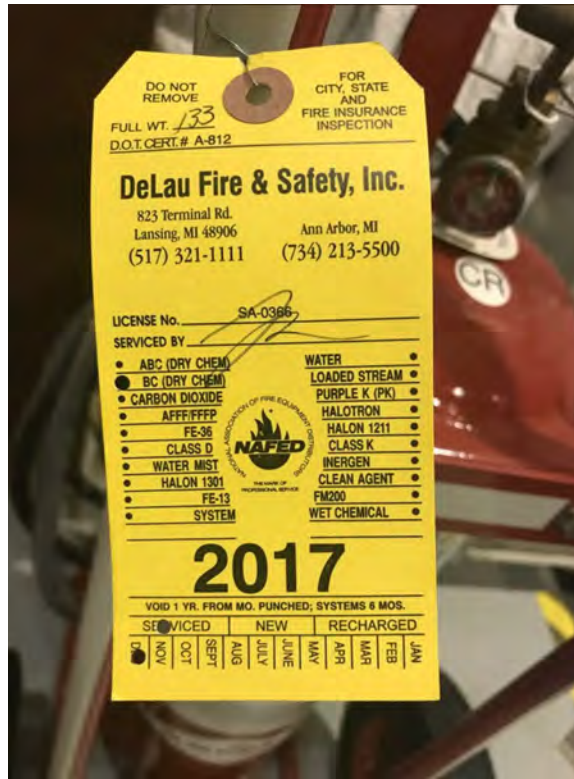
Tag on fire extinguisher presented in Photograph No. 3. Photo taken on 7 June 2018

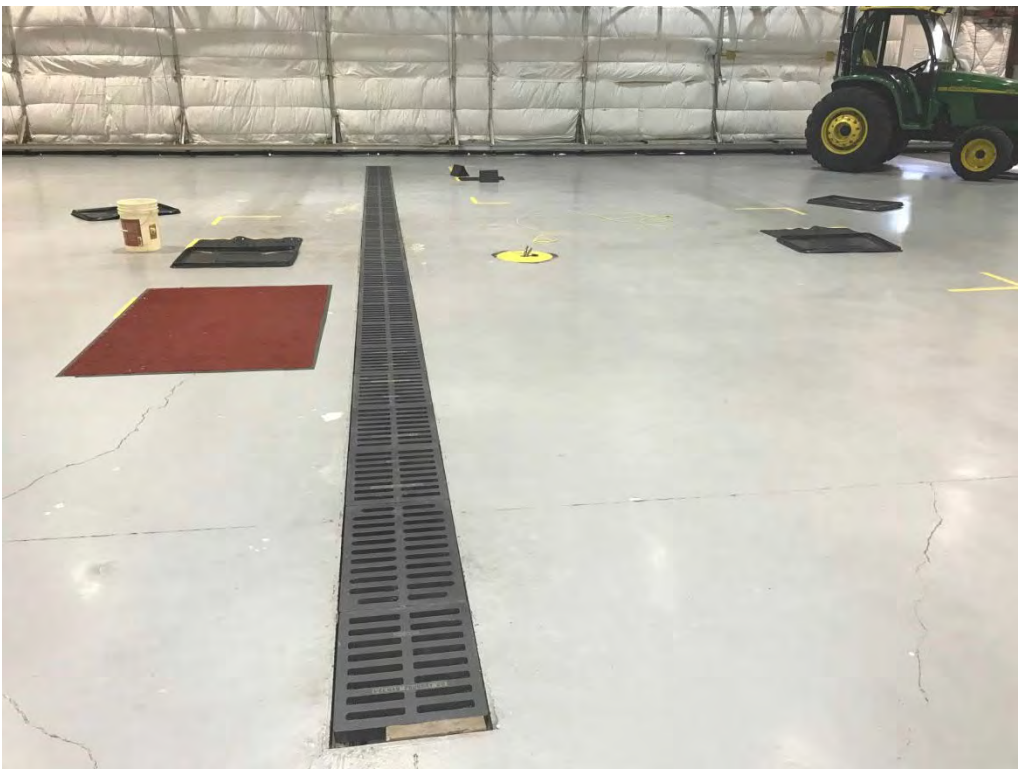
Photograph No. 4

Floor drain located in center of the hangar. Photo taken on 7 June 2018.
