# Final Preliminary Assessment Report Grand Ledge Army Aviation Support Facility and Armory, Michigan

Per- and Polyfluoroalkyl Substances (PFAS) Impacted Sites  
ARNG Installations, Nationwide

October 2019

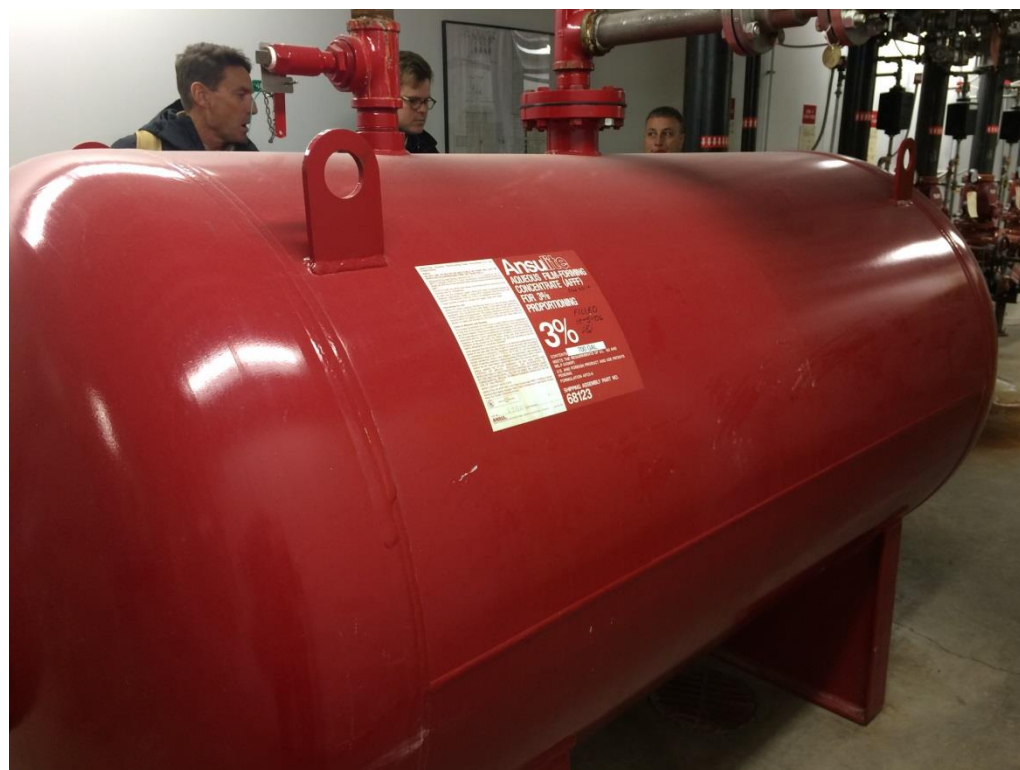
### Photograph No. 2

| Testing includes inspection, draining of 700gal tank by contractor. Only ever done 2x including liner replacement. Contents pumped back into tank. No spills or leaks. | Storage (Solution) |

AASF Hangar: 700-gallon AFFF fire suppression system tank. Second floor of AASF building.

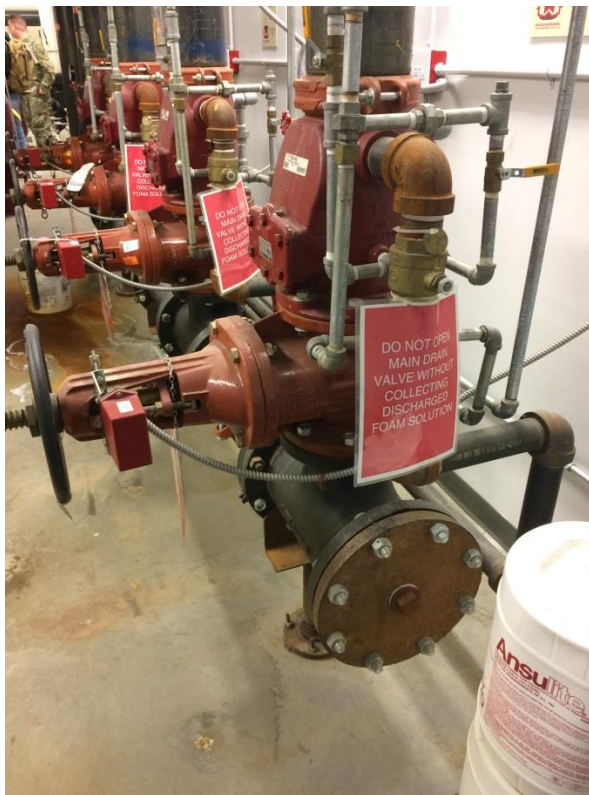
AASF Hangar: AFFF fire suppression system piping and warning labels. Second floor of AASF building.

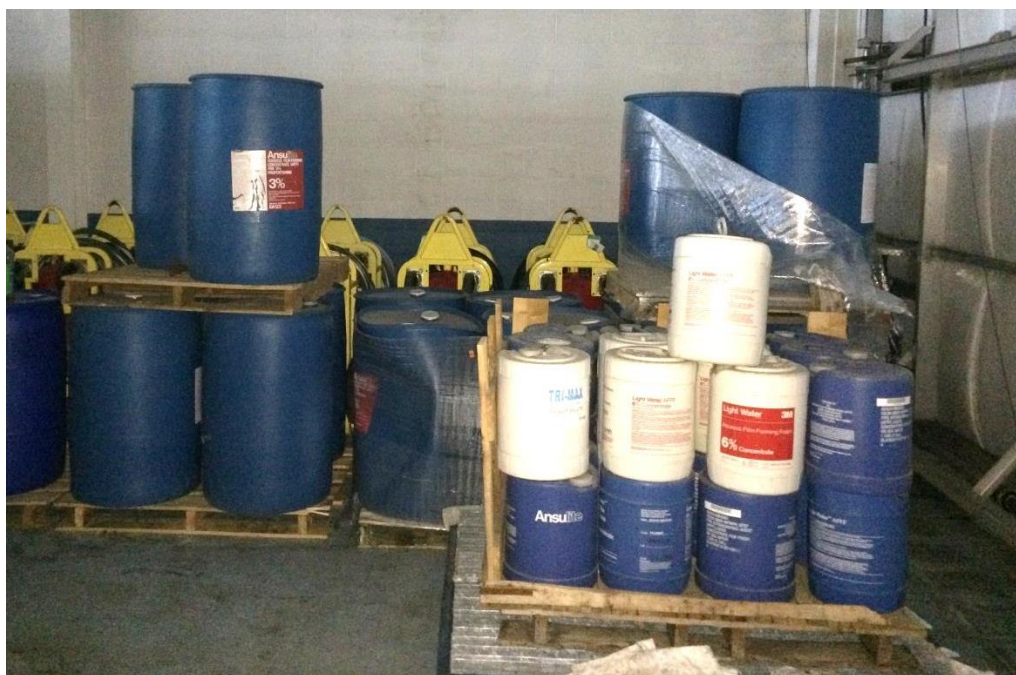
### Photograph No. 4

Annex building, storage area. Excess AFFF concentrate stored in 55-gallon and 5-gallon buckets. Empty Tri-Max 30 extinguishers in background.

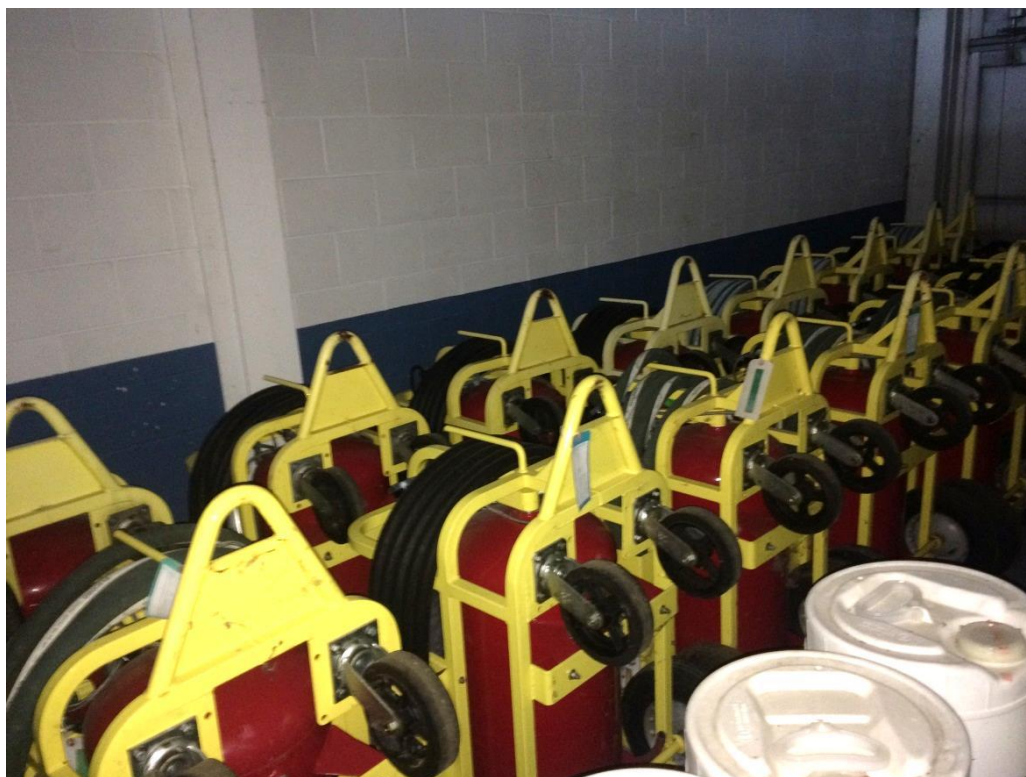
Annex building, storage area.  
Empty and tagged compressed  
air foam portable fire  
suppression systems (Tri-Max  
30 extinguishers). 5-gallon  
buckets of AFFF concentrate  
in foreground.

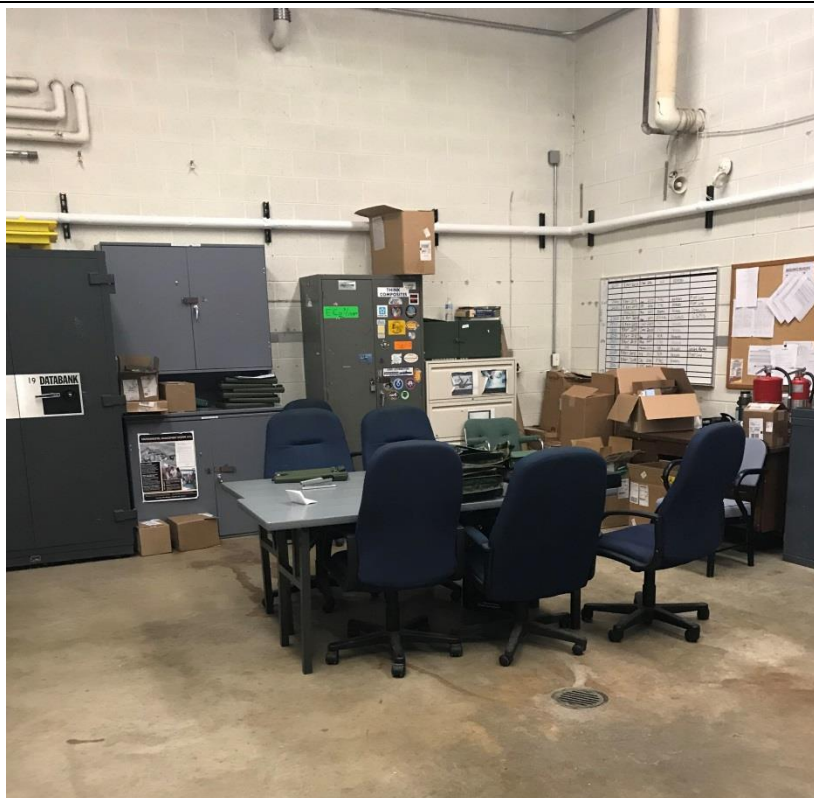
Armory building. Garage  
where fire truck used to be  
stored. Now used as general  
office/storage space.
