FINAL Preliminary Assessment Report Fort Custer Training Center, Augusta, Michigan

Perfluorooctane-Sulfonic Acid (PFOS) and Perfluorooctanoic
Acid (PFOA) Impacted Sites
ARNG Installations, Nationwide

February 2020

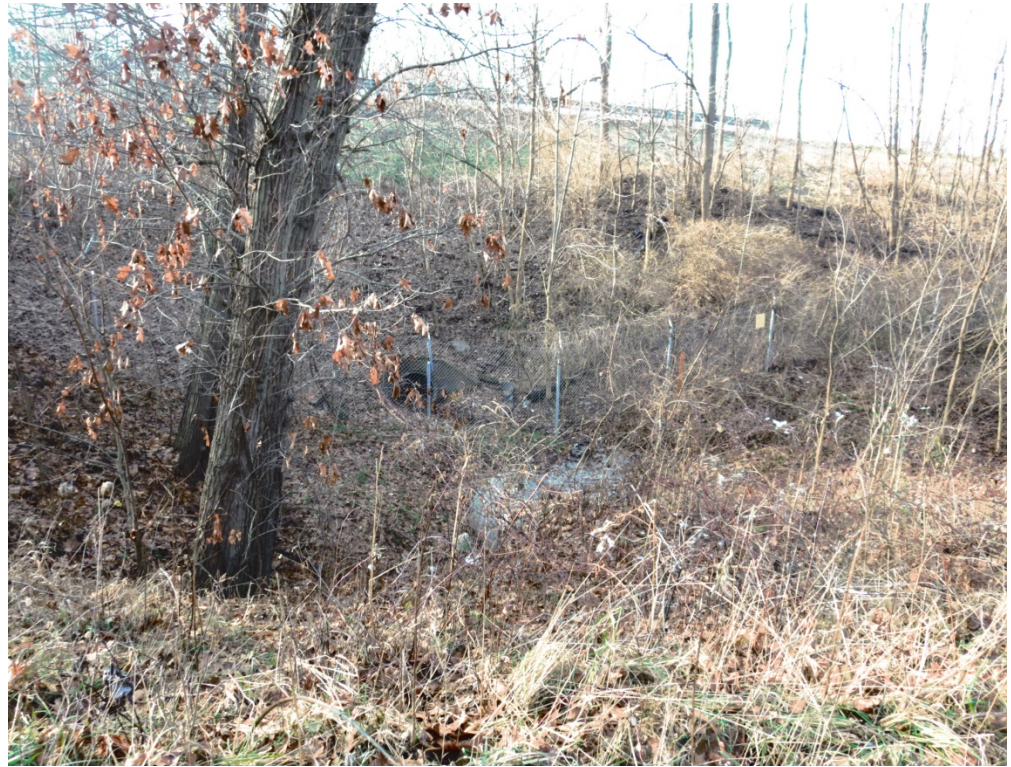
Area of interest (AOI) 1: Fort Custer Training Center (FCTC); Standing on Perimeter Road facing southwest. I-94 is in the foreground. This is the location near I-94 where the truck fire took place. A culvert is located to the north of the truck crash site.

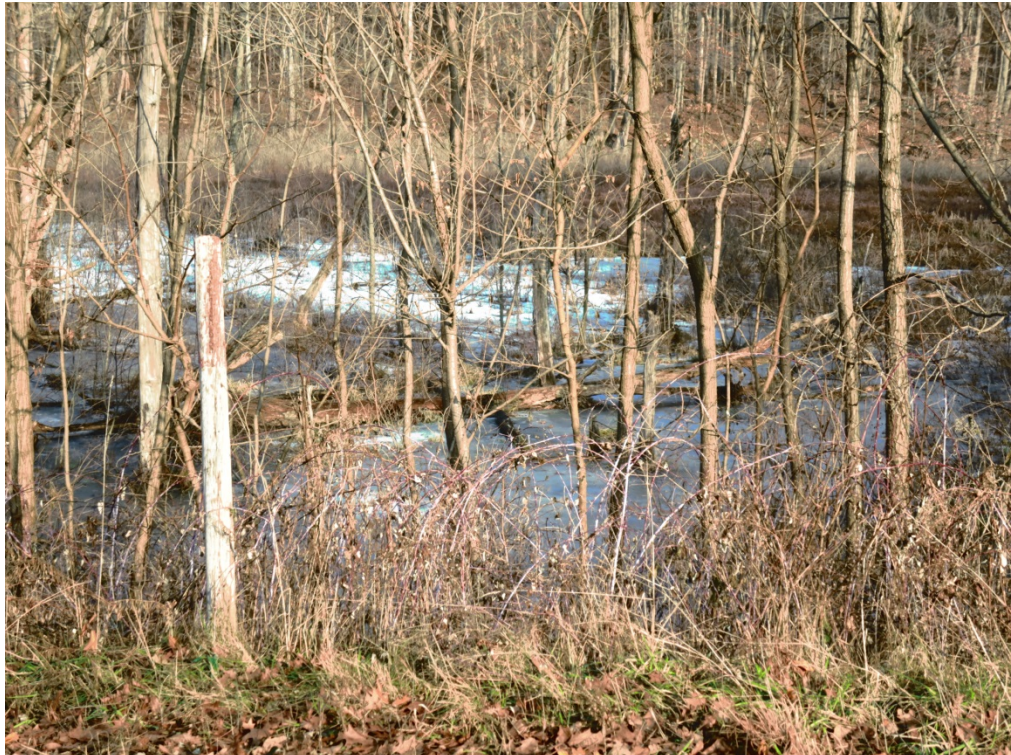
Photograph No. 2

AOI 1: FCTC; Standing on Perimeter Road just north of the culvert shown in Photograph No. 1 facing north. View of a wetland area that is directly north of the culvert that may drain water from I-94. The culvert appears to drain into the wetland area.

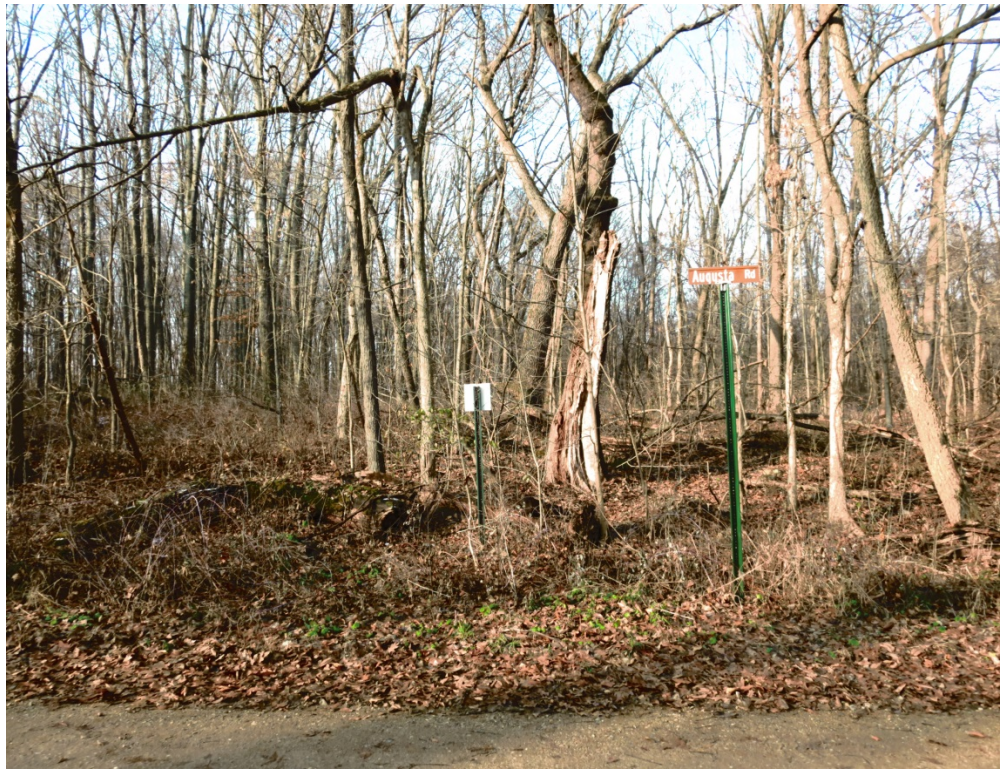
AOI 1 FCTC: Standing on Augusta Road looking west at the area where the truck that was dragged onto FCTC from I-94 was left.

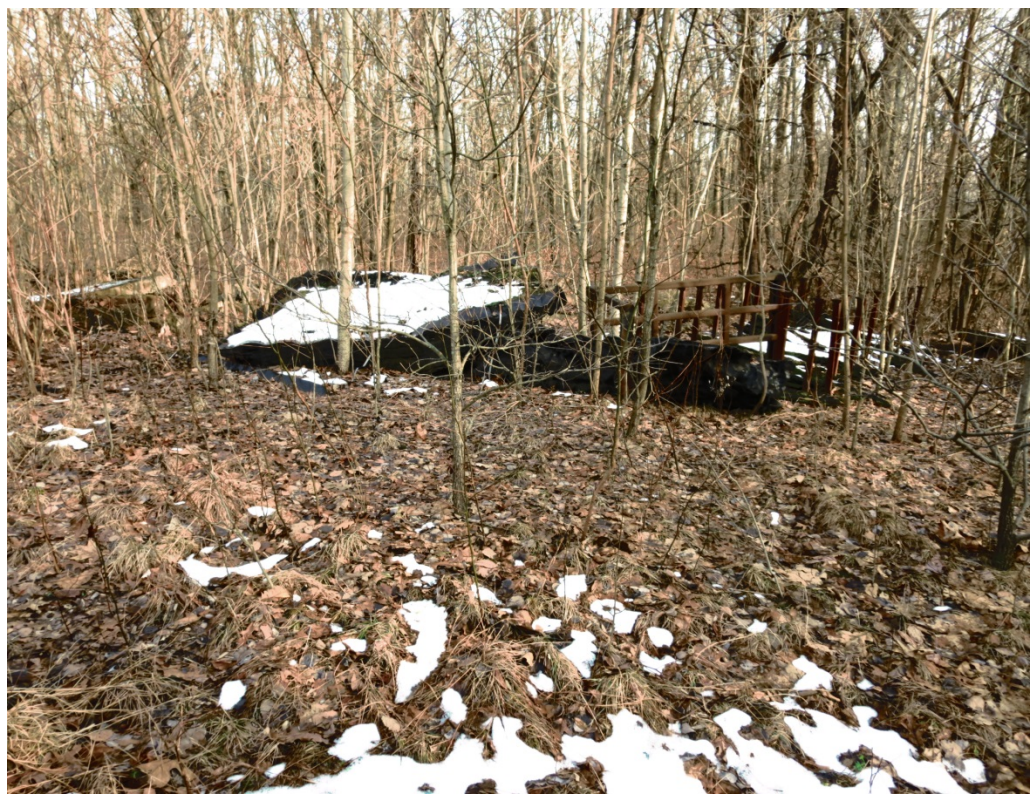
Photograph No. 4

AOI 2 FCTC: Standing in an area east of Longman Road looking east at the geo-grid that caught fire.
