## Preliminary Assessment Report

### Camp Ripley, Minnesota

Perfluorooctane-Sulfonic Acid (PFOS) and Perfluorooctanoic Acid (PFOA) Impacted Sites  
ARNG Installations, Nationwide

November 2019

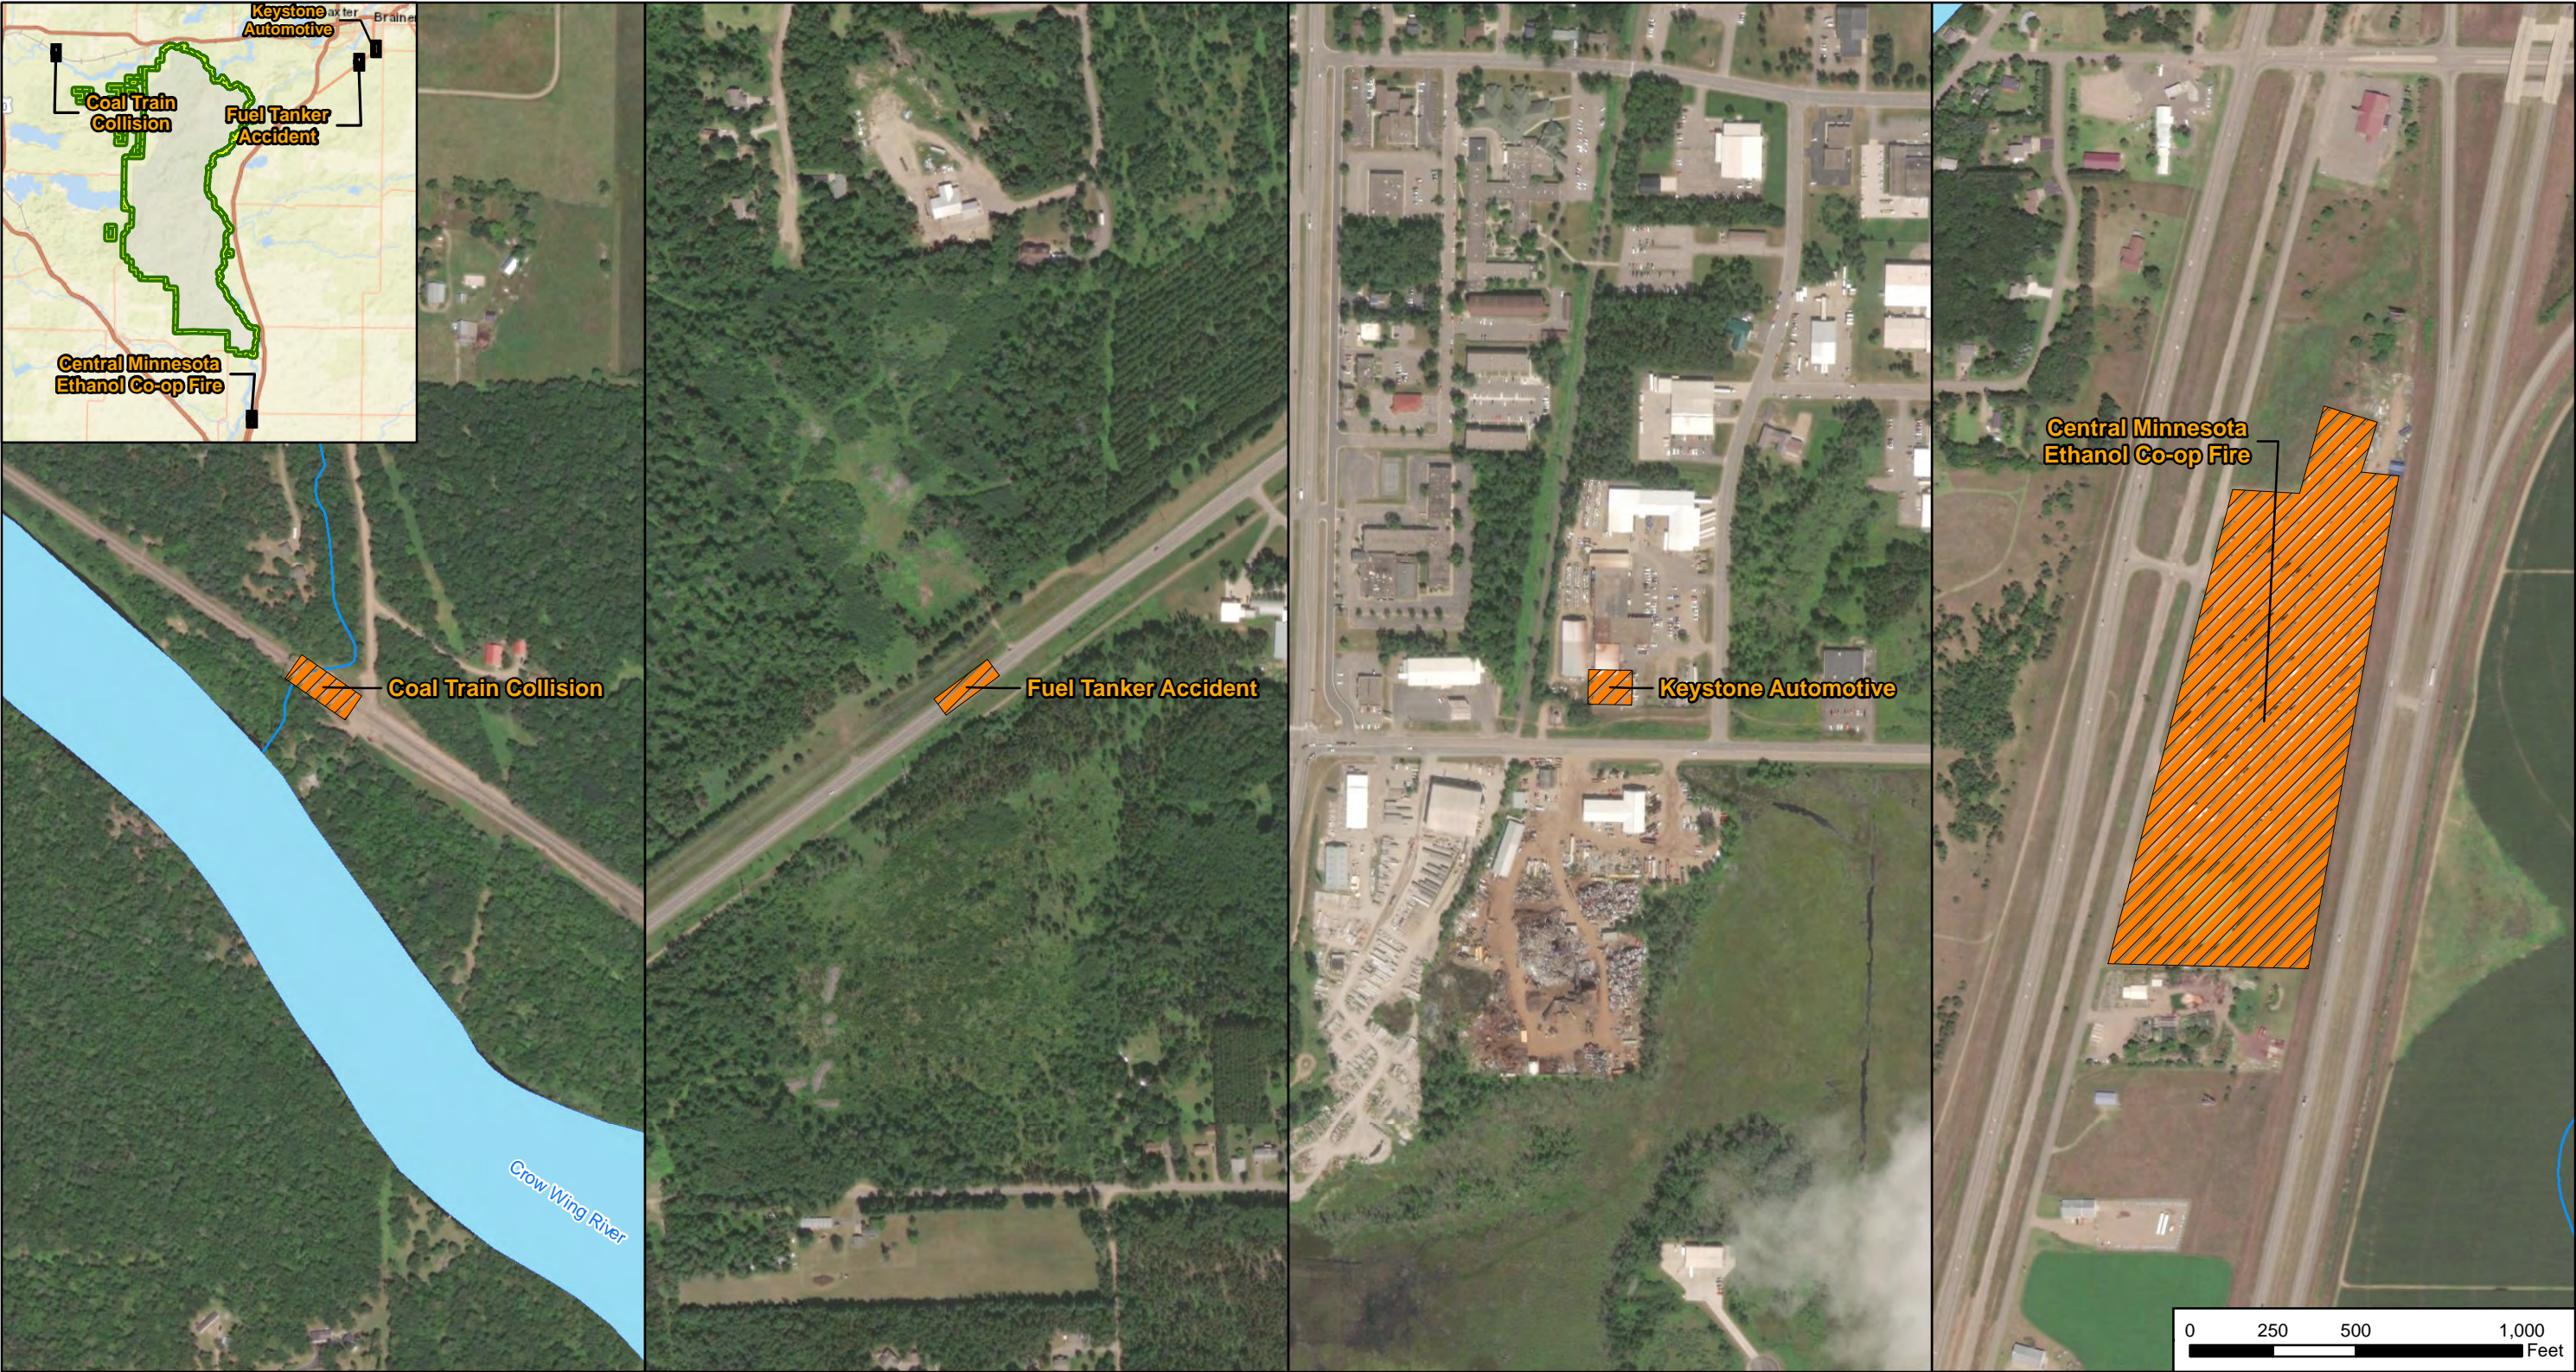
construction workers via ingestion and inhalation; and groundwater to site workers, construction workers, trespassers, off-facility recreational users, and off-facility residents via ingestion. Potential off-facility PFAS release areas exist upgradient of Camp Ripley (**Figure ES-2**). It is unknown whether the potential off-facility release areas affect Camp Ripley. The CSM for Camp Ripley is shown on **Figure ES-3**.

Four potential off-facility sources of PFAS near Camp Ripley, not under the control of the MNARNG, were identified during the PA. One potential off-facility source is a chrome plating facility. The other three potential off-facility sources were identified through the terms of the Cuyuna Agreement with the Range Fire Chiefs Association, which allows surrounding communities to use AFFF from Camp Ripley for response to emergency events outside of the facility. If AFFF from Camp Ripley is used for an emergency event outside the facility, the AFFF is replaced by the responding agency that used the AFFF. A description of each potential off-facility source is presented below, and the locations of are shown on **Figure 5-1**.

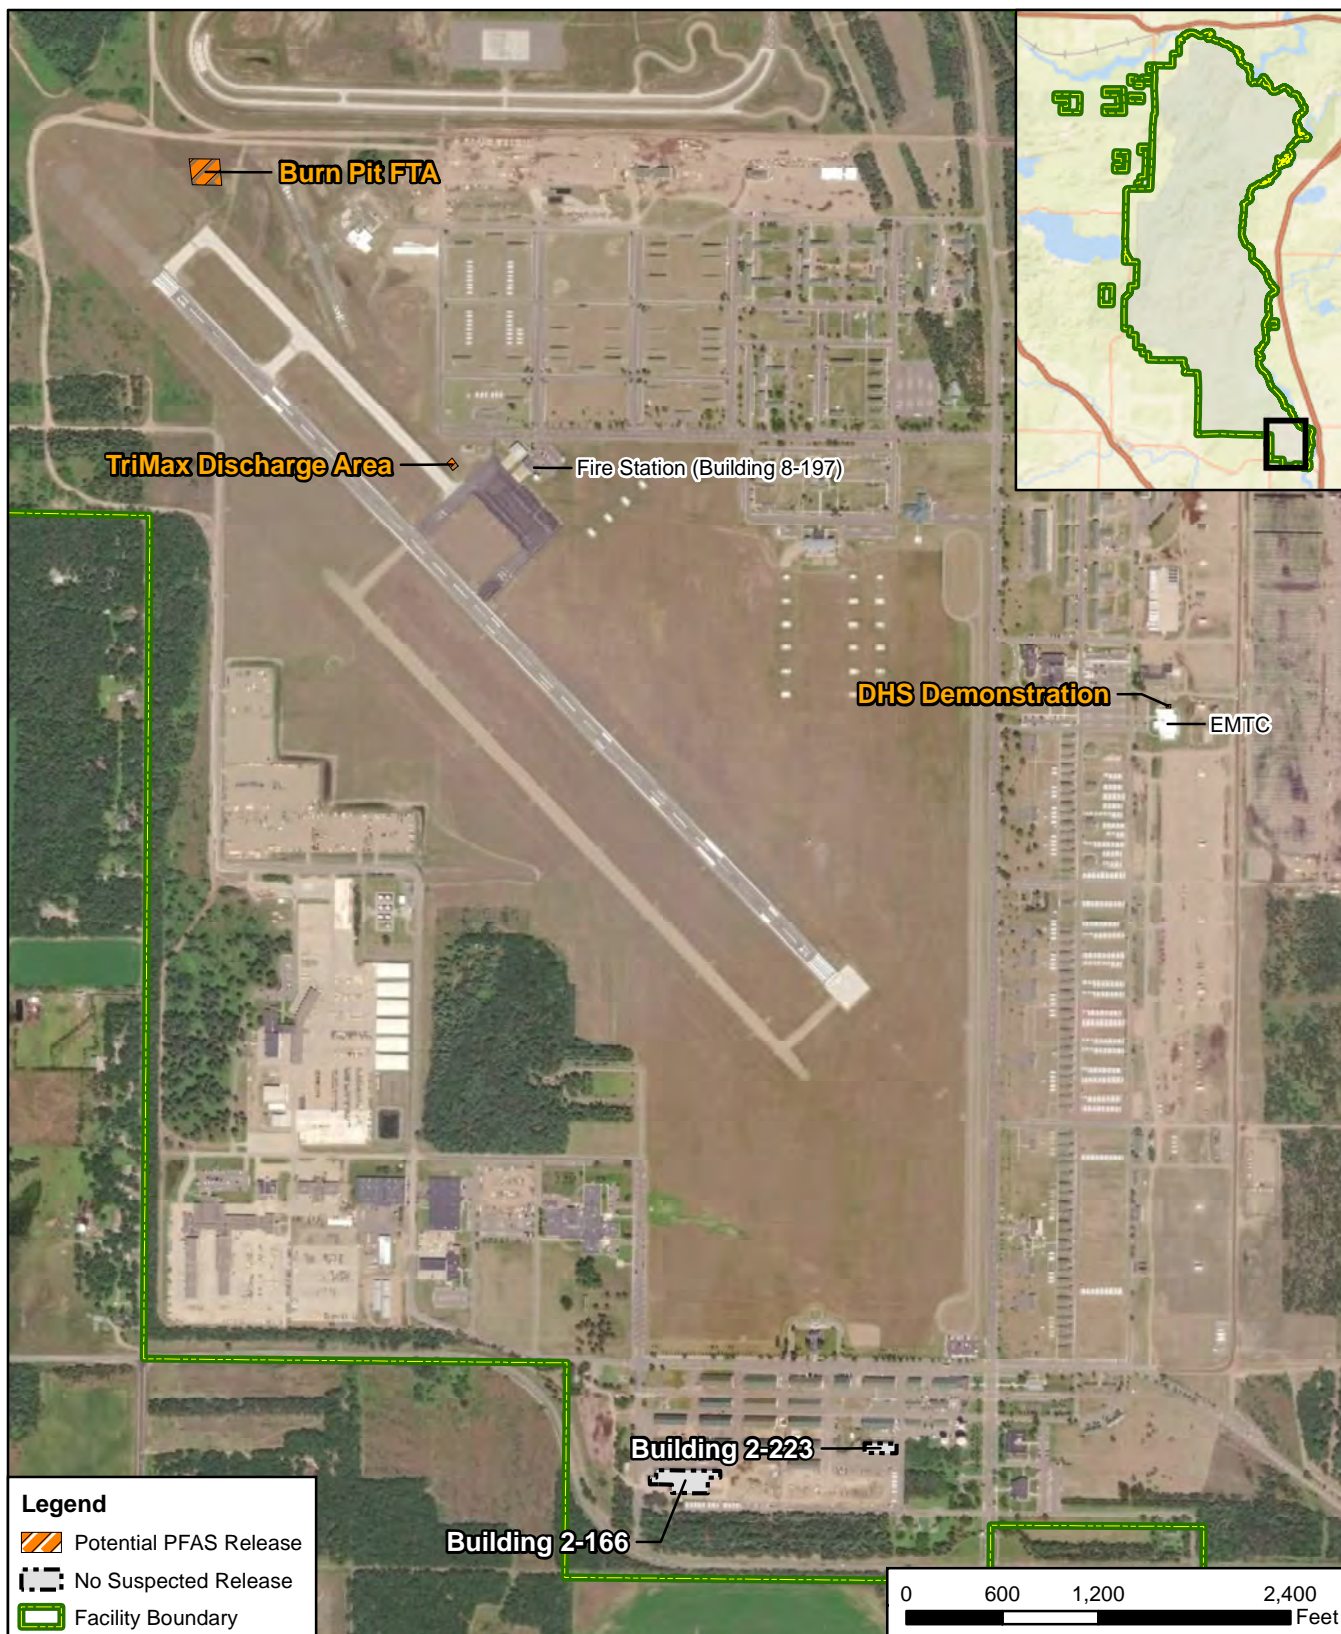
During an interview with the former Randall Fire Department Fire Chief, a Burn Pit FTA was identified at the north end of the Camp Ripley runway. The geographic coordinates are 46°05'56.4"N and 94°22'03.7"W (**Figure 2-1**). The former Randall Fire Department Fire Chief recalled one coordinated fire training event at the Burn Pit FTA in the late 1980s with the MNARNG and the US Air Force's (USAF) 133<sup>rd</sup> Airlift Wing from Minneapolis. Fuel was ignited during the training exercise and the fire was extinguished with AFFF by the MNARNG and the USAF. No information was available with regard to the concentration, type, or amount of AFFF used during the fire training event. Other retired MNARNG personnel indicated the Burn Pit FTA may have been used for fire training exercises on multiple occasions.

AOI 2 is the Burn Pit FTA. One coordinated fire training event occurred at the Burn Pit FTA in the late 1980s with the MNARNG and the USAF's 133rd Airlift Wing from Minneapolis; however, the burn pit may have been used for coordinated fire training exercises on multiple occasions.

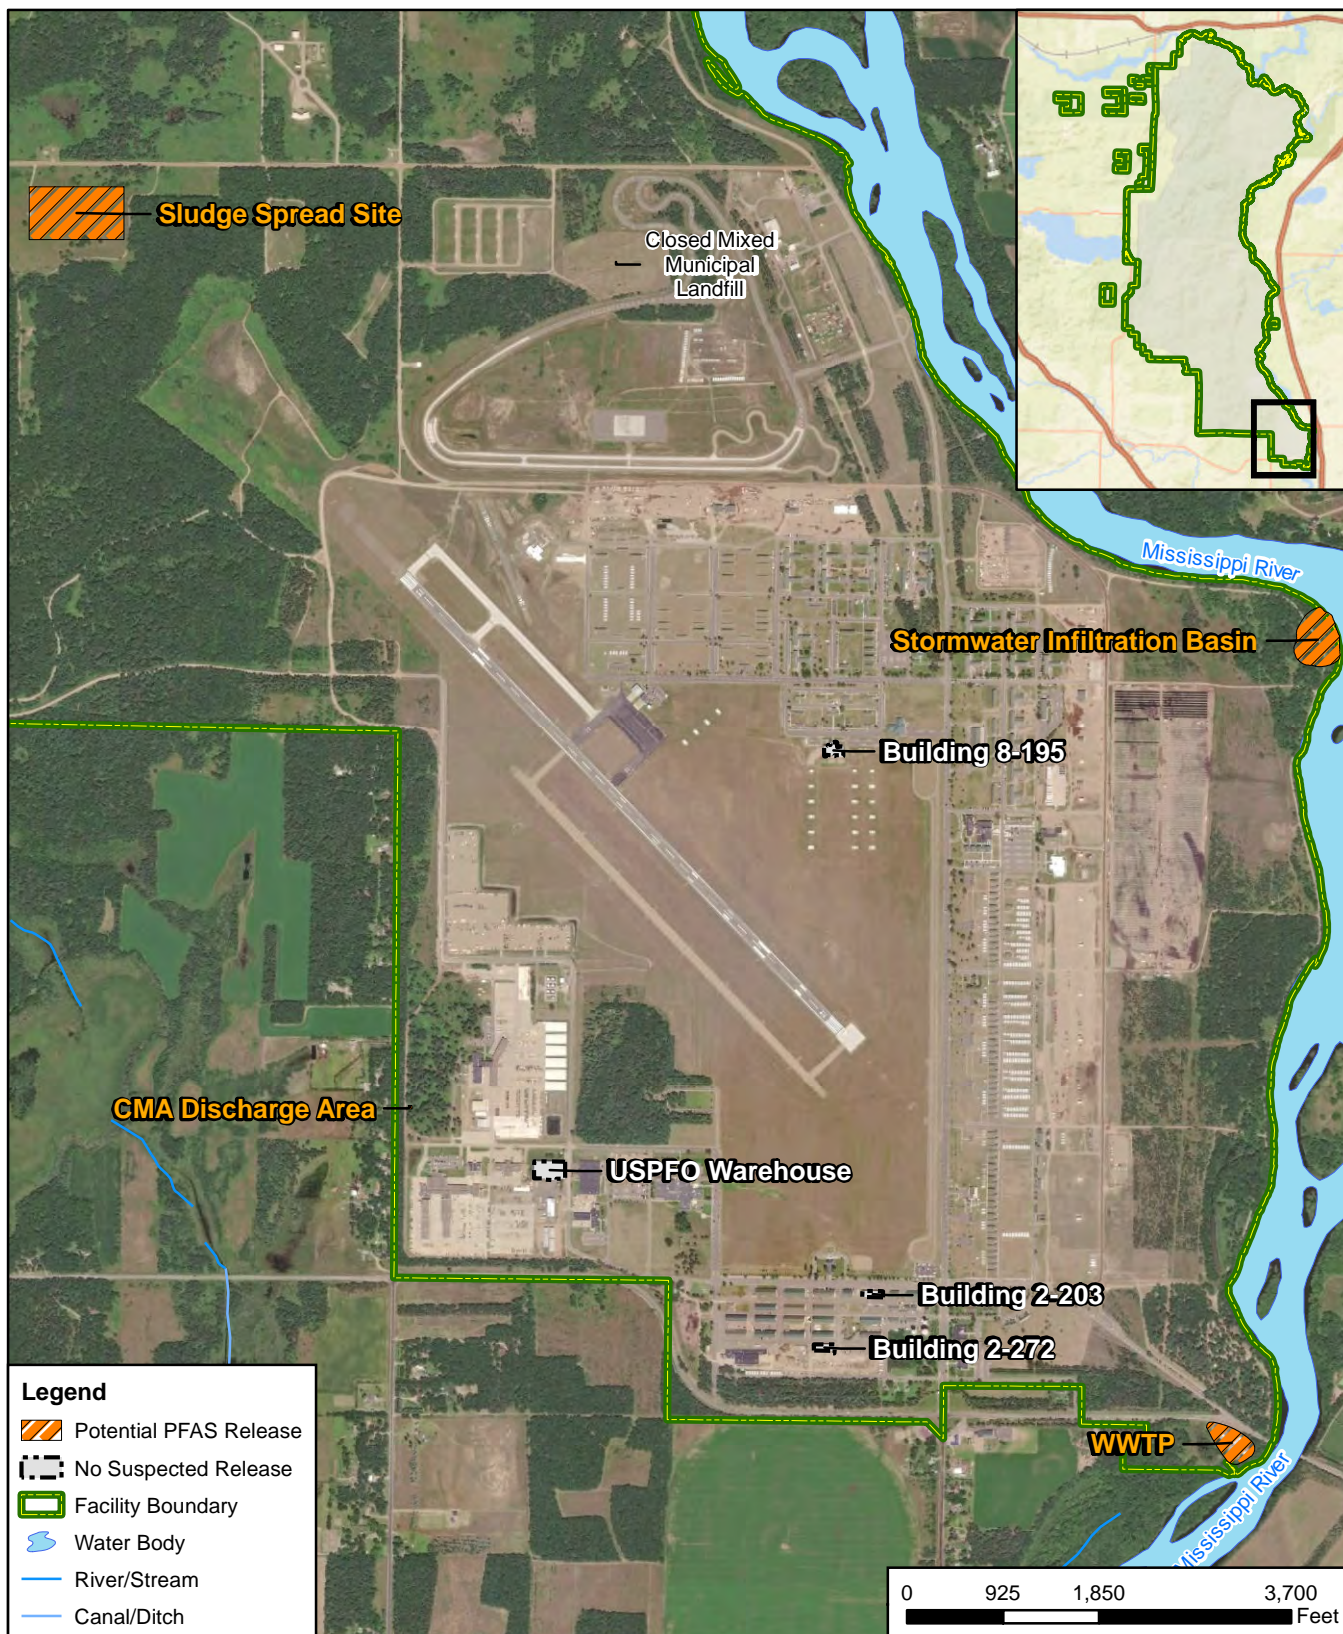
Based on interviews, the disposition of the remaining foam mixture used during the fire training event at the EMTC (**Section 2.3**) was most likely dispensed to the stormwater sewer system. The volume of mixture dispensed would have been less than the original 100 gallons which was made for the training event. The stormwater sewer system, in the cantonment area drains to the stormwater infiltration basin located north of Chickamauga Road, approximately 100 yards from the Mississippi River (**Figure 3-1**). The geographic coordinates are 46°05'42.87"N and 94°20'05.44"W.

AOI 6 is the Stormwater Infiltration Basin. One gallon or less of Chemguard C363 3 percent x 6 percent AR-AFFF concentrate was mixed with 100 gallons of water and used to perform practical training exercises at the EMTC (**Section 6.3**). Camp Ripley Fire and Emergency Services personnel indicated that all of the foam mixture was not used during the event, but the final disposition of the remaining foam mixture was most likely disposed of in the stormwater sewer system within the cantonment which drains to a stormwater infiltration basin.

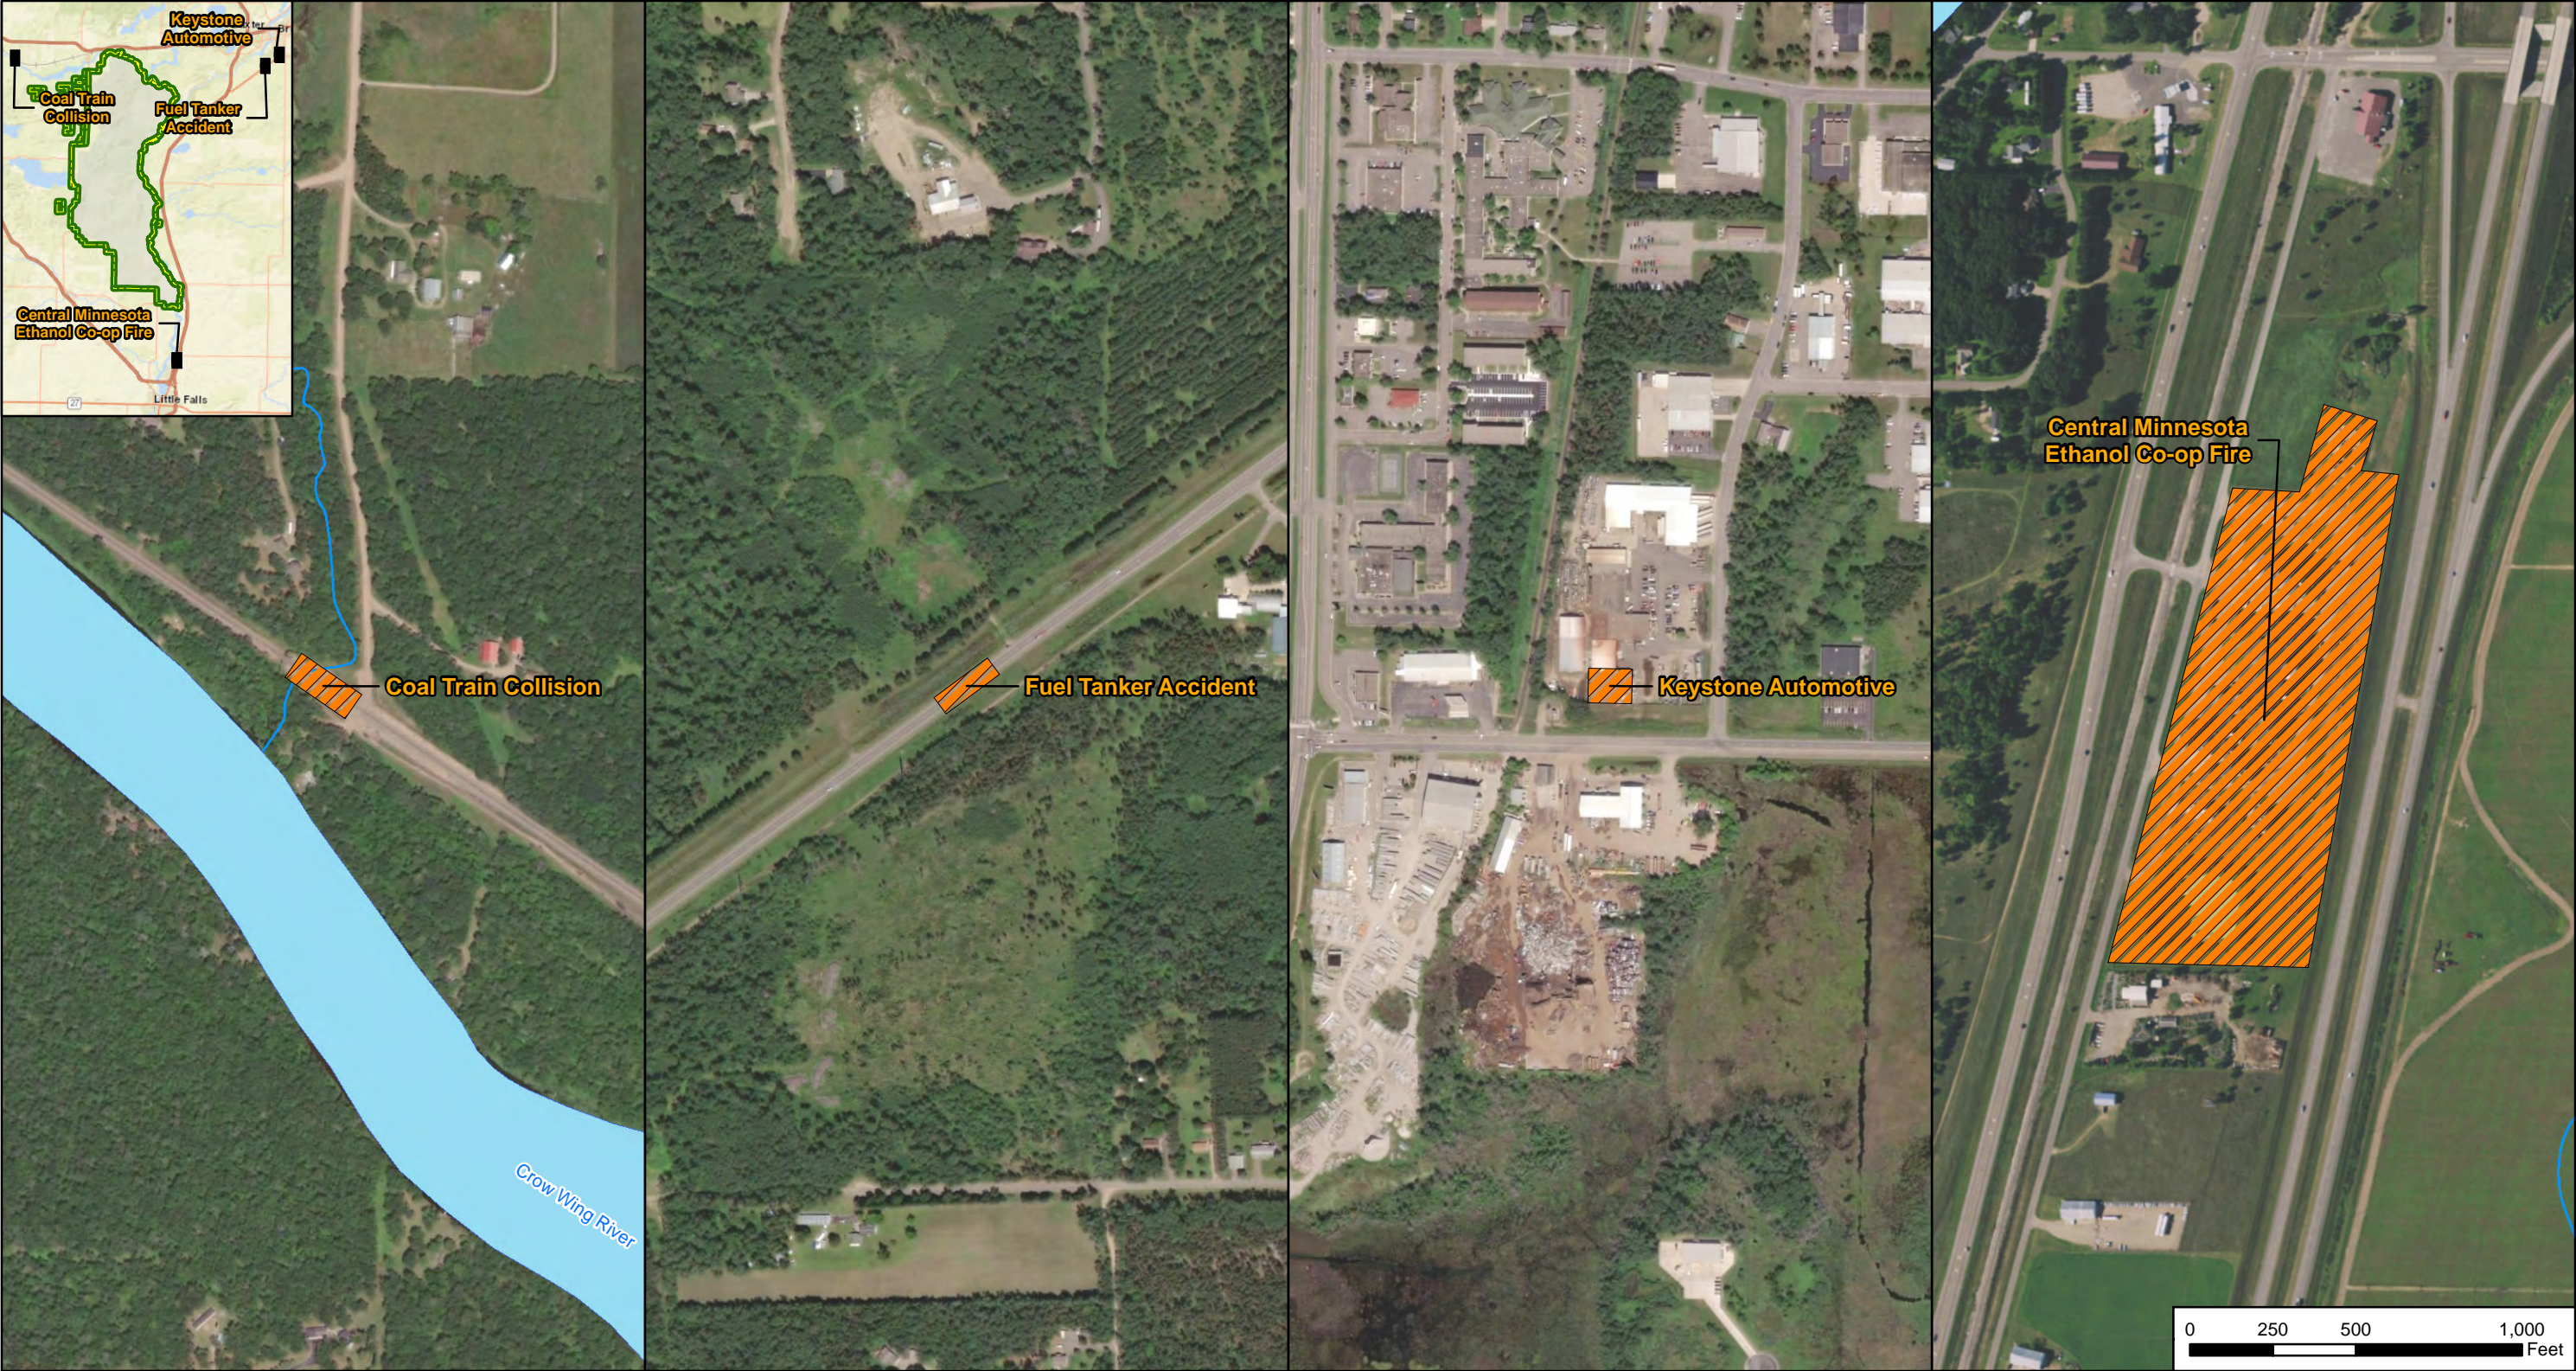
On 29 October 2007 smoldering wood chips in a gasification silo at the Central Minnesota Ethanol Cooperative caused the roof of the silo to explode and collapse. Approximately 300 gallons of AR-AFFF concentrate were taken from Camp Ripley by the Little Falls Fire Department to respond to the emergency event. The Central Minnesota Ethanol Co-op is about five miles south of Camp Ripley. The geographic coordinates are 46°01'16.0"N and 94°20'20.8"W (**Figure 5-1**).

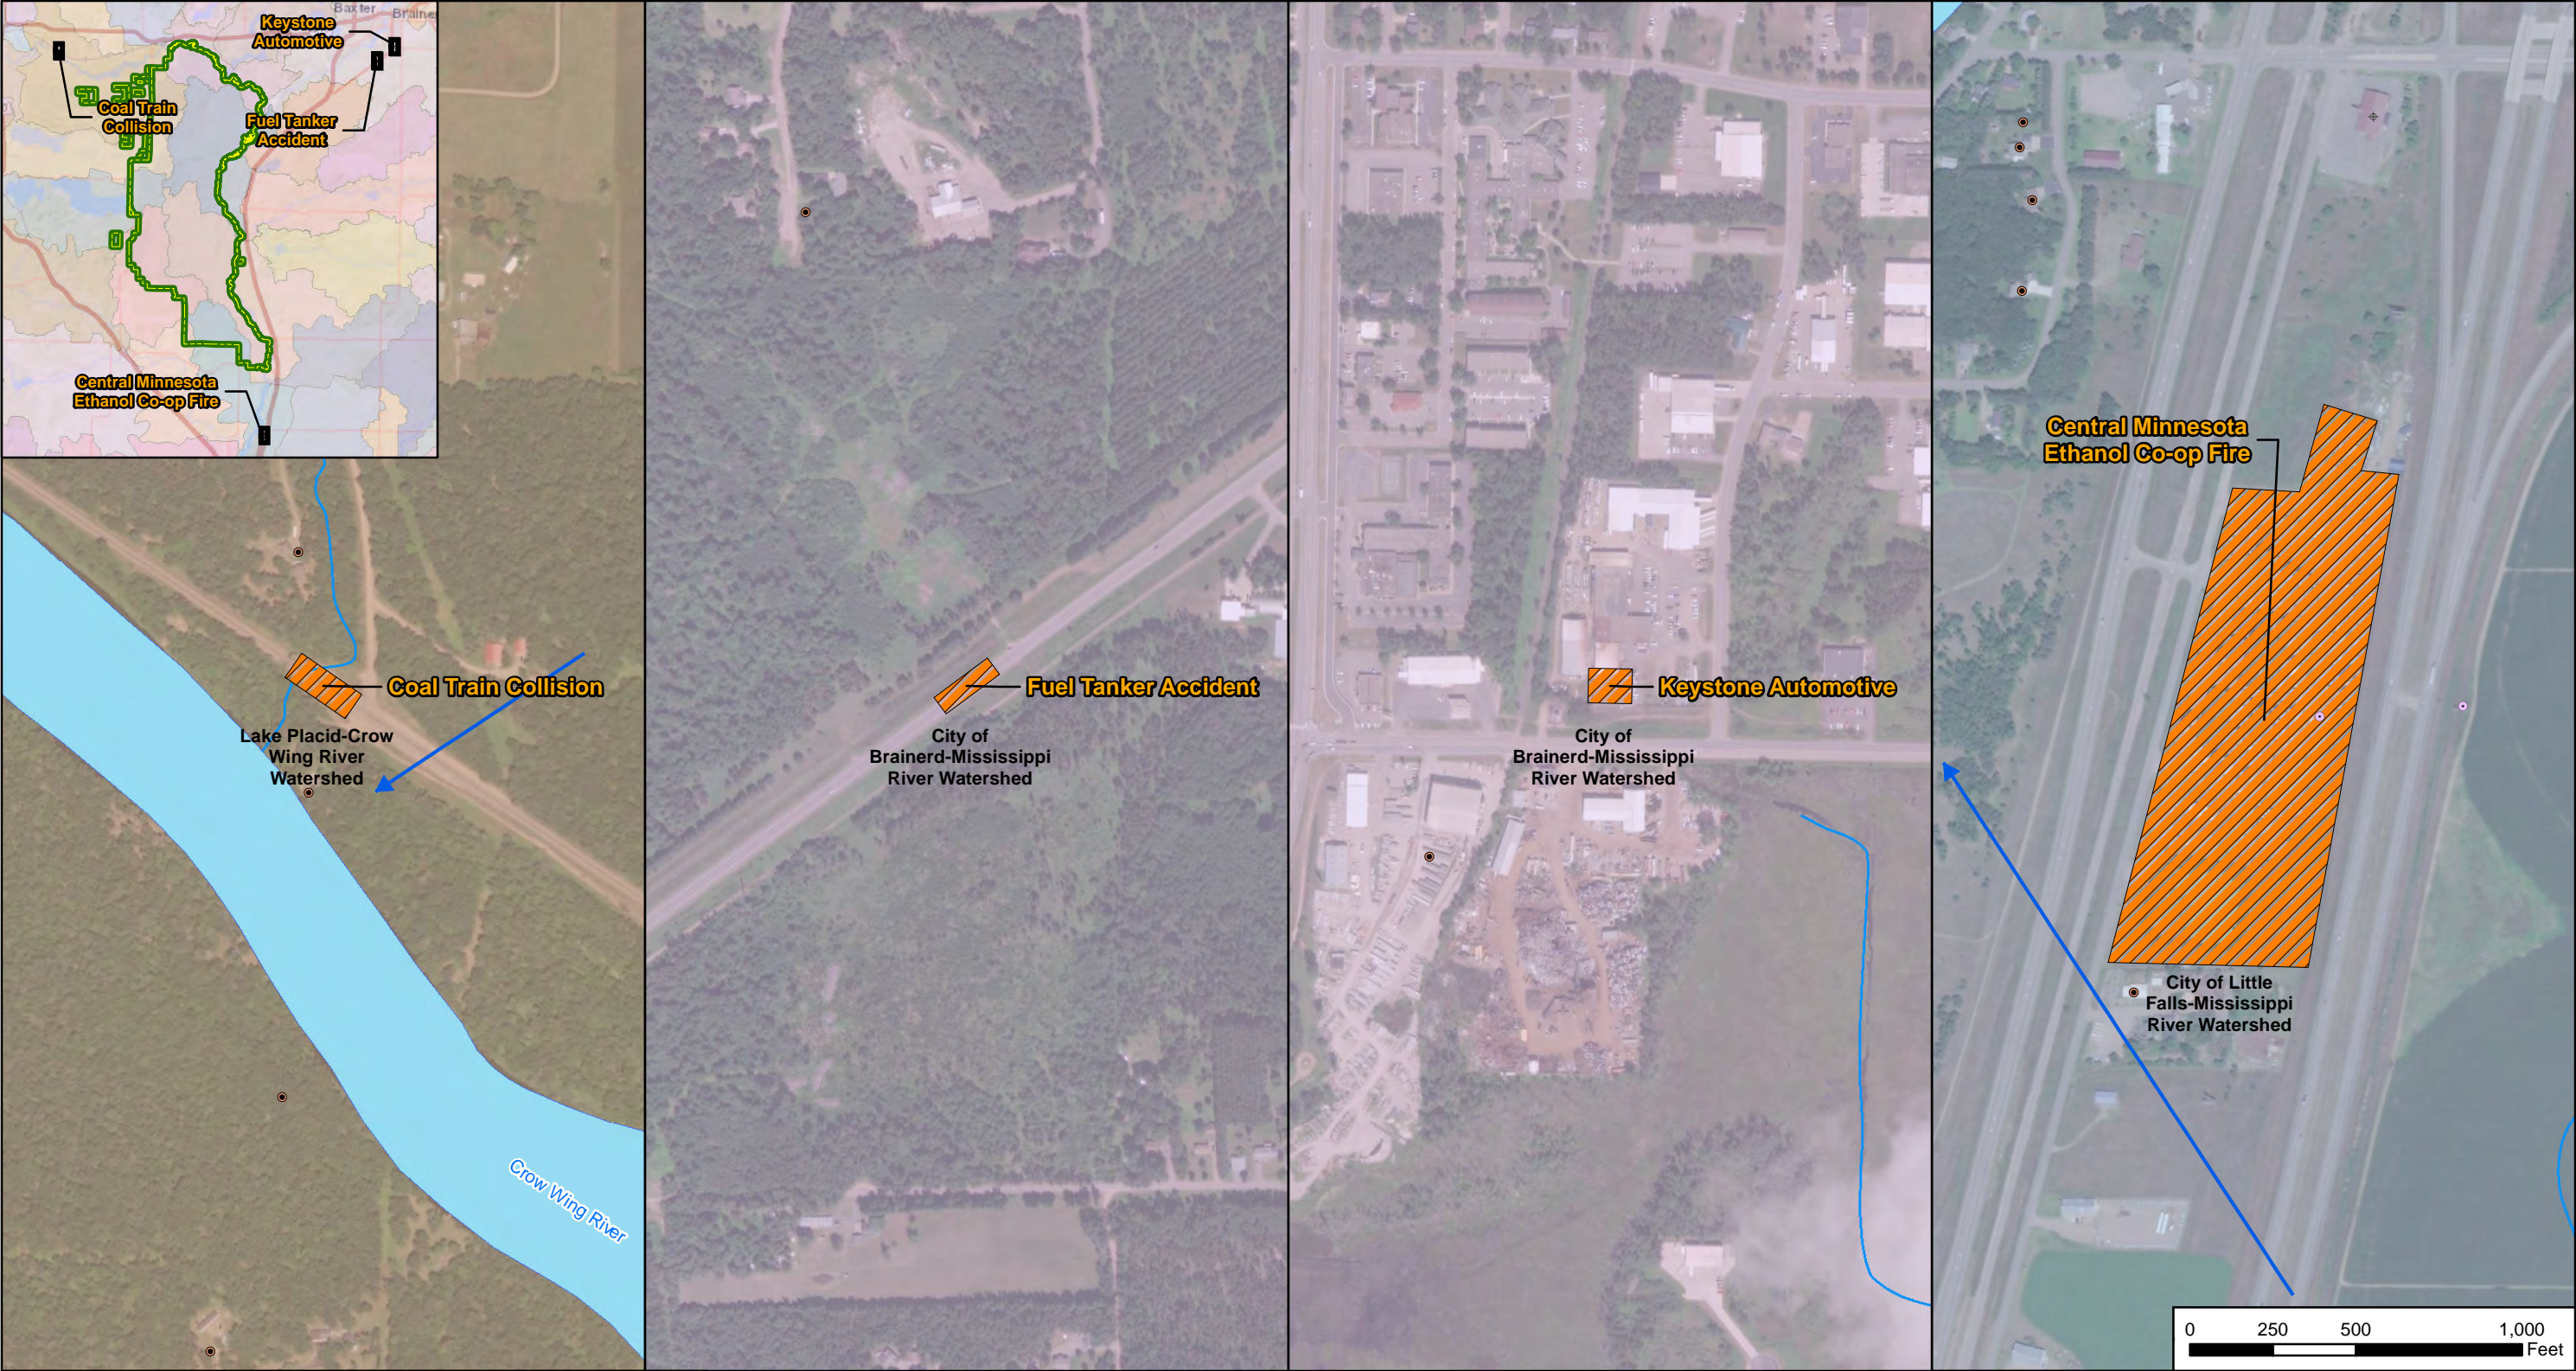
Based on the PA findings, six AOIs were identified at Camp Ripley: AOI 1 TriMax Discharge Area, AOI 2 Burn Pit FTA, AOI 3 DHS Demonstration, AOI 4 CMA Discharge Area, AOI 5 WWTP and Sludge Spread Site, and AOI 6 Stormwater Infiltration Basin. The AOI locations are shown on **Figure 6-1**. Potential off-facility PFAS release areas exist upgradient of Camp Ripley, it is unknown whether the potential release areas affect the facility (**Figure 6-2**). The following sections describe the CSM components and the specific CSM developed for each AOI. The CSM identifies the three components necessary for a potentially complete exposure pathway: (1) source, (2) pathway, (3) receptor. If any of these elements are missing, the pathway is considered incomplete.

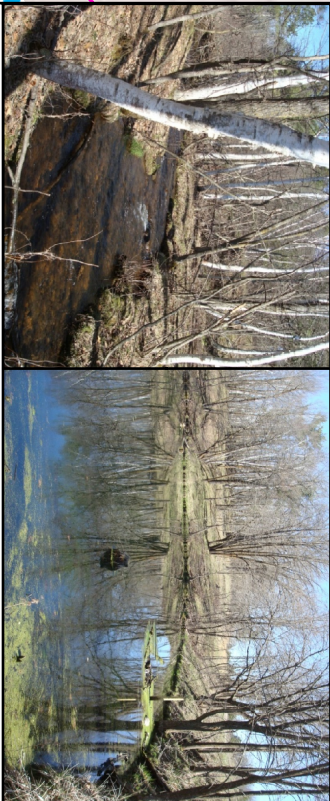
Potential source-area MCOC may migrate from operational areas via surface-water infiltration into shallow groundwater and subsequently discharge to off-range streams and wetlands.

These images, captured during the May 2011 site visit, are examples of the dominant flow paths found on the installation.

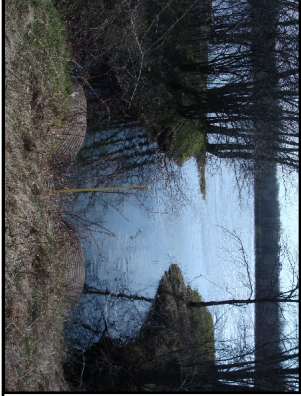
This image (taken during the May 2011 site visit) shows a small tributary flowing off installation into the Mississippi River, which is the only off-operational range receptor location.

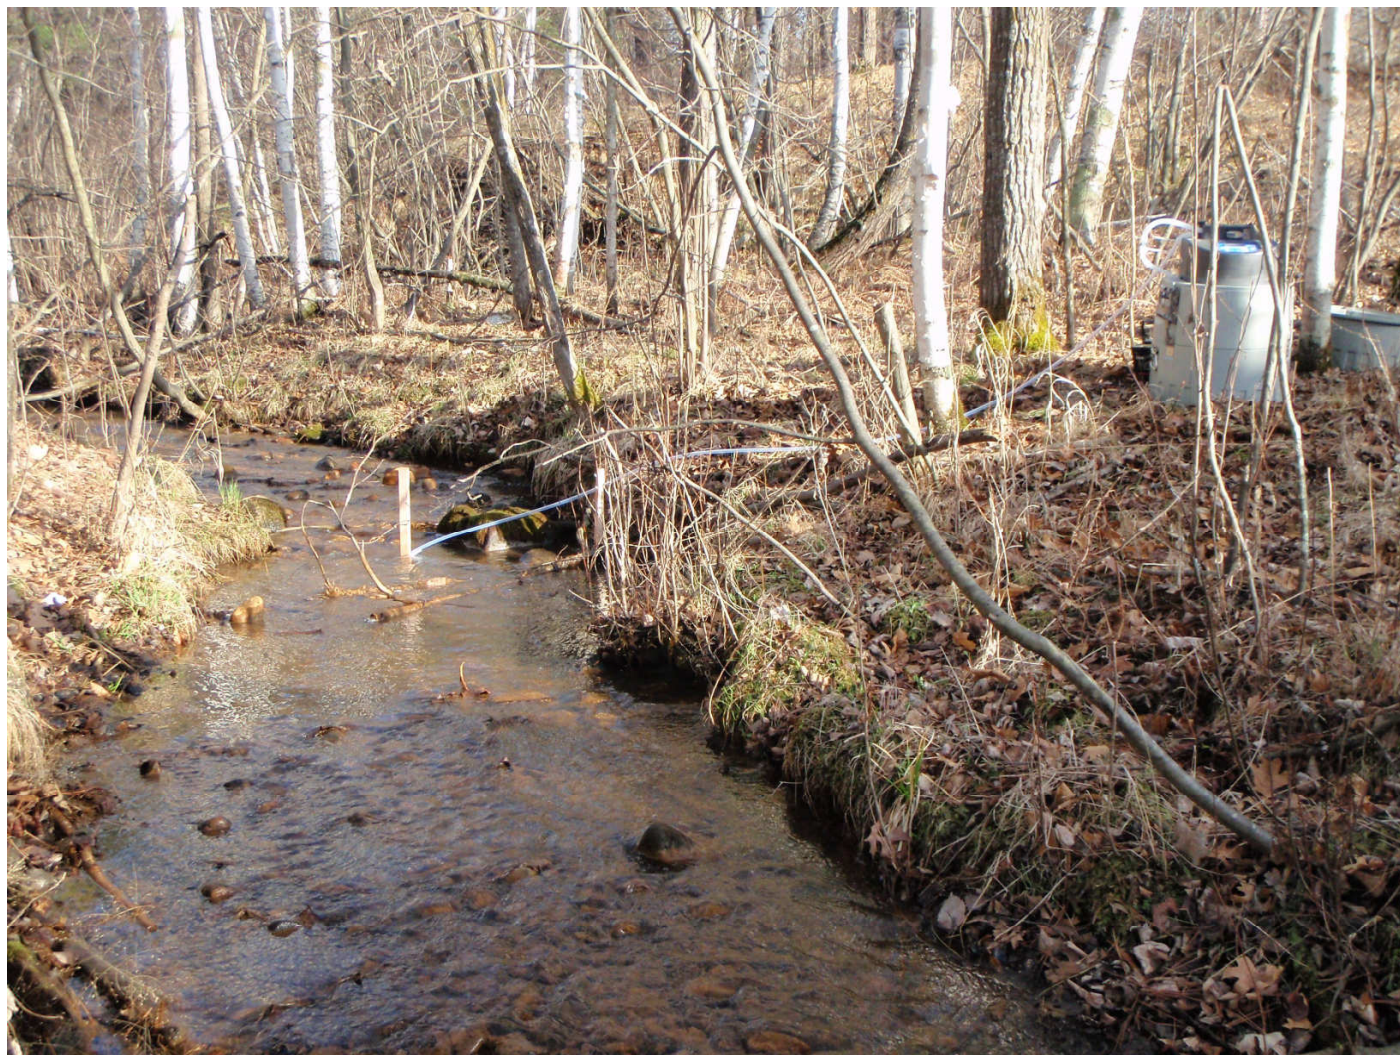
**Location:** Camp Ripley, Sample Location RP01

View of sampling location RP01 taken on 3 April 2012. Photograph is taken facing west (upstream).

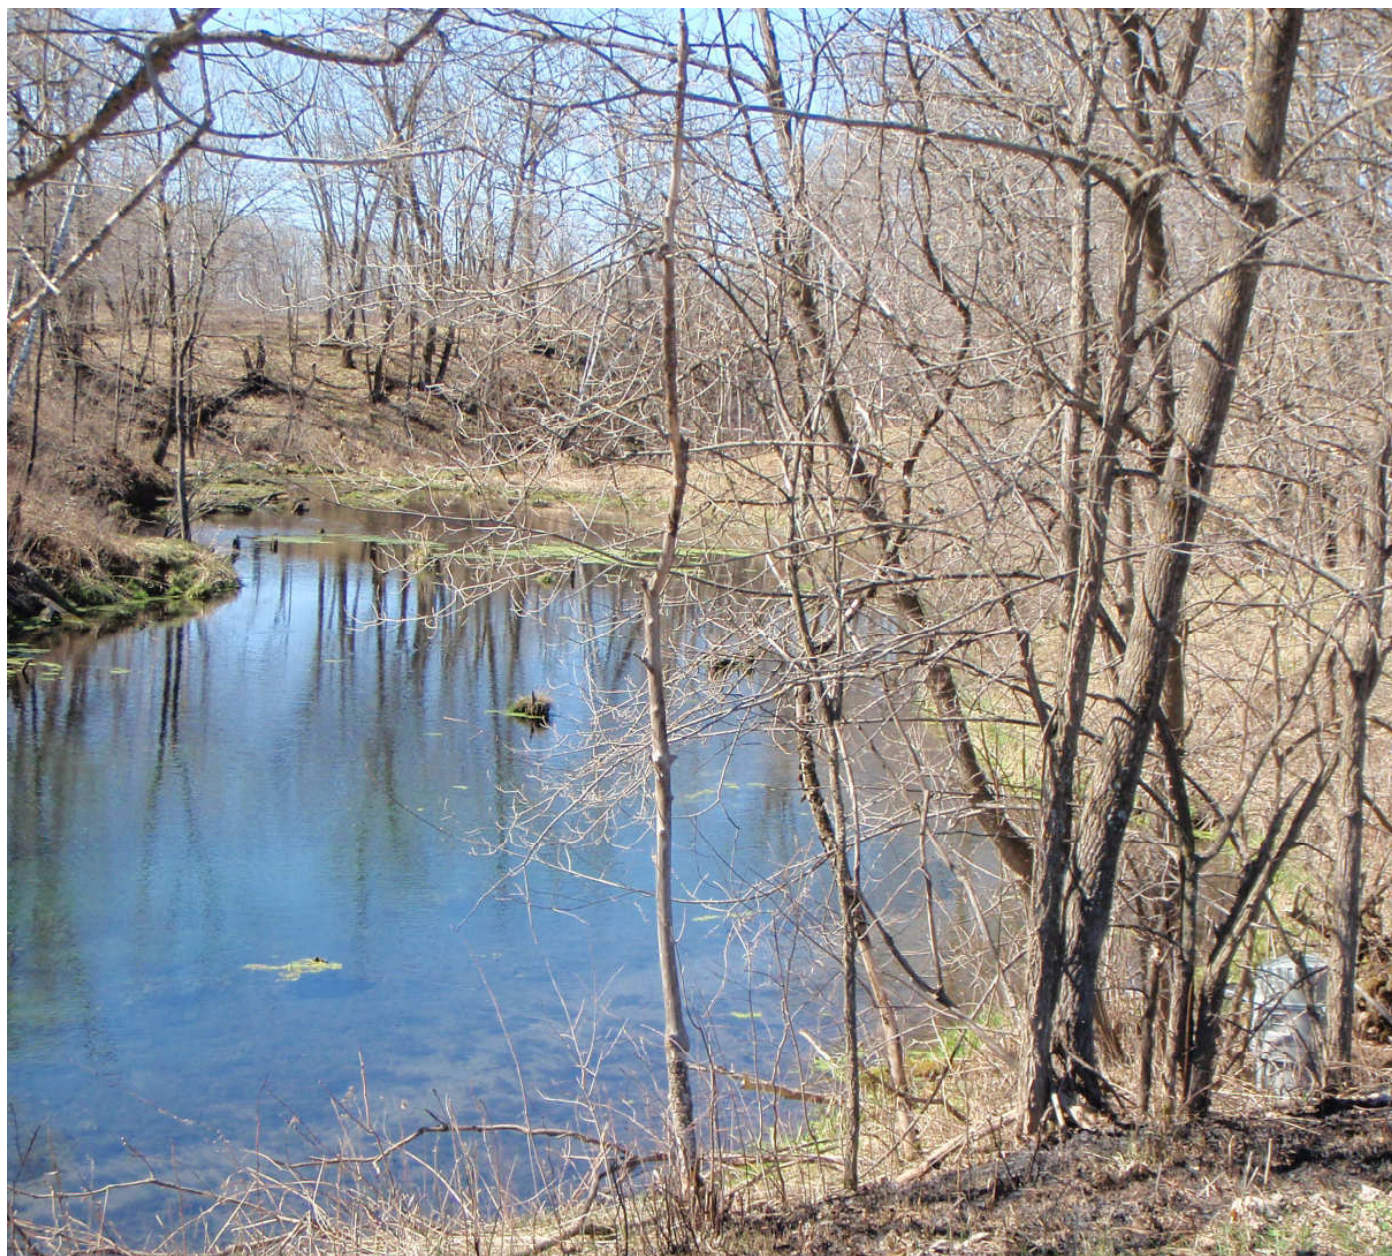
**Location:** Camp Ripley, Sample Location RP02

View of sampling location RP02 taken on 3 April 2012. Photograph is taken facing west (upstream).

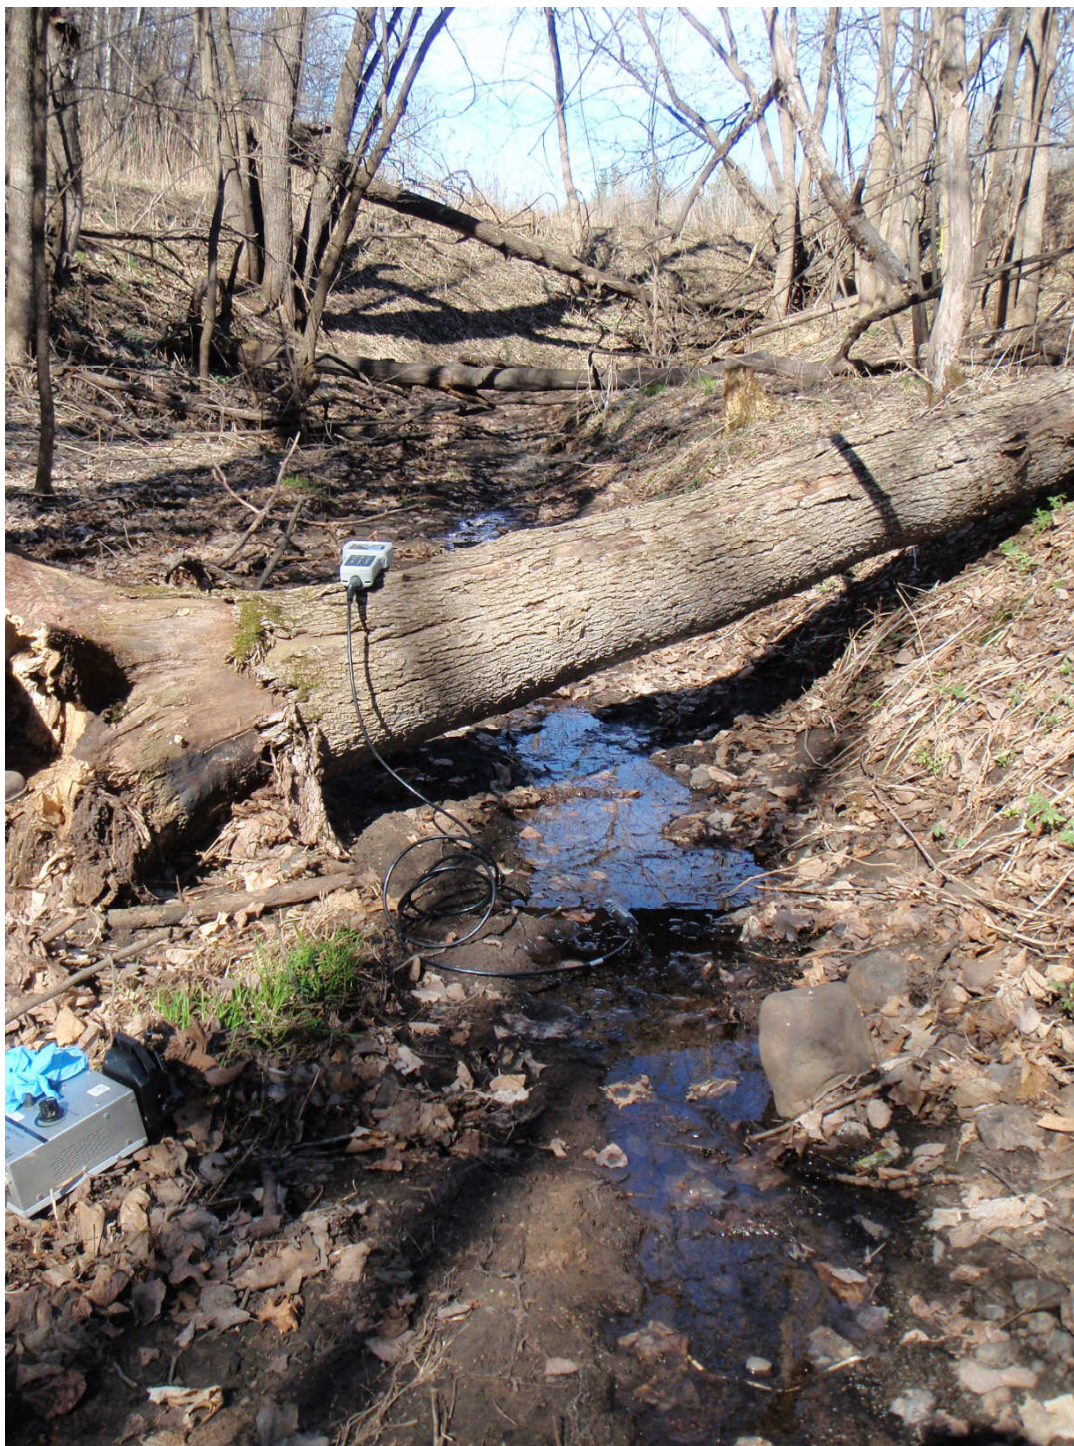
**Location:** Camp Ripley, Sample Location RP03

View of sampling location RP03 taken on 4 April 2012. Photograph is taken facing east (downstream).
